Painting 23 Acres of Steel Water Tanks

Jerry Duppong, Corrosion Specialist, CH2M HILL
Brigitte McCarty, Project Manager, AWWD
Matt Leach, Construction Manager, CH2M HILL

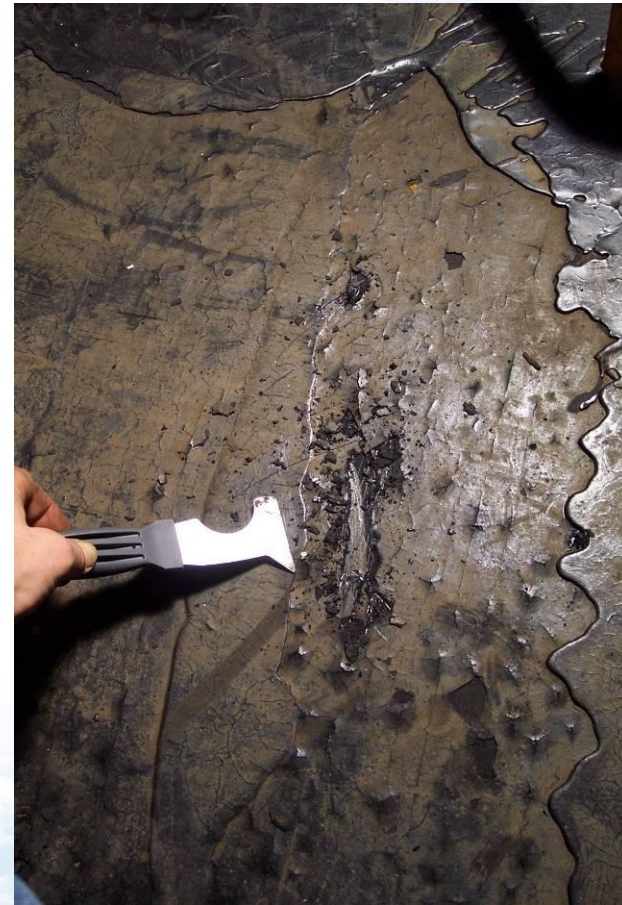
Canyon Park Interior

- Coal tar enamel (wall and floor)
 - Up to 1/2-inch thick
 - Fair to poor adhesion
 - Water behind coating
 - Low lead levels
- Coal tar solution (roof)
 - Nominal 16 mils thick
 - Very poor condition

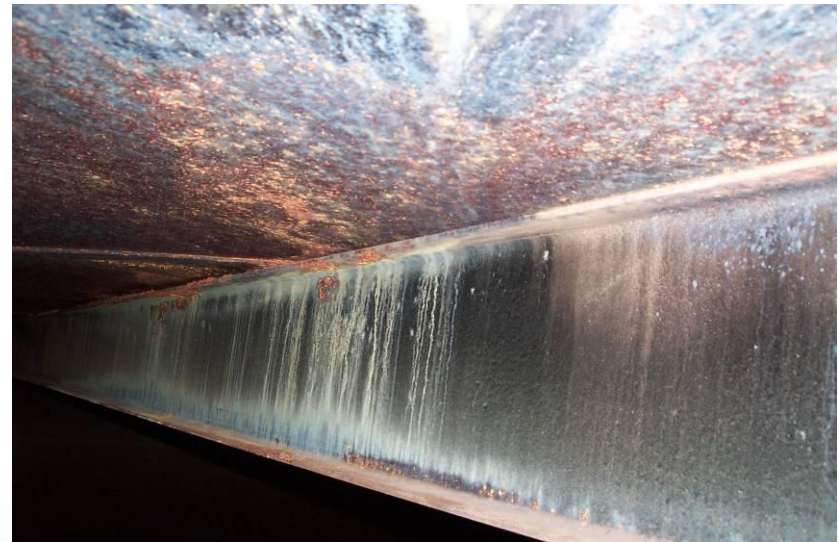
Reservoir 2 Interior

- Coal tar enamel (wall and floor)
 - 50 to 300 mils thick
 - Puddles
 - Fair to good adhesion
- Coal tar solution (ceiling)
 - Very poor condition
 - Rust on ceiling
- Low levels of lead

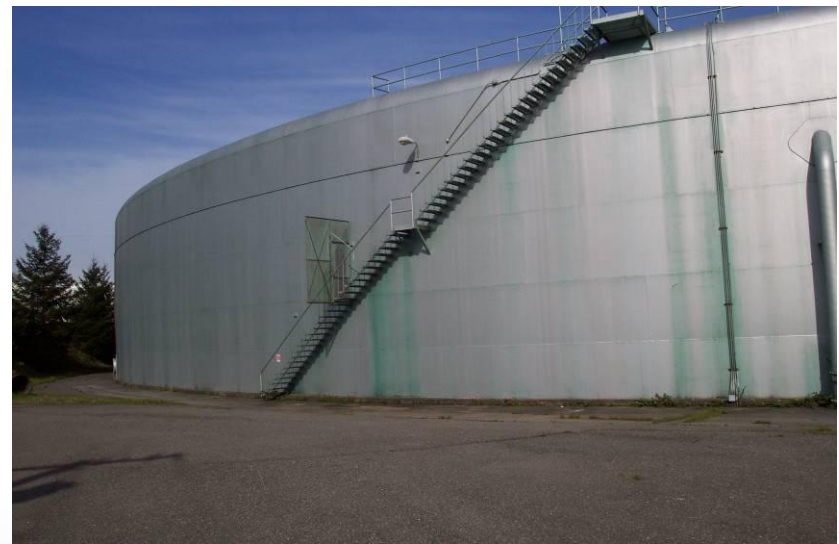
Reservoir 2 Exterior

- Lead based primer, aluminum alkyd finish
- Topcoated in 1992
- Good adhesion
- Nominal thickness of 6 mils
- Lead content 20%

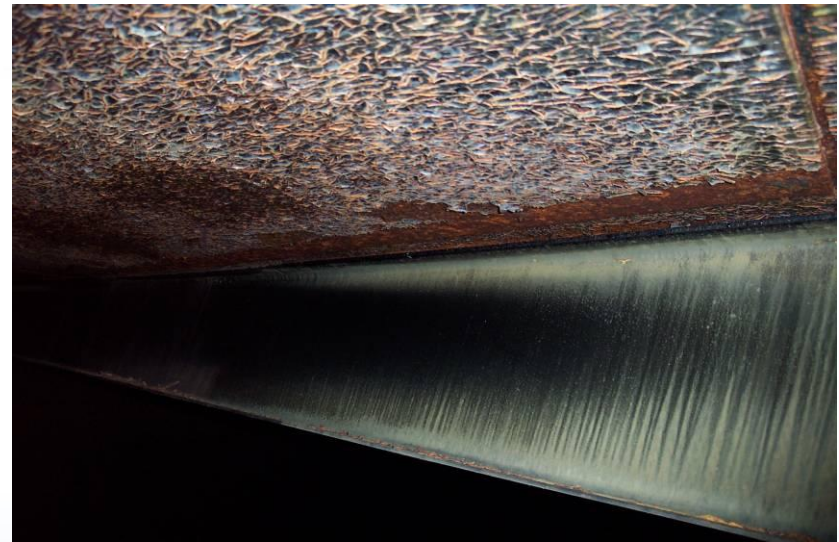
Reservoir 3 Interior

- Hot coal tar (walls, floor)
- Coal tar solution (ceiling)
- Low lead levels
- Similar conditions to Reservoir 2

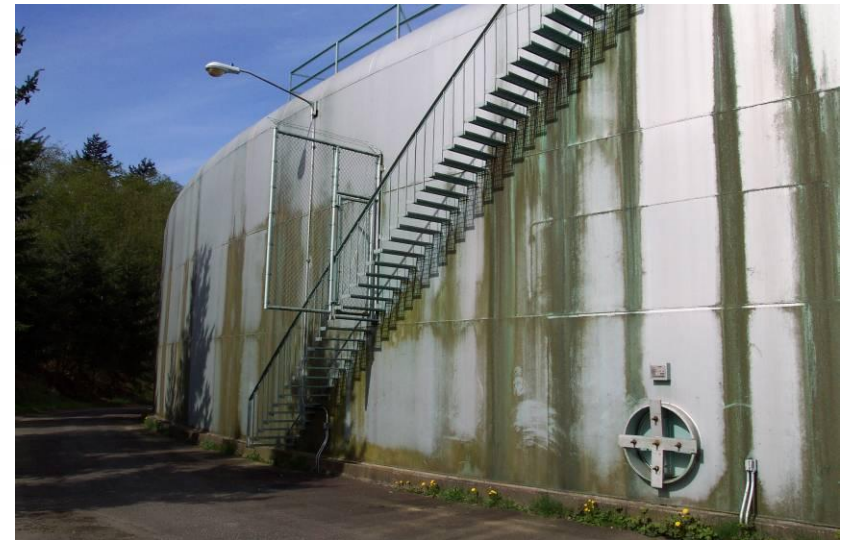
Reservoir 3 Exterior

- Zinc primer, aluminum alkyd finish
- Topcoated in 1992
- Fair adhesion of primer to steel
- Poor adhesion of finish to primer
- Nominal 6 mils thick
- Moderate lead (0.1%)

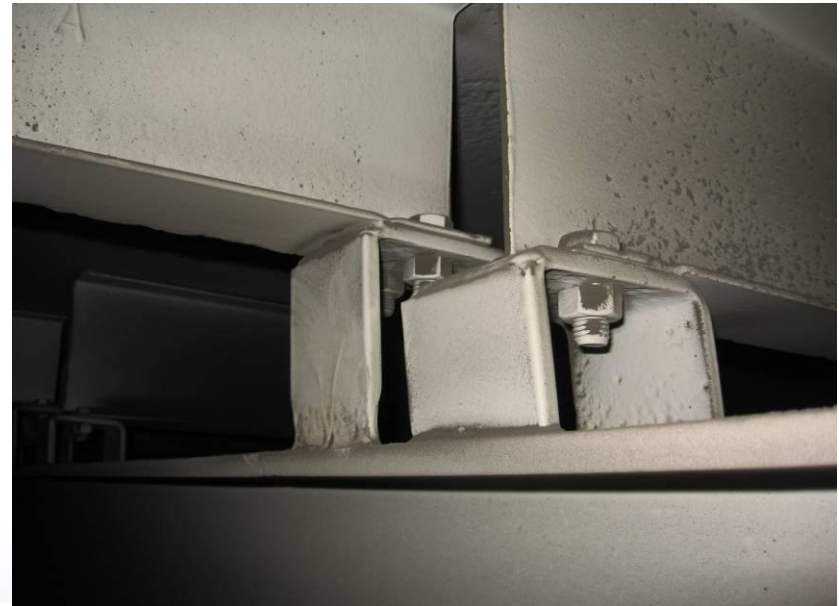
Reservoir 2 Interior

- October 2007, begins roof blast
- Blasting time exceeds planned schedule
 - Unexpected level of corrosion on roof
 - More surface area
 - Rafter to girder connections
 - Structural inspections and repairs

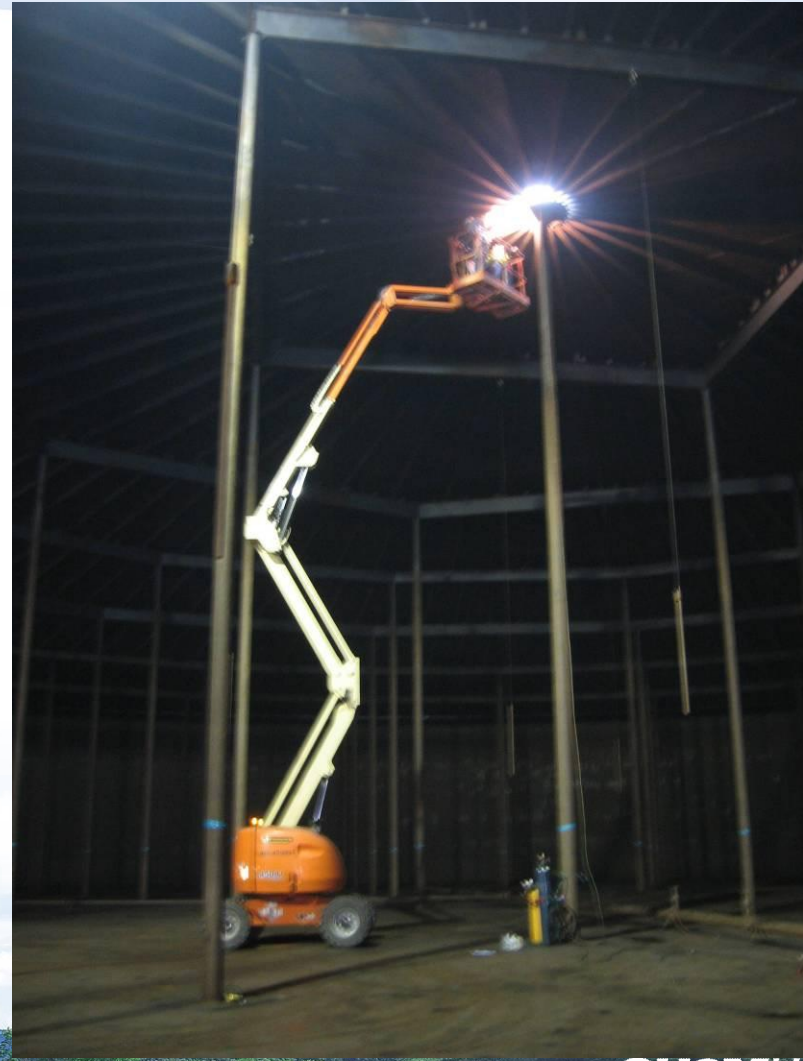
Reservoir 2 Structural

- Inspection after blasting
 - Rafter corrosion
 - Missing bolts
 - Rotated rafters
- Inspected all 1,700 rafters and girders by lift
- Repairs identified for 97 rafters
 - 1 foot to 15 feet long
 - Weld plates
 - Replace rotated rafters

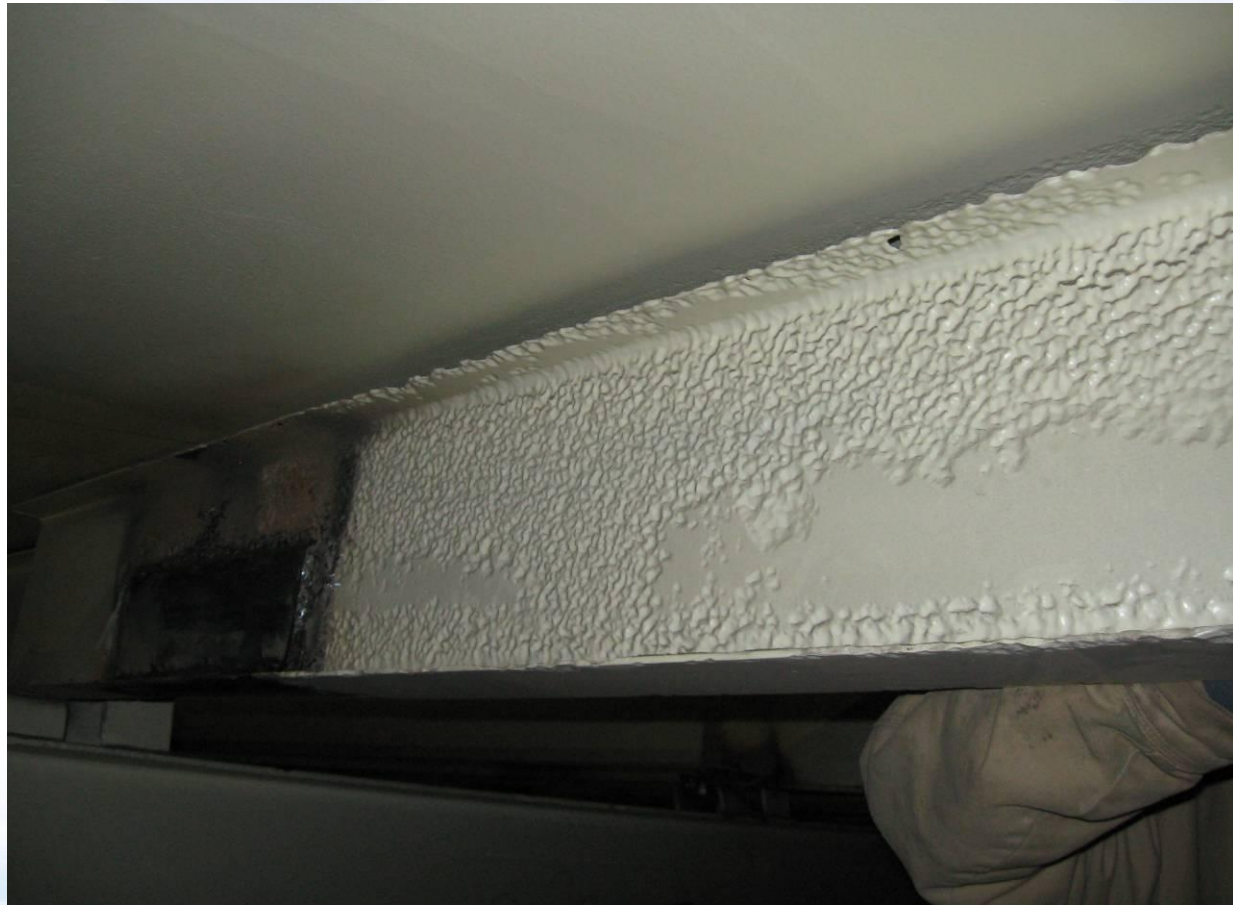
Reservoir 2 (Rafter Corrosion)

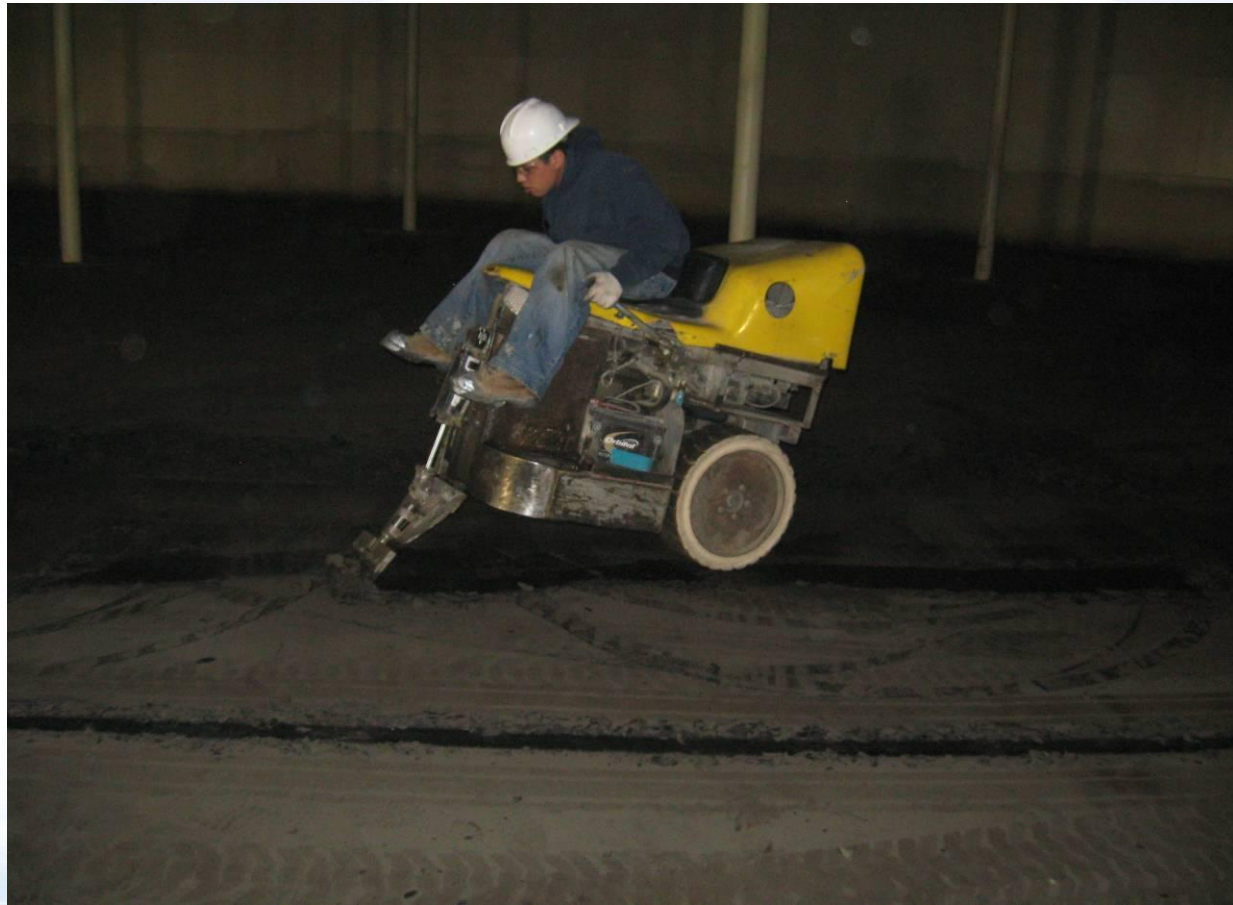
Reservoir 2

(Coal Tar Removal from Floor)

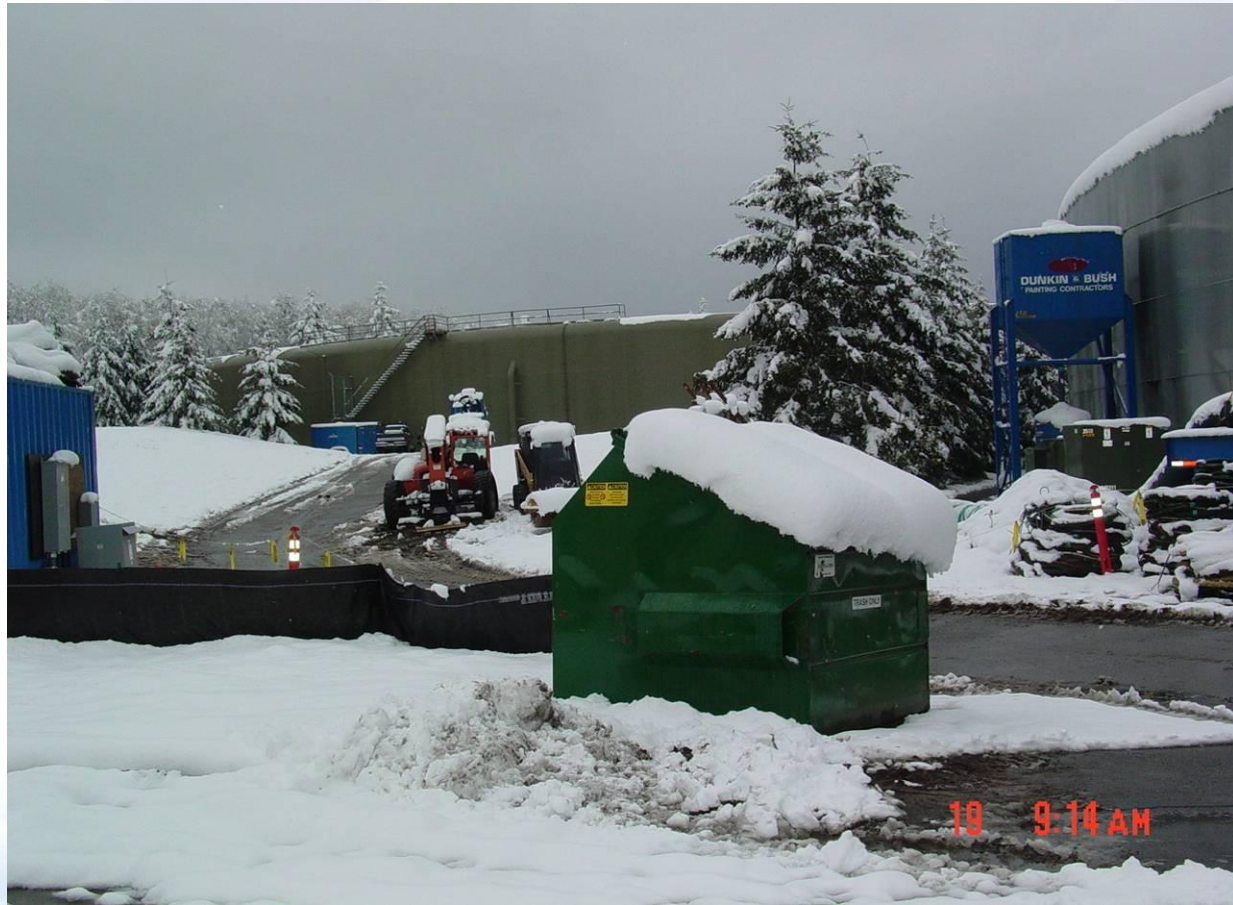
Reservoir 2

(Latest Challenge – April 19, 2008)
