Three Earthquakes: Haiti, Chile, and Calexico

Don Ballantyne
MMI Engineering
Federal Way, Washington

Pacific Northwest Section of the AWWA
May 14, 2010

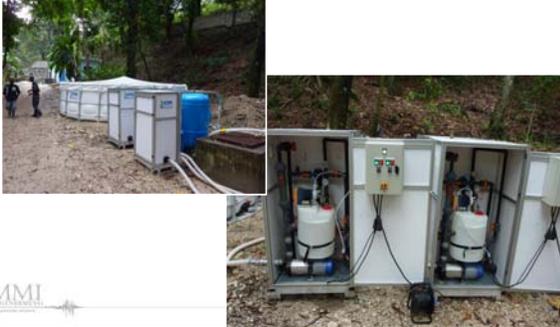
Emergency Treatment Plant at Turgeau

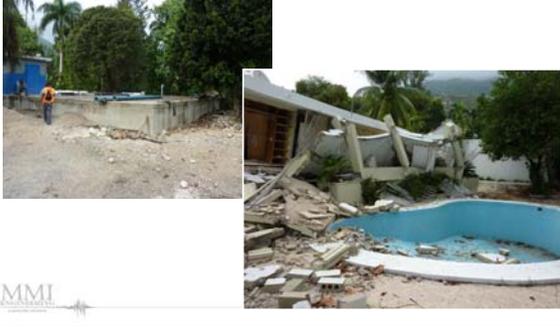
Undamaged Reservoir/House Behind

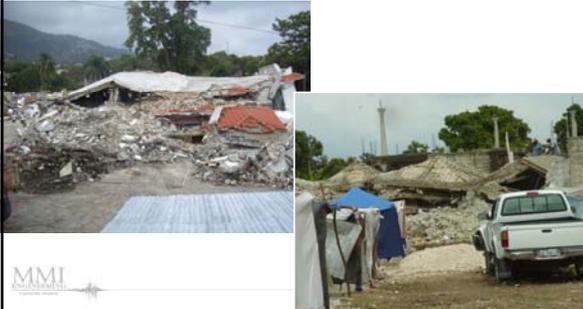
Collapsed Building at University Near Reservoir

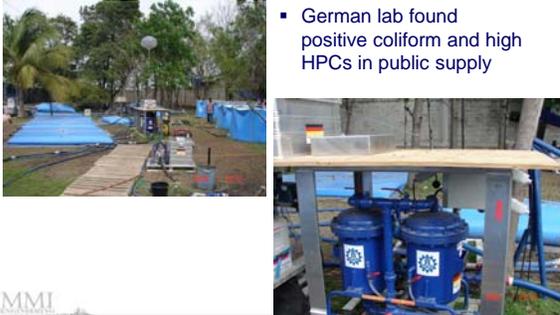
Emergency WTP from Germany

- German lab found positive coliform and high HPCs in public supply

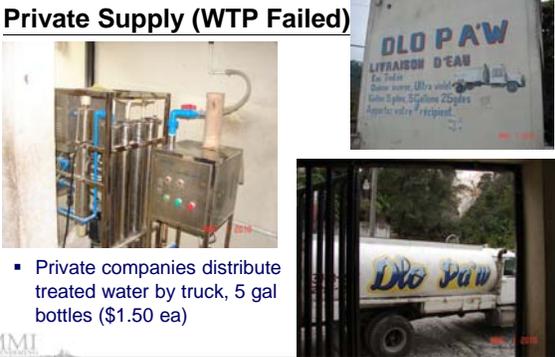
Private Supply (WTP Failed)

- Private companies distribute treated water by truck, 5 gal bottles (\$1.50 ea)

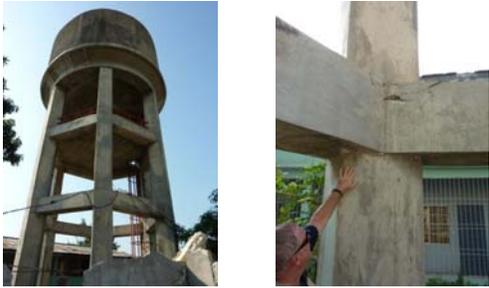
Elevated Concrete Tank Damaged

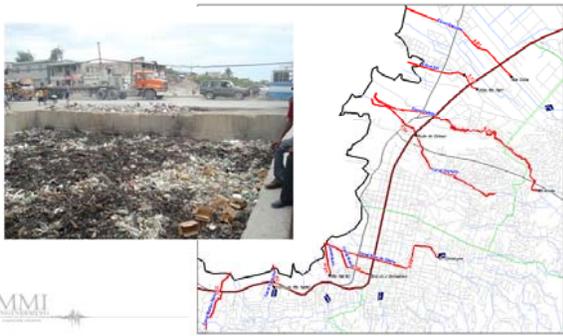
Drainage System Needs Cleaning

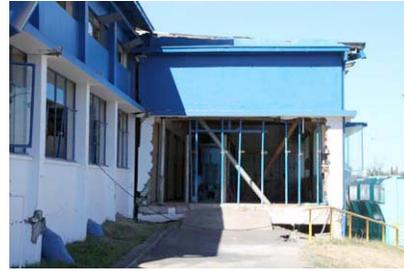
- Concepcion and Talcahuano most heavily damaged
- Concepcion – Mochita WTP, 57 MGD
 - PGA – 25-30%g
 - Pumps raw water from Bio Bio River
 - Trash rack – 1 ft lateral spread differential mvt
 - Pump station – extensive structural damage
 - 4 flocculator/clarifiers; filters, chlorination
 - Center column, baffles, and tube settlers damaged
 - Filters OK; gallery piping OK
 - Computer monitors and computers fell and broke
 - 1/3 lab counter top equipment fell and broke
 - Onsite piping broke

Collapsed Wall Mochita WTP PS

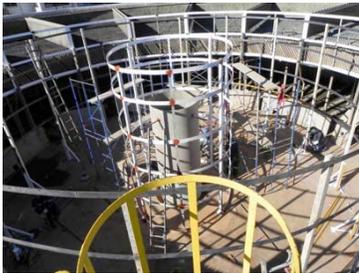
Clarifier Under Repair, Mochita WTP

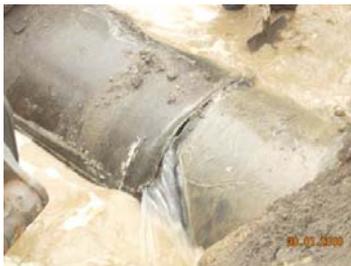
- Total 1,200 km of pipe
- Treated water transmission lines leaving plant
 - 500-1,000 mm diameter – 72 failures
- Distribution 6" – 12"
 - Cast iron-oldest areas; AC-intermediate; PVC and HDPE used now (no failures)
 - 1,000 pipeline failures (most PGD); 2,000 service failures
- 40% unaccounted for water before; 60% after
- Restoration issues:
 - Loss of cellular telephone service
 - Loss of offsite power (had gen sets at WTP and larger PSs)

Damaged Welded Steel Pipe
