# SEISMIC RETROFIT OF STEEL RESERVOIRS

Presented by Jon Conner, P.E., S.E.  
RH2 Engineering

# MT. VIEW-EDGEWOOD WATER CO. SOUTH RESERVOIRS

# OAK LODGE WATER DISTRICT VIEW ACRES RESERVOIRS

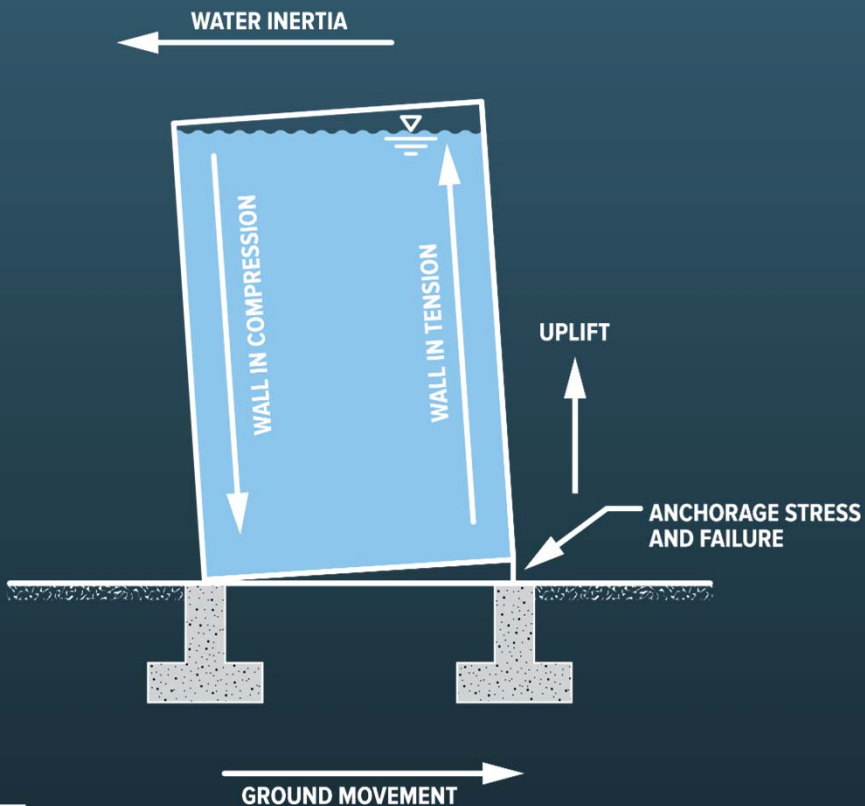
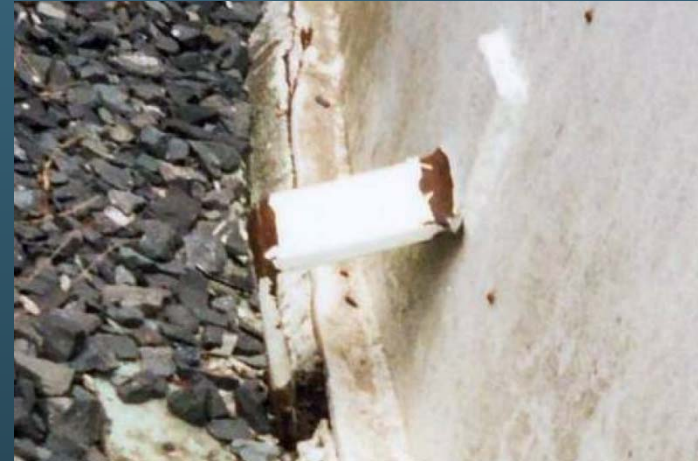
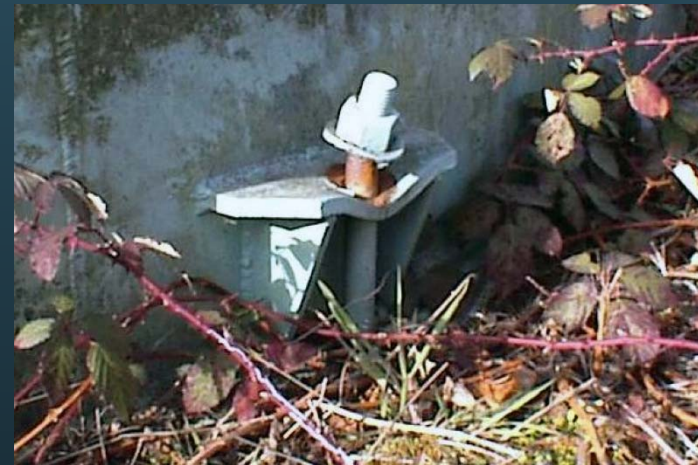
## Anchorage failure

- Primary: Anchorage stress

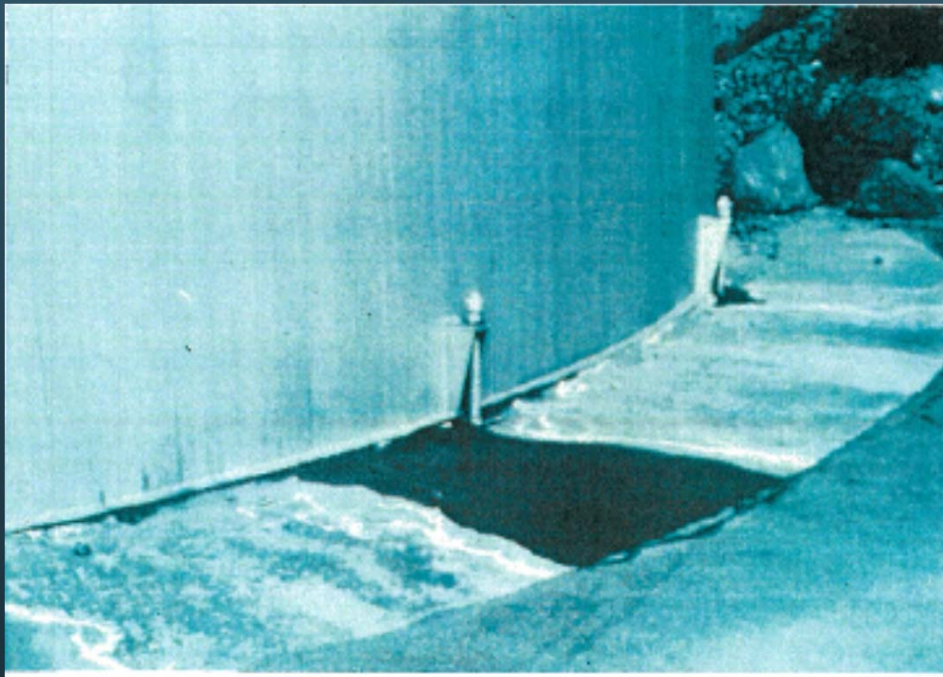
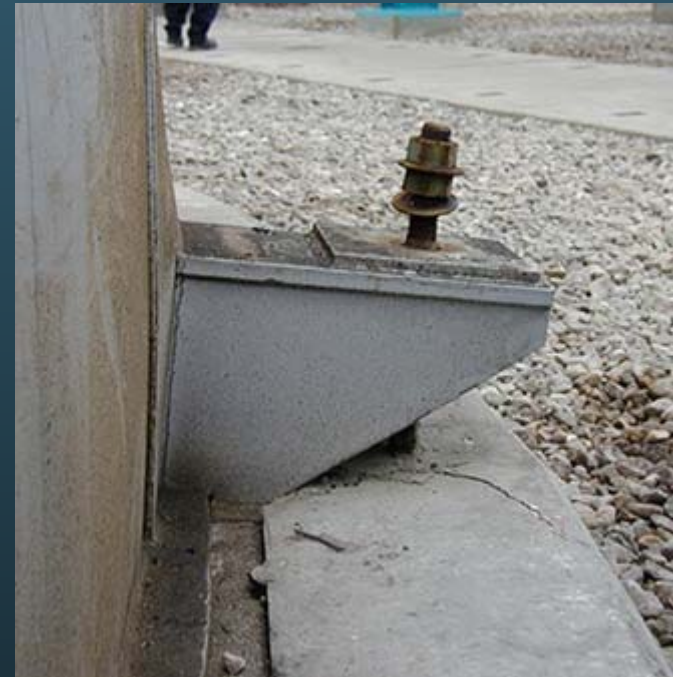
## Anchorage failure

- Secondary: Floor cracking

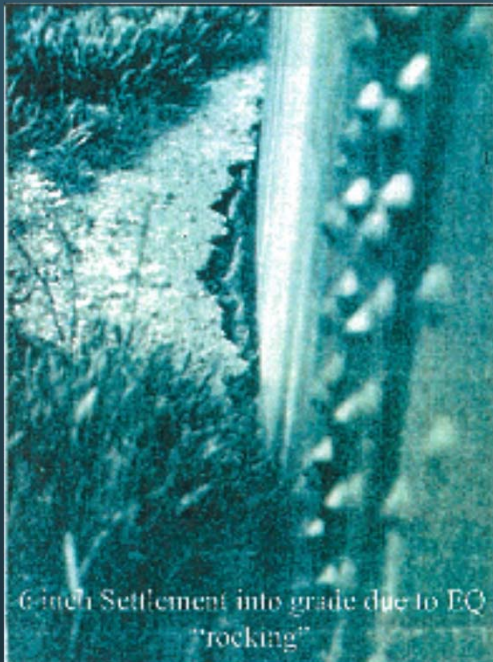
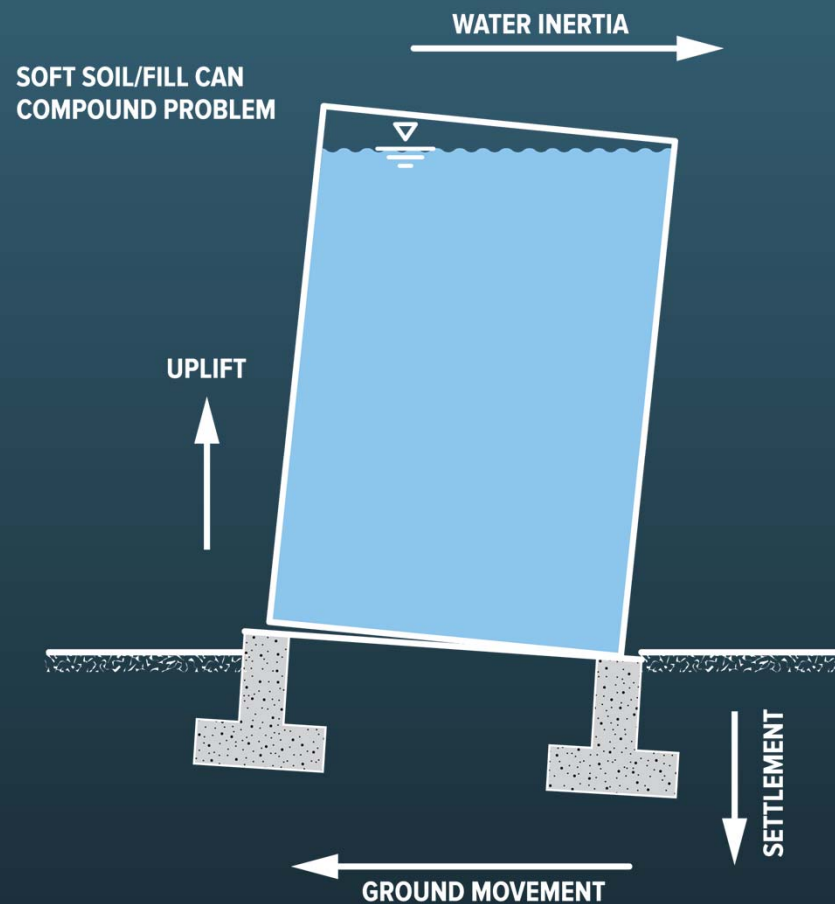
## Soil failure (Inadequate Foundation)

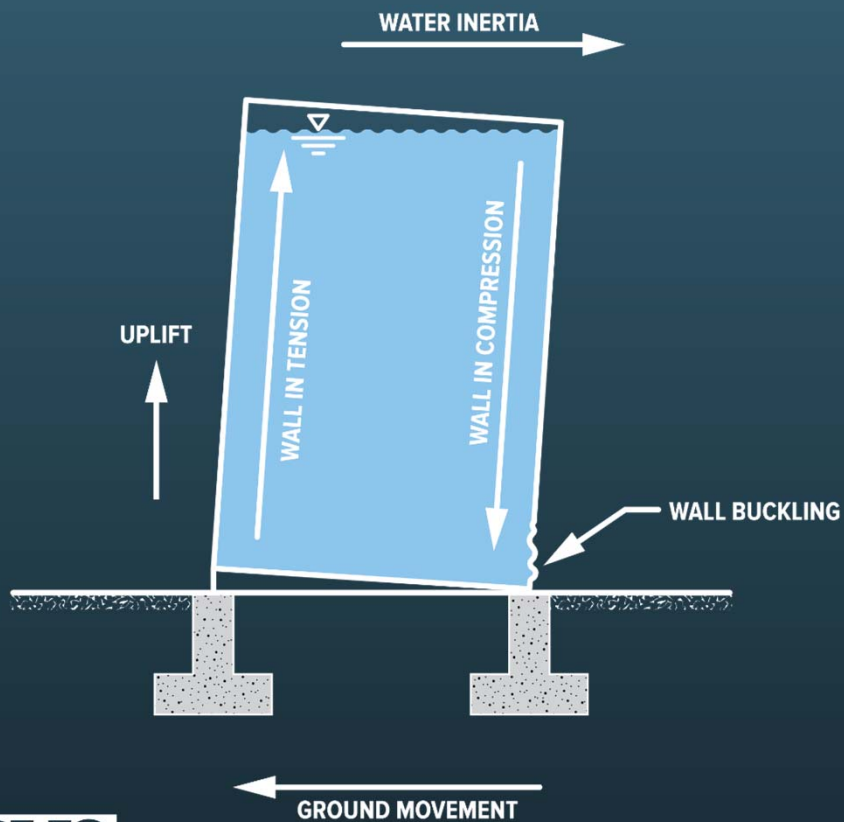
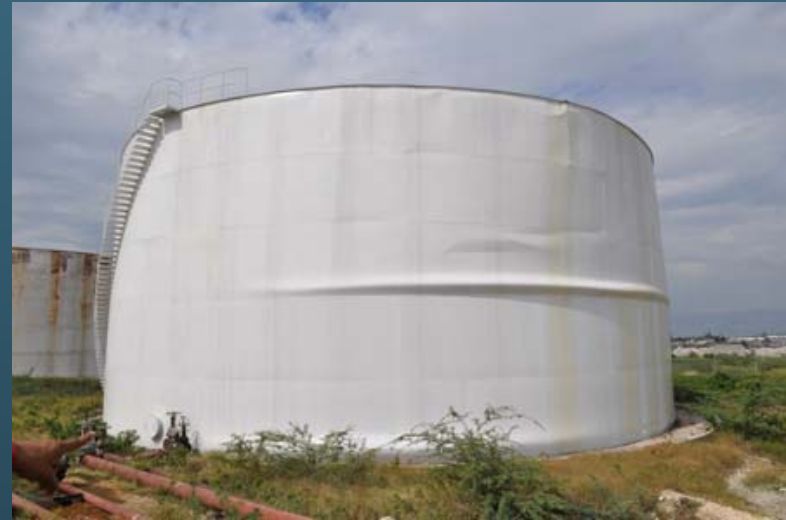
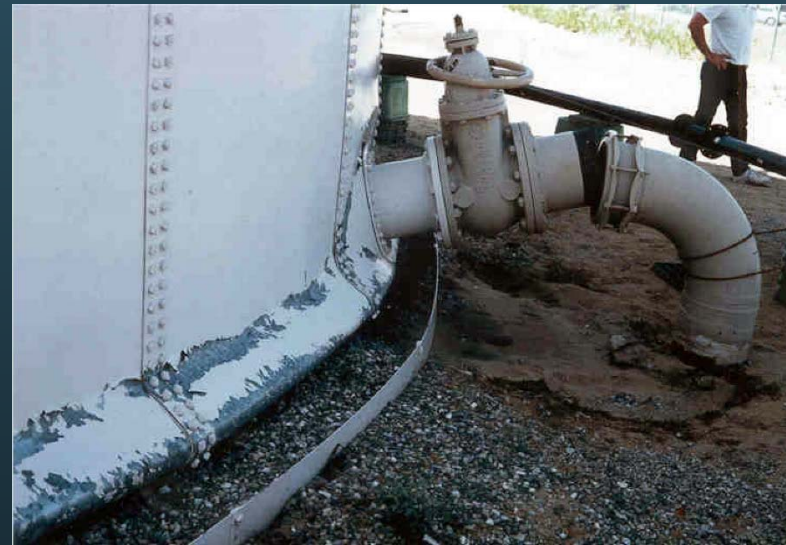
## Shell buckling (Elephant Foot)

- Stiffen shell
- Add interior ballast ring
- Lower water level

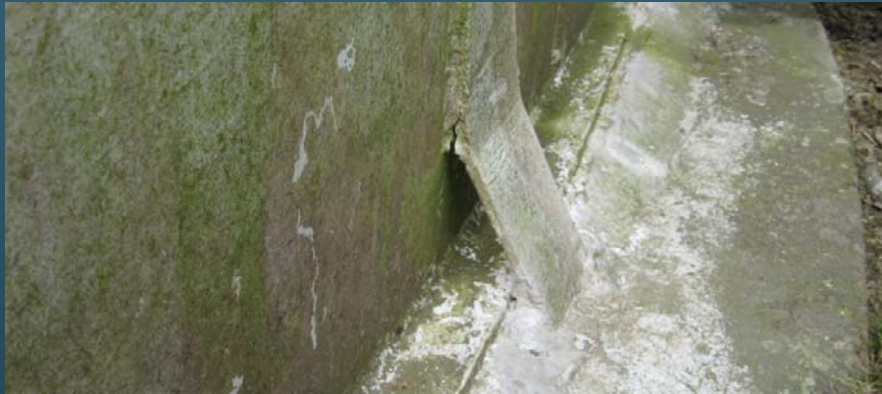
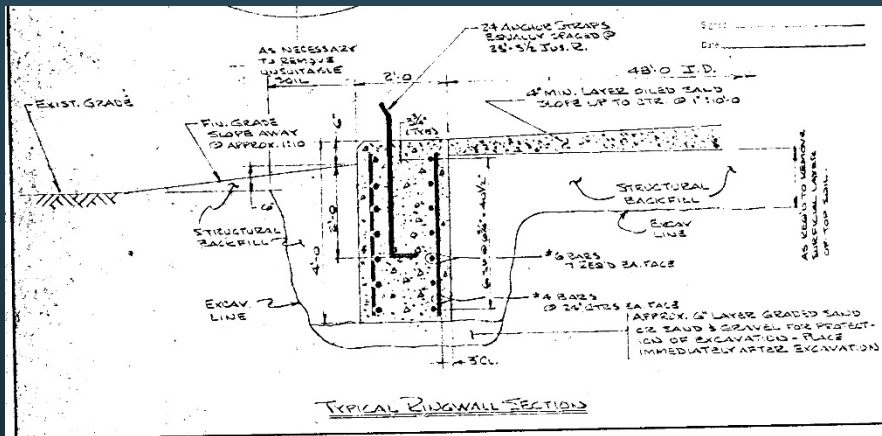
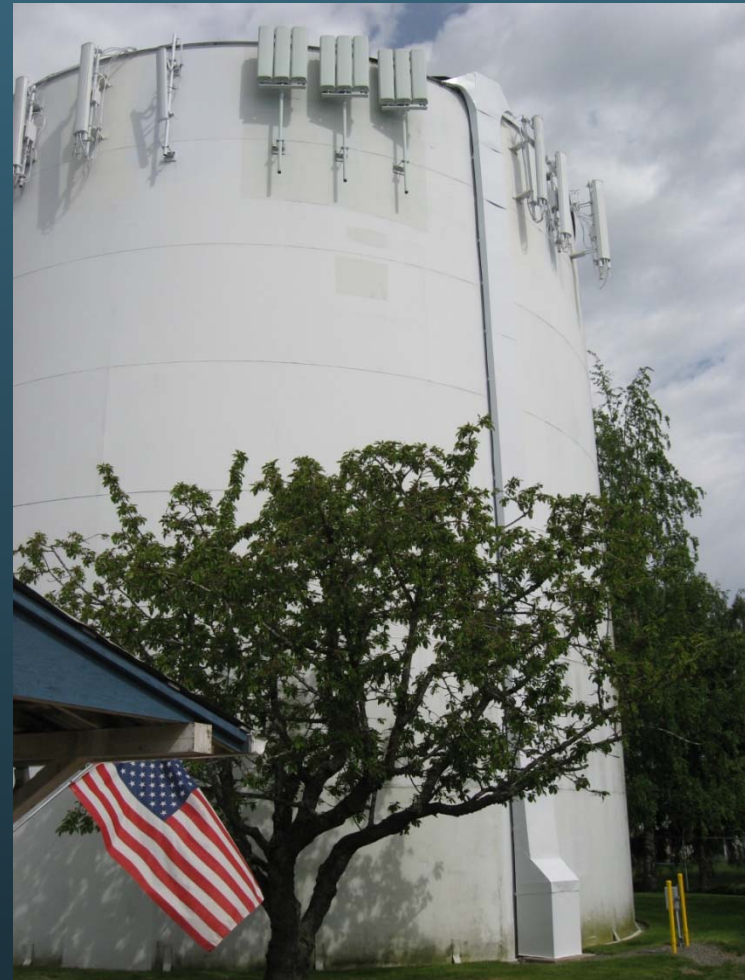
# WEST RESERVOIR

- Small Foundation = high bearing pressure
- Anchor Straps
