Reservoir Challenge: Rehab or Replace

May 9, 2014

2.0 MG City Reservoir

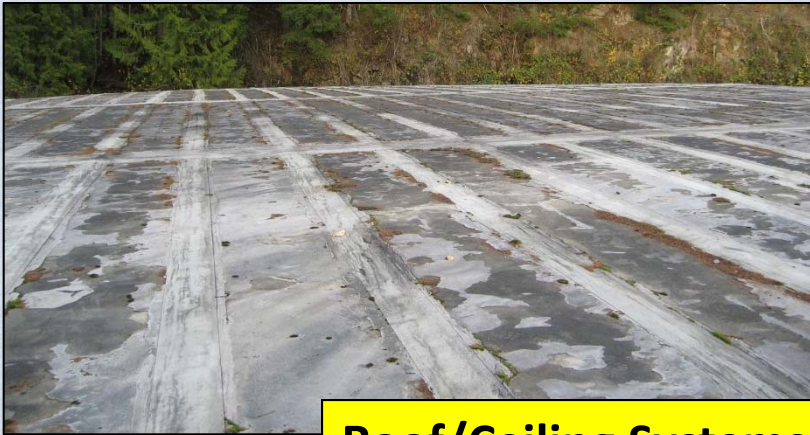
Roof/Ceiling Systems

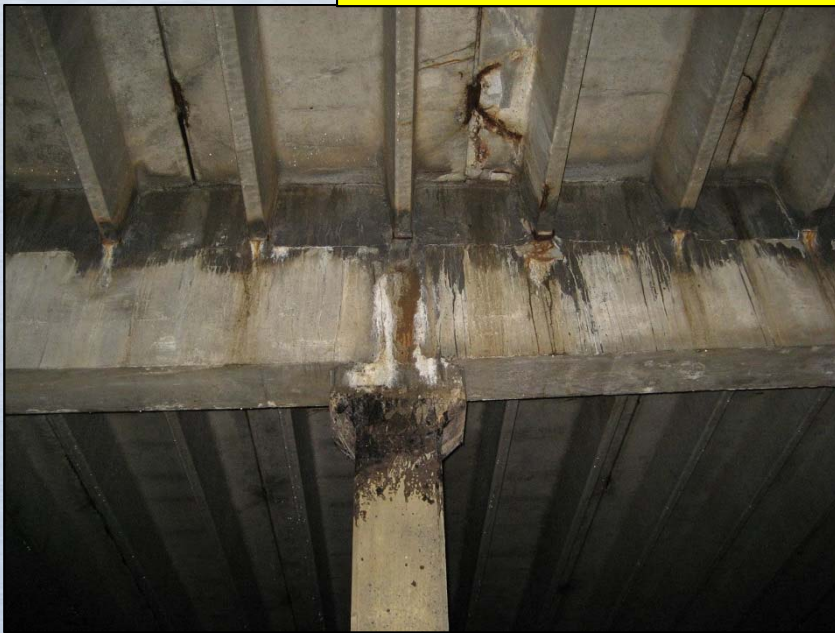
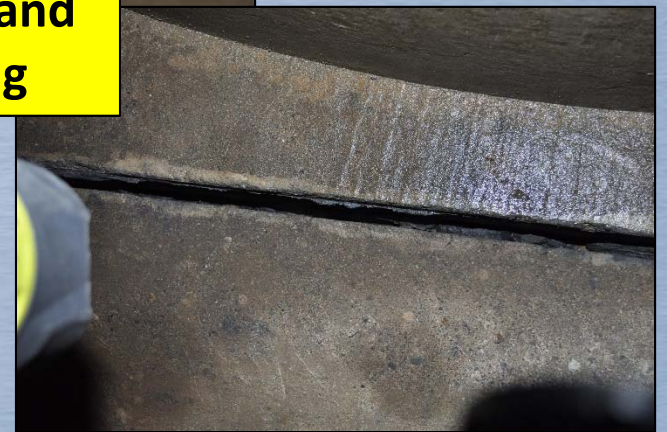
Floor slab and wall footing

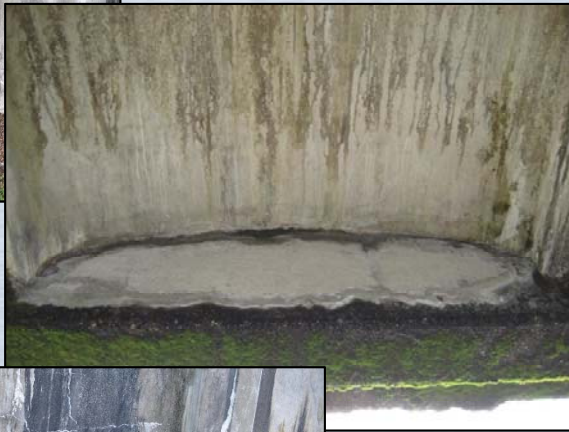
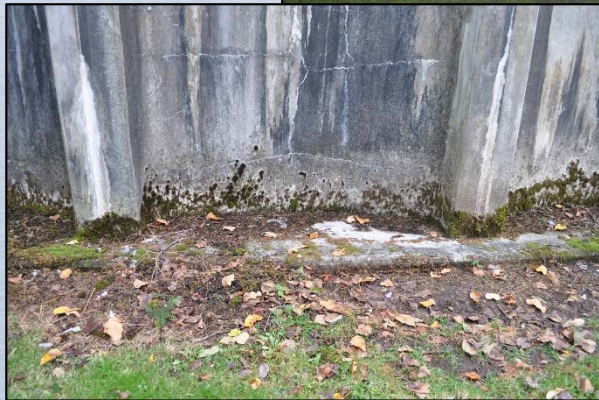
Wall panels and tension ring systems

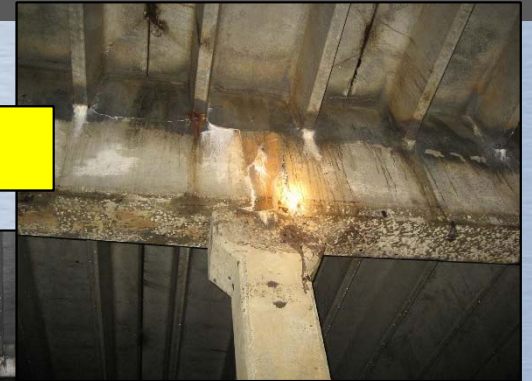
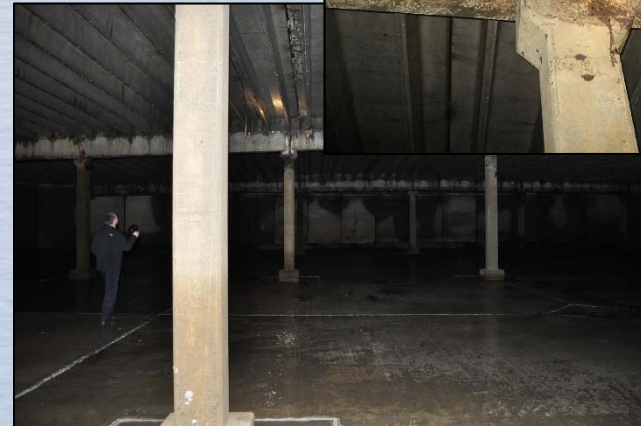
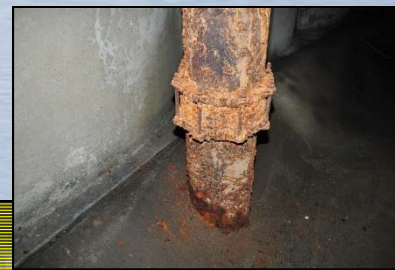
Columns

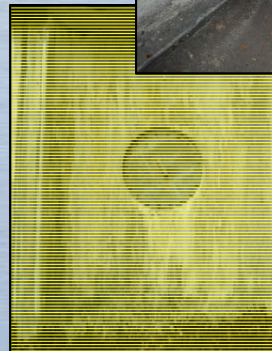
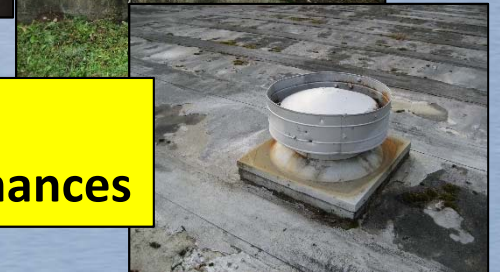
Piping/ Appurtenances

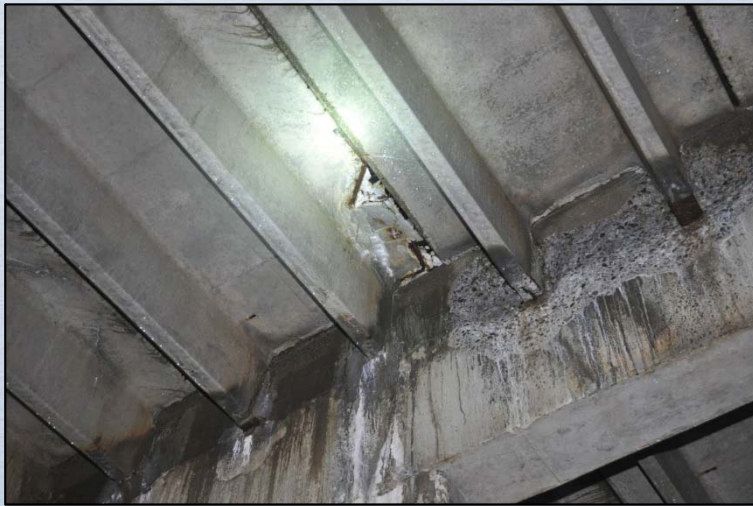
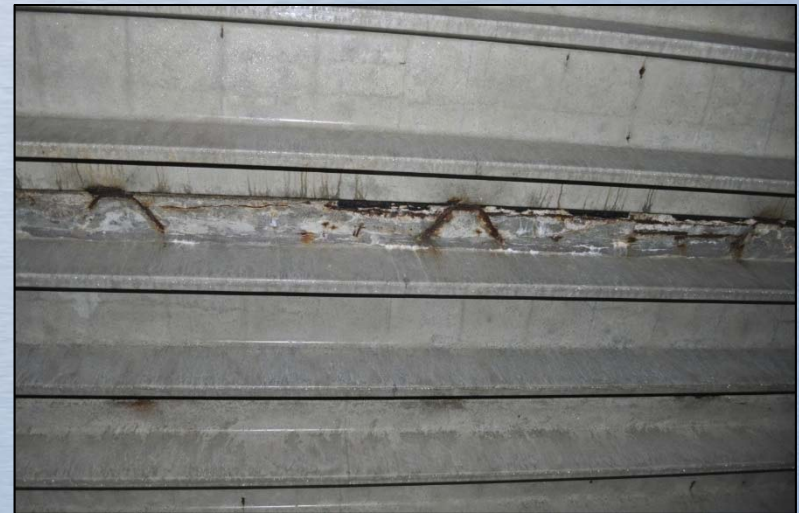
- ❑ **Pritzker Tank in Enumclaw**
- ❑ **Signs of concern – Precast roof**

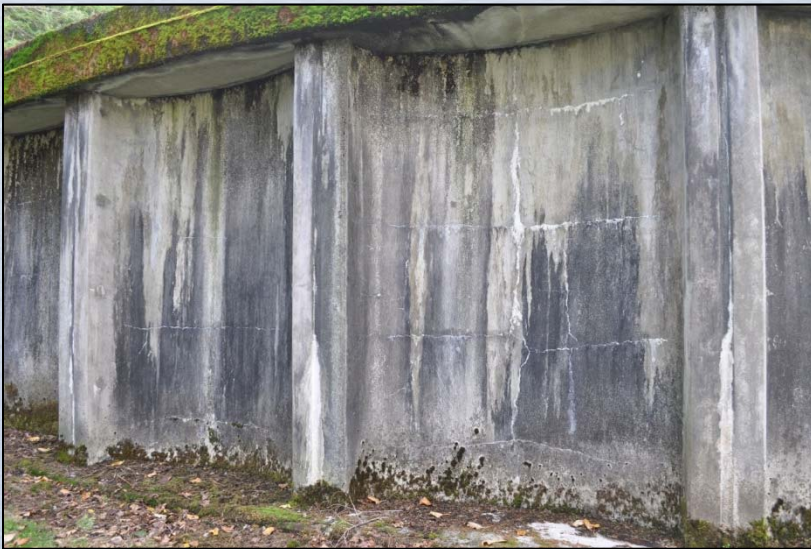
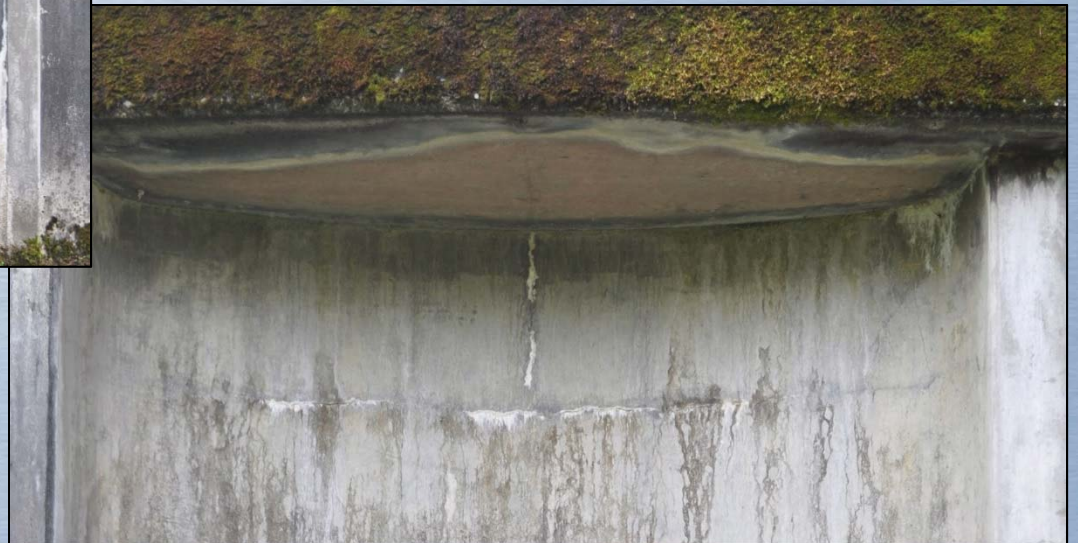
- ❑ **Pritzker Tank in Enumclaw**
- ❑ **Signs of concern – Precast panels**

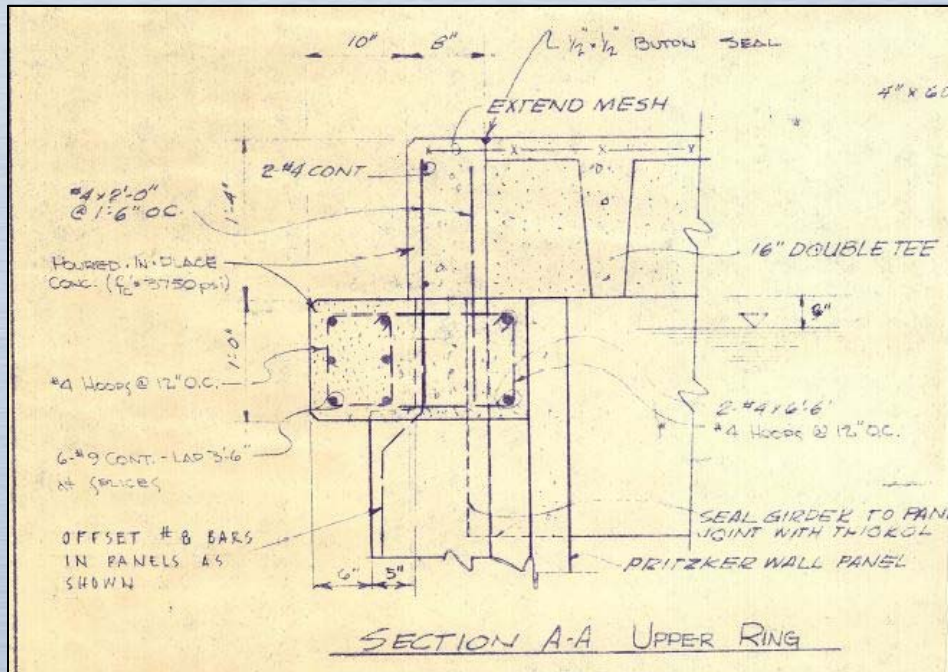
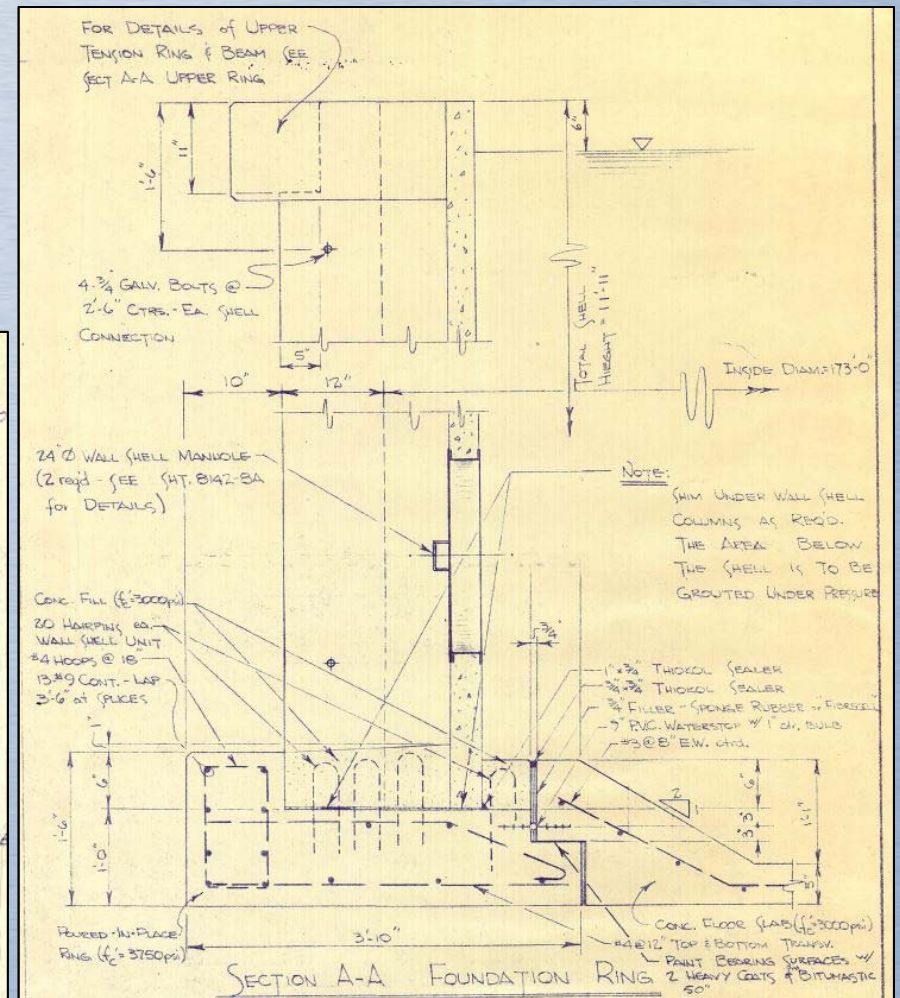
□ Details and potential failure modes
