# Gabbert Reservoir Seismic Upgrade Project

Tom Boland, P.E.

May 9, 2014

# Existing 200,000 gallon Gabbert Reservoir

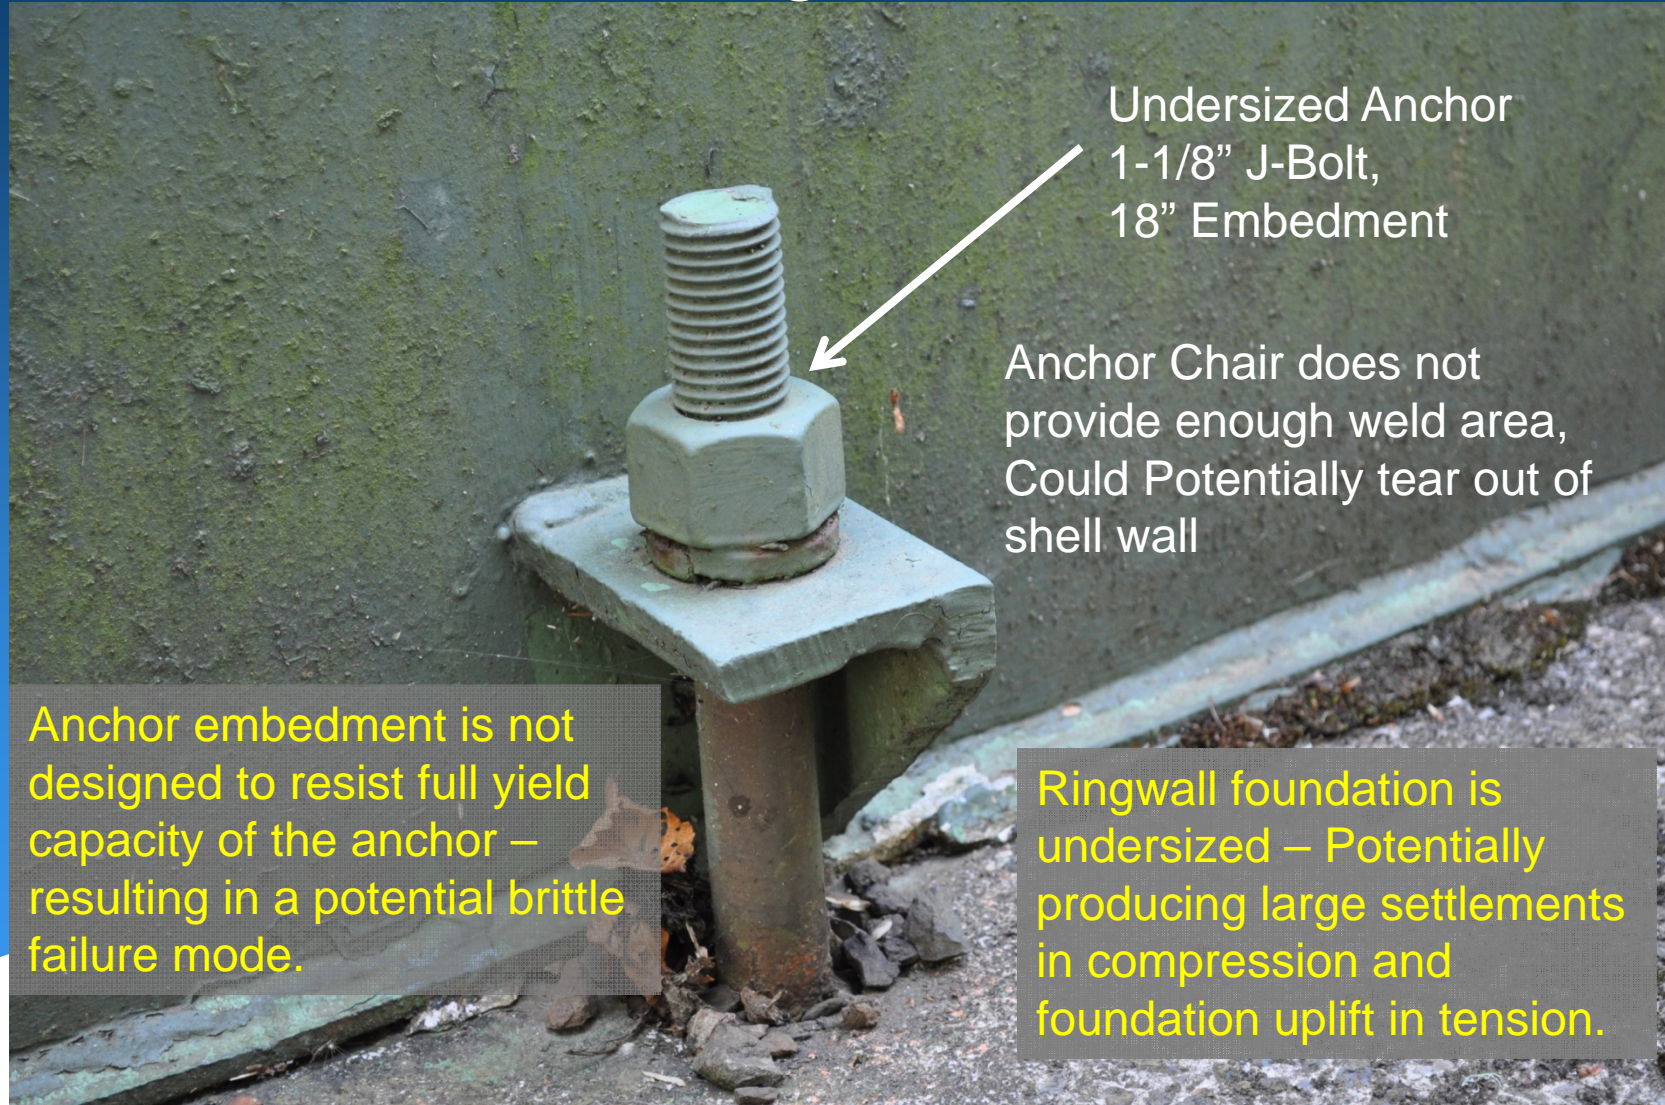
Undersized Anchor  
1-1/8" J-Bolt,  
18" Embedment

Anchor Chair does not  
provide enough weld area,  
Could Potentially tear out of  
shell wall

Anchor embedment is not  
designed to resist full yield  
capacity of the anchor –  
resulting in a potential brittle  
failure mode.

Ringwall foundation is  
undersized – Potentially  
producing large settlements  
in compression and  
foundation uplift in tension.

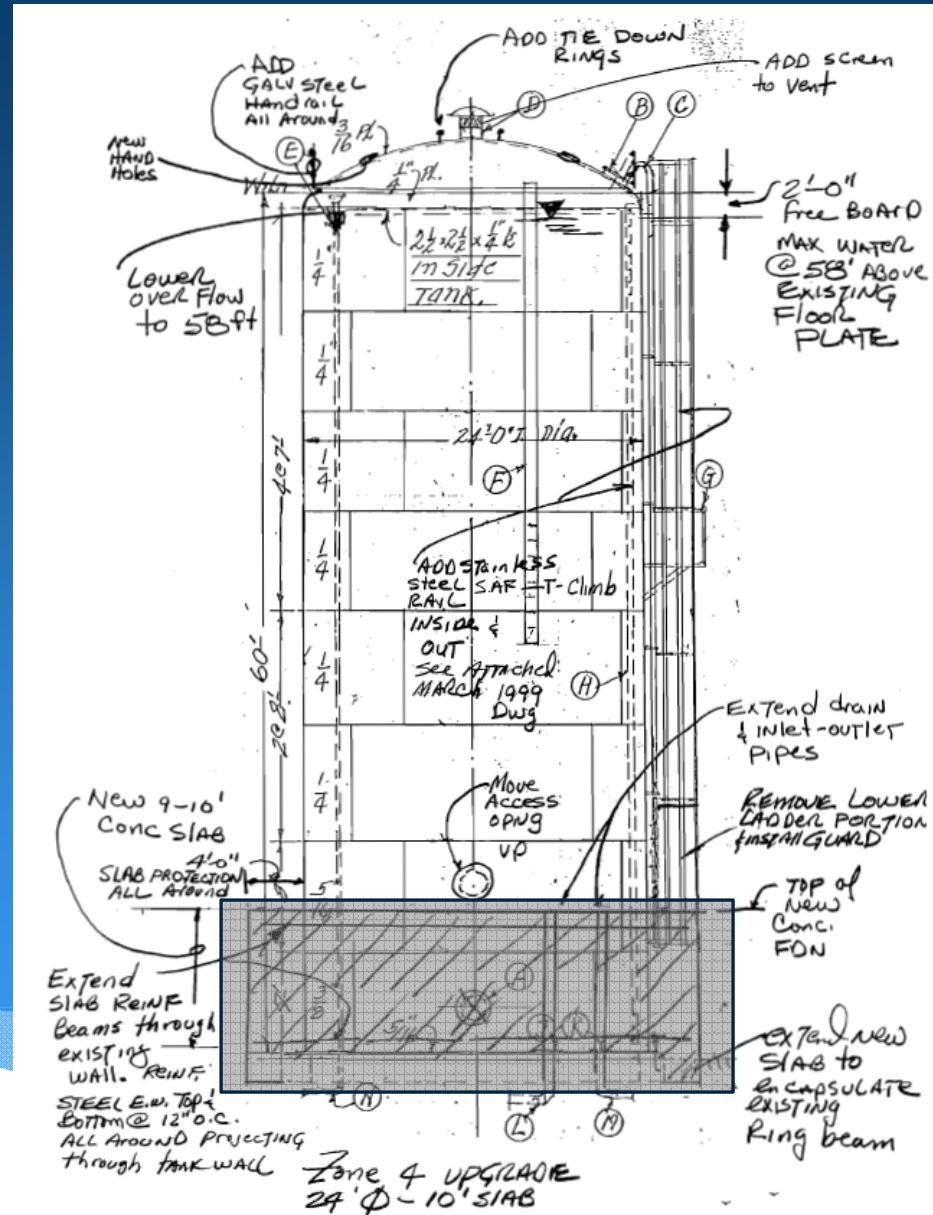
1999 - Zone 4 upgrade  
 10' thick ballast slab  
 Storage loss & potential  
 settlement

- Improve anchorage
- Improve foundation
- Ballast or Piles?
