“Solving Multi-faceted Challenges to Replace  
1920s-built Outlet Facilities at the City Lake  
Reservoir in Port Townsend, WA”

Ian Jablonski (City of Port Townsend)  
Birol Shaha, P.E. (WA) (HDR)

PNWS-AWWA Conference, May 09, 2014

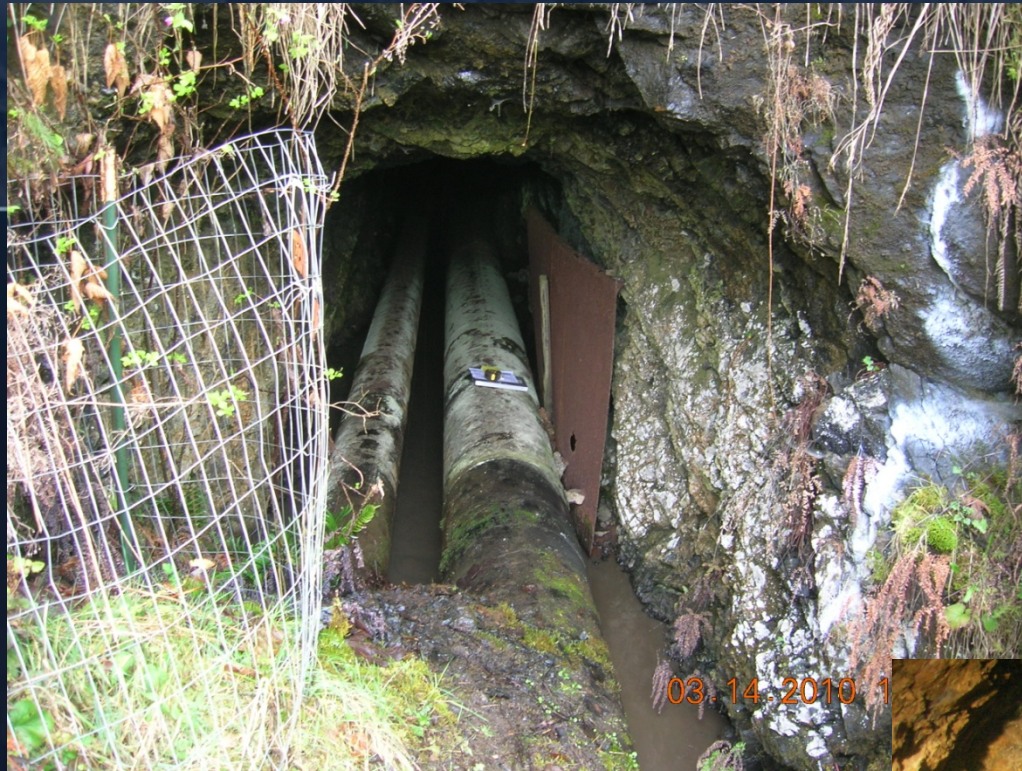
Tunnel Entrance with 24"  
Outlet Pipe and 16"  
Drain/Overflow Pipe

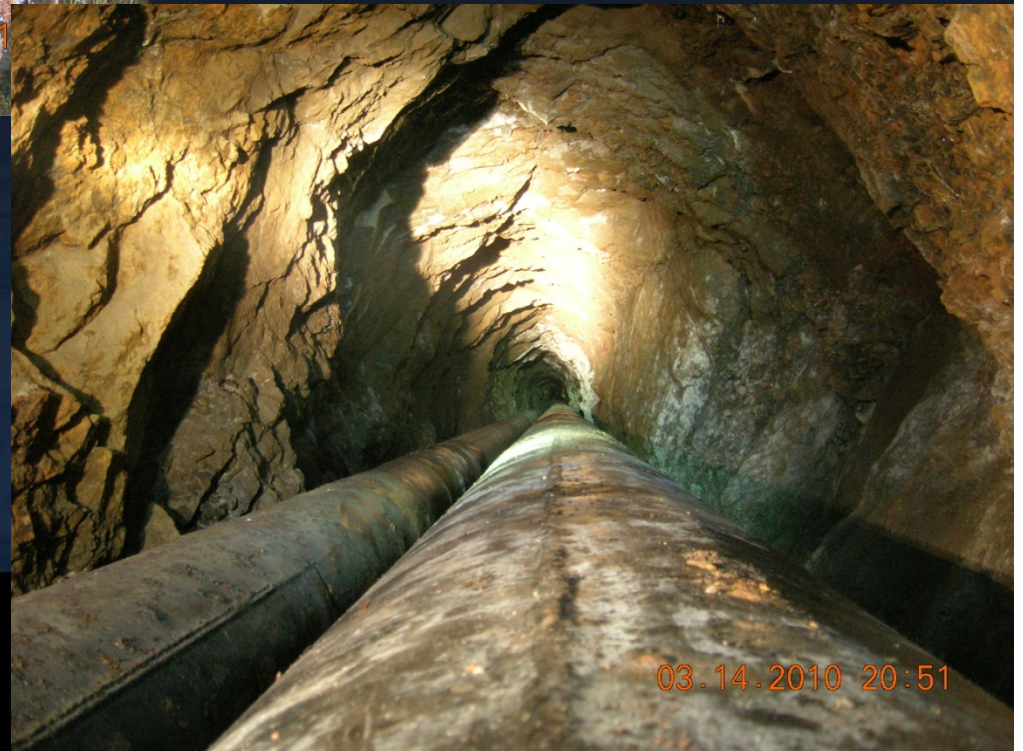
Un-lined Tunnel with Outlet  
Pipe and Overflow/Drain pipe

Difficult access  
Susceptible to damage from  
rock fall

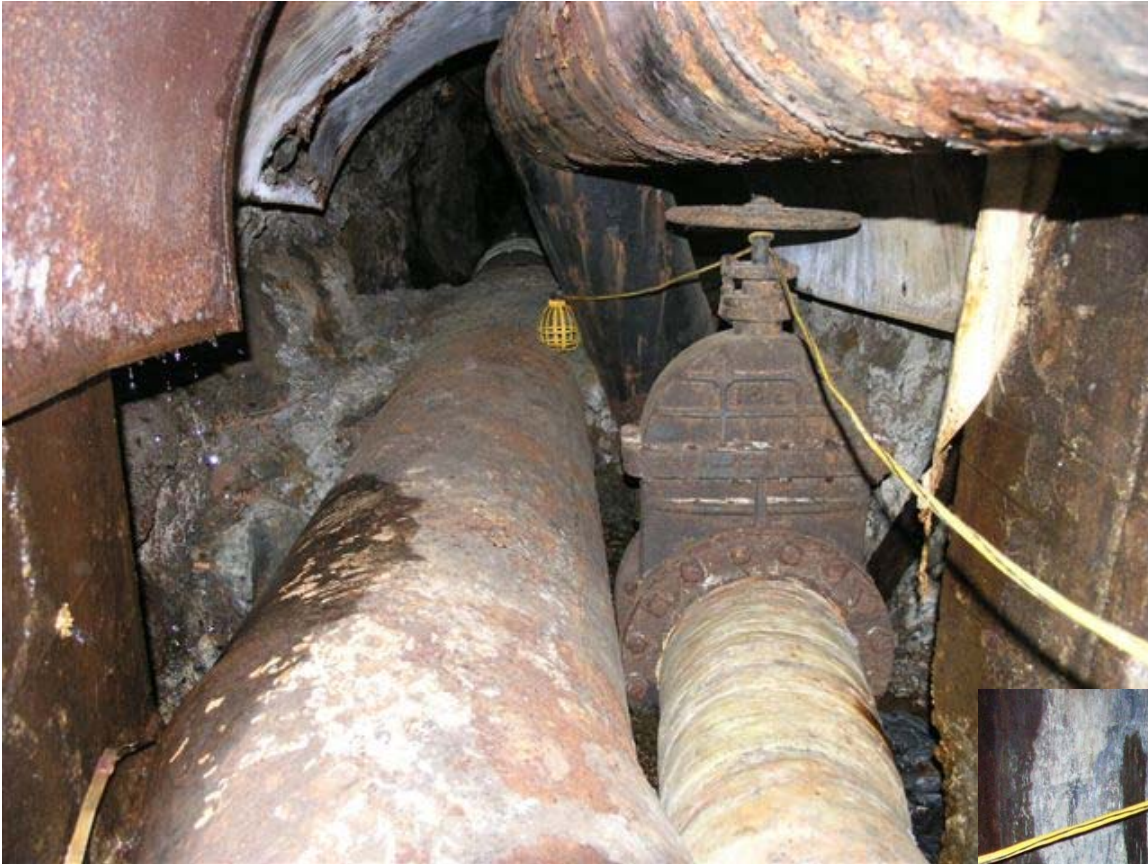
Overflow/Drain pipe Valve  
and Outlet Pipe inside  
tunnel

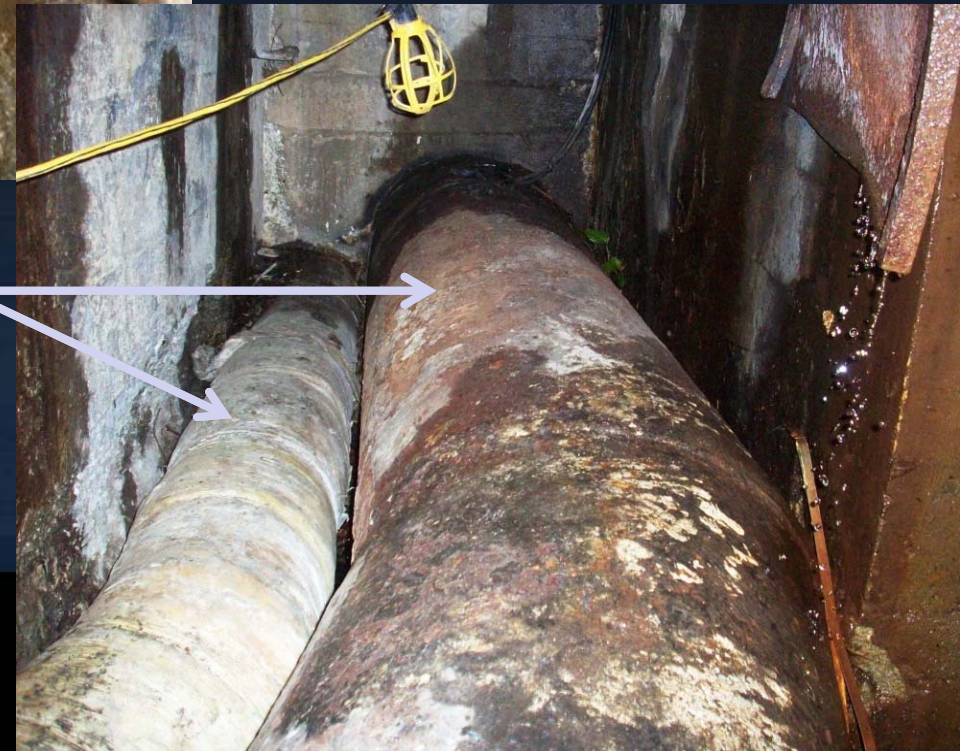
*Temporary Repair with Carbon  
Fiber Wrap*

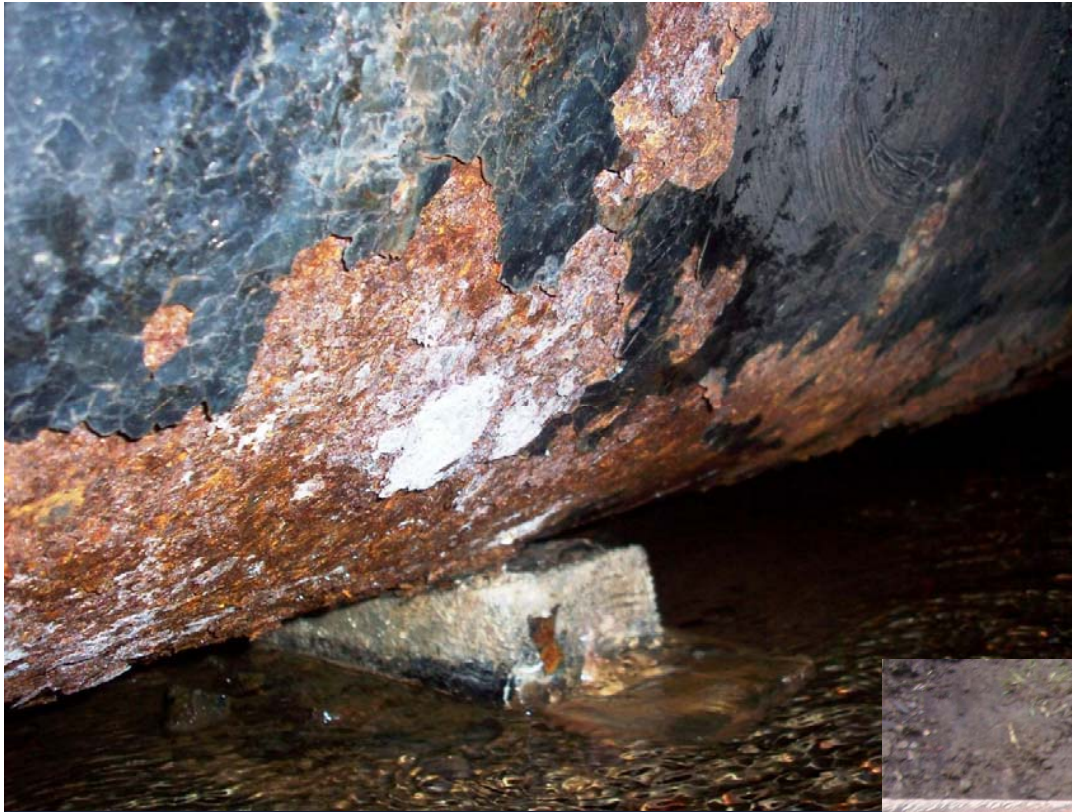
Outlet pipe and Overflow/drain  
pipe at bulk head inside tunnel

Corroded Outlet Pipe,  
poorly supported on a  
deteriorating piece of wood

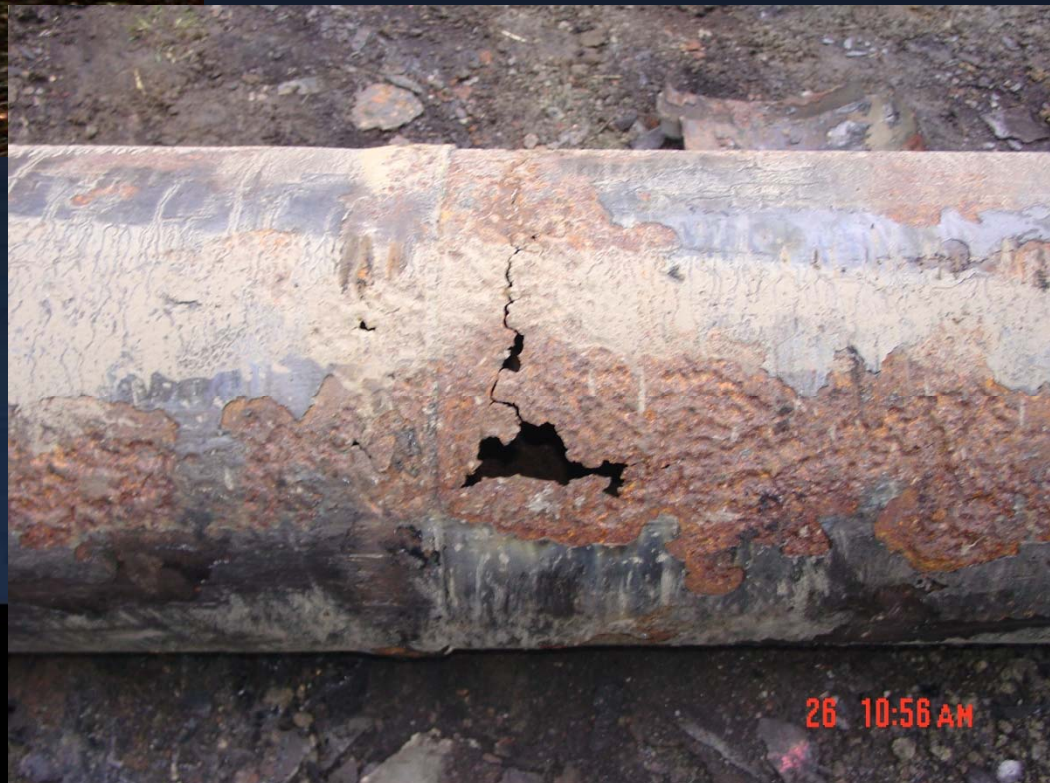
Corrosion of Drain  
Pipe

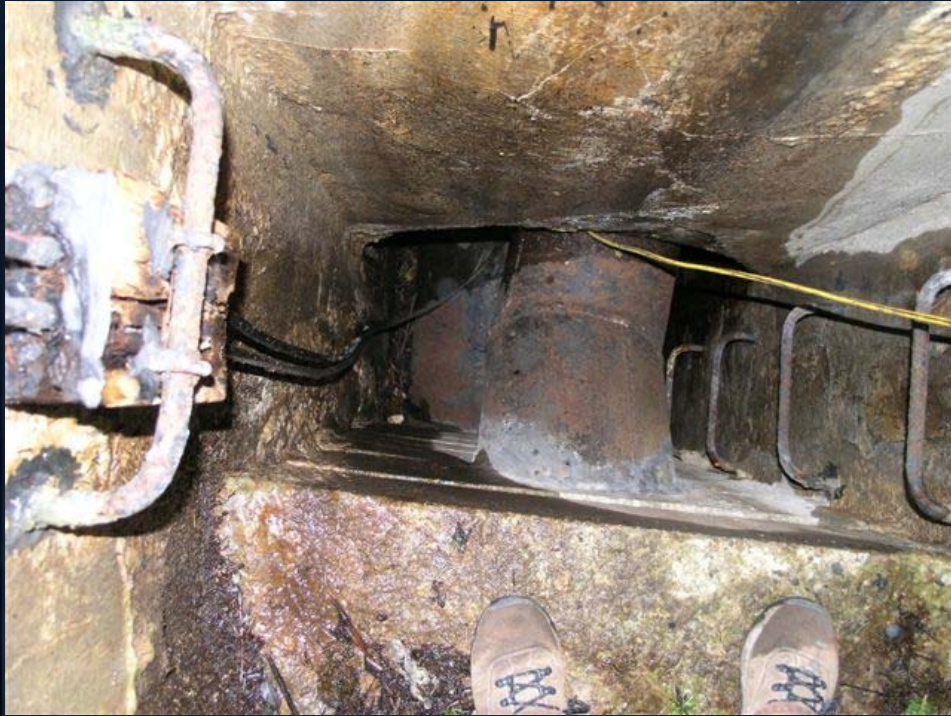
Extremely Tight Space inside Shaft  
Hard to Assess

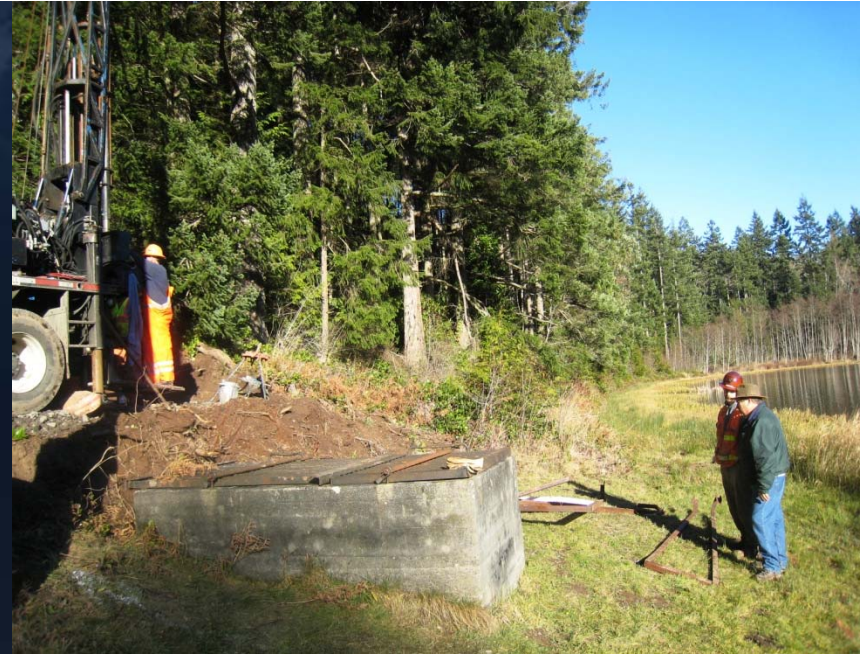
Overflow, Wet Shaft

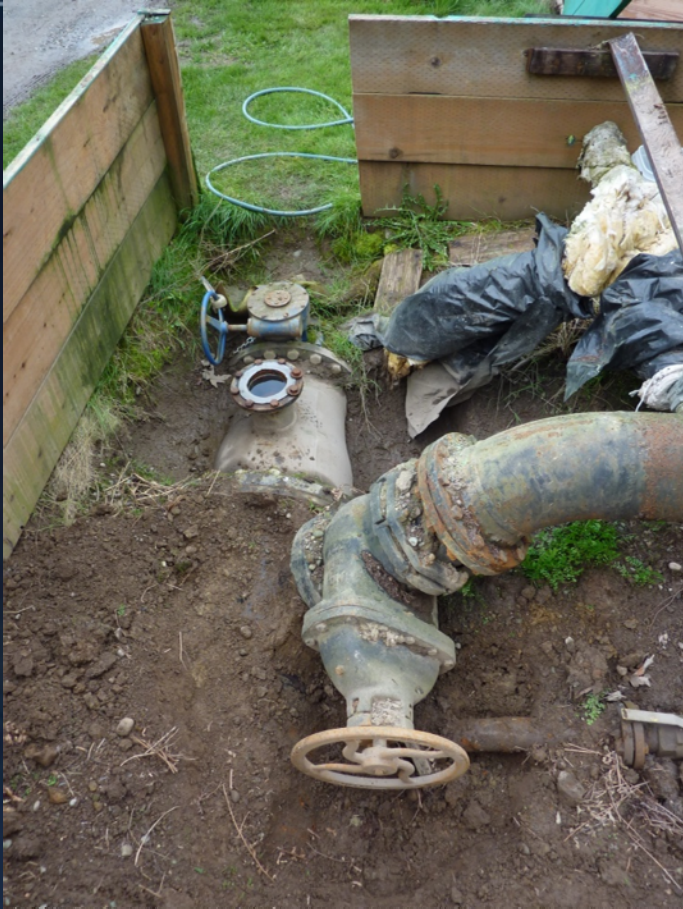
20" Isolation Valve for Current  
Flow Control  
(Manual , Cavitating )

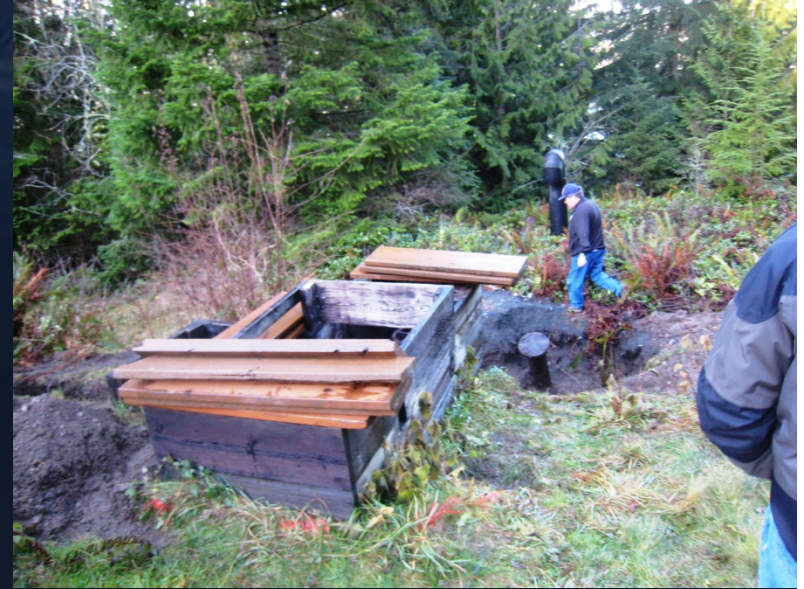
Wooden Vault

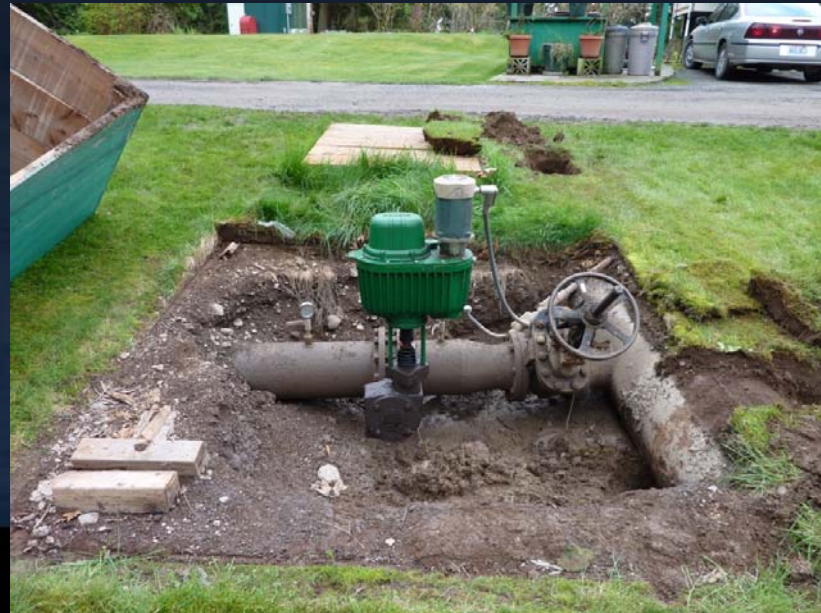
10-inch Isolation Valve (motorized)

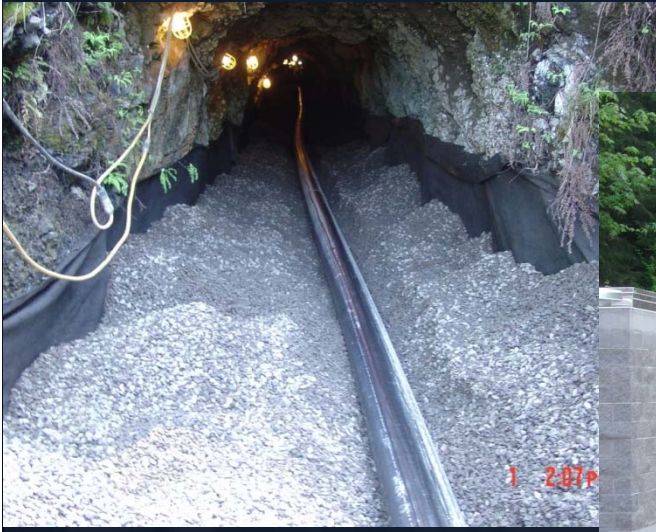
Drain Pipe at the bottom of Dry Tunnel

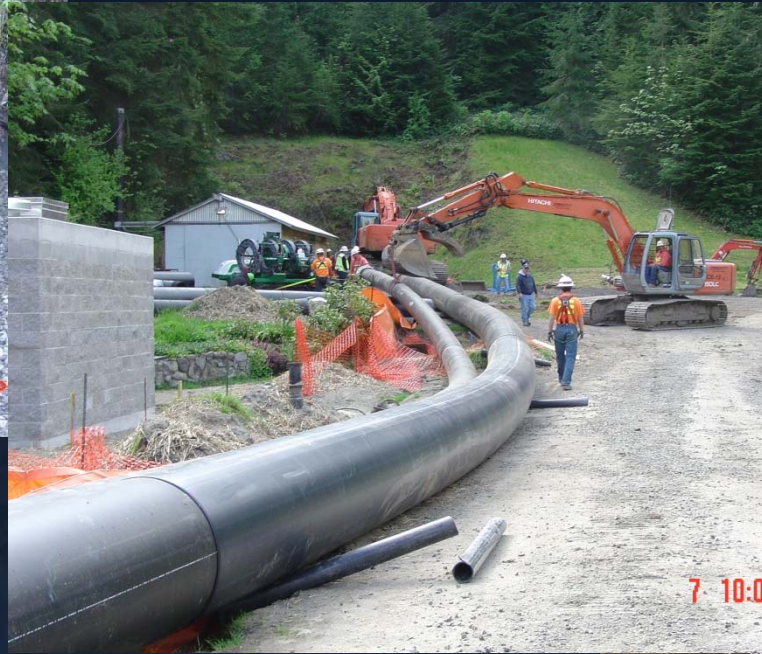
28" Outlet Pipe and 16" Overflow/drain pipe (HDPE)

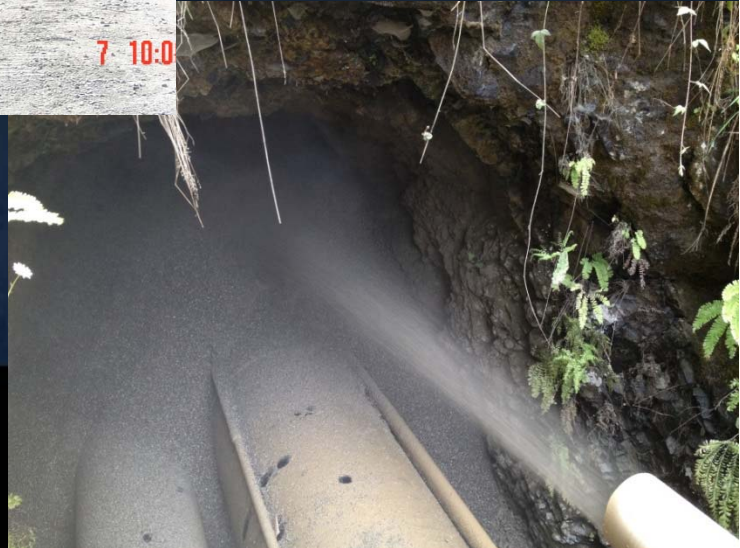
Blowing backfill inside dry tunnel
