Condition Assessment: City of Bellingham Supply System

2015 PNWS-AWWA Conference

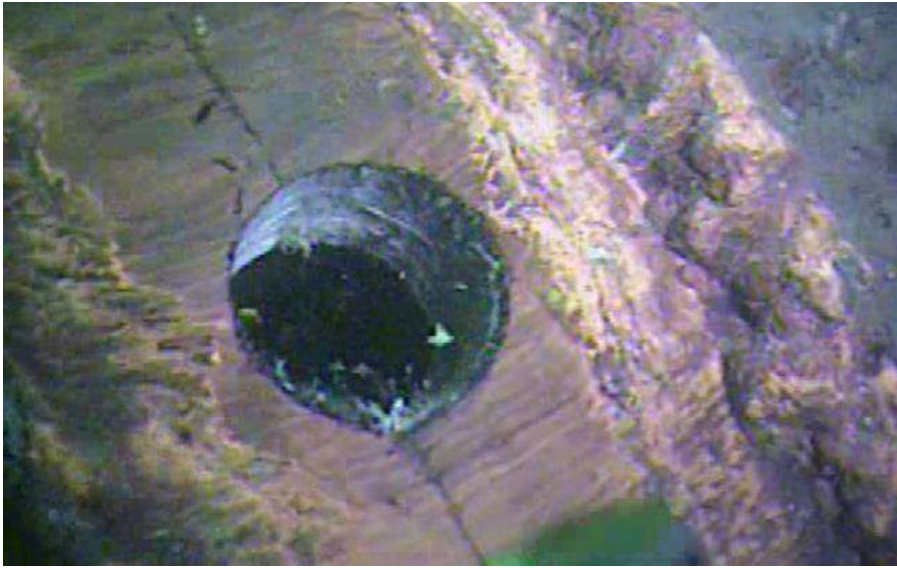
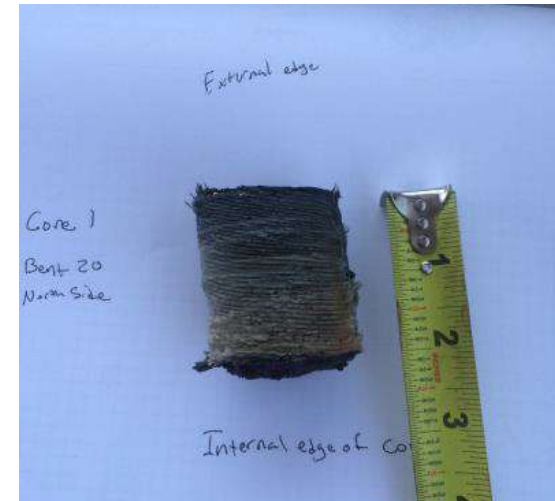
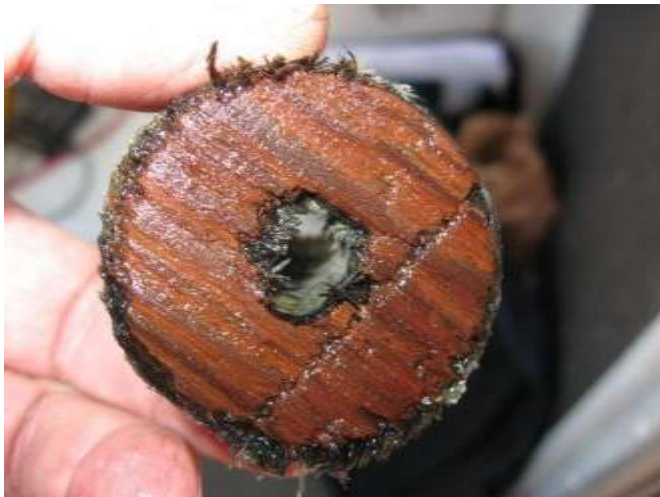
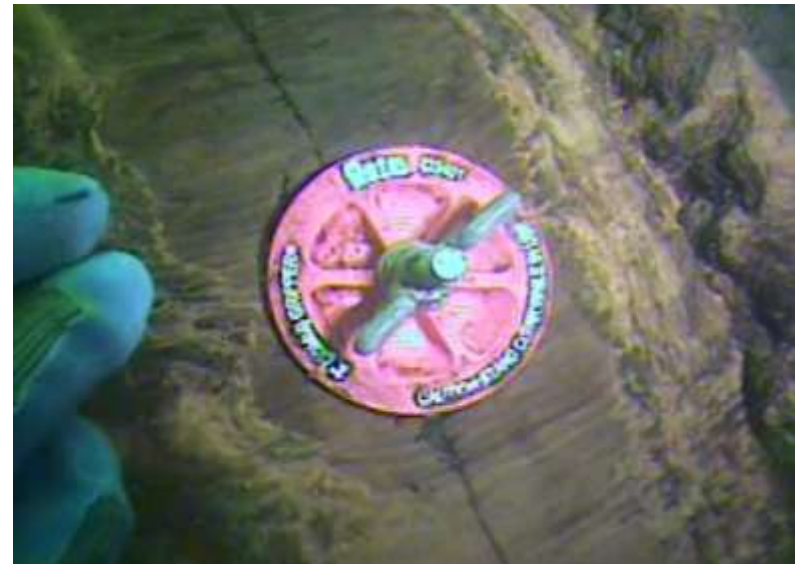
Wood Condition

- Wood in good condition
 - Support structural components
 - Stave pipe (interior and exterior)
- SST bands in good condition
- Original steel fasteners in fair condition
- Some original steel rods corroded to failure

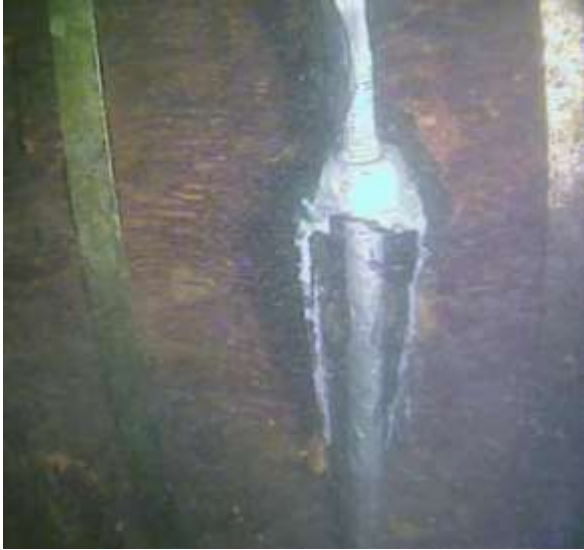
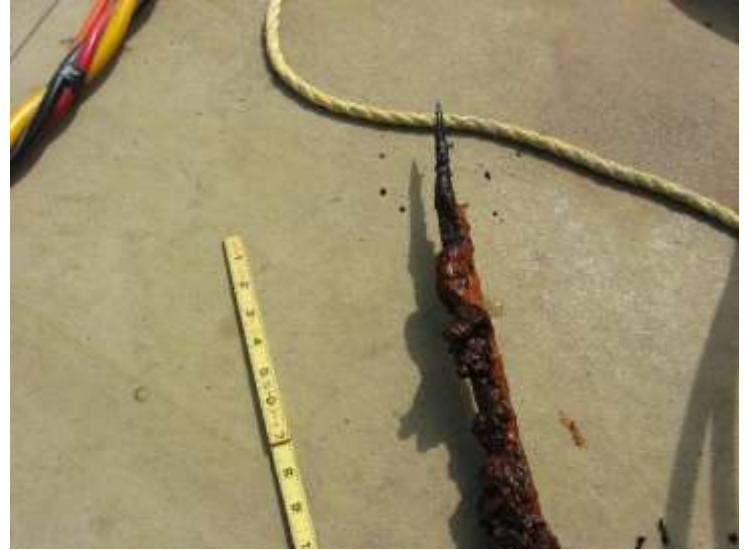
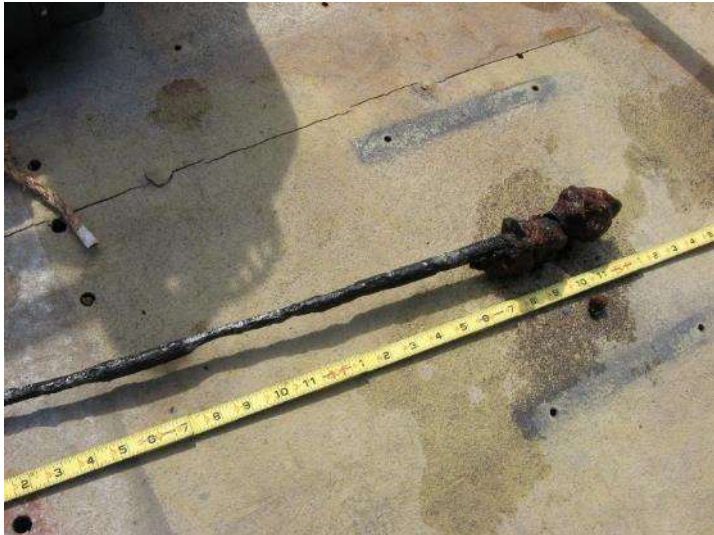
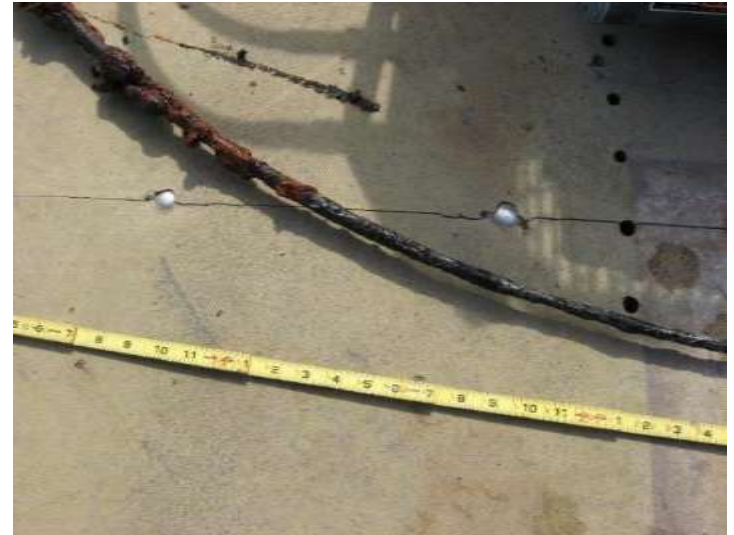
Condition of Steel Rods

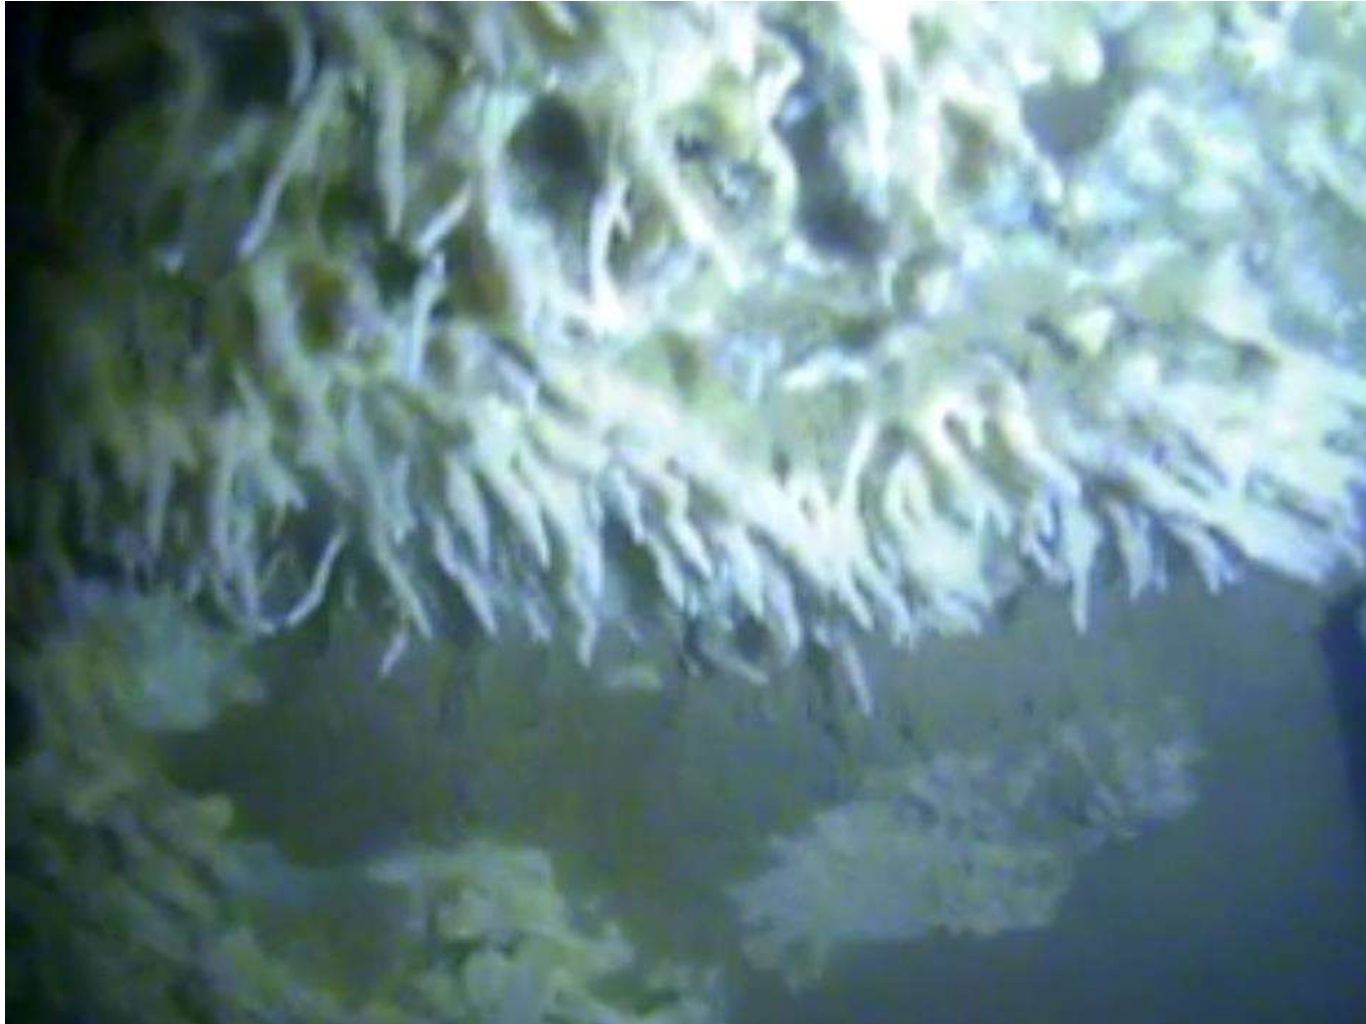
Sponge Inside Intake Pipe

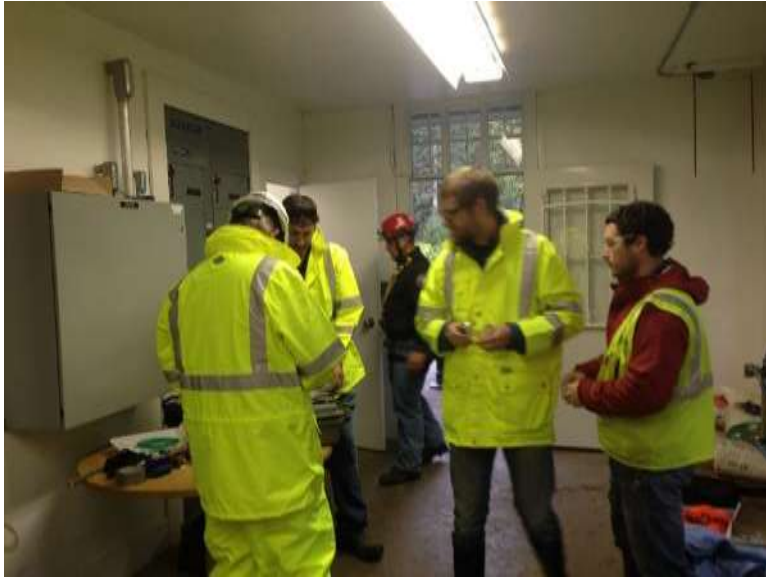
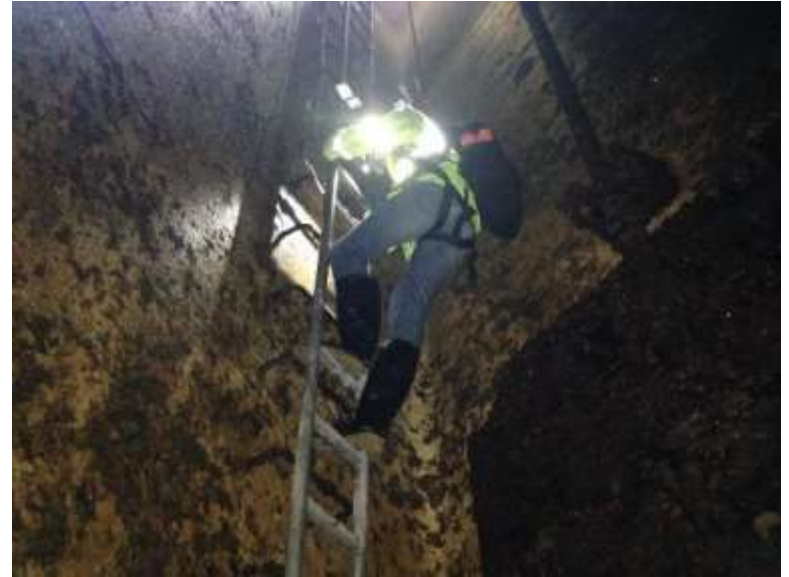
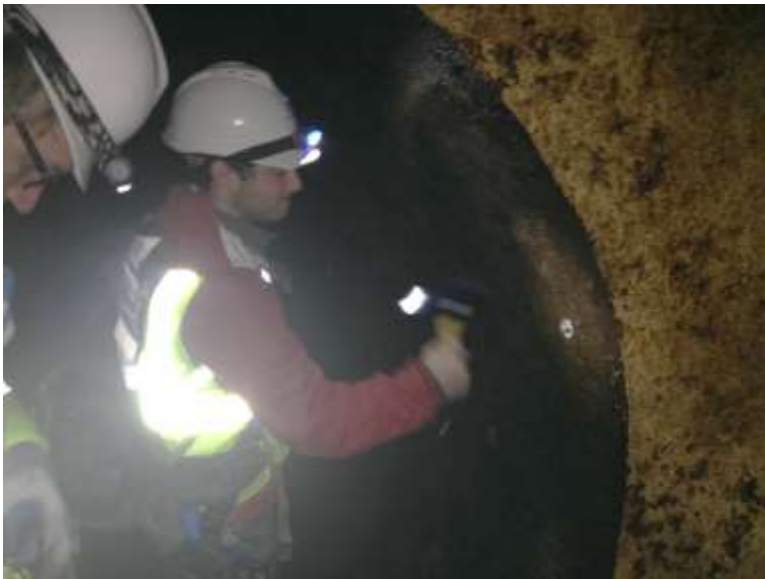
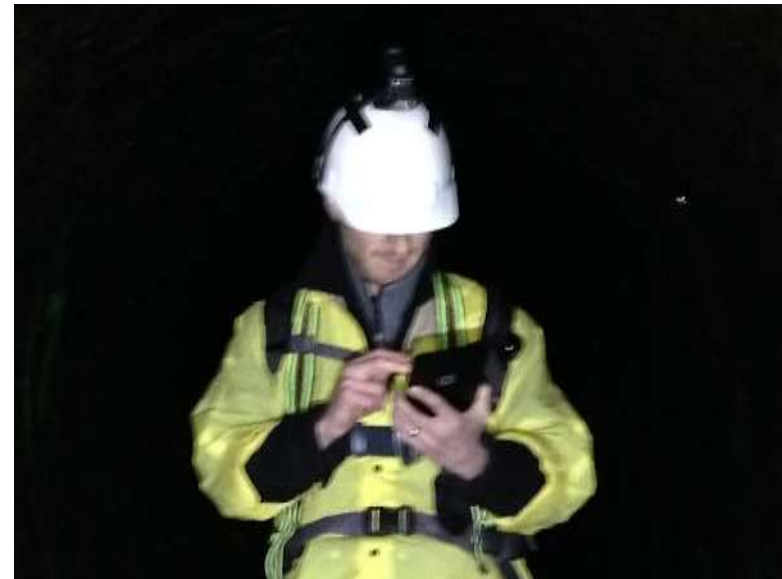
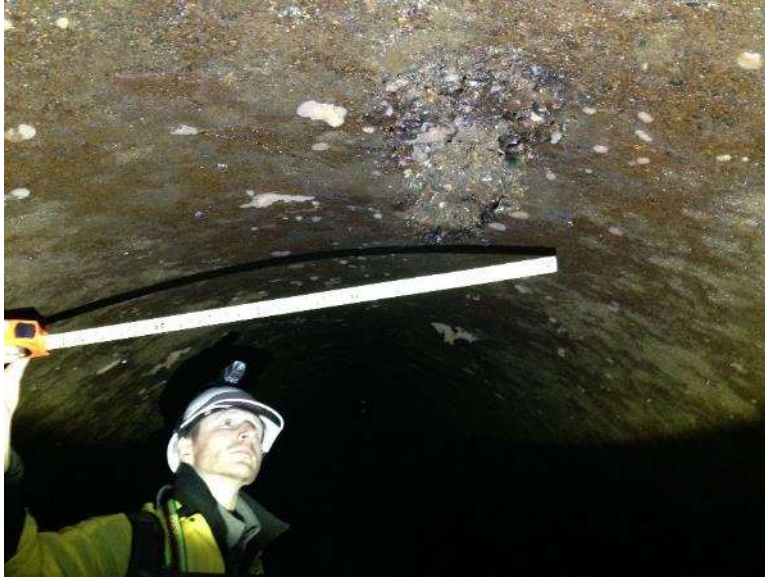
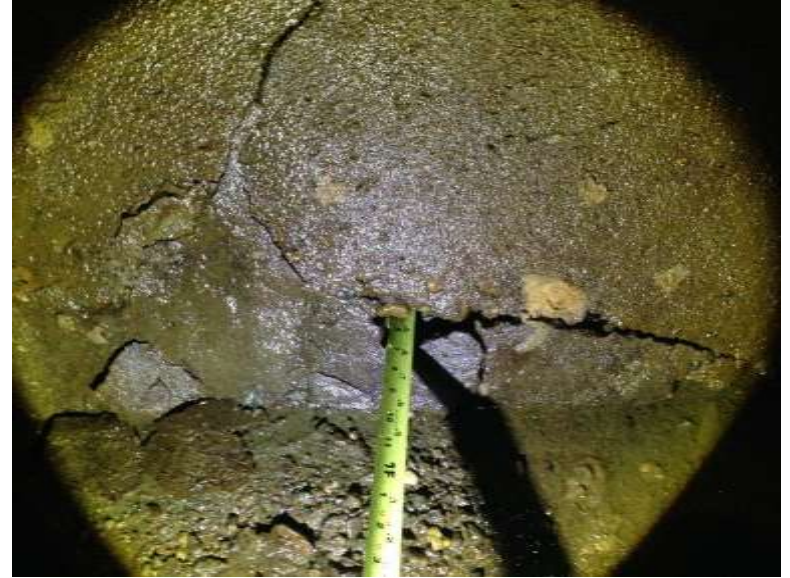
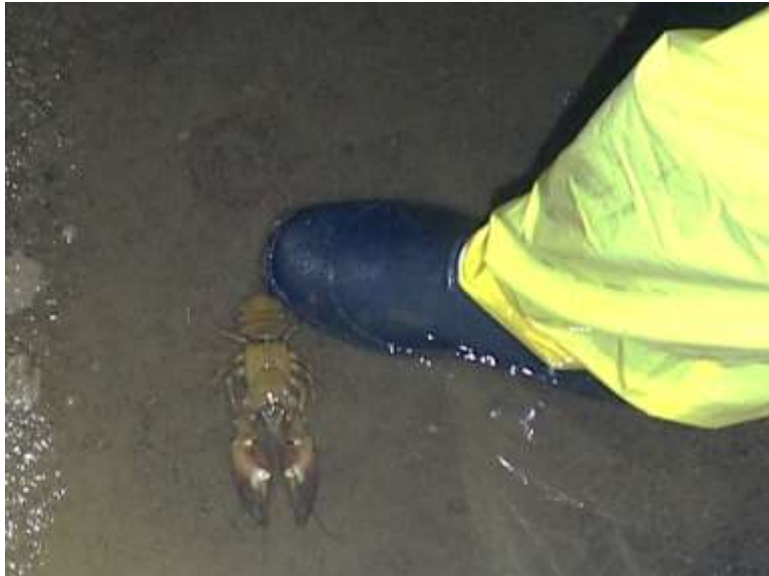
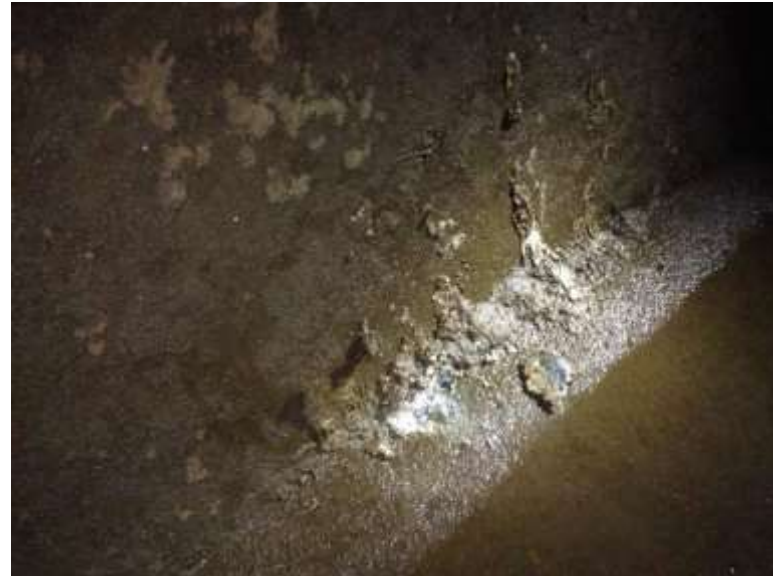
Man-entry Tunnel Inspection

- No major deformation
- Isolated liner defects
- Limited, minor fracture acceleration
- Next Step: Point repairs, monitoring plan

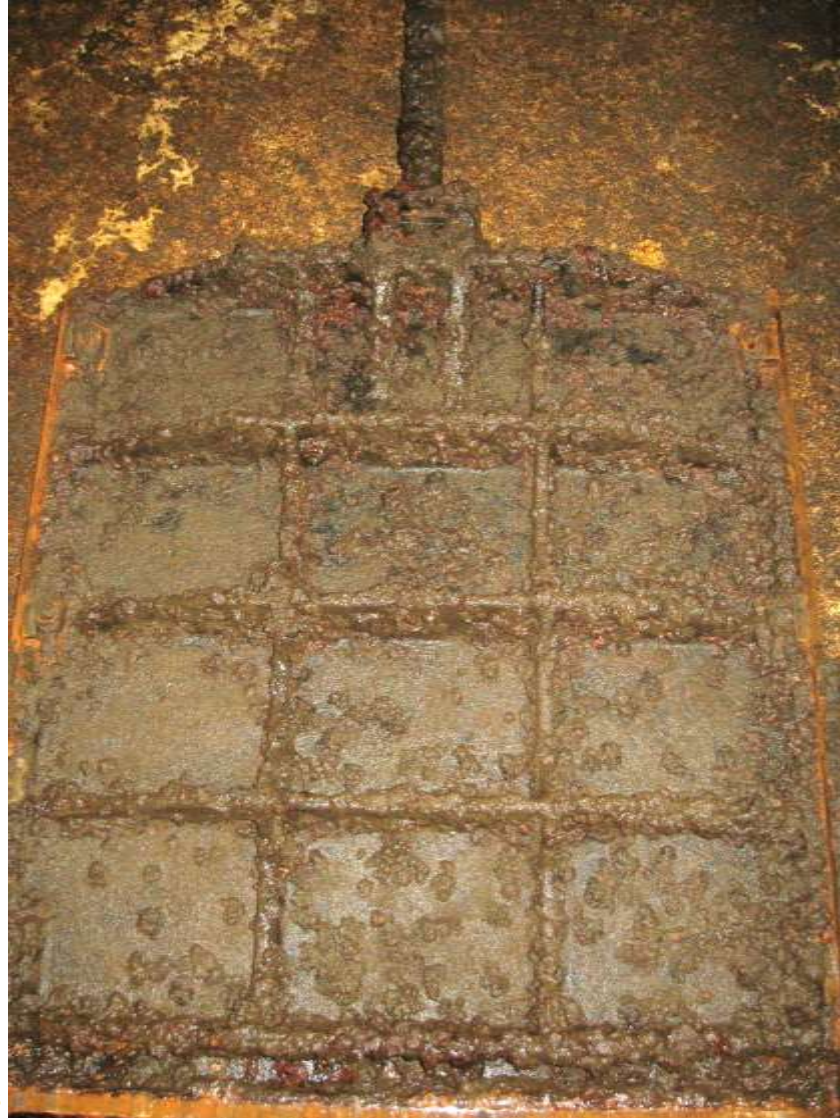
Slide Gate

- Concrete structure in good condition
- Travelling screens in good condition
- Slide gates
 - Heavy tuberculation
 - Some corrosion loss
 - Replacement needed
- Steel pipes (3) need rehabilitation

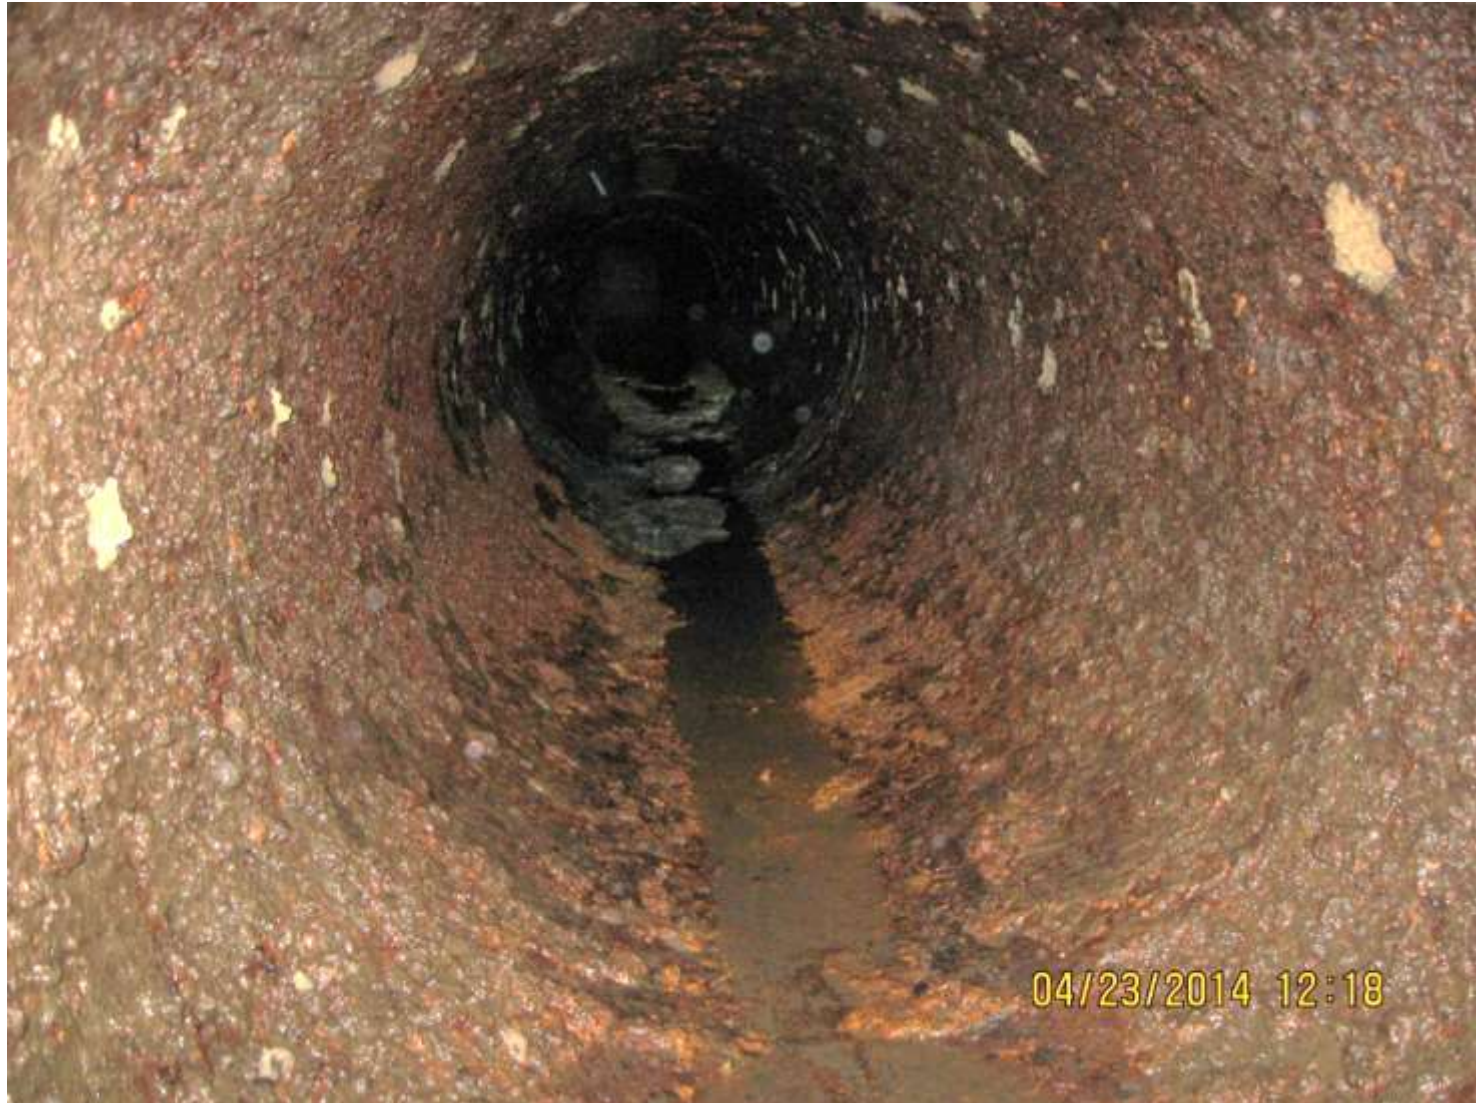
Internal Steel Pipe Condition

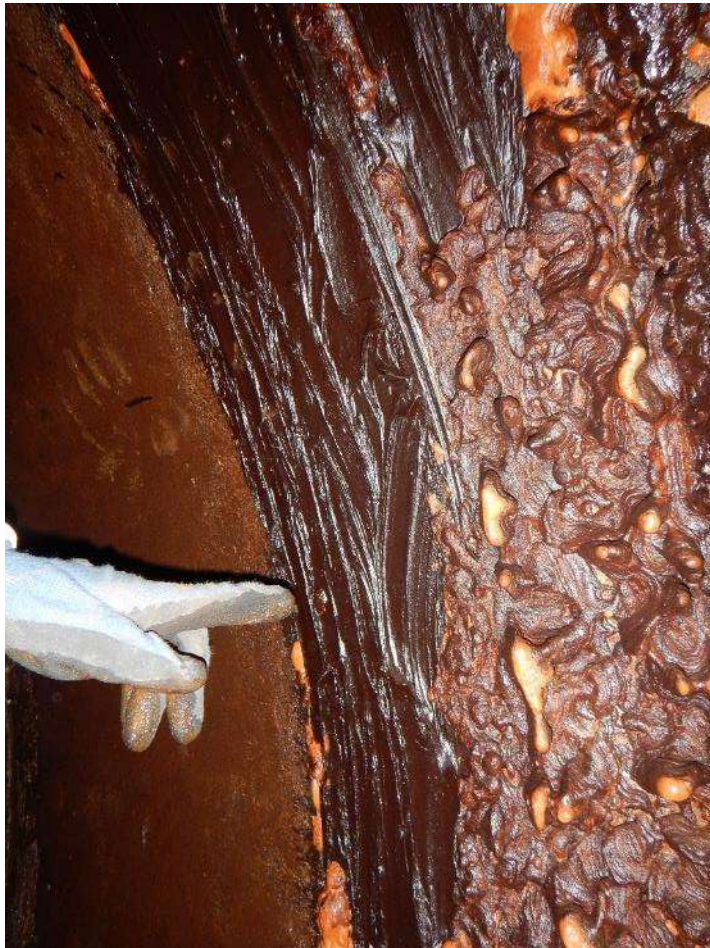
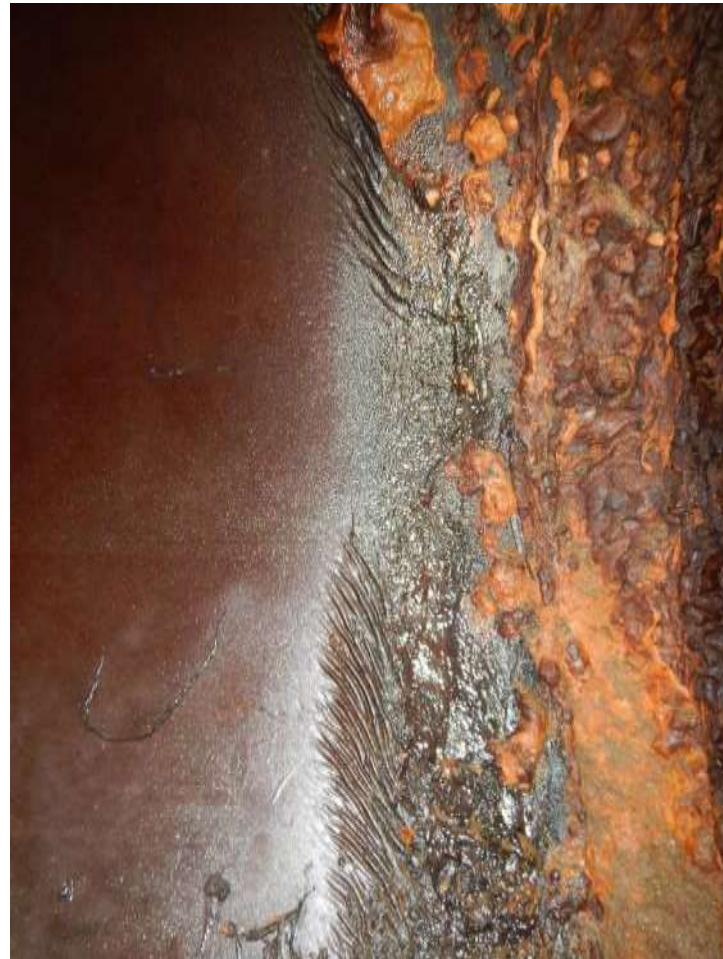
Tier 2 Internal – Concrete/Steel Pipe Joint

- External Tier 1 Complete
 - Corrosive soils
 - Stray current
- External Next Step: Tier 2 Test Pits
 - Evaluate coating/pipe condition
 - Test for stray current
- Internal Tier 2 Inspection
 - Coal tar enamel lining – excellent condition
 - Minor corrosion at coating defects
 - Localized repairs at few joints required

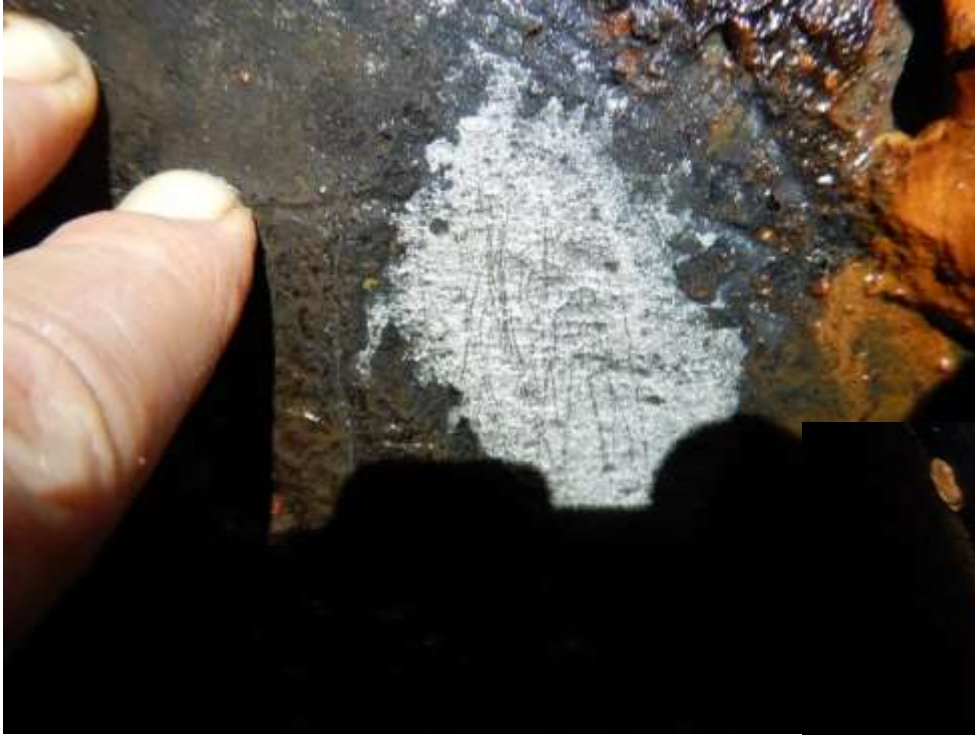
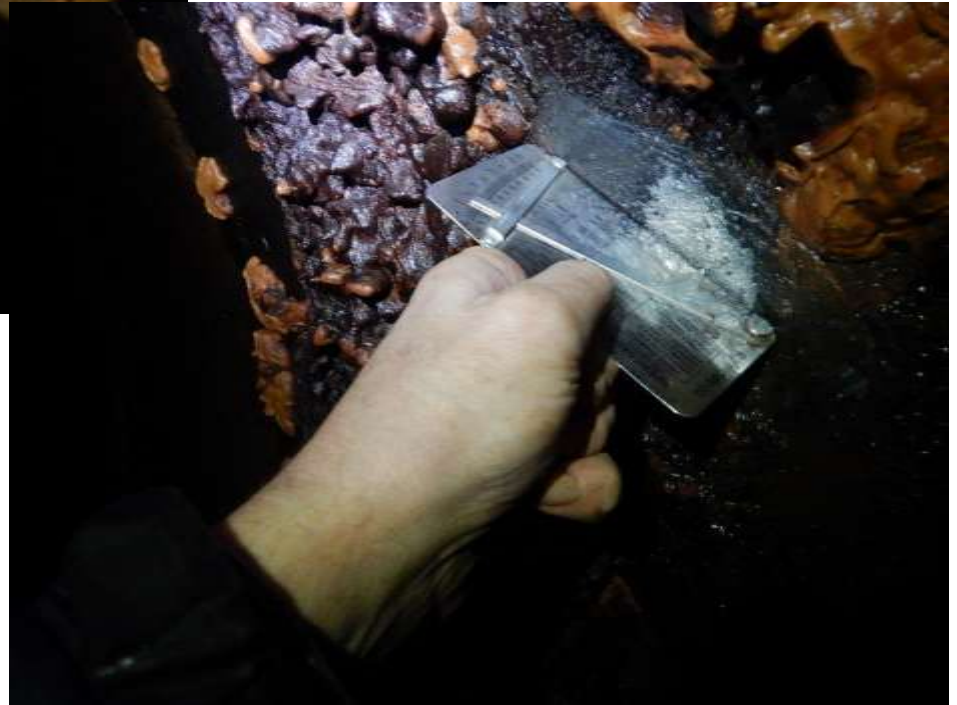
Tier 2 Internal - Pitting

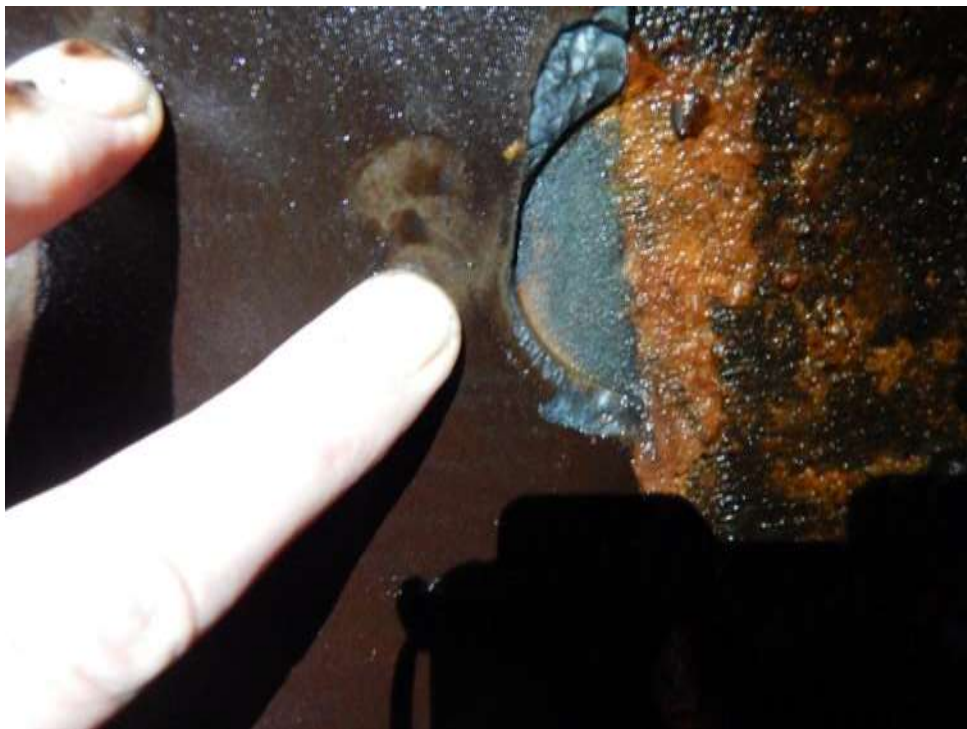
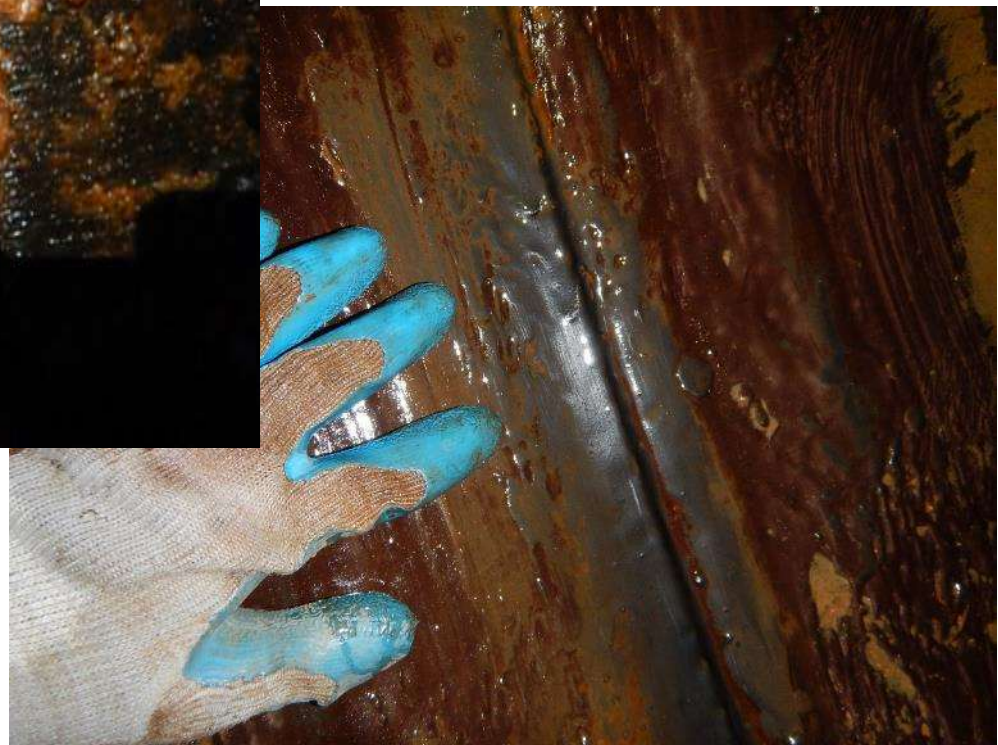
Tier 2 Internal – Coal Tar Lining

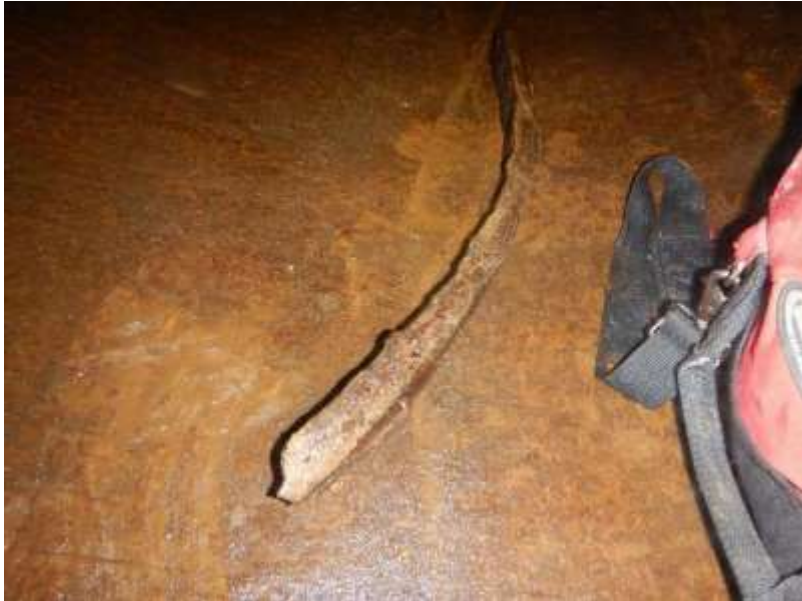
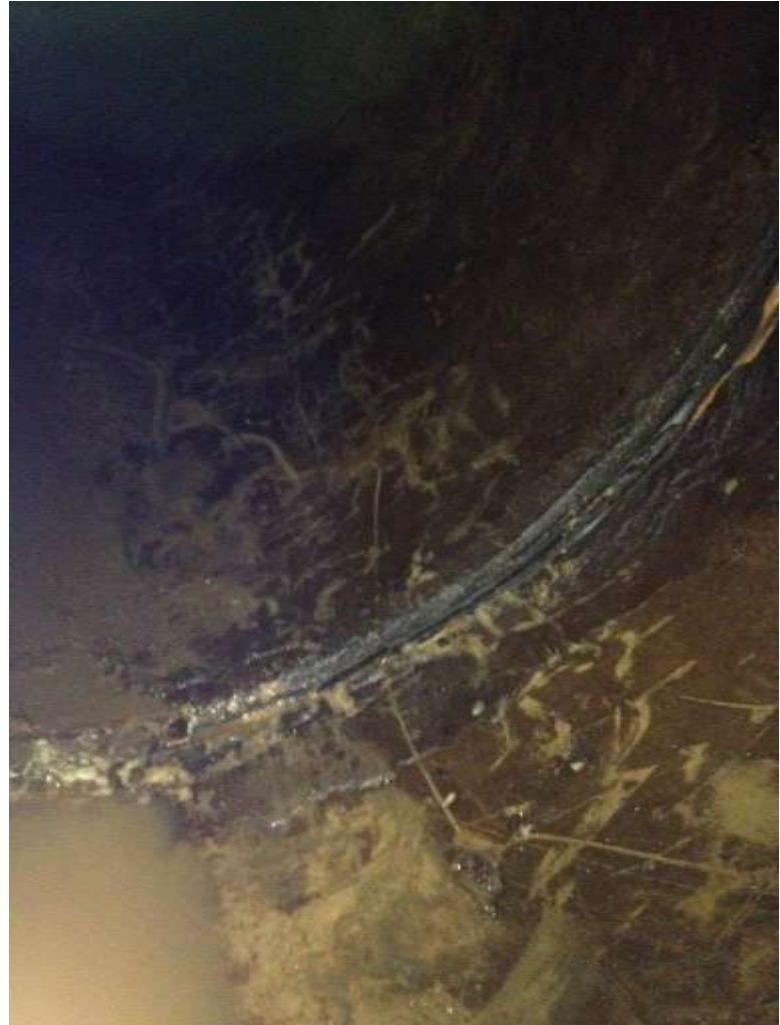
Tier 2 Internal – Cement Mortar
