Corrosion Conditions and Mitigation in Reclaimed Water & Groundwater Treatment Facilities

Milt Larsen, PE
Robert Ryder, PE

Kennedy/Jenks Consultants

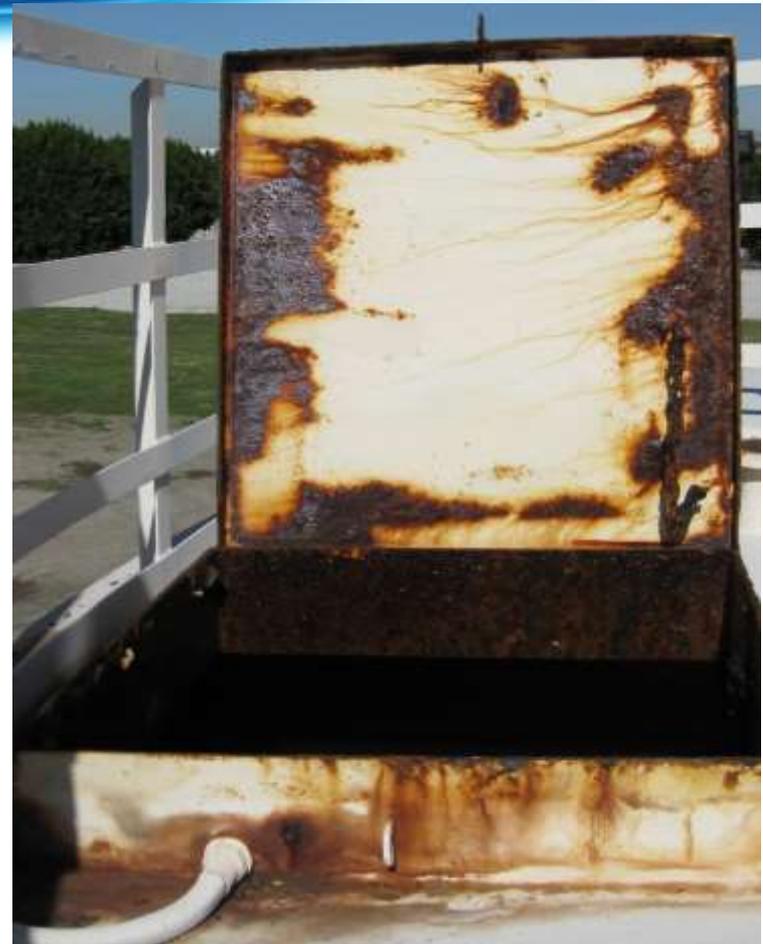
Carson Nitrified Product Water Tank

- Cl₂ Residual 5–10 mg/l
- DO 1–8 mg/l
- Conductivity 700-1200 μS/cm
- NH₃-N 0.15-2.5 mg/l
- TOC 9-13 mg/l
- Fe 0.5-2.5 mg/l

▶ 225,000 gal steel tank

▶ 10 years of service

- ROV robotic inspection
- Coating extensively blistered
- Extensive pitting
 - > 60 mils on walls
 - 1/8" to 1/4" pits on floor
 - 25 mils/yr pitting rate

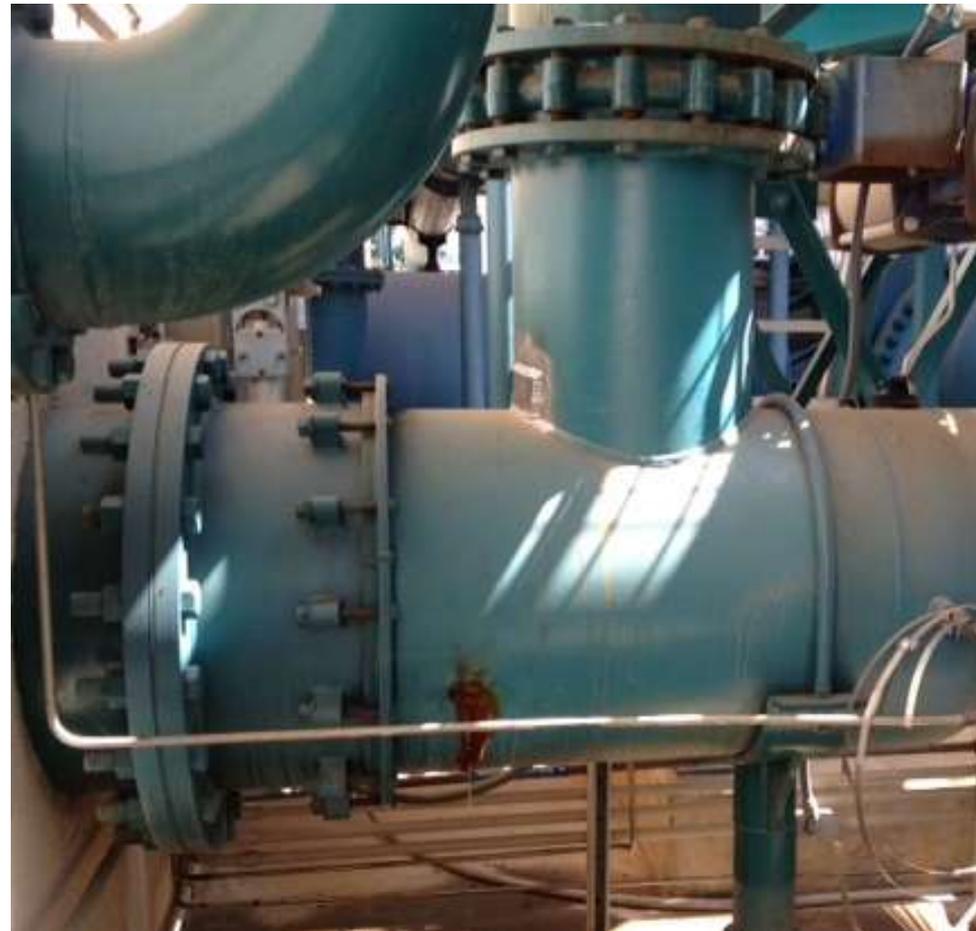
Edward C Little Filter Piping Corrosion

- ▶ Pitting failures: tees downstream of backwash supply control valve
- ▶ Initial leaks \approx 10 years after filter startup
- ▶ \approx 5 leaks per year

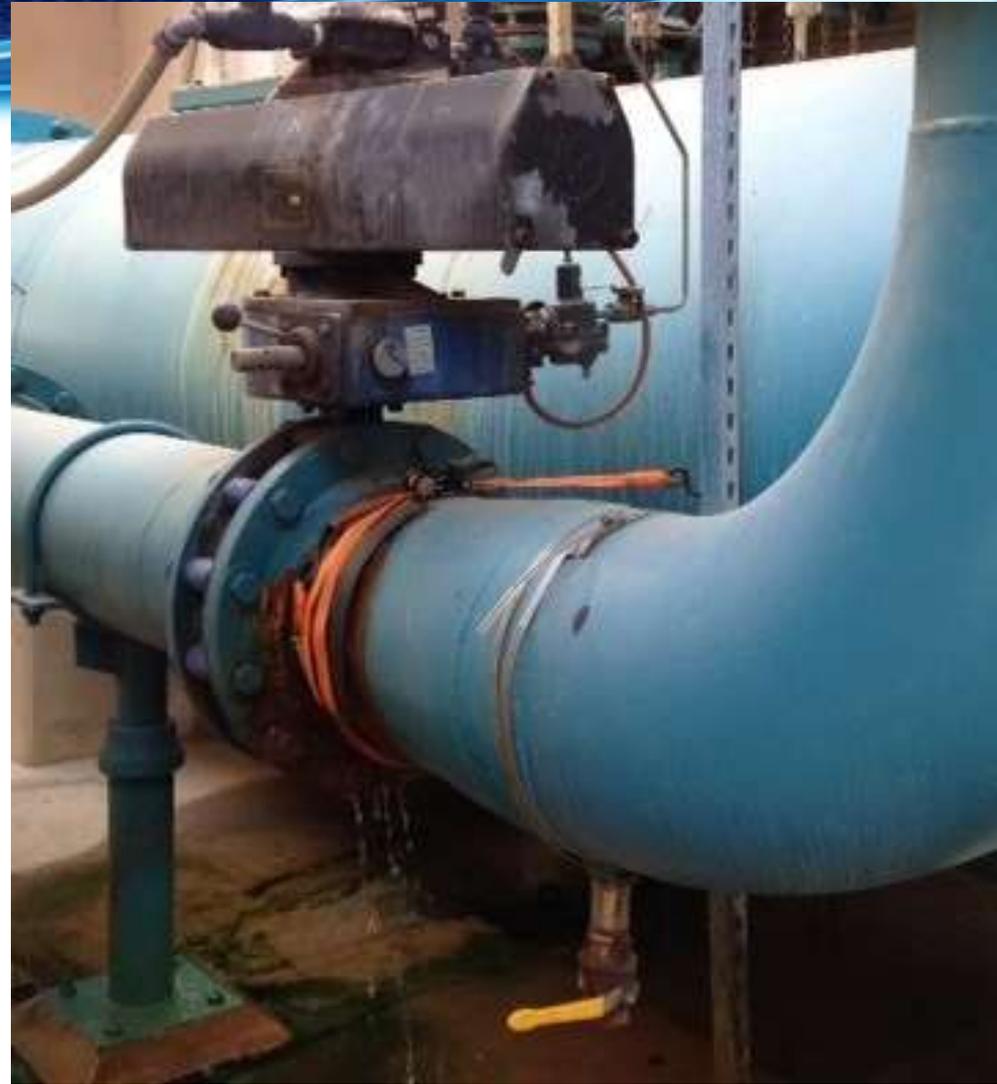
Filter Piping Corrosion

- ▶ Downstream of main backwash flow control valve
- ▶ Initial leaks \approx 2 years after filter startup
- ▶ Initial repairs: pipe clamps & rubber seals

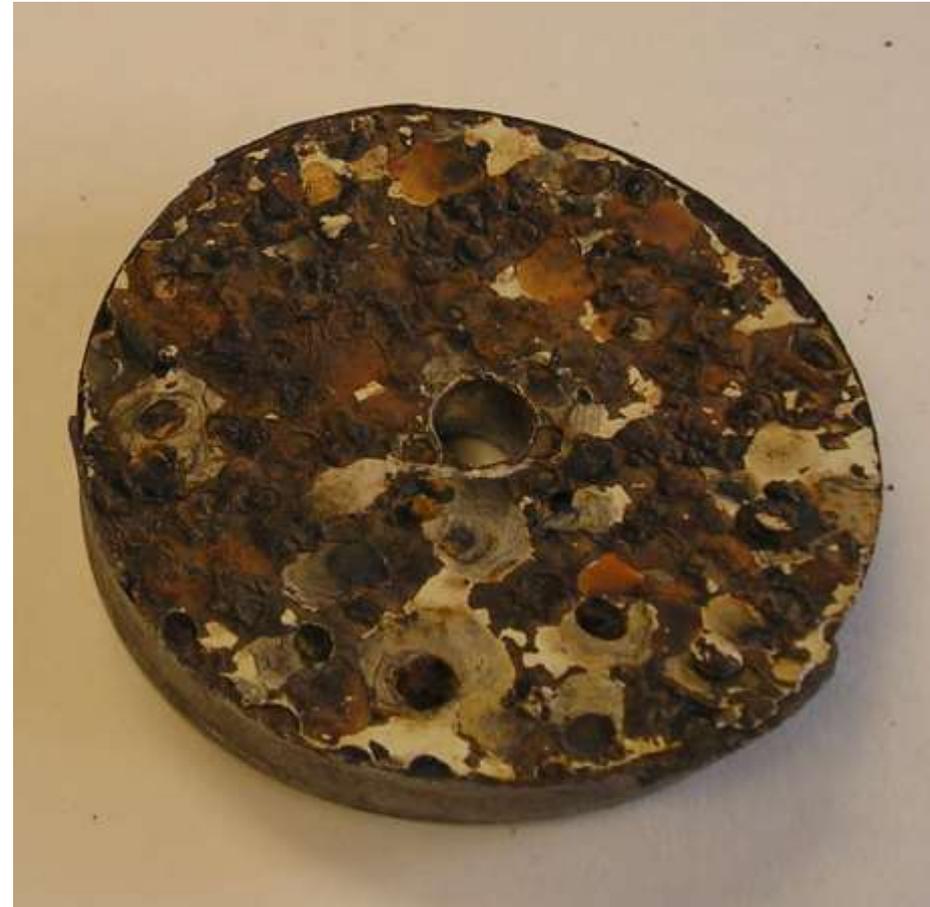
Filter Piping Corrosion

- ▶ 2.5" Φ coupon
- ▶ Remaining epoxy coating
 - \approx 10% coverage
 - Brittle & chalking
- ▶ Pits
 - 15 to 40 mils deep
 - Black ferrous oxide in the bottom of the pits
 - Pitting rate estimated 6.7 mils/yr assuming epoxy lining did not fail for 10 years
 - Remaining pipe life 25 to 40 years

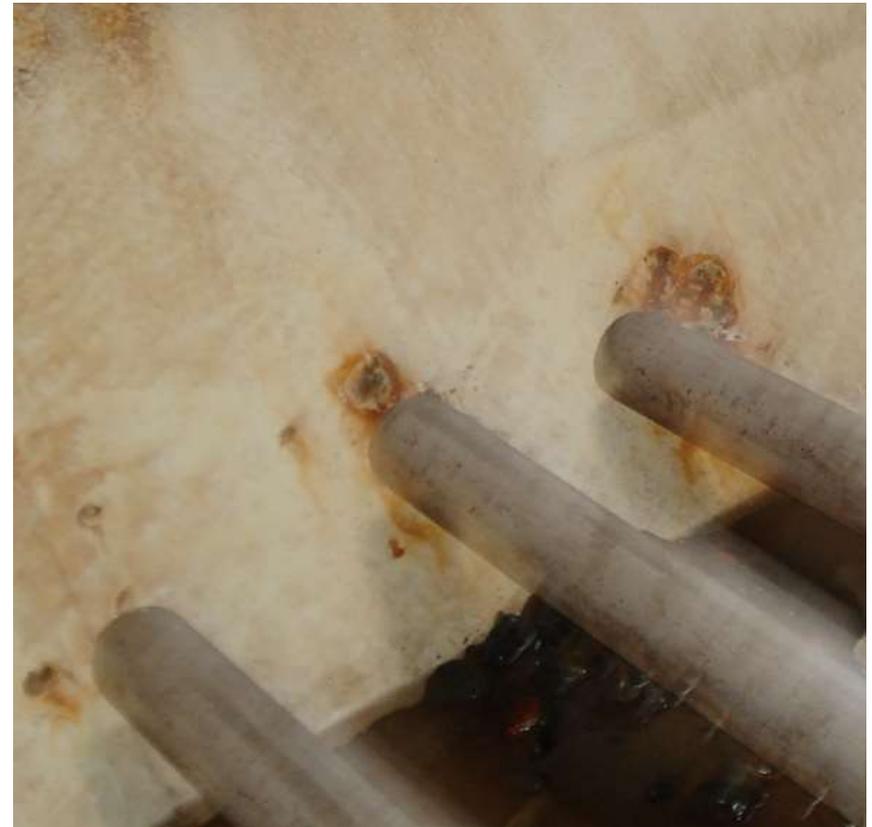
Ellsworth Pressure Filter Corrosion

- ▶ Filter lining: 3 coat polyamide epoxy
- ▶ Adhesion test > 1200 psi after 20 years service
- ▶ Pitting adjacent SS laterals
- ▶ Some pits up to $\frac{1}{8}$ " to $\frac{1}{4}$ " deep
- ▶ Dissimilar metals
