Portland
Water
Bureau's
Experience
with a Non-
Acute Total
Coliform
Rule
Violation:
Part 1 of 2

KIMBERLY GUPTA, PE
PORTLAND WATER BUREAU

AWWA PNWS CONFERENCE
BELLEVUE, APRIL 30, 2015

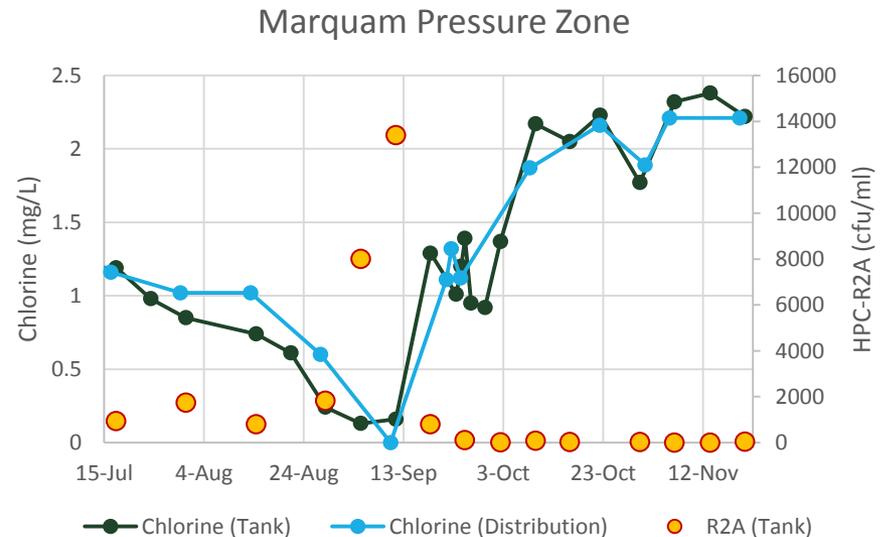
Water Quality in Marquam PZ Prior to the Incident

Water quality improved in the Marquam Hill Tanks and PZ as a result of these activities, however....

...it is possible that a slug of this water may have been inadvertently pumped up to Bertha Pressure Zone

Bertha is supplied by the Marquam Hill Tanks

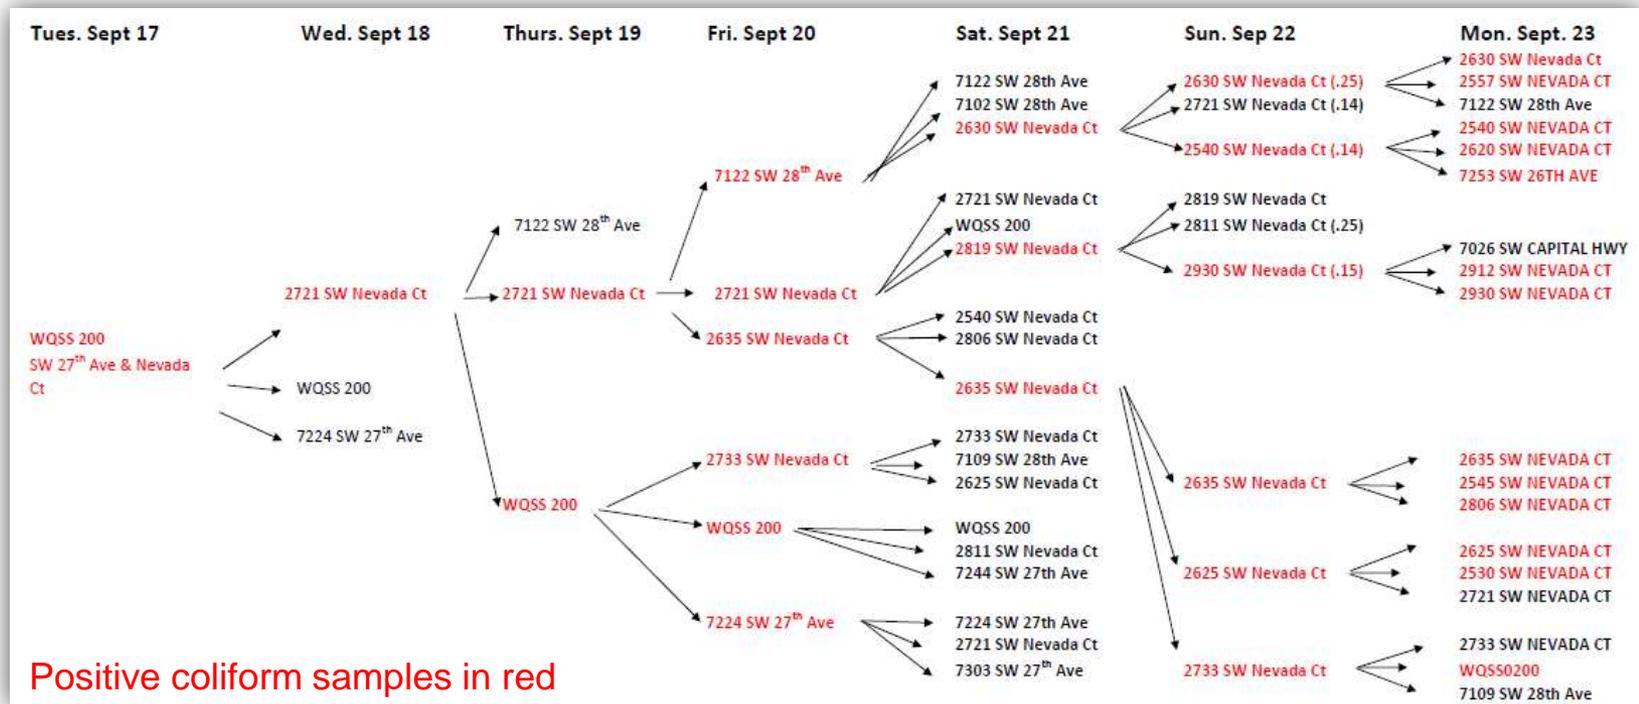
Sampling: Sept 18-23

The situation in Bertha was especially unusual because the resamples also came back positive for total coliforms. Typically our resamples come back negative, but this was not the case here.

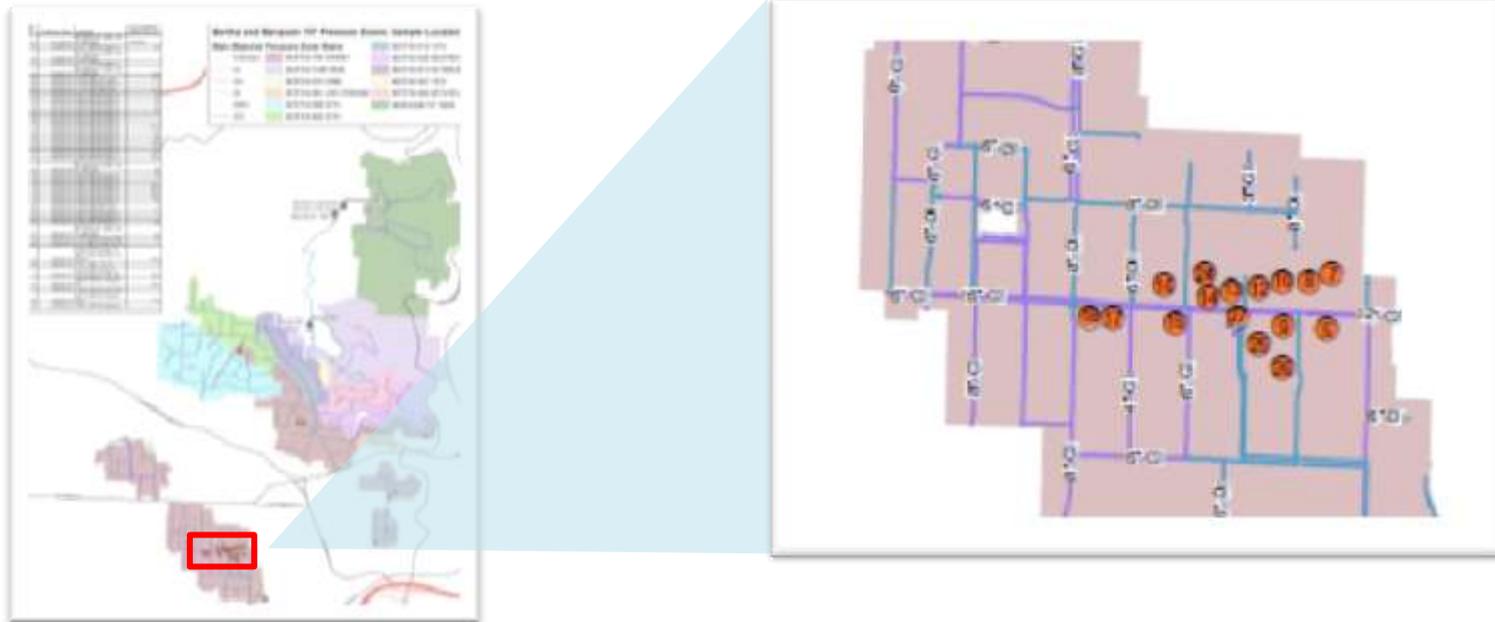
Positive samples were clustered in a small pocket of the Bertha 750 PZ

Due to the extensive sampling conducted Sept 18-30 (67 voluntary surveillance samples in addition to the routine TCR samples collected during this time) as well as the hydraulics in the area, PWB felt confident that the contamination was limited to a small pocket in the SW of the system
