North Transmission 12th & Baseline Main Break

PNWS – AWWA 2015 CONFERENCE

Tyler Wubbena, PE
Engineering Manager, City of Hillsboro

Matthew Duffy, PE
Pipelines Engineer, HDR Inc.

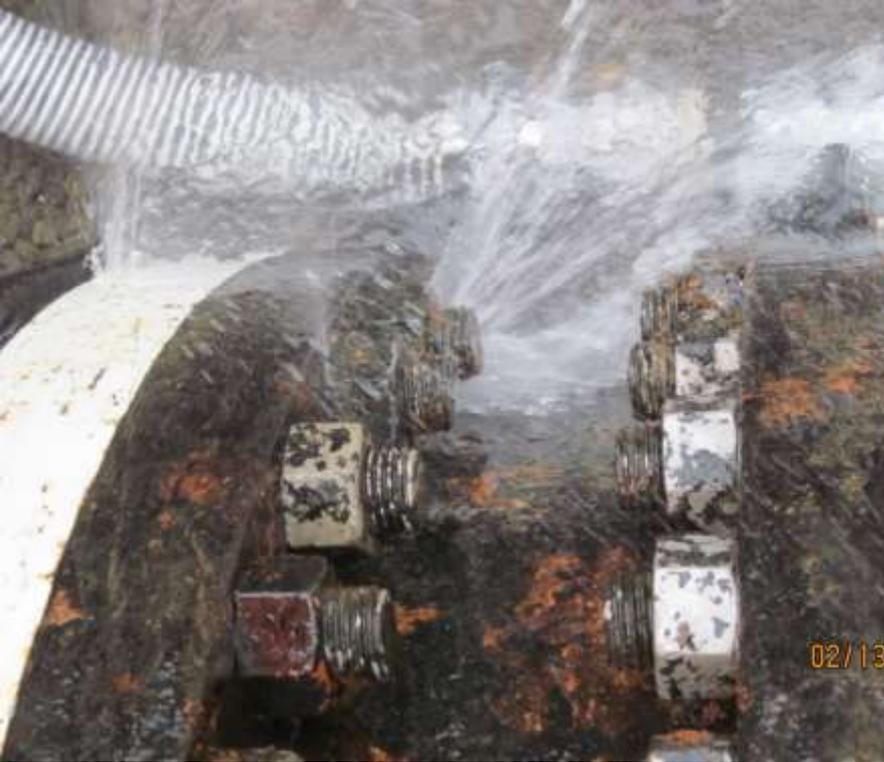
Thursday, Feb 13: Leak inspection by HDR and Hillsboro Engineering staff.

BFV in service 11 years. At the time of failure, no other mainline valves on the NTL had experienced service issues.

- NTL only pressurized on S. side of BFV
- Visible crack in valve body
- Water spraying through bolt holes and flange
- Unable to excavate further

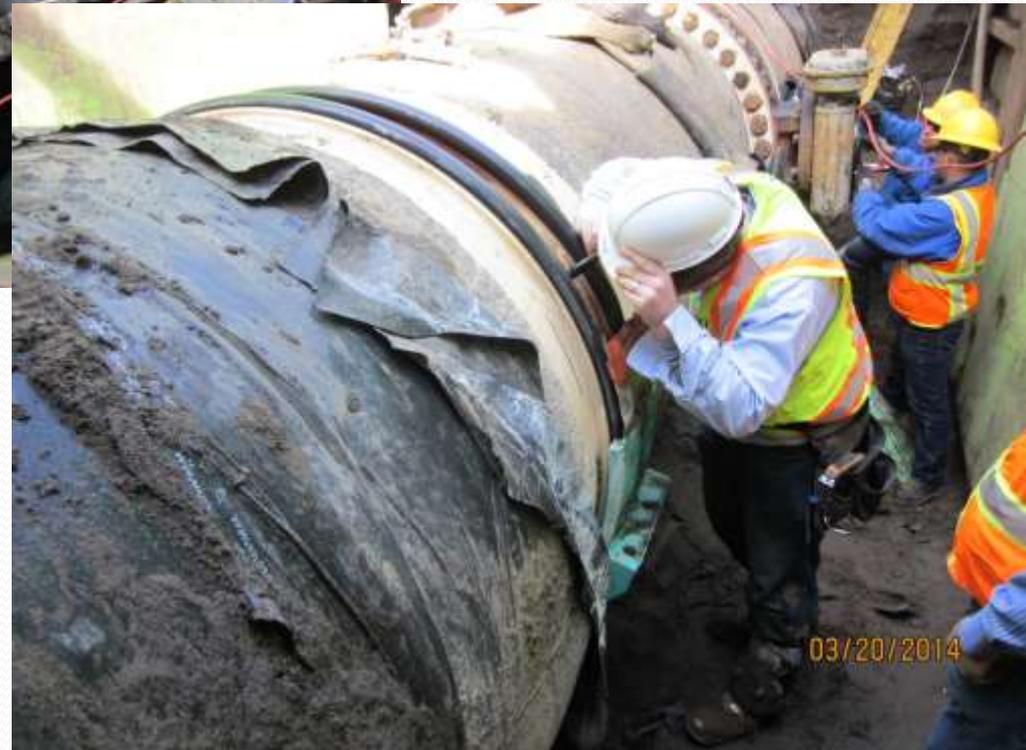
Unusually narrow gap
at top of coupling

- 54 inch BFV installed with tension from adjacent coupling
- Vertical Mis-alignment during initial construction
- Potential for some settlement in the immediate vicinity of the valve (sand backfill)
- Vibrations from adjacent railroad tracks

- Remove all strain from valve
- Provide full support through valve and excavation area – CLSM (low strength concrete) above spring line
- Replace coupling with butt-strap

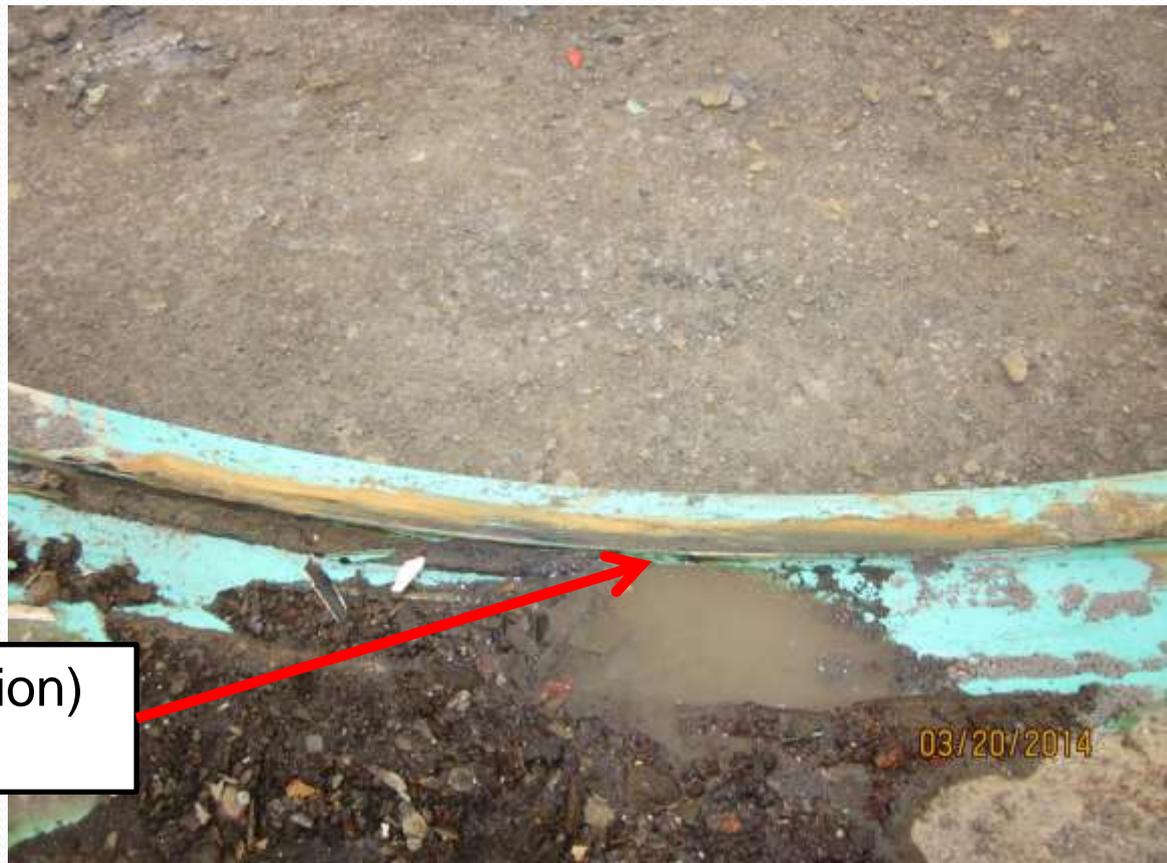
Evidence of binding (in tension)
at bottom of coupling

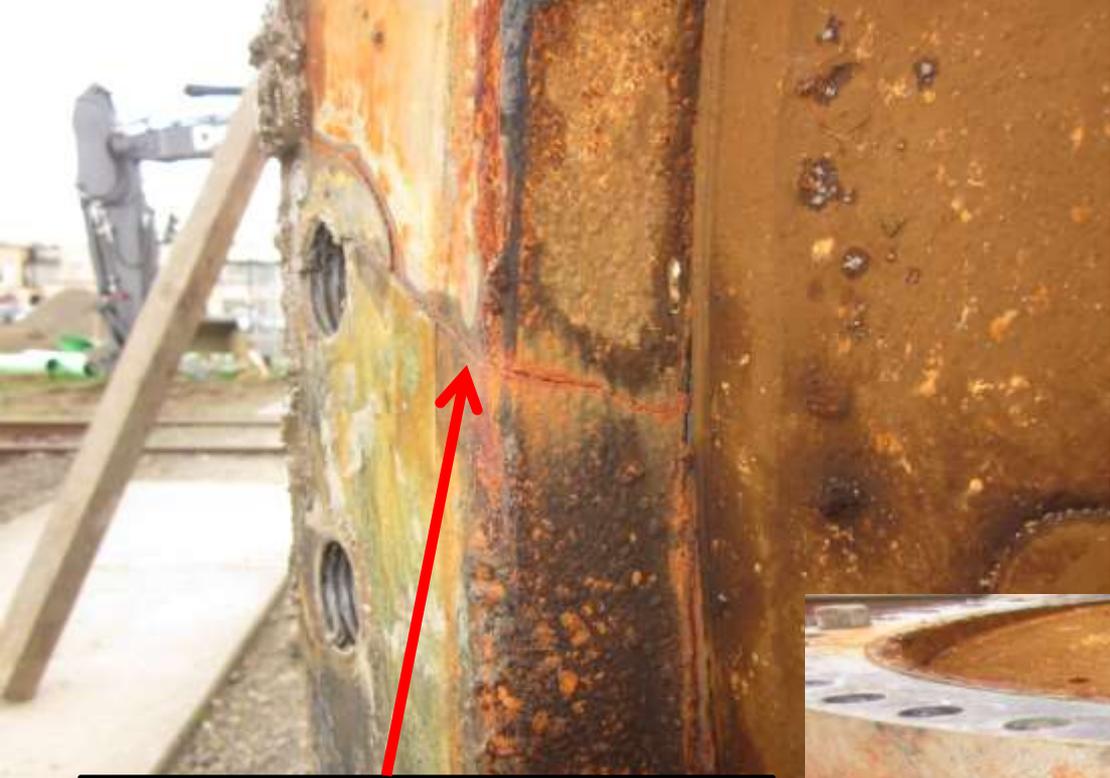
Crack through flange face
(south side of valve)

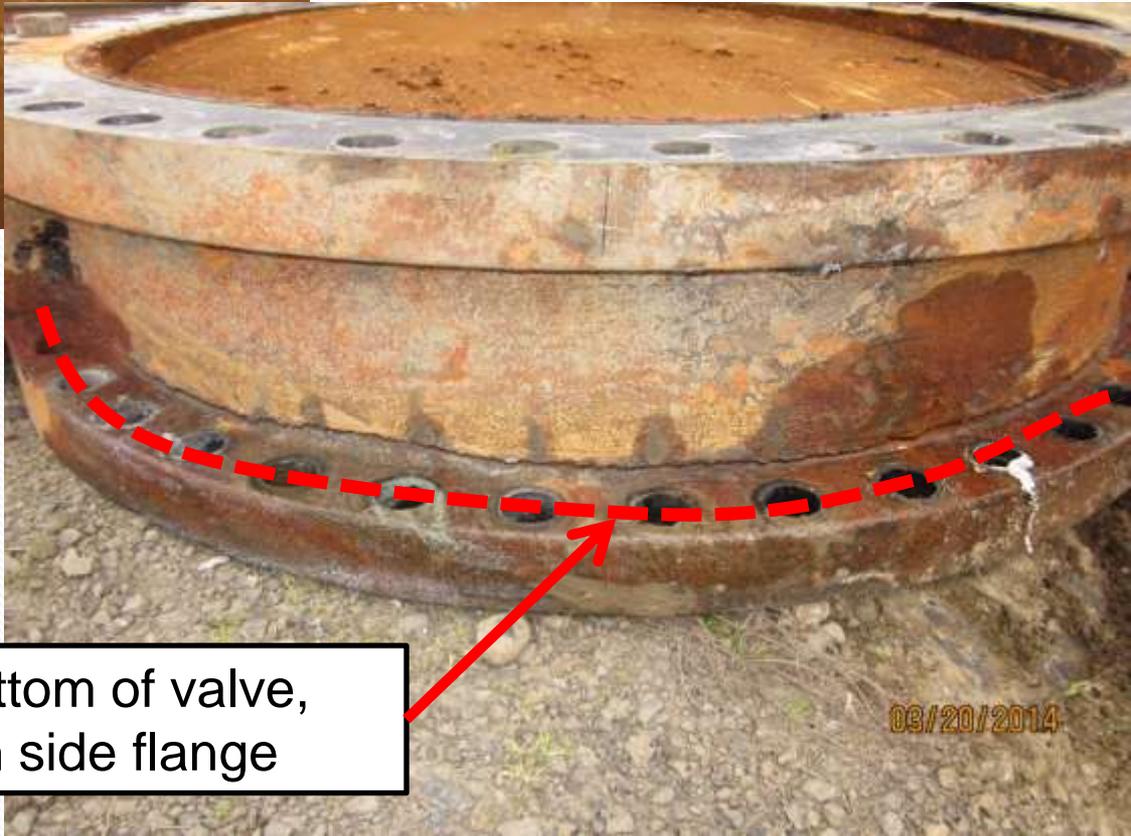
Crack across bottom of valve,
adjacent to north side flange

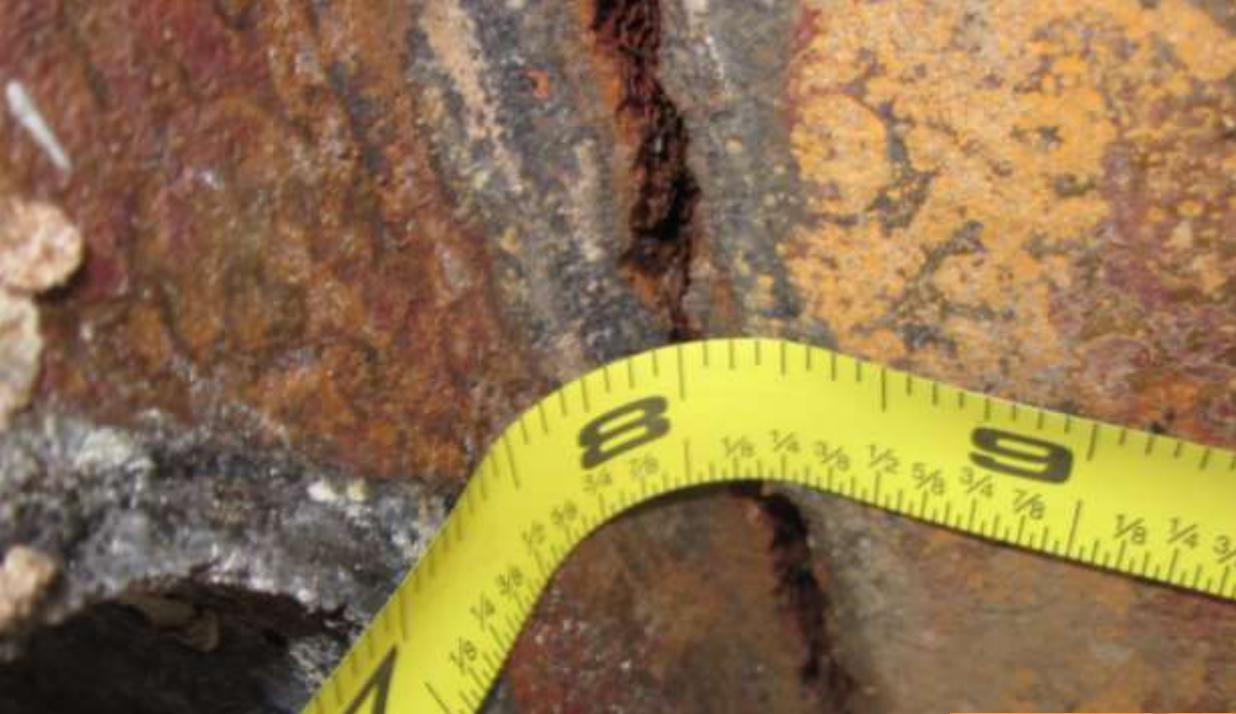
Close up views
cracks in valve body

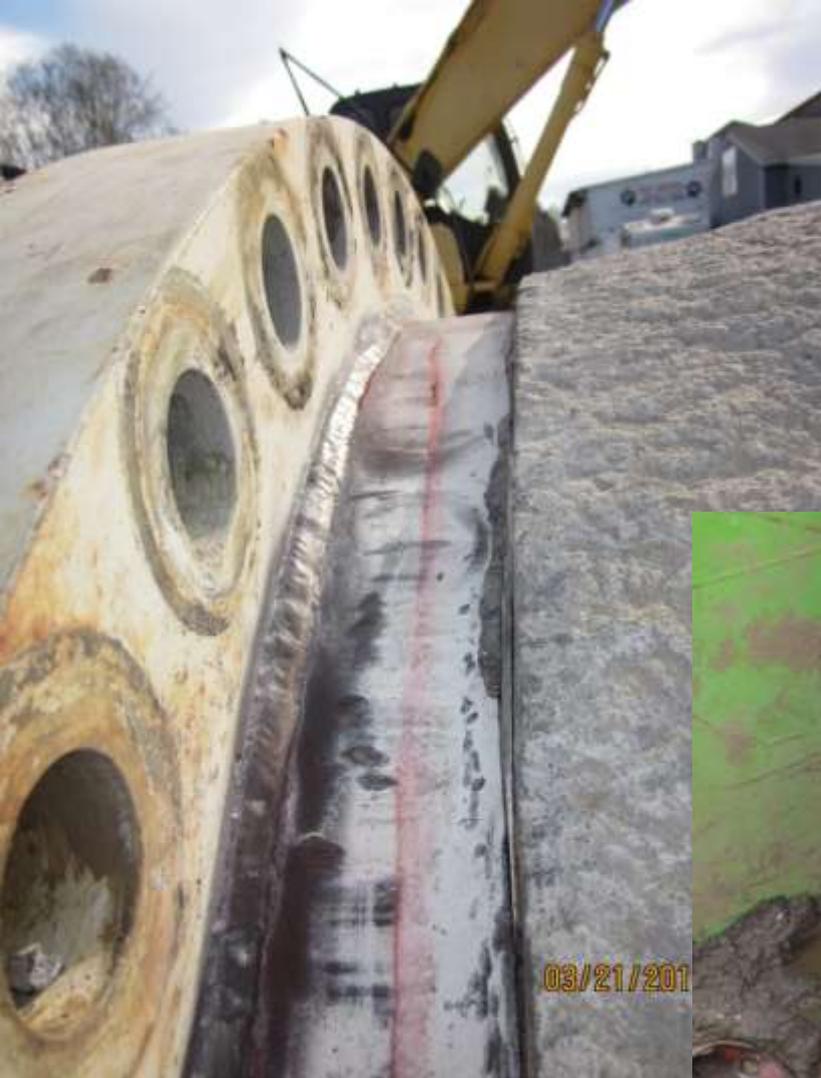
Friday March 21:
Magnetic particle
testing of existing
flanges

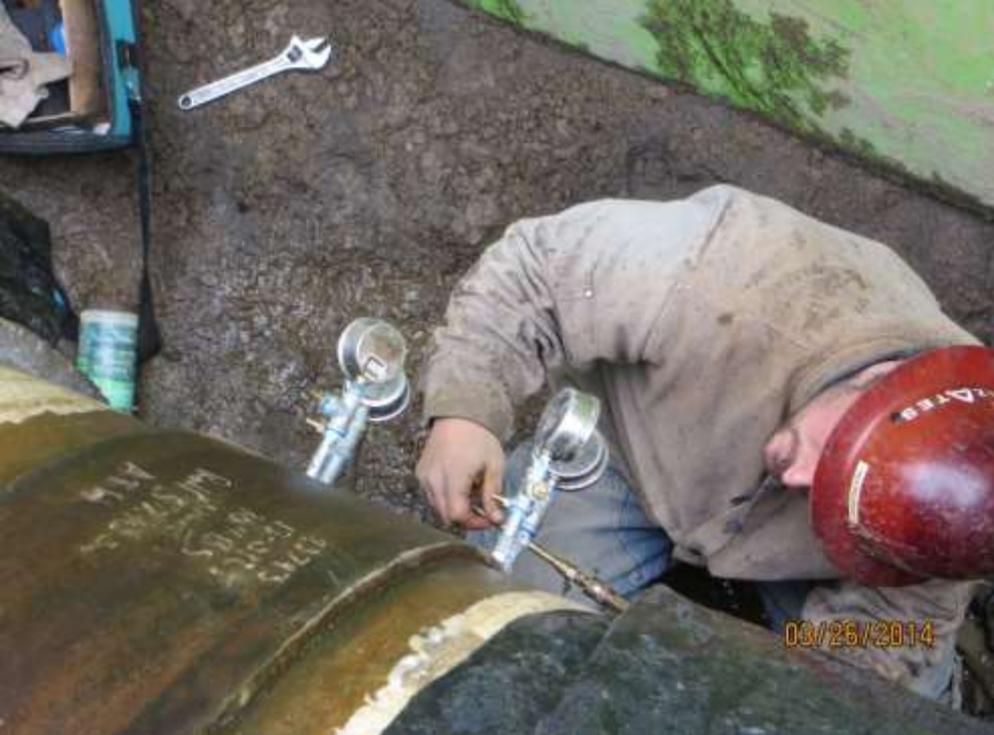
Wednesday March 26: air
test inspection of welded
butt strap joints
