# SEISMIC ANALYSIS OF VANCOUVER'S WATER TOWERS

Nick Robertson, OBEC Consulting Engineers  
Patrick Craney, City of Vancouver

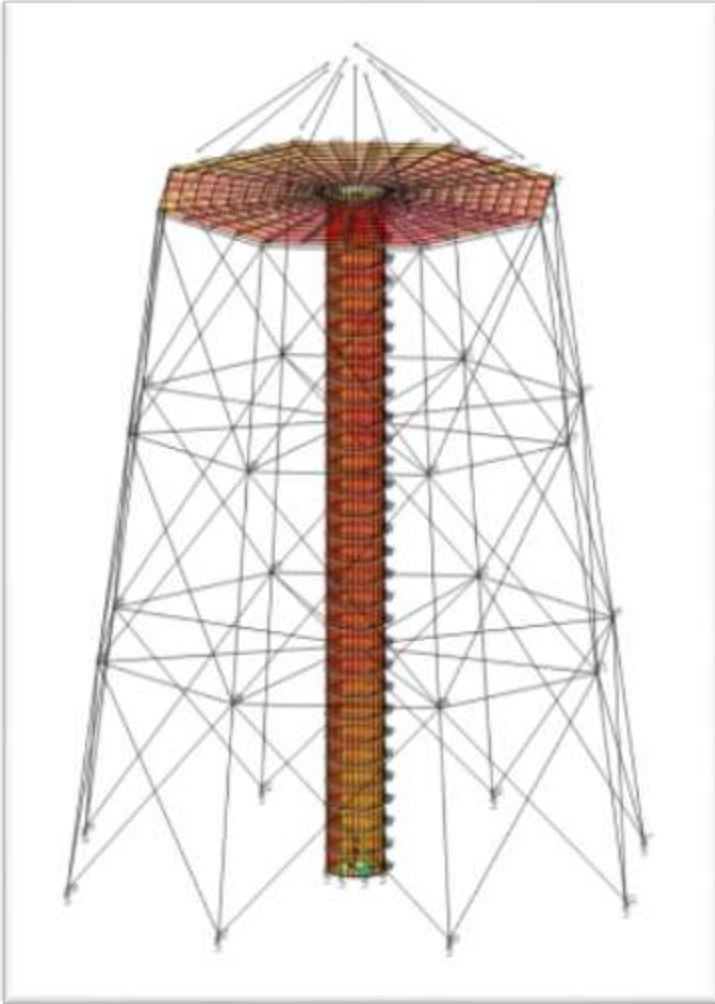
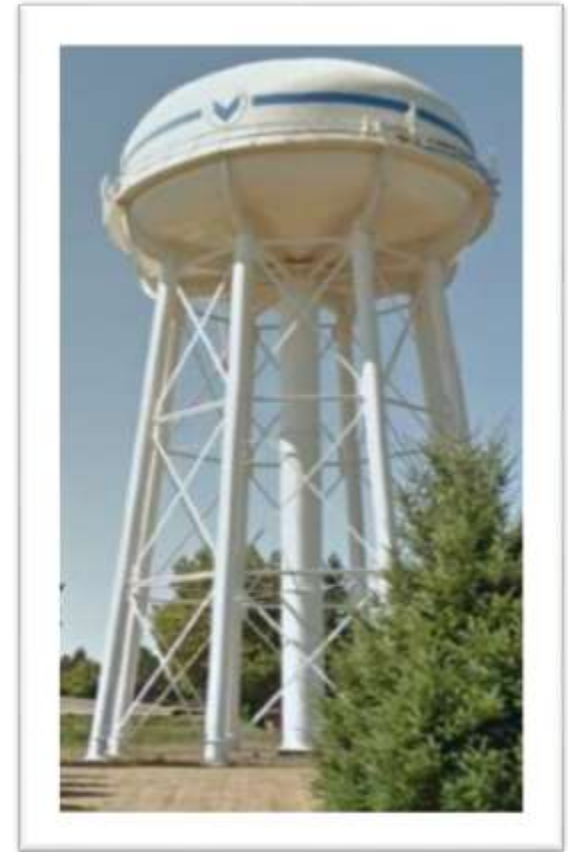
# >> Water Station 5

Seismic analysis results	
Fundamental Period:	1.79 sec
Deflection at top of columns (BSE_2E)	9.6 in.

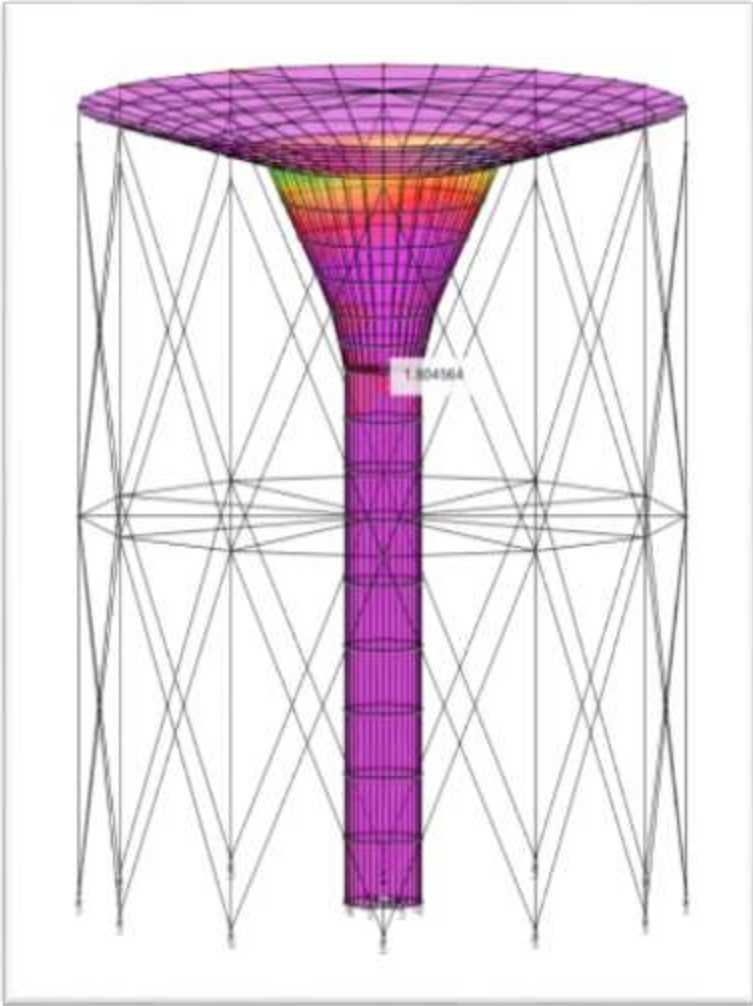
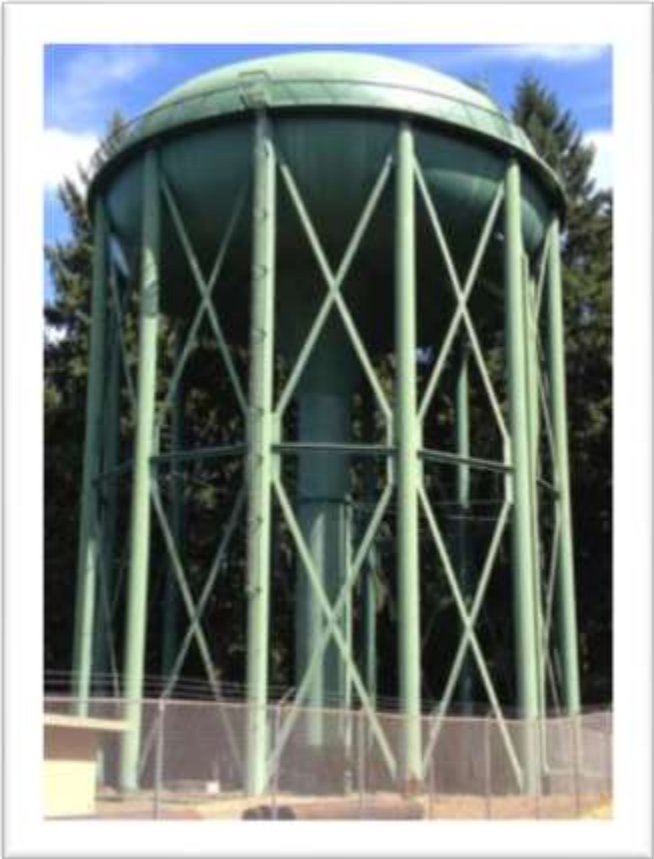
# Water Station 6

Seismic analysis results	
Fundamental Period:	1.96 sec
Deflection at top of columns (BSE_2E)	10.5 in.

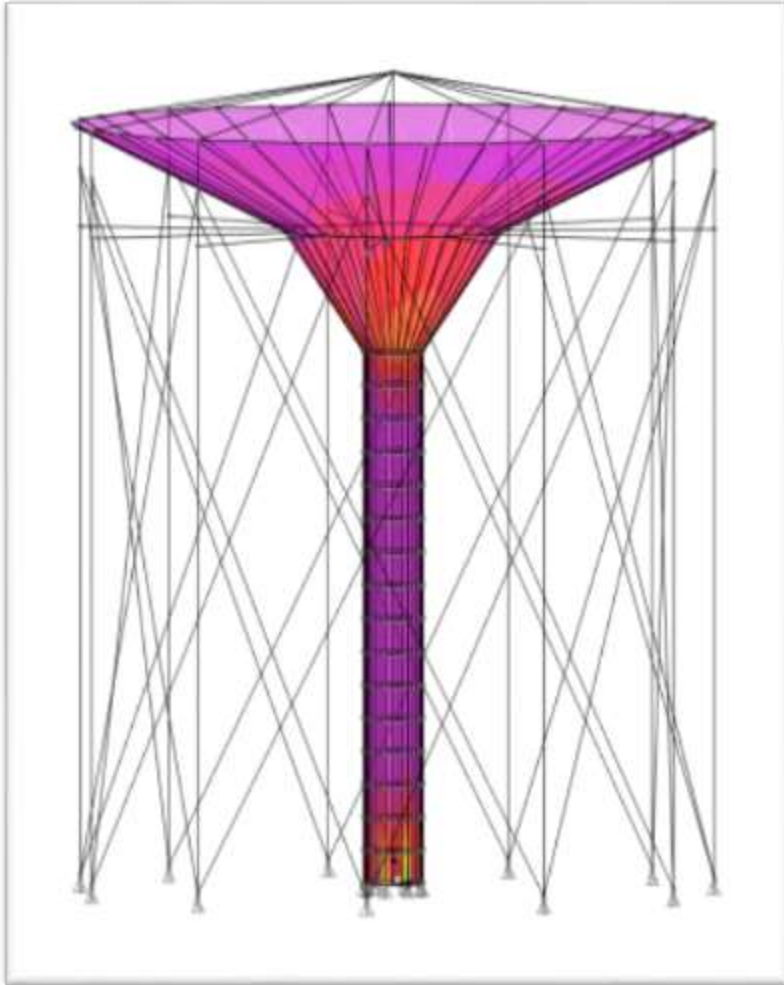
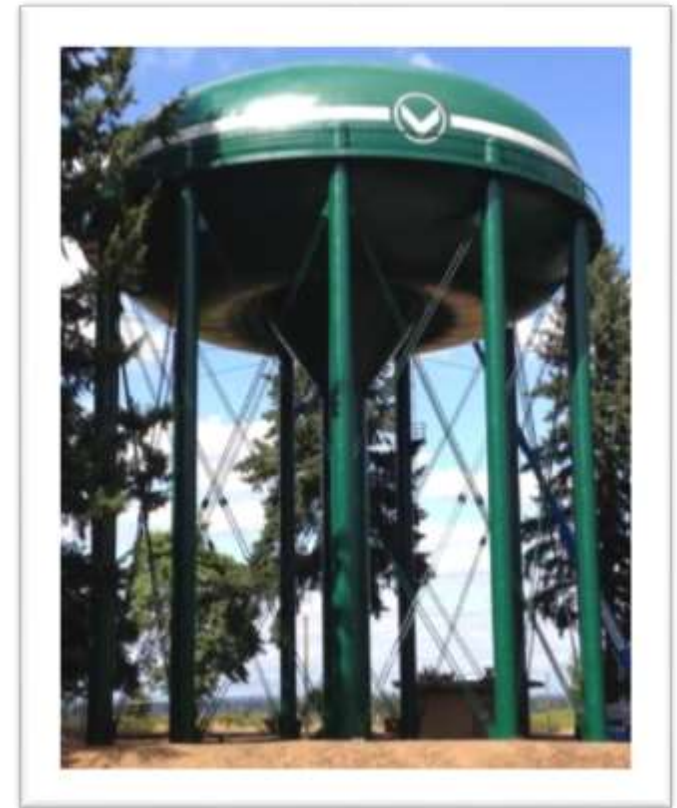
# >> Water Station 7

Seismic analysis results	
Fundamental Period:	1.76 sec
Deflection at top of columns (BSE_2E)	9.3 in.

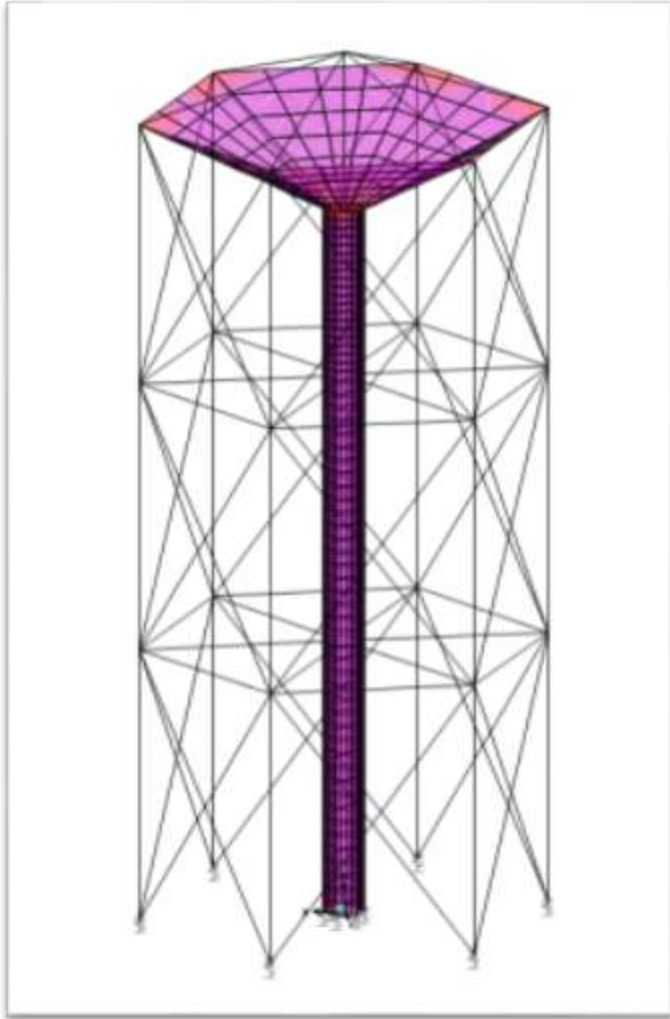
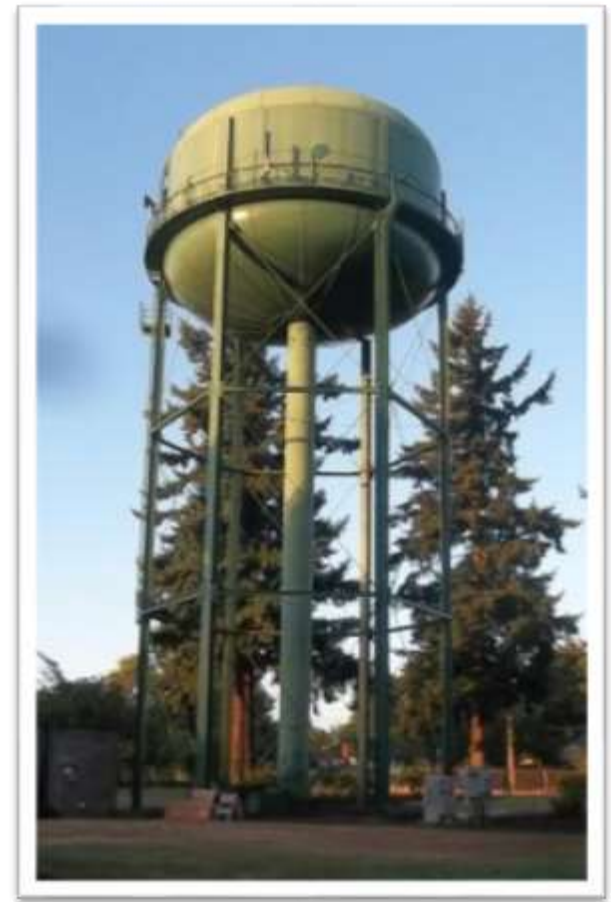
# >> Water Station 3

## Seismic analysis results

Fundamental Period:	3.33 sec
Deflection at top of columns (BSE_2E)	23.7 in.
