Lead Pig Tail Investigation and Removal Program

PNWS-AWWA Section Conference April 27, 2018

Ken Johnson, Operations Superintendent, Medford Water Commission

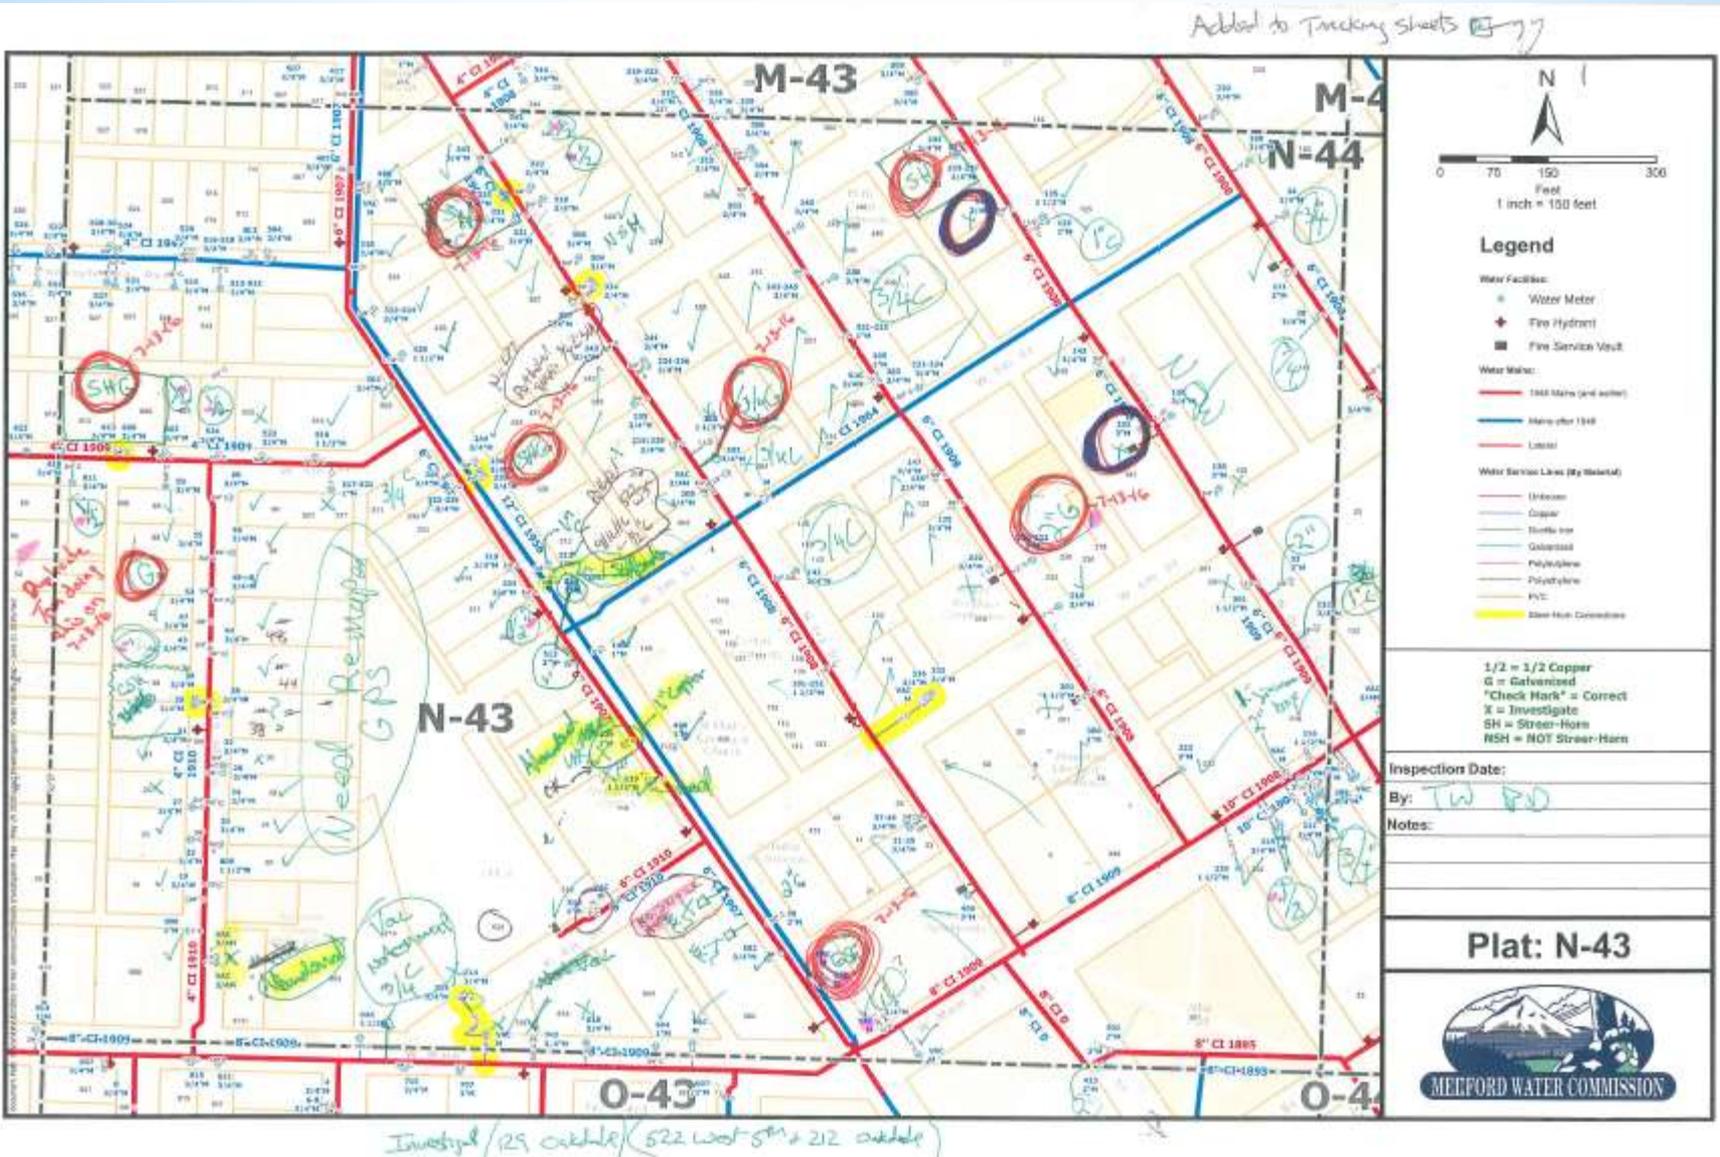
77 Plat Maps Created for the Initial Investigation- (With field notes)

Investigative Plats - 1946 Age Pipe of Older

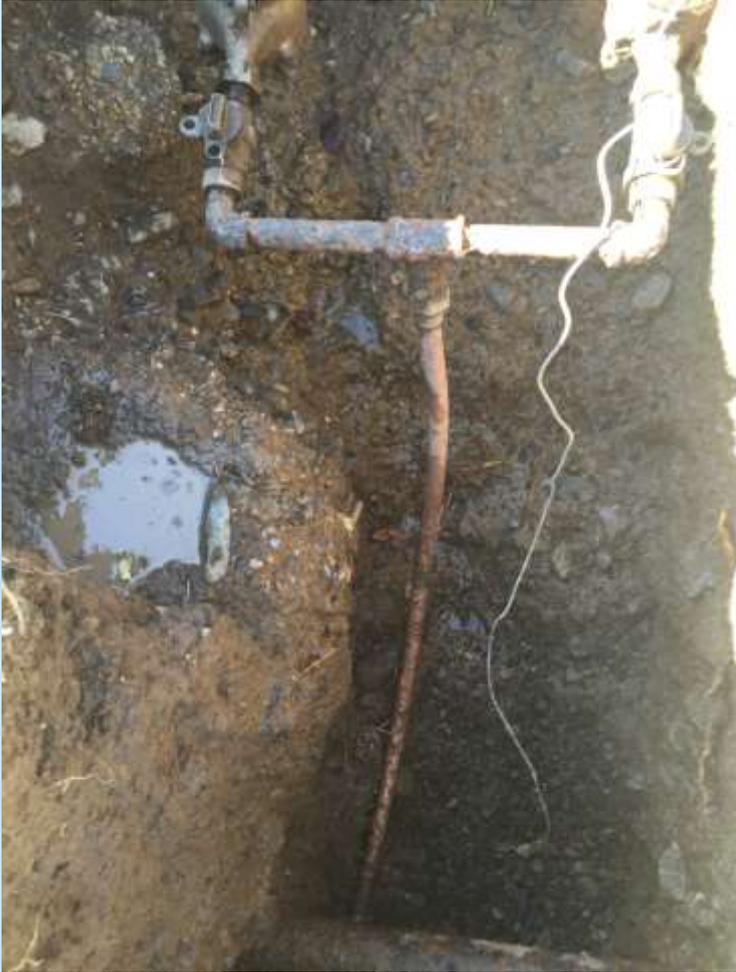
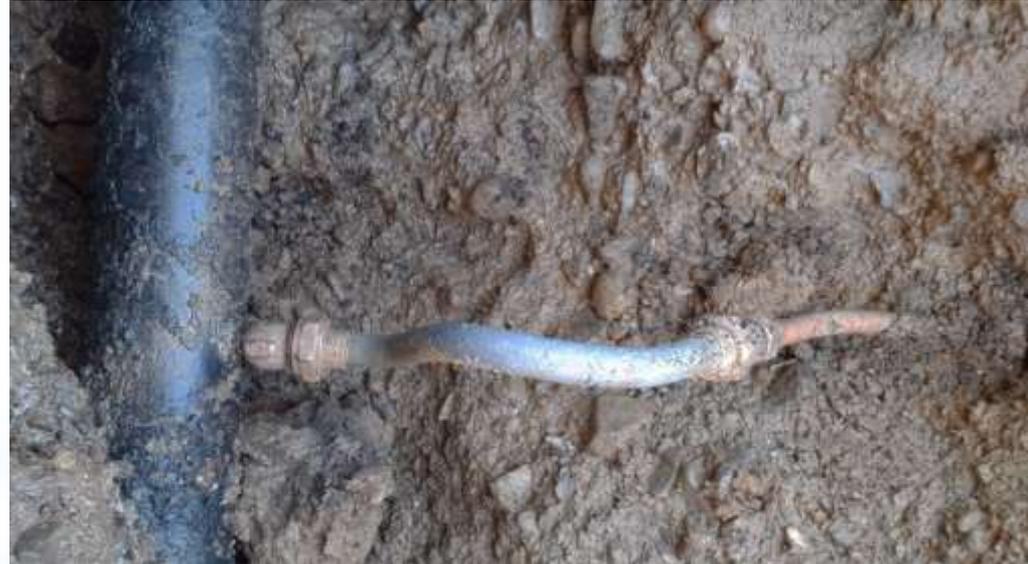
Galvanized Steer-Horn to Copper to Lead Pigtail

What a Steer Horn?
