Assessment of a Leaky Transmission Main

ASSESSING AND DEVELOPING OPTIONS TO REDUCE
VULNERABILITY OF AGING CRITICAL INFRASTRUCTURE

Presented by
Jeff Jones, PE

36-INCH WATER TRANSMISSION MAIN ASSESSMENT PHASE I

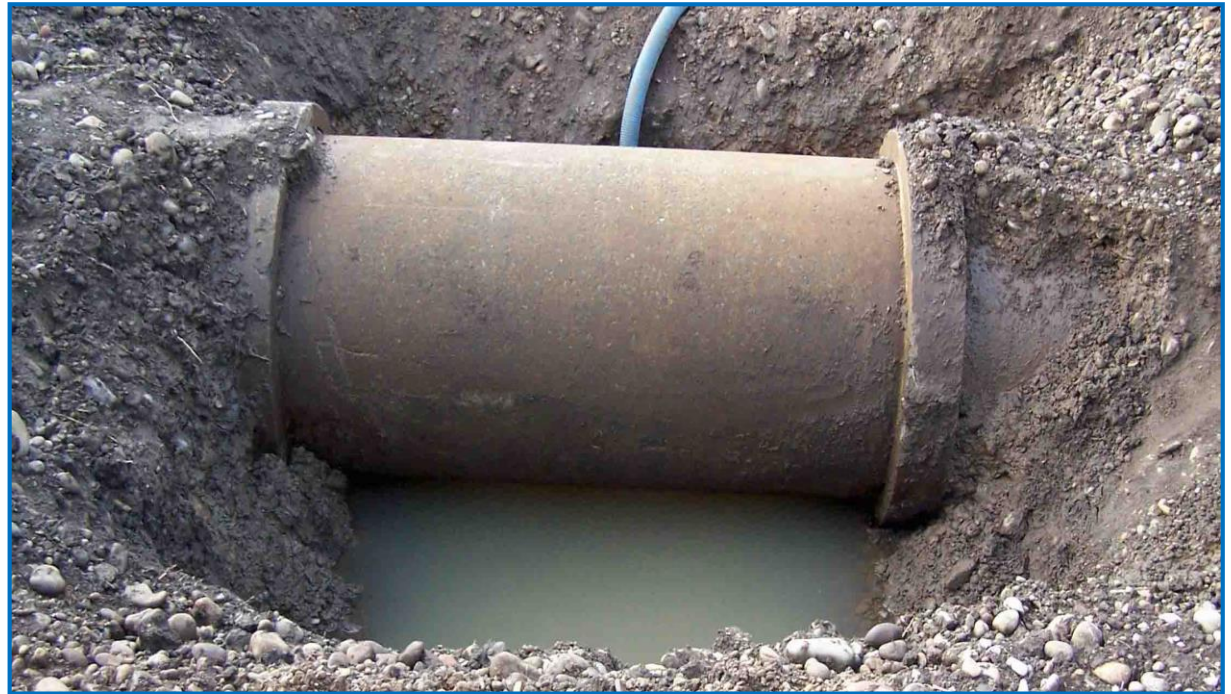
36-inch Diameter / Reinforced Concrete Pressure Pipe / 8-foot lengths

Exterior appears sound / no exposed steel reinforcement / no spalling or cracking

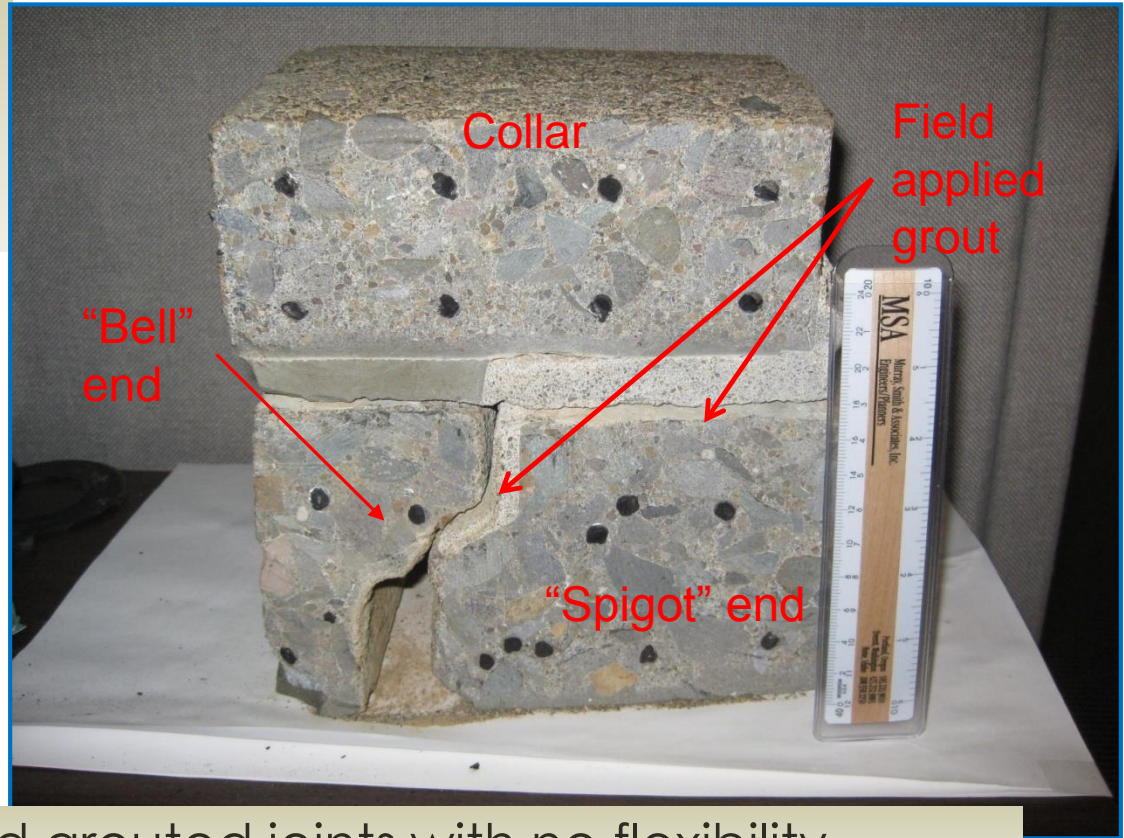
Factory installed collars to form a “bell end”.

Hardened grouted joints with no flexibility.

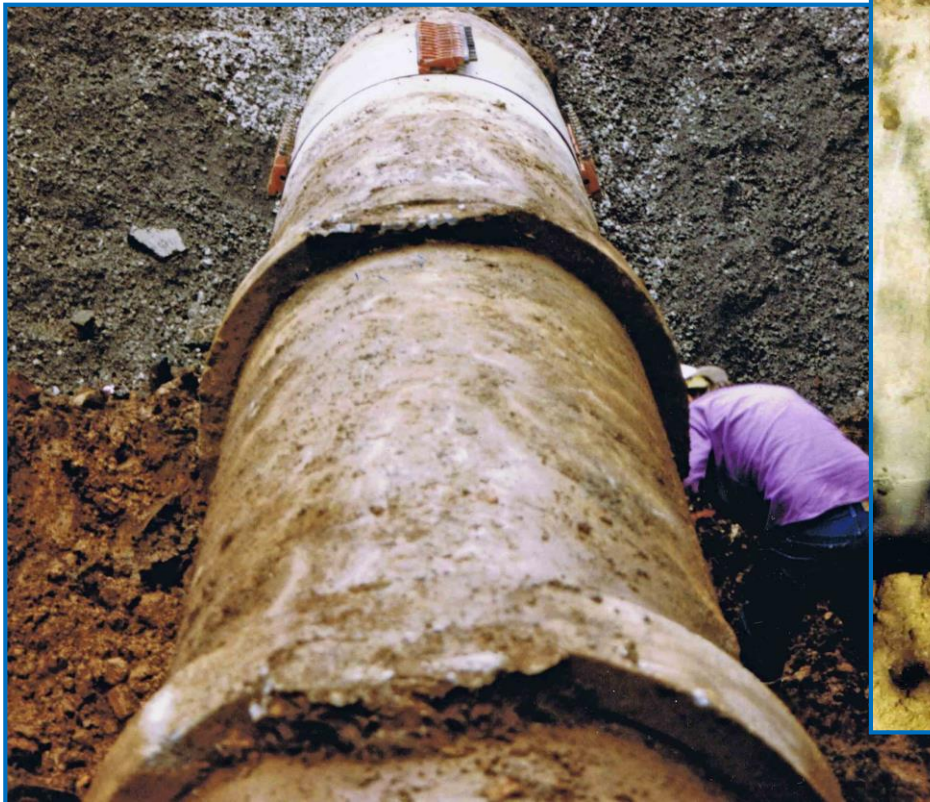
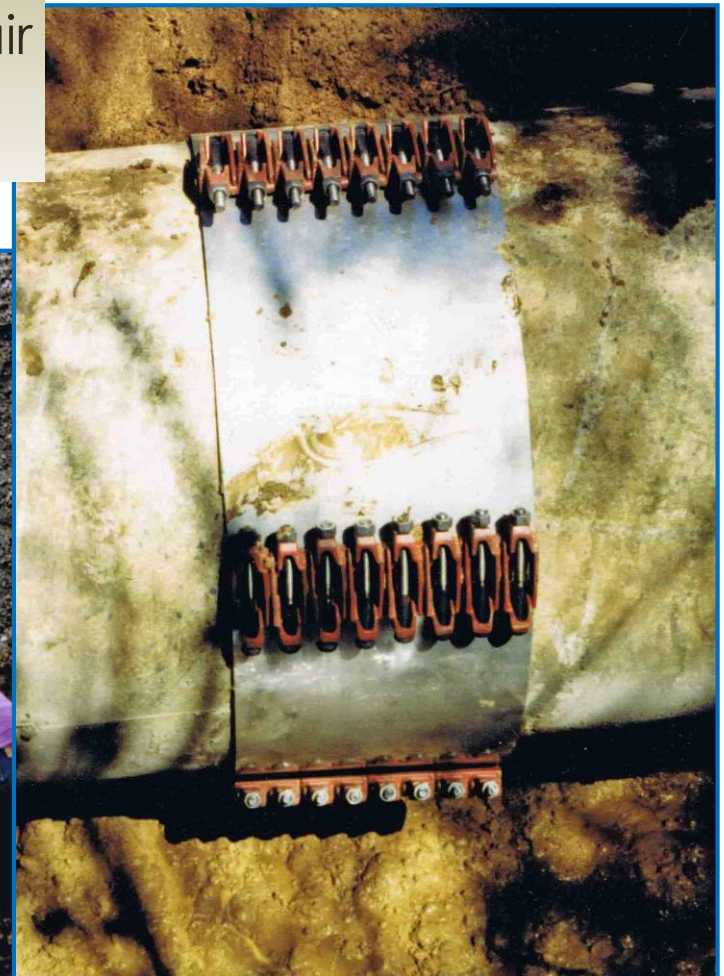
EXTERNAL CONCRETE PIPE ASSESSMENT: CONCRETE PIPE JOINTS CONSTANTLY NEED REPAIRING

City crews keep stainless steel repair sleeves on hand

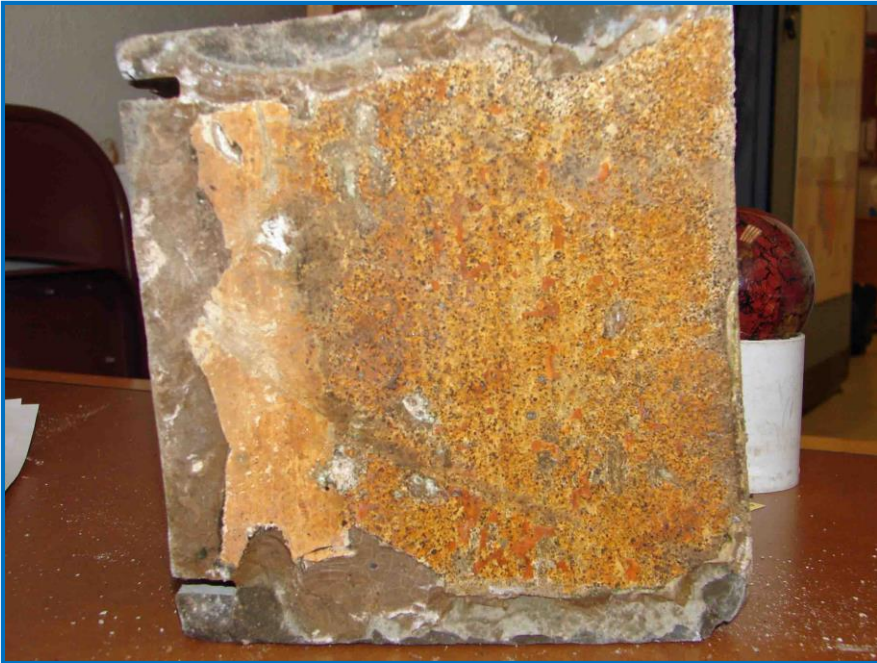
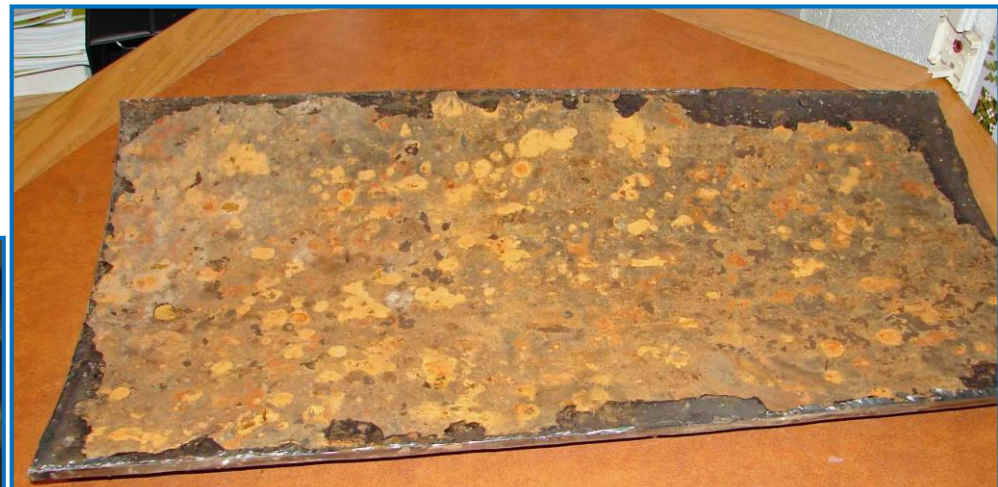
Concrete pipe lining
appears to be a skim
coat of some kind

Steel pipe interior asphaltic coal tar
lining with signs of deterioration and
corrosion

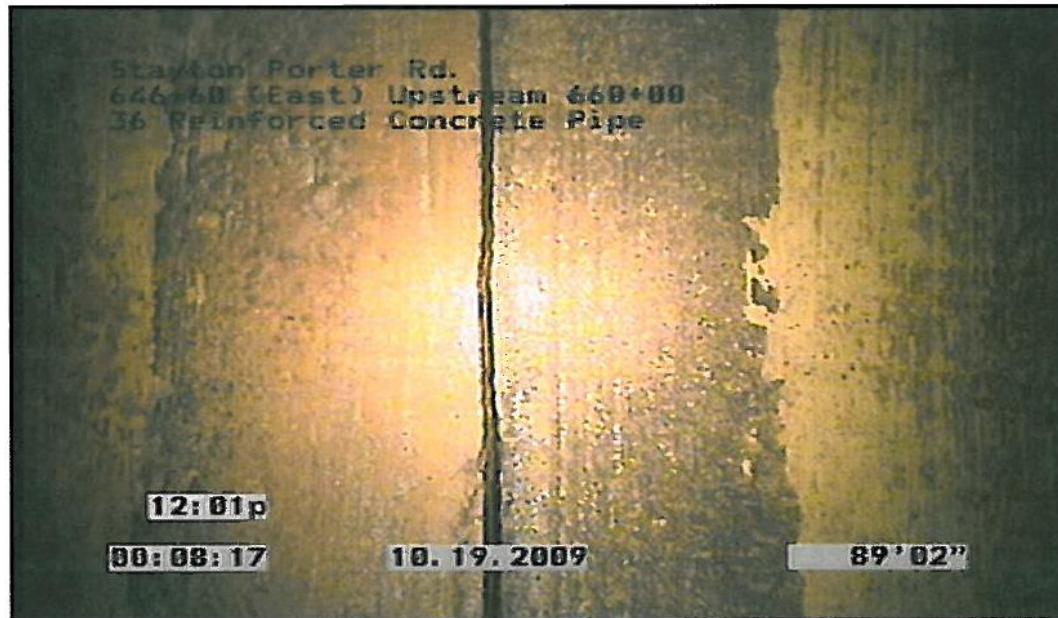
Photo: 660+00_646+60 (East)_101909_120115_A.JPG, VCR #:
10.19.09
89.06FT, Joint Separated Medium

Concrete joint separating

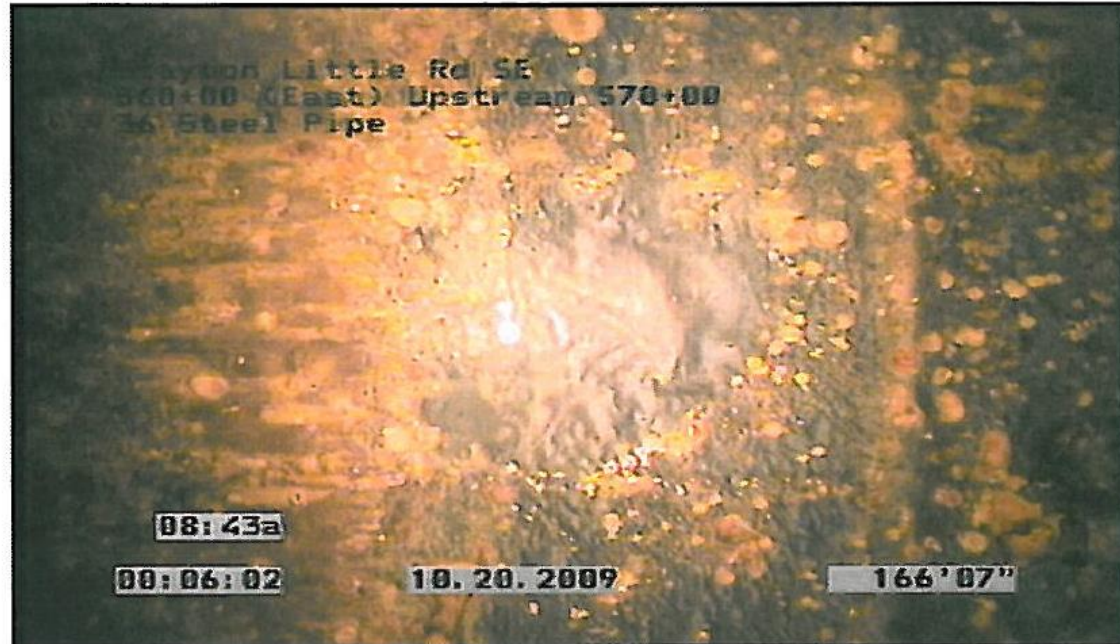
Photo: 570+00_560+00 (East)_102009_084320_A.JPG, VCR #:
10.19.09

166.35FT, Lining Failure Blistered, from 11 to 01 o'clock, within 8
inches of joint: YES

Lining in steel pipe at this location is failing

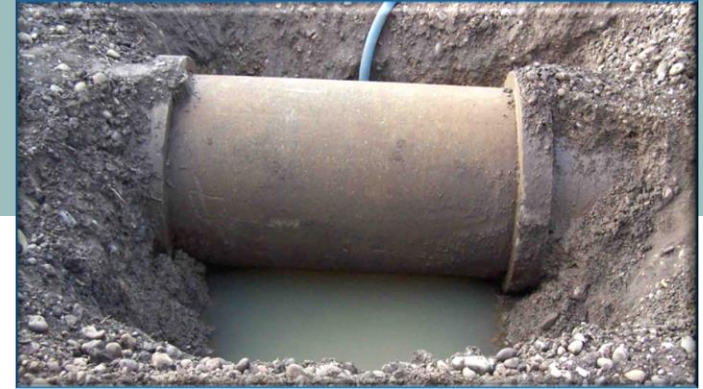
- Structurally in good condition
- Pipe joints cracked and failing grout
- Ground water infiltrating
- Chlorine detected in road ditches indicating chronic leakage
- Many leaking concrete pipe joints appear at roadway and railroad crossings

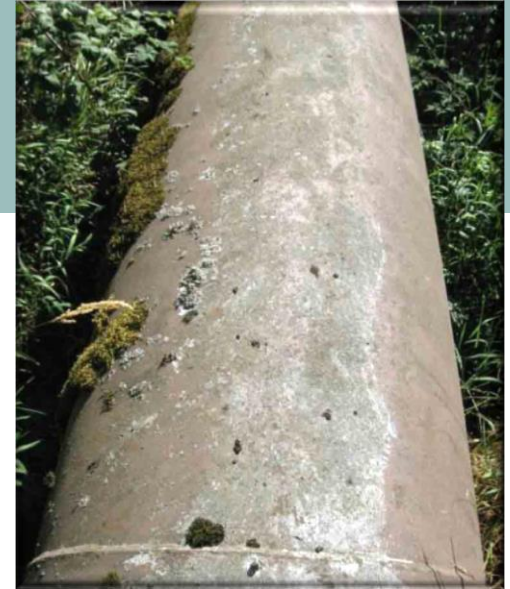
- Exterior appeared to be in good condition
- Buried coal tar coating appears intact
- Minor damage from tree roots, irrigation piping, or previous excavation
- Interior surface has moderate to extensive corrosion
- Corrosive soil conditions throughout the pipe sections surveyed.
