Condition Assessment of a 100-year Old Well Station

City of Spokane Hoffman
Well Station

AWWA PNWS Annual Spring
Conference

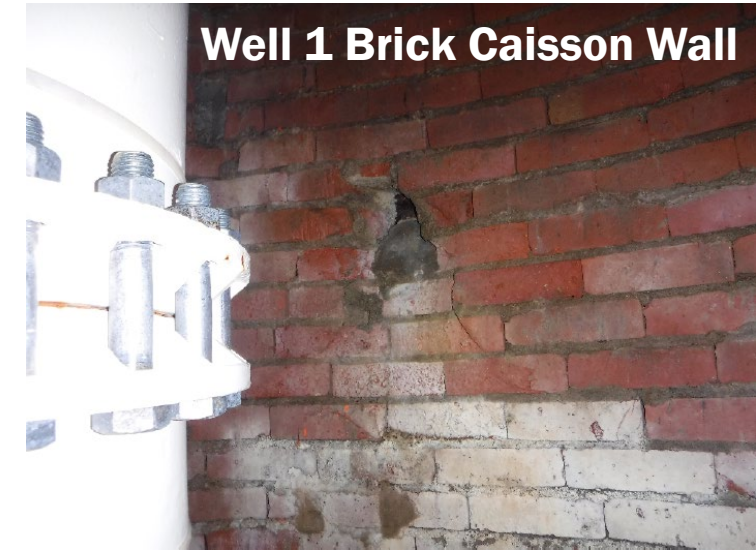
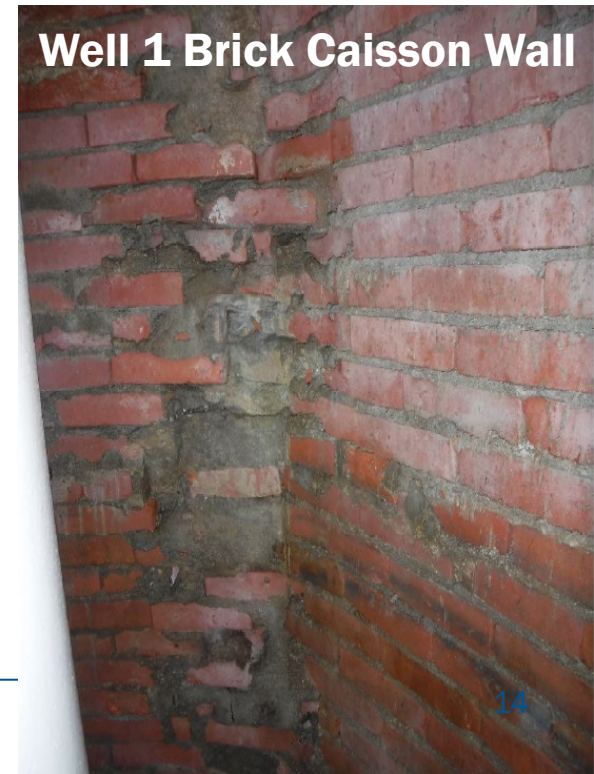
Well 1:

- Currently operational
- Visible portions of brick caisson appear in generally good condition
- Some missing bricks, likely remnants of old platform framing
- Areas of possible deformation in roundness of caisson wall, patched with mortar
- Pumping system obstructed access for below-water video surveys

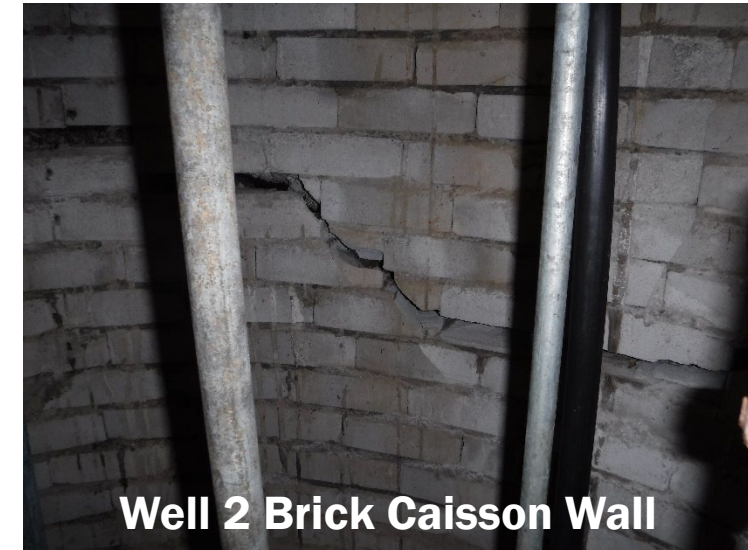
Well 2 Brick Caisson Wall

- Offline since 1993 and not equipped with pumping system
- Some cracks in brick caisson wall observed at a few locations
 - Up to 1-1½ inches wide with some to no surface offset
 - Some cracks filled with black mortar
- Middle section of caisson wall contained a few hairline cracks
- Some evidence of past minor water seepage; no active seepage was observed at the time of the survey.
- Bell of caisson coated with gunite
- Some minor deformation has taken place since 1993 inspection, particularly in the middle and lower portions
- Minor encrustation of casing perforations
- Generally in good condition overall

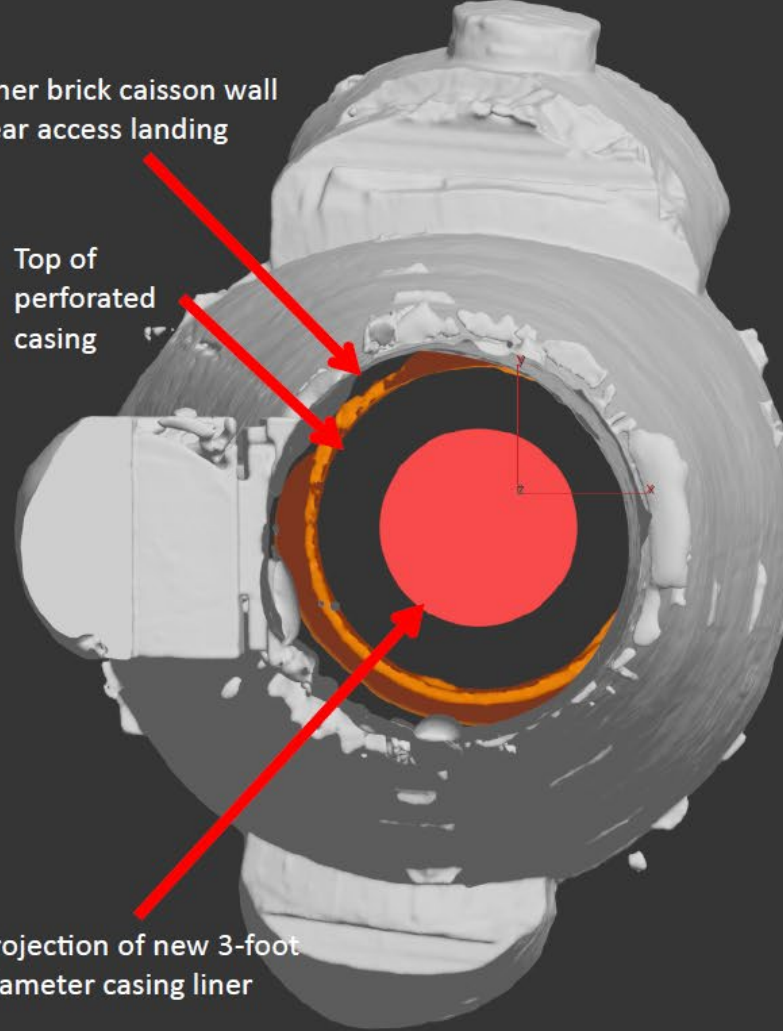
A – TOP VIEW OF CAISSON NEAR ACCESS LANDING

Inner brick caisson wall
near access landing

Top of
perforated
casing

Projection of new 3-foot
diameter casing liner

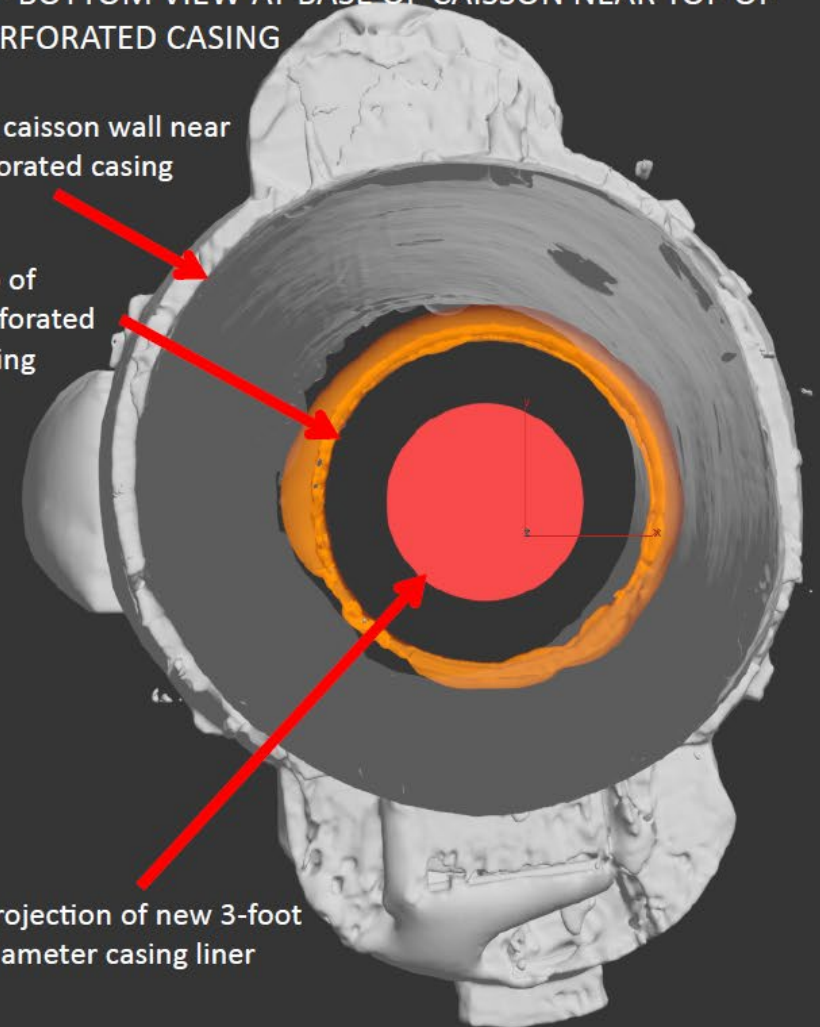
B – BOTTOM VIEW AT BASE OF CAISSON NEAR TOP OF
PERFORATED CASING

Inner brick caisson wall near
top of perforated casing

Top of
perforated
casing

Projection of new 3-foot
diameter casing liner
