Restoring Deer Creek WTP Performance

Pierre Kwan, PE

April 29, 2022
PNWS-AWWA Conference

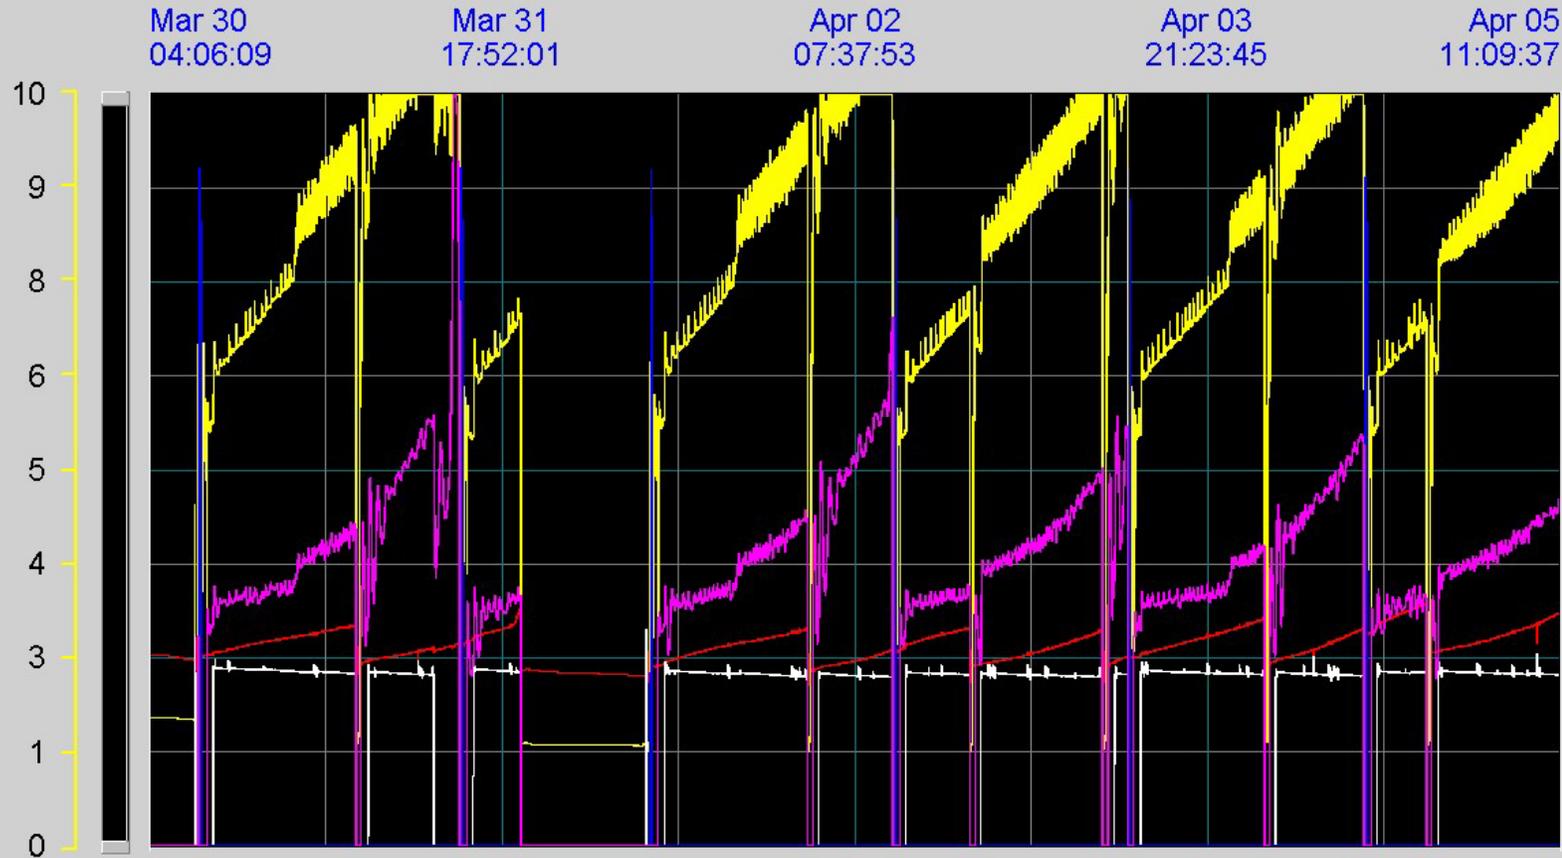
Clean Bed Headloss Increased from 3 psi to 6 psi

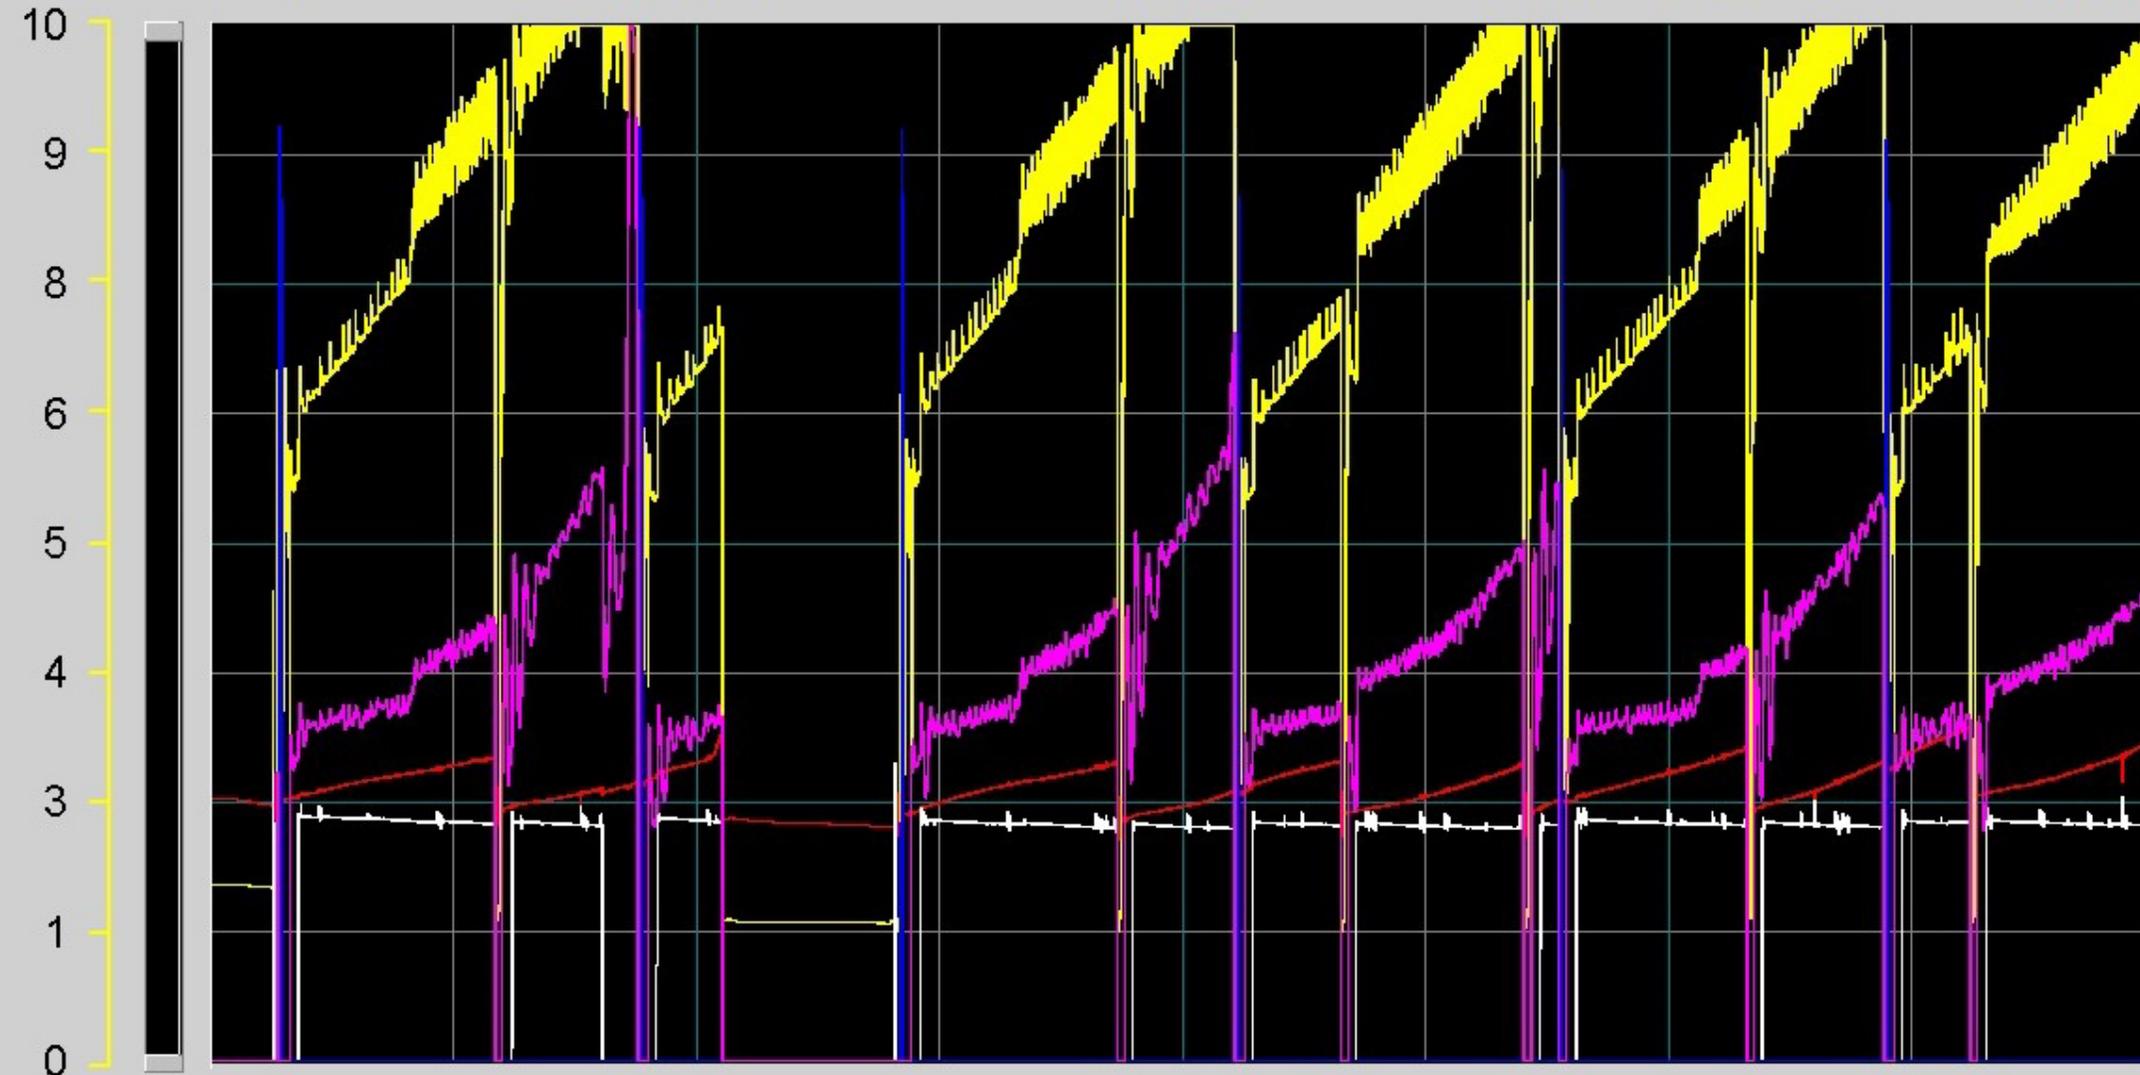
Initial Low Noise

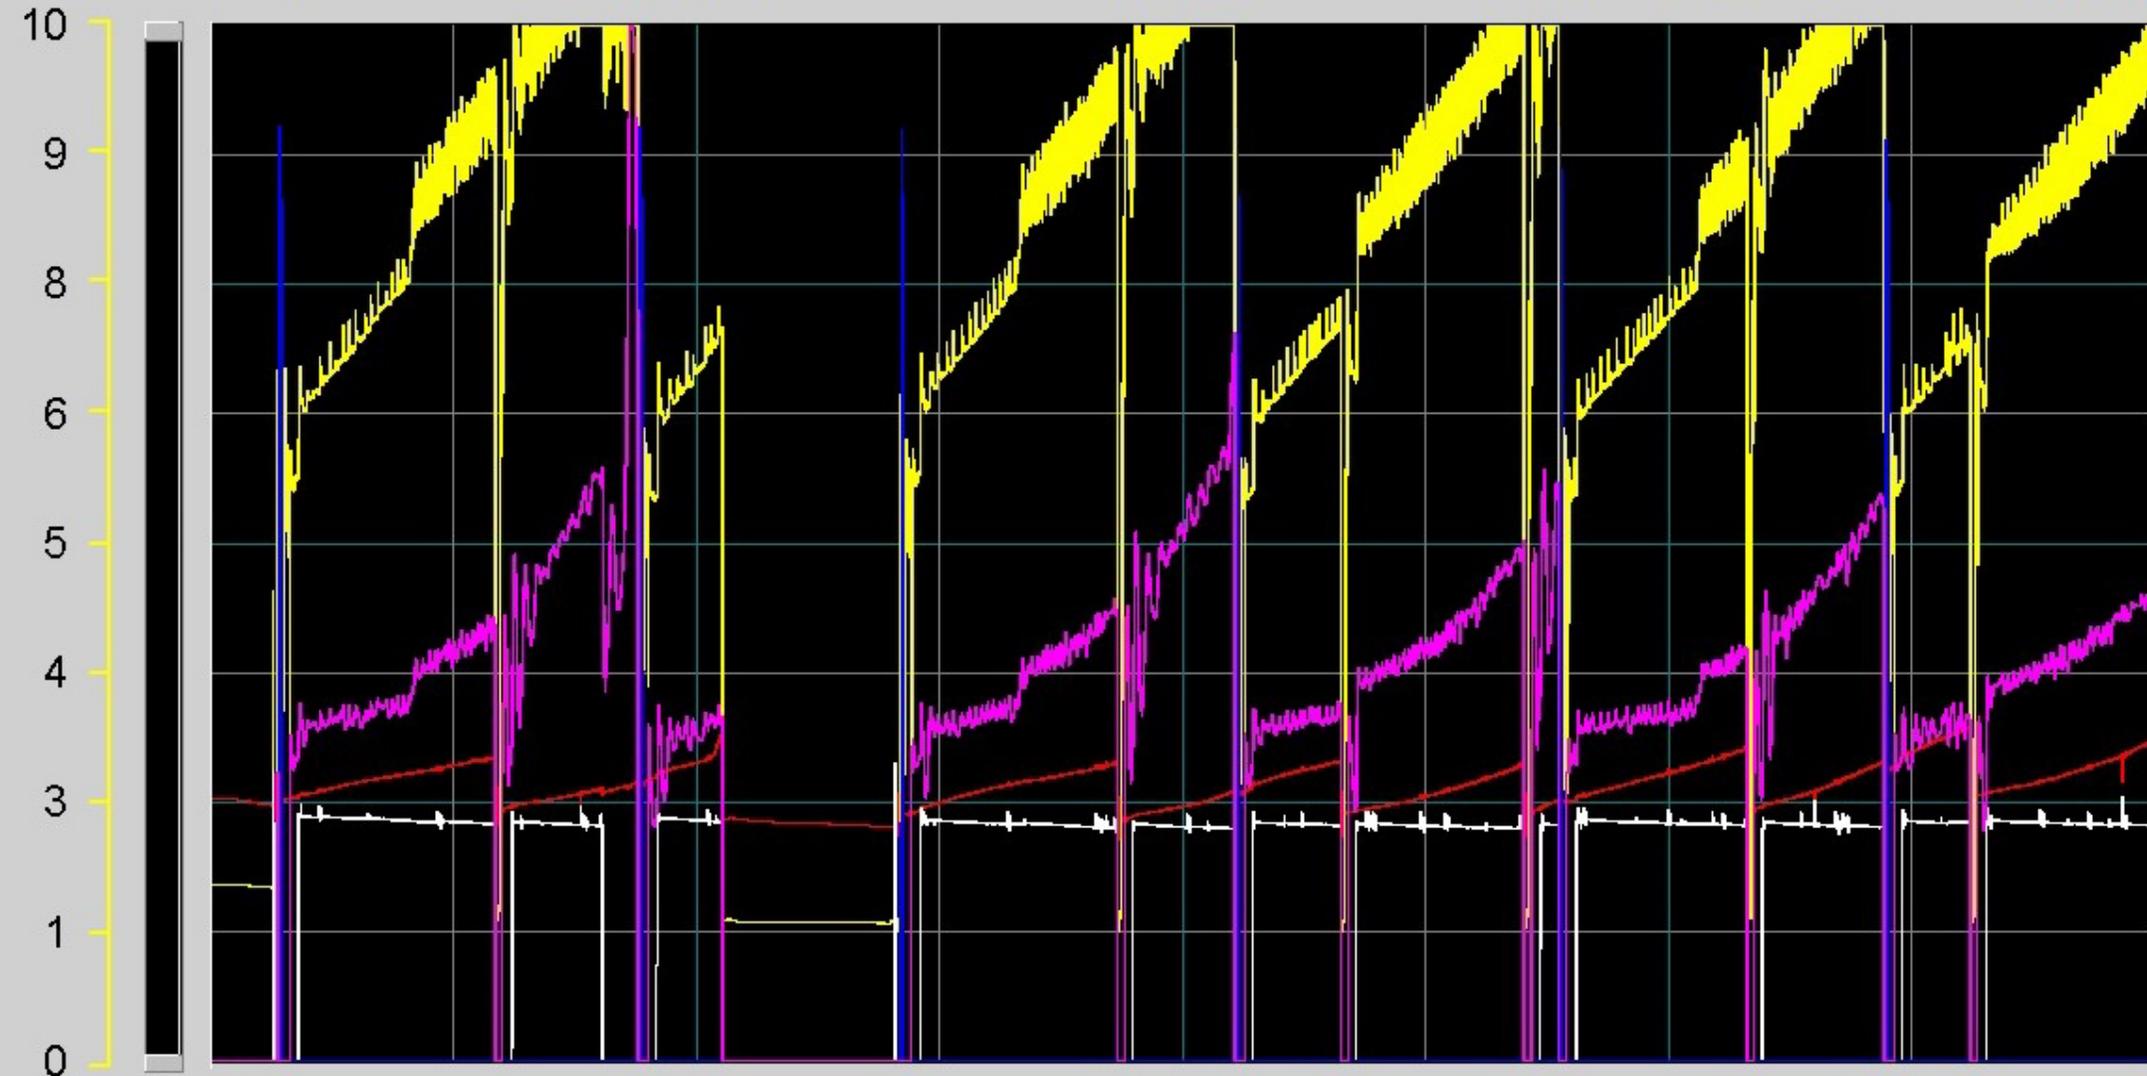
1 psi Pressure Jump Right at ~6 hours

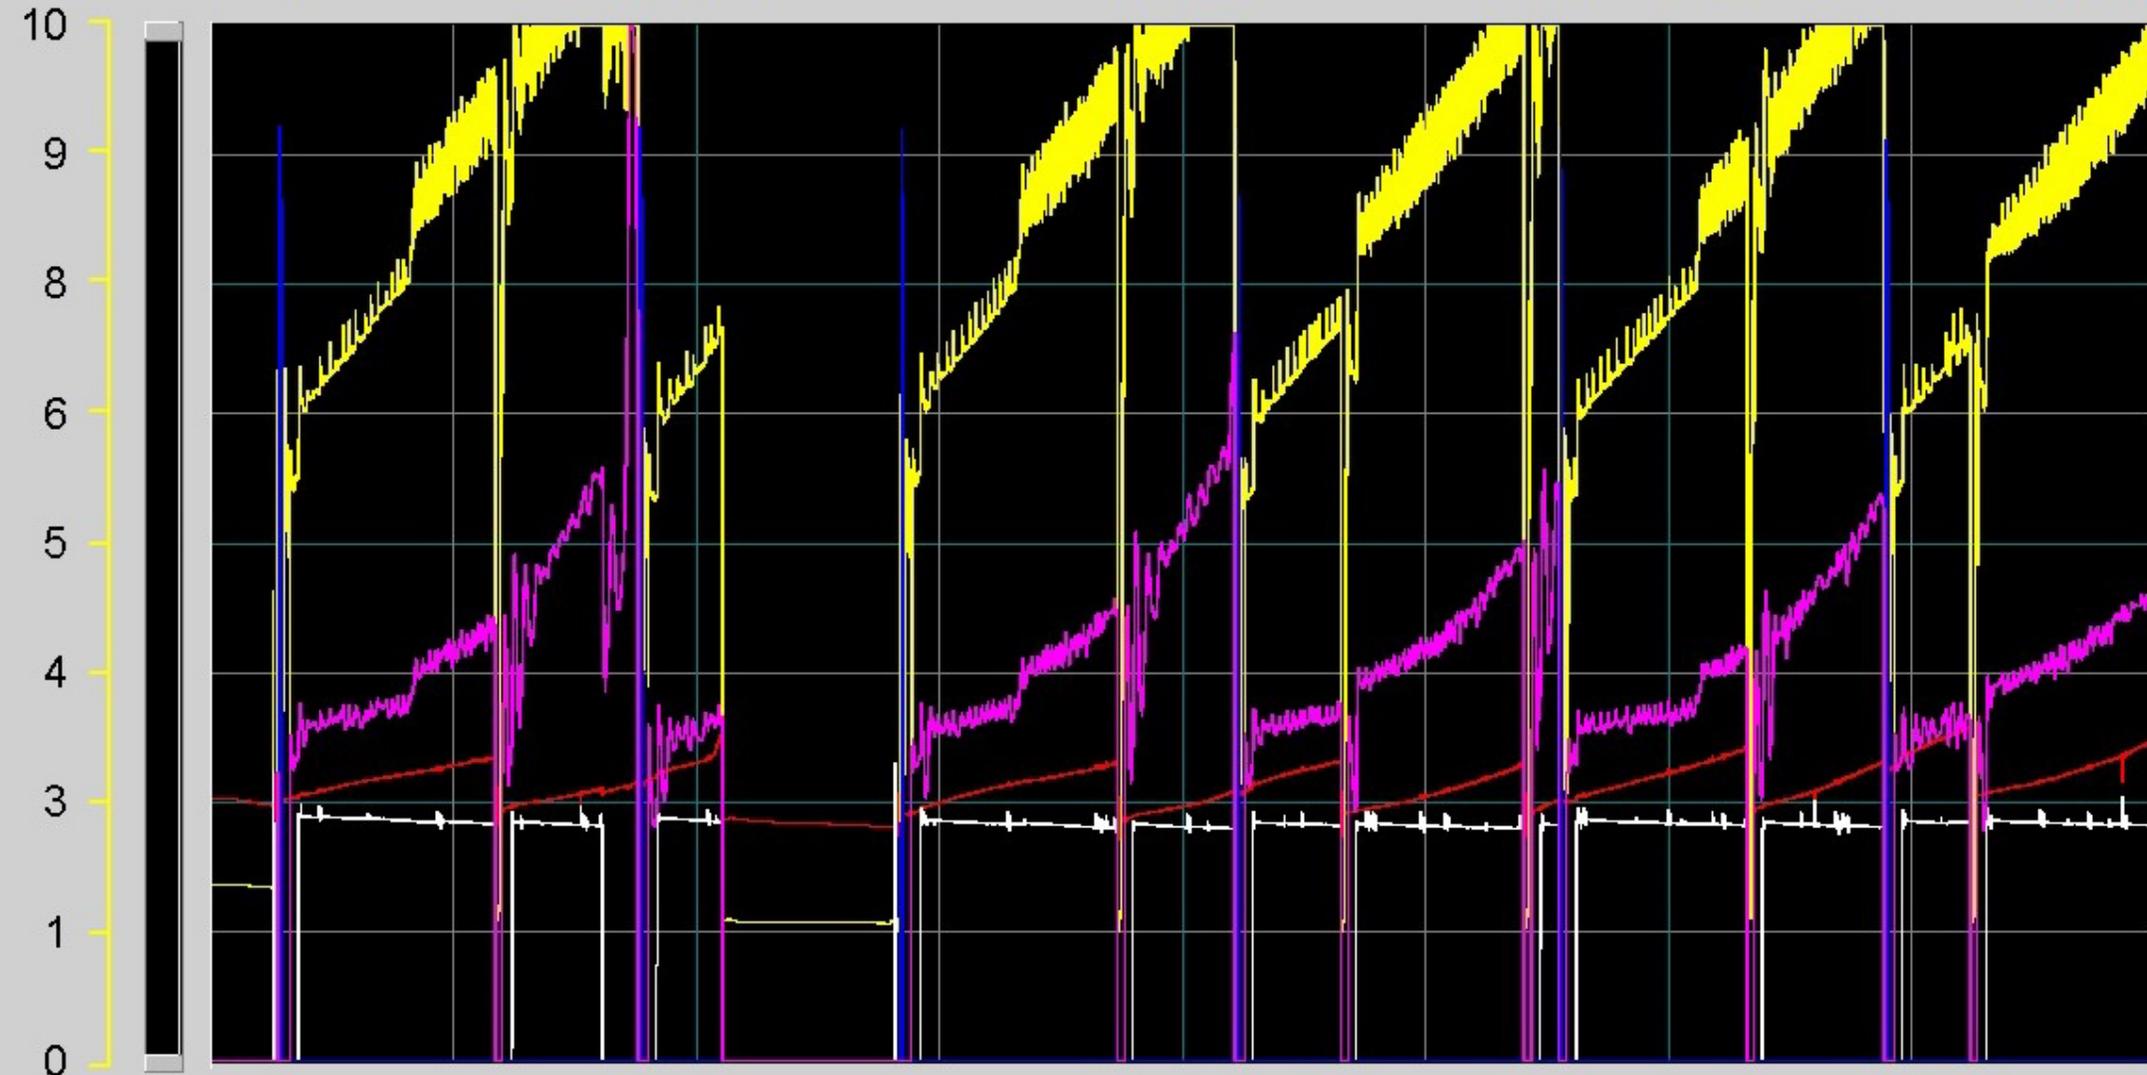
High Signal Noise

- Tested every level element
- Found **both** level elements were off.
- Feedwater level sensor had faulty transmitter and had to be replaced
- Backwash sensor needed to be re-scaled

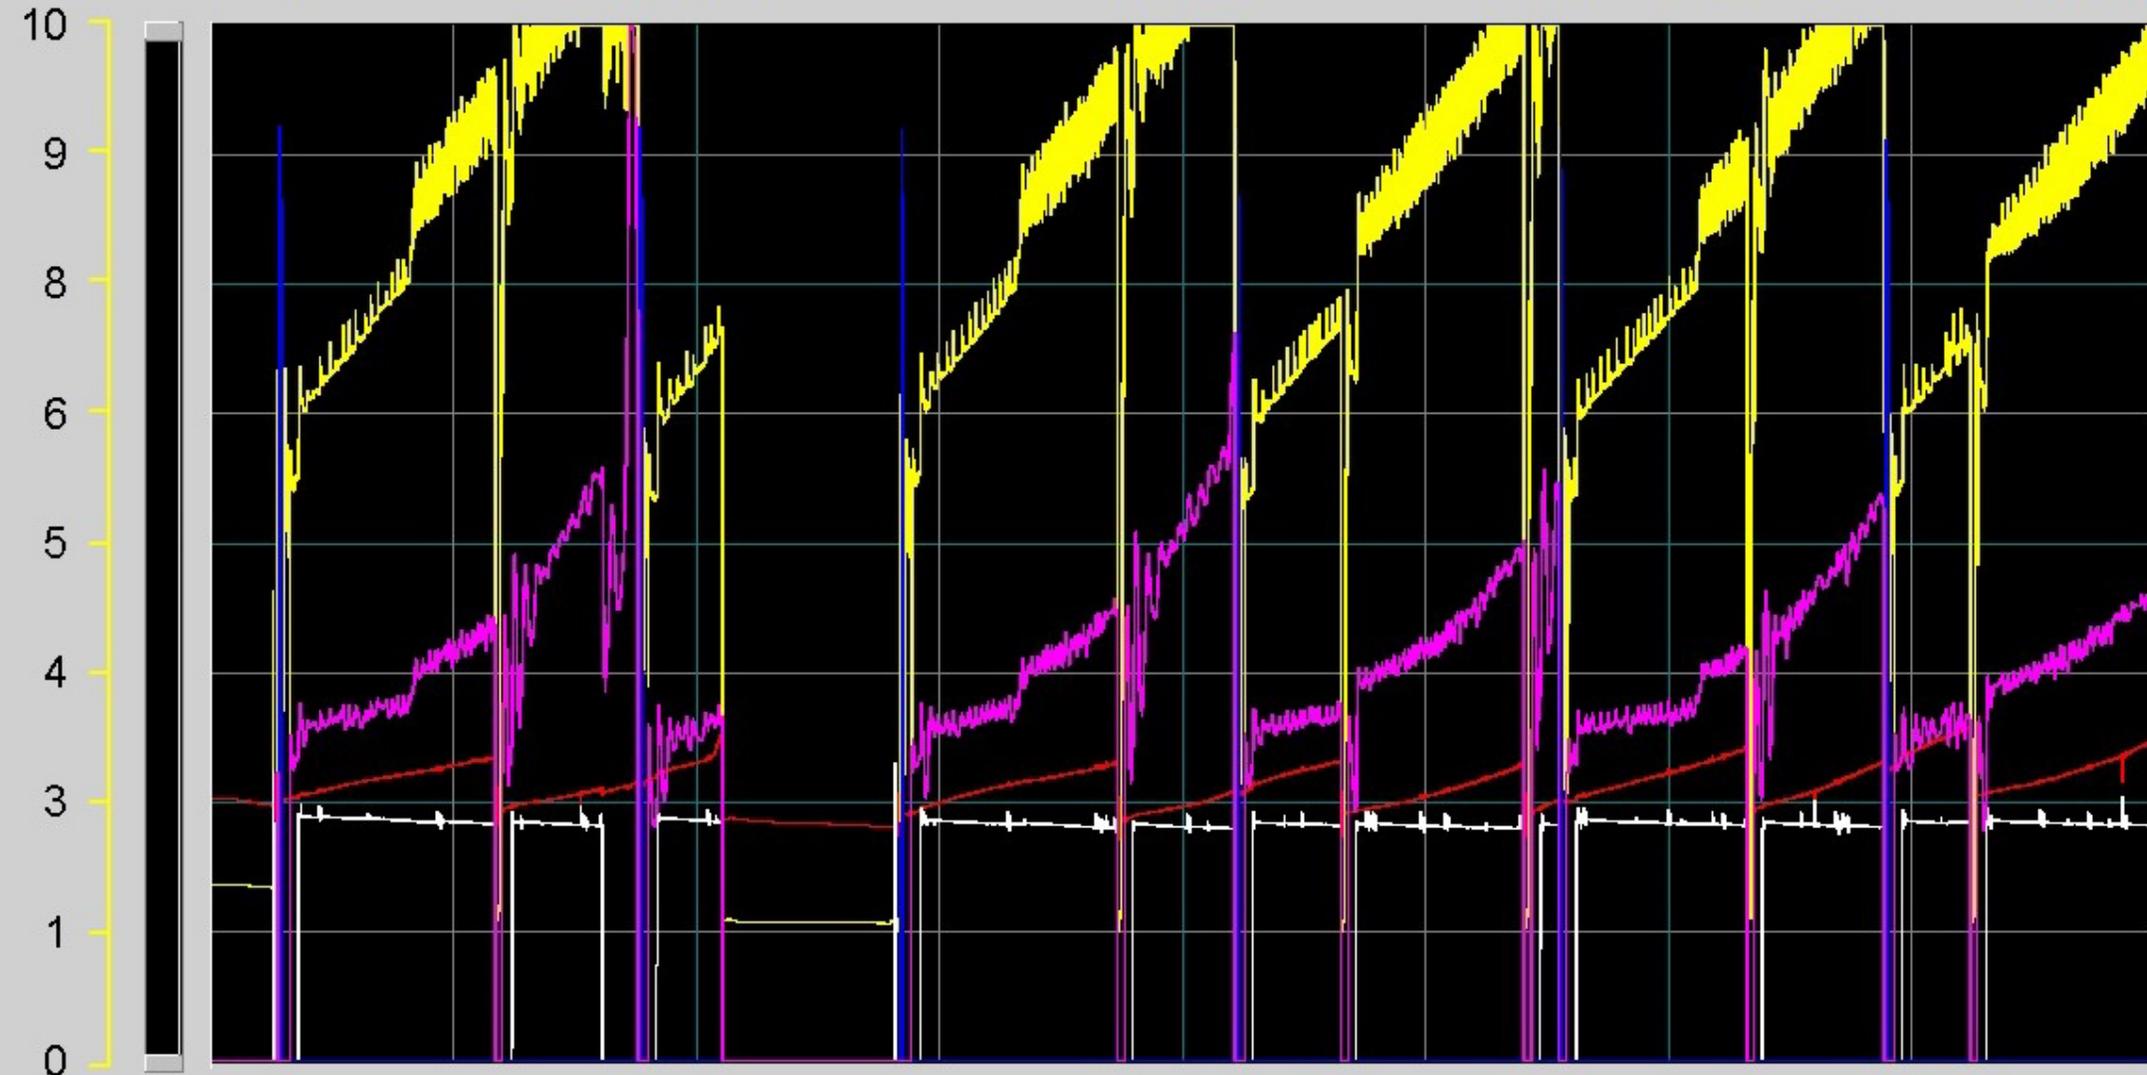
Hit 10 psi Terminal Headloss Too Soon

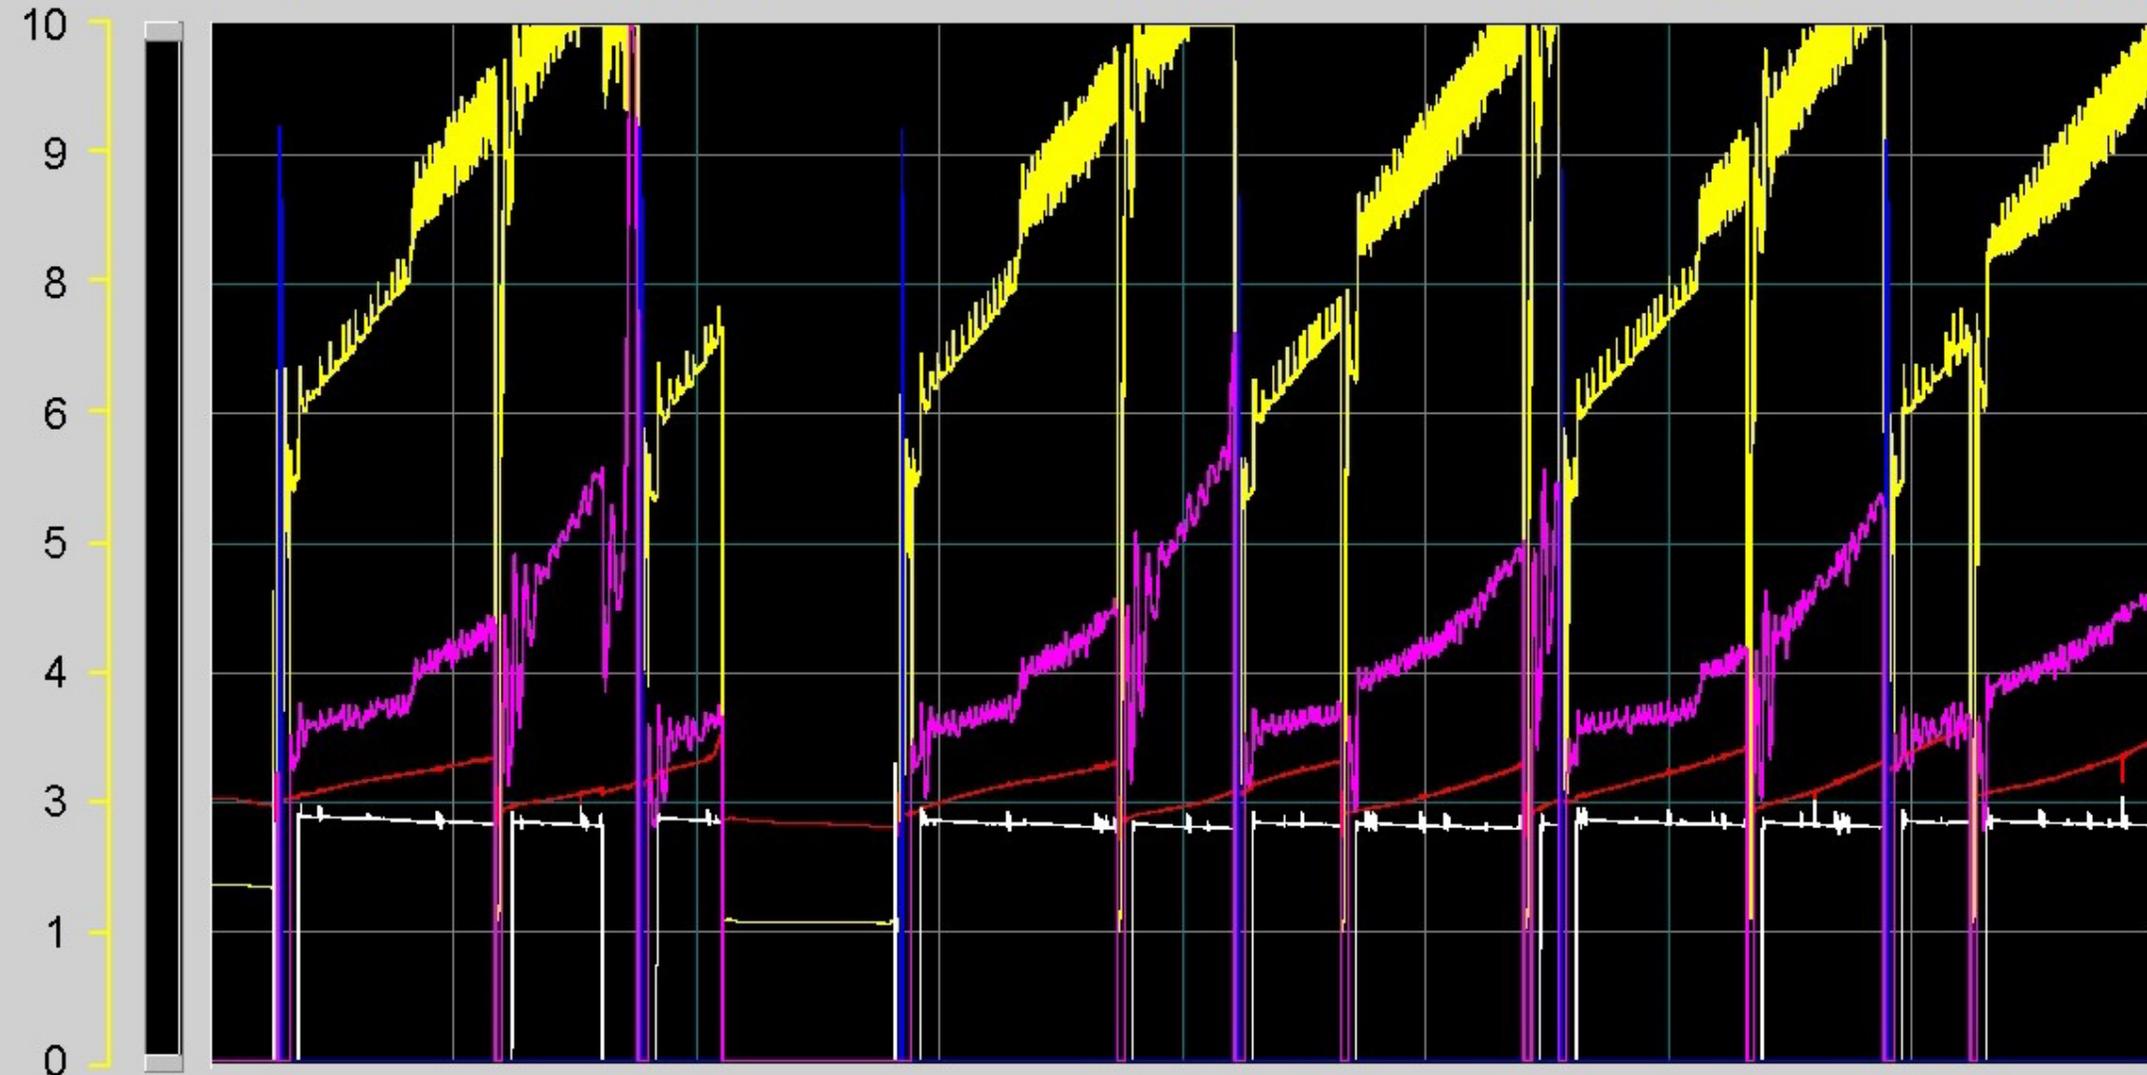
Bubbly Filter

- Bubbles coming up from filter bed
- During entire filter run
- All across filter bed
- Worse when filter was resting

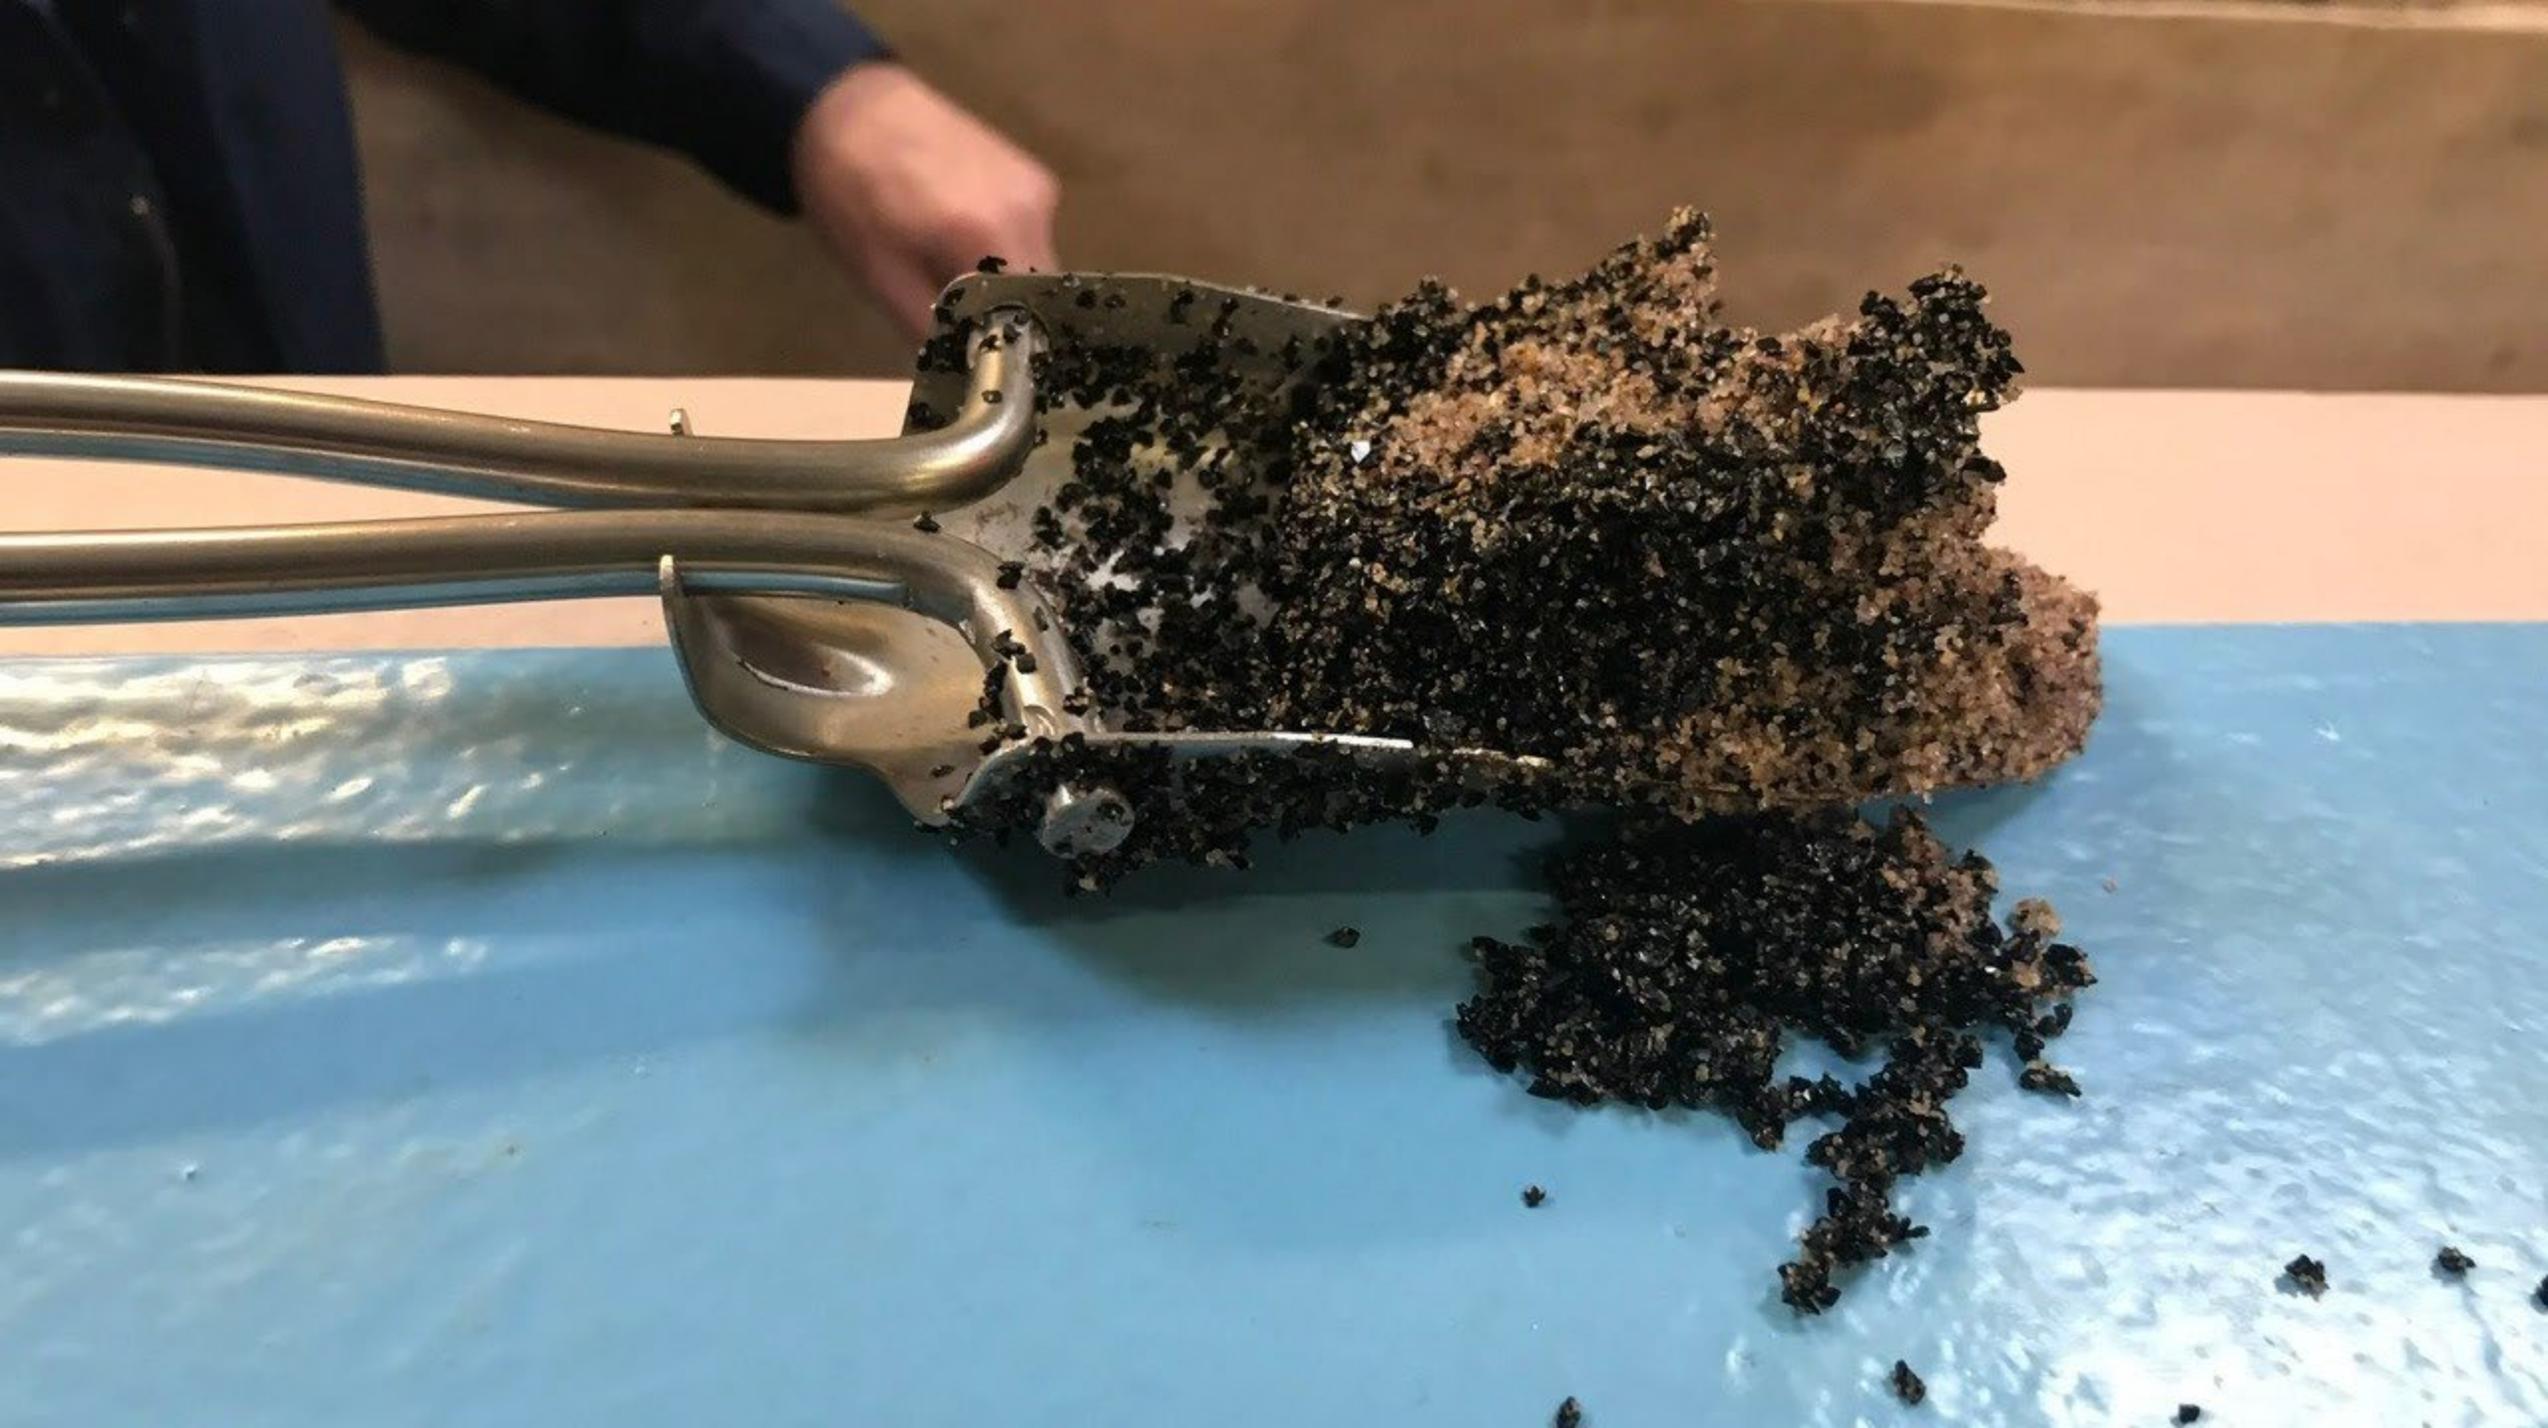
Excessive Polymer Usage Causing Mudballs?

- Plant polymer usage has been inconsistent and sometimes high.
- Coagulant aid polymer sometimes dosed up 1.0 mg/L

Free Chlorine Soak

- Added 8 gallons of 12.5% sodium hypochlorite directly to filter.
- Used blower to mix hypochlorite throughout bed.
- 24-hour soak, more chlorine when residual <0.5 mg/L.
- Backwashed at the end.
- Mudballs eliminated!

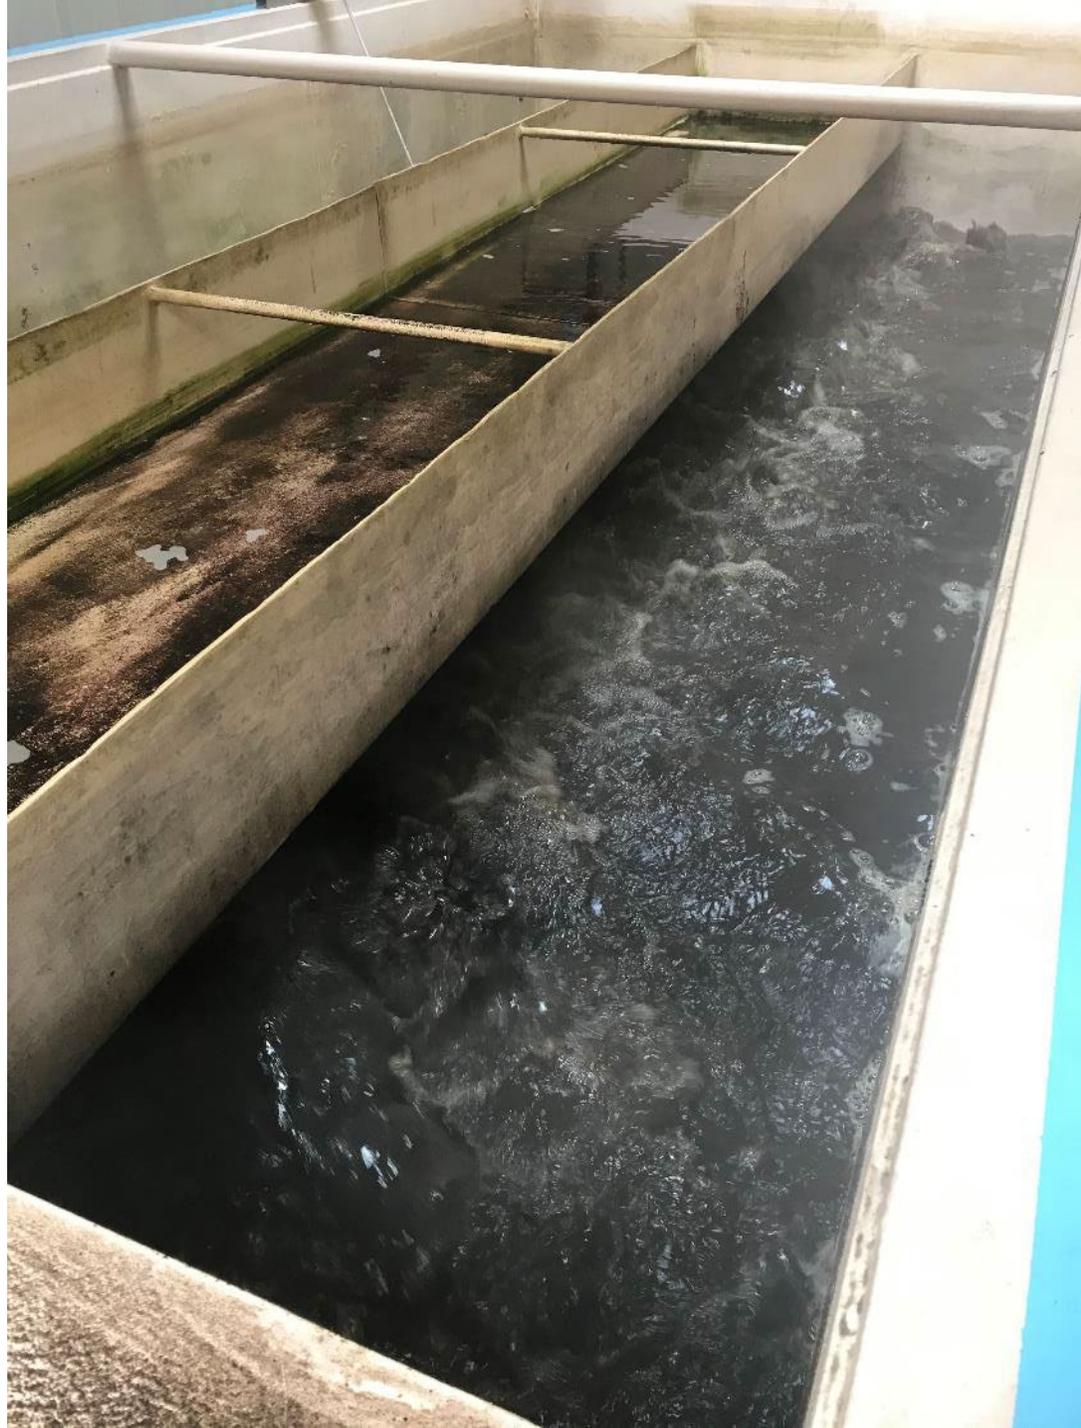
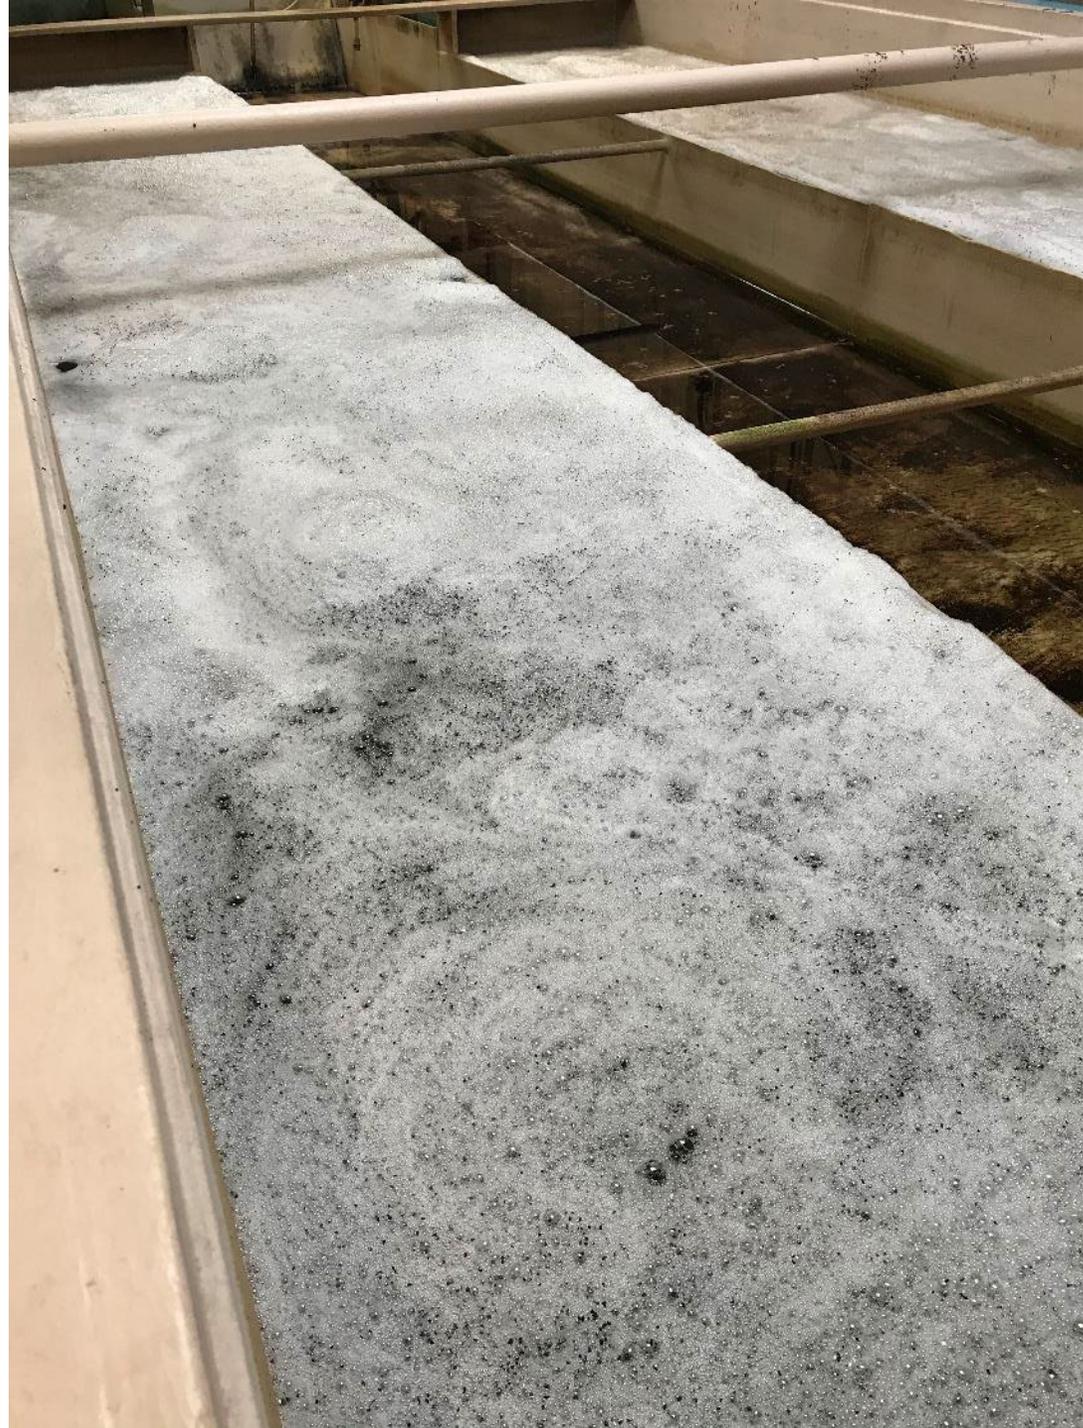
Media Investigation

- Cored filter to get media profile
- Dug up media down to the underdrains
- Pulled samples from various depths for analysis
- Media was consistent with specifications
- Media mixing was discovered throughout entire bed

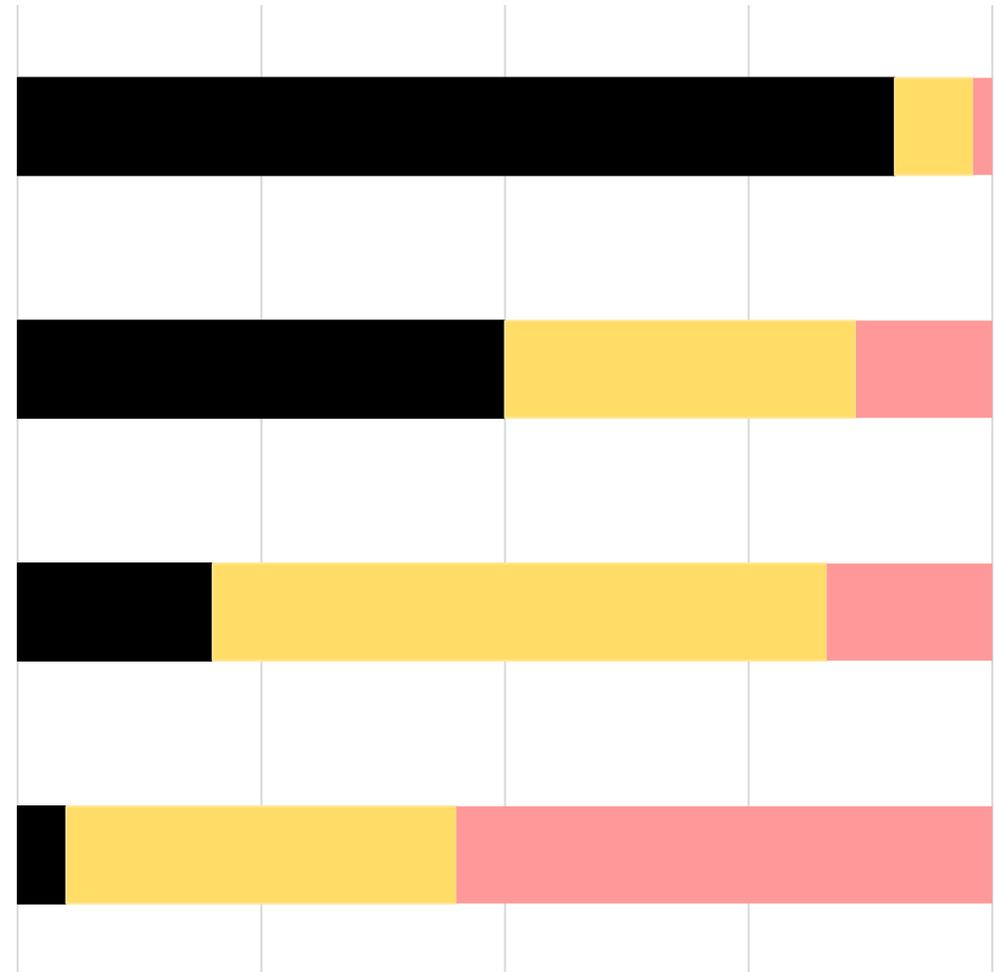
Estimated Media Distribution by Depth

Media Restratification

- Backwashing rate overshoots backwashing setpoint
- Could cause media to mix and 'boil'
- Restratify media using an extended backwash
- Media was successfully restratified
- Added 4 – 6 hours to filter run times.
- Still not back to normal.

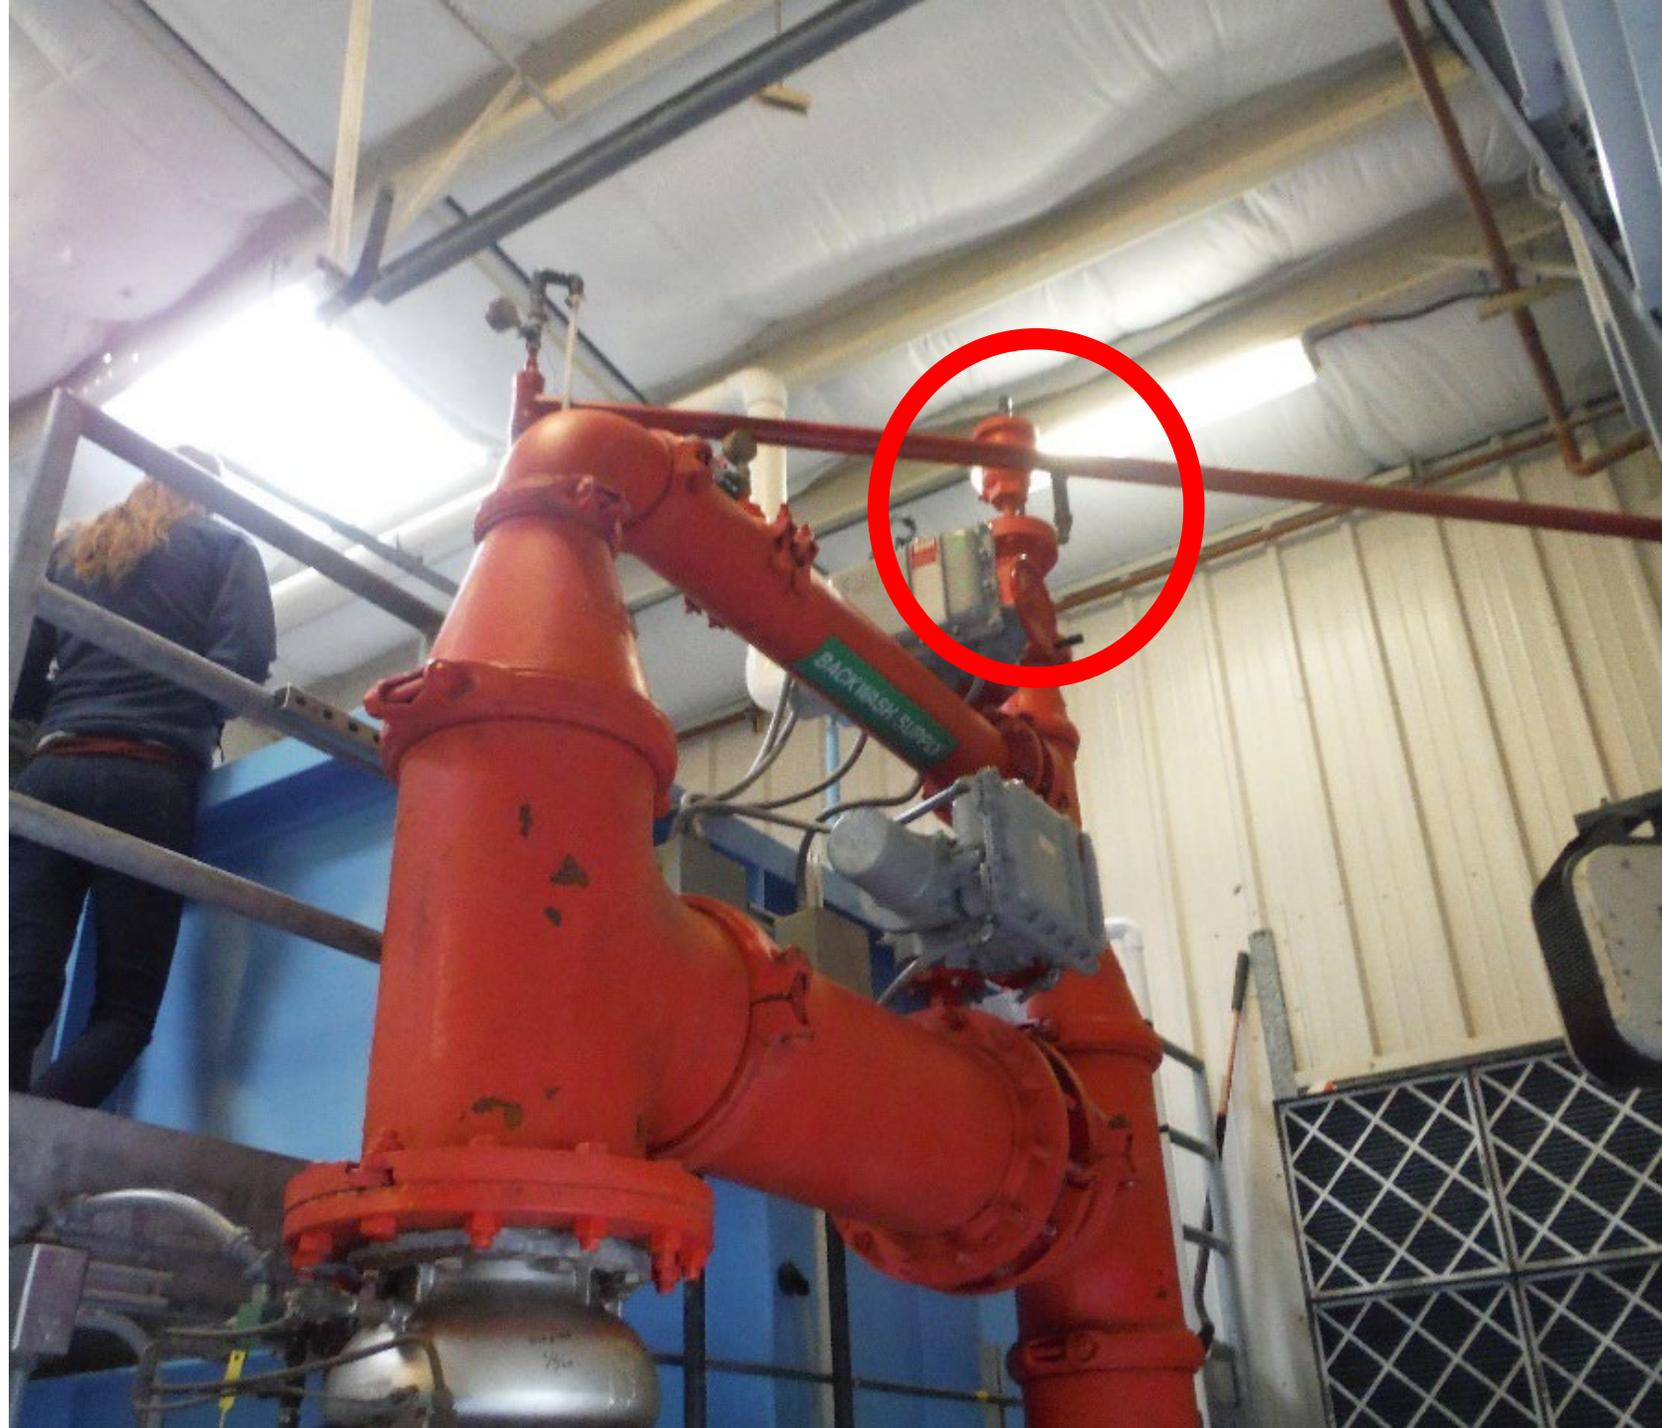
Found the Source!

- Air release valve on backwash waste line
- Meant to purge air with line is filled with backwash
- Wasn't seating and sucking air into pipe during filtration
- Air slowly built up in underdrains
