Restoring Deer Creek WTP Performance

Pierre Kwan, PE

April 29, 2022
PNWS-AWWA Conference

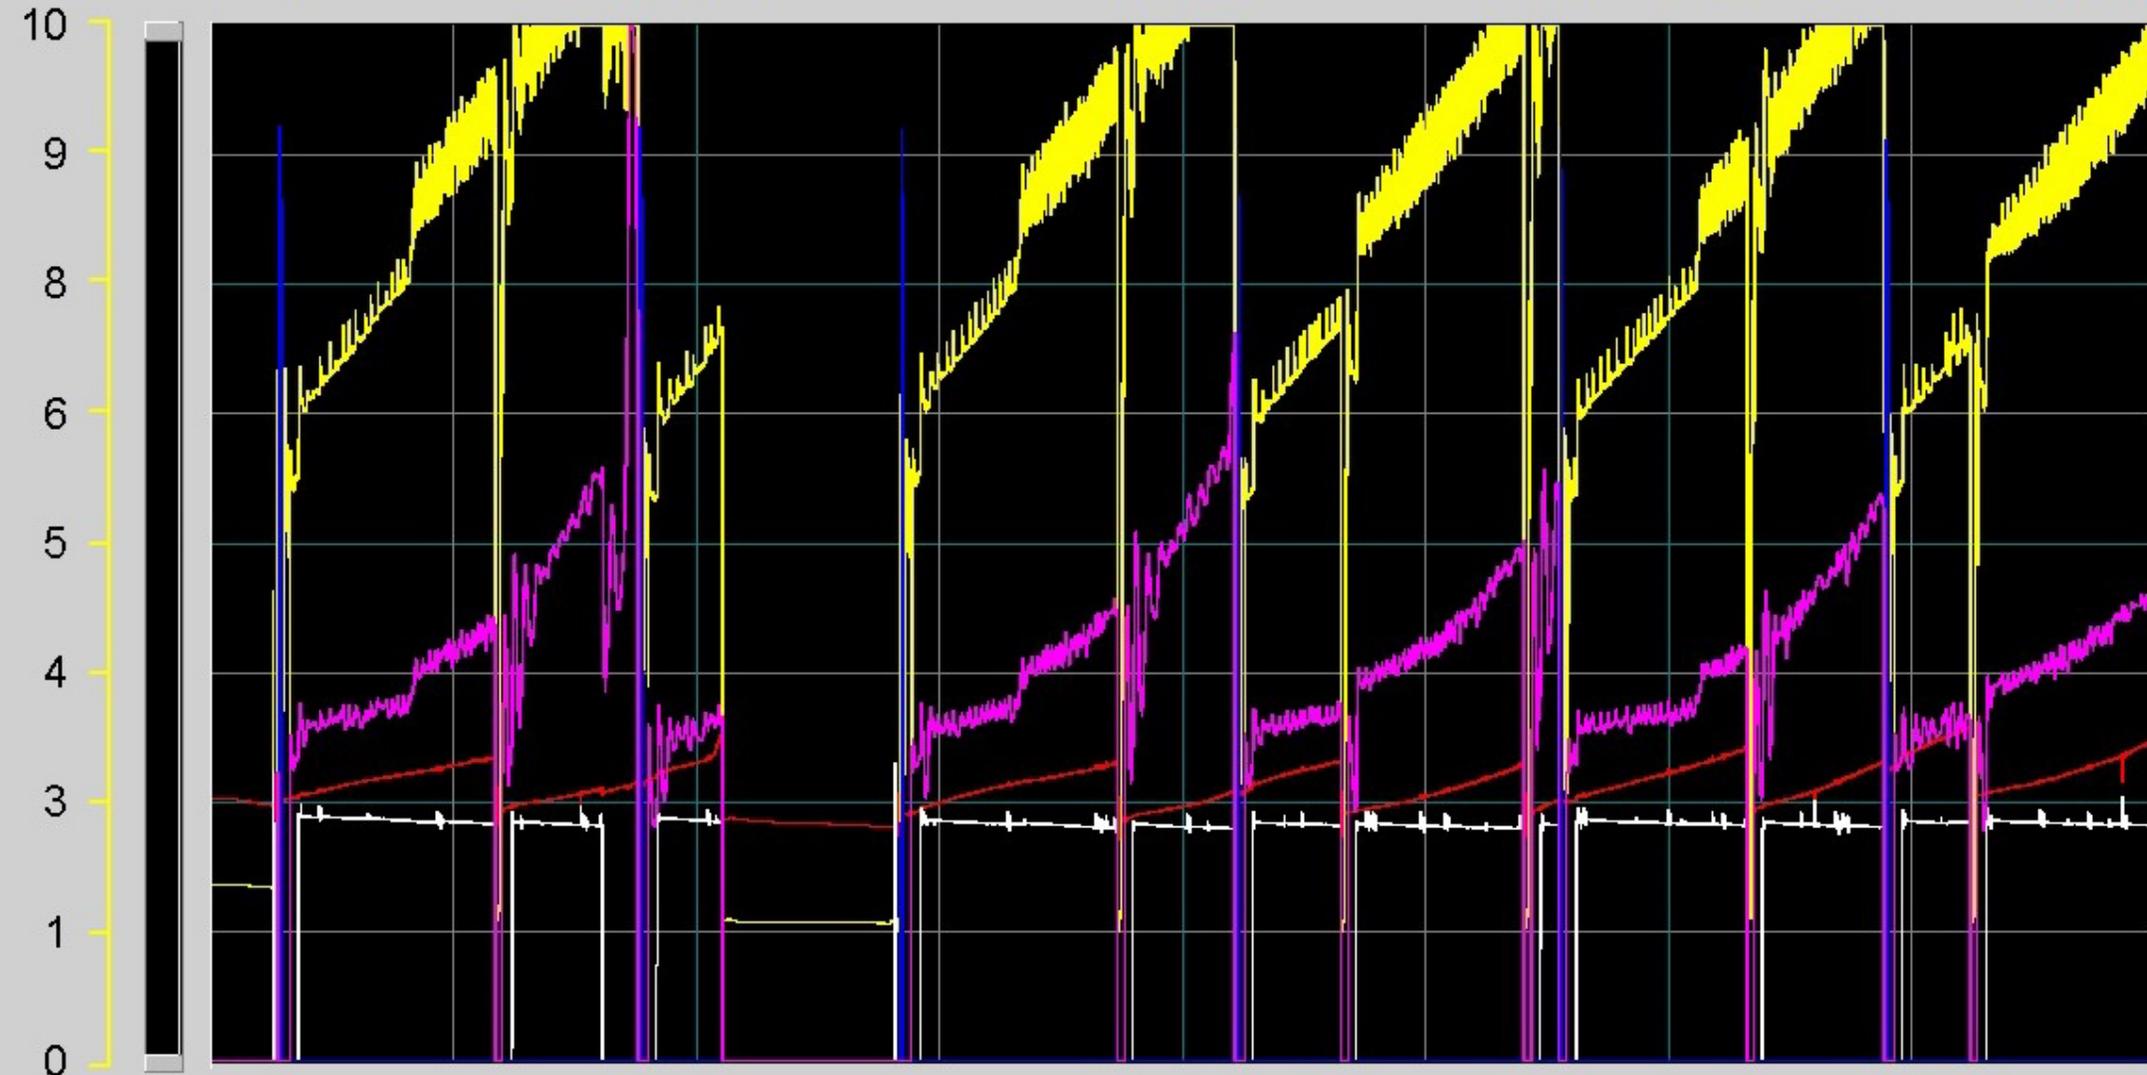
High Signal Noise
