# Whack-A-Mole

## Waterproofing a 100-year-old Clear Well

for The City of Albany, Oregon

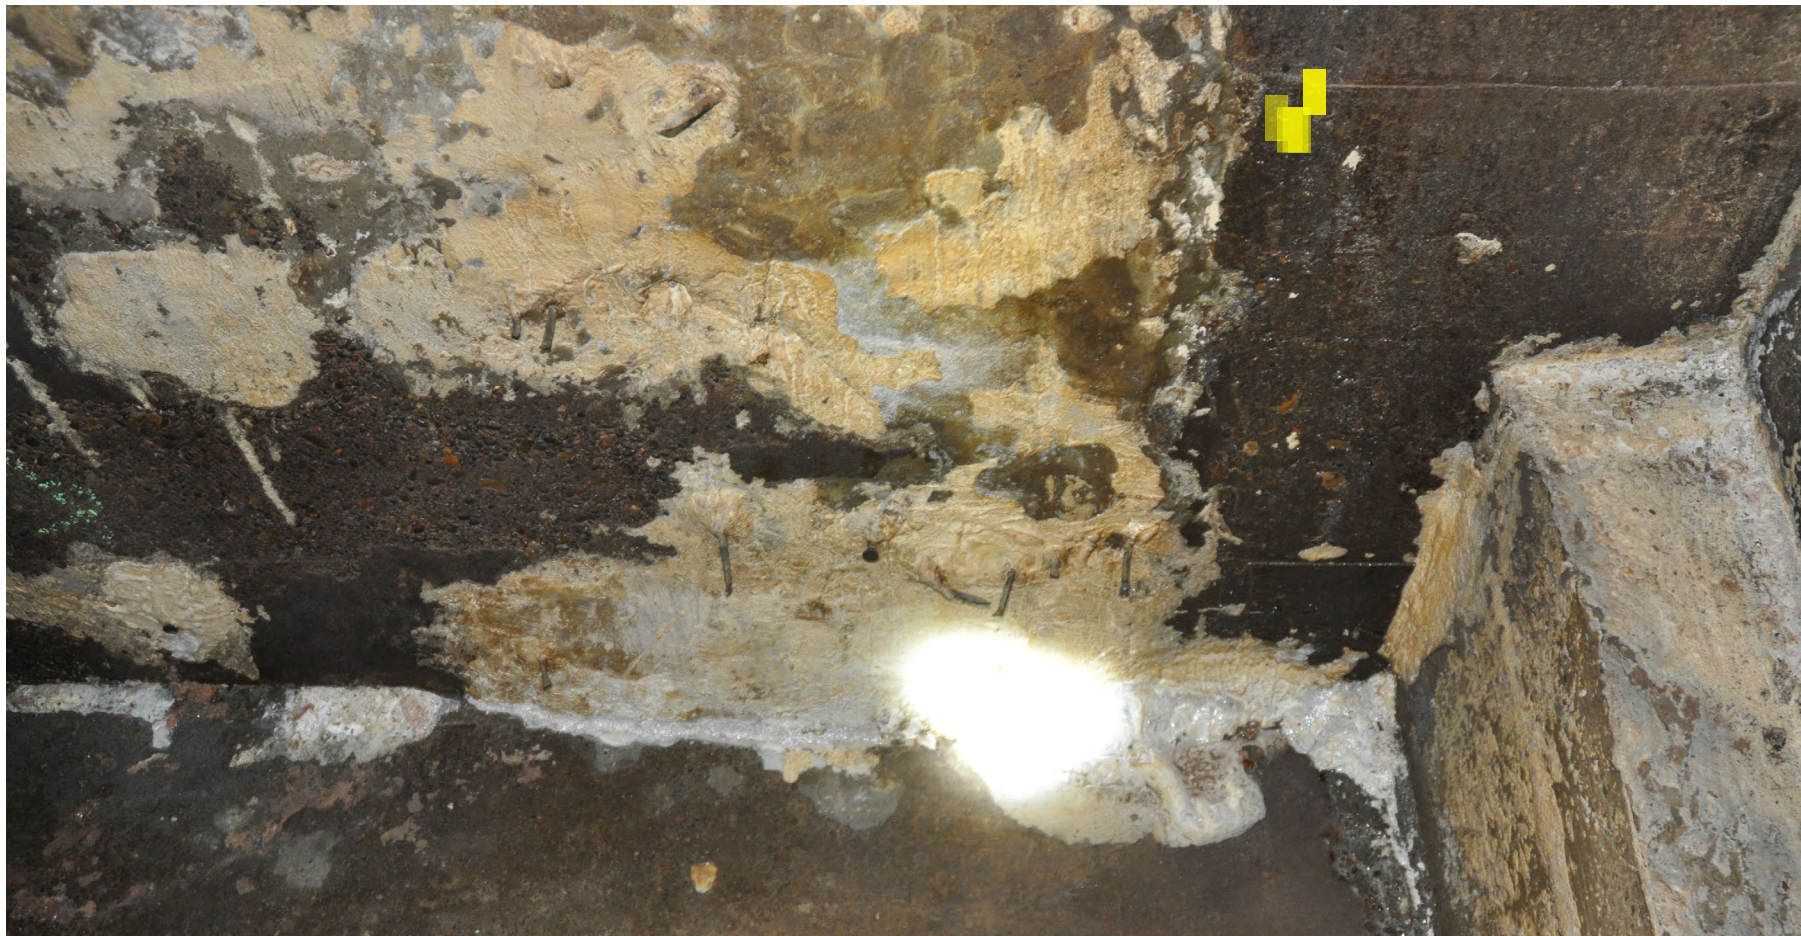
**EAST WALL POLYURETHANE INJECTION**

- 2010 Contech Completed Repairs
- Found leaks during repair work
- Injected concrete with polyurethane
- Once they injected one area the leaks move to another
- Source of water was unknown

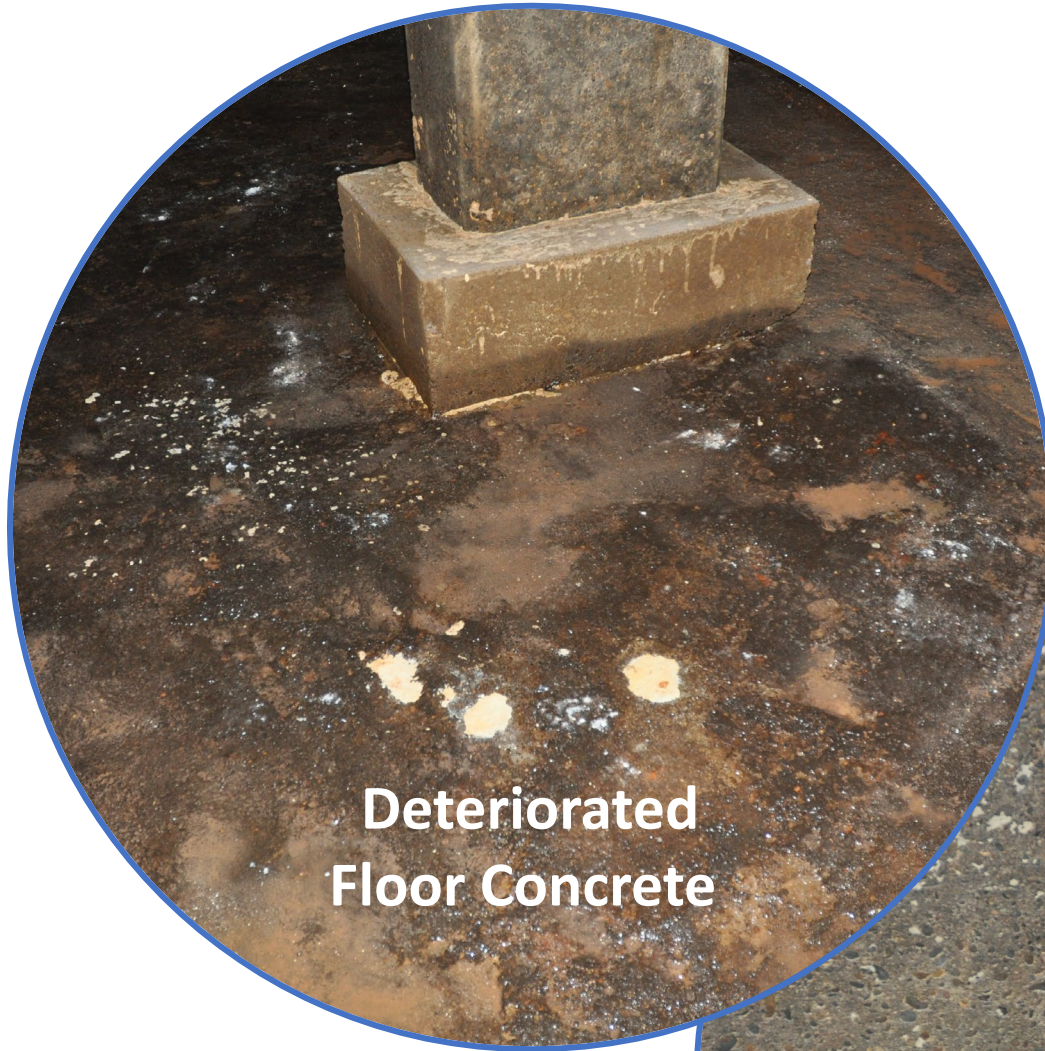
Deteriorated  
Floor Concrete

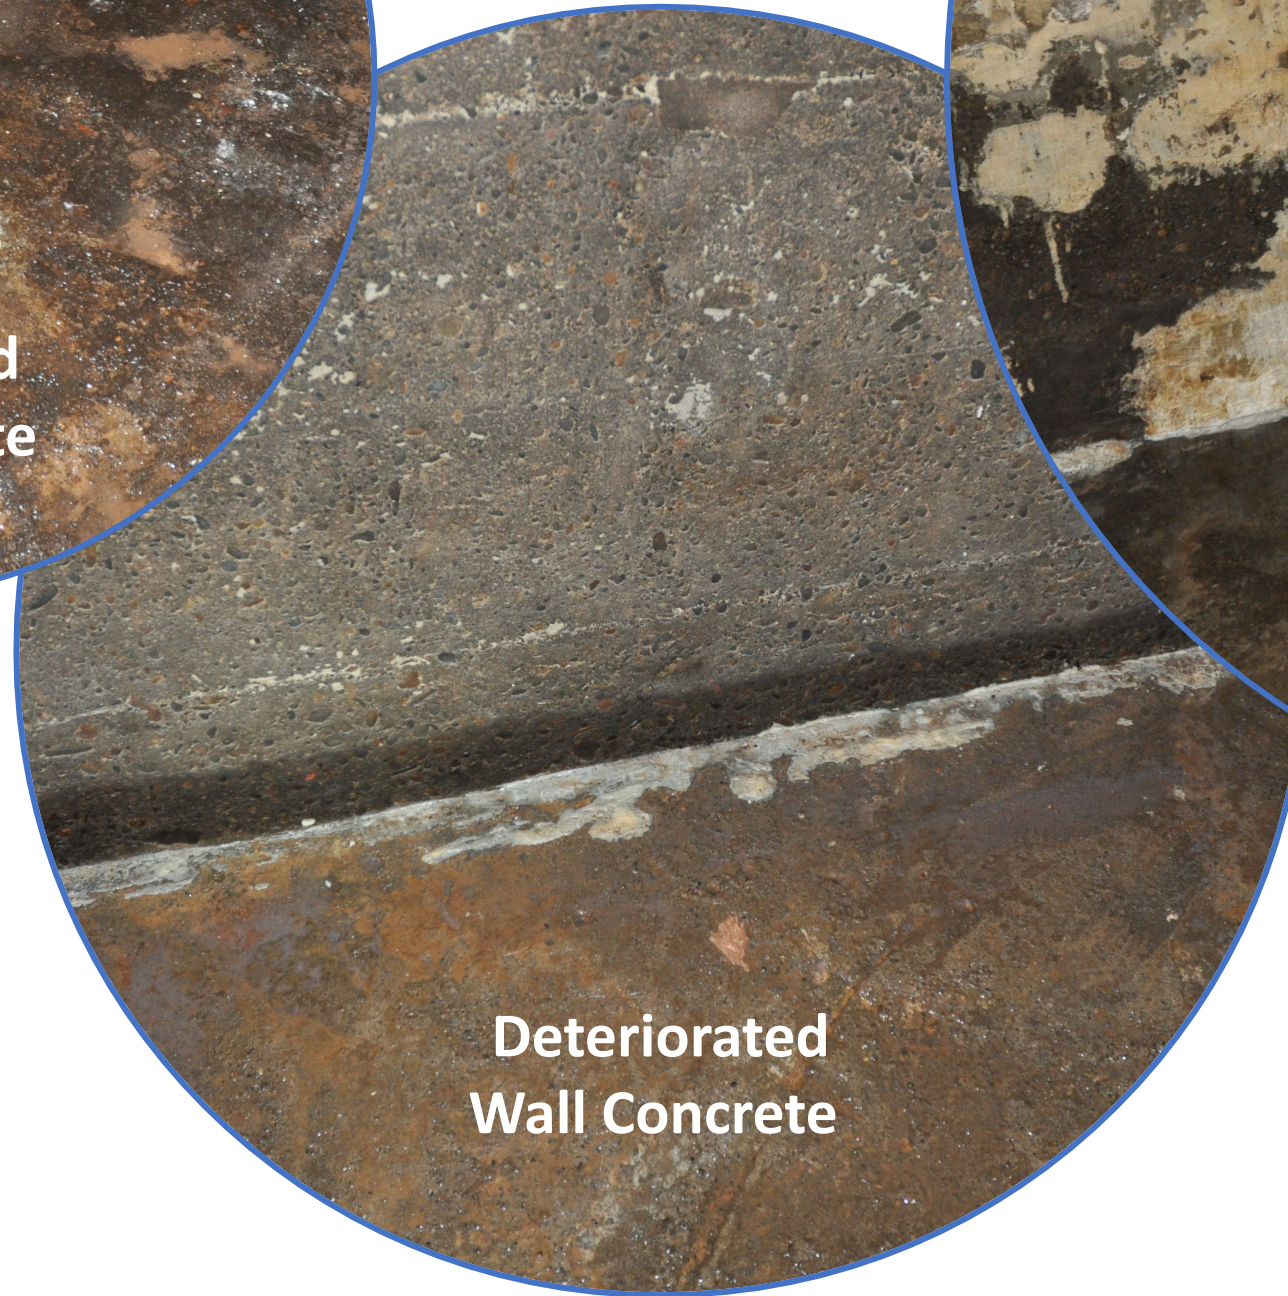
Deteriorated  
Wall Concrete

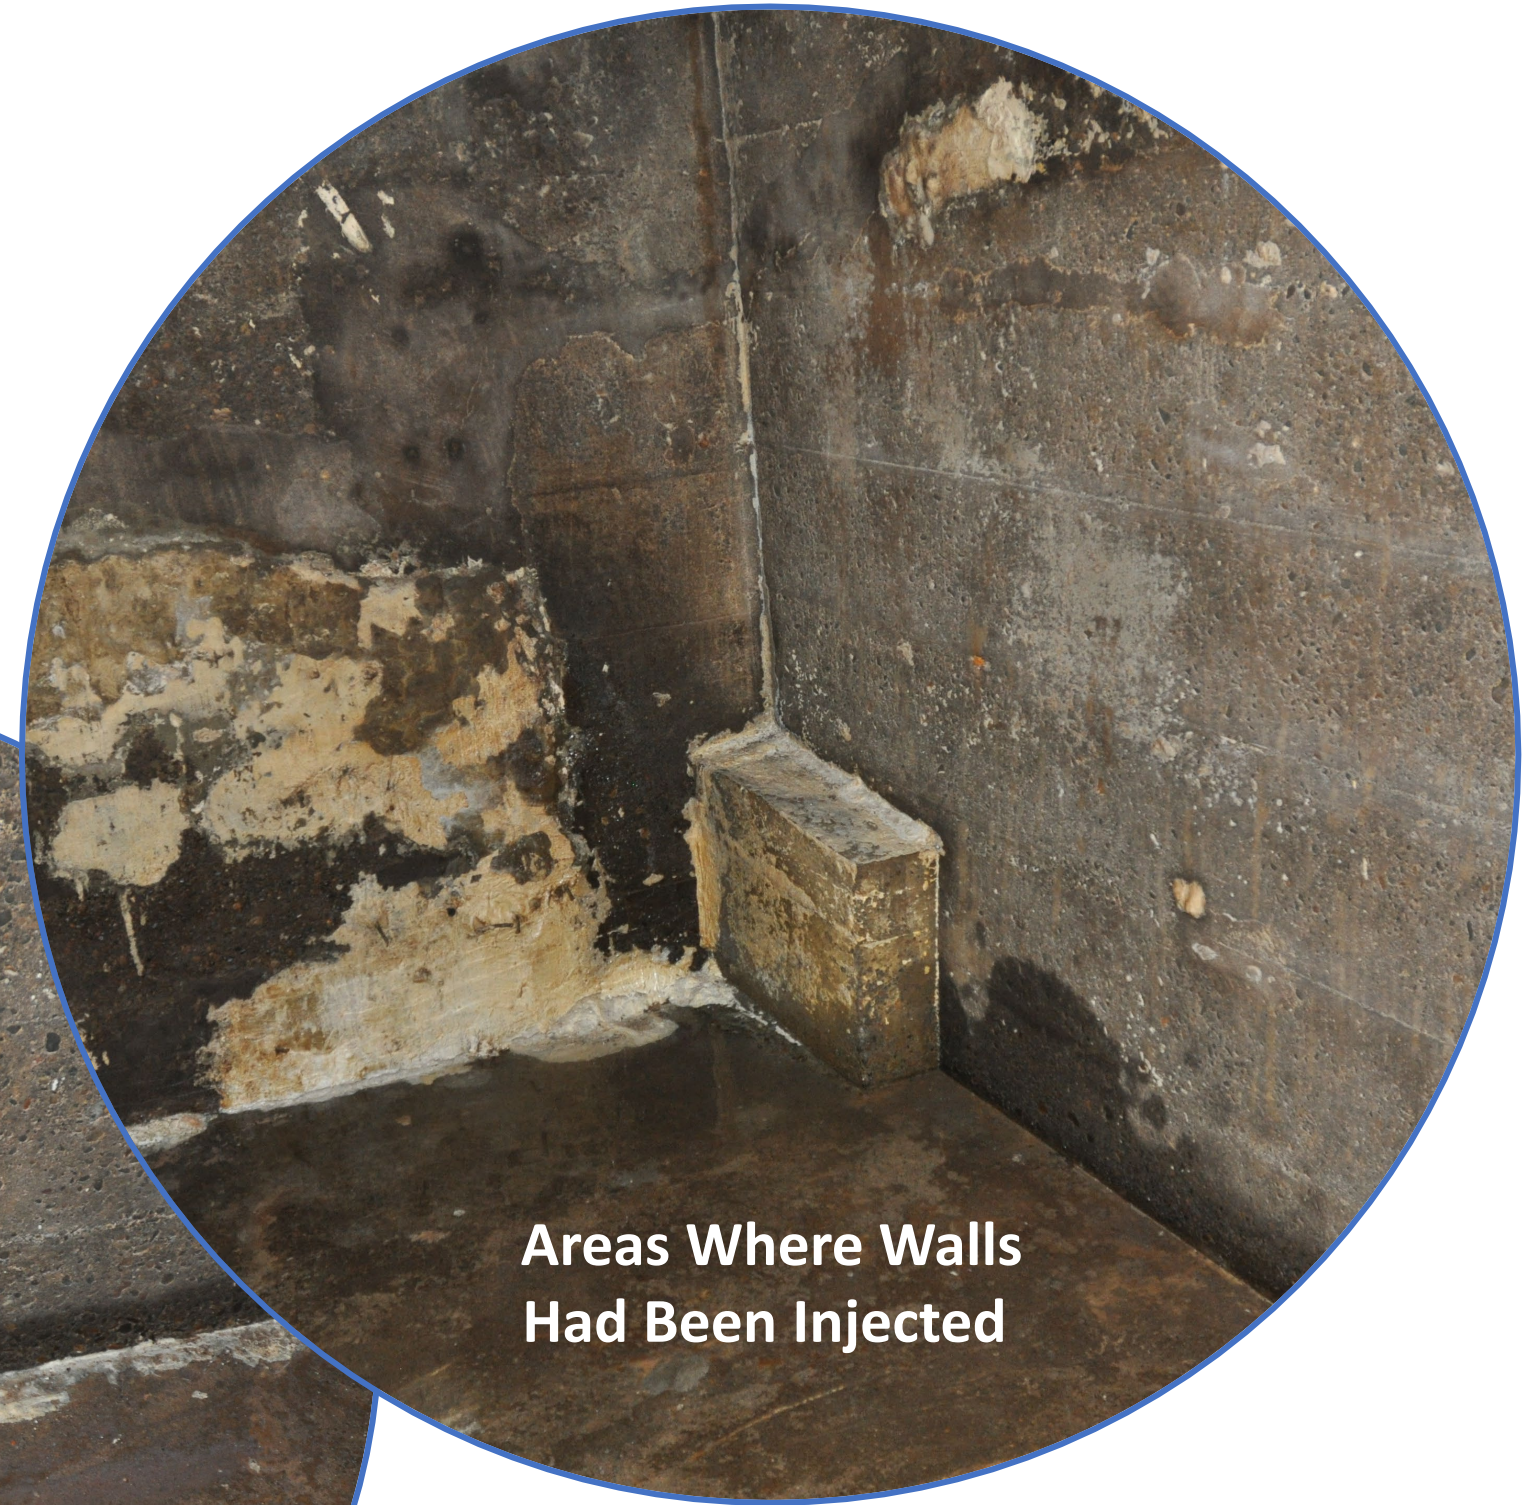
Areas Where Walls  
Had Been Injected

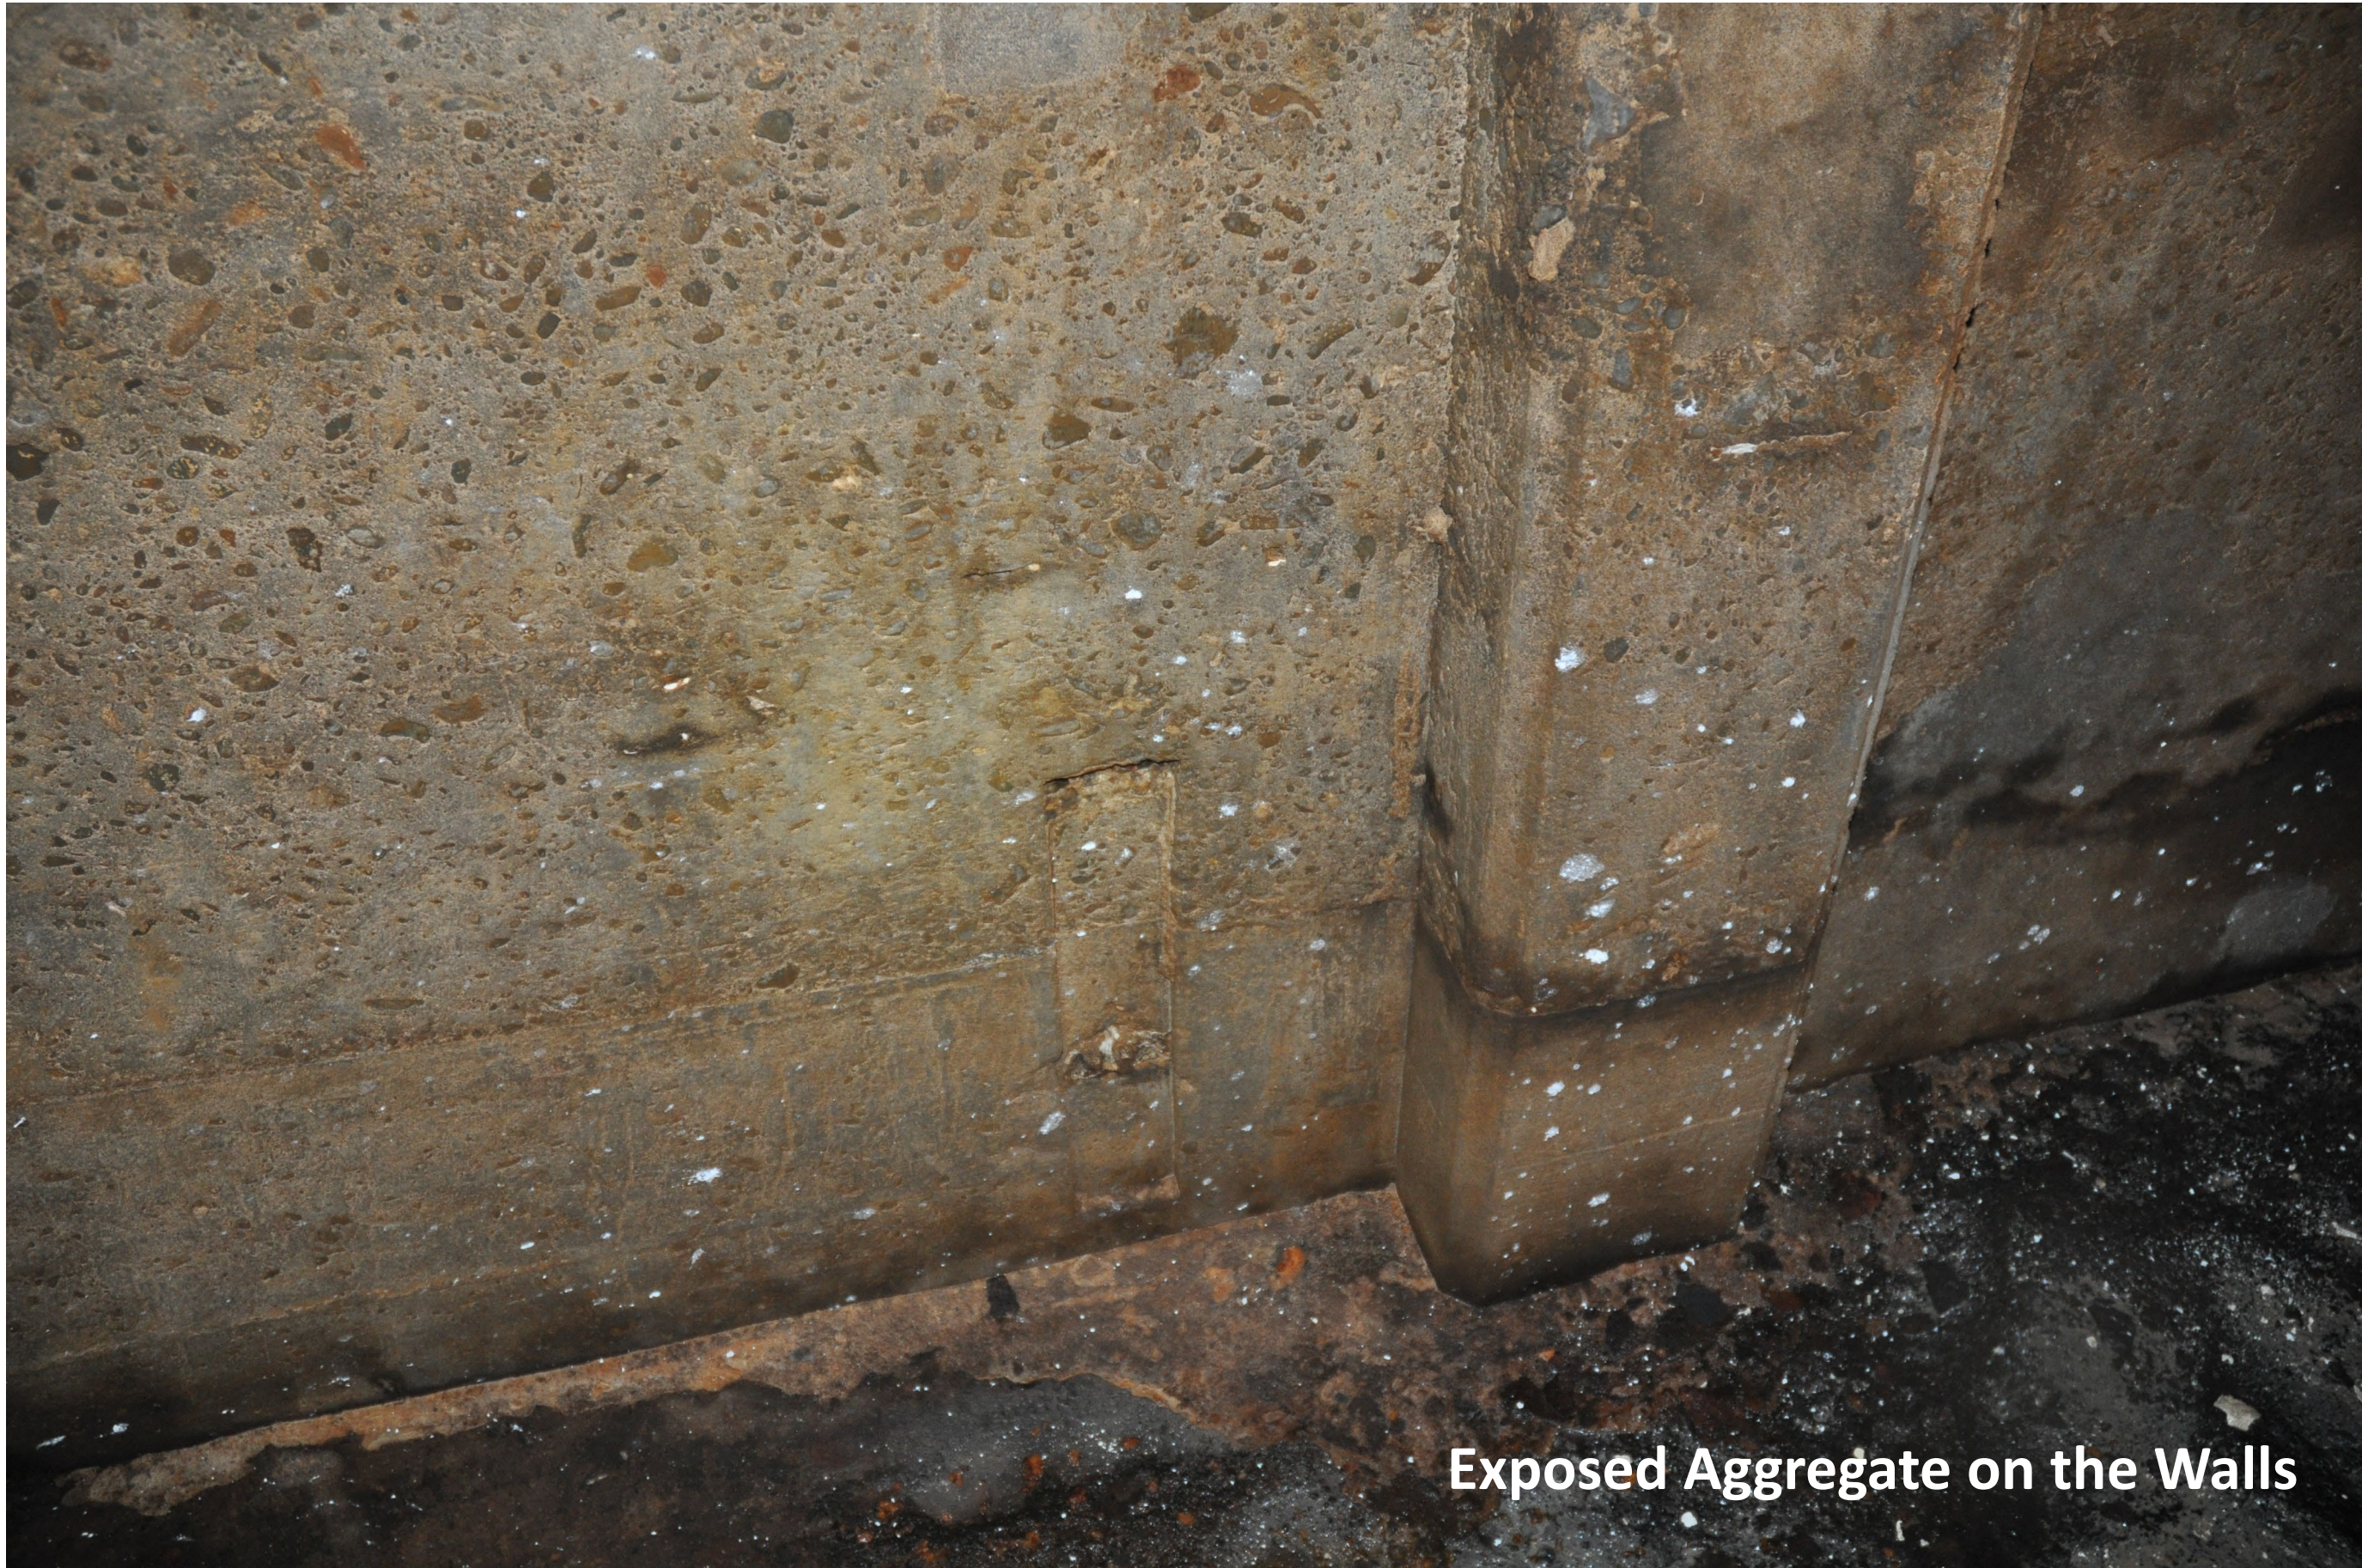
Exposed Aggregate on the Walls

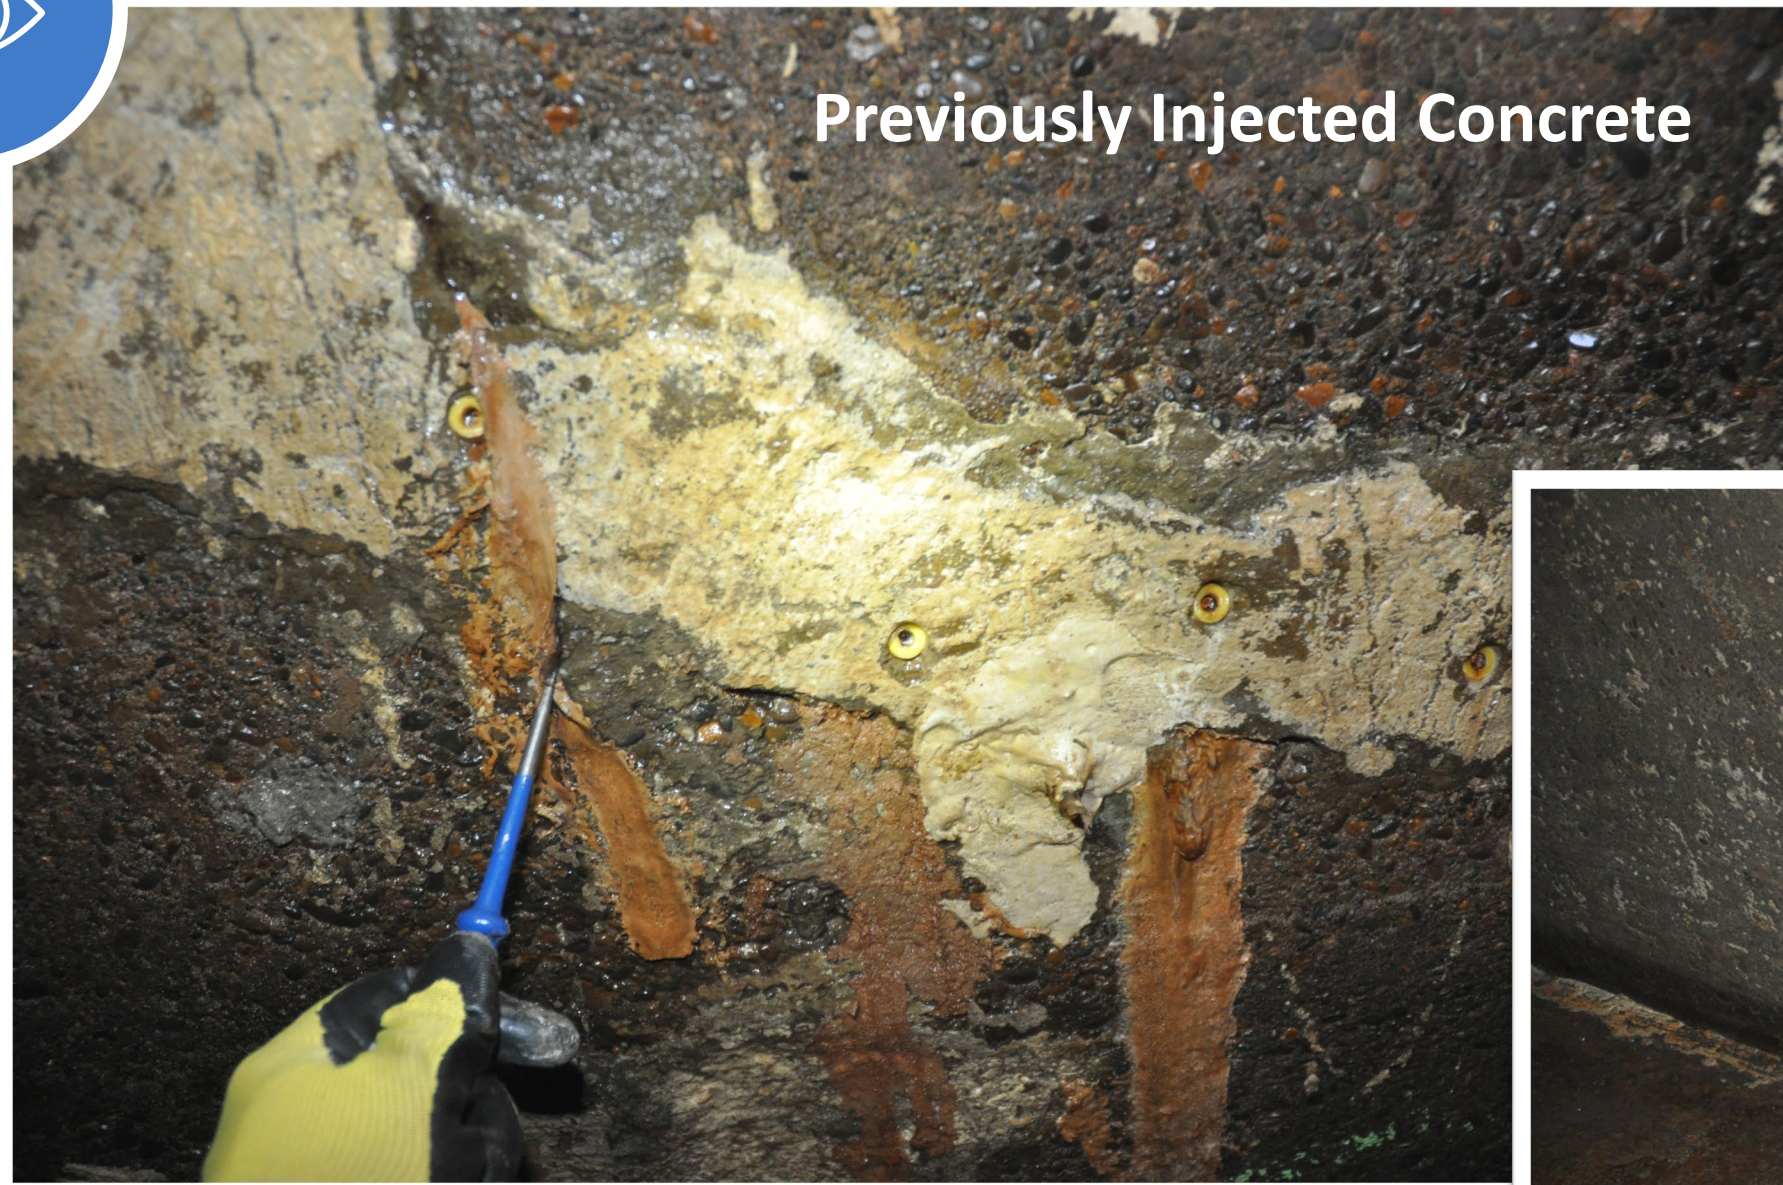
Previously Injected Concrete

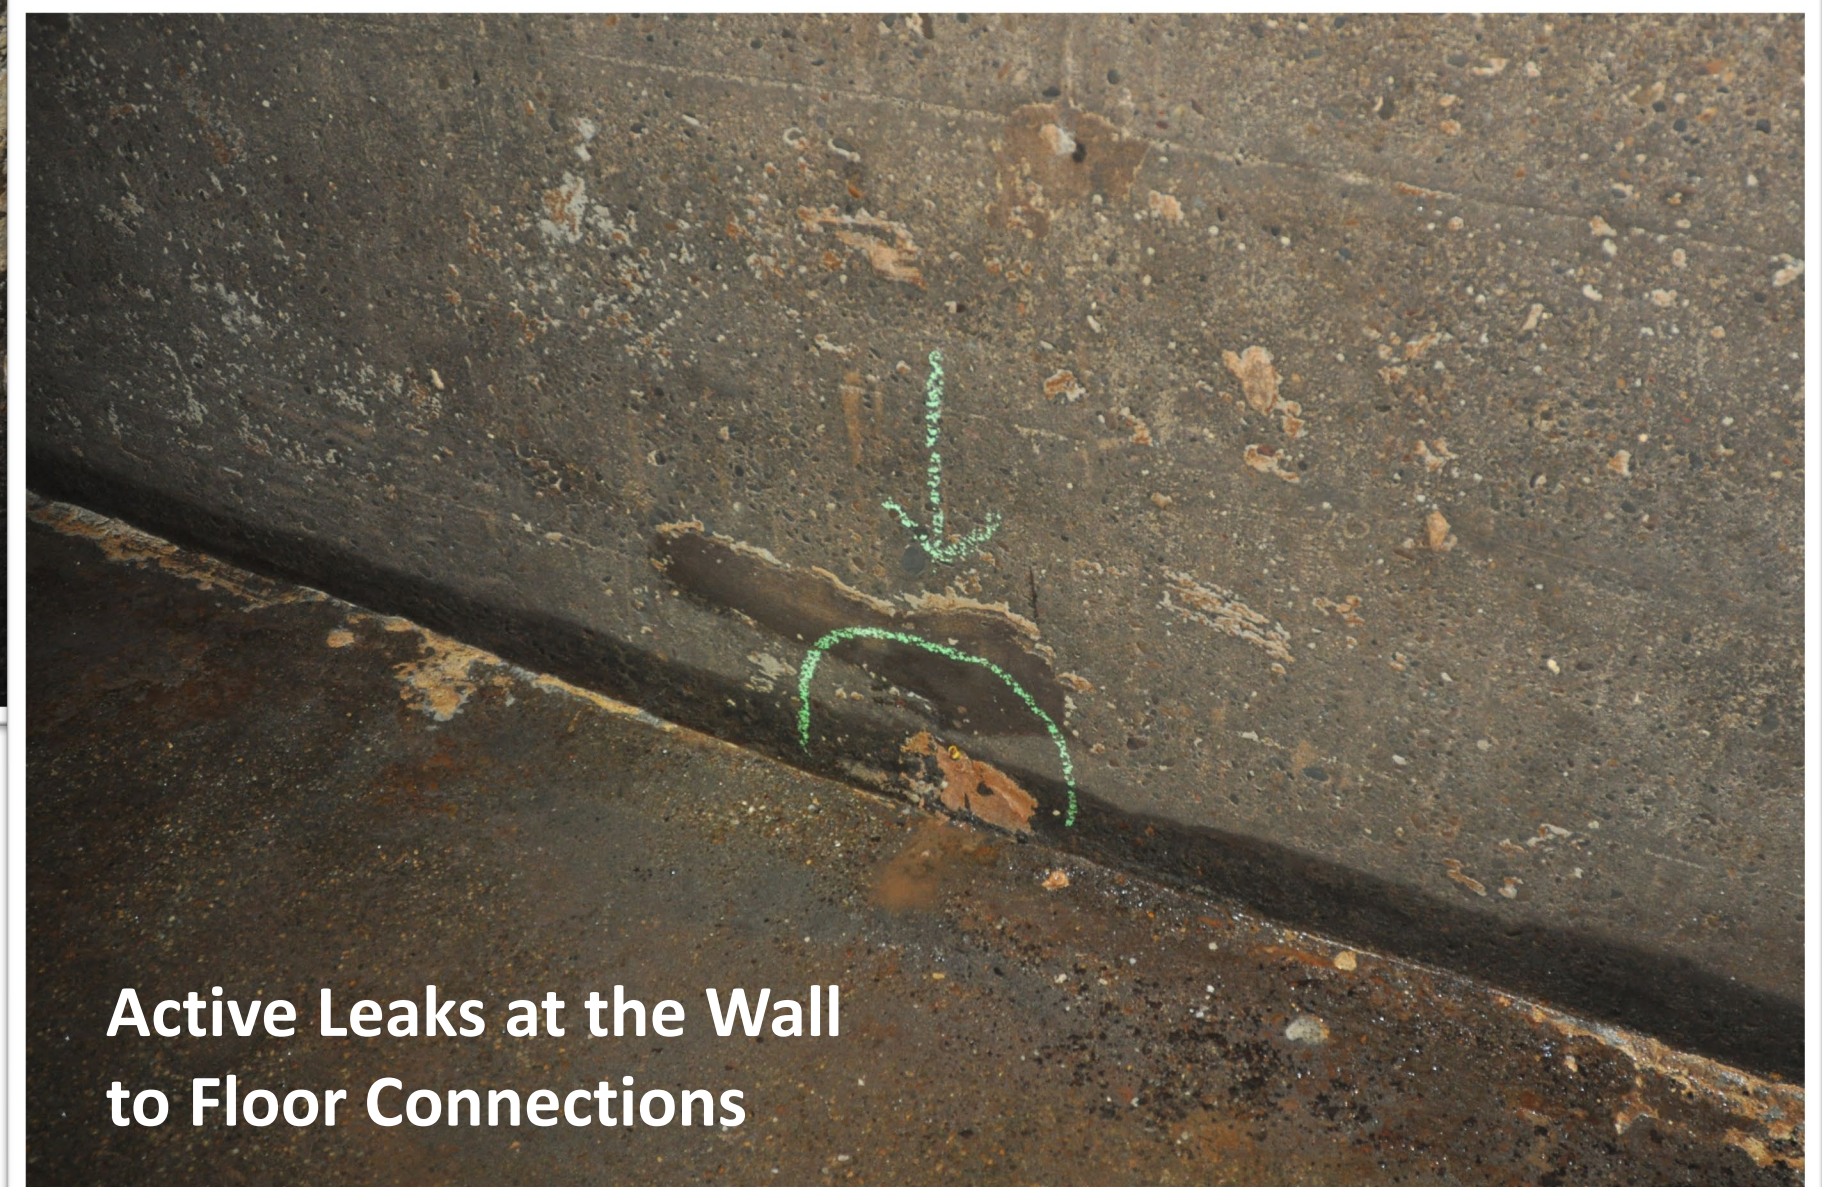
Active Leaks at the Wall  
to Floor Connections

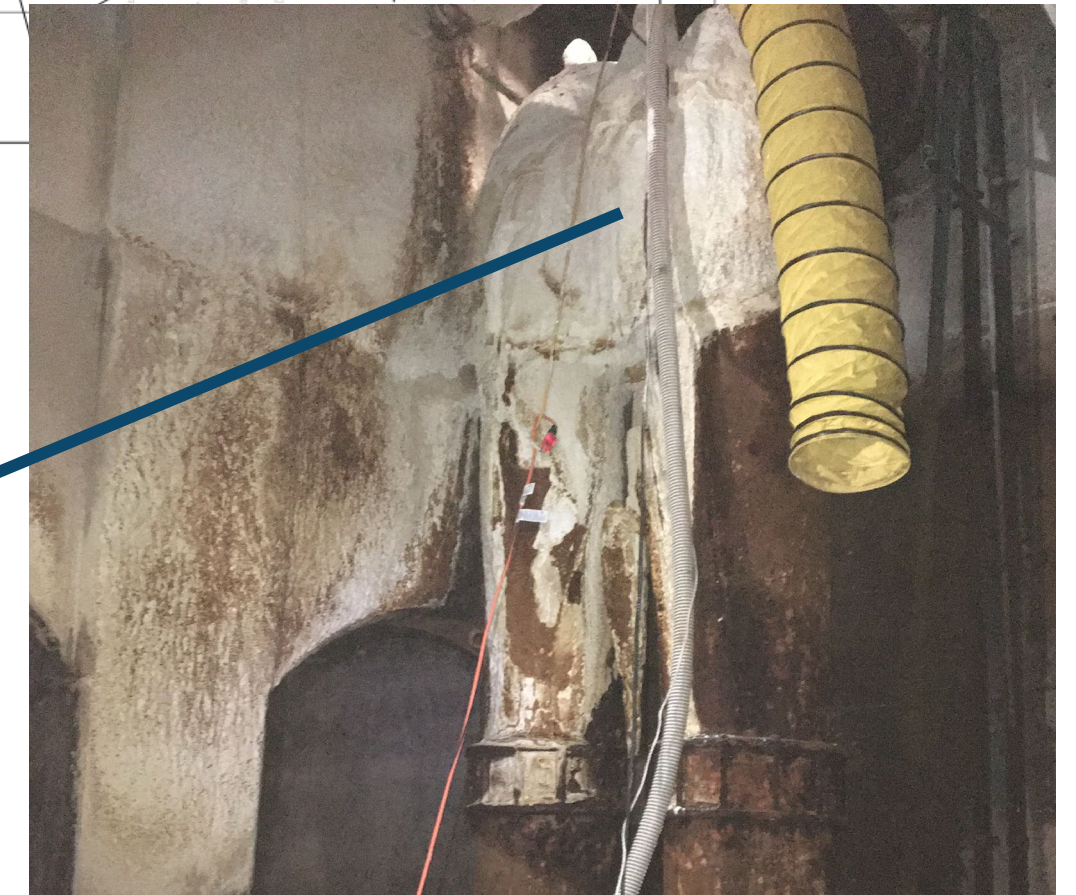
Heavy Soda Ash Buildup on Inlet Pipes

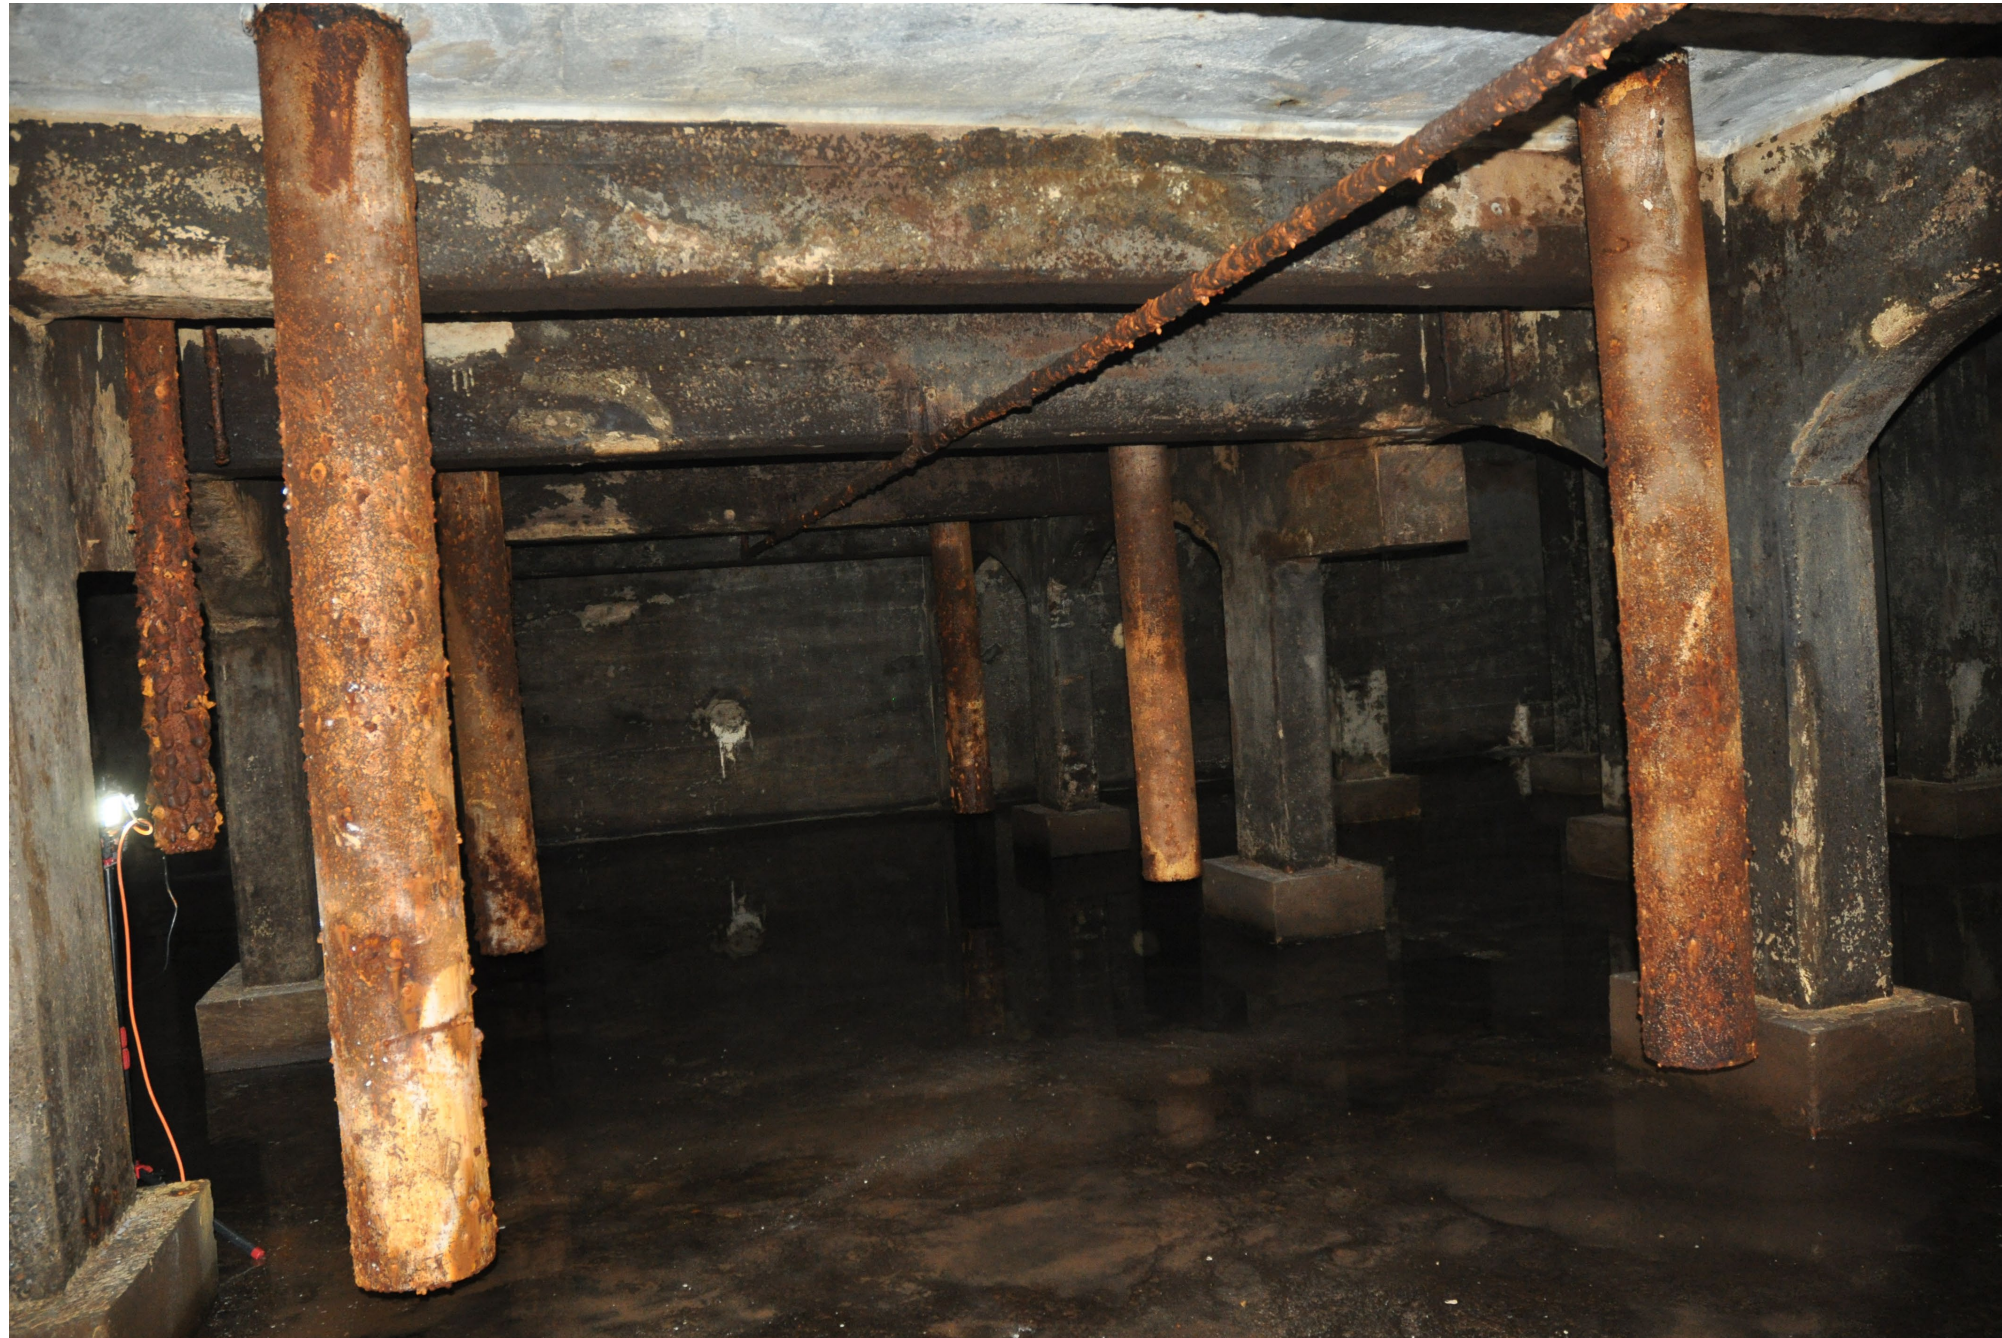
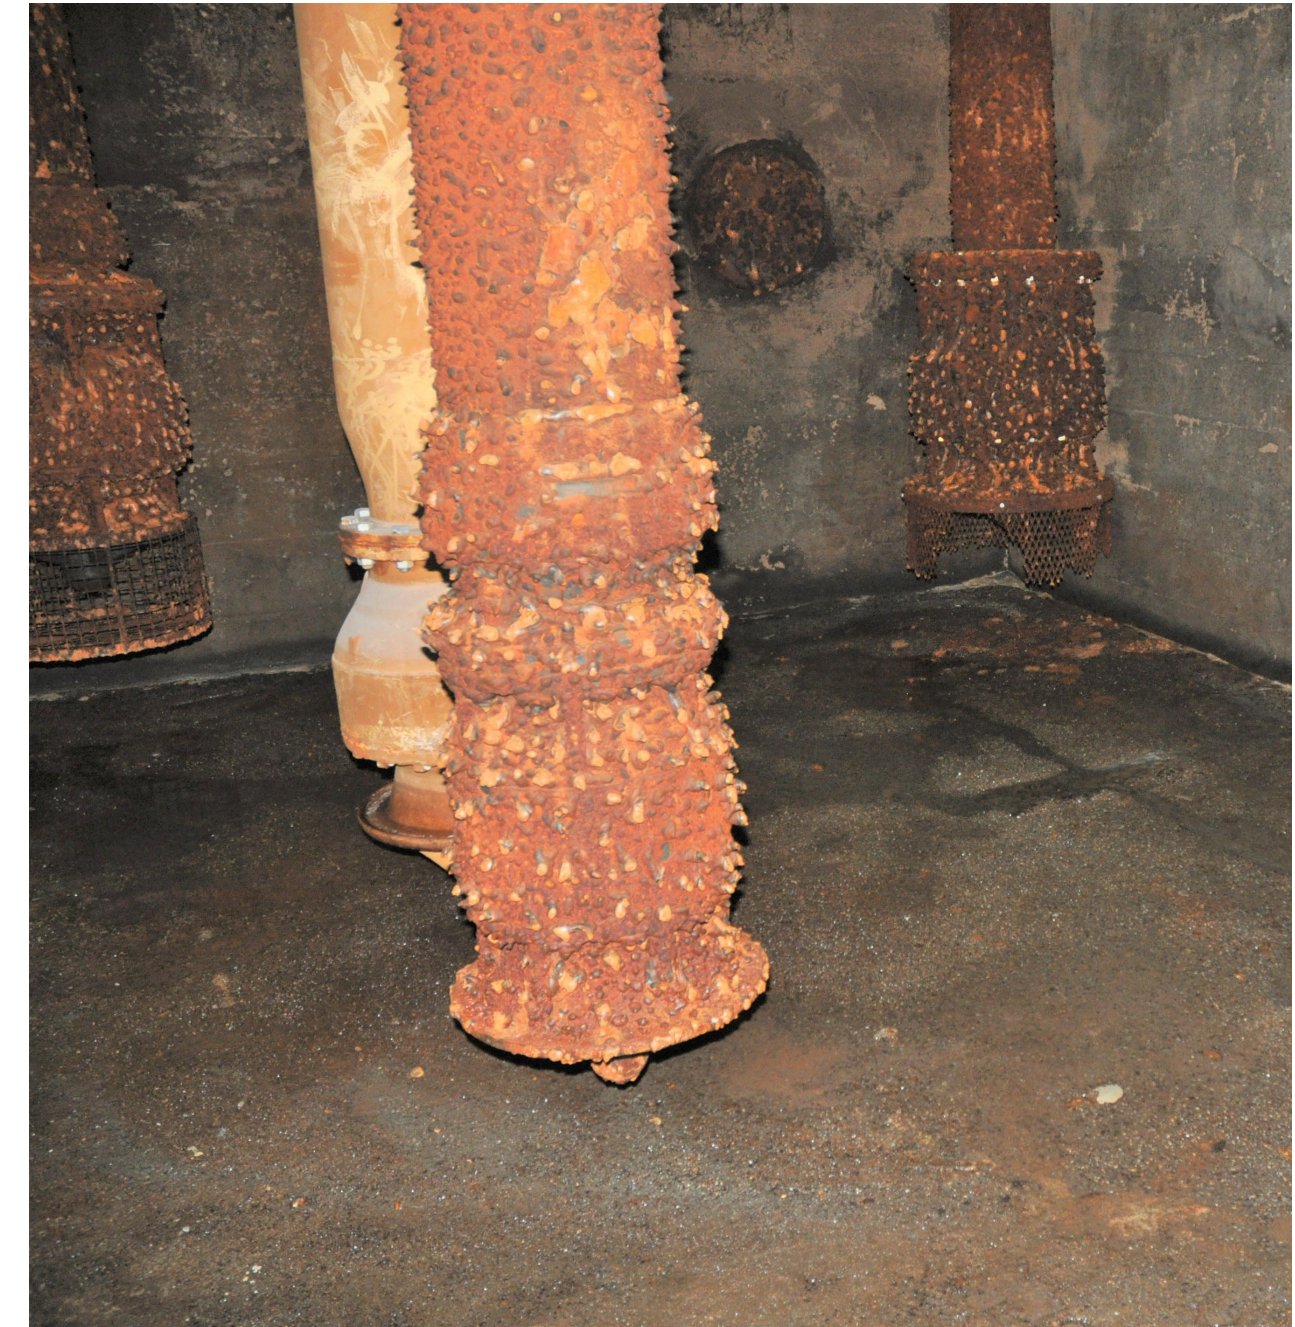
Existing Pipes and Pump Suction Lines Created Challenges relative to the Concrete Floor and Wall Shotcrete

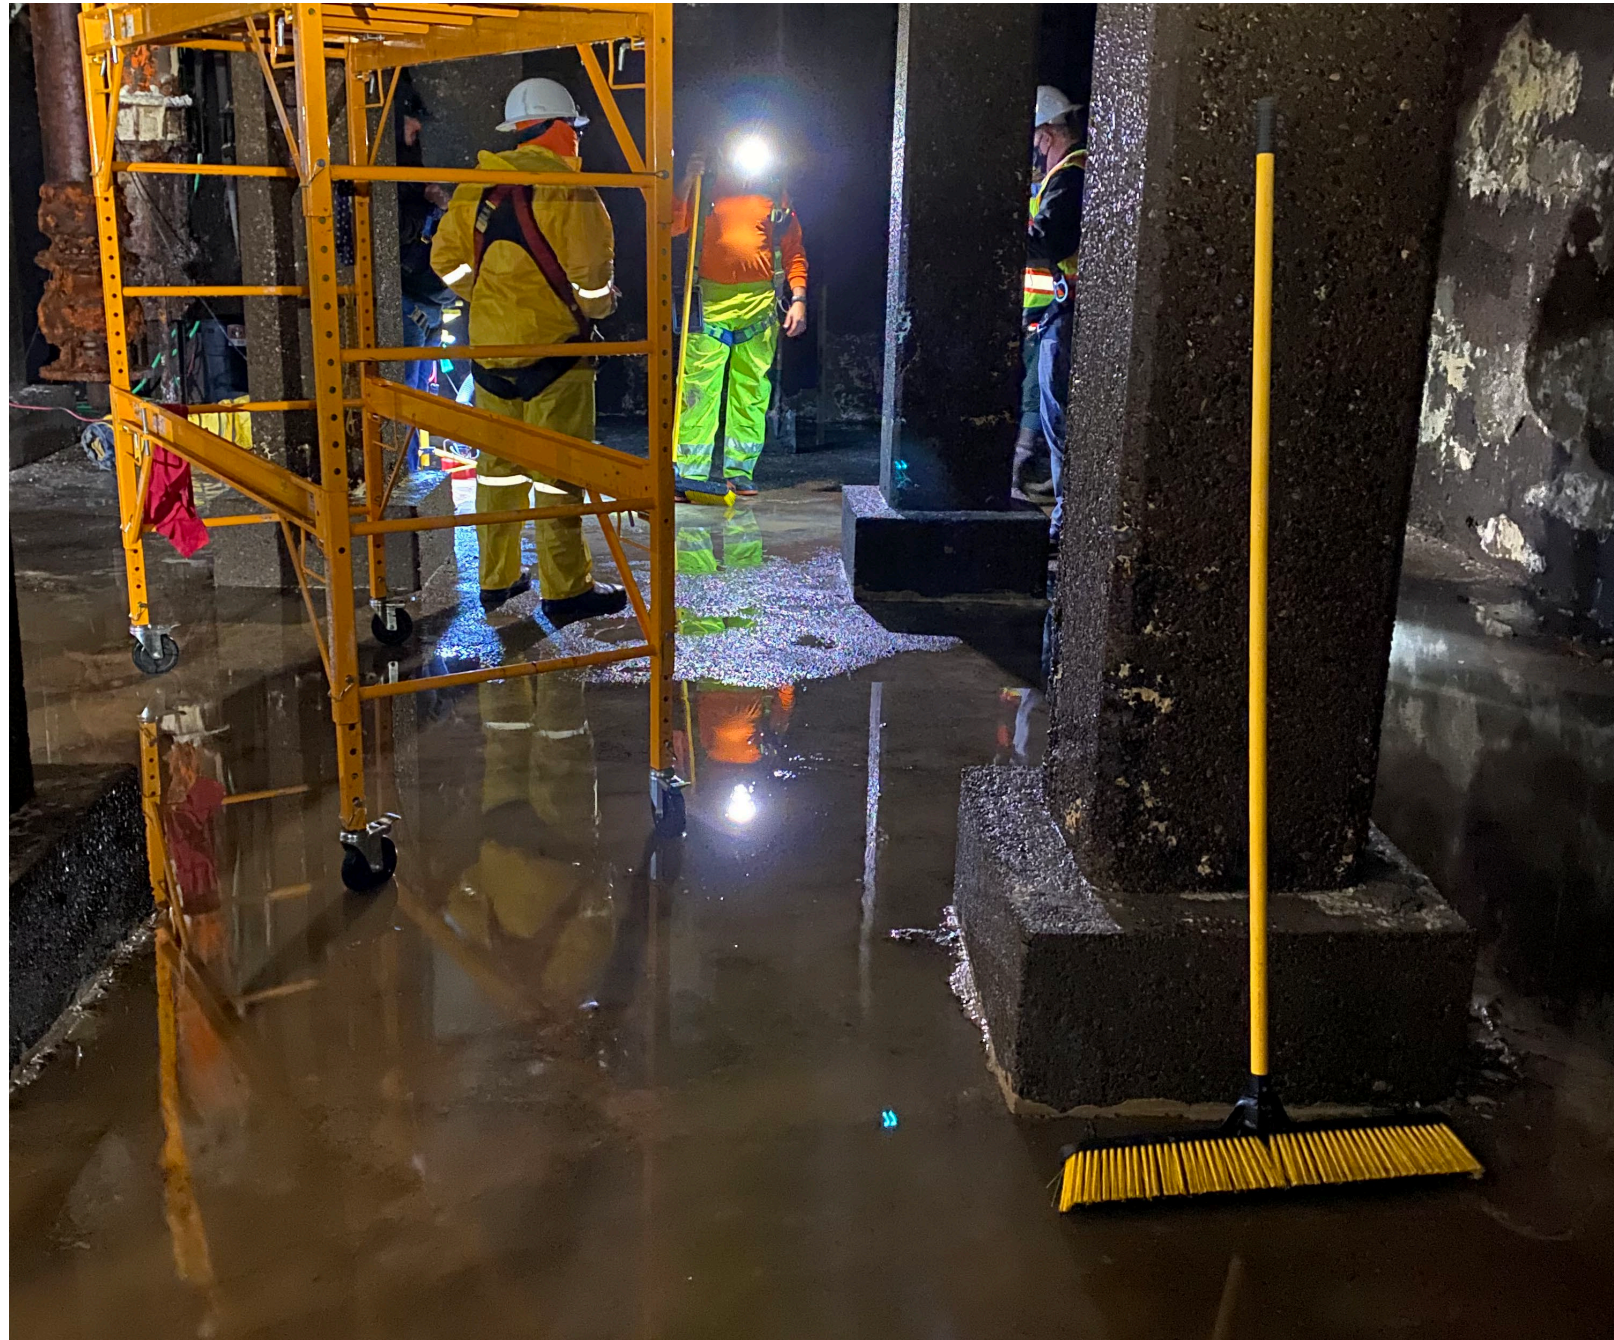
- Water Intrusion Continued During Construction
