# Whack-A-Mole

## Waterproofing a 100-year-old Clear Well

for The City of Albany, Oregon

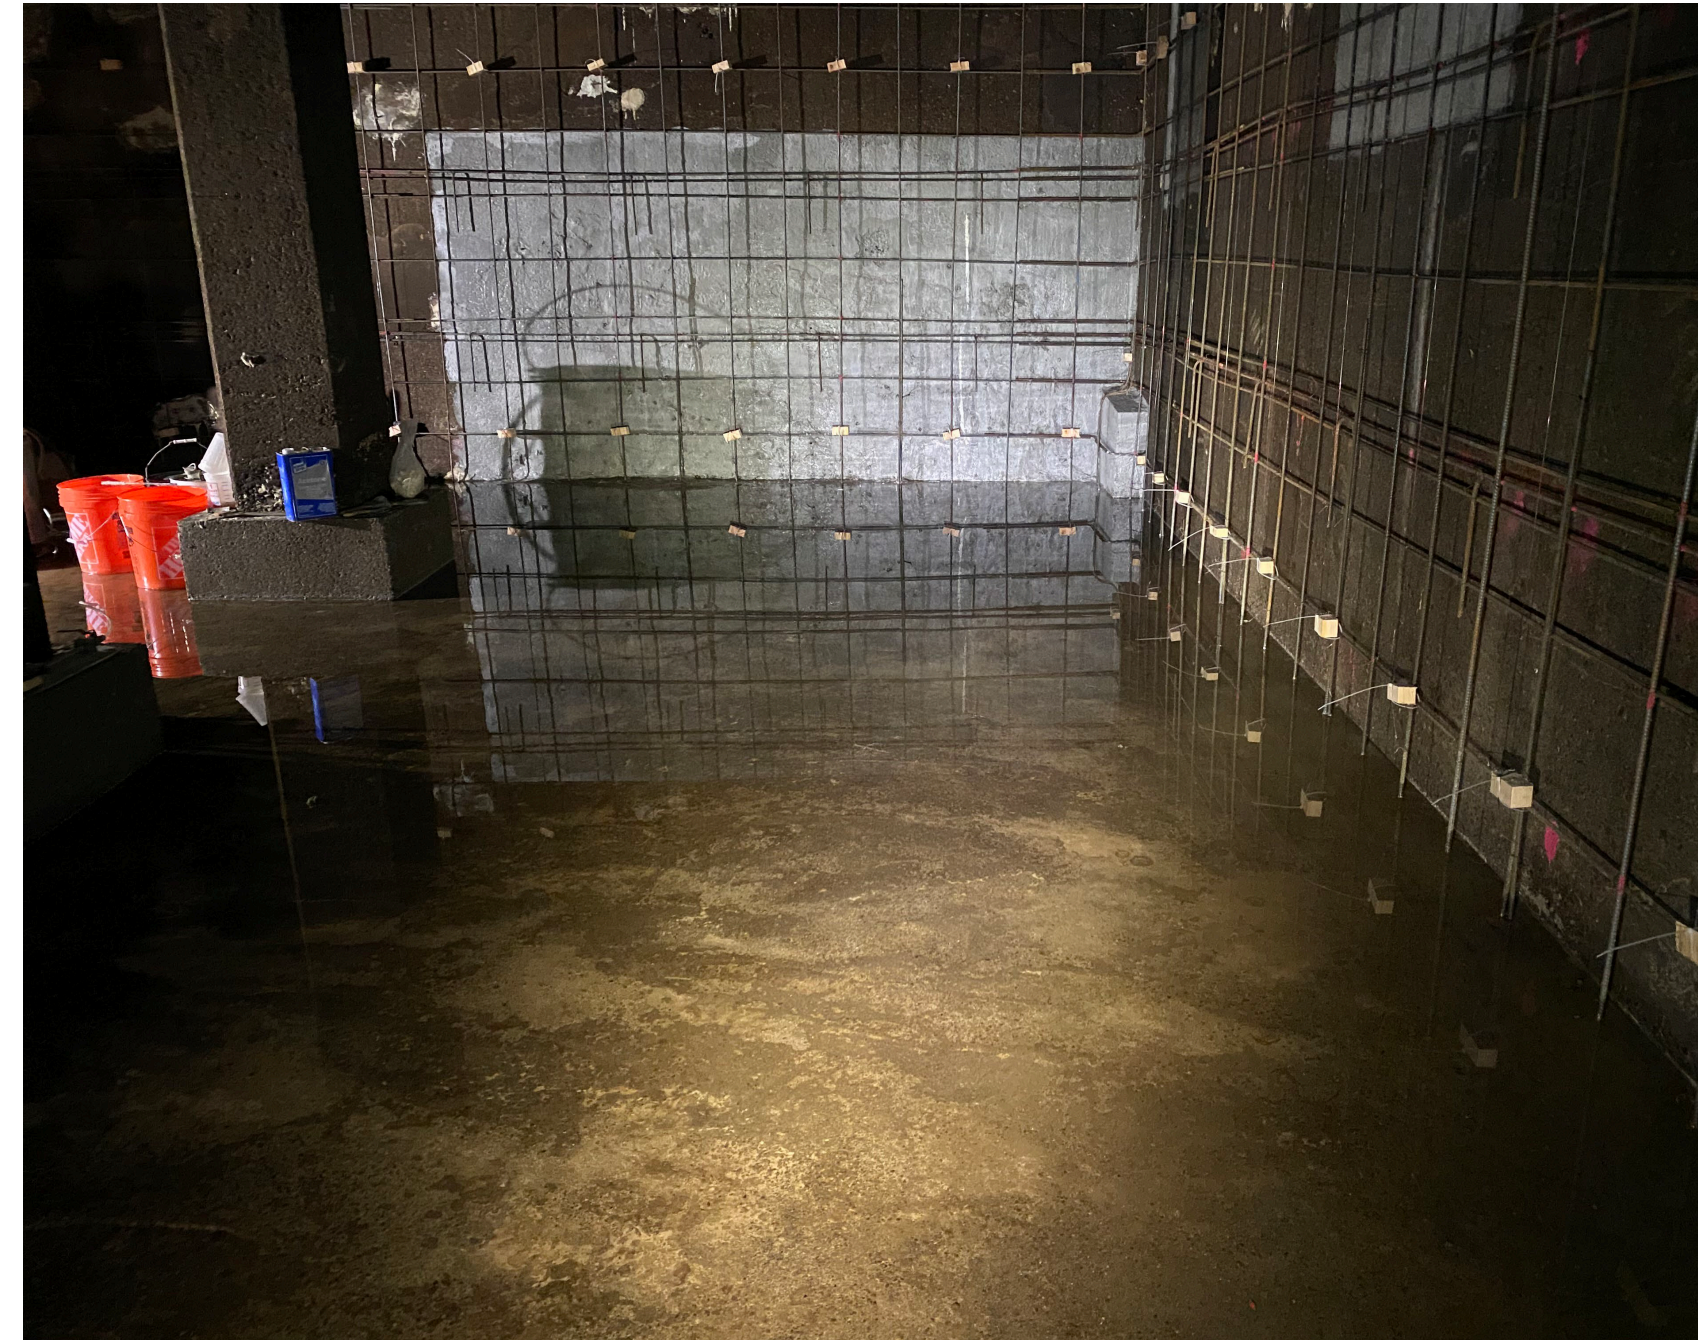
- Xypex Applied to Wall to Slow Water Intrusion
- Concern with Water Intrusion Impacting Strength of Shotcrete
