Water Supply Well Condition Assessments

Real-World Applications and Results

PNWS-AWWA Annual Conference
May 3-5, 2023

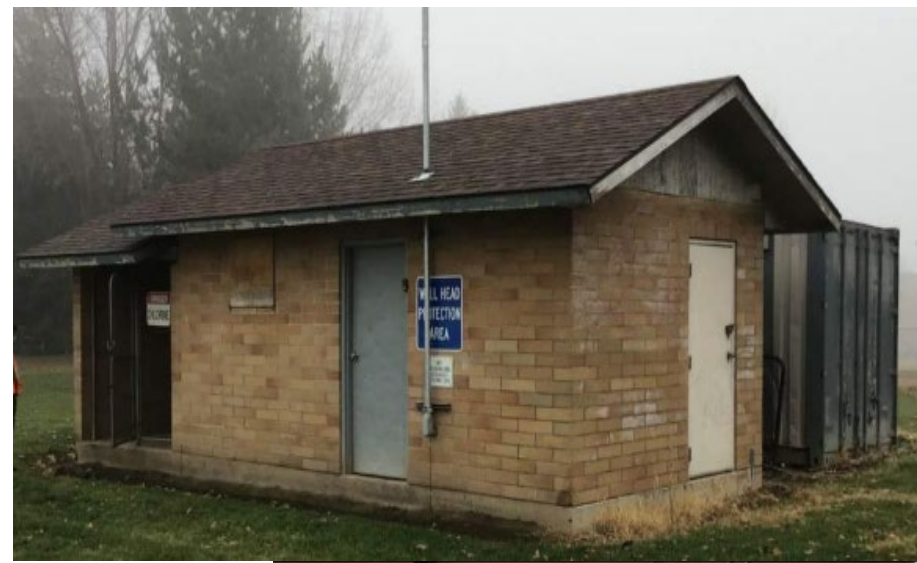
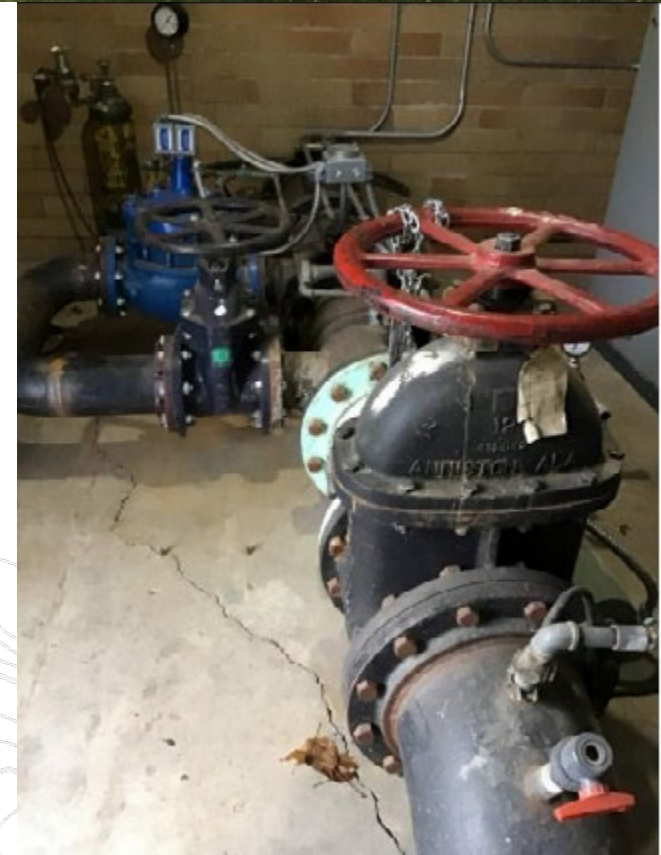
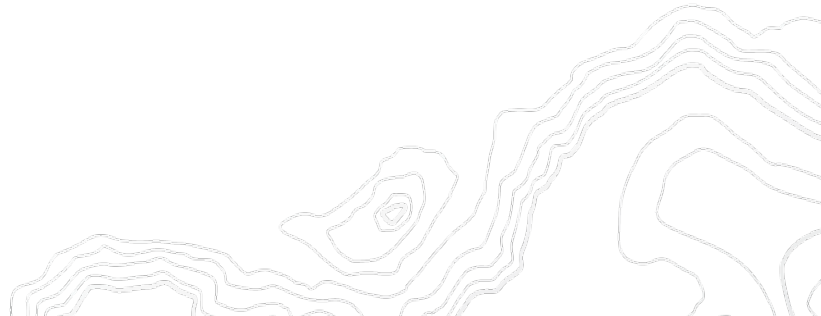
Case Studies: WW 7

- 50 y.o., unused for 30 years
- History of warm water with H₂S
- Power surcharge to start motor, so not exercised
- Building demolition required to pull pump
- PP&L Requested system test late 2022

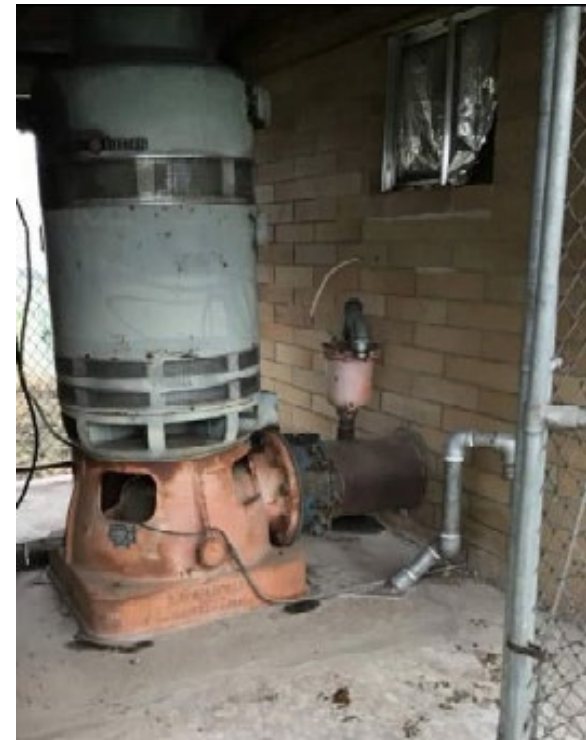
Case Studies: WW 7

- The motor ran, and water was pumped (2,700 gpm)
- Biological profile showed low activity
- H₂S was not noted
- Water cleared in 5 minutes
- Specific capacity had not declined
- Take-Away: Even though this well seemed like problems were likely, it remains in good operational condition

(casing not inspected)

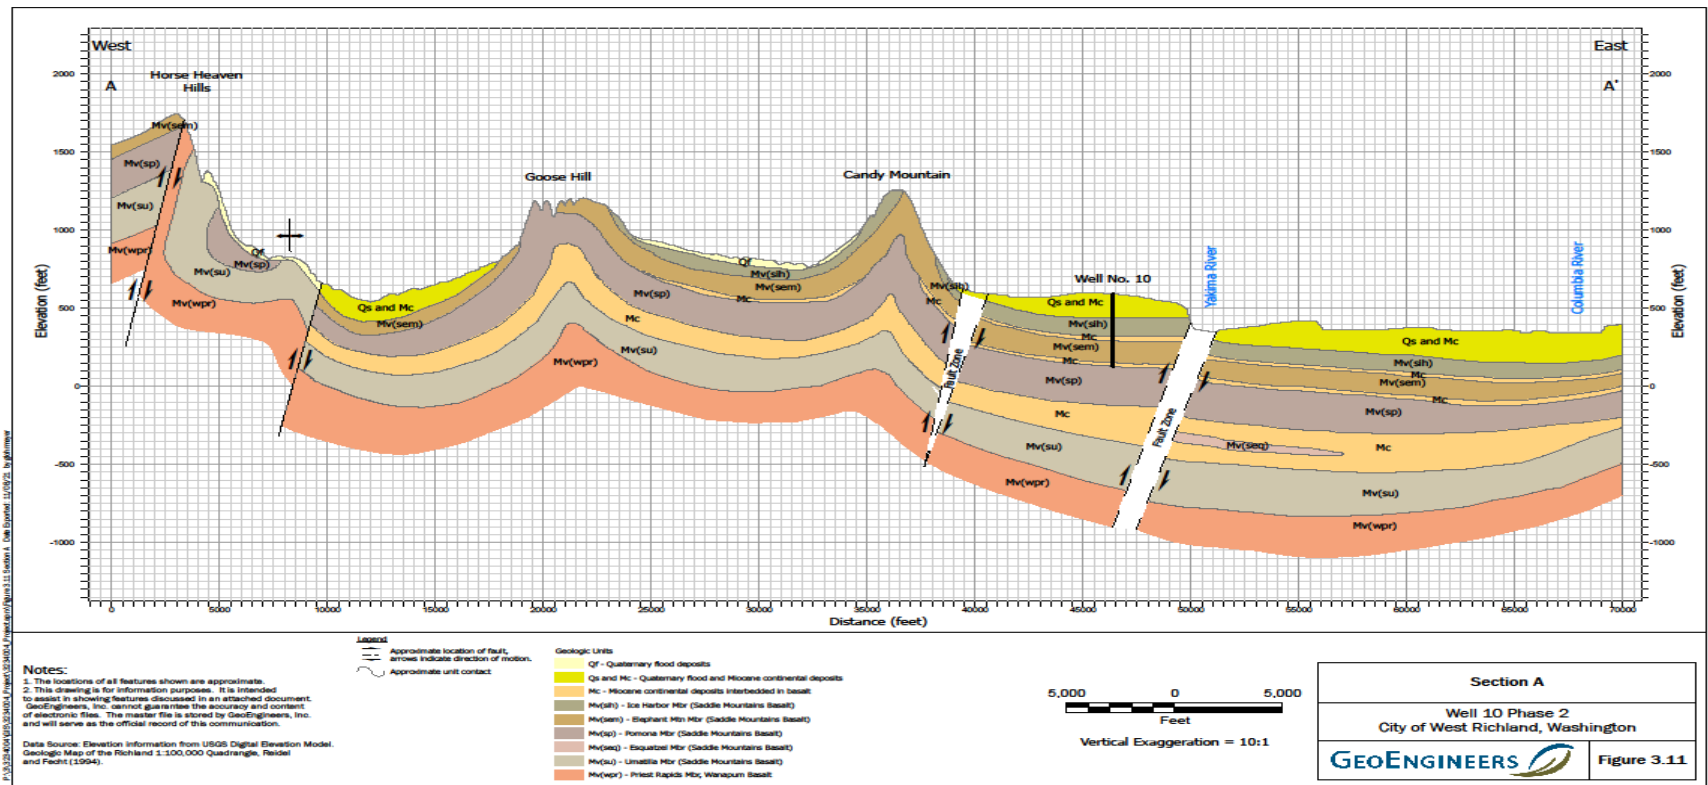
Case Studies: WR 10

- Findings: (1) Water quality had improved, (2) Screens clean, (3) Well productive, (4) Brush and disinfection only
- Outcome: (1) ASR is feasible, (2) City still needs to meet peak demand

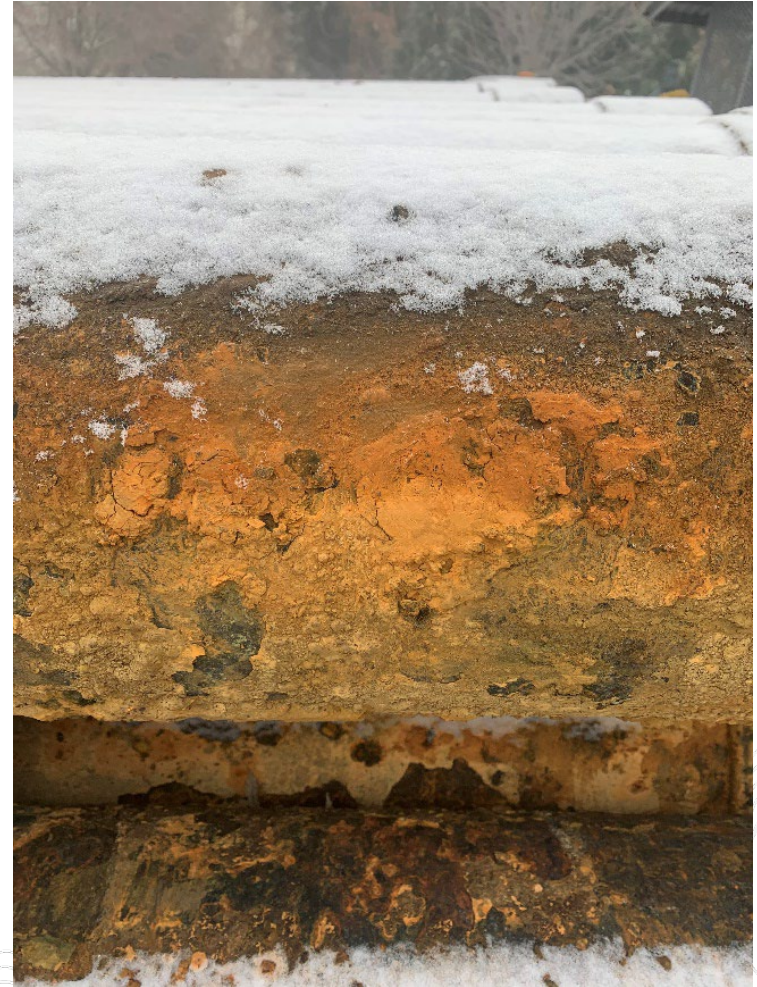
Case Studies: WW5

- Well moderately active
- Significant MIC (corrosion)
- Casing required cleaning prior to condition evaluation
- Cleaning process caused casing failure
- Well was re-built with new casing and seal
- Water was clean post-disinfection
- Well is now suitable for ASR

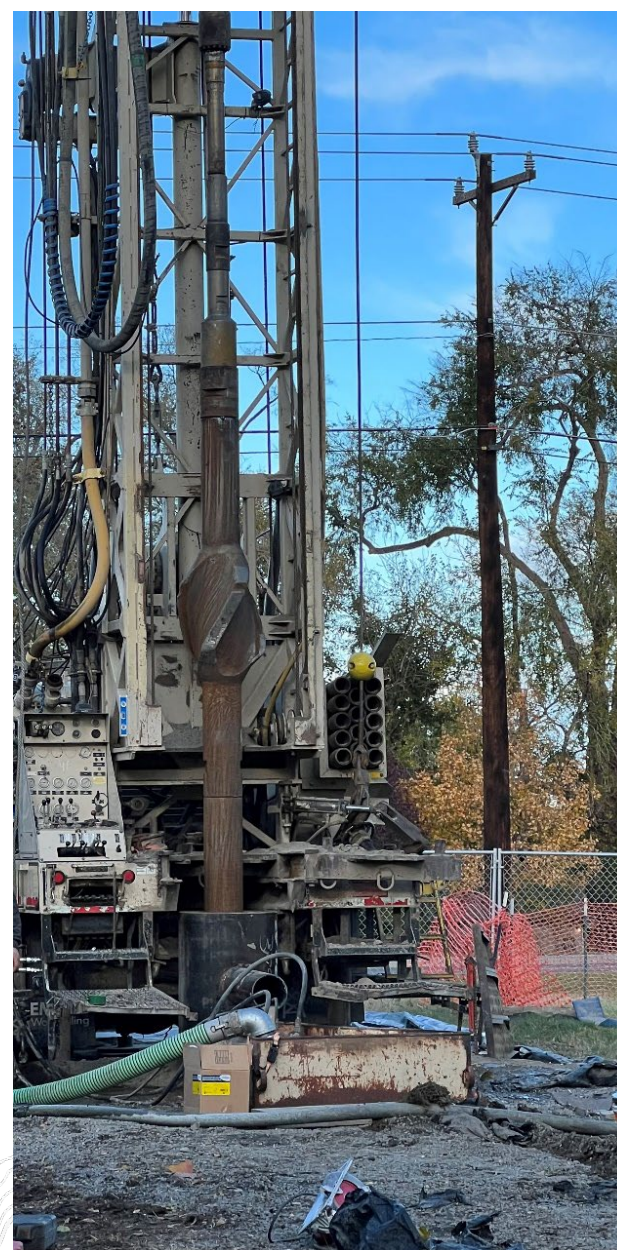
Case Studies: WR2

- Basalt Well
 - Shallow well in developed area, WQ
 - Water Rights allow deeper completion
 - Downsizing to case, seal, advance = too small
- Outcome –
Decomm/Replace

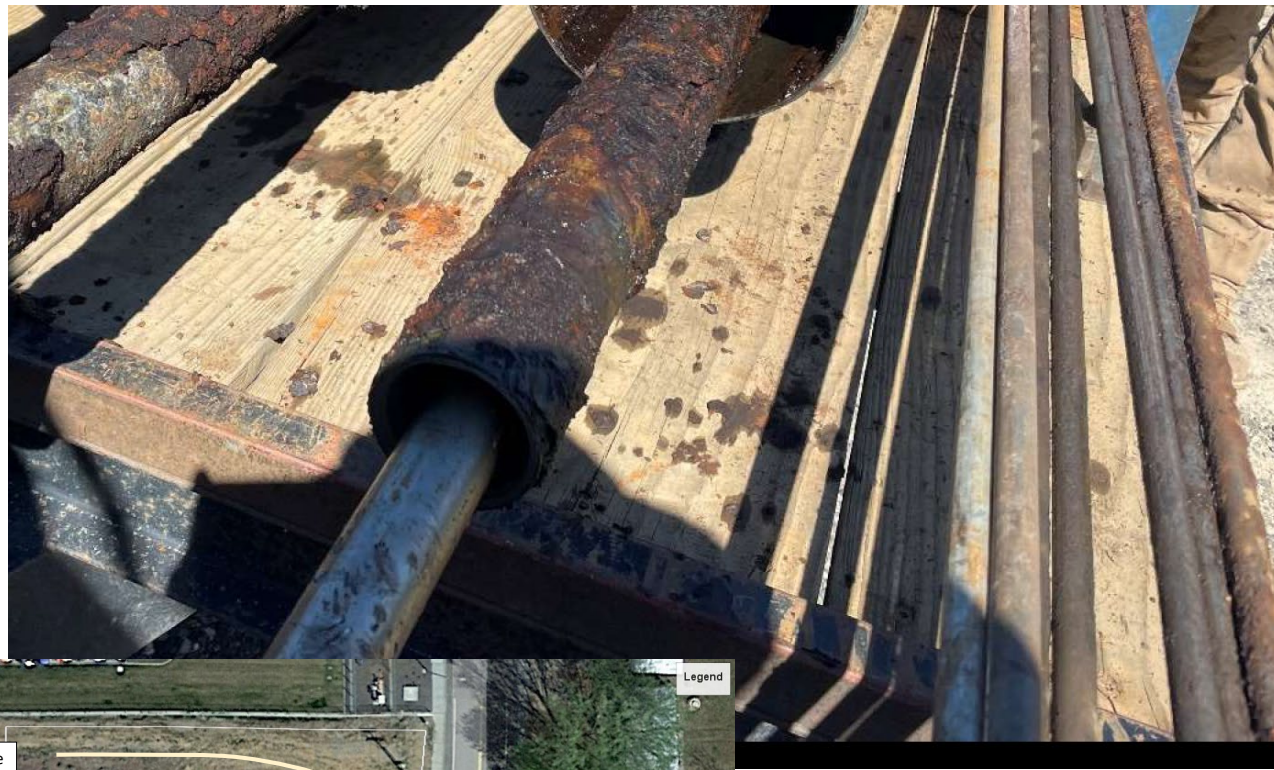
Case Studies: WR 3

- Findings: corroded, debris, last rebuild, options limited
- Outcome: decomm/replace
