Retrofitting your old Concrete Water Tank

CONCRETE TANK SERVICES

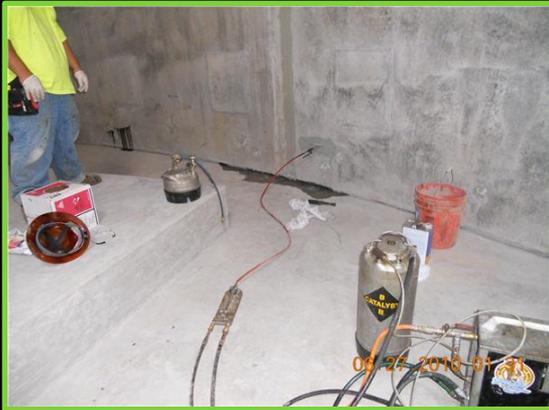
Problem: Earthquake Damage

Low pressure epoxy injection of wall joints and cracks

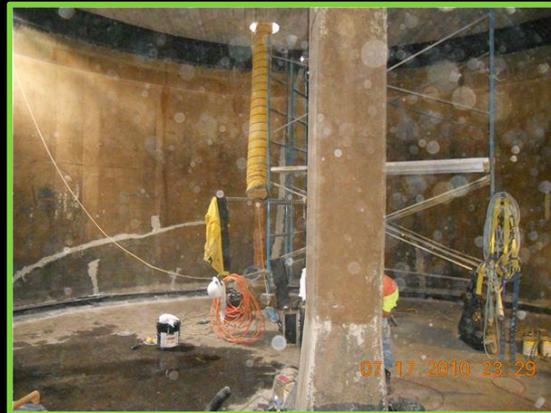
NSF approved non-sag epoxy used to "cap seal" cracks.

Note: LP-epoxy injection ports

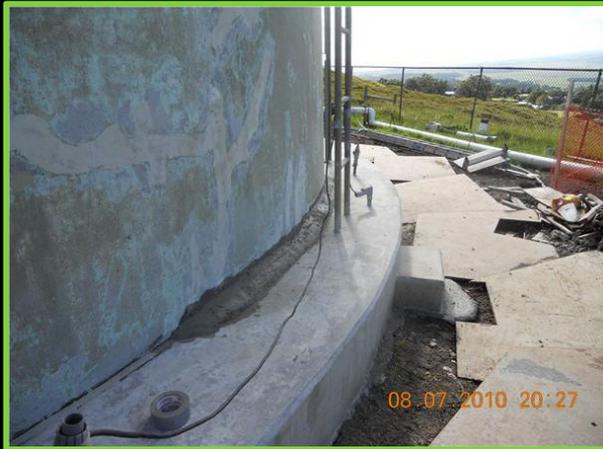
Exterior wall to footing connection, dam system installed to retain LP-epoxy injection of joint. Dam is removed after curing of epoxy.

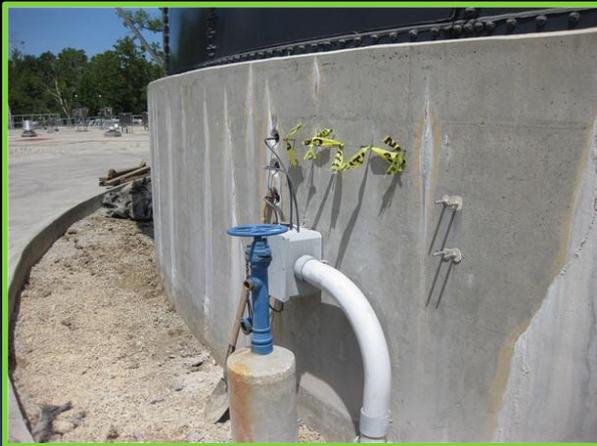
Calcium stains and leaking
due to insufficient structural
reinforcement

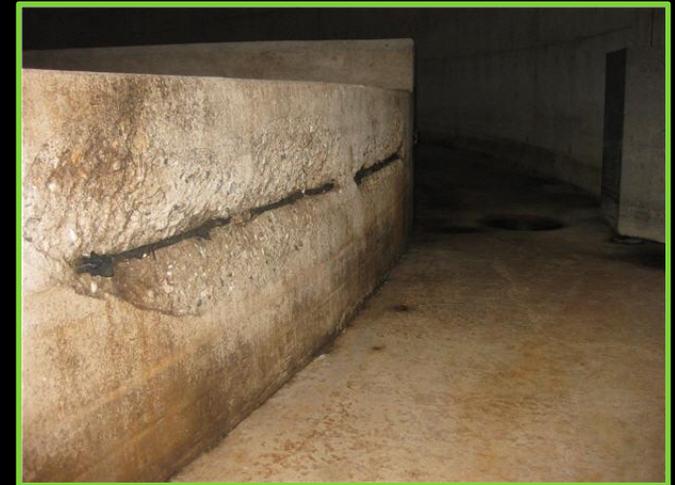
Spalded area due to corrosion

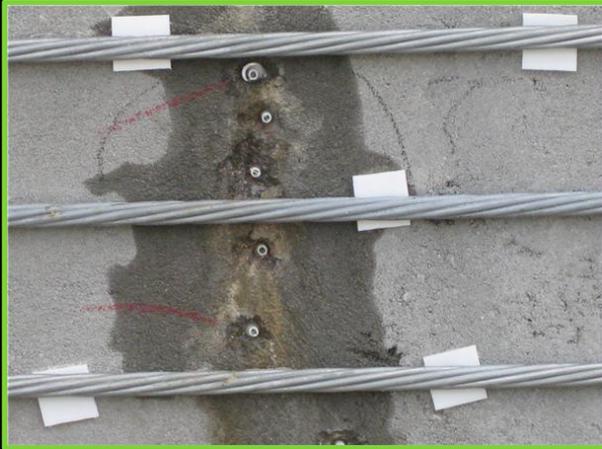
Leak testing before shotcrete cover coat. Areas that were showing leaks were epoxy injected with 2-part high viscosity material using low pressure pump system
