PNWA – AWWA 2013

Water Infrastructure Seismic Considerations

Potential Geotechnical Hazards of Seismic Events

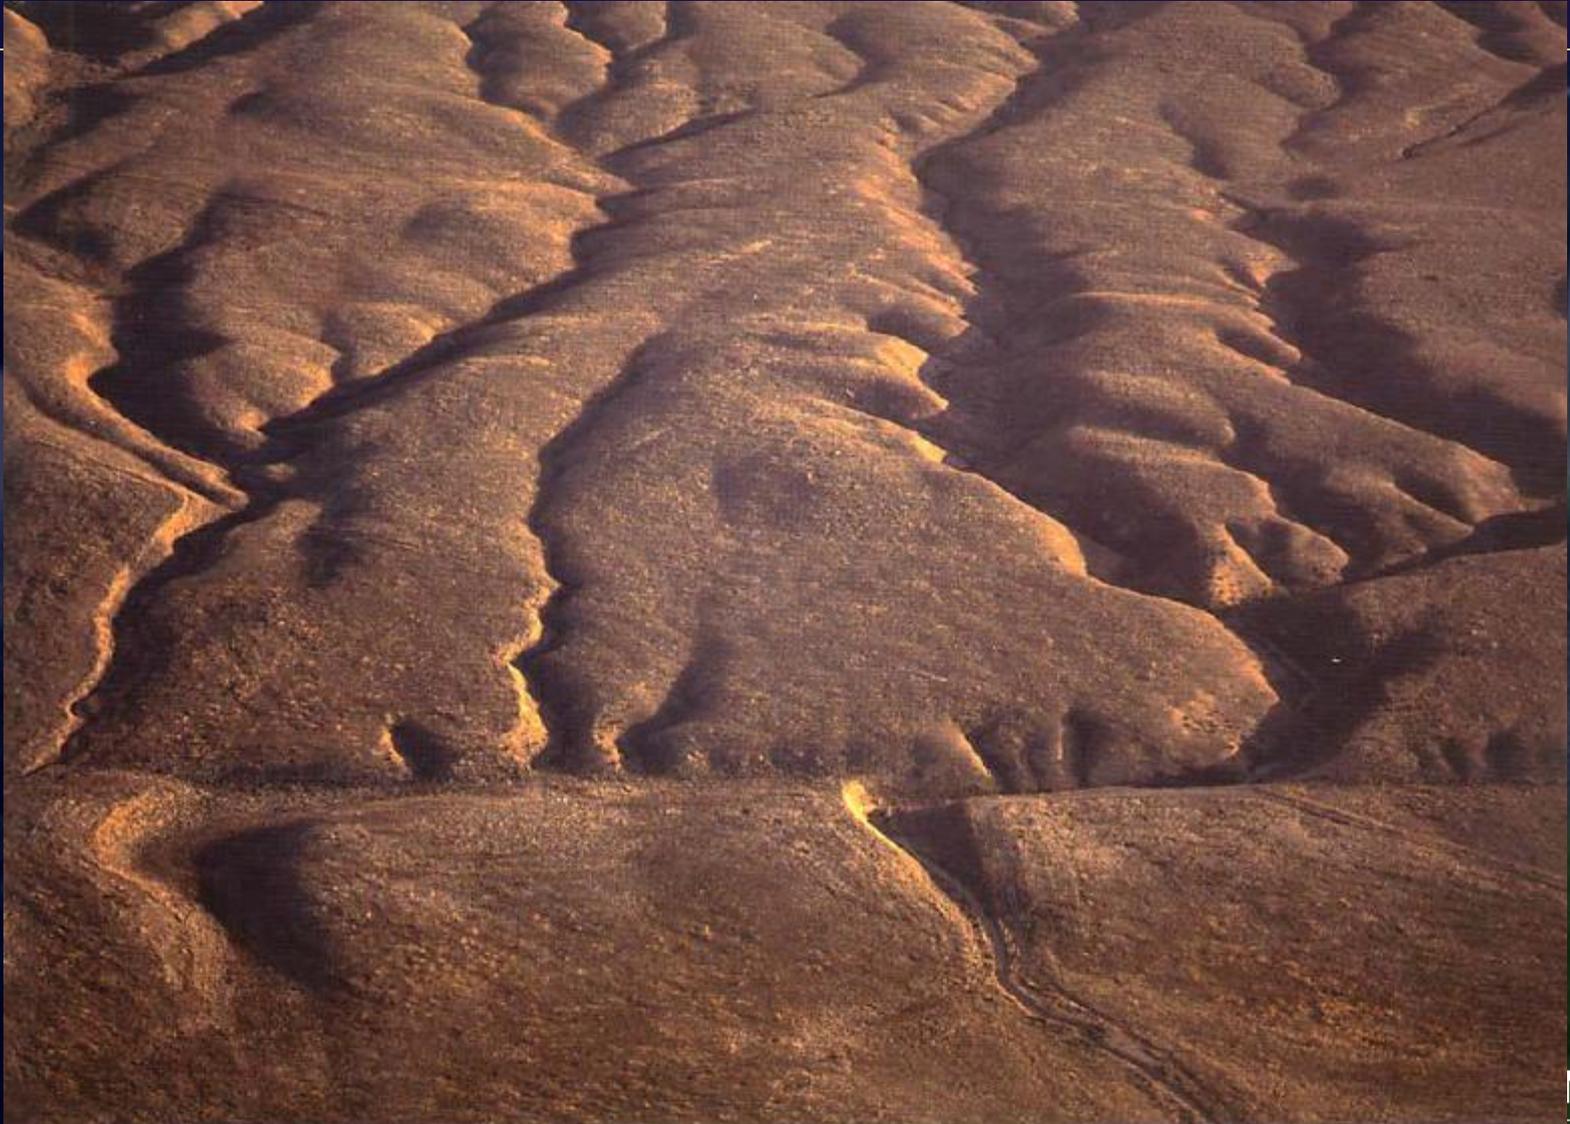
The San Andreas fault from the air. (Michael Collier, photographer)

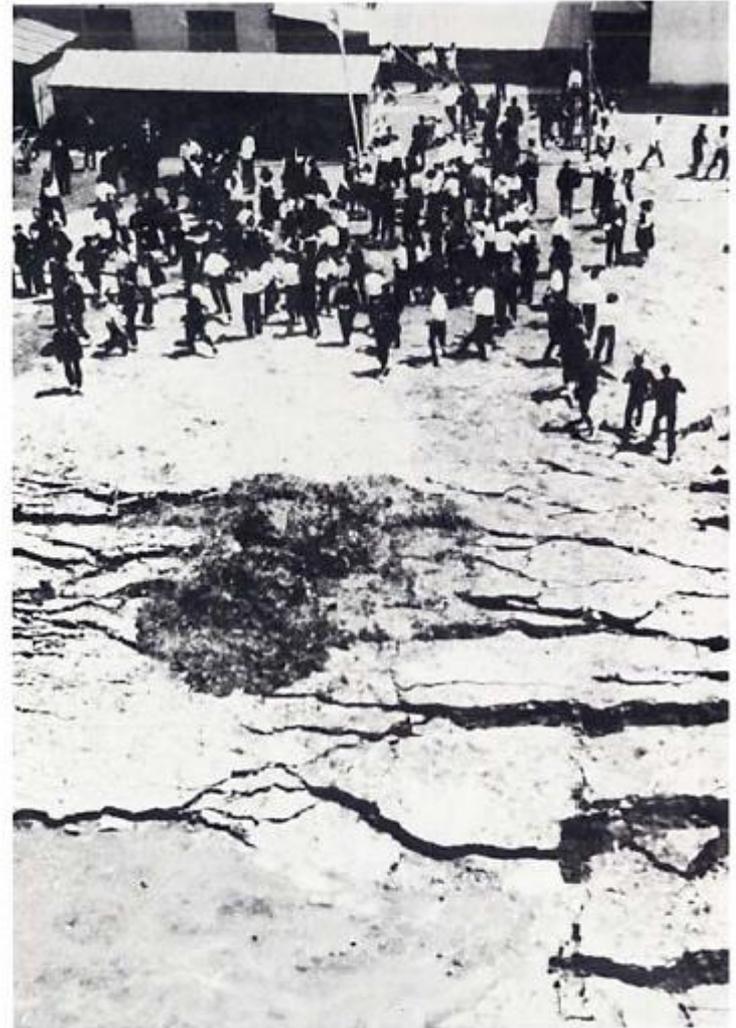
Initial Stage of Sand Boil

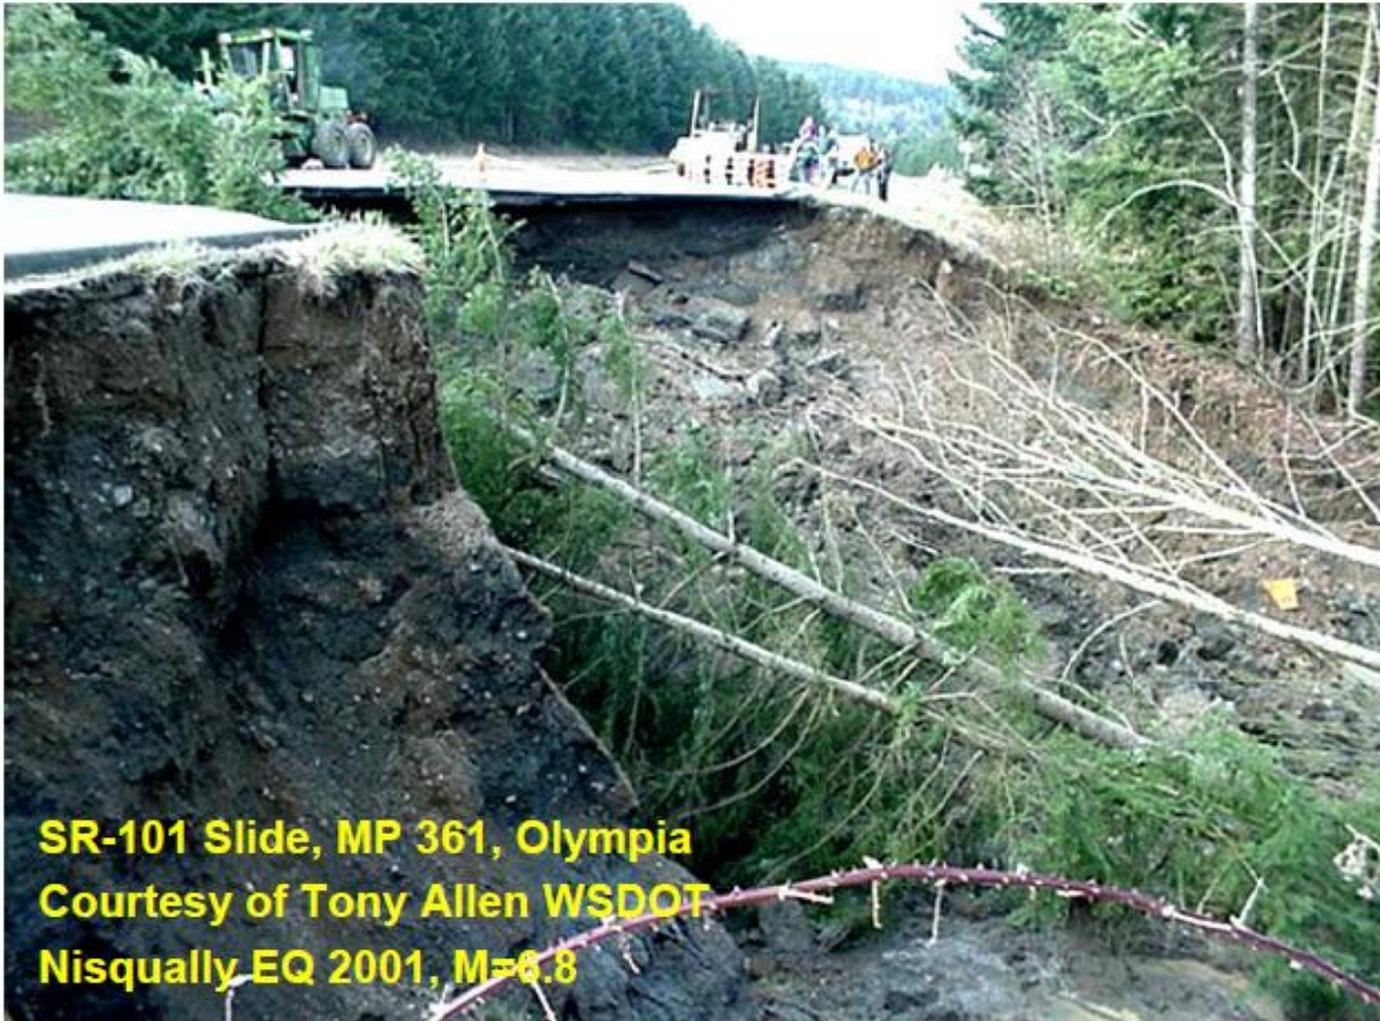
**SR-101 Slide, MP 361, Olympia
Courtesy of Tony Allen WSDOT
Nisqually EQ 2001, M=6.8**

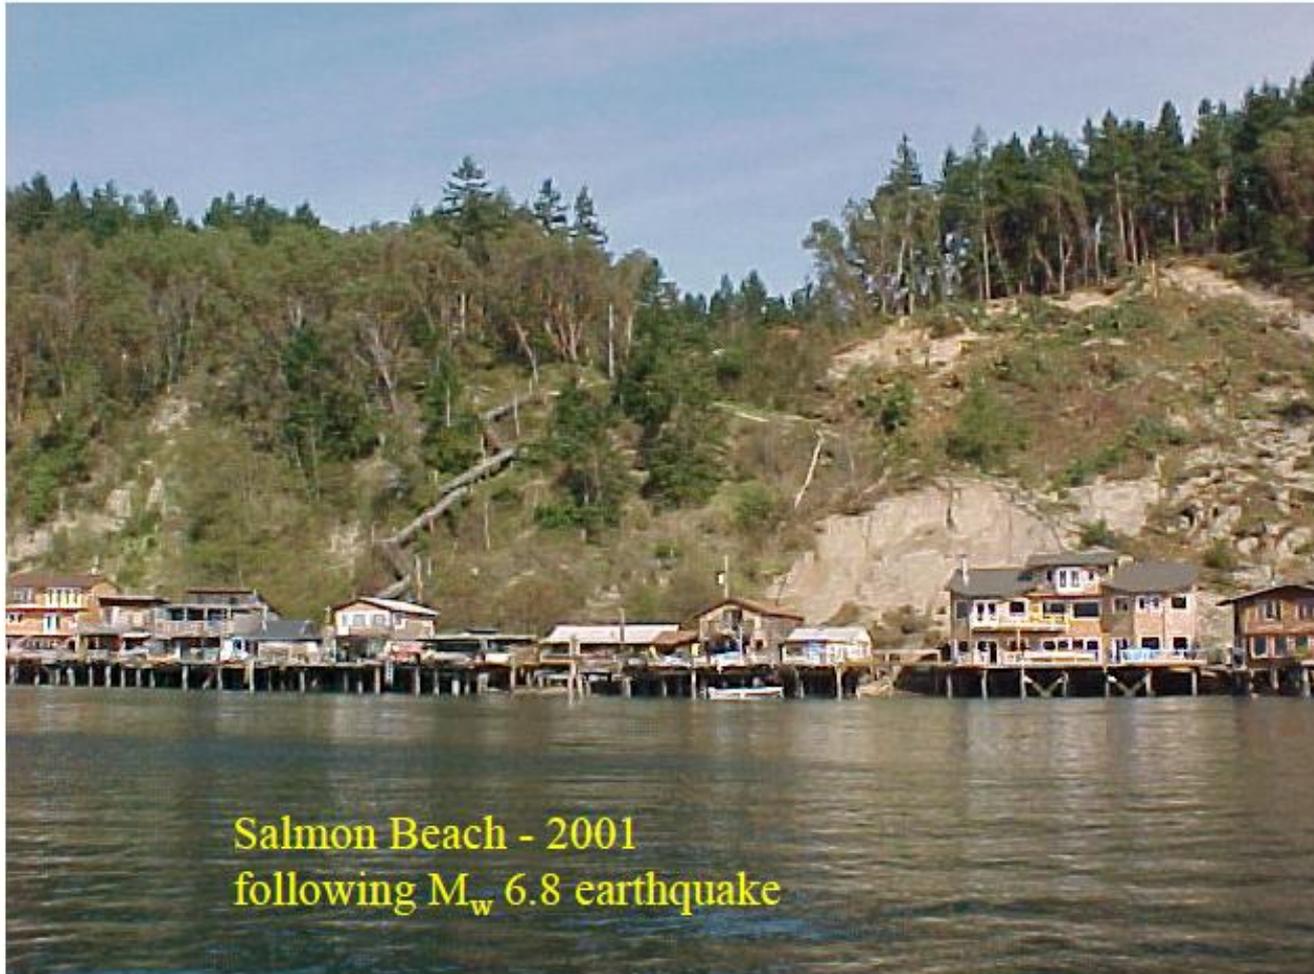
Salmon Beach - 2001
following M_w 6.8 earthquake

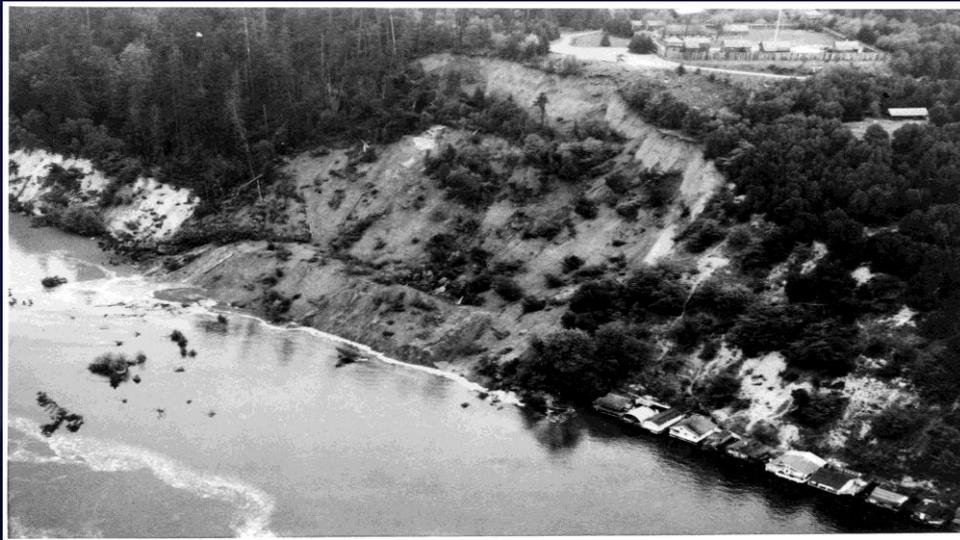
This landslide into Tacoma Narrows occurred 3 days after the 1949 earthquake and generated an 8 ft tsunami at Gig Harbor that reflected back and drowned all of these houses 3 ft deep

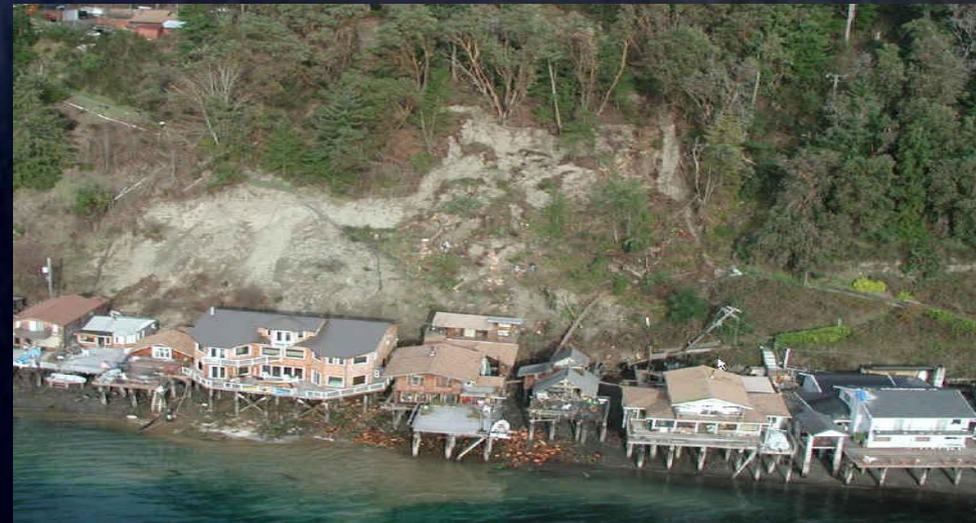
This landslide at Salmon Beach triggered by the Nisqually earthquake (2001) destroyed the houses that survived in 1949

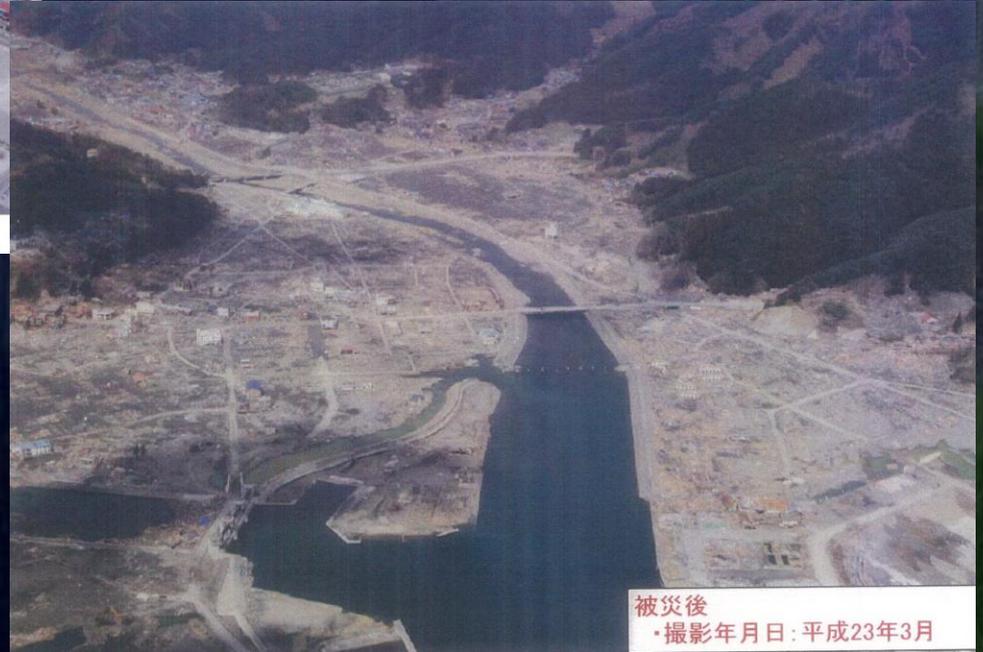
被災後
・撮影年月日:平成23年3月
