# Reservoir Seismic Upgrades and Improvements

## City of Corvallis' North Hills 1<sup>st</sup> Level East Reservoir Improvements Project

# A Case Study of Concrete Reservoir Seismic Upgrades and Improvements

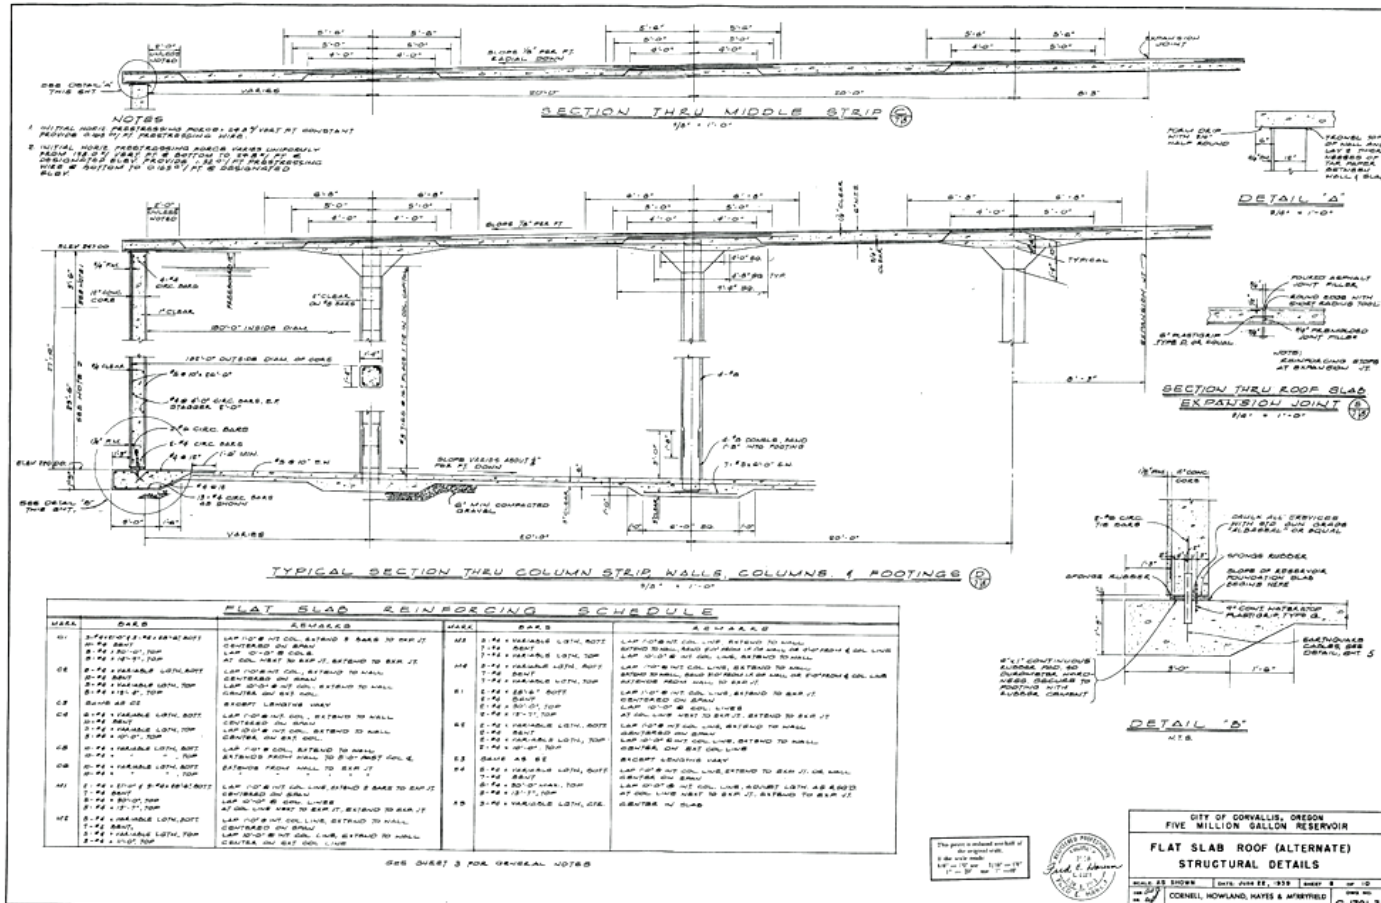
## Column Supported Slab Roof Alternate

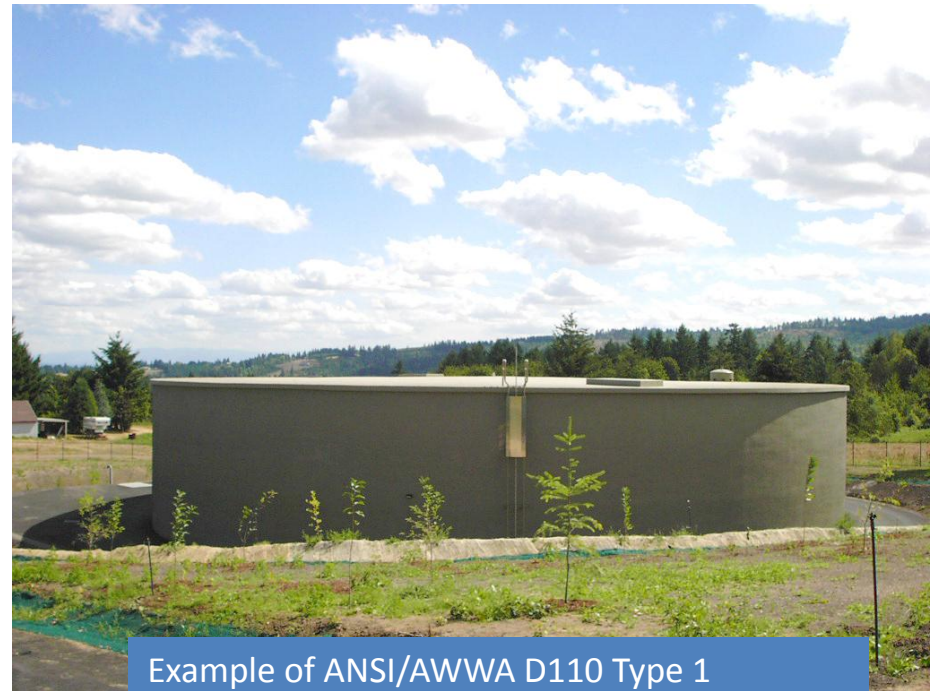
Example of ANSI/AWWA D110 Type 1  
Sherwood's 3.0 MG Kruger Road Reservoir

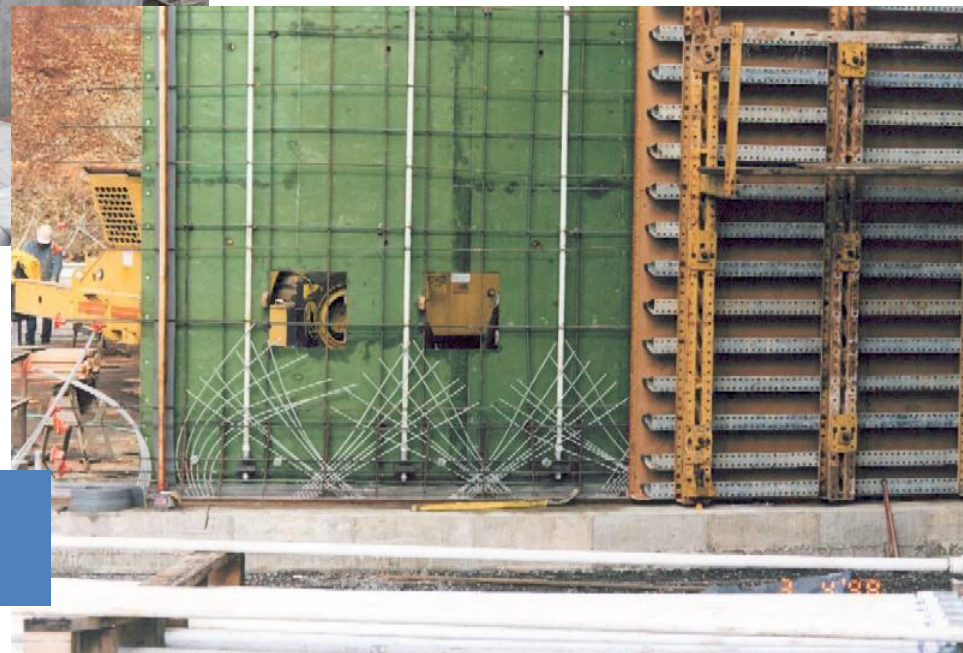
**Core Wall and Roof Slab Construction**

**Forming for Core Wall: Note Seismic Cables Cast in Footing**

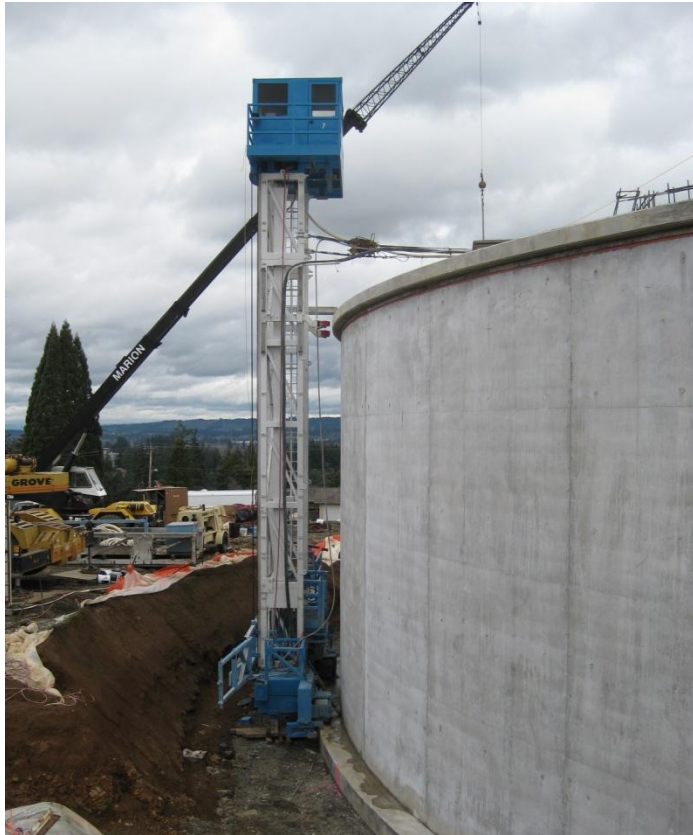
**Circumferential Prestressing Machine (Wrapping Machine) Preparing to Wrap Strand**

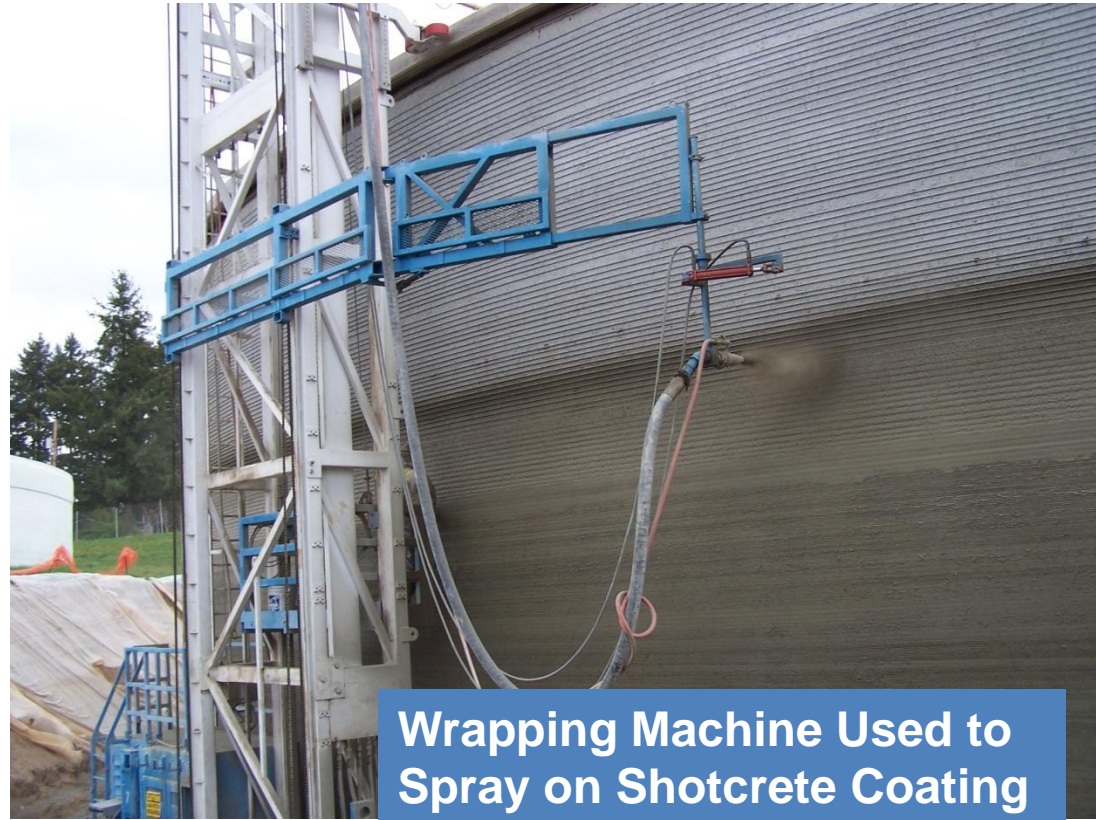
**Wrapping Machine Used to Spray on Shotcrete Coating Over Strand**

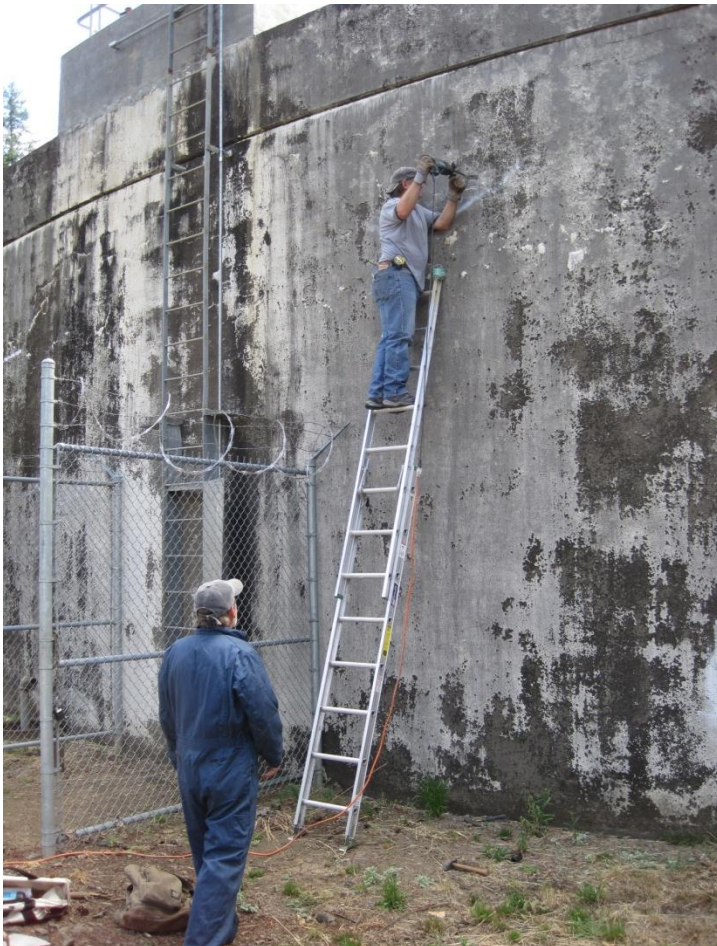
Exposing wire wrap for inspection

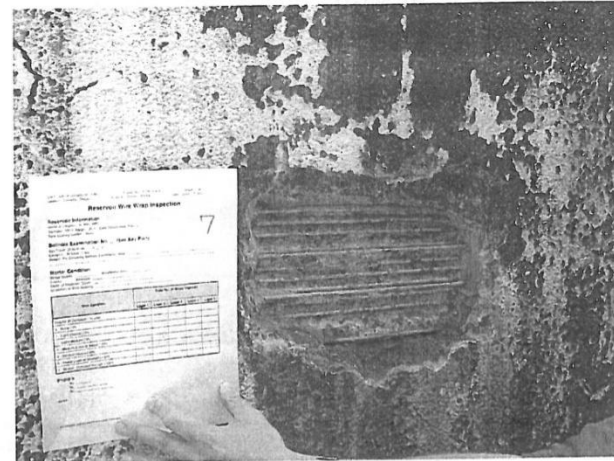
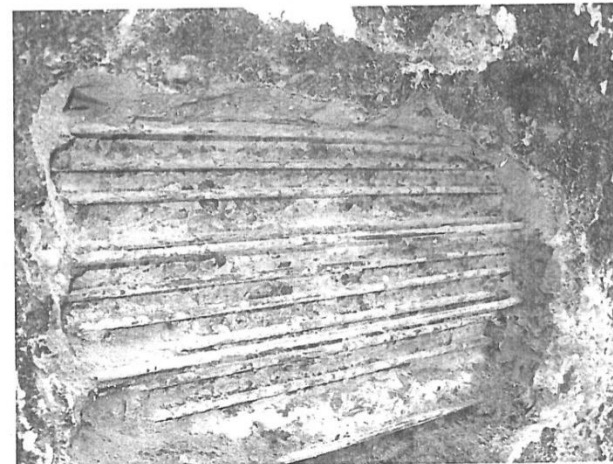
Photo No. 10. Bellhole No. 7.

- Voids from delaminating of the wall shotcrete is confined to the upper 2 to 4 feet of the wall. Wire exposed in the wall show no signs of corrosion though some wire in dome compression ring are corroded.
- Roof cracks appear to fully penetrate roof likely providing pathway for water to reinforcement
- Though floor expansion joint sealant appears to be functioning properly, it is reaching the end of its service life
- Overall, condition of concrete floor and core wall appear in good condition.

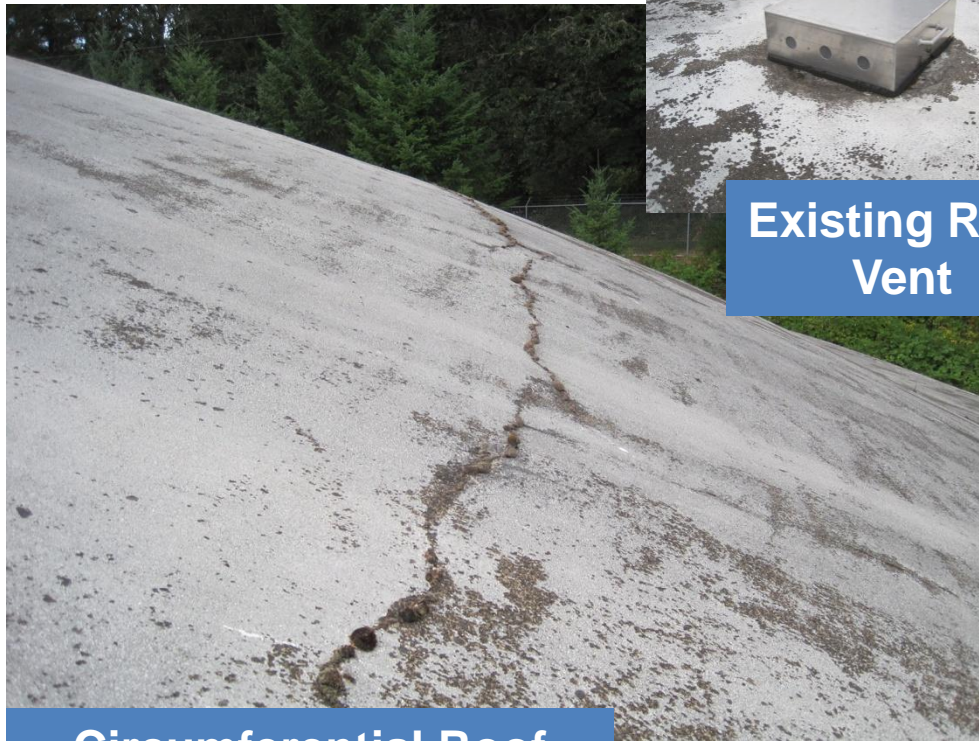
**Circumferential Roof Cracks Observed**

**Existing Roof Vent**

- Upsize existing roof vent
- Recoat all steel appurtenances
- Remove existing skim coat inside roof access hatch and recoat with an epoxy coating
- Coat exterior walls and roof including concrete surface repair as required
- Modify overflow piping brackets
- Replace interior access ladder
- Replace floor joint sealant
- Seal dome roof cracks

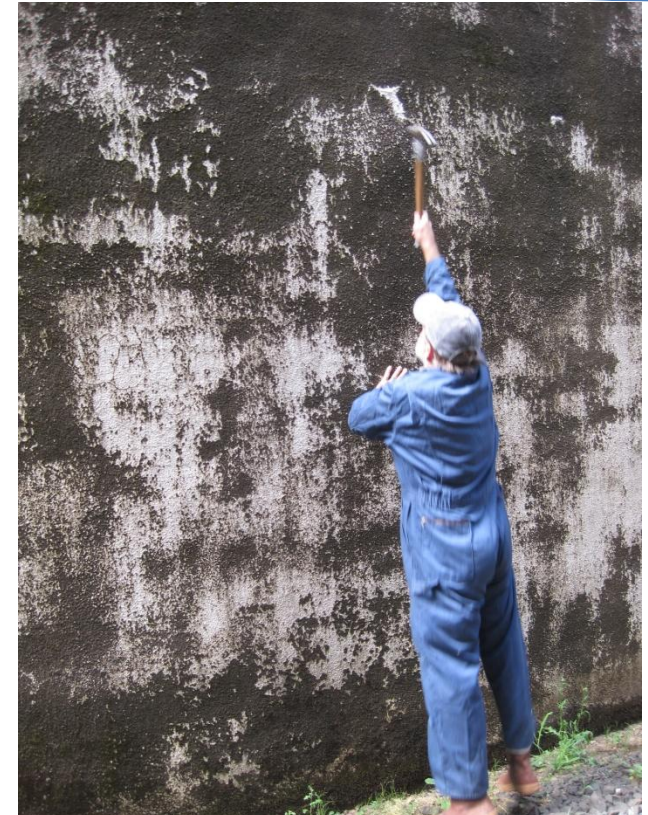
**Sounding shotcrete to locate voids that identify delaminating areas**

- Roof dome compression ring repairs including removing delaminating shotcrete coating, install additional prestressed strands and apply new shotcrete coating
- Install interior roof to wall connection system
- Modify dome compression ring roof edge profile to improve water drainage
- Inject epoxy grout to seal and fill the delaminated shotcrete coating voids

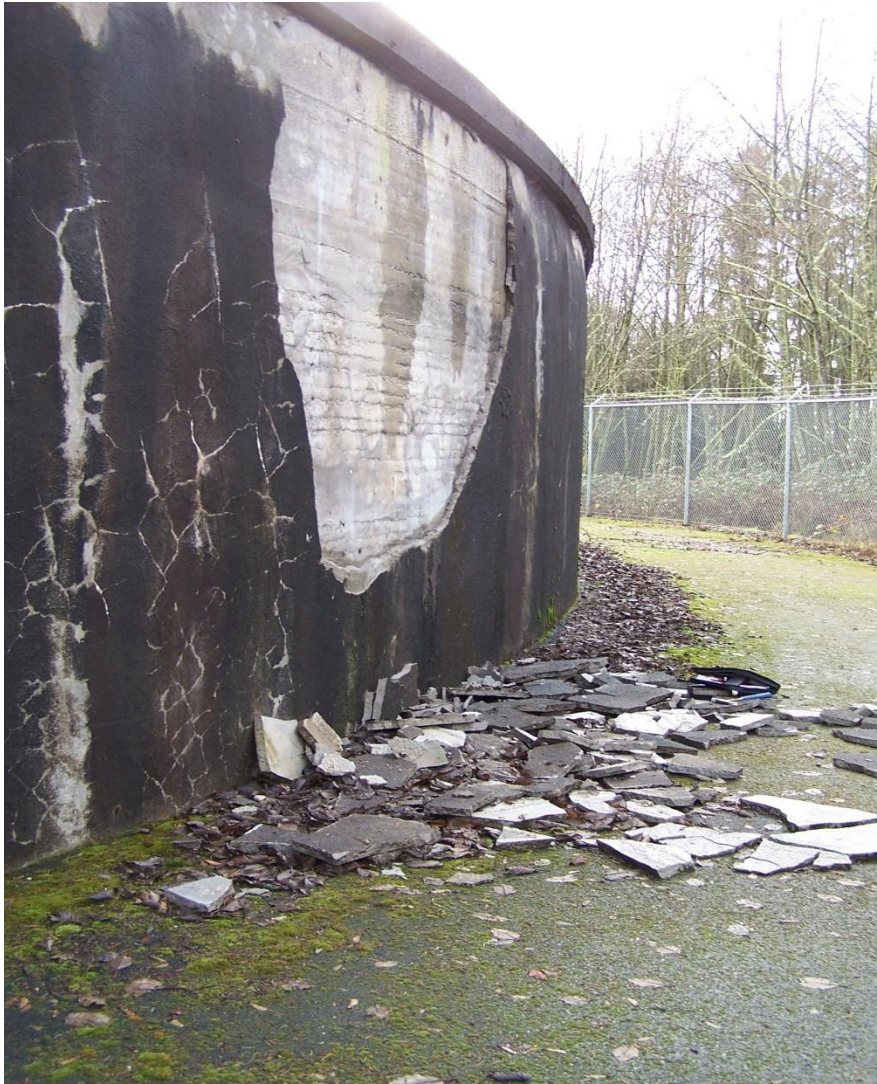
**Example of Delaminating Shotcrete Coating Failure of the Mt Solo Reservoir, City of Longview**

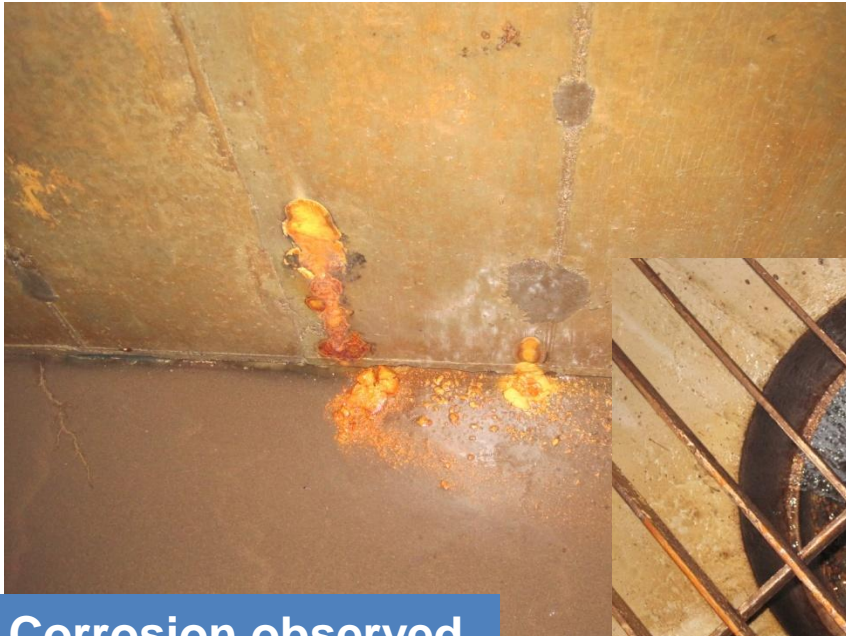
**Corrosion observed  
Determined not to be  
rebar**

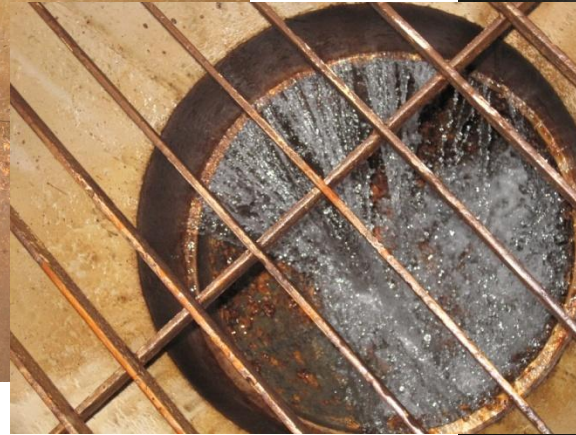
**Inspect ladders, overflow, drain  
and other appurtenances**

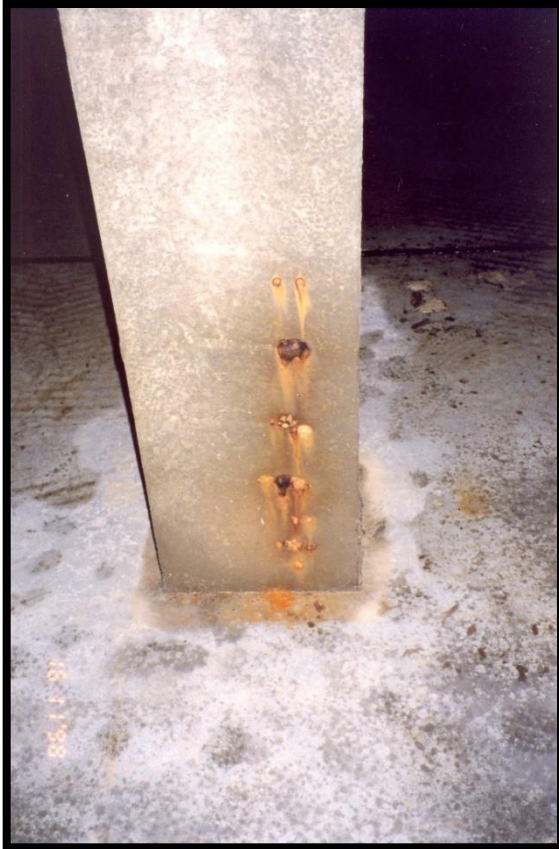
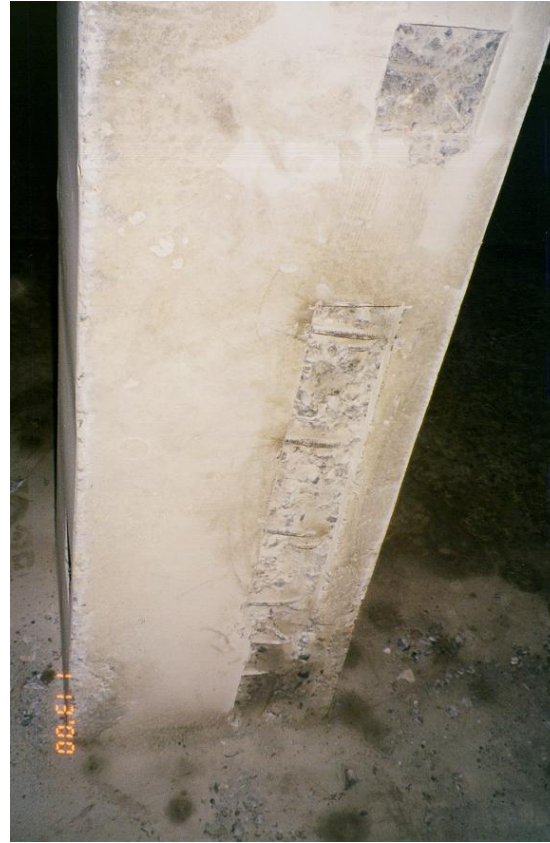
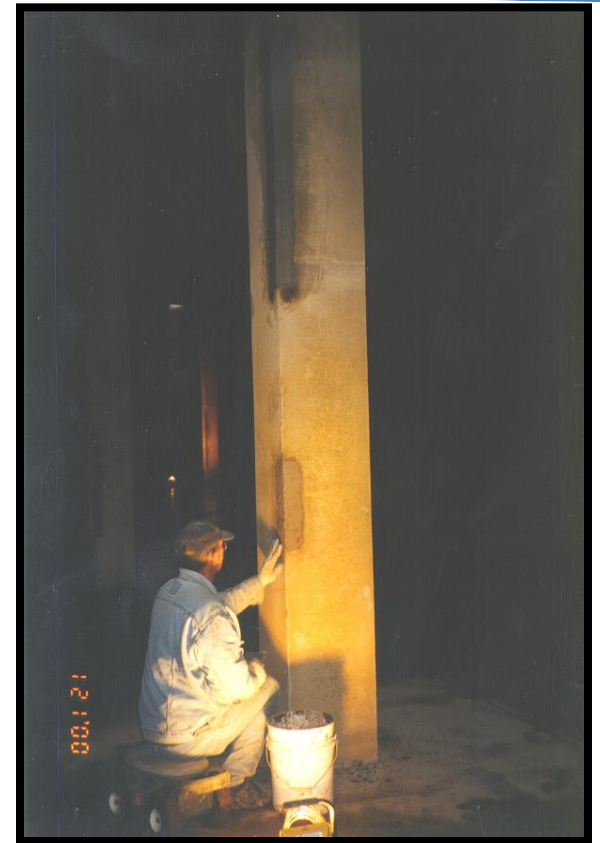
Example of corroded rebar and concrete repair, Sexton Mountain Reservoir, City of Beaverton

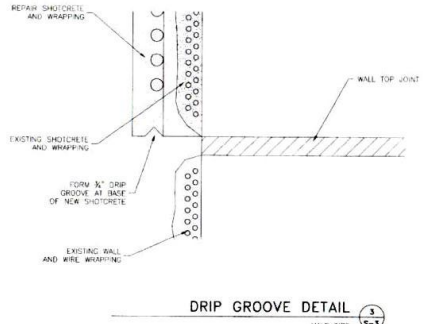
<b>RESERVOIR DOME RING UPGRADE DETAILS</b>		SHEET <b>S-3</b>
PROJECT NO. 10-1147-202	SCALE: AS SHOWN	DATE: JUNE 2011

**DESCRIPTION:**  
BASED ON HISTORICAL INVESTIGATION THE UNEXPECTED PRESTRESSING WRAPPING ON THE DOME COMPRESSION RING HAS EXPERIENCED LOCALIZED CORROSION AND LOSS OF RING SECTION. THE PURPOSE OF THESE DOCUMENTS IS PROVIDE SPECIFICATIONS AND REPAIR/UPGRADE OPTIONS FOR THE DOME RING WRAPPING WHICH INCLUDES A SEQUENTIAL STEP BY STEP EXPLANATION OF THE PROPOSED REPAIR AND STRUCTURAL CALCULATIONS SUPPORTING THE PROCESS AND FINAL DOME STRESSES BASED ON THE PROPOSED AMOUNT OF WRAPPING TO BE ADDED TO THE DOME COMPRESSION RING. INSTALLATION OF ROOF EDGE FLASHING AND A DRIP GROOVE ARE TO BE INCORPORATED WITH THE REPAIR AS DETAILED IN THESE DRAWINGS.

**ORIGINAL WRAPPING SPECIFICATION:**  
THE ORIGINAL RESERVOIR DESIGN DOCUMENTS SPECIFY THE 3'-0" TALL DOME RING HAVE AN INITIAL HORIZONTAL PRESTRESSING FORCE OF 3220 KIPS/FT OR A TOTAL OF 9660 KIPS. REFERENCE THE PROVIDED COPY OF ORIGINAL DRAWINGS FOR MORE INFORMATION.

1. USING HYDROBLAST METHODS REMOVE DELAMATED/DAMAGED AREAS OF EXISTING SHOTCRETE FROM OUTSIDE SURFACE OF DOME RING TO EXPOSE WIRE WRAPPING AND DETERMINE ACTUAL % LOSS OF EXISTING WRAPPING MATERIAL. (NOTE: PREVIOUS INVESTIGATIONS ESTIMATE % LOSS OF WRAPPING TO BE BETWEEN 20% AND 50%).
2. REMOVE CORROSION FROM ALL EXPOSED WIRE SURFACES.
3. APPLY NEW SHOTCRETE OVER EXISTING WIRE SURFACES.
4. COVER AND FLUSH SURFACE UPON WHICH TO APPLY NEW GALVANIZED STRAND.
5. APPLY NEW GALVANIZED SEVEN WIRE STRAND AS SPECIFIED IN THE APPROVED CONTRACTOR SUBMITTAL. IF MULTIPLE LAYERS OF STRAND ARE REQUIRED APPLY SHOTCRETE LAYERS WITH 1/2" COVER BETWEEN LAYERS.
6. FINAL SHOTCRETE LAYER TO BE A MINIMUM OF 1 1/2" COVER OVER FINAL WRAPPING LAYER.

**REPAIR/UPGRADE WRAPPING MINIMUM REQUIREMENTS:**  
THE MINIMUM REQUIRED FINAL WRAPPING FORCE AFTER REPAIR (WHICH INCLUDES THE REMAINING FORCE IN THE EXISTING WRAPPING) SHALL BE EQUAL TO THE ORIGINAL WRAPPING FORCE PLUS AN ADDITIONAL 16 KIPS/FT OR A TOTAL OF 227 KIPS.

1. MIN. 10' LUNG #316SS SECTIONS - 16 GAGE - BENT AS SHOWN.
2. SAWCUT 1/2" DEEP KEIF AS SHOWN.
3. APPLY EPOXY ADHESIVE IN KEIF IMMEDIATELY PRIOR TO INSTALLING FLASHING SECTION. THE EPOXY SHOULD BE THICK AND VISCIDUS SO AS TO BE ADEQUATELY TROWELED AND RETAINED IN THE KEIF DURING FLASHING INSTALLATION.
4. CALL OUT END JOINTS AT SECTION OVERLAPS.

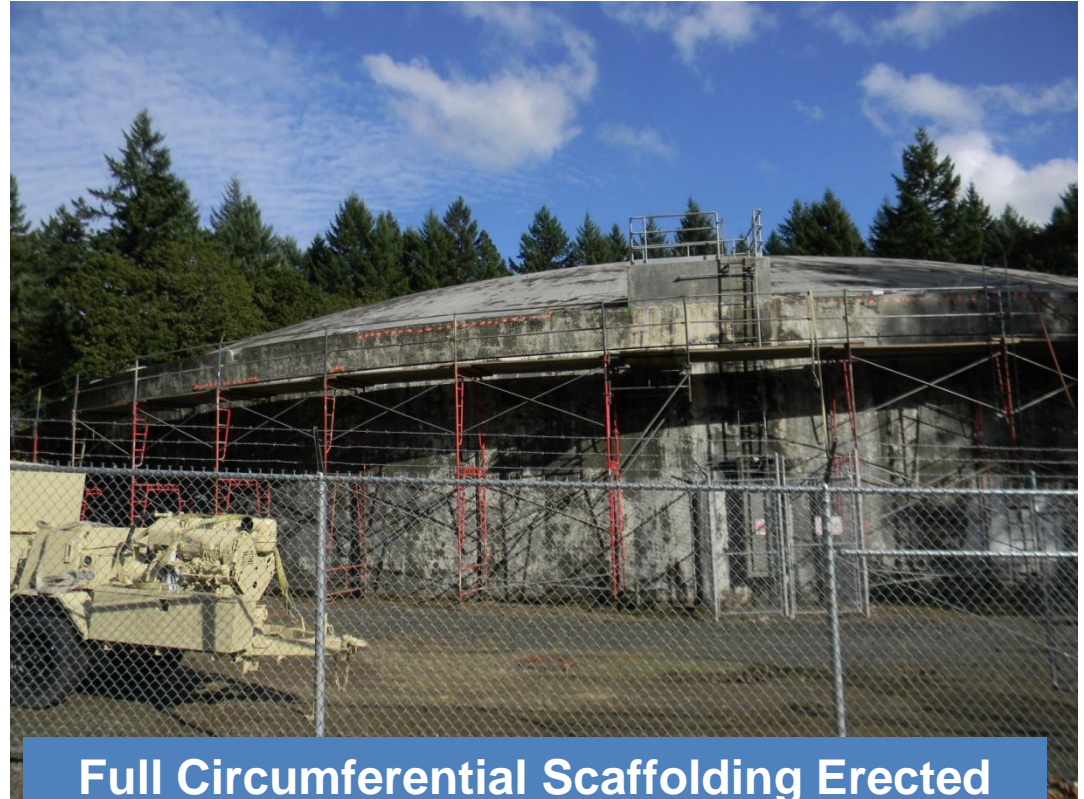
DYK and structural engineer conducted field investigation to determine existing wire wrap corrosion loss.

**Full Circumferential Scaffolding Erected  
for Dome Ring Repair**

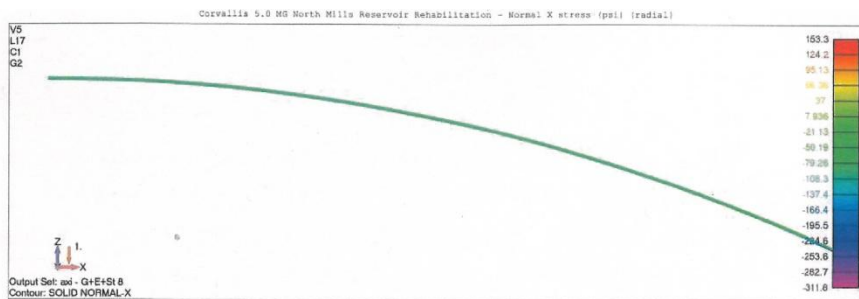
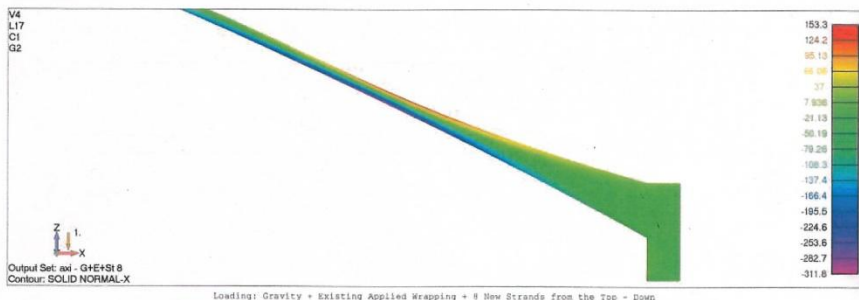
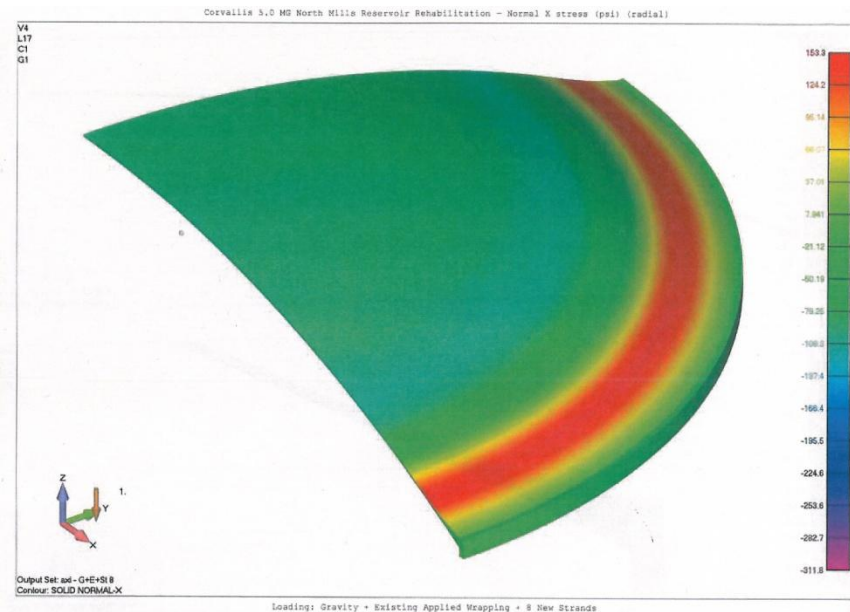
Based on corrosion loss of 15%, DYK performed three-dimensional Finite Element Analysis (FEA) of the dome and dome ring, submits for structural engineer review.

### Typical Radial Loading Diagrams

Eight Strands of Galvanized 7 Wire Cable with an Applied Force of 24.41 k/Strand Was Adopted.

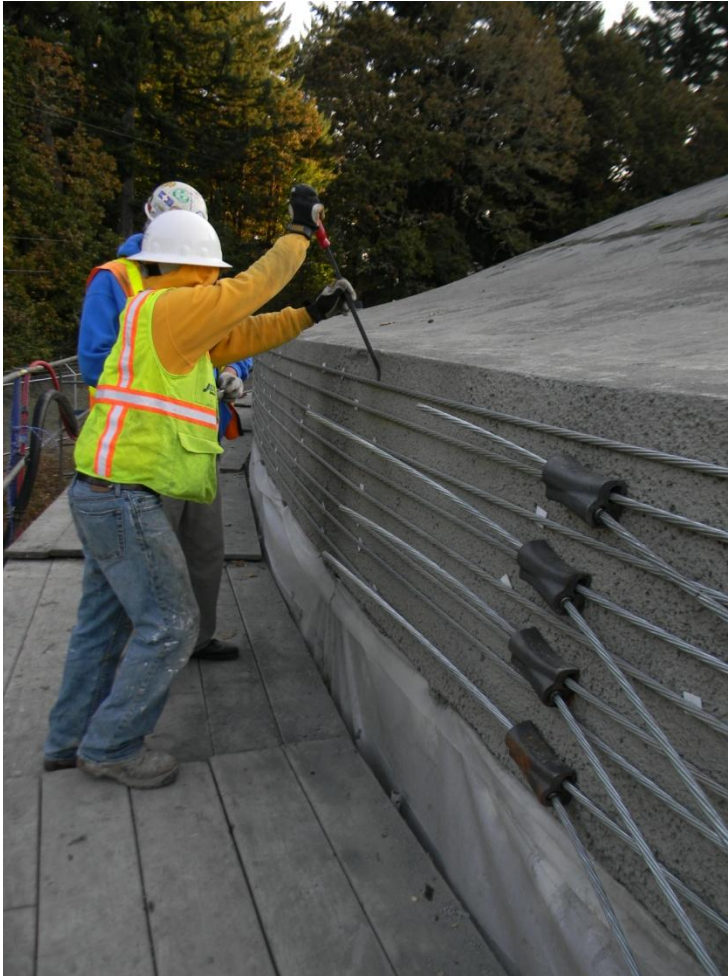
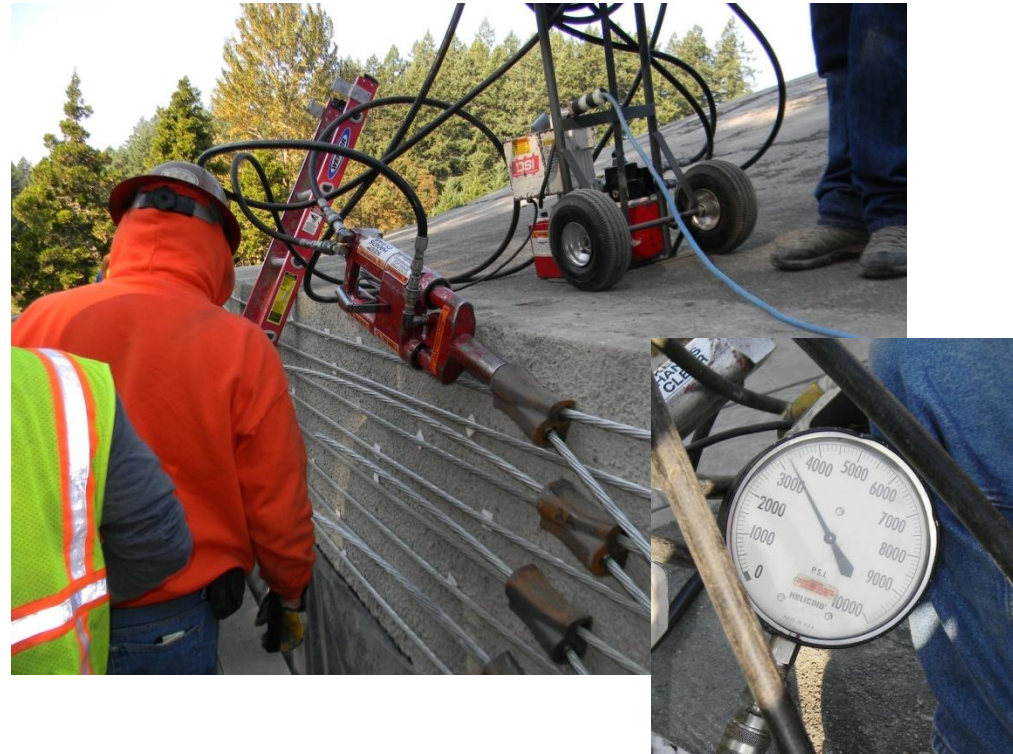
“Stretching” Strand to achieve desired elongation

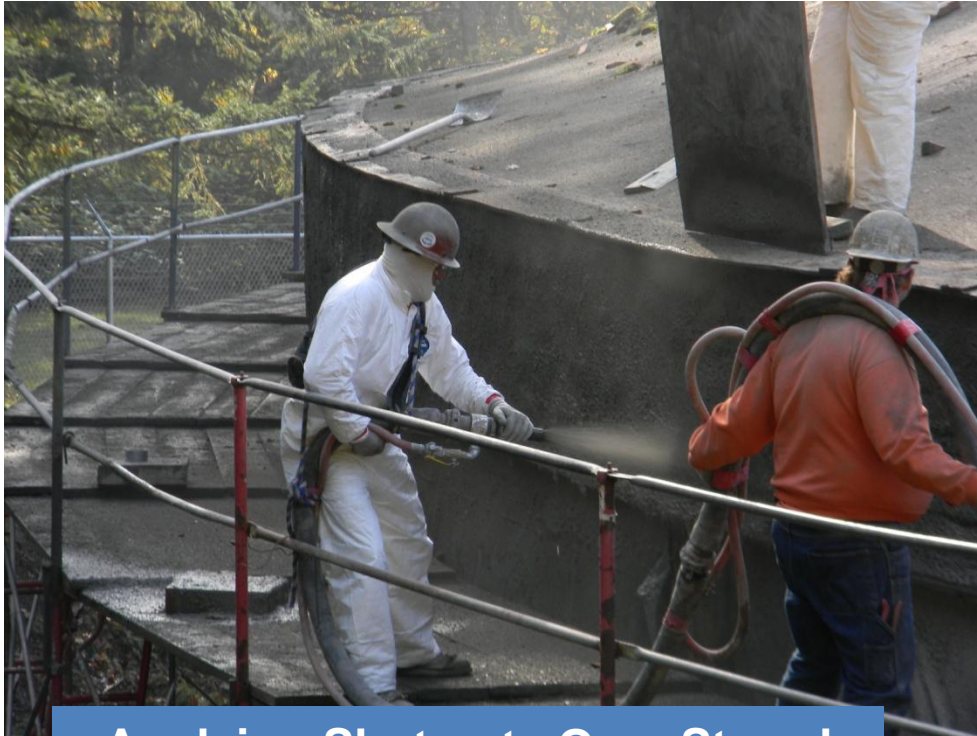
Applying Shotcrete Over Strand

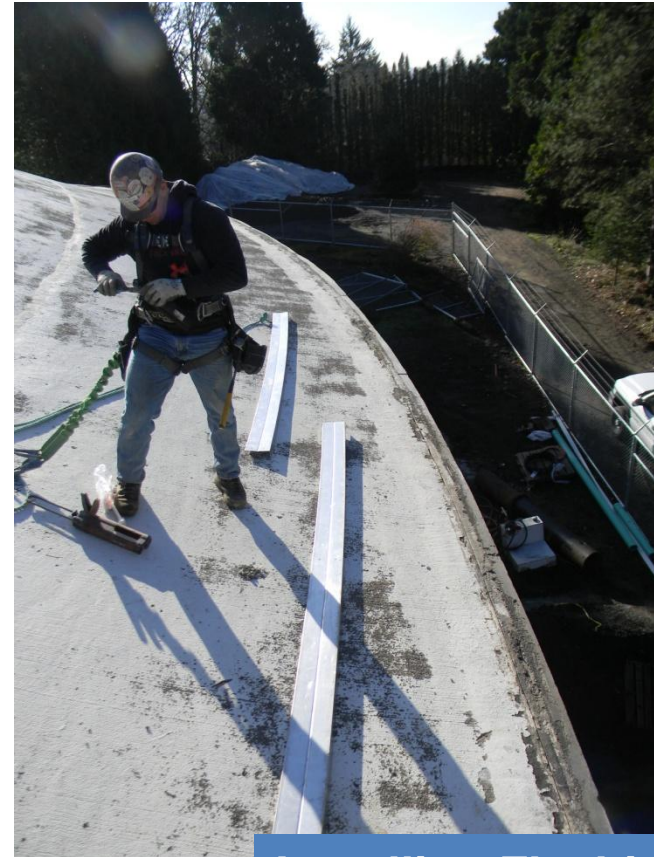
Installing Flashing

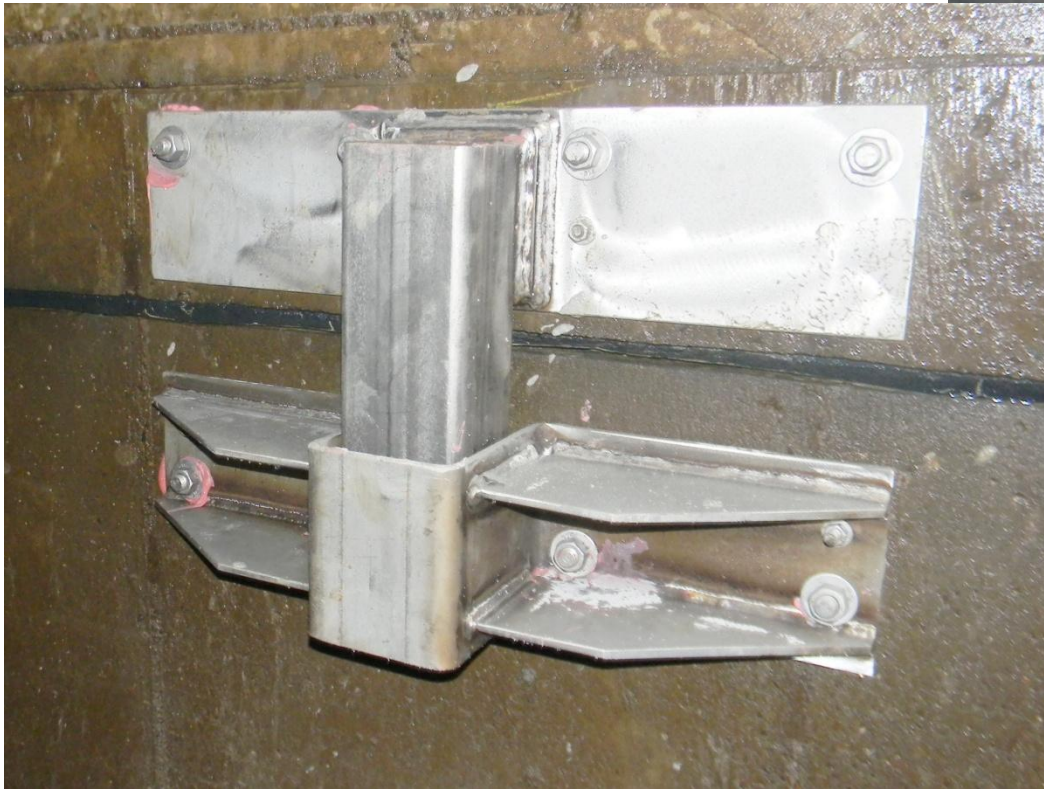
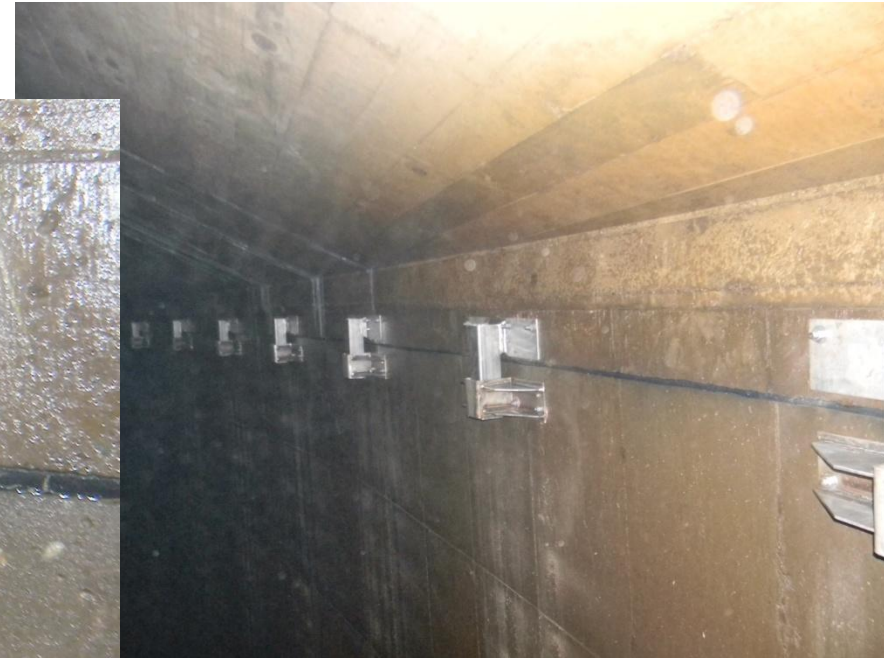
## Dome Roof to Wall Connection Improvements

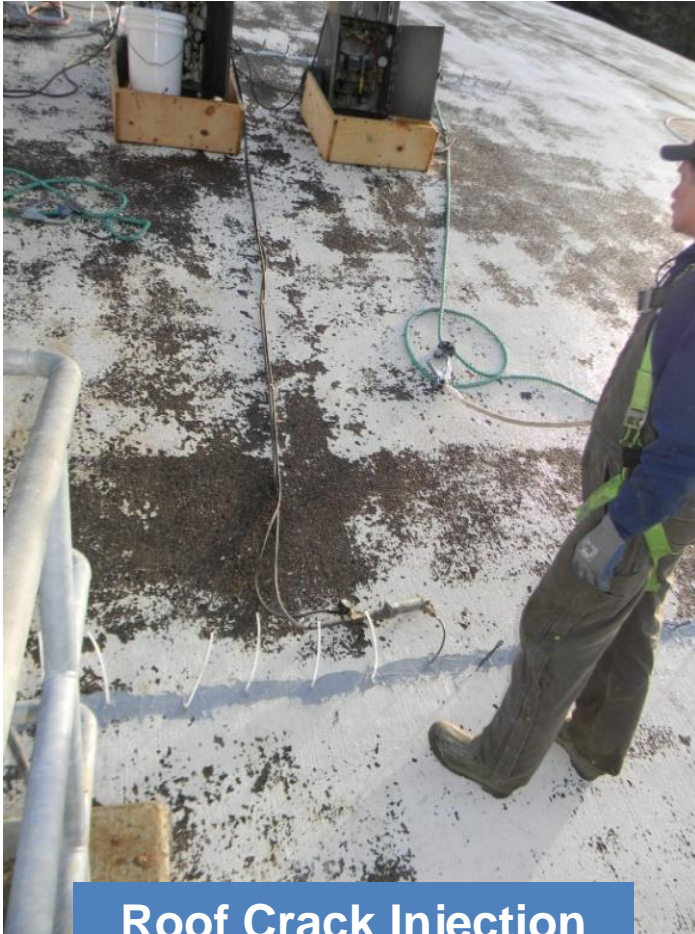
Roof Crack Injection

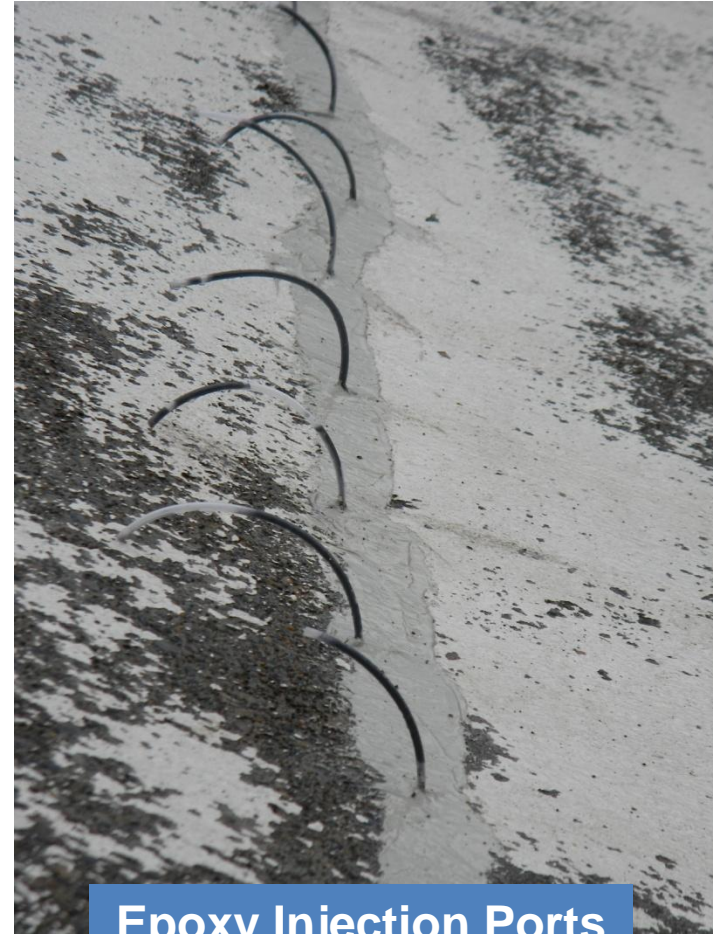
Epoxy Injection Ports

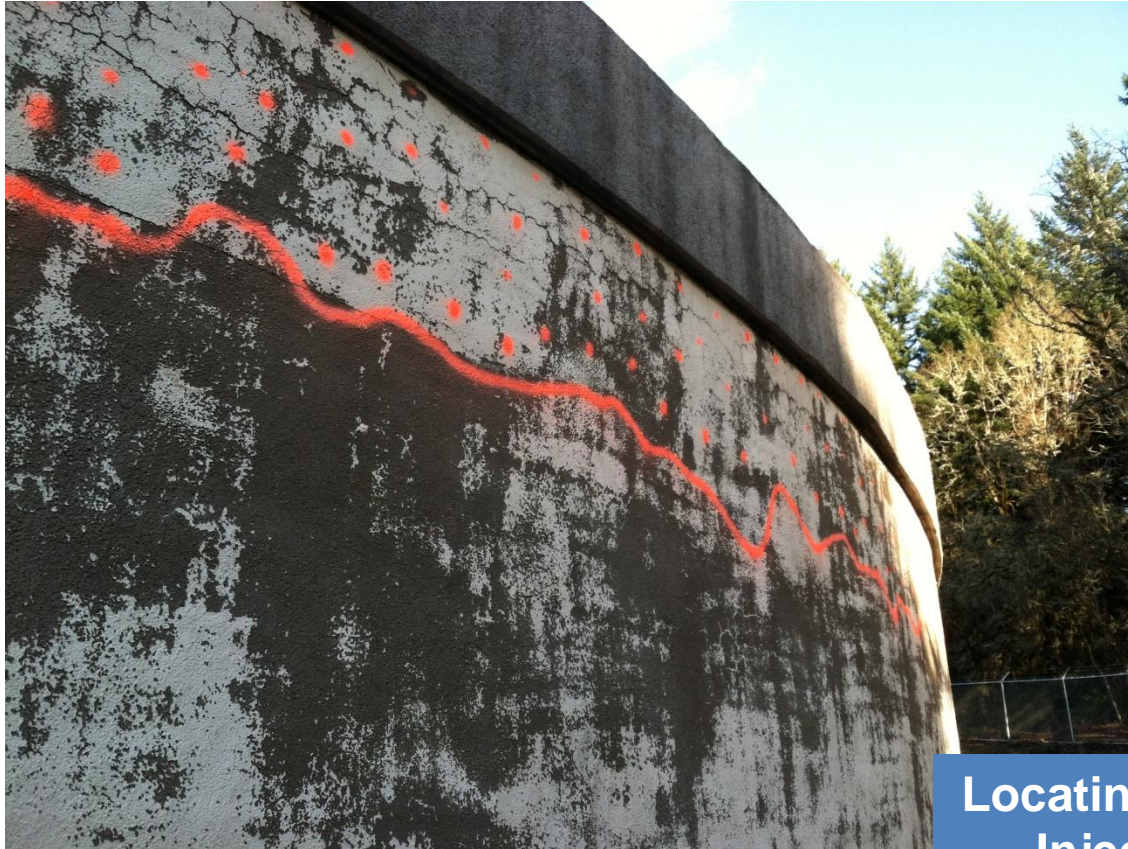
**Locating Voids and Laying out  
Injection Port Locations**

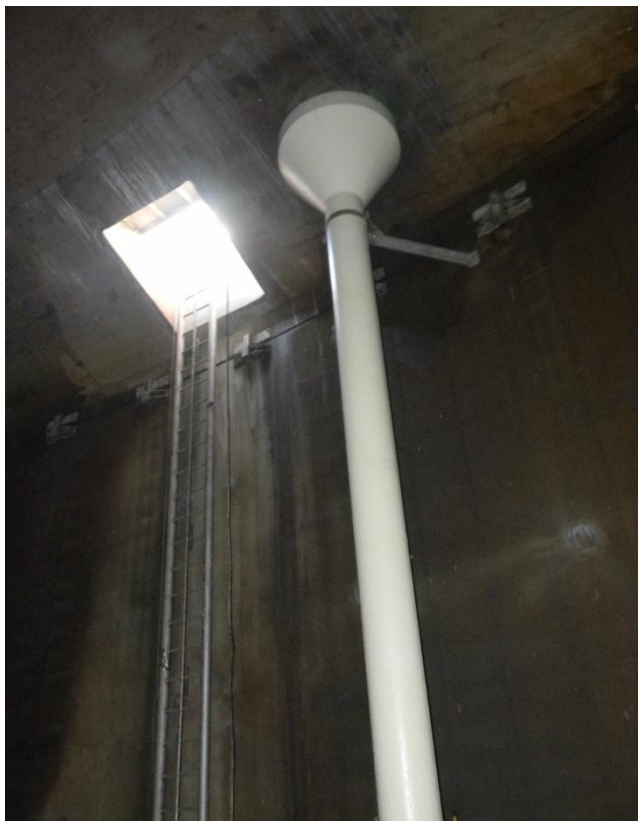
**New SS Ladder and Painted Overflow Piping**

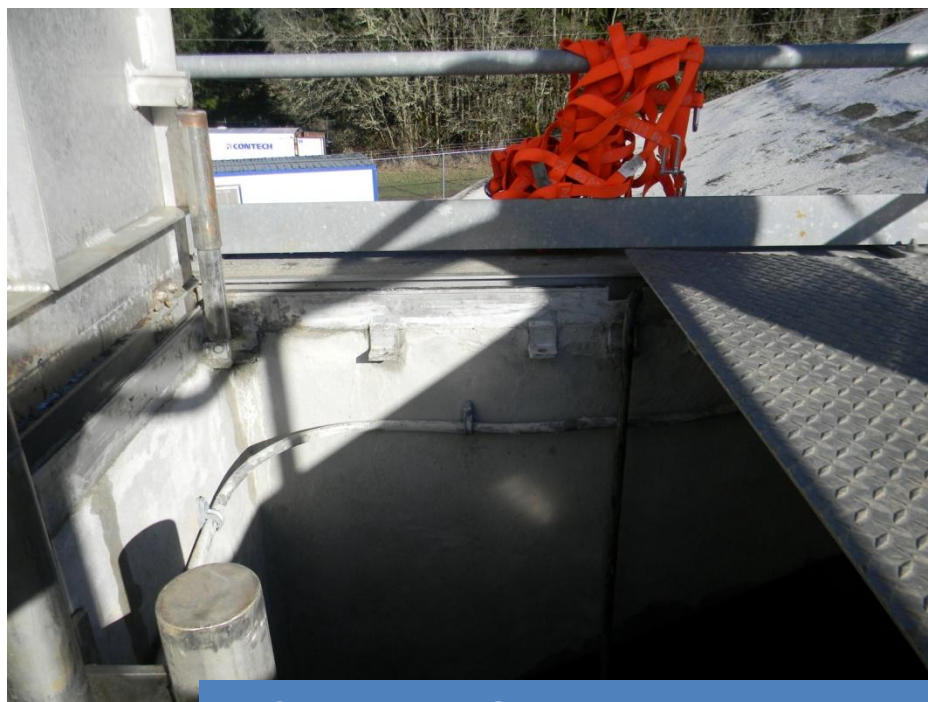
**Concrete Surface Repair and Coating of Inside Access Hatch**

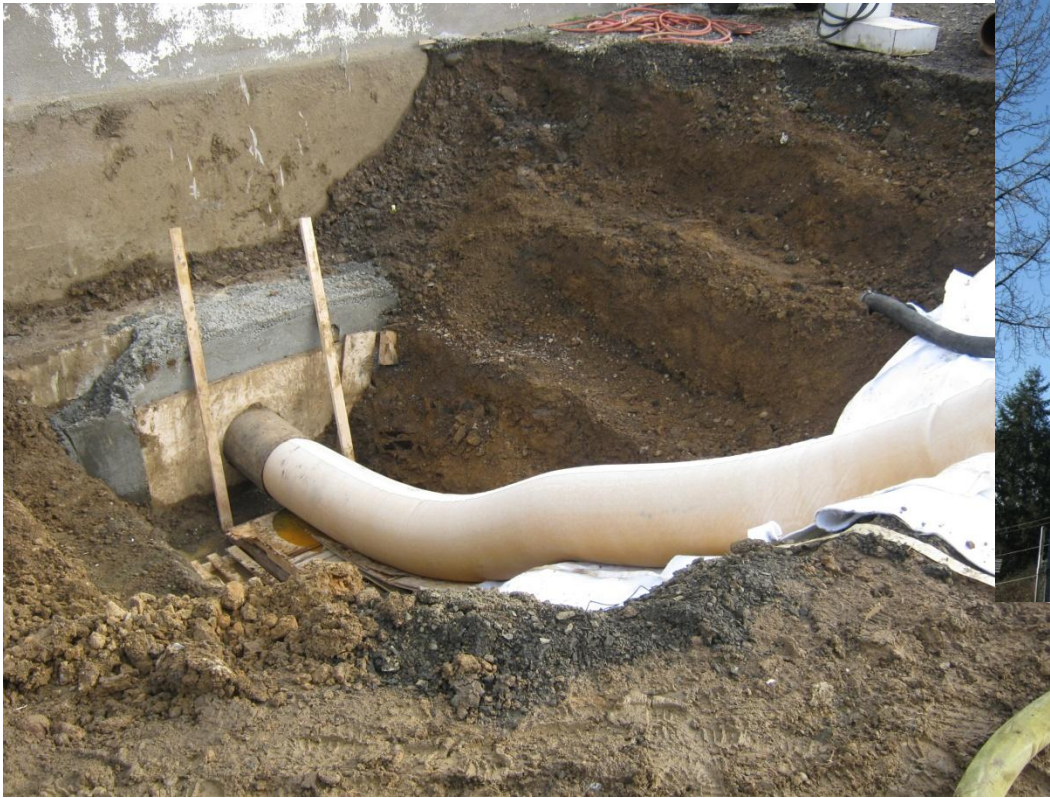
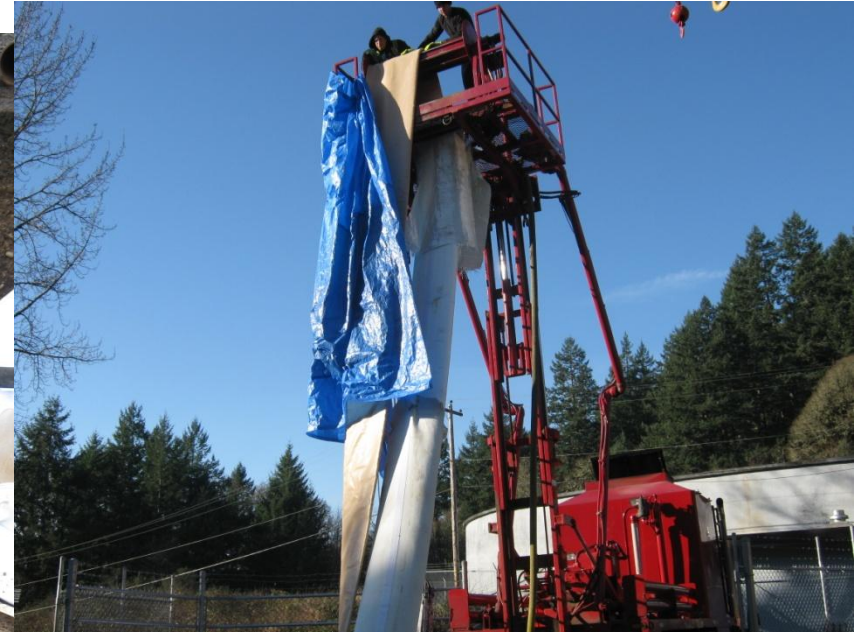
Installing CIPP into 20-inch CI  
Inlet/Outlet/Drain Piping
