# Reservoir Seismic Upgrades and Improvements

## City of Corvallis' North Hills 1<sup>st</sup> Level East Reservoir Improvements Project

# A Case Study of Concrete Reservoir Seismic Upgrades and Improvements

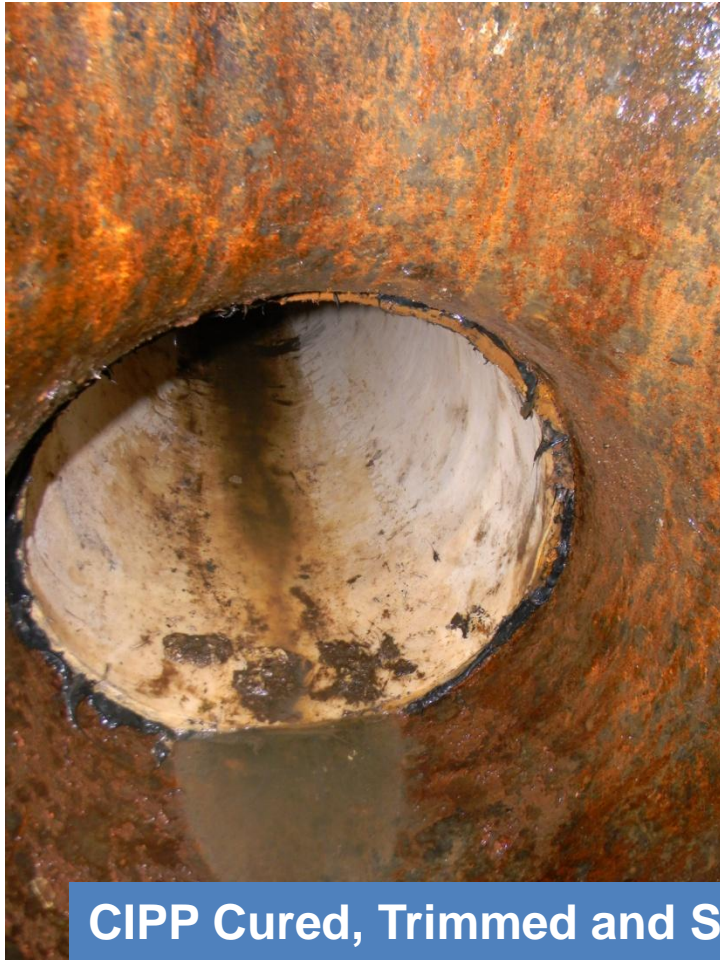
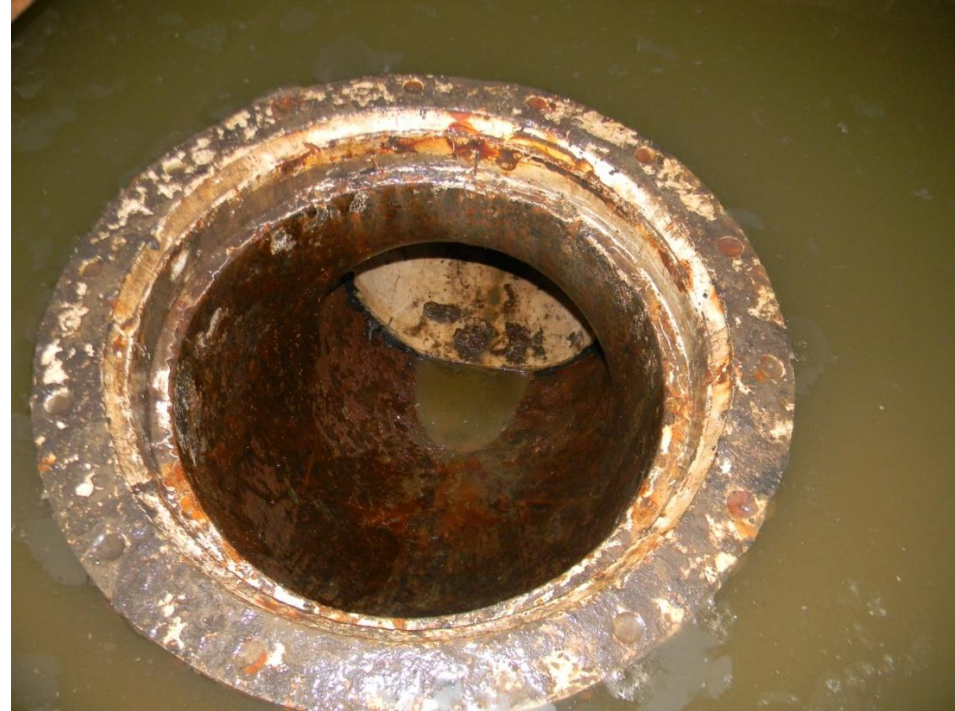
**CIPP Cured, Trimmed and Sealed at Reservoir Floor Sump**

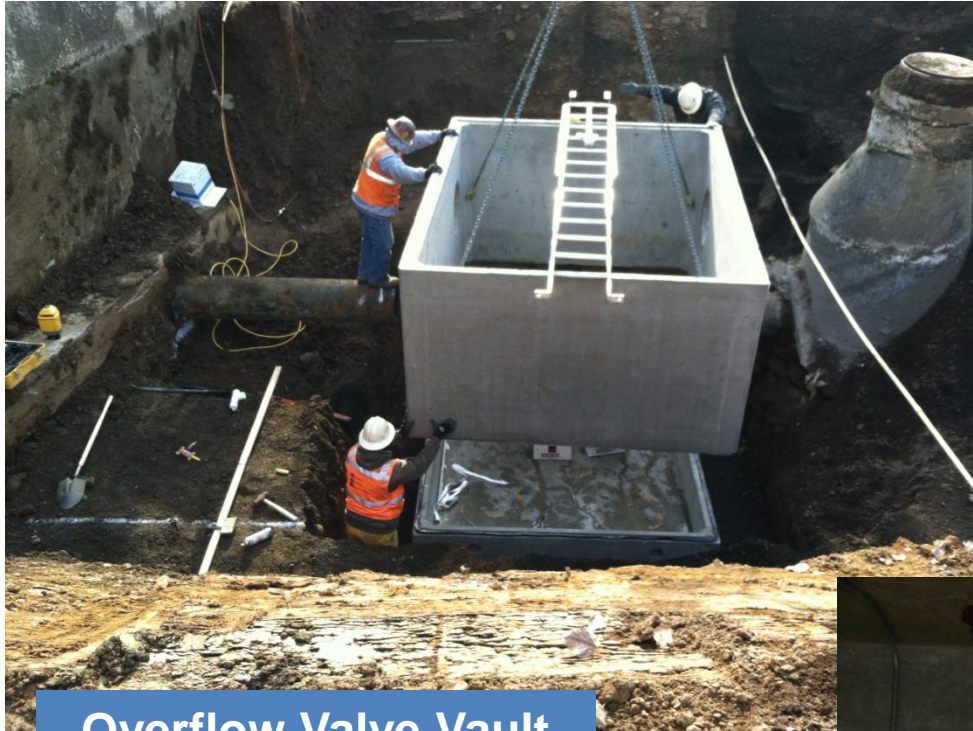
Overflow Valve Vault

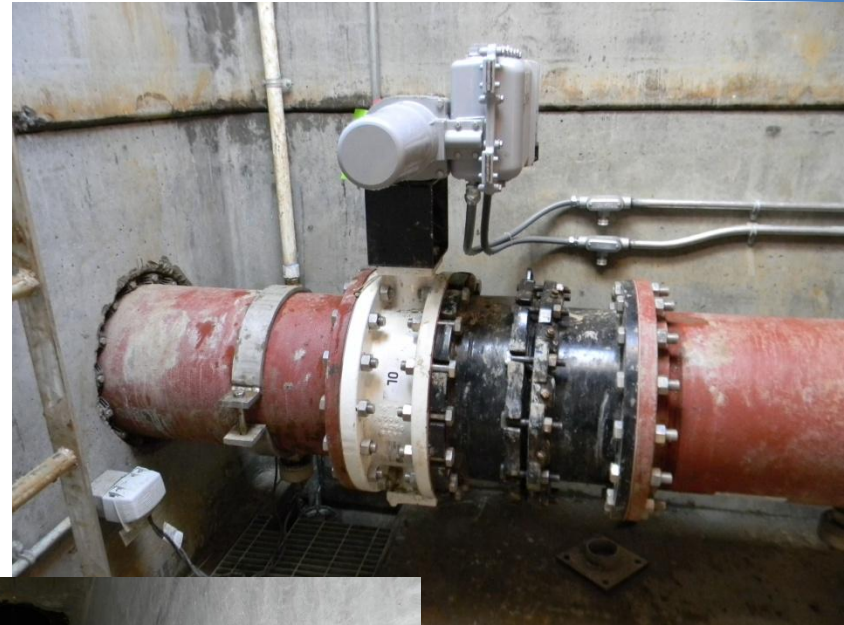
Seismic Controlled  
16-inch BFV with 120  
VAC Motorized  
Actuator and UPS

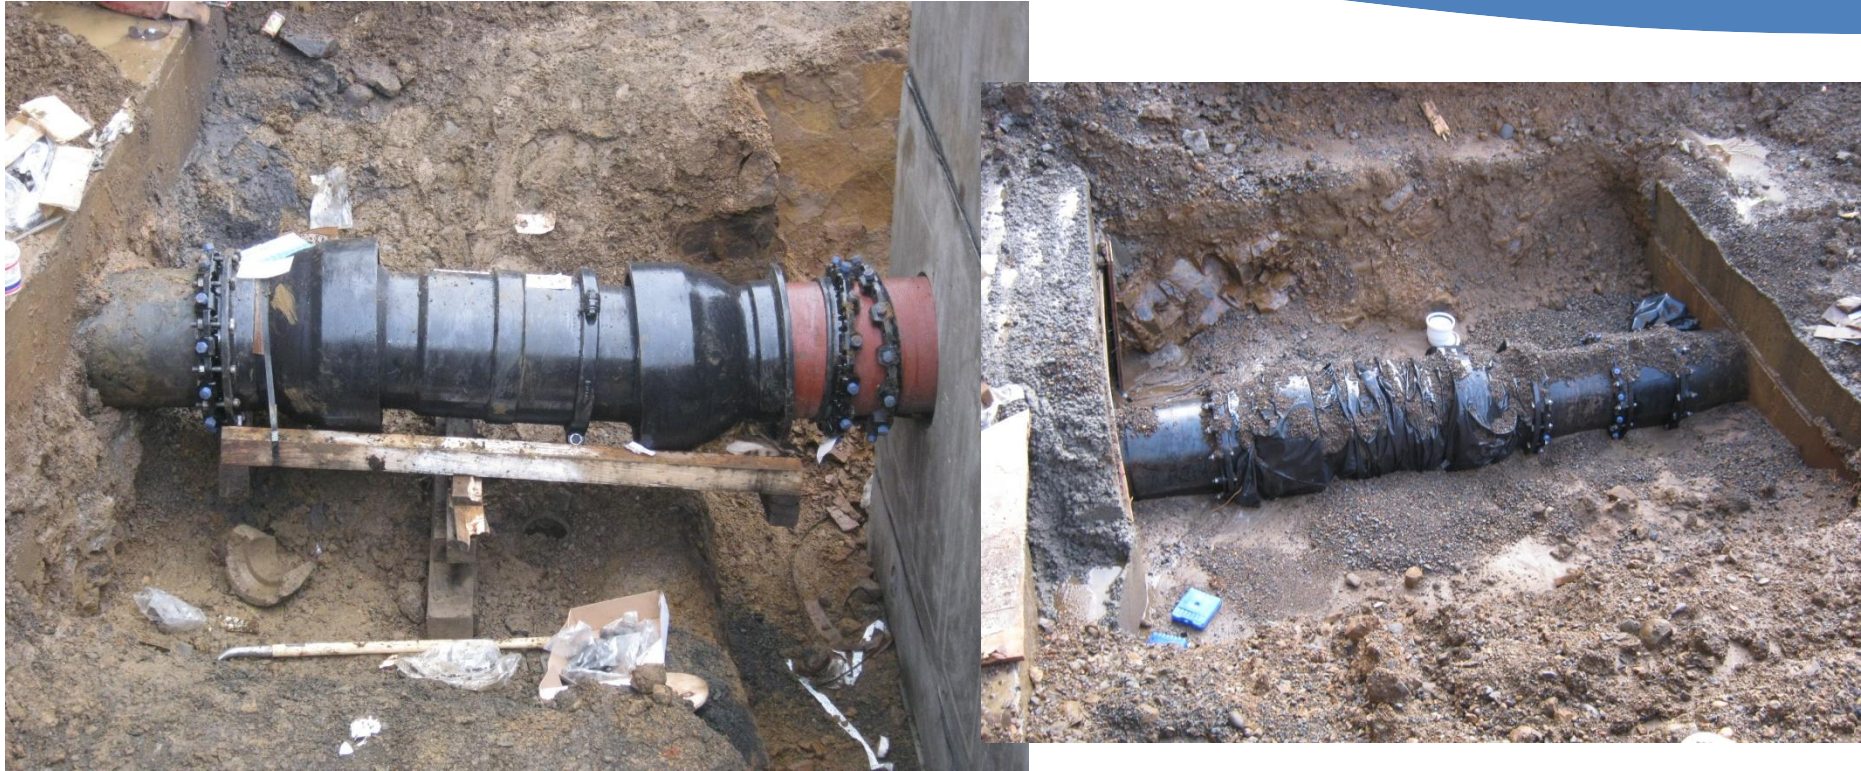
**Flexible Expansion Joints Installed on 16-inch CI Reservoir Overflow  
and 20-inch CI Inlet/Outlet/Drain Pipes**
