# Raising The Roof

## **An Unconventional Approach to Reducing Seismic Demand**

*Covington Water District Tank 2B*

Ken Dahl, PE, SE – BHC Consultants

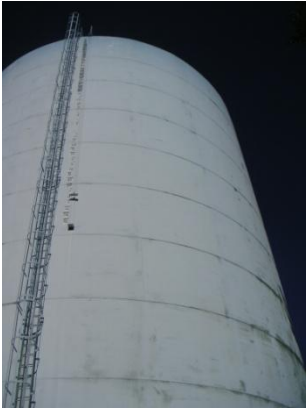
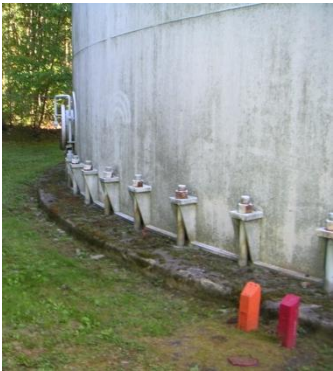
# Tank 2B Prior to Retrofit

Tank Data	
Capacity	4.0 MG
Diameter	84'-9"
Sidewall Height	86 ft
Total Height	104.38 ft
Water Depth	94.37 ft
Structure Weight	696 kips (roof 82 kips)
Water Weight	33,215 kip
Anchors	90 each @ 3 inch dia.

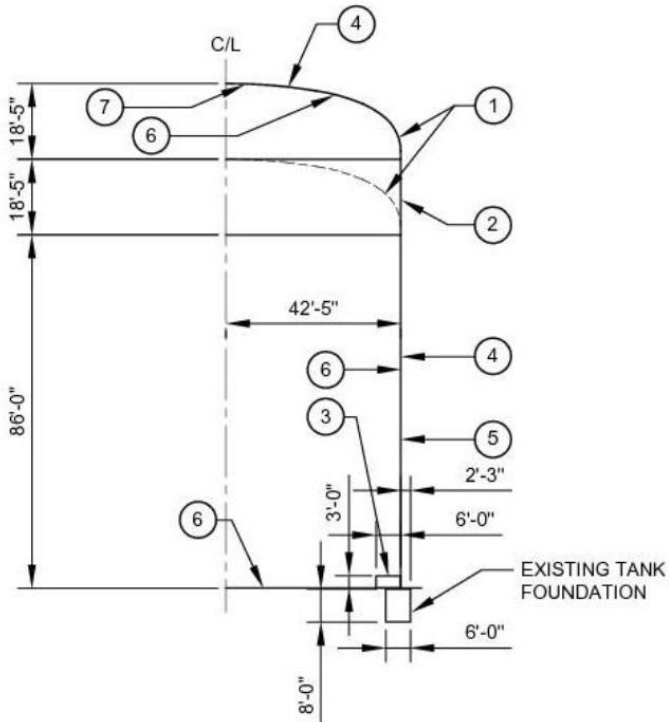
# Alternative 2 – Raise The Roof

Item	Description
1	Add rigging elements as required, prepare laydown area, cut off and remove existing dome. Reinstall dome after shell height has been increased. If laydown and salvage are more expensive than dome demolition and reconstruction, then use the cheaper option.
2	Add 15 feet of new .325" steel shell at top of existing shell. ASTM A131/A or other AWWA Class 1 material. Interior side, prep metal by abrasive blasting to white metal finish, followed by two coats of NSF-61 approved 2-component epoxy to a total dry finish thickness (DFT) of 8-14 mils. Exterior side prep metal by abrasive sand blasting to near white metal finish, followed by a three coat coating system. Prime coat inorganic Zinc; intermediate coat 2-components epoxy; top coat polyurethane. Total 10-16 mils DFT.
3	Construct an interior concrete footing, 3 ft high x 6 ft radial distance. Assume .75" x 4" Nelson studs at shell, say 356 total. Provide .25" liner plate on top and exposed face. Assume 4,000 psi concrete, 165 CY. Assume rebar at 185 lbs/CY, including lap. Coat exposed surfaces on liner plate as described in Item 2 above for interior shell plate.

4	Recoat existing exterior surfaces. Grind down all weld damaged surfaces and prep to near white metal surface. If selective prep is more expensive than tenting the tank and taking the entire tank down to bare metal, then use the cheaper option. Prep existing coatings to remain per tiecoat manufacturer's specifications. Provide epoxy tiecoat and polyurethane topcoat to approx 10 mils total DFT.
5	Add 15 ft of exterior painted steel caged ladder. Install 15 feet on interior stainless steel caged ladder. Add 15 feet on 8" vertical drop pipe for overflow.
6	Completely remove and dispose of all interior coatings inside tank to white metal finish. Selective patching of corroded floor plate areas. Interior coating system same as described in Item 2 above. Removal and recoat not required in areas that will be covered by new concrete inside footing.
7	Seal weld existing roof stiffeners and painters rails. Estimate total length of weld at 2424 feet (double sided welds counted as 2 ft/lf of joint).

- Estimated construction cost saving \$552,000. Faster schedule
- Roof seal welds, painting and appurtenances can be done on the ground
- Roof survivability improved, no superstructure strengthening required
