WHERE DO WE START

Leak Repair Summary Report

LOCATE DETAIL SHEET

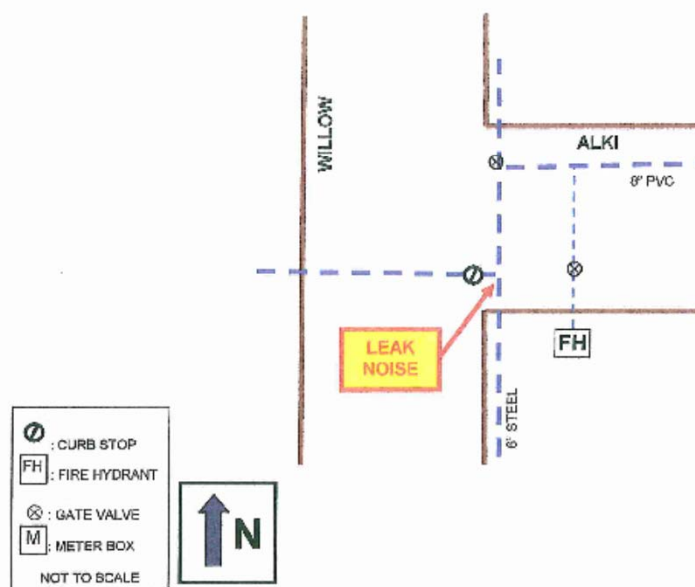
LOCATE: 3

TYPE & SIZE OF MAIN: 6 inch Steel

REMARKS: Leak noise best on curb stop for 525 N Willow. Ground mic of area indicates leak may be on blind flange nearby.

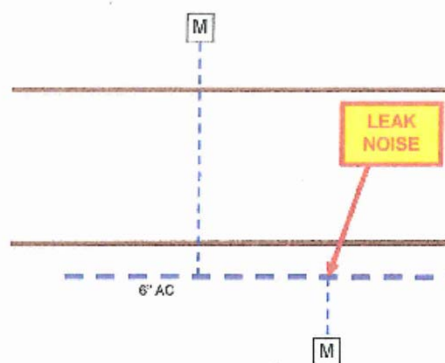
LOCATE: 1

TYPE & SIZE OF MAIN: 6" AC SERVICE: 11010 E Cataldo

REMARKS: Leak noise greater on service for 11010 E Cataldo.
