Little Changes can cause **Big Problems**
in a Water Distribution System

Jeff Coleman
Water Quality Supervisor
City of Longview

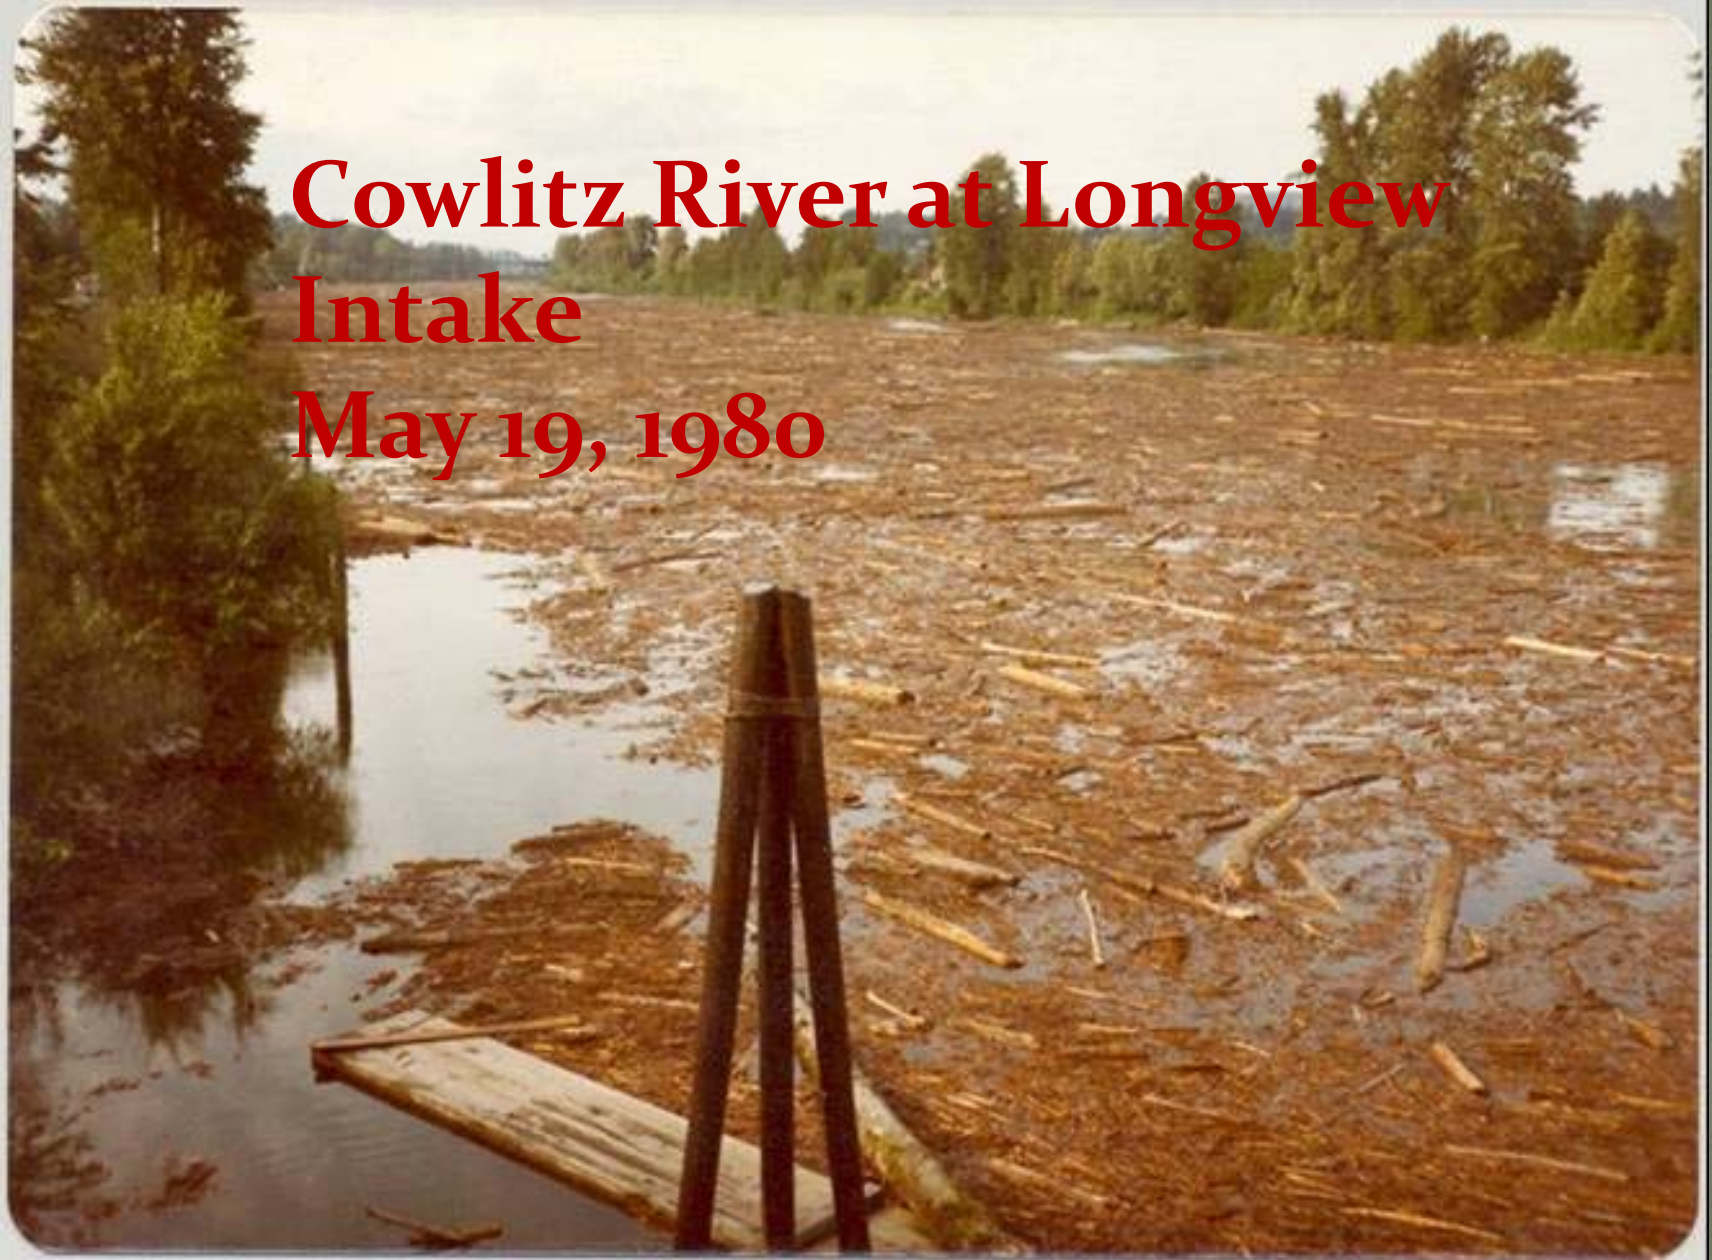
**Cowlitz River at Longview
Intake
May 19, 1980**

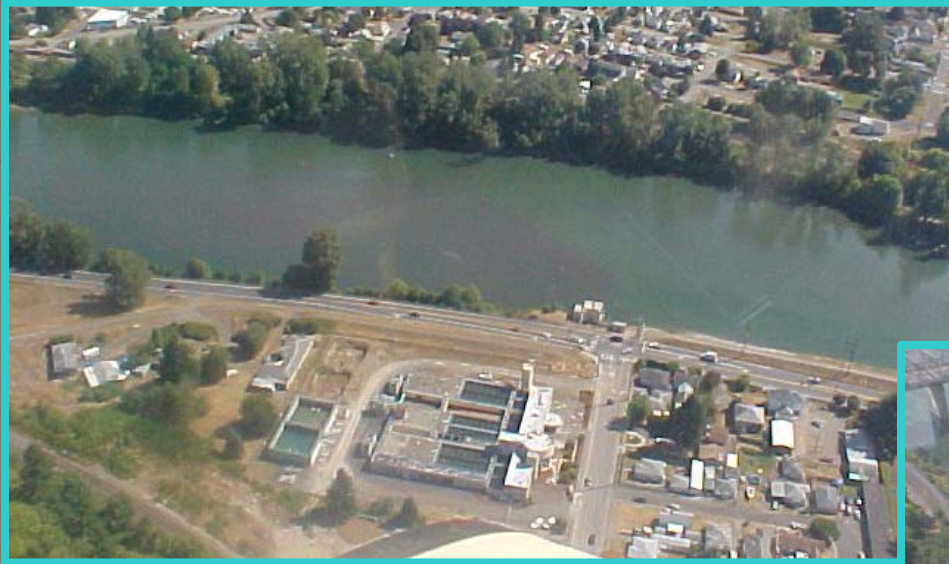
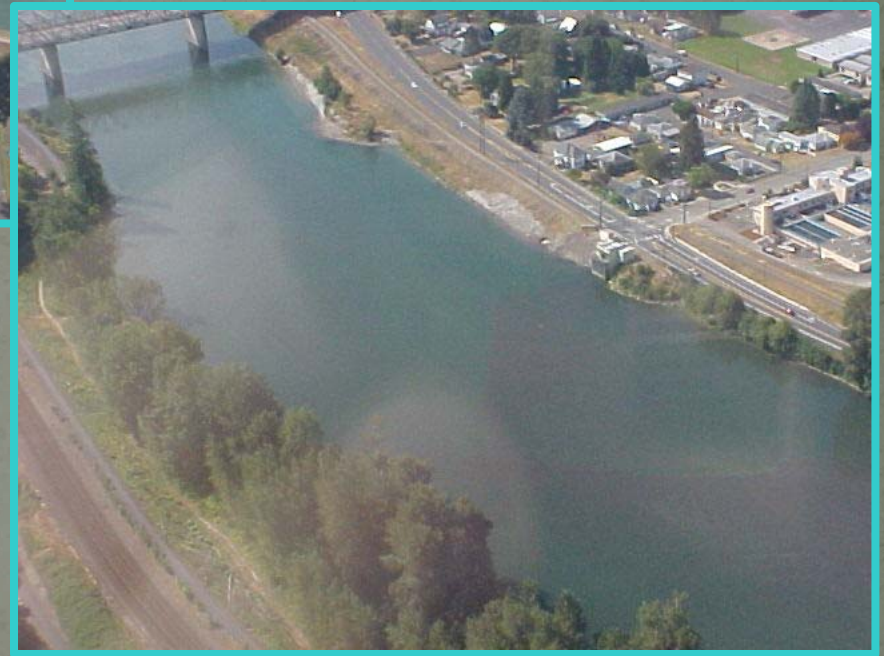
**Longview Regional Water Treatment Plant and Intake
September, 2005**

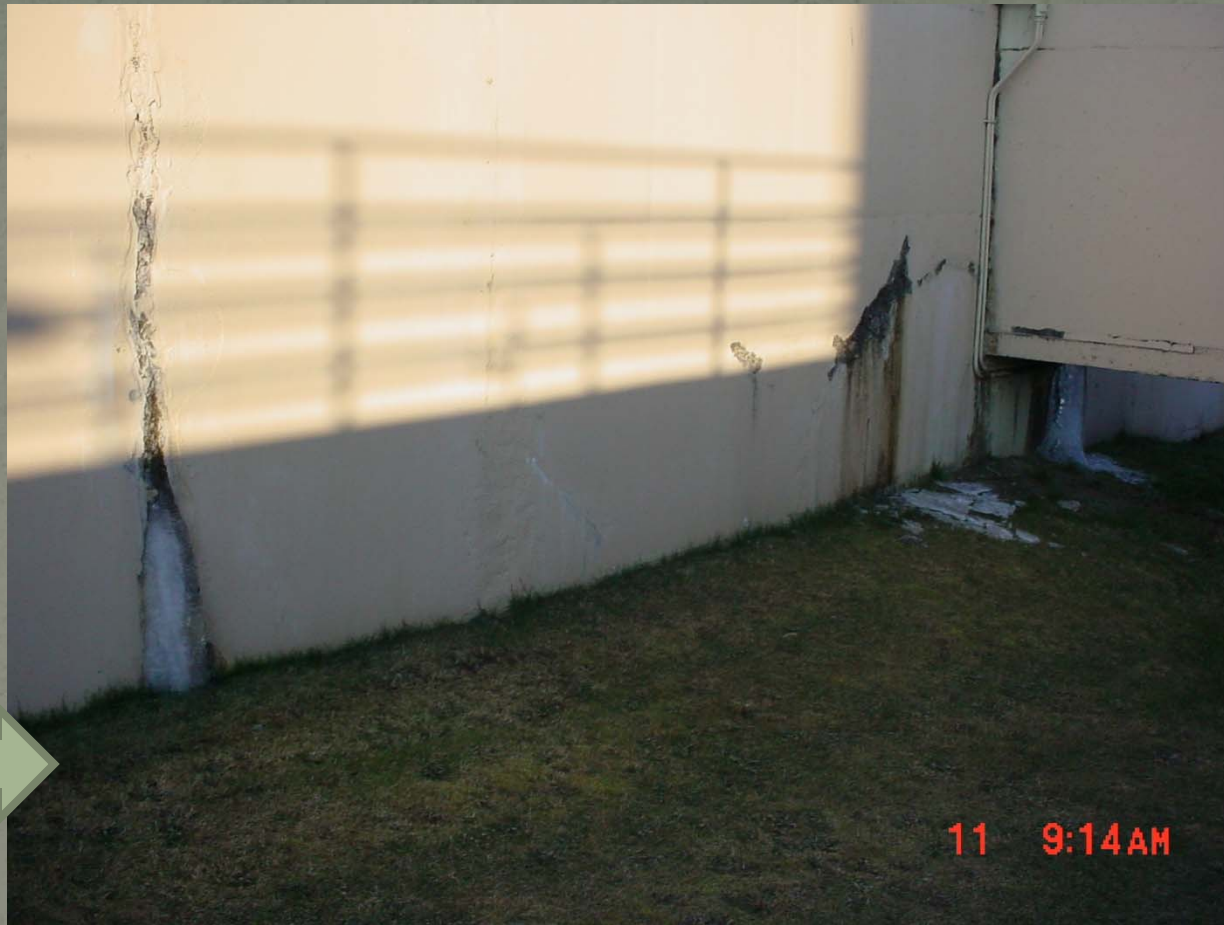
Ice

**Sedimentation Basin
Winter, 2009**

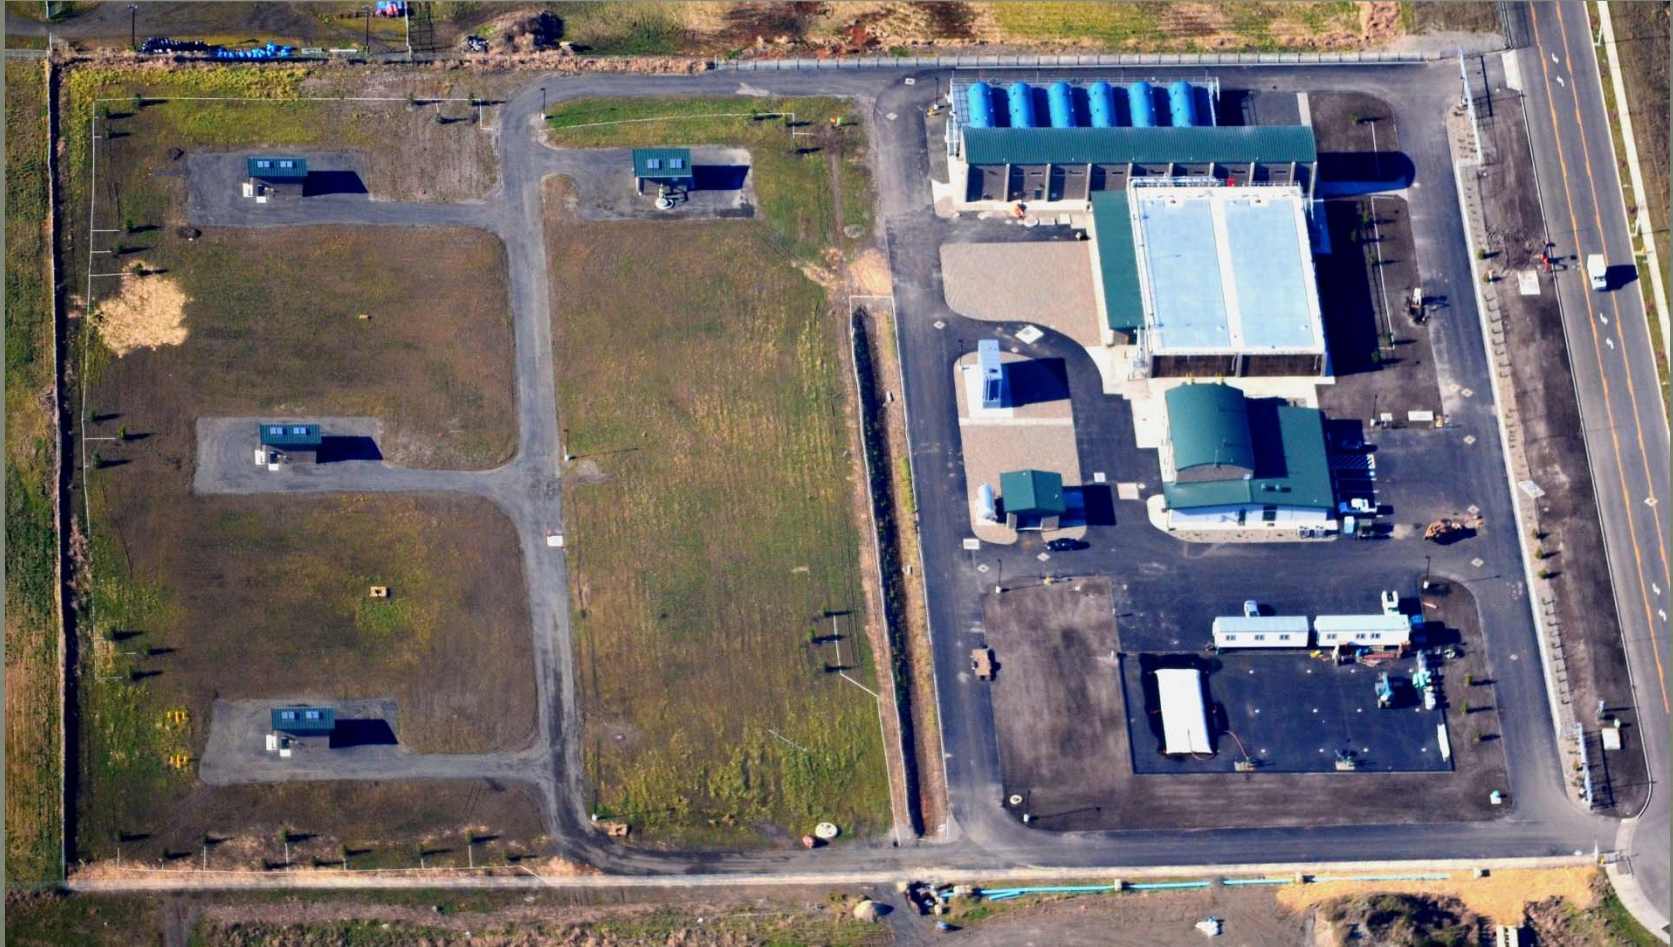
Mint Farm Regional Water Treatment Plant

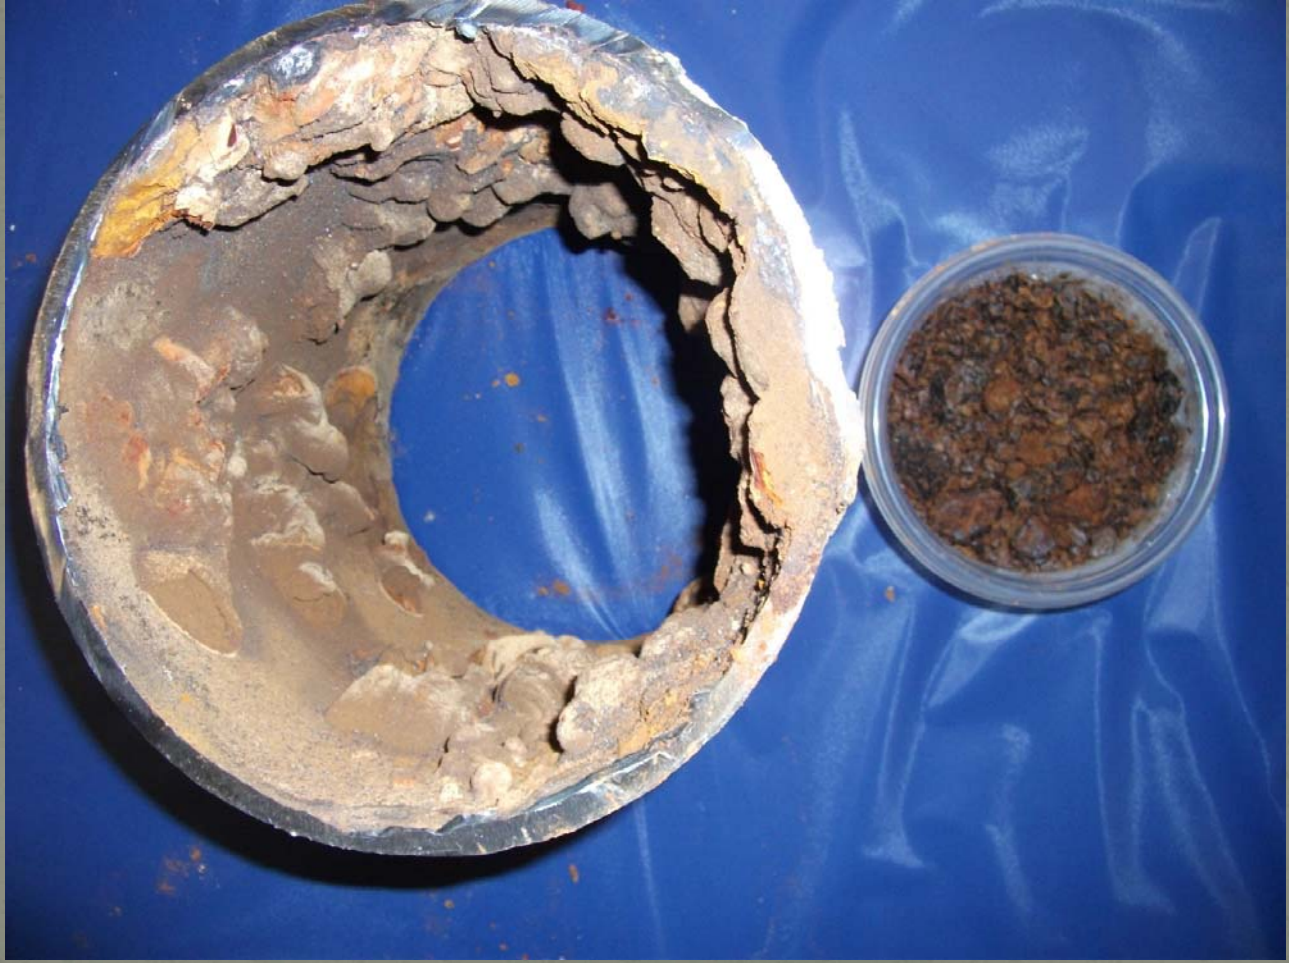
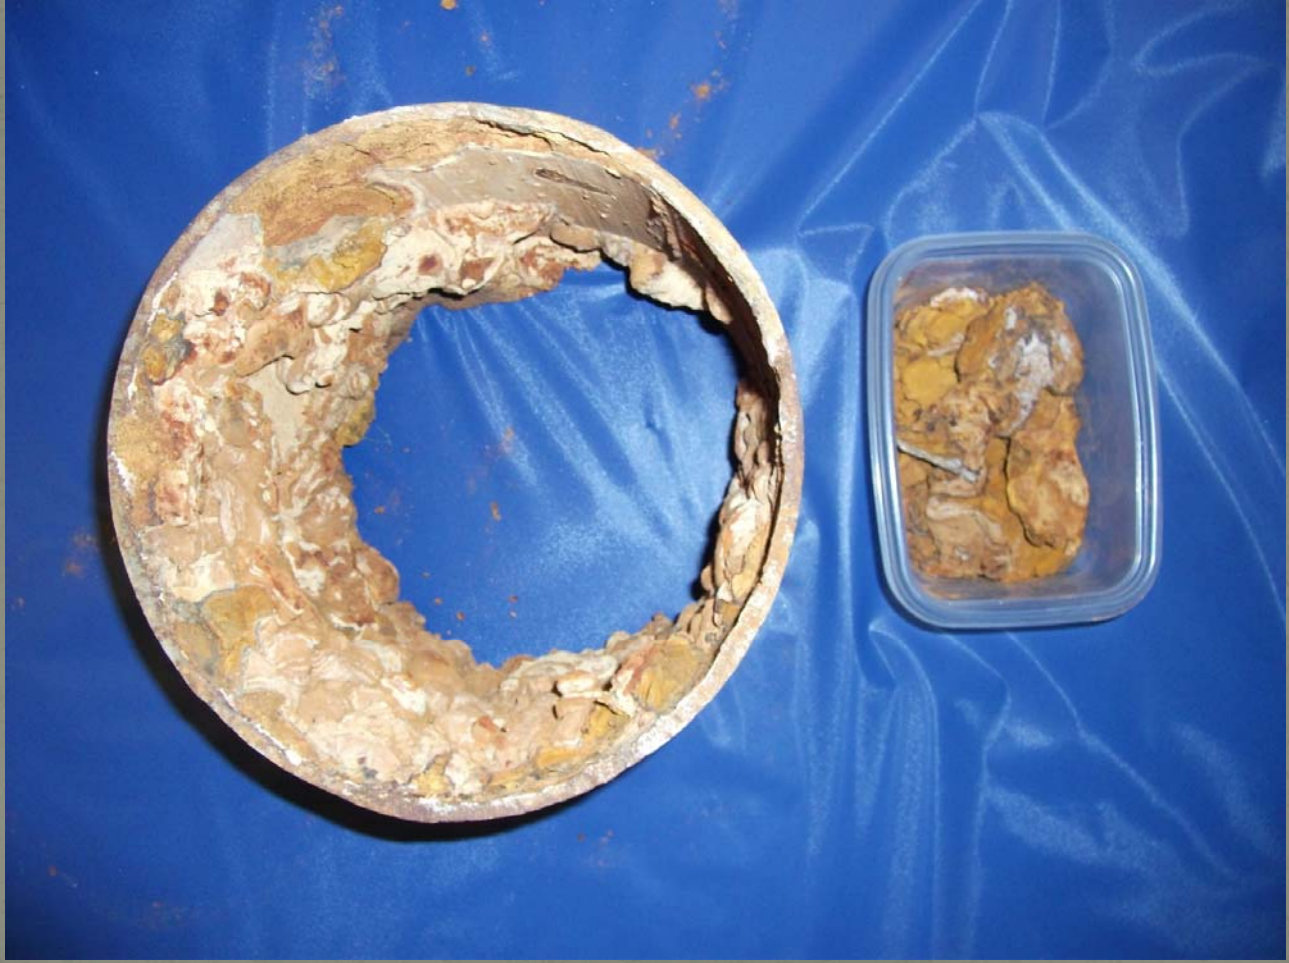
Before

After
