Getting the Pipes Clean– A Tale of Two Cities....

**PNWS AWWA
Eugene, OR
May 9, 2014**

**Presented by: Melinda Friedman, P.E.
Confluence Engineering Group, LLC**

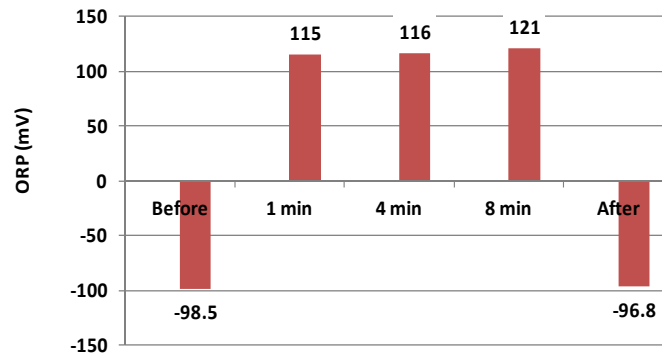
Took Months for Chemistry to Stabilize

Oxidation Reduction Potential

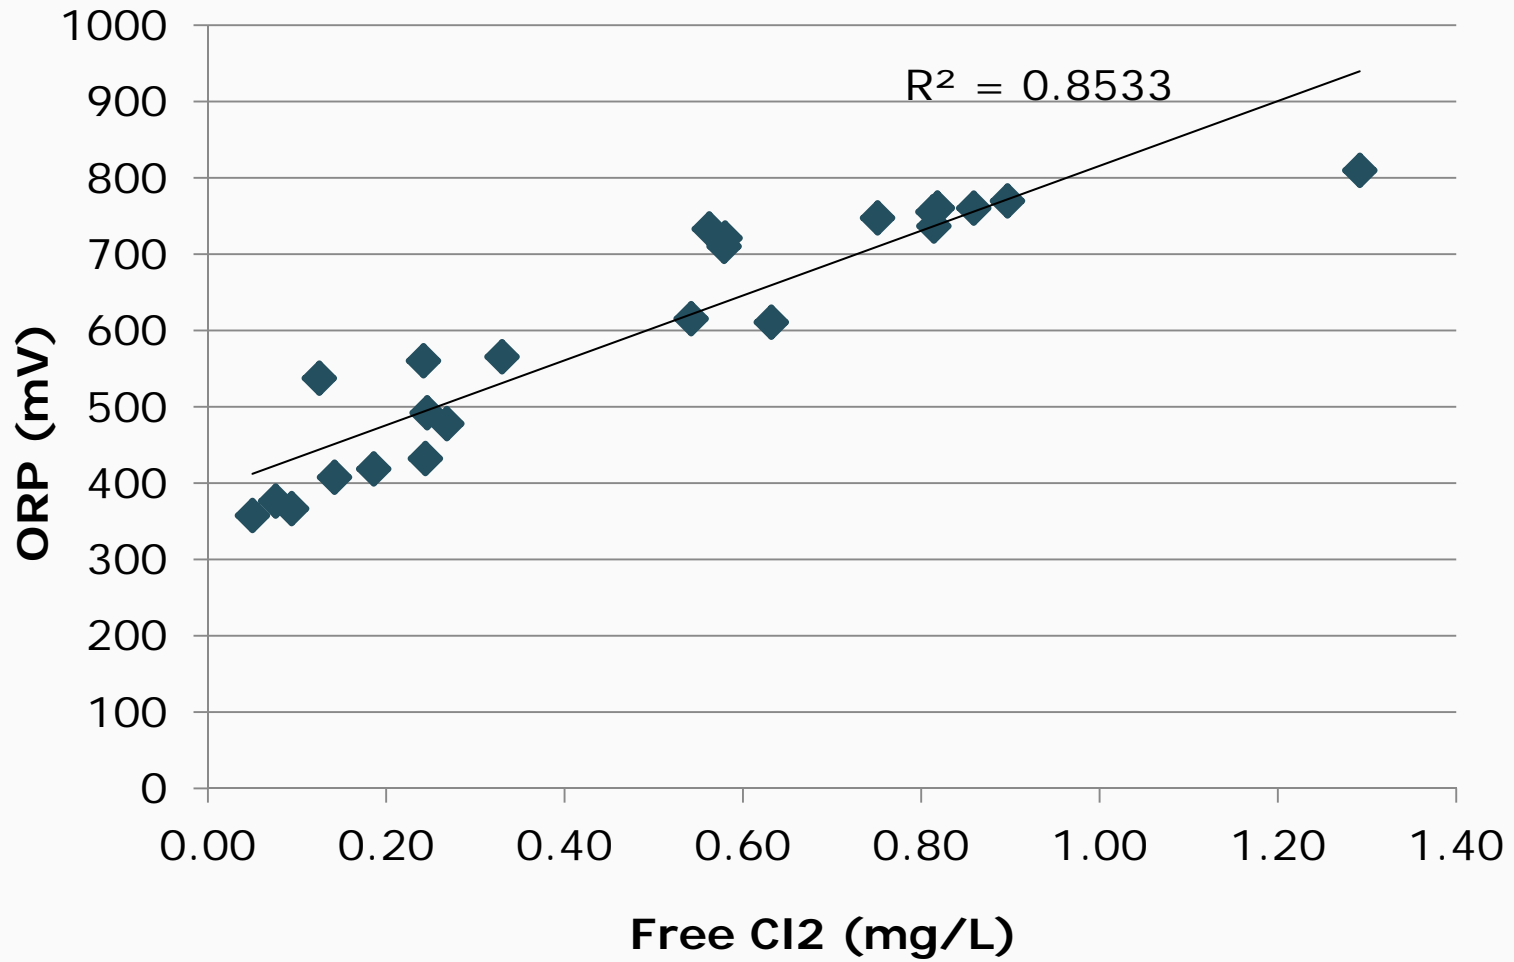
Chlorine vs. ORP

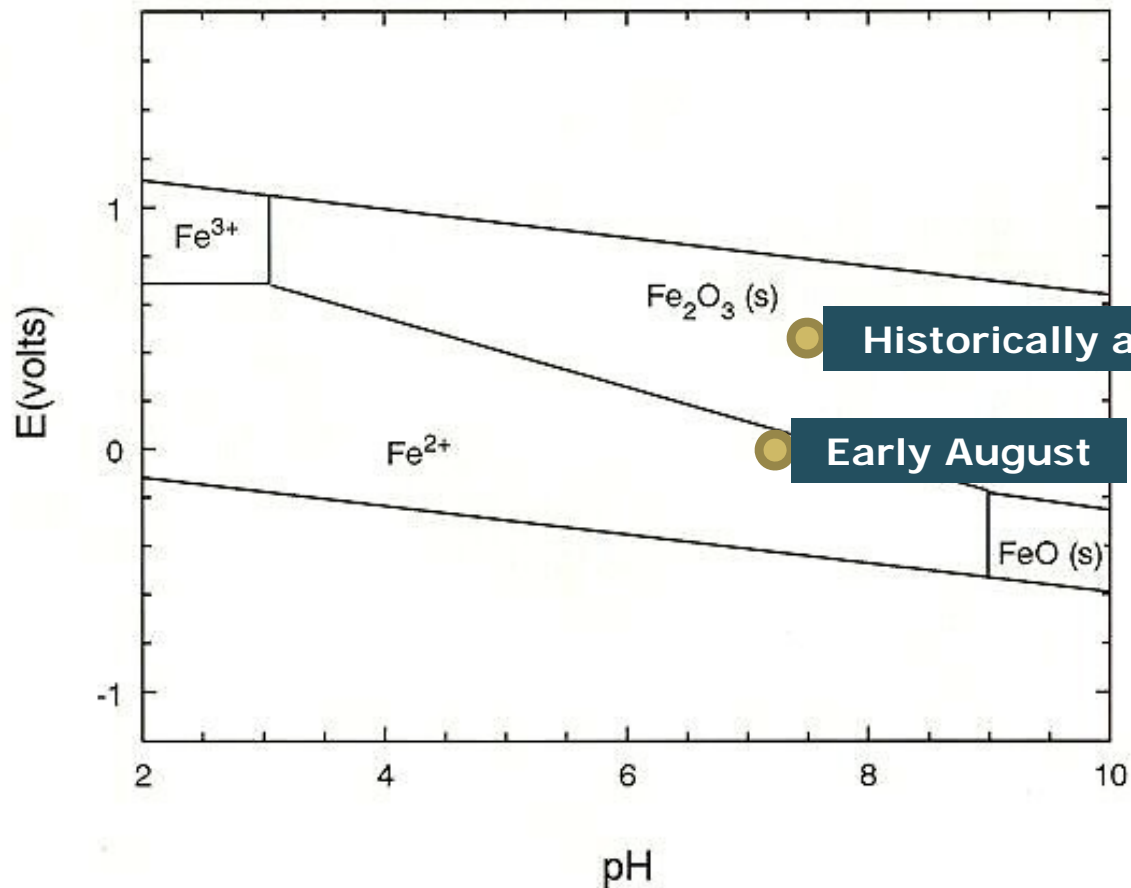
Effect of ORP Plunge

Simplified Pourbaix Diagram for Some Naturally Occurring Forms of Fe

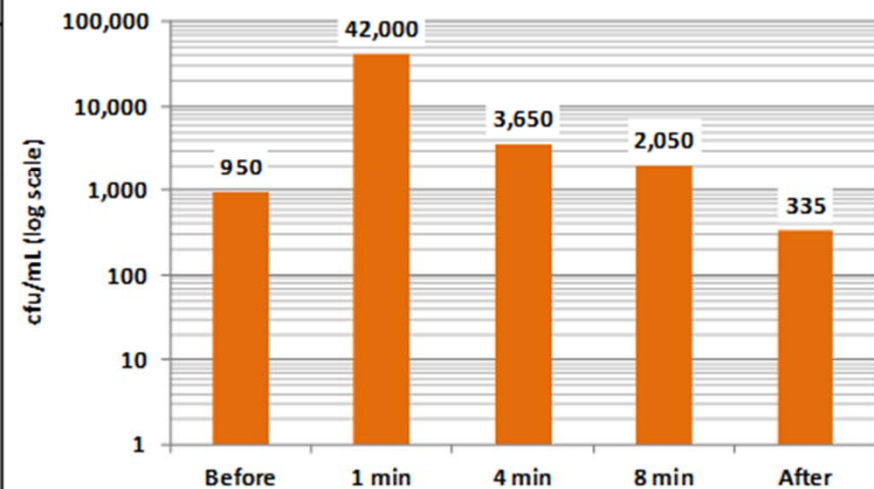
Heterotrophic Plate Count

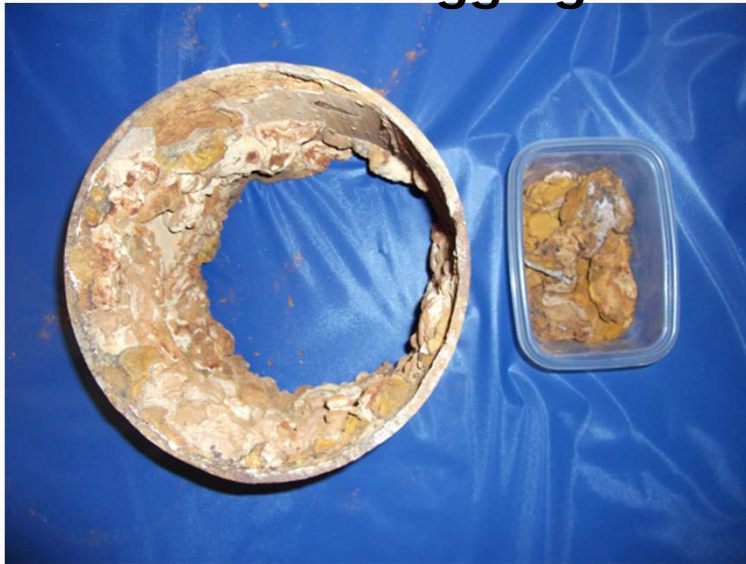
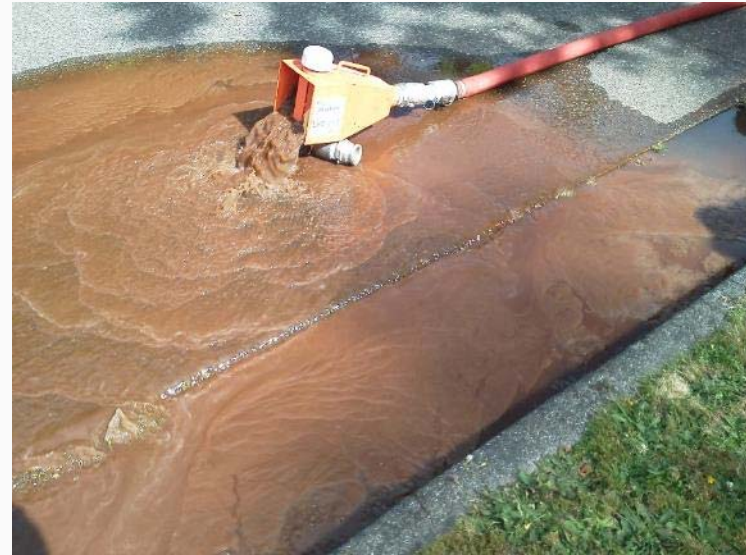
Tubercles Before and After Ice Pigging

Before Ice Pigging

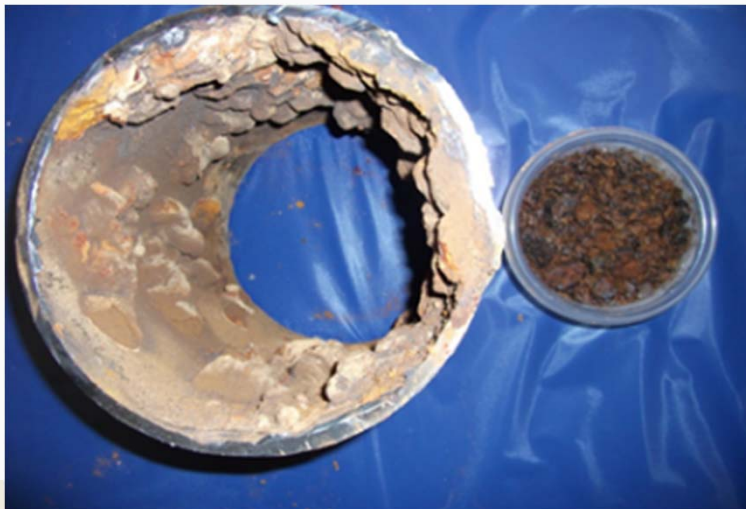
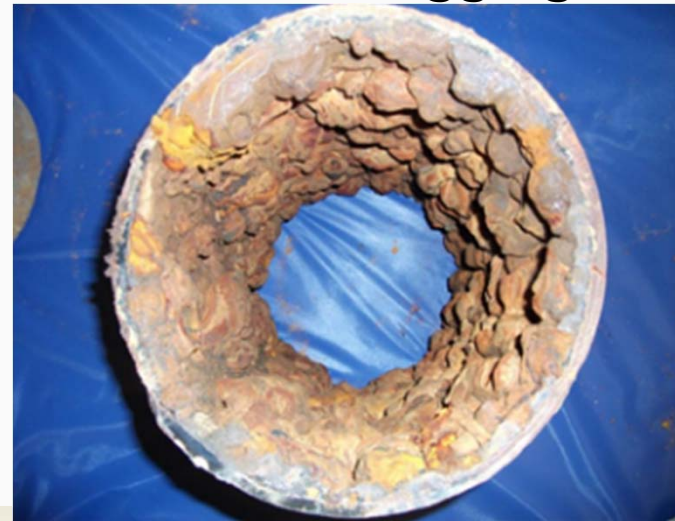
After Ice Pigging

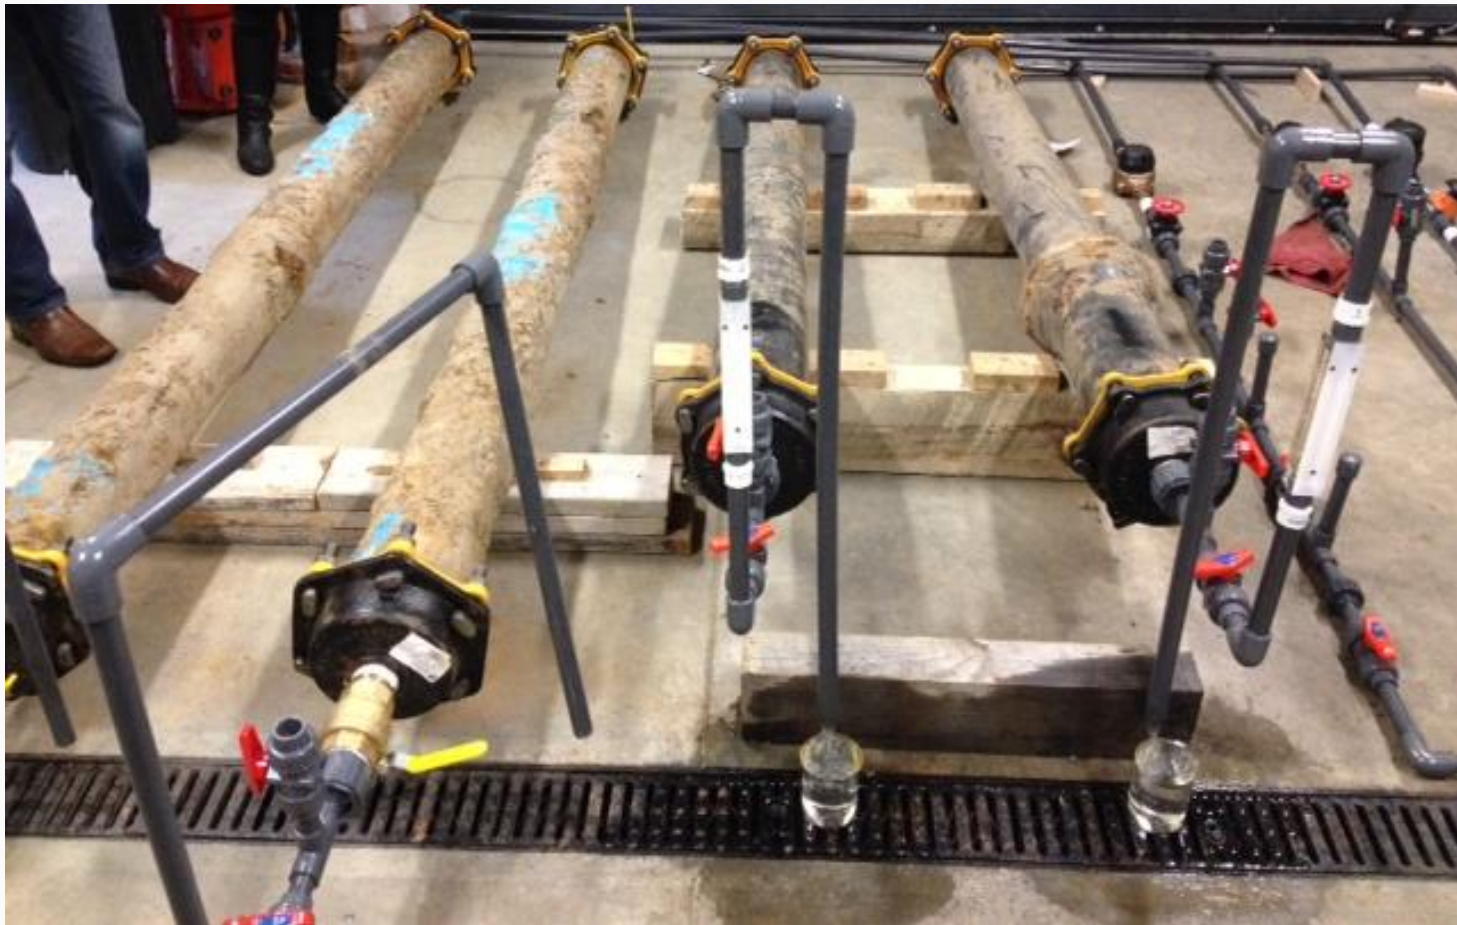
On-Going Study using Pipe Rigs

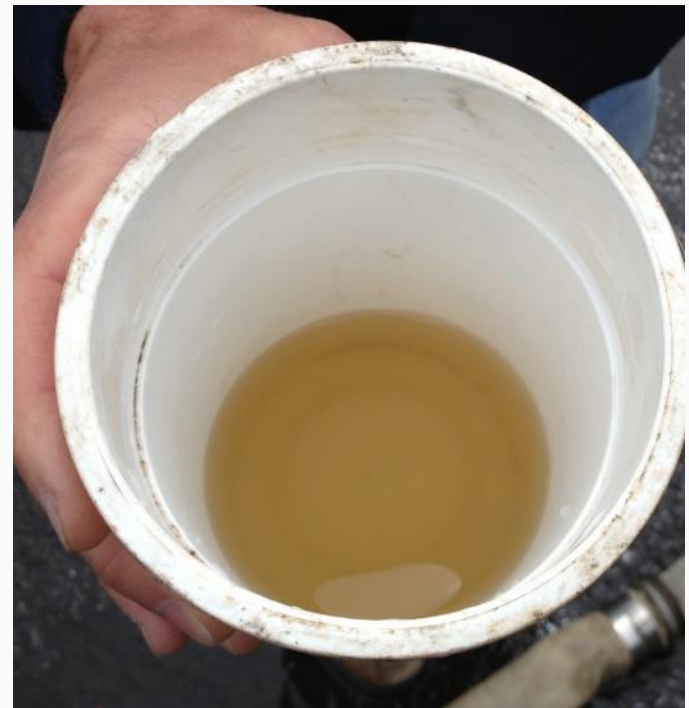
Accumulated particles in Tigard's DS are fine, light, loose, and impart a rust-colored appearance.

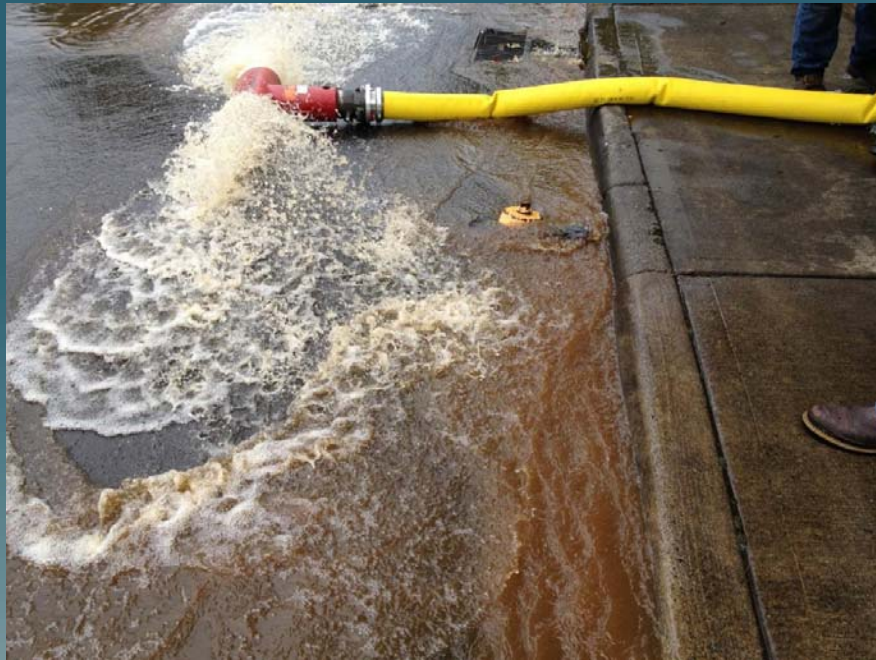
Color associated with 200 NTU flushing discharge, the average turbidity seen during the first pipe volume of pilot area loops.

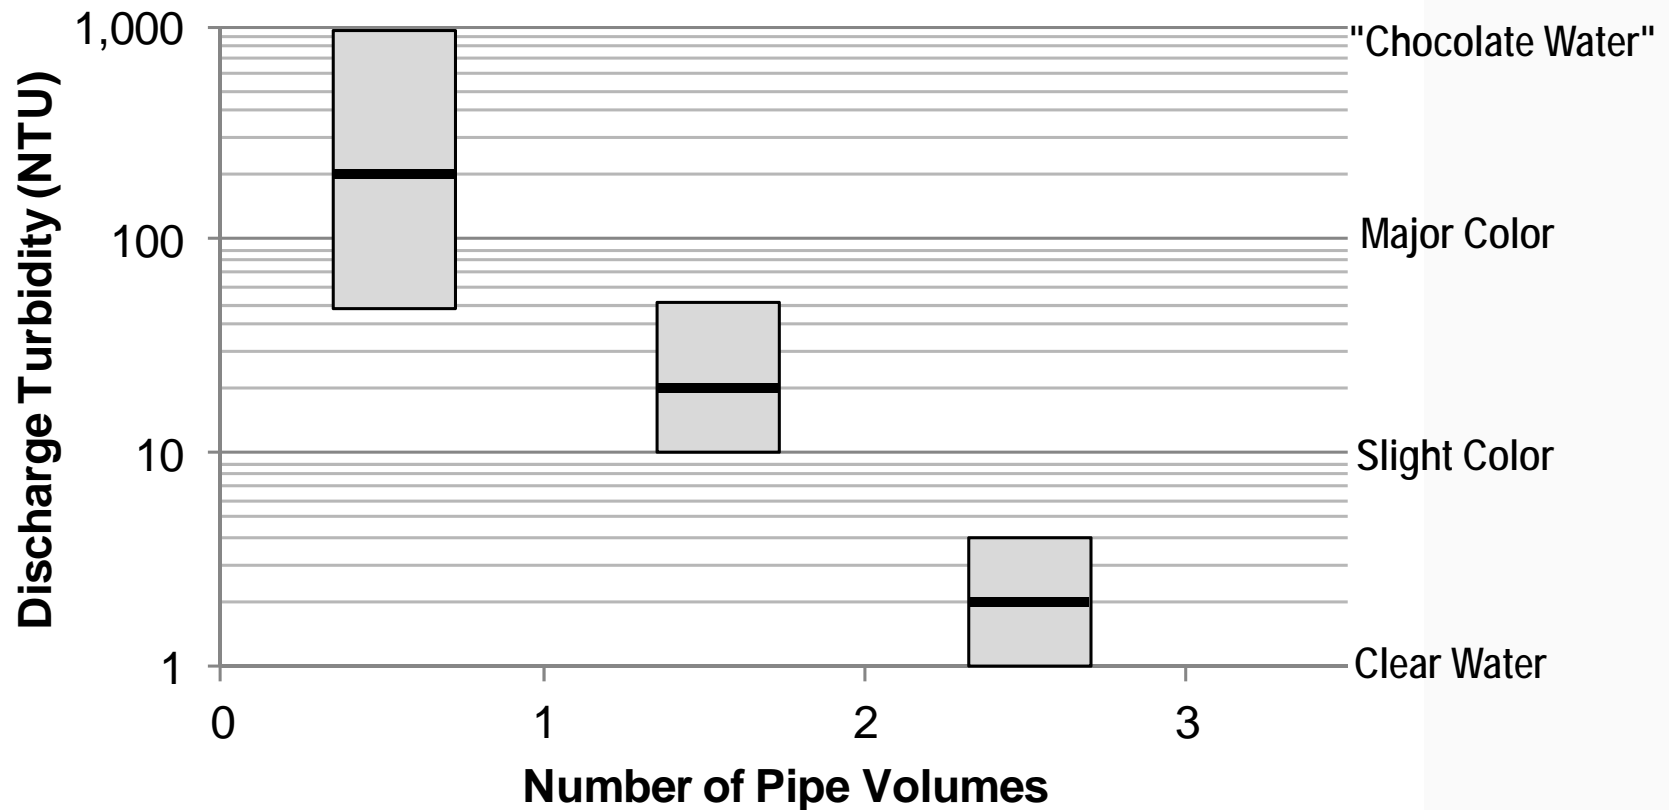
Sediment Removal Trends

For flushing velocities ≥ 4 fps

Velocities as low as 1.5 fps caused long, slow, turbidity "bleeding" process

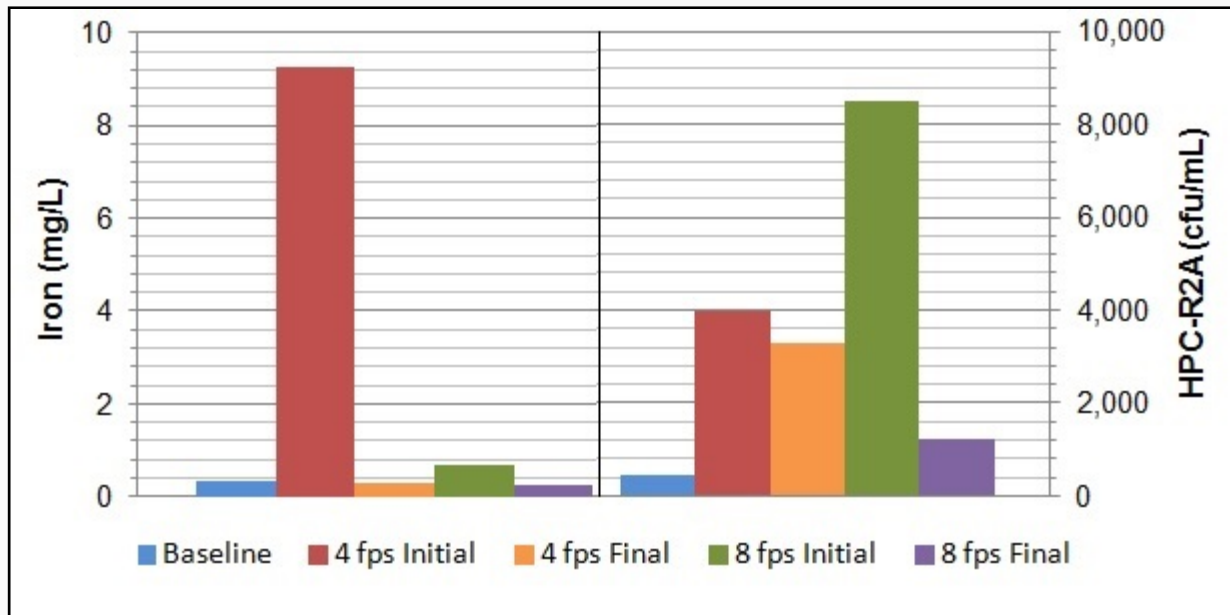
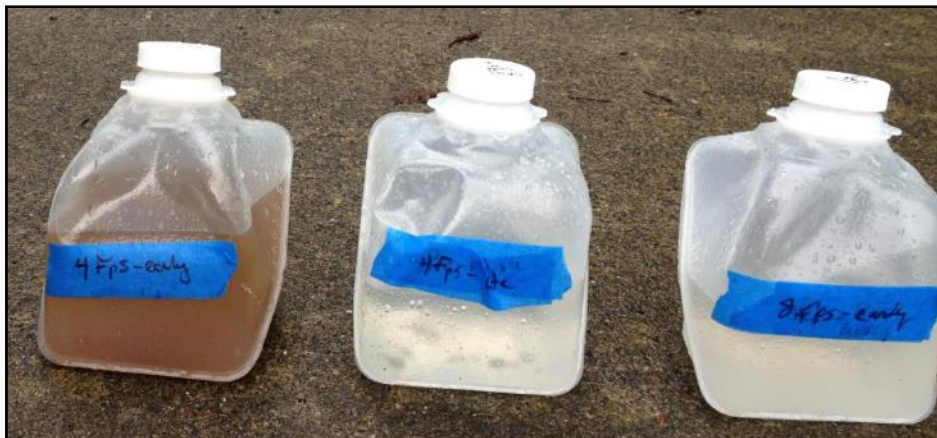
Contaminant-Specific Velocity Performance

Cannot rely solely on visual appearance to determine optimal flushing velocity.

For Tigard, increasing the flushing velocity up to 8 fps improved biofilm scouring.
