Columbia WTP Membrane Replacement Project

Bill Carr
Dustin Whyman

United Water Idaho
Carollo Engineers

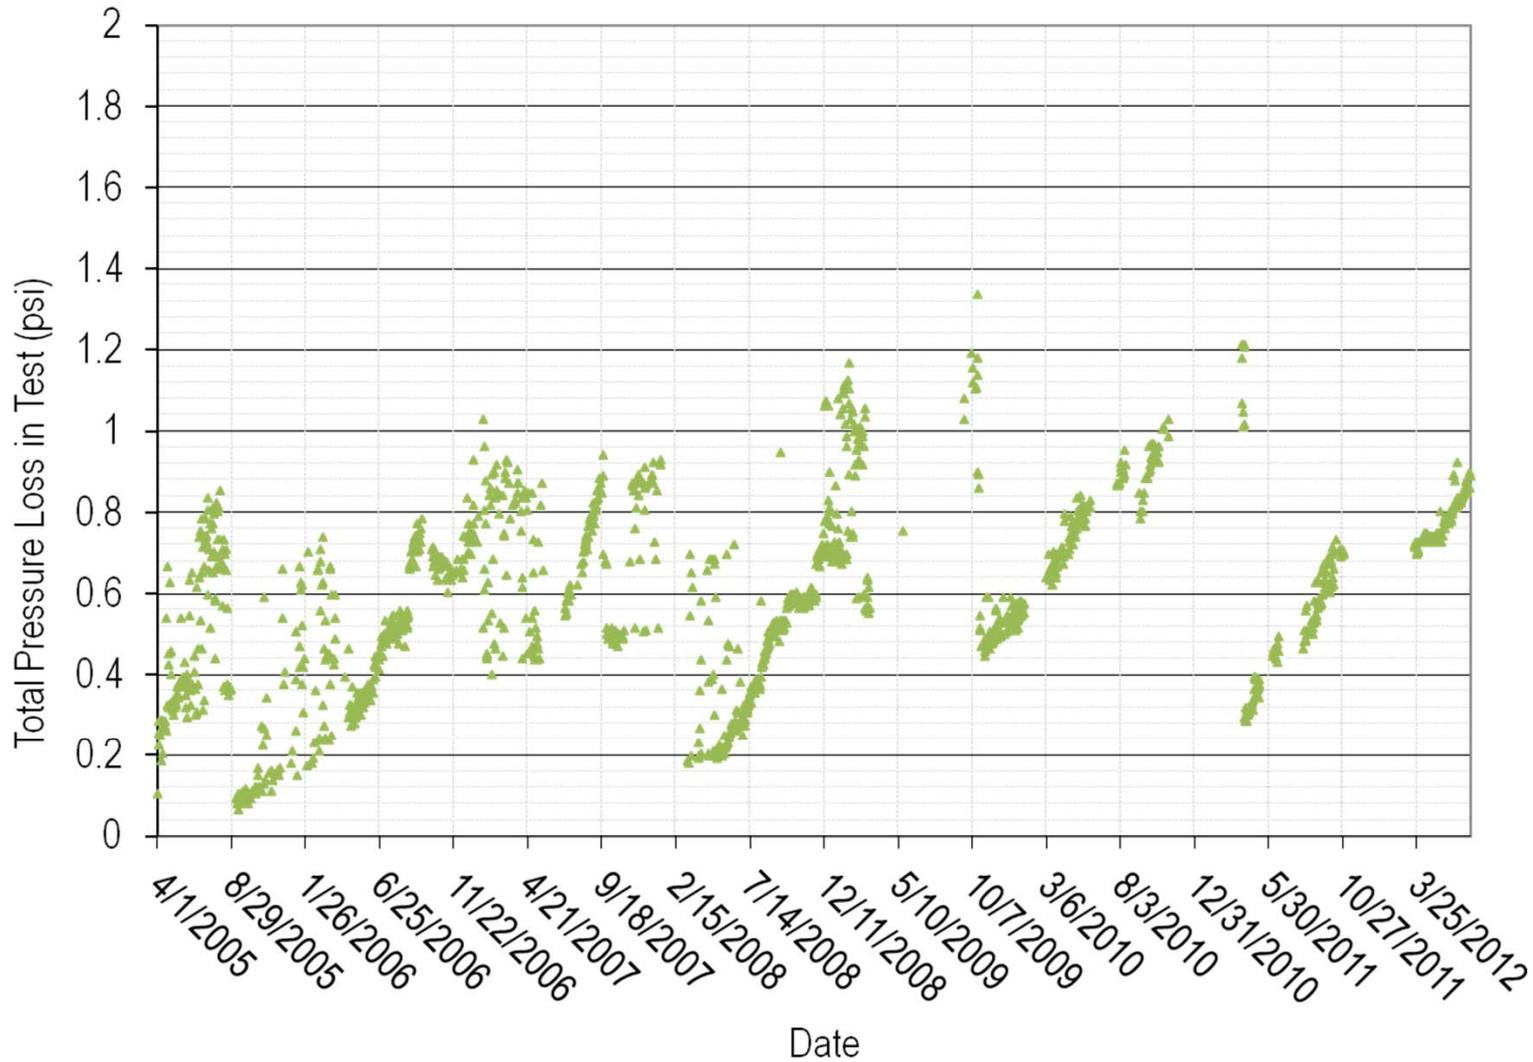
Membrane Integrity Was a Continuous Issue

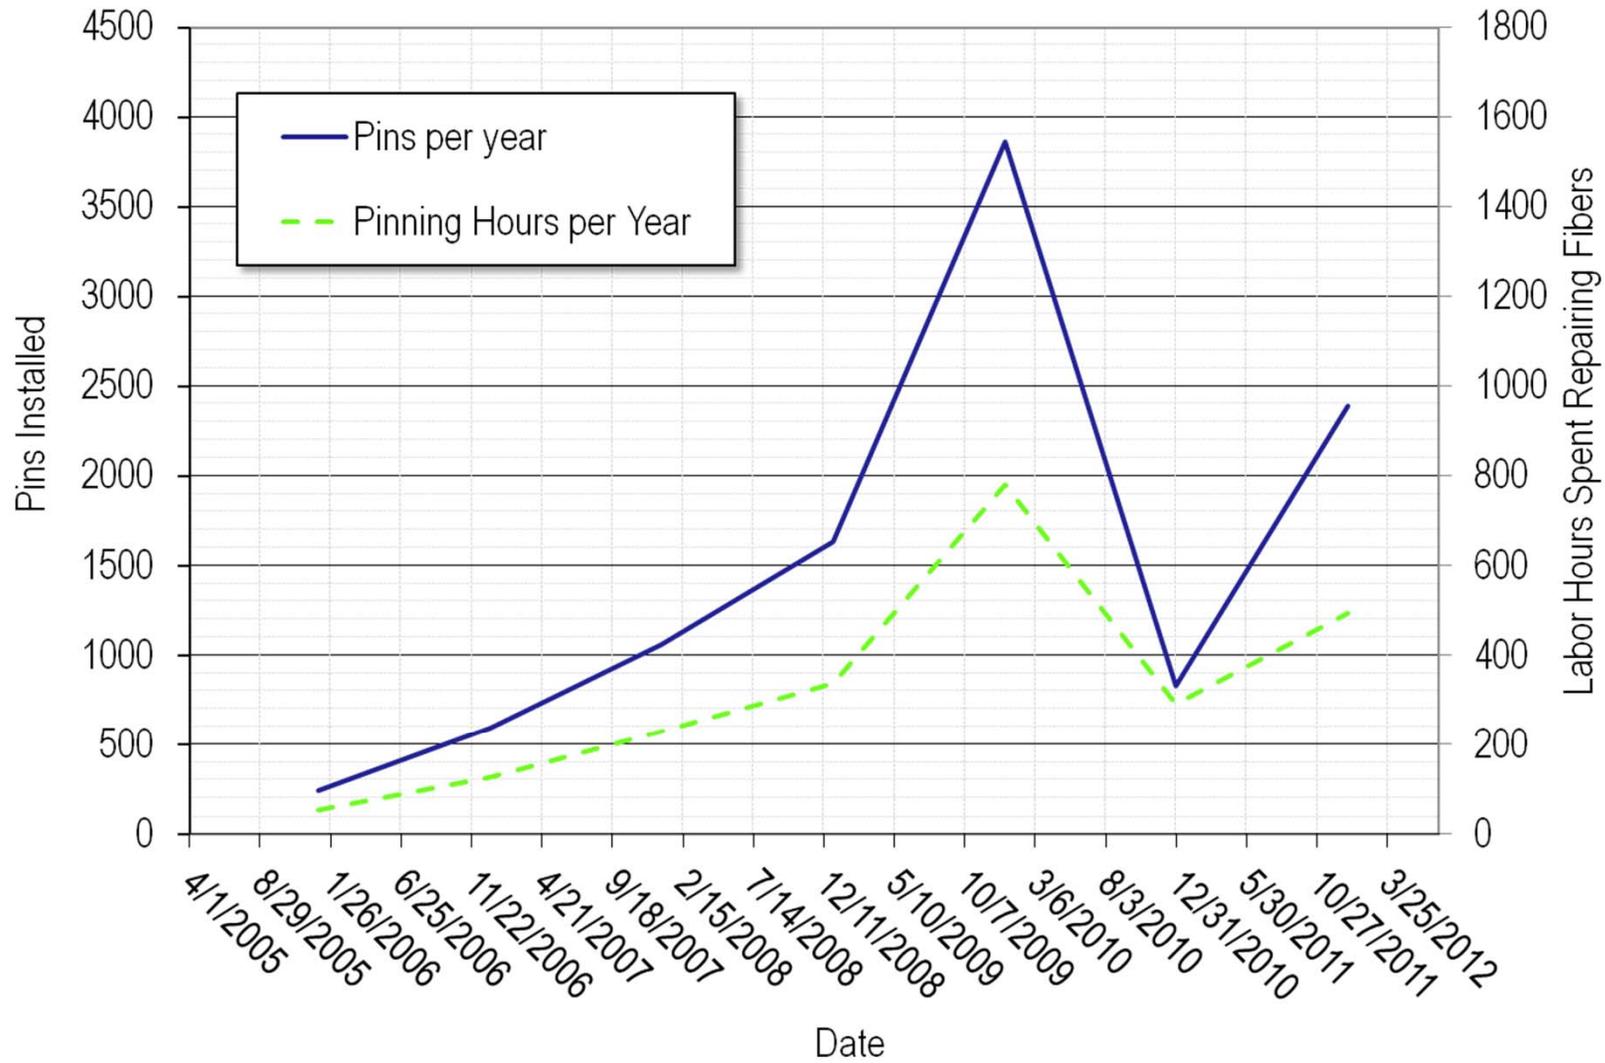
Repairing Fibers Became a Significant Part of Our Maintenance Duties and Costs

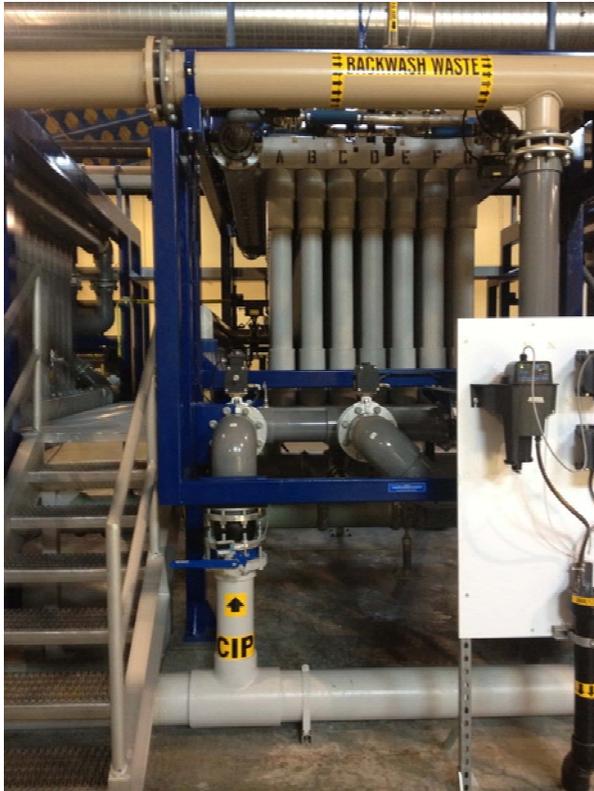
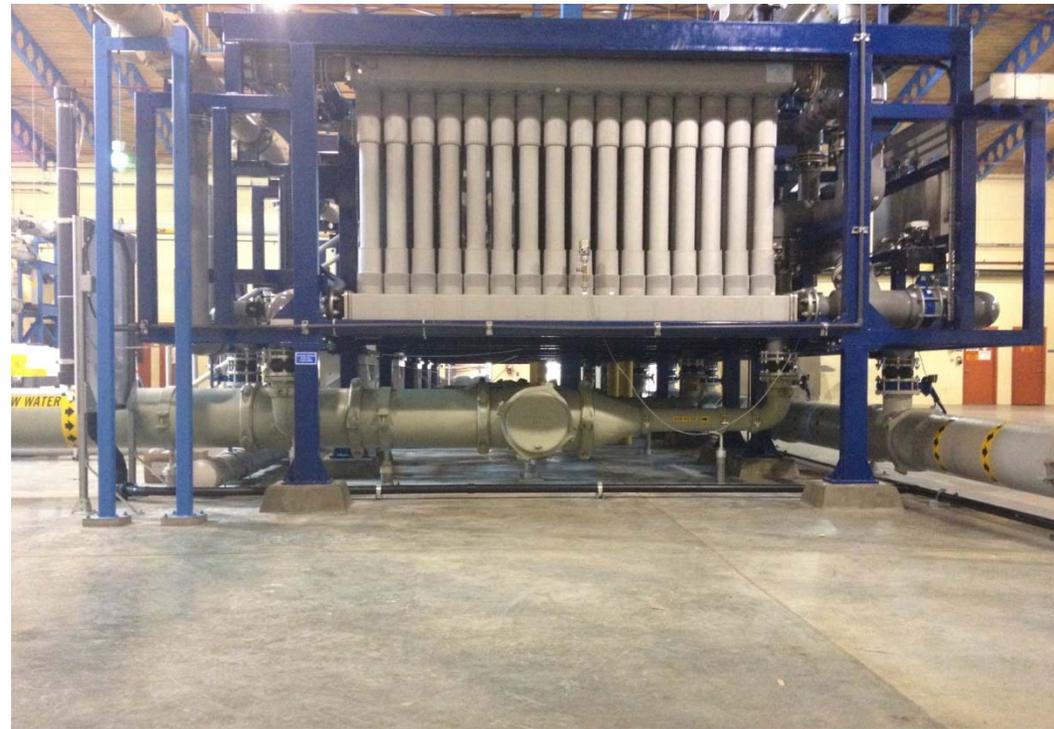
Replacement Options... Replace Modules With New Membranes From Current Supplier

Existing: Proprietary design and specialized components, compact design.

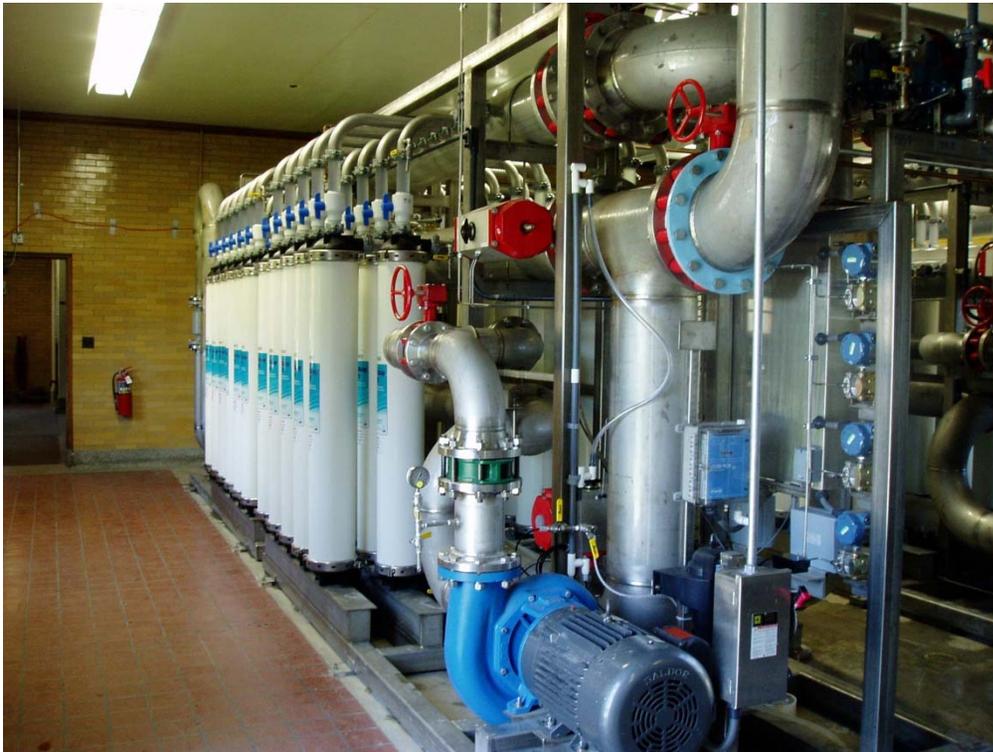
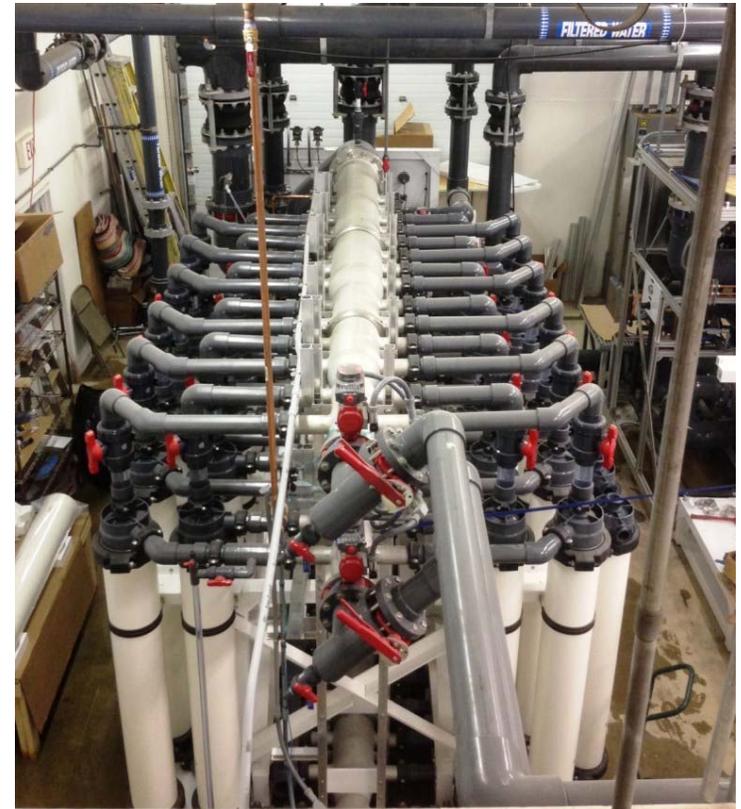
Replacement Options... Switch to a New Open Platform Membrane System

Open platform examples (2): Headers/ports with space for modules in between.
Many parts available from local potable water supplier .

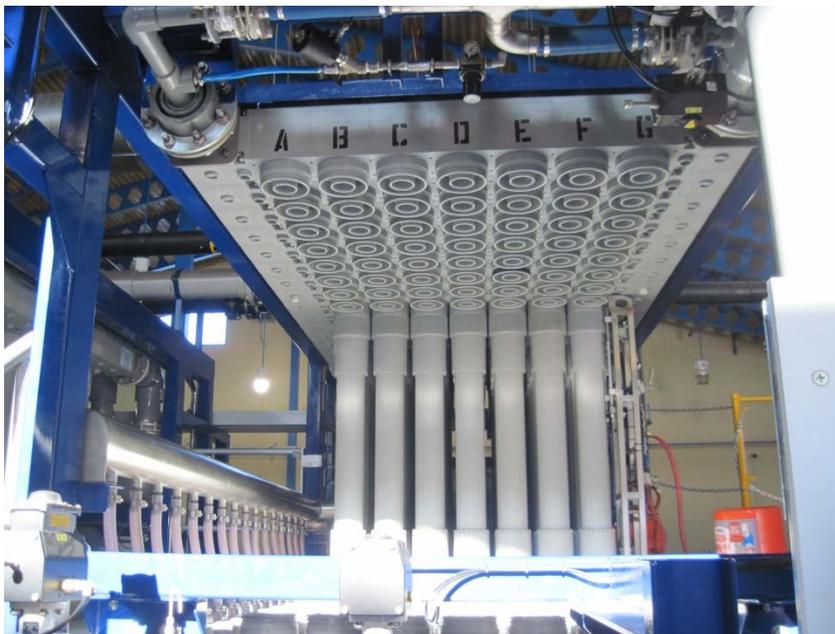
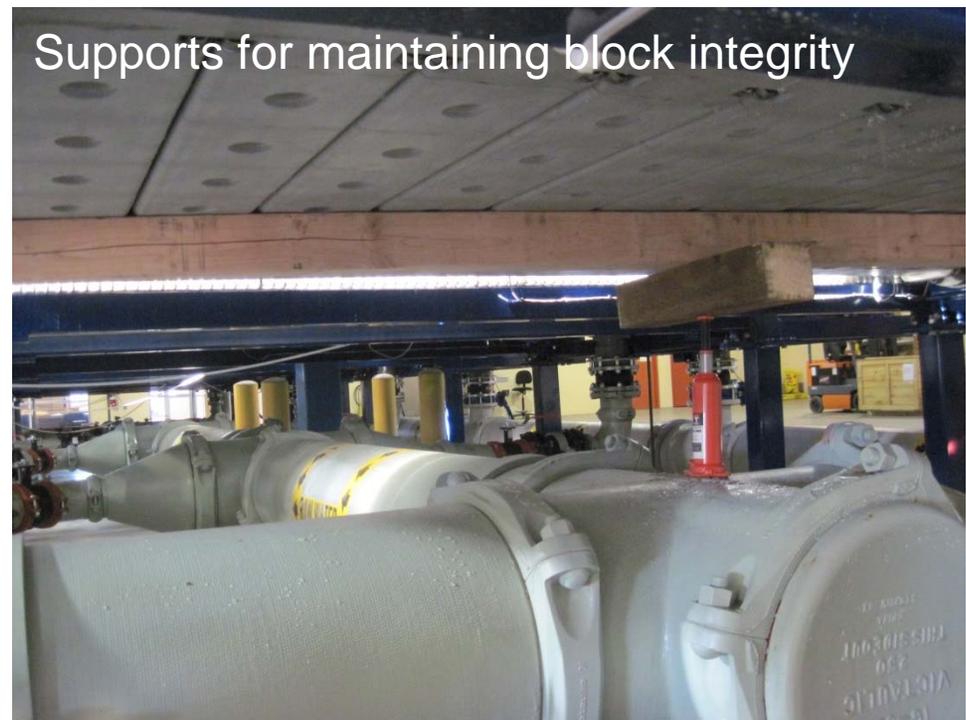
Removed 1/2 of the rack at a time

- Contracted with membrane manufacturer to provide a three person team; Team installed membranes in two weeks. One person stayed an additional week for programming and start-up. One United Water (UW) person assisted with installation and provided coordination with UW operations staff

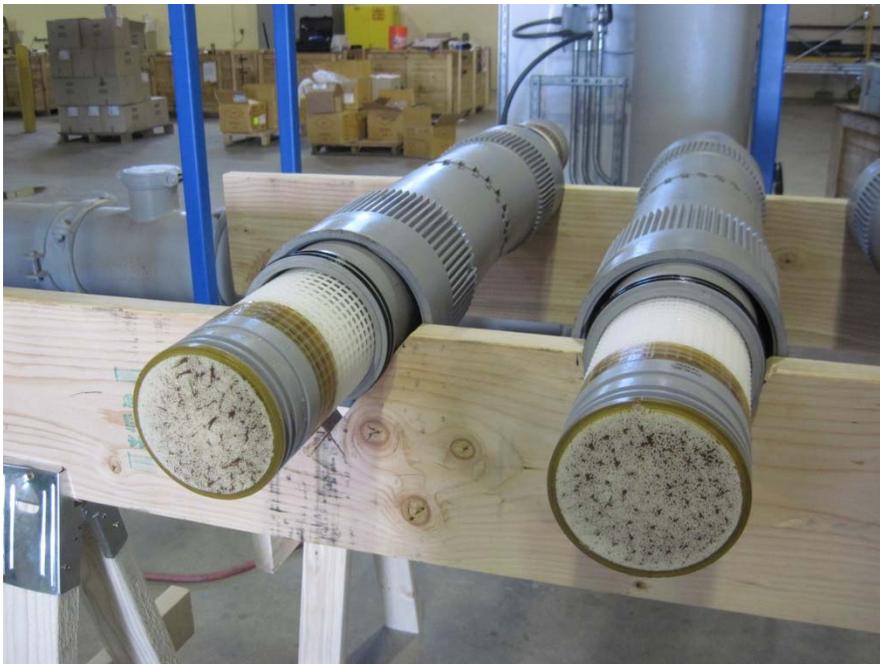
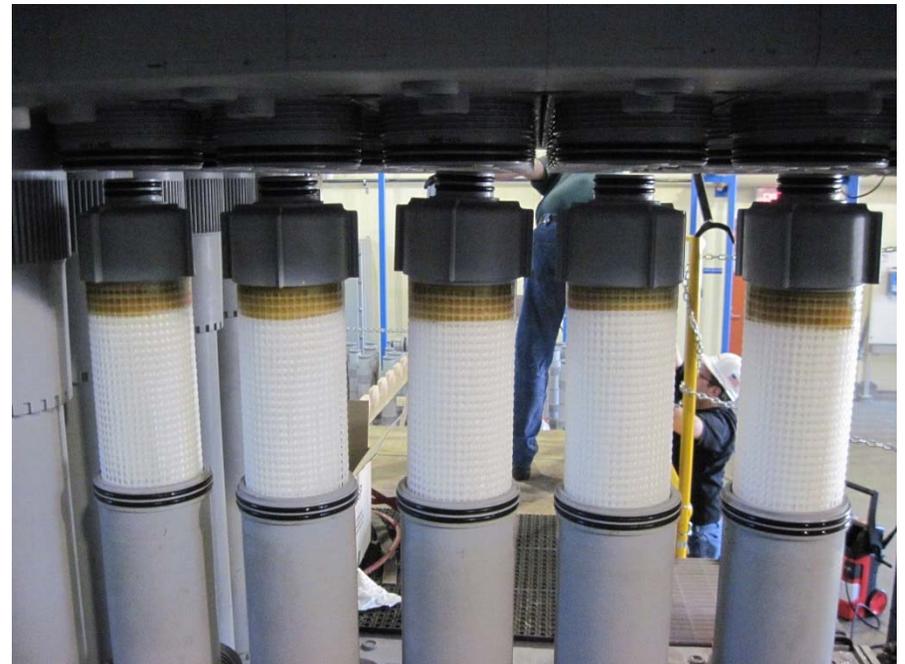
Methodical installation, in stages, needed to maintain hydration of membranes

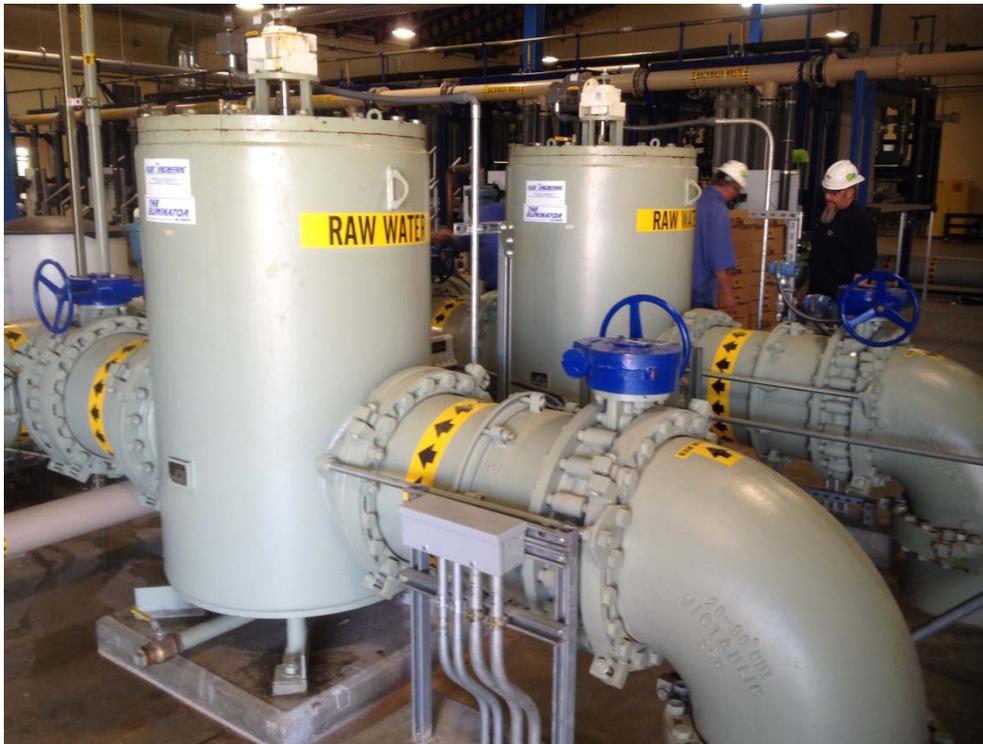
Existing duplex strainer assembly

To protect the new membrane modules, and comply with warranty requirements the existing 500 micron strainers were replaced with 250 micron strainers

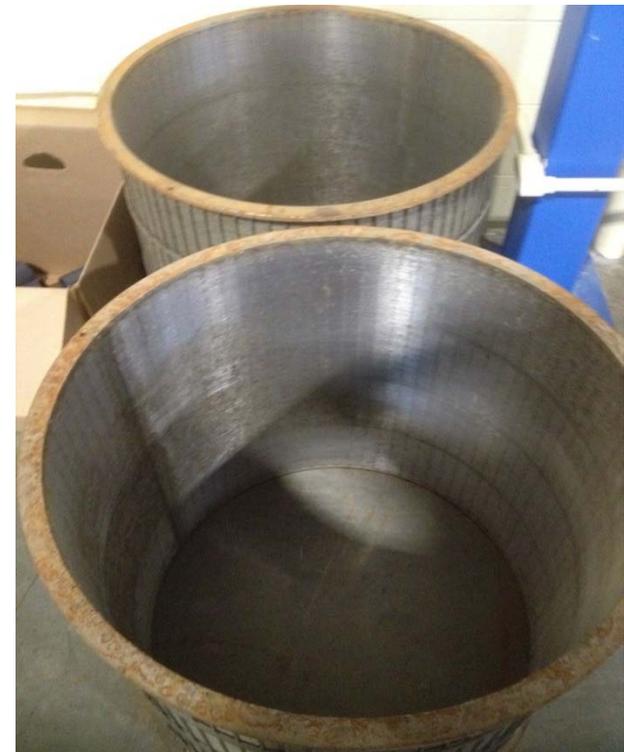
Retired 500 micron strainers

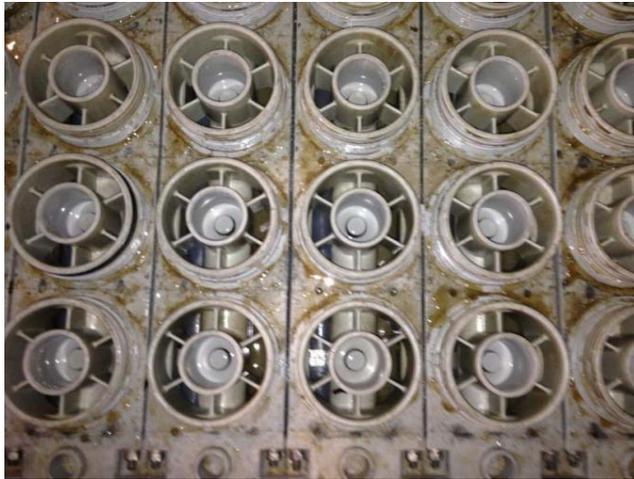
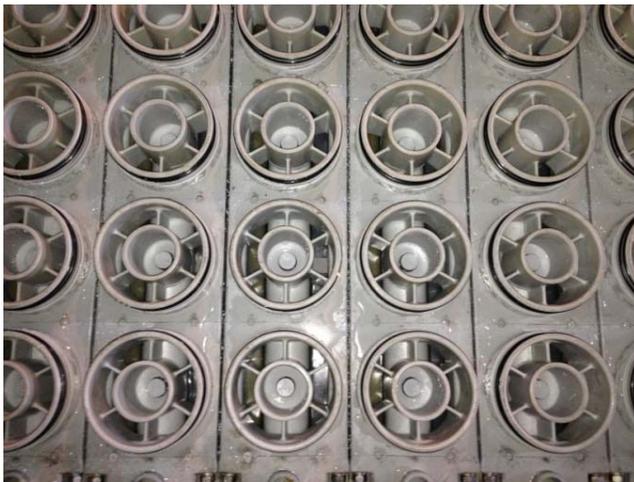
Power Washing

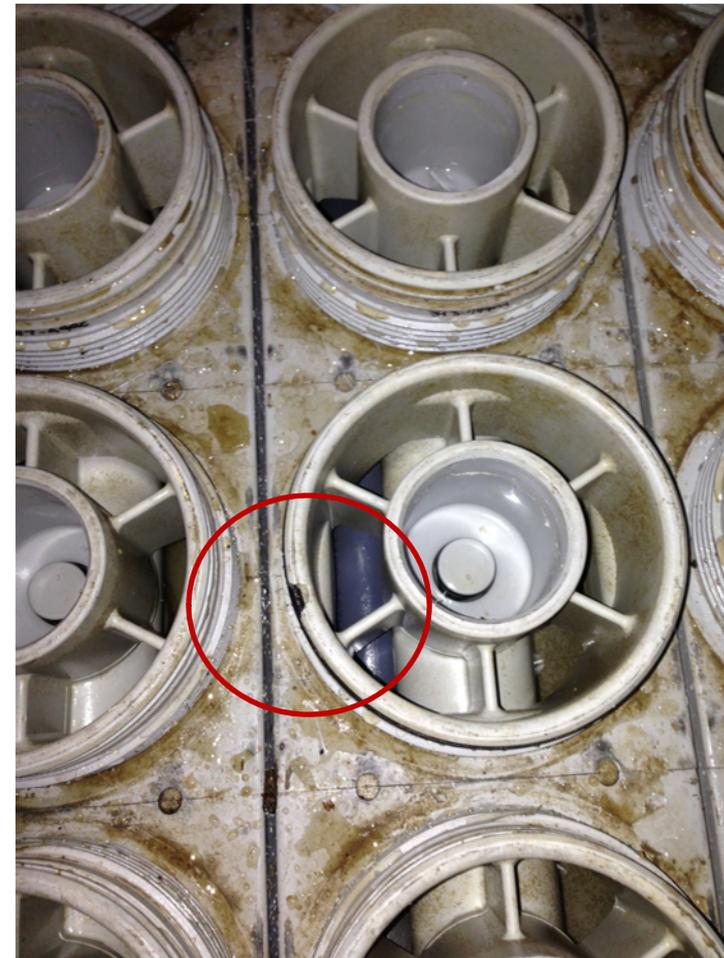
Damaged Blocks

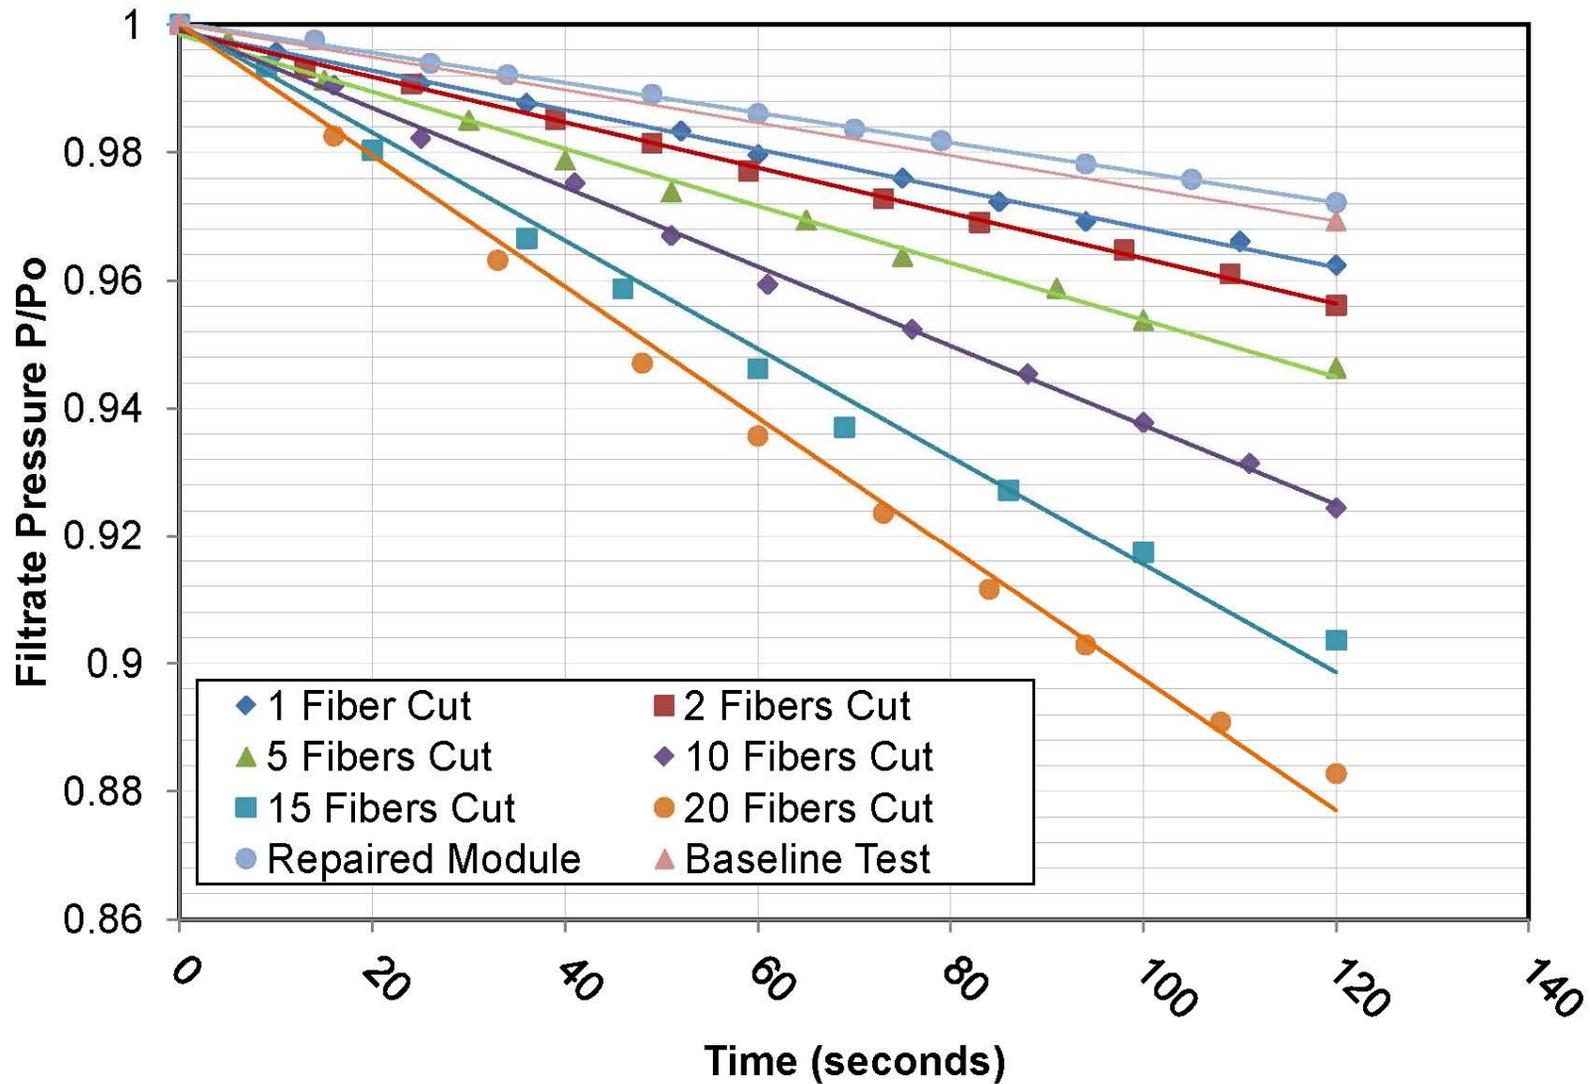
Integrity Test Validation

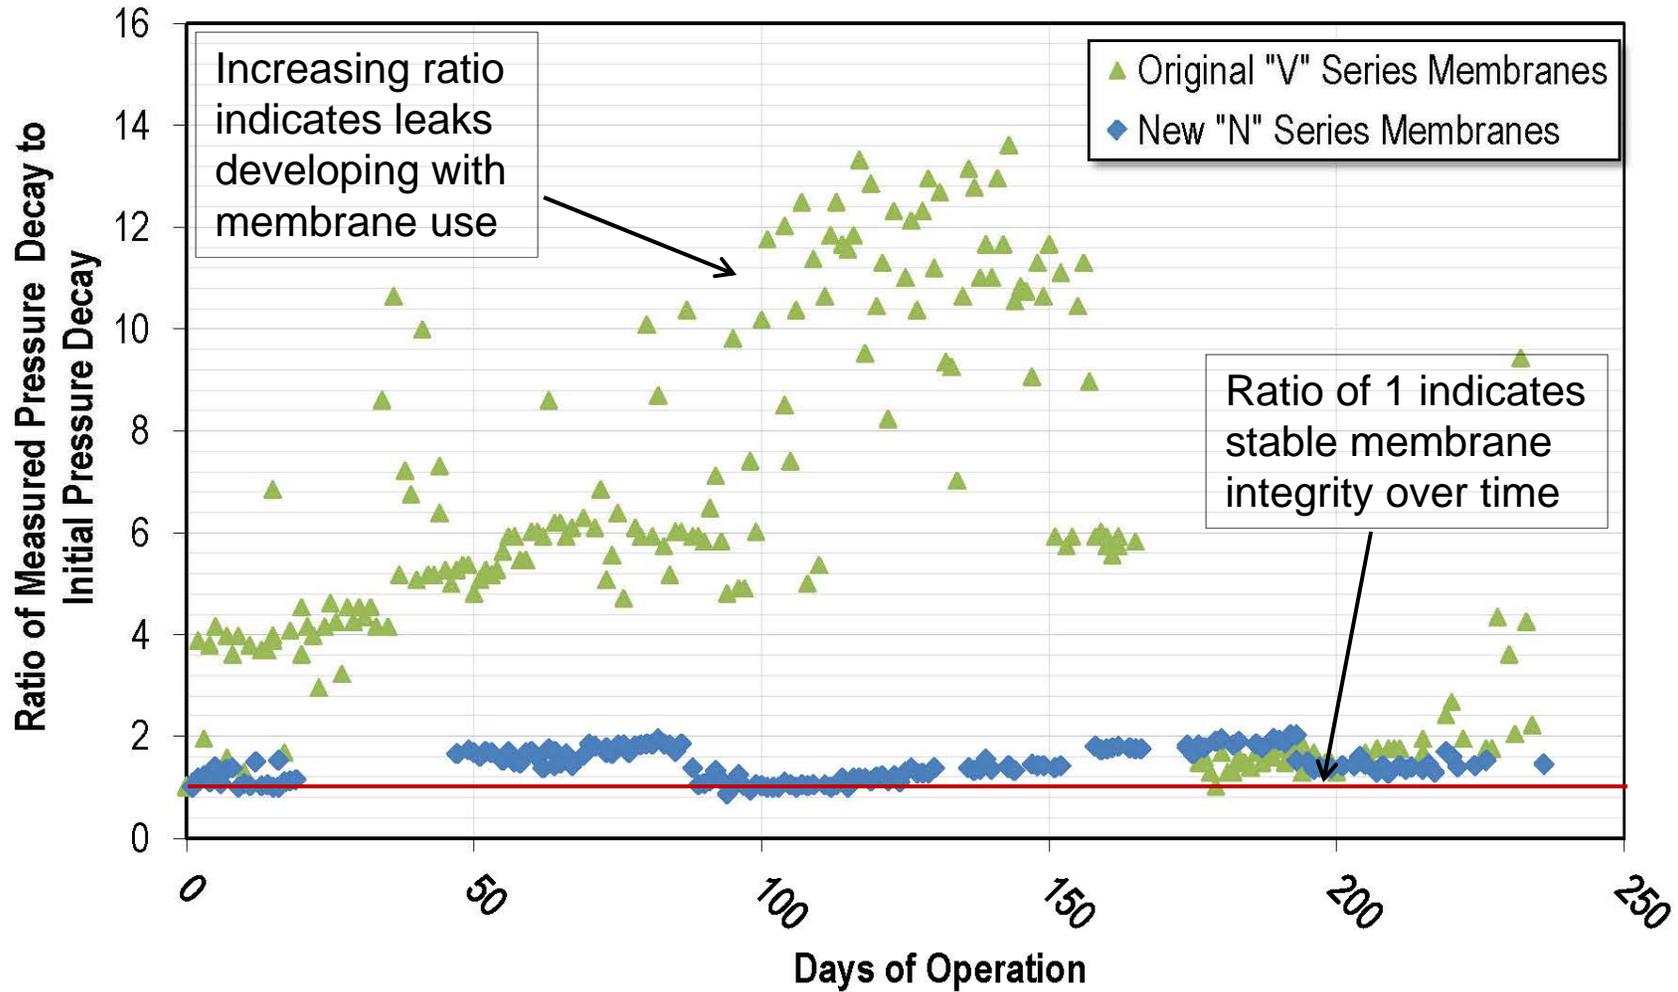
Integrity Problems Have Been Significantly Reduced

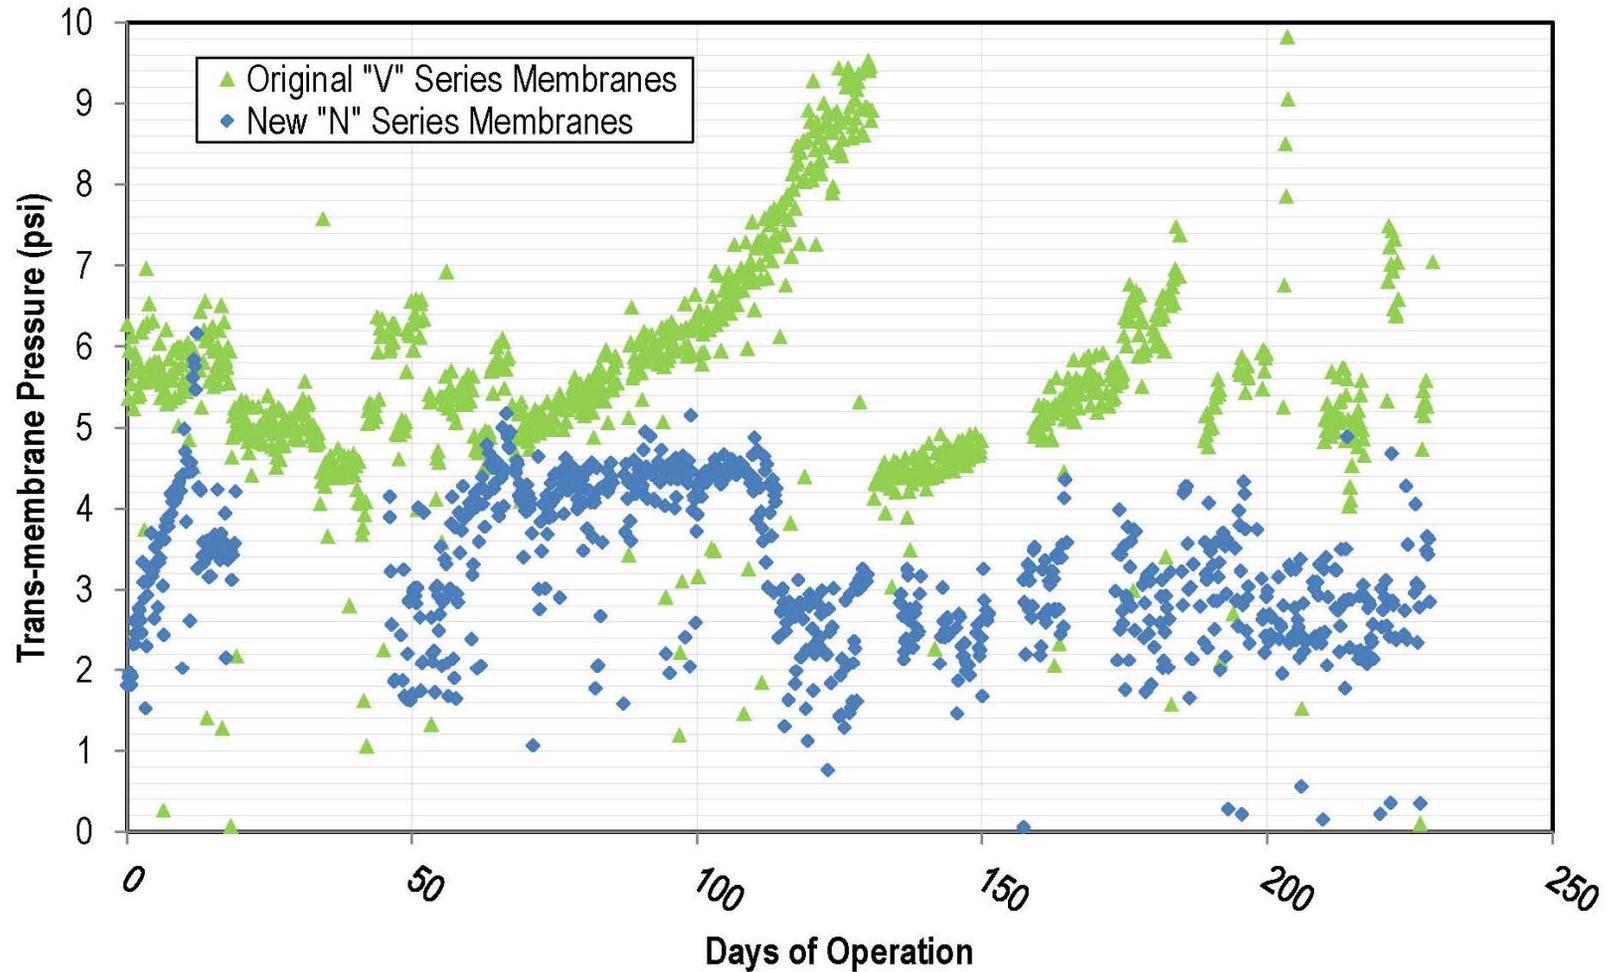
Decrease in TMPs With New "N" Series Membranes

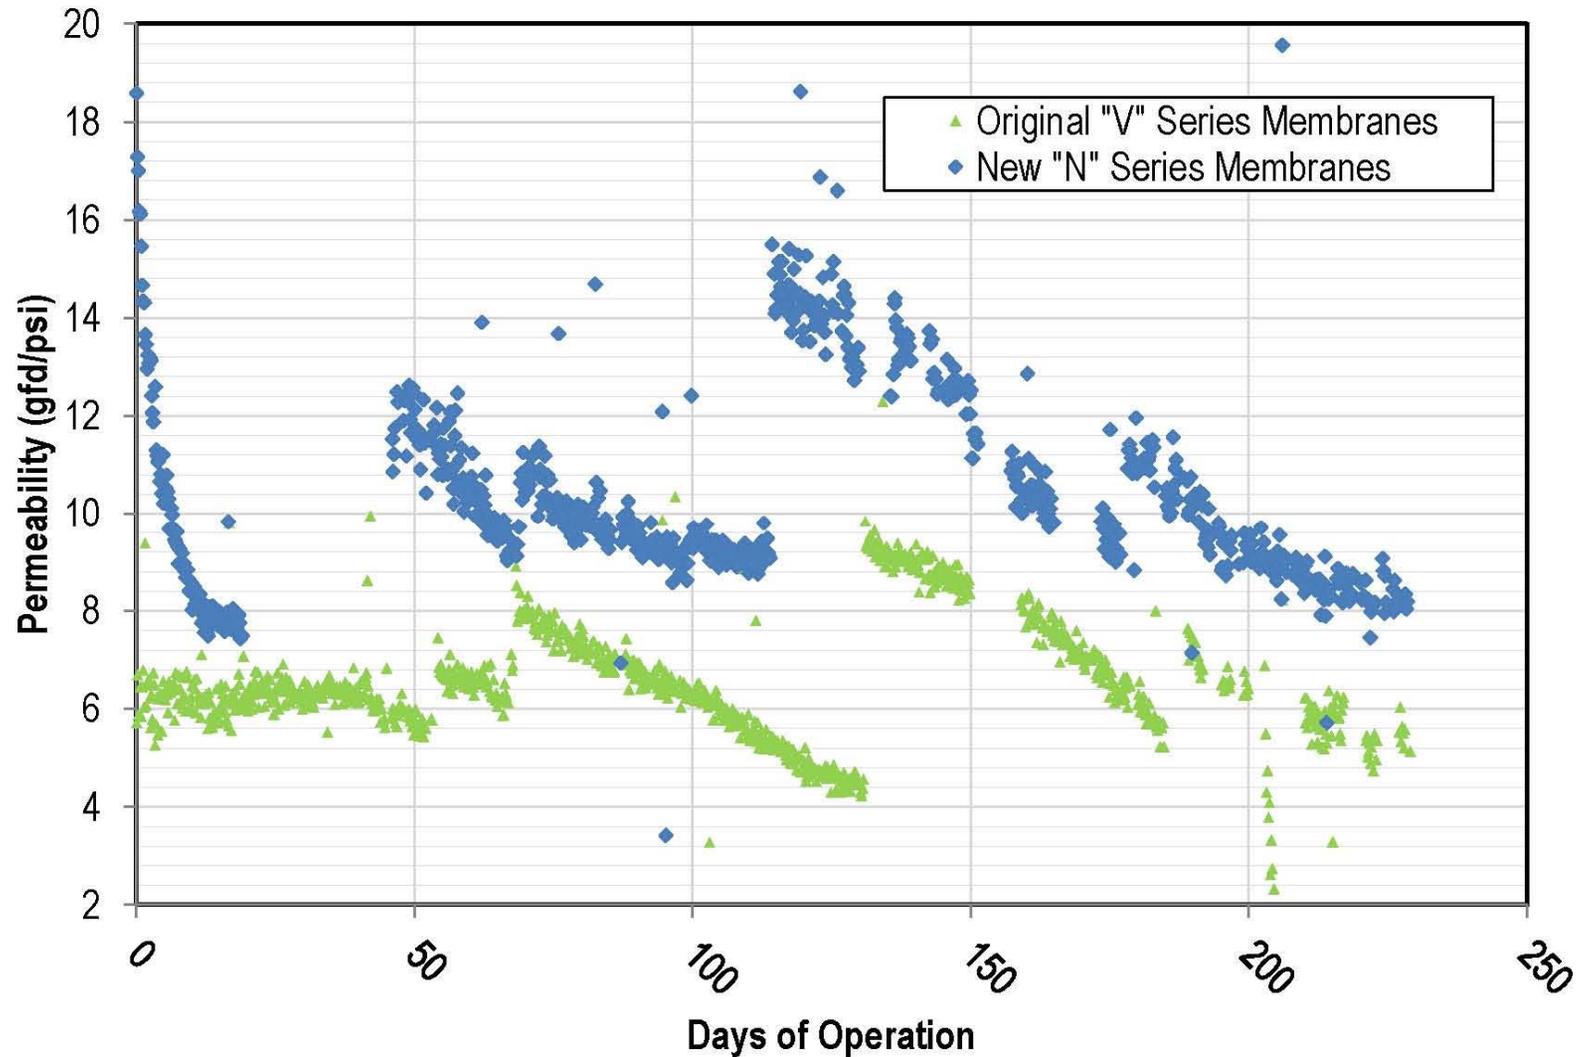
Significant Increase in Permeability Compared to the Original "V" Series Membranes
