A FILTER LESS GRAVELED

**City Of Bellingham
Filter Plant Upgrade**

**AWWA PNW Section Conference
May 8th, 2014**

**Bill Evans
Chief Operator Water Treatment
City of Bellingham**

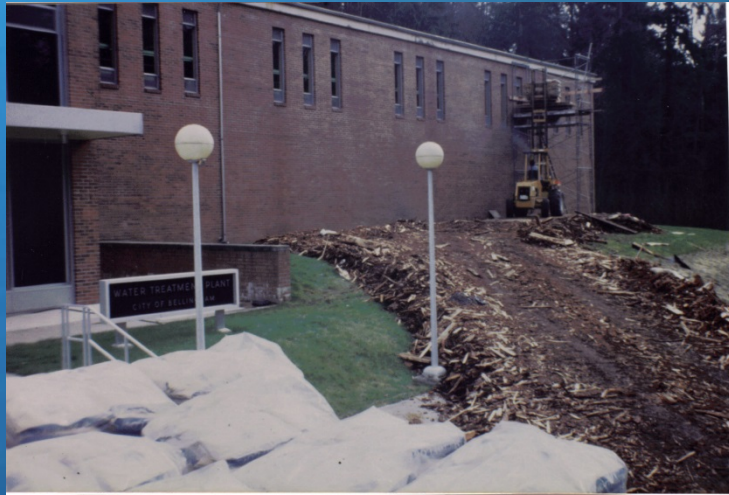
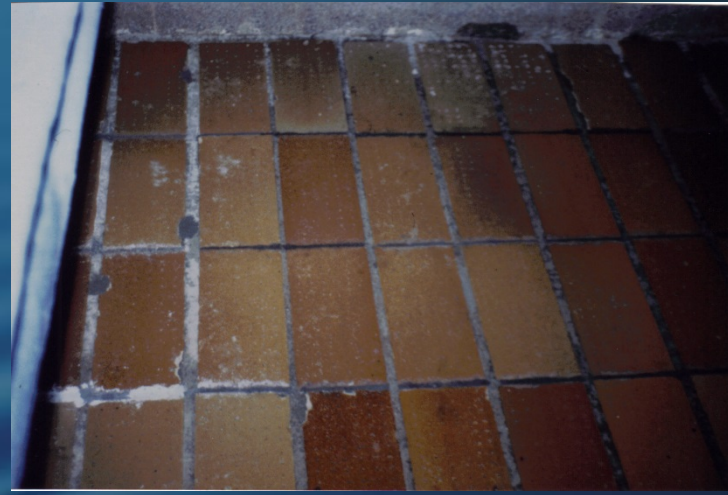
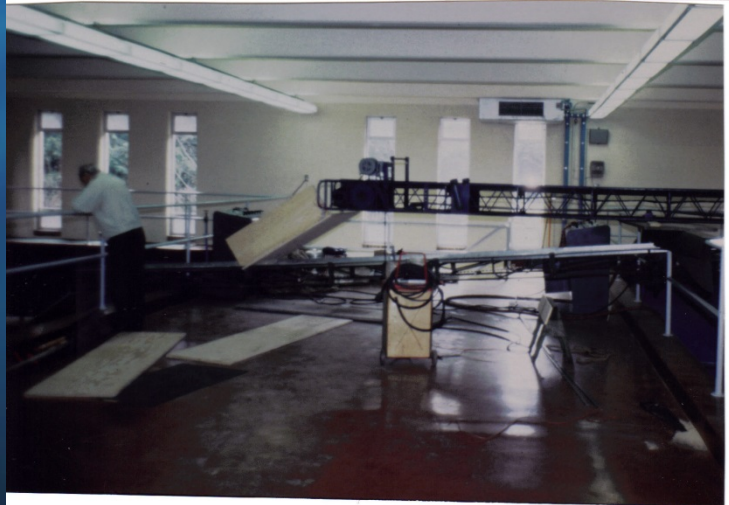
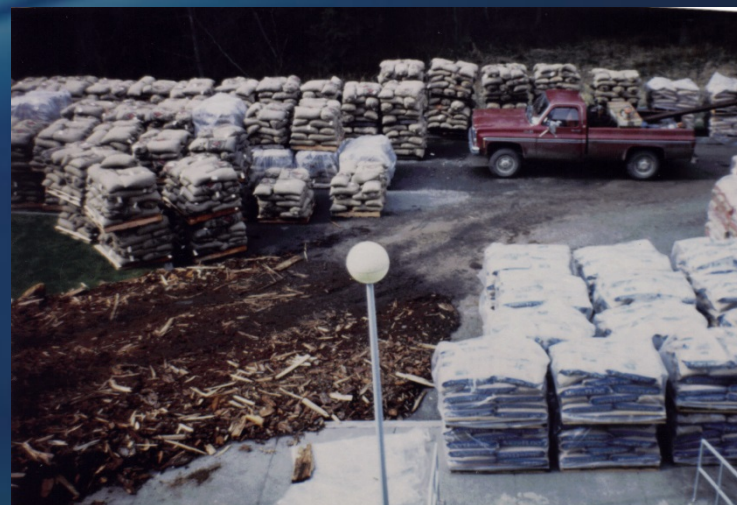
1981 MEDIA REPLACEMENT PROJECT

New Media Configuration

**Table 3.7-1
Filter Media (Top to Bottom)**

Pilot Filter Media	Filter No.		
	1,2,3,4	5	6
Media			
Anthracite Coal (1.5 SG) 22"	1.10 ⁽¹⁾	1.15 ⁽¹⁾	1.25 ⁽¹⁾
Sand (2.6 SG) 11"	0.525	0.525	0.525
Garnet (4.0 SG) 3"	0.35	0.35	0.35
Support Gravel			
High Density (4.0 SG) 3"	0.0555-0.1875 ⁽²⁾	0.0555-0.1875 ⁽²⁾	0.0555-0.1875 ⁽²⁾
Fine Gravel (2.6 SG) 3"	0.1875-0.375	0.1875-0.375	0.1875-0.375
Medium Gravel (2.6 SG) 3"	0.375-0.75	0.375-0.75	0.375-0.75
Coarse Gravel (2.6 SG) 3"	0.75-1.5	0.75-1.5	0.75-1.5

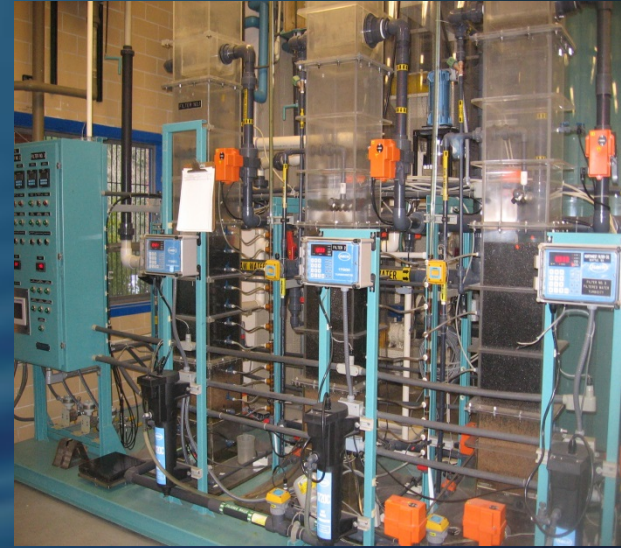
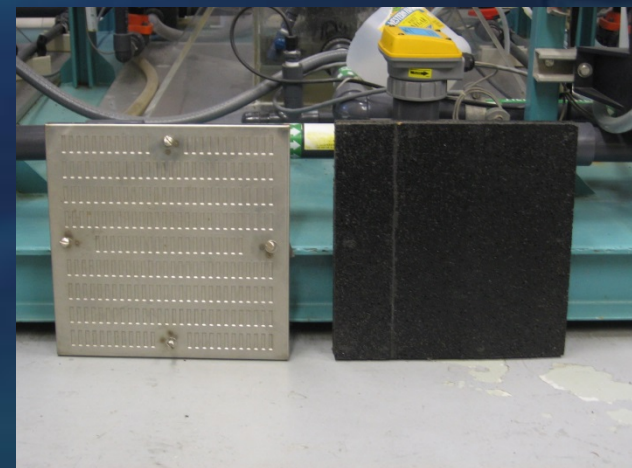
- ♦ Goal of study was to standardize media & under drain design
 - Tested graveless under drains
 - Tested 3 different media configurations

Pilot Filter	Media Configuration
1	32" Anthracite, 12" Sand
2	44" Anthracite Only
3	39" Anthracite, 5" Sand

- The plant coagulated water was supplied to the pilot filters.
- There were a total of 50 pilot filter runs completed at various flow rates.
- Based on pilot testing results the filter media in pilot column #1 proved to be the best.
- Both the IMS cap (plastic) and the AWI (stainless) under drains compared well.
- Traveled to different plants that are currently using the 2 under drain systems.

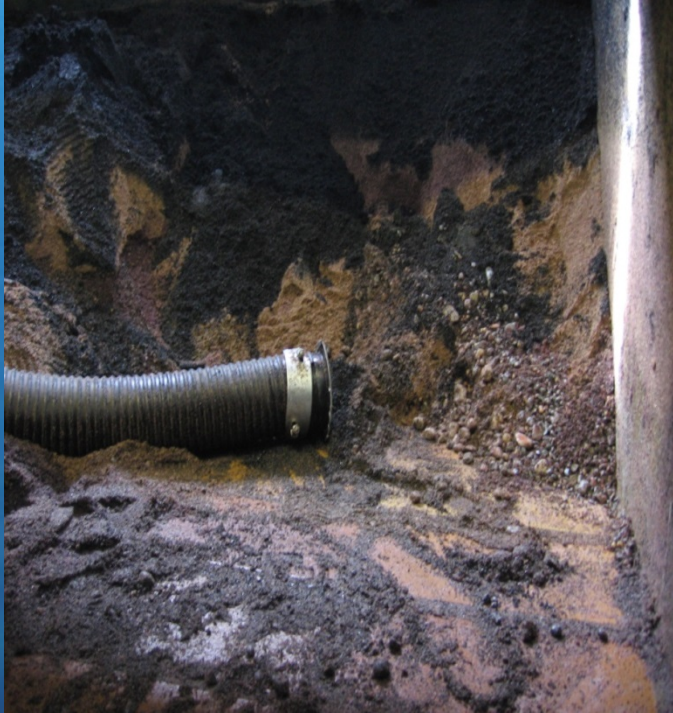
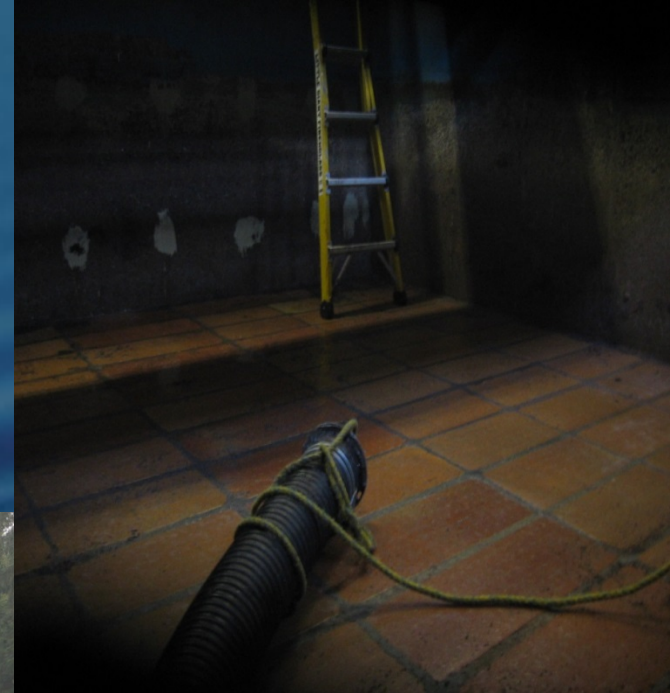
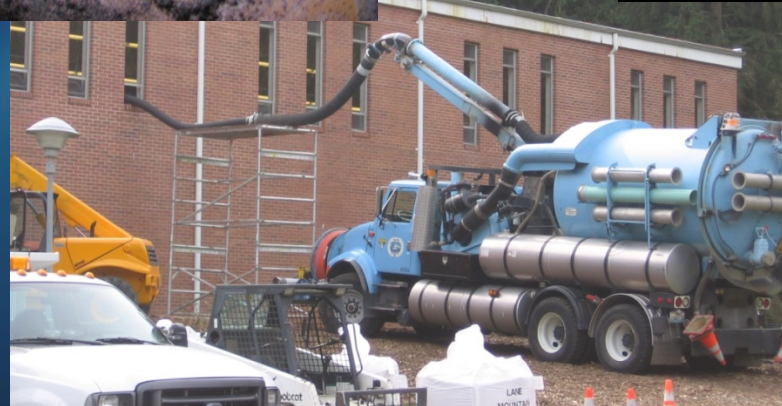
Media Removal

- Remove filter Media – City crews
- Remove under drains
- Build under drain support base
- Install under drains
- Structural integrity test – Backwashing no media
- Add sand, B/W, check level
- Add anthracite, B/W, Skim, B/W, check lvl
- Filter Disinfection, Bacteria test, next filter
