Solutions for Water Quality Issues in Your Water Storage Tank

Presenter: Mark Moore
Concrete Tank Services

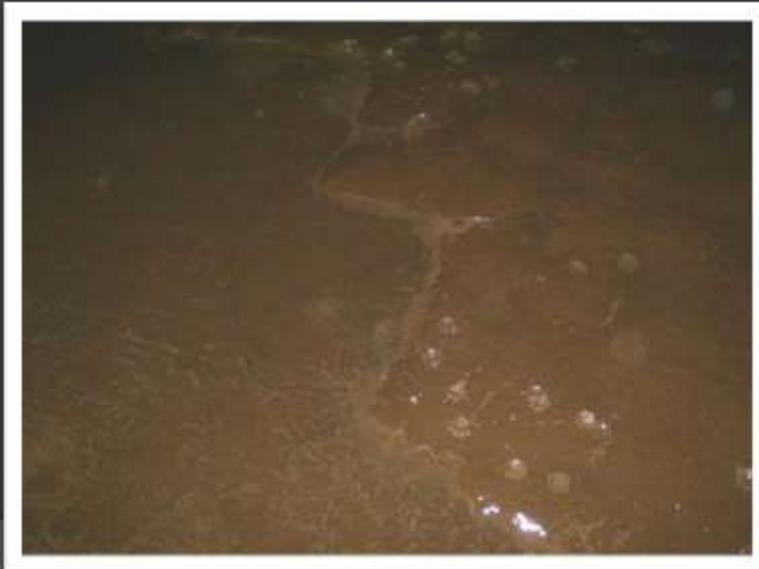
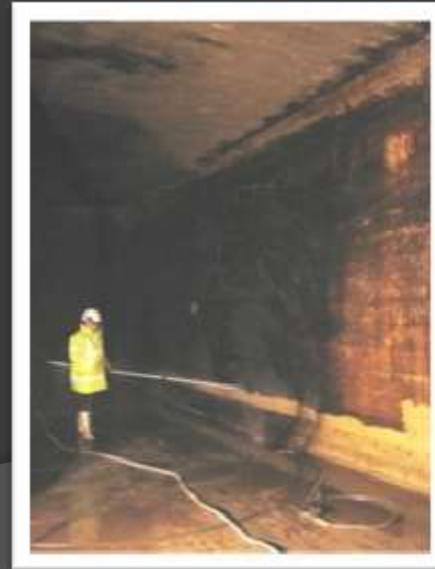
• Sediment Buildup

- Causes staining and discoloration
- Water flow increase can stir up sediment, causing discoloration
- Creates an environment for bacterial growth

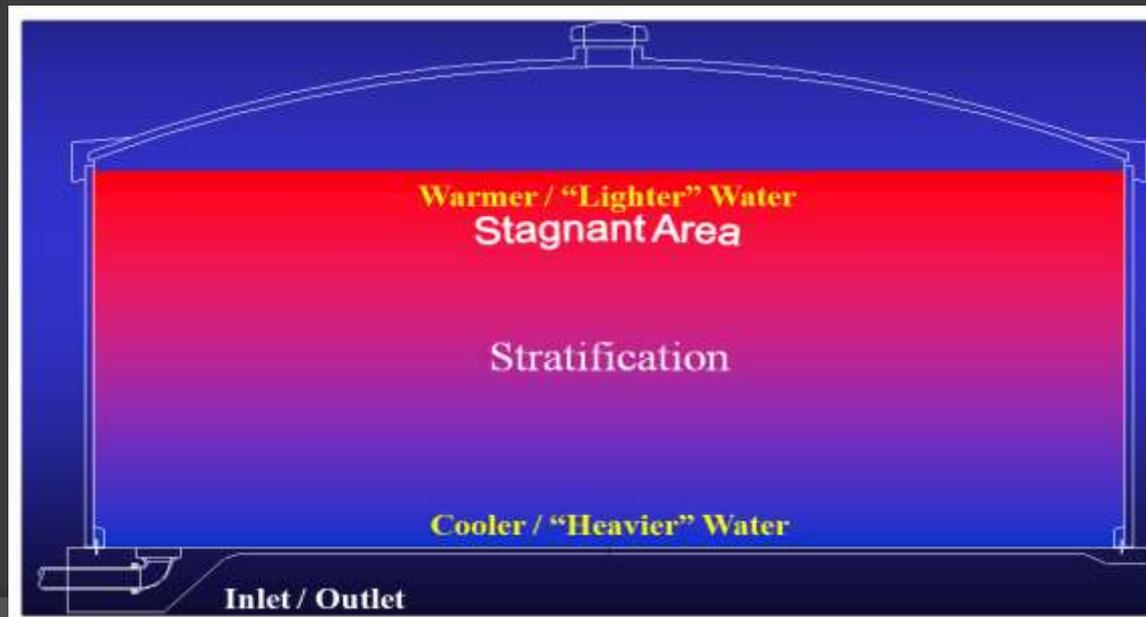
• Stratification

○ Thermocline

- Creates layer of cooler “heavier water” and warmer “lighter water”
- Inhibits mixing by creating barrier in water level

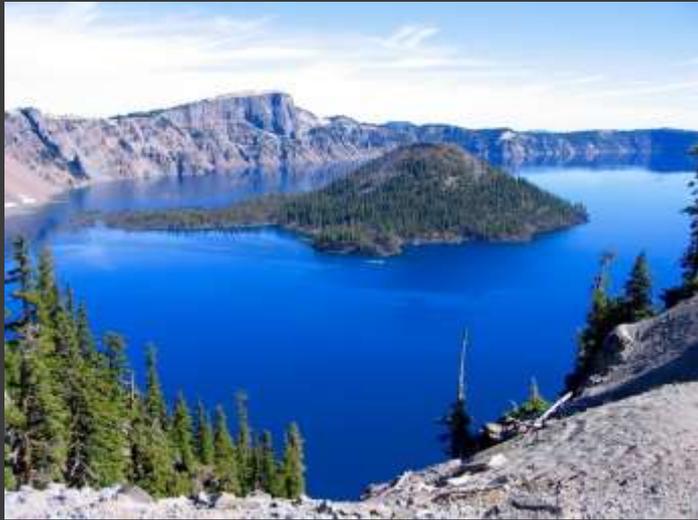
- ⦿ Mixed by wind
- ⦿ Cooled by air

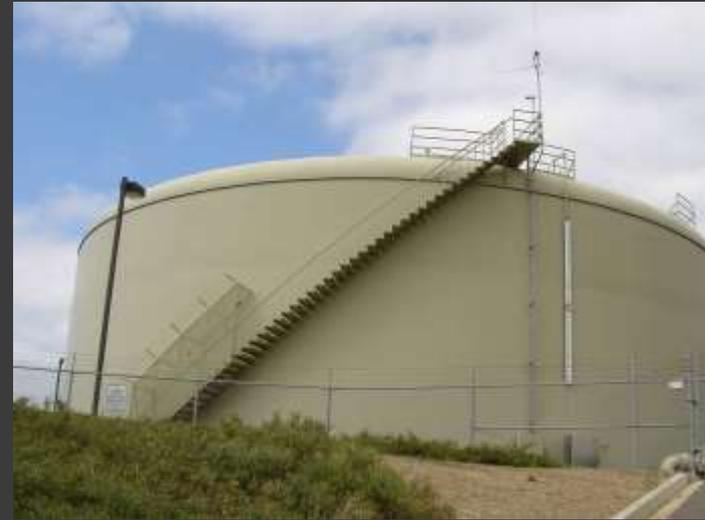
- ⦿ Sealed – no wind
- ⦿ Sealed – not cooled

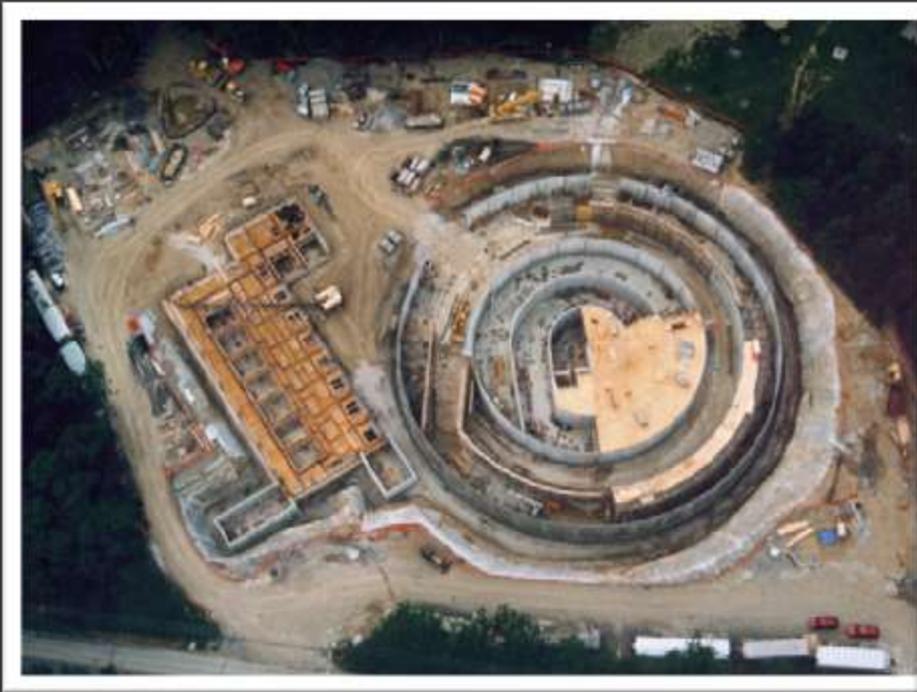
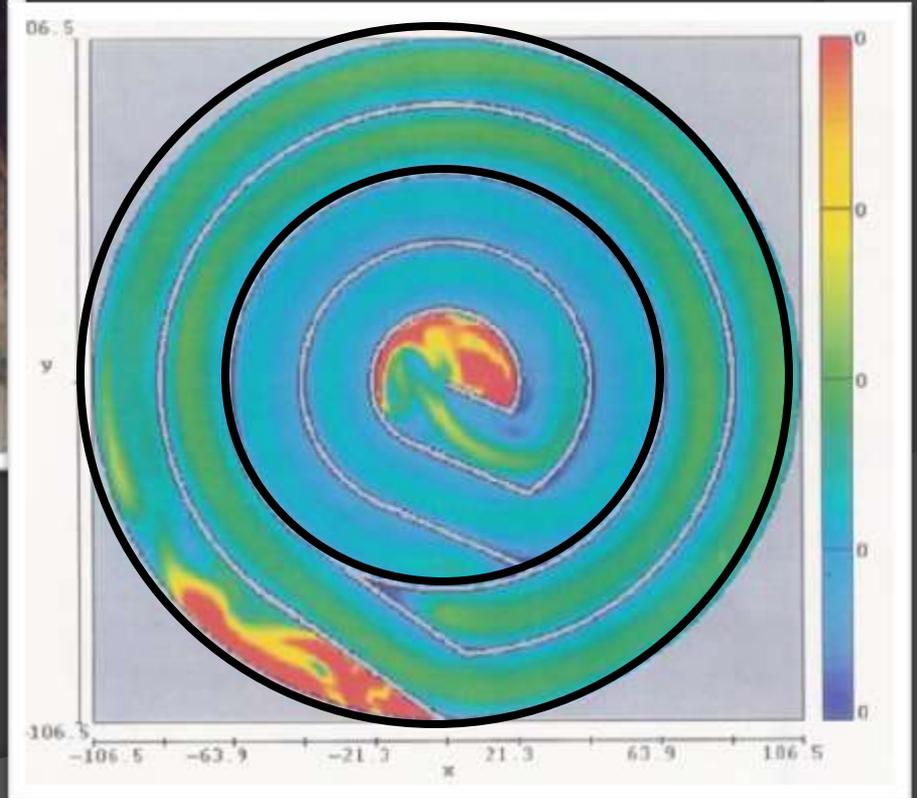
2.0 MG Tank within 5.0 MG Tank both with Interior Baffles

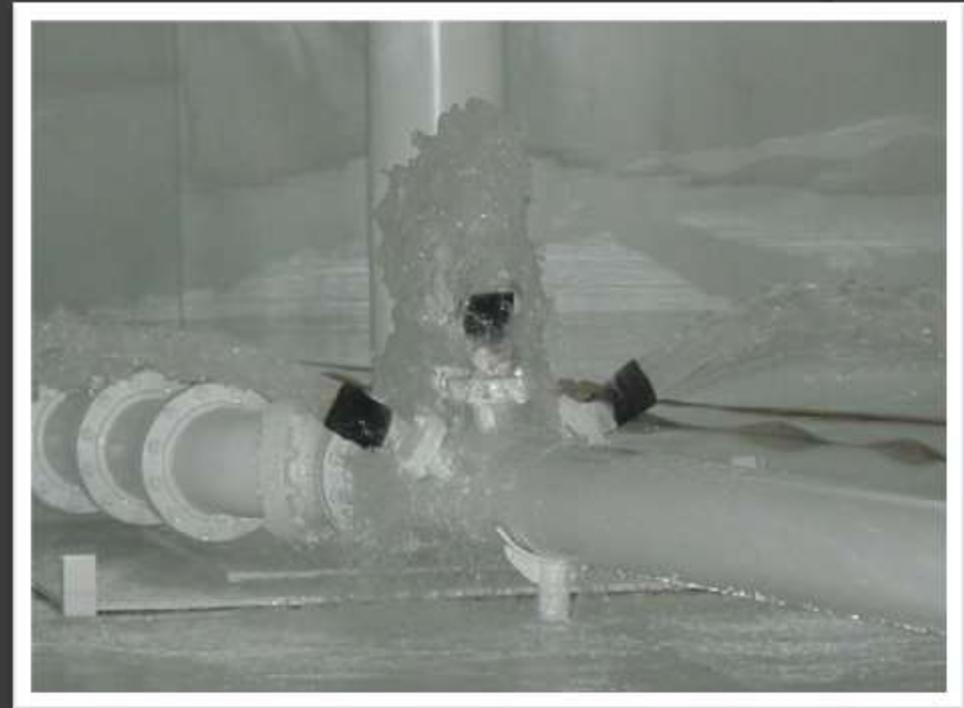
Hydrodynamic Mixing Systems

- Provides complete mixing of water in tank. Not plug flow.
- Eliminates stagnant water areas in tank
- Can be installed horizontally or vertically

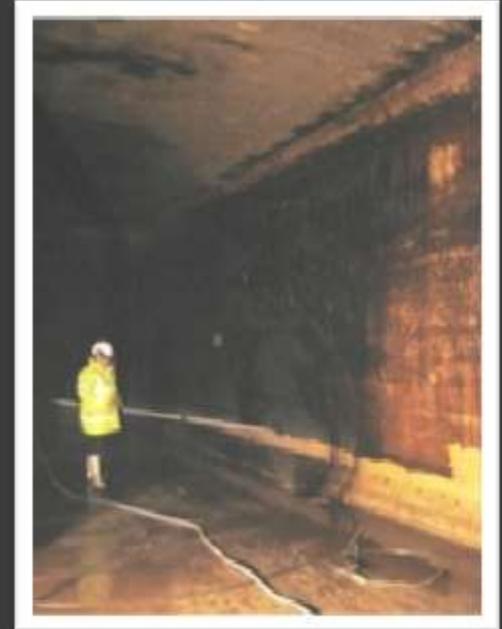
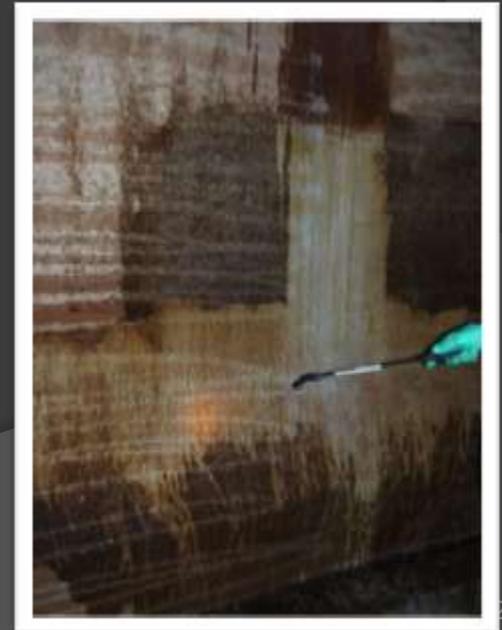
⦿ Chemical Cleaning

- Iron & Manganese Removal
 - Fe & Mg may be present in groundwater
- Removes Biofouling
- Chlorine Alternative – Less Harmful

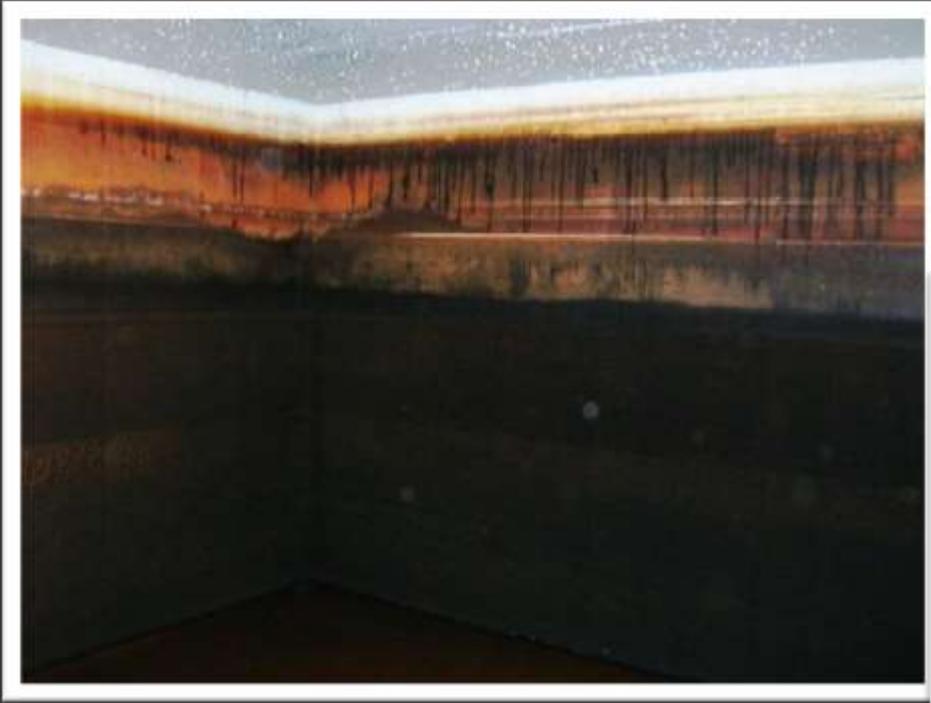
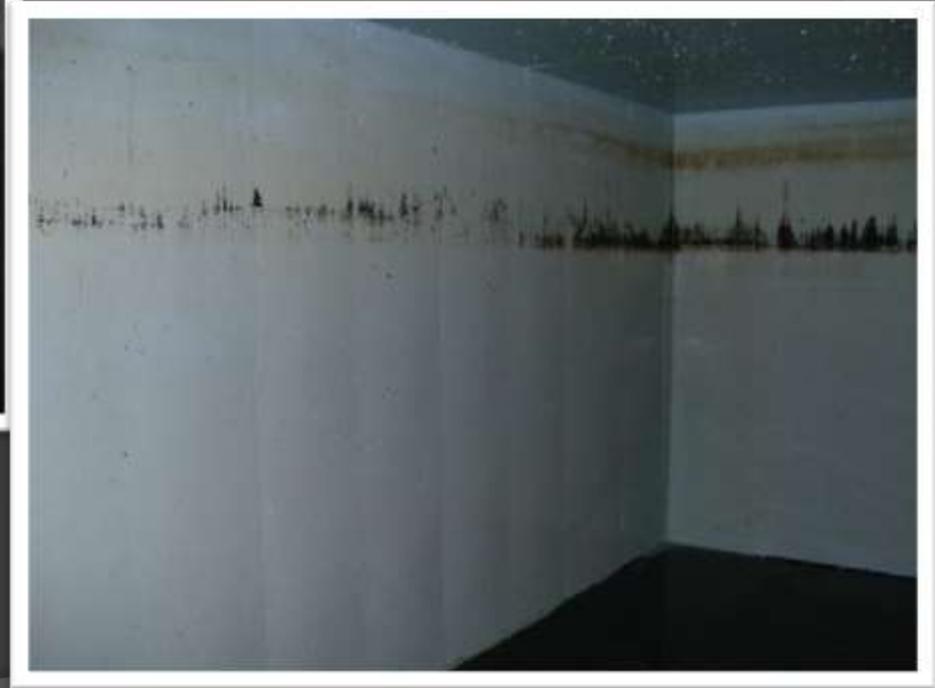
Clearwell with Heavy Iron & Manganese Buildup

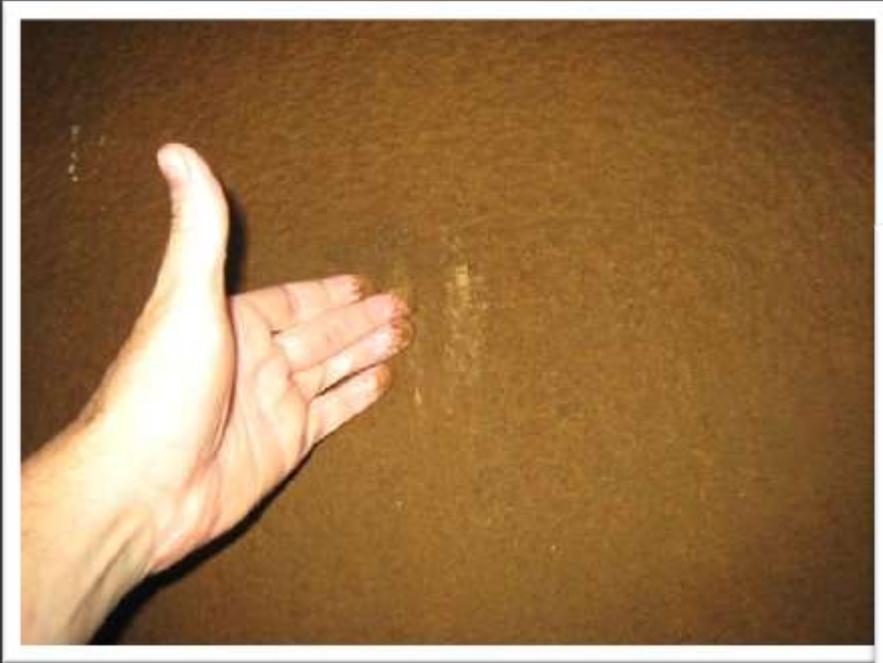
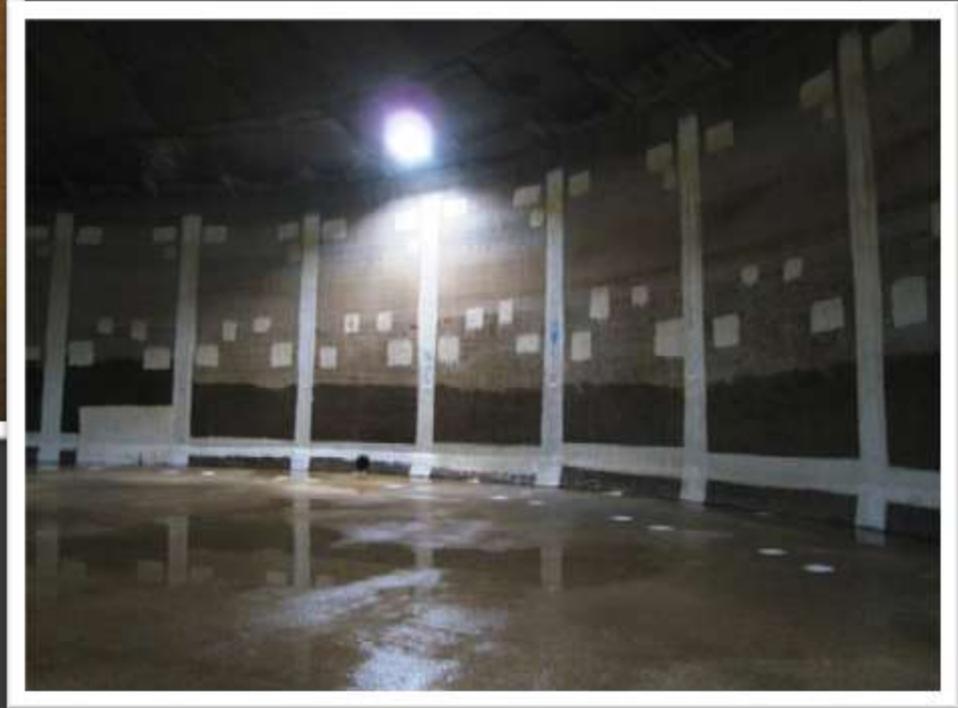
Biofouling and Iron & Manganese Buildup

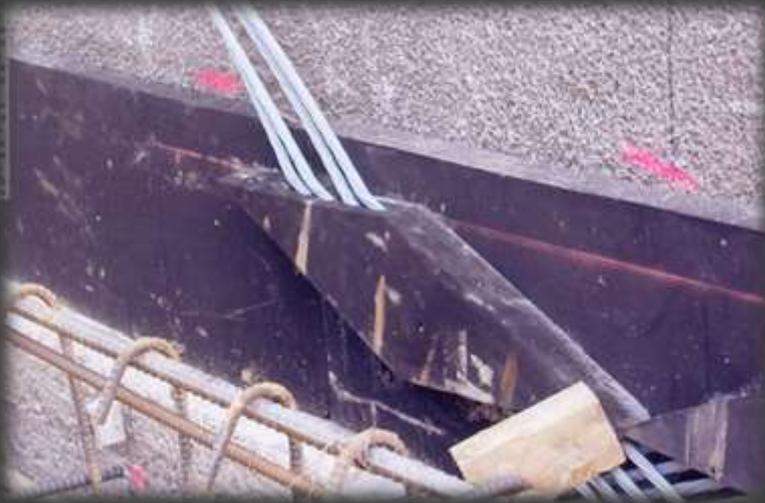
Forming of new machine footing and seismic cable system application

Location: Oakland, CA
Problem: Seismic Retrofit

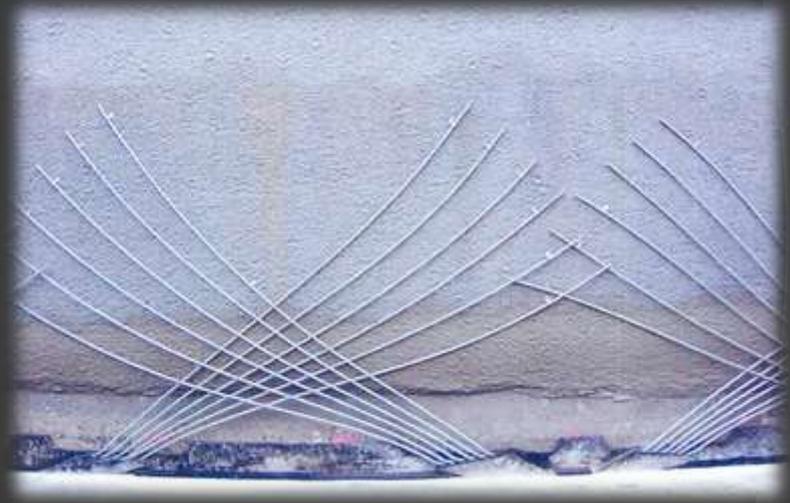
Seismic cable attached to wall before automated shotcrete application
