Clark Public Utilities – Salmon Creek Crossing

What do you mean we can't do HDD?

Presented by Matt Hickey, PE | Murray, Smith & Associates, Inc.
and Russ Knutson, PE | Clark Public Utilities

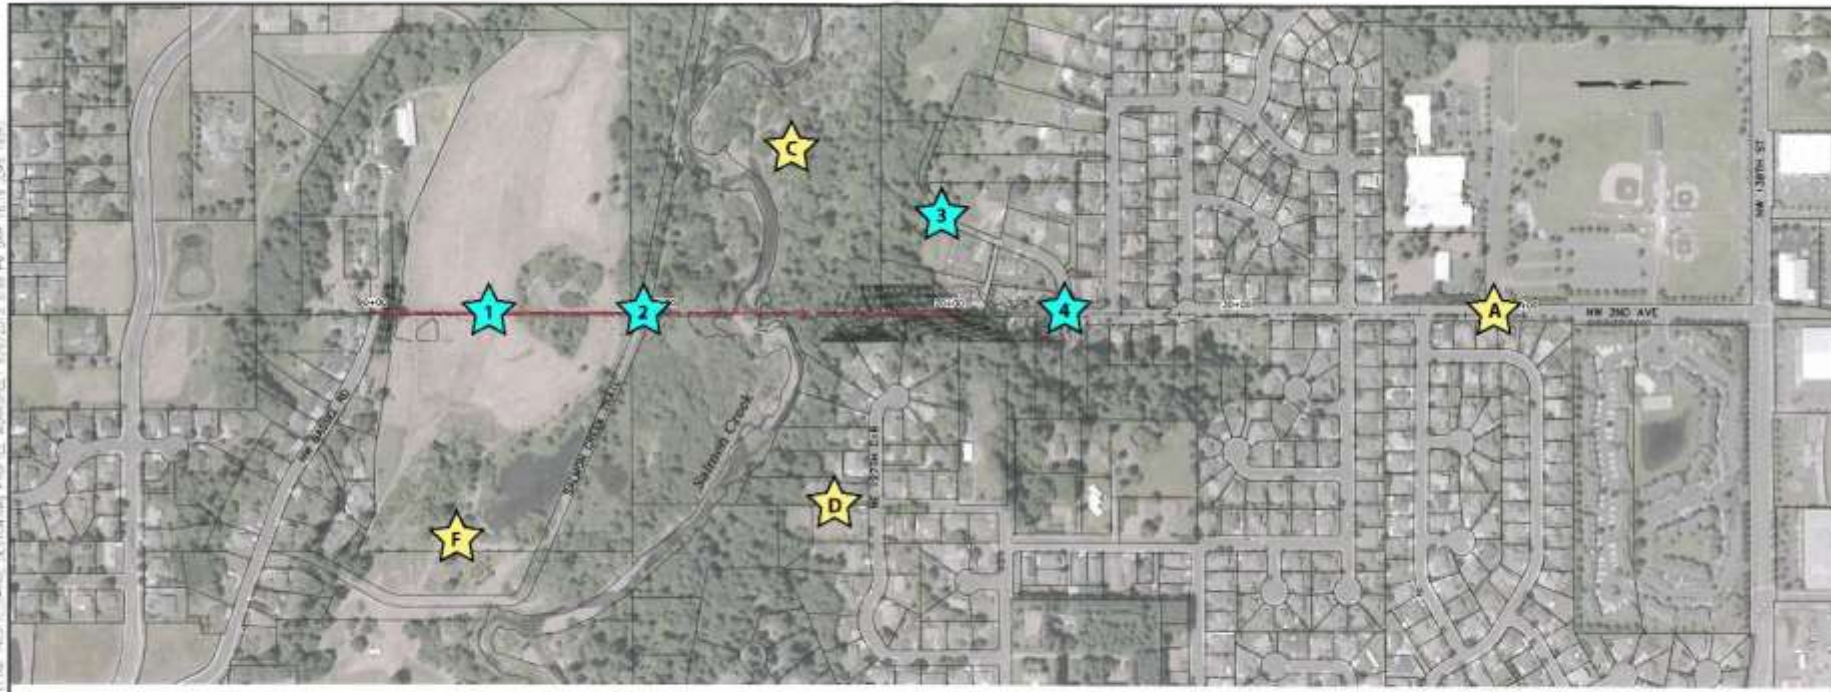
PLAN
SCALE: 1"=300'

- Based on new HDD alignment
- Deeper bores
- Revised bore locations
- Mud rotary drilling
- Installation of piezometer

1 EL -40
2 EL -50
3 EL -20
4 EL 50

PROFILE
SCALE: 1"=200' HORIZ, 1"=50' VERT

- Clay and mud...then sand and more clay...
- Cemented gravels
- Loose gravels, cobbles and sand
- Loss of drilling mud
- Drill hole caved
- Sonic drilling

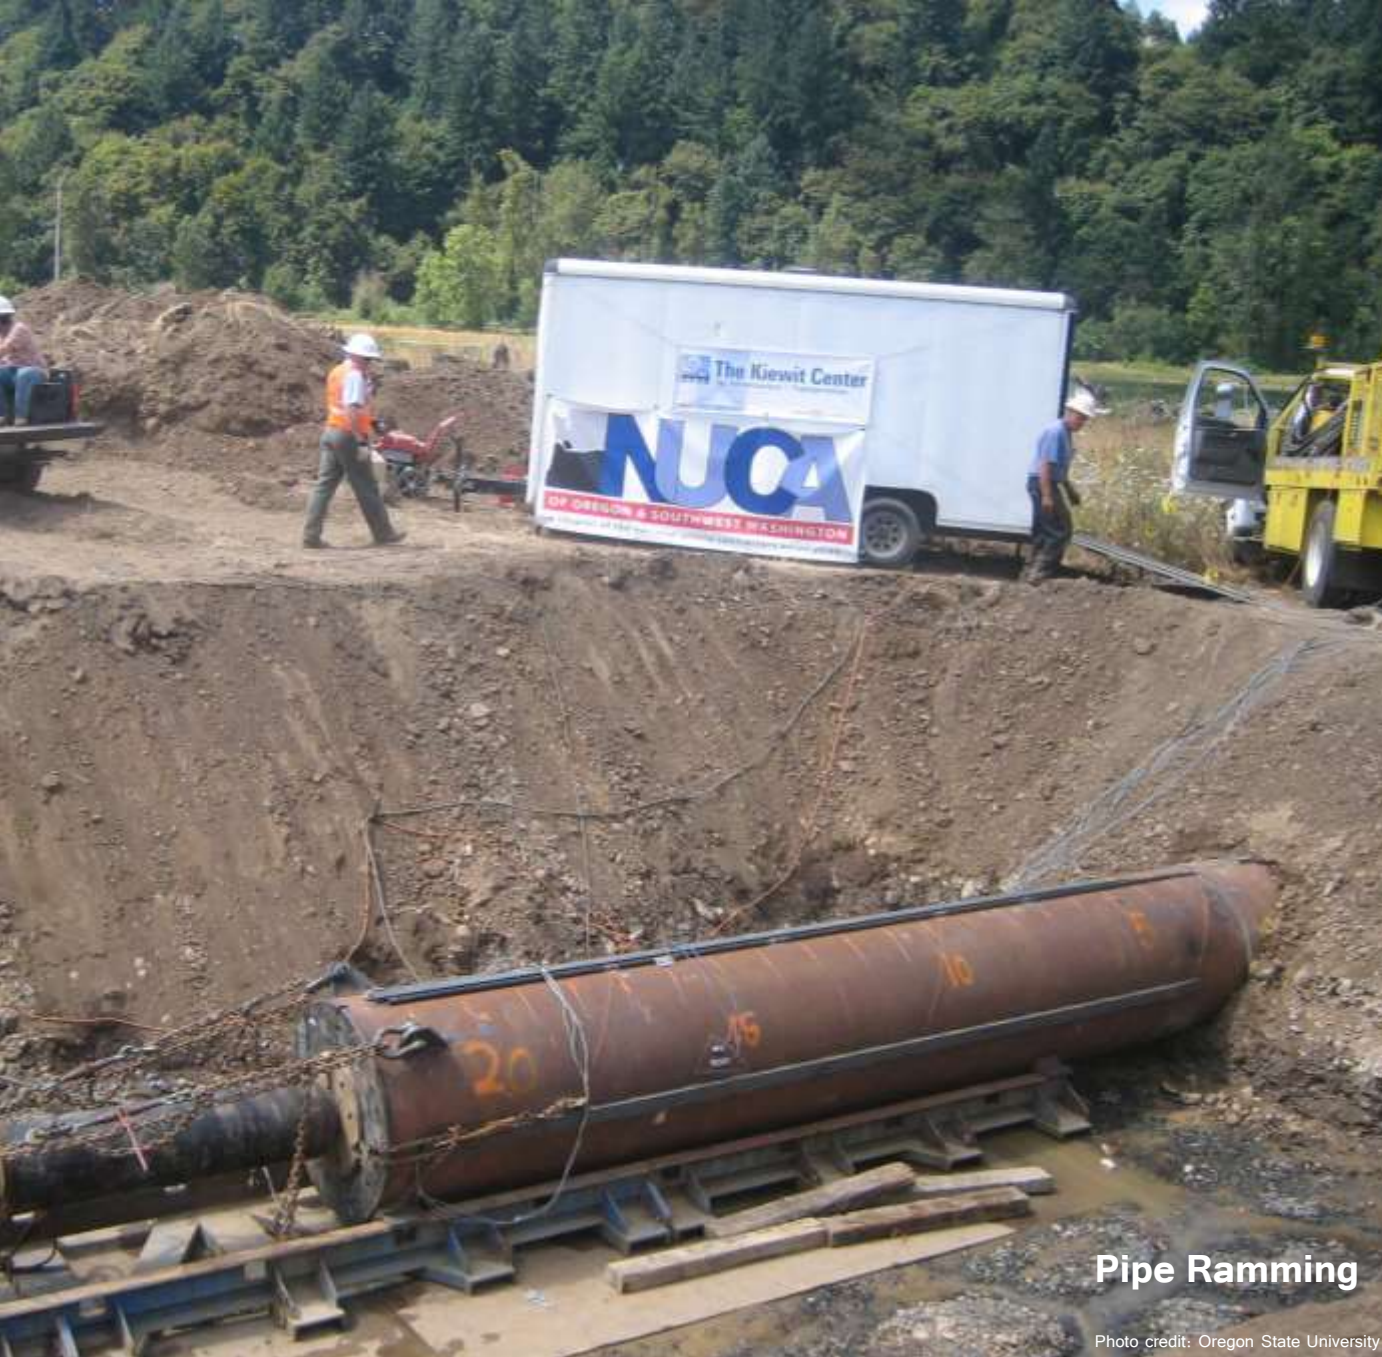
Pipe Ramming

- Addresses collapsing hole
- Challenges
 - Limited length
 - Pits in water table
 - High cost

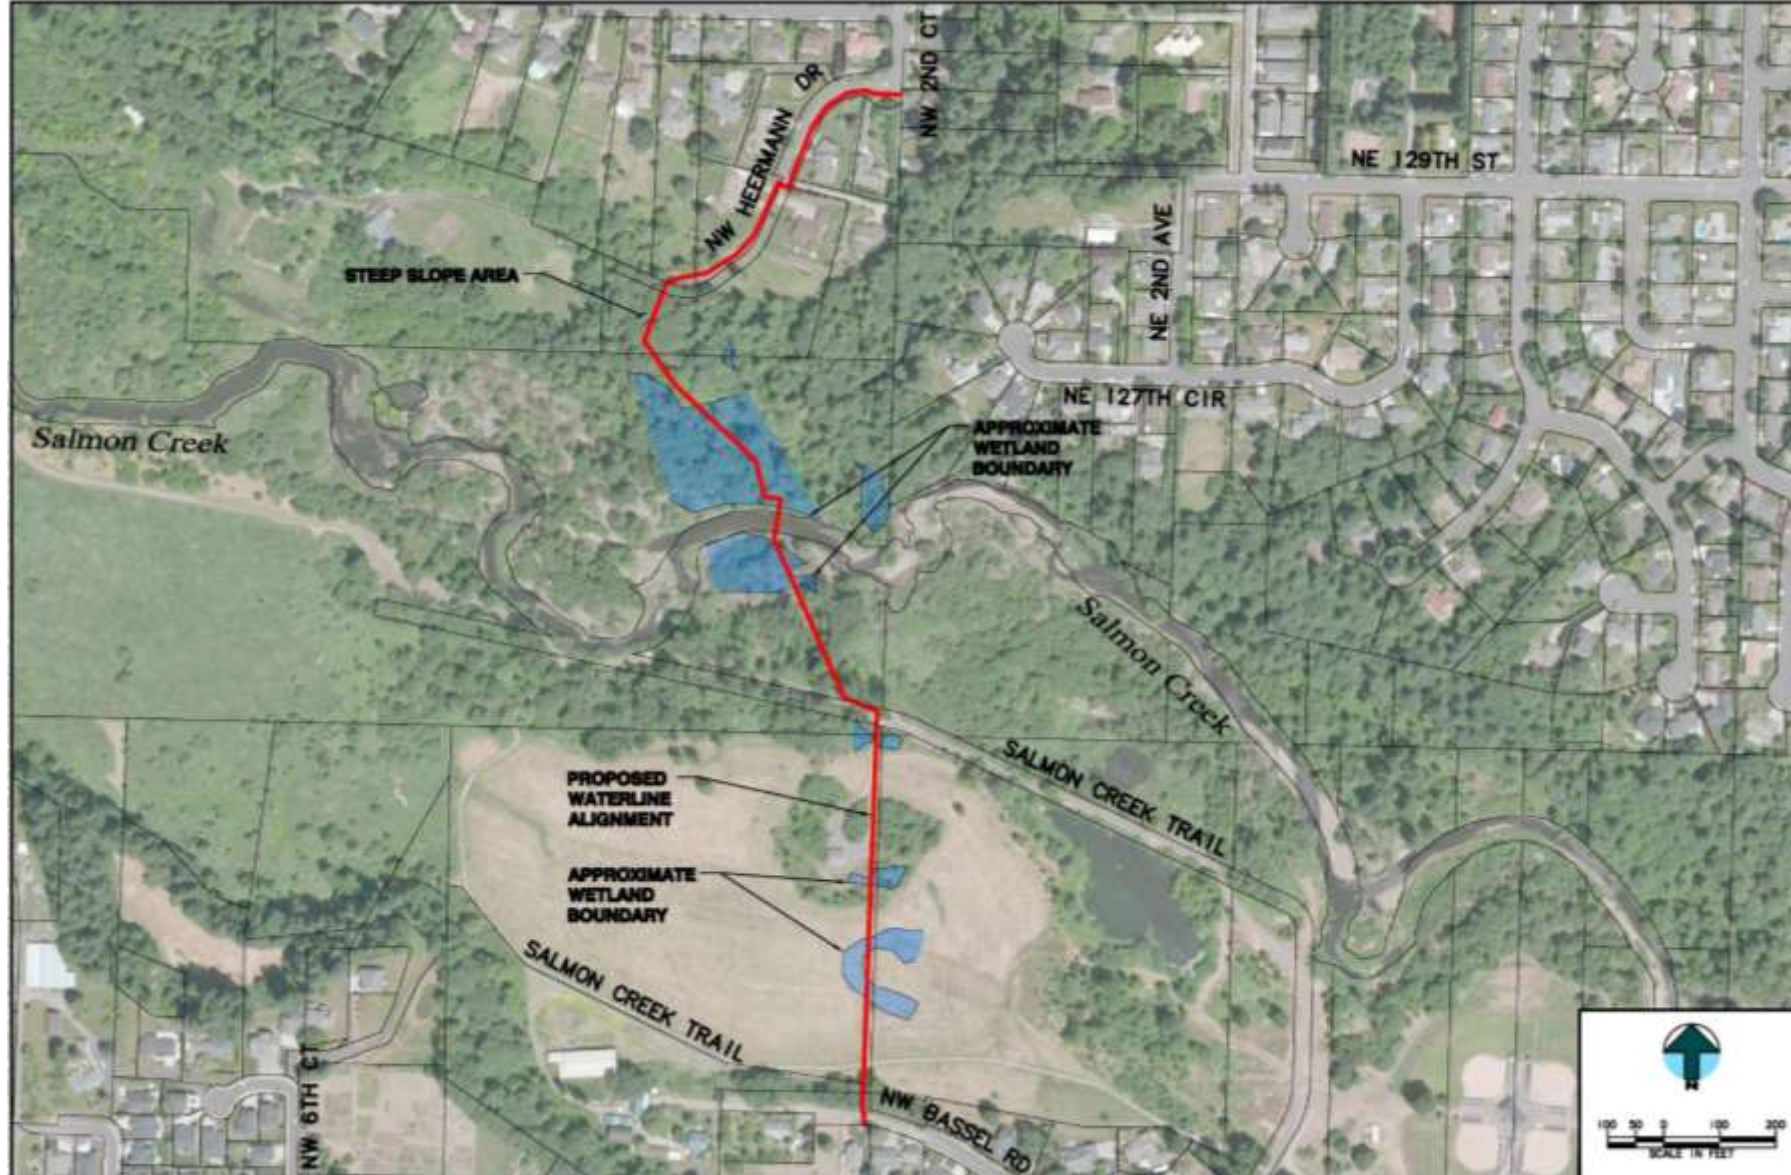
- Steep grades
- Trees
- Slides
- Private property

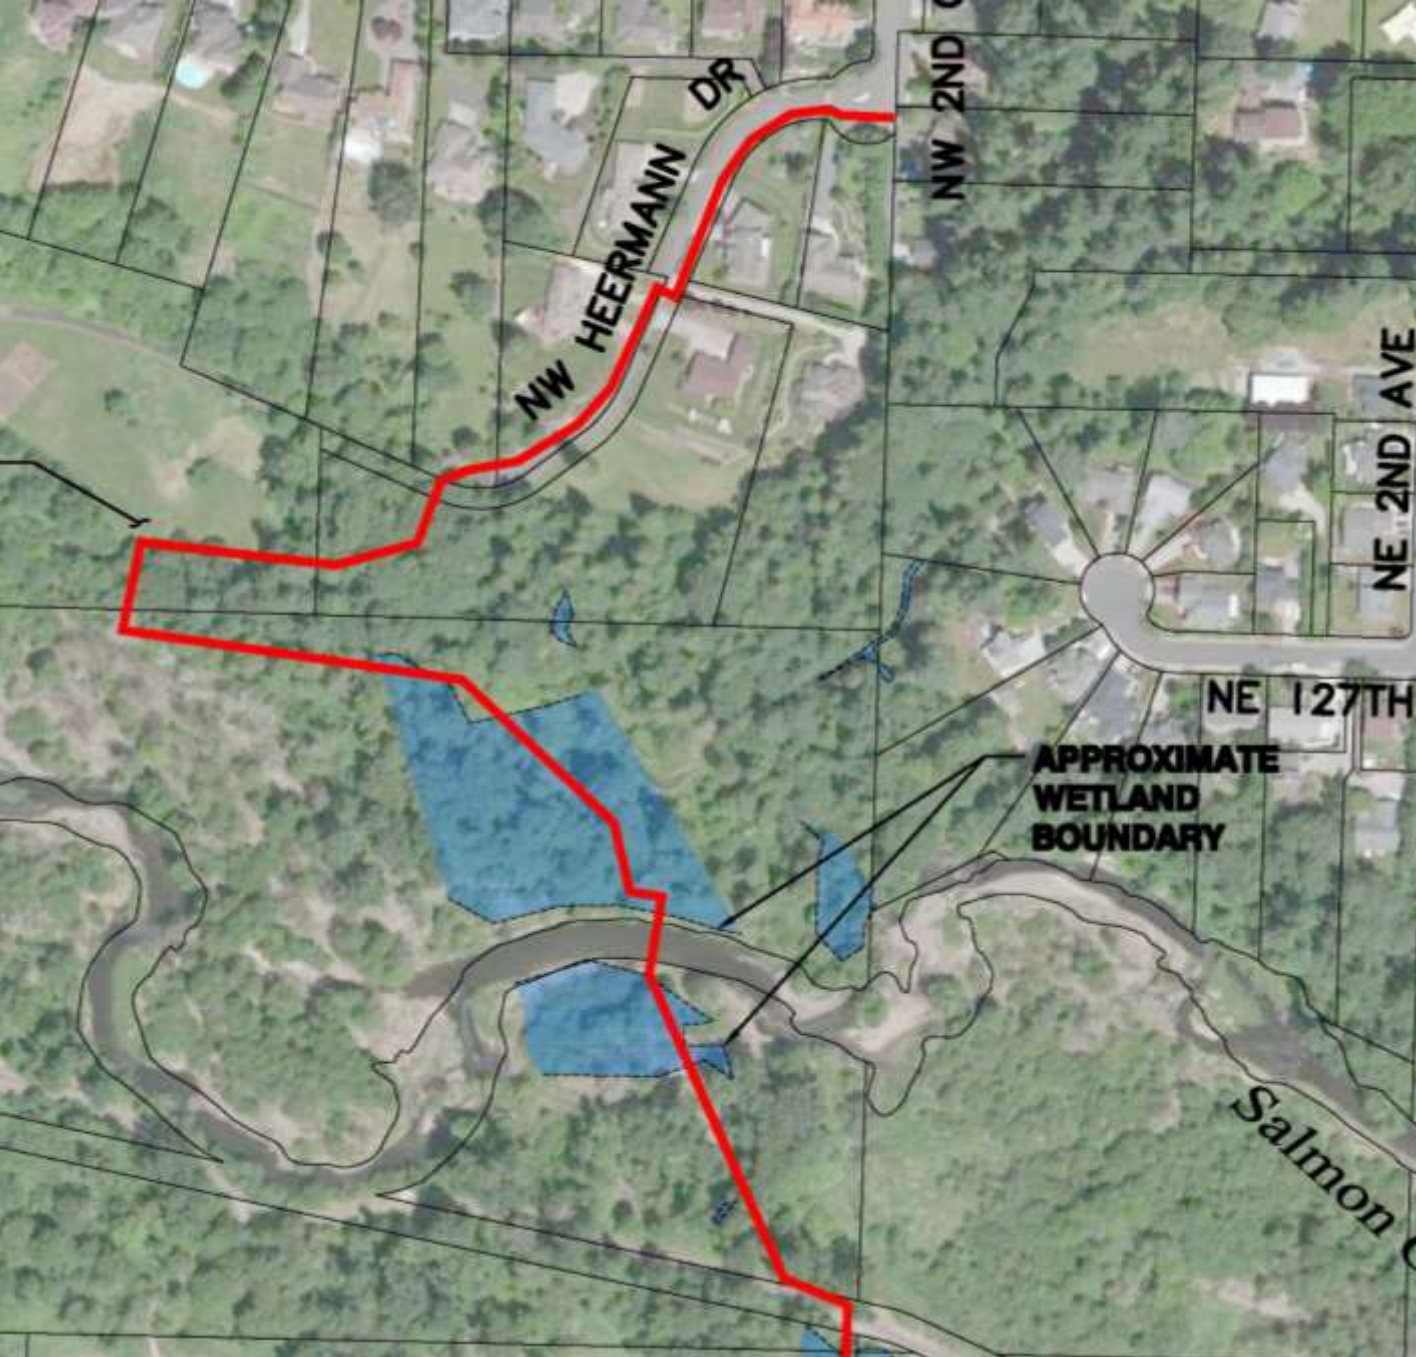
Revised Plan “Plan D”

- Open trench
- Use existing pipe under creek
