How to Cost Effectively Add Reliability to an Aging WTP

The Chehalis Experience

Kenny Packard
PNWS AWWA Conference - May, 2016

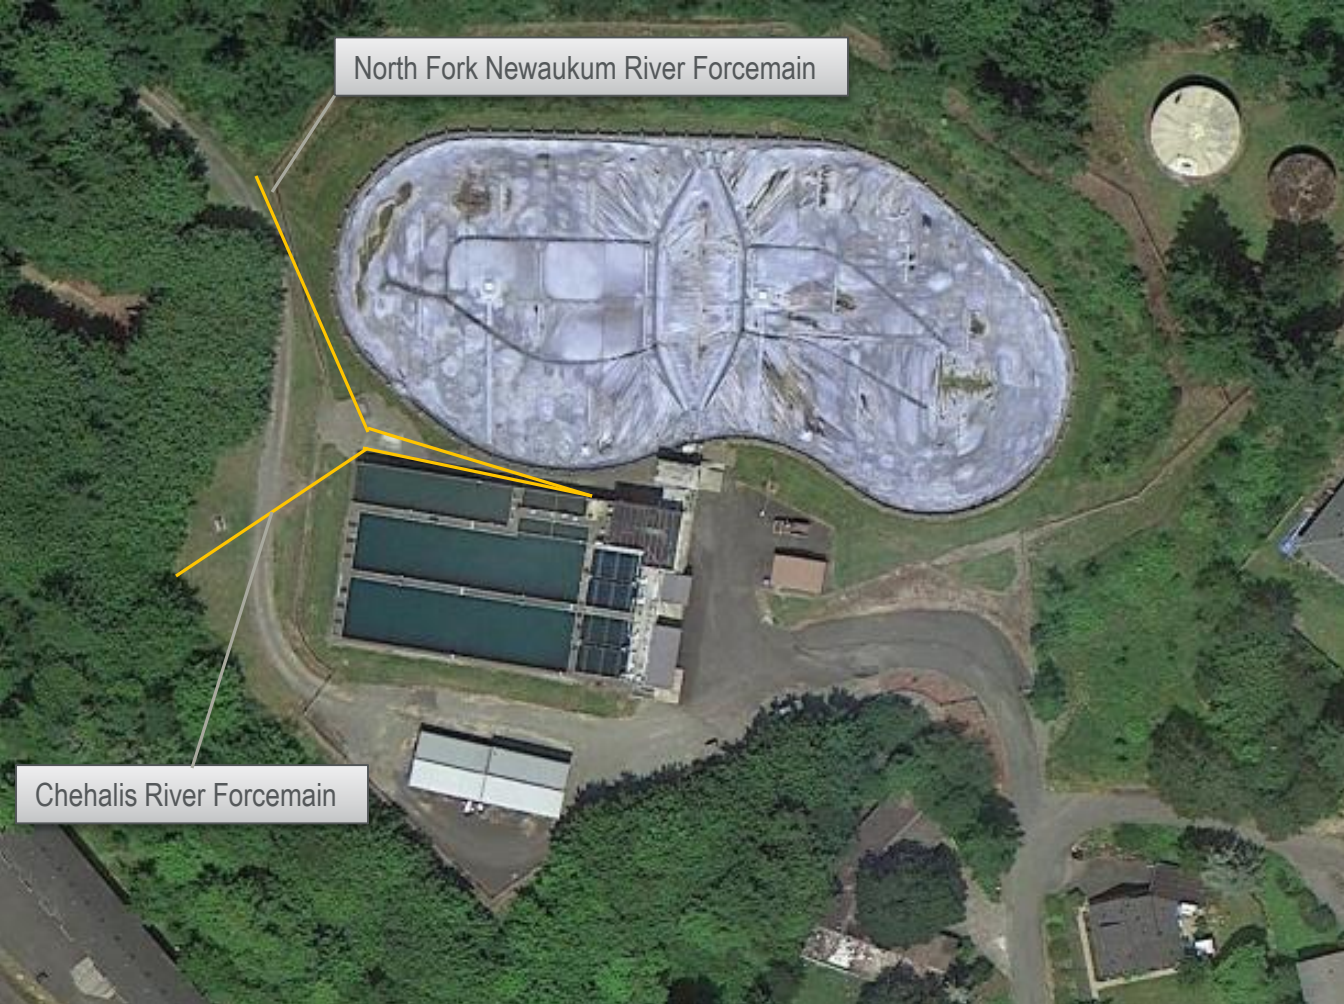
Existing Water Treatment Plant

Major Unit Processes

- (1) Rapid Mix Basin
- (1) Two-Stage Flocculation Basin
- (1) Presedimentation Basin
- (2) Sedimentation Basins
- (2) Rapid Sand Filters

Chemical Systems

- Calcium Hypochlorite Saturator
- Gas Chlorine Backup
- Sumaclear 801B

Built in 1961

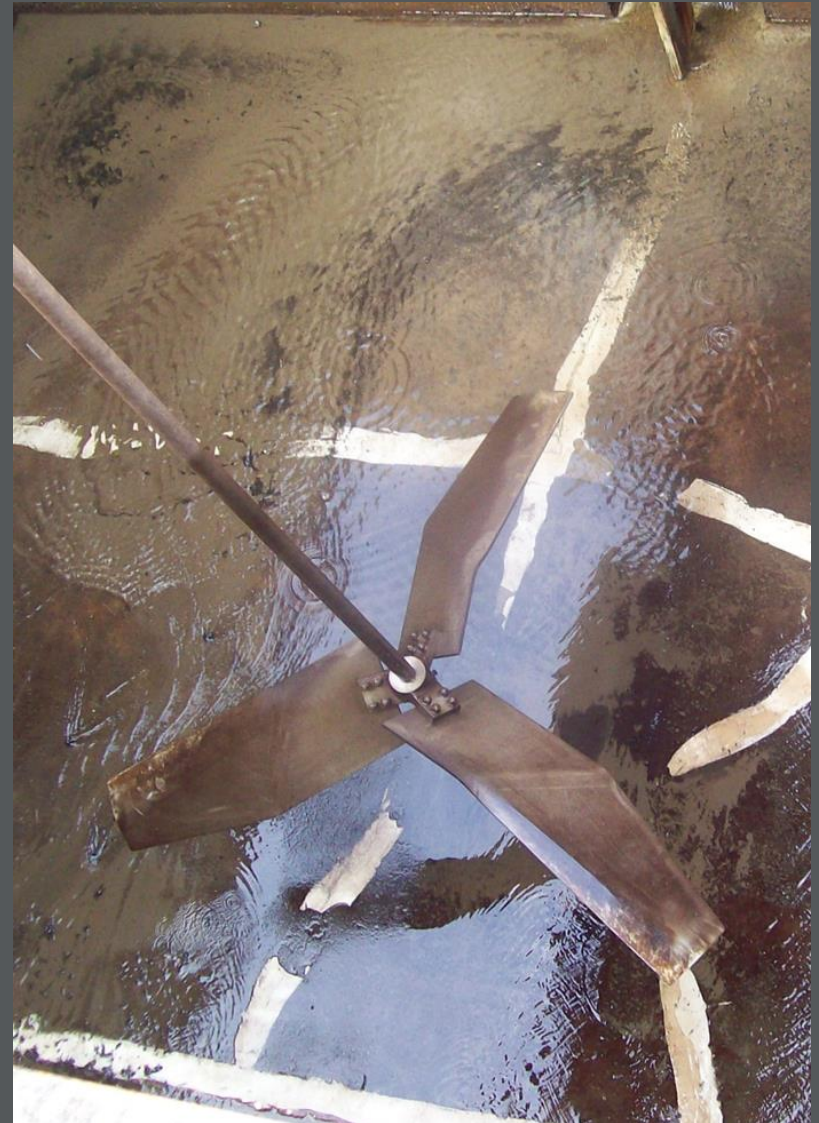
Basin	Hydraulic Retention Time
EX Rapid Mix	30 seconds
EX Flocculation	(2) at 10 minutes each
Ex Presedimentation	13 minutes

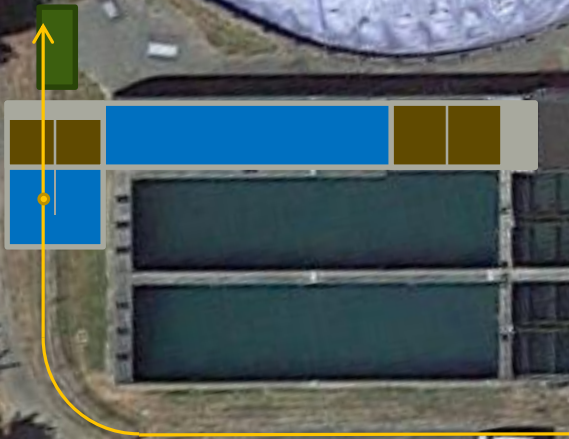
Flow Control Building

- Automatically distributing flow from either forcemain to either rapid mix basin.

- Prefabricated building vs. below grade vault.

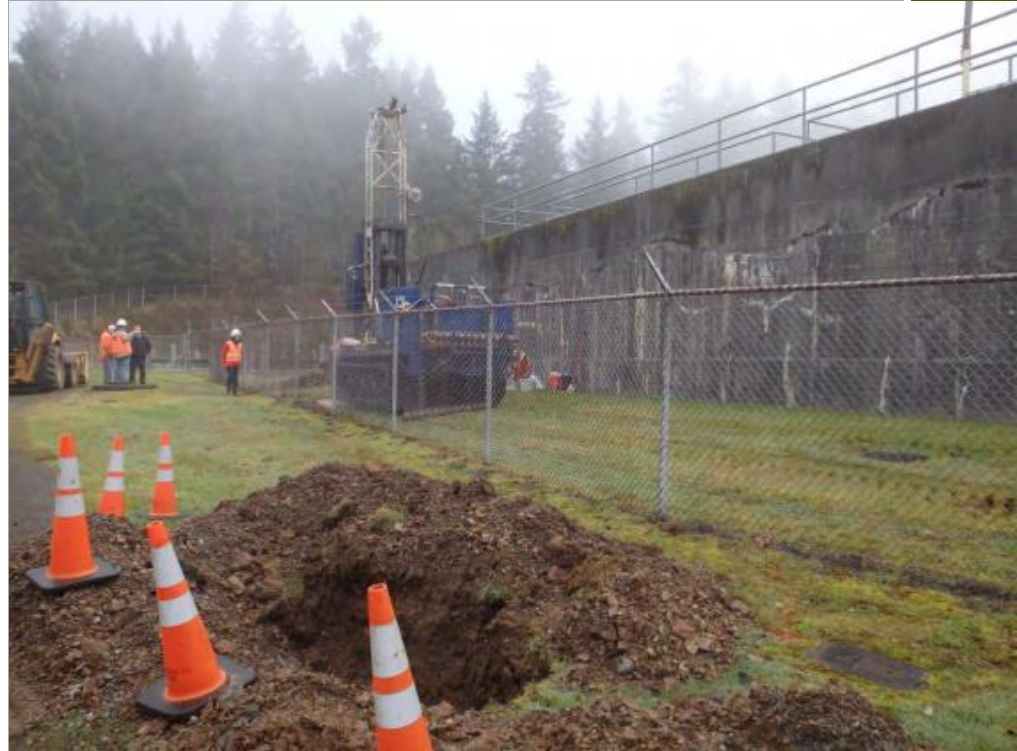
Geotechnical Information

Findings:

- Entire site is on fill.
- Fill is not adequate to support new basins.

Recommendations:

- Basins should be pile supported.
- Differential settlement will occur.

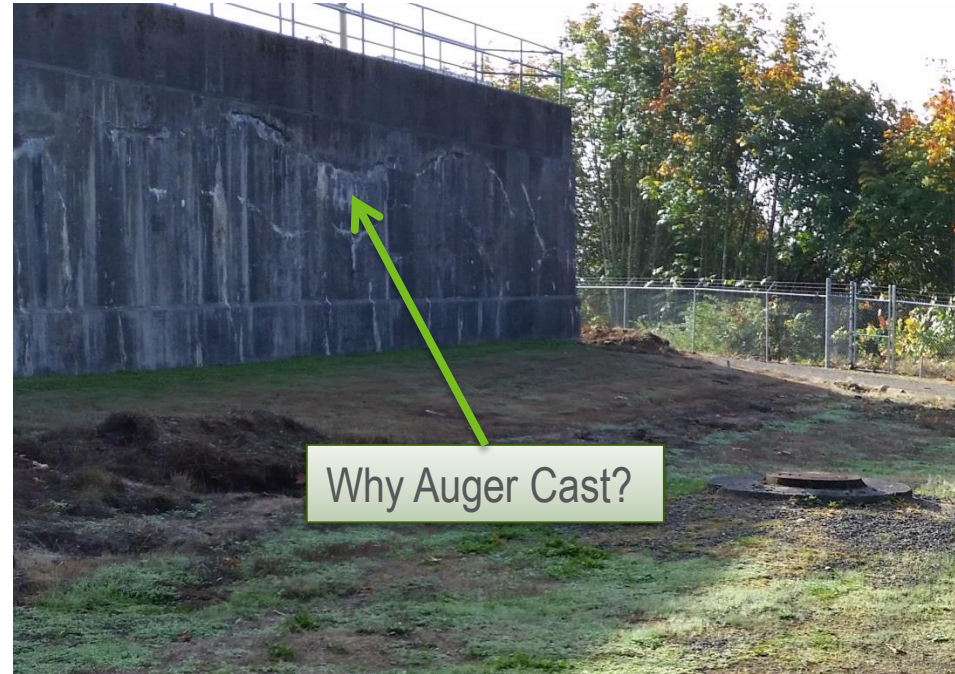
Pilings

- **(42)** 24-inch-diameter auger cast pilings.
- Each are 40 FT deep.

Drove the need for cost reductions

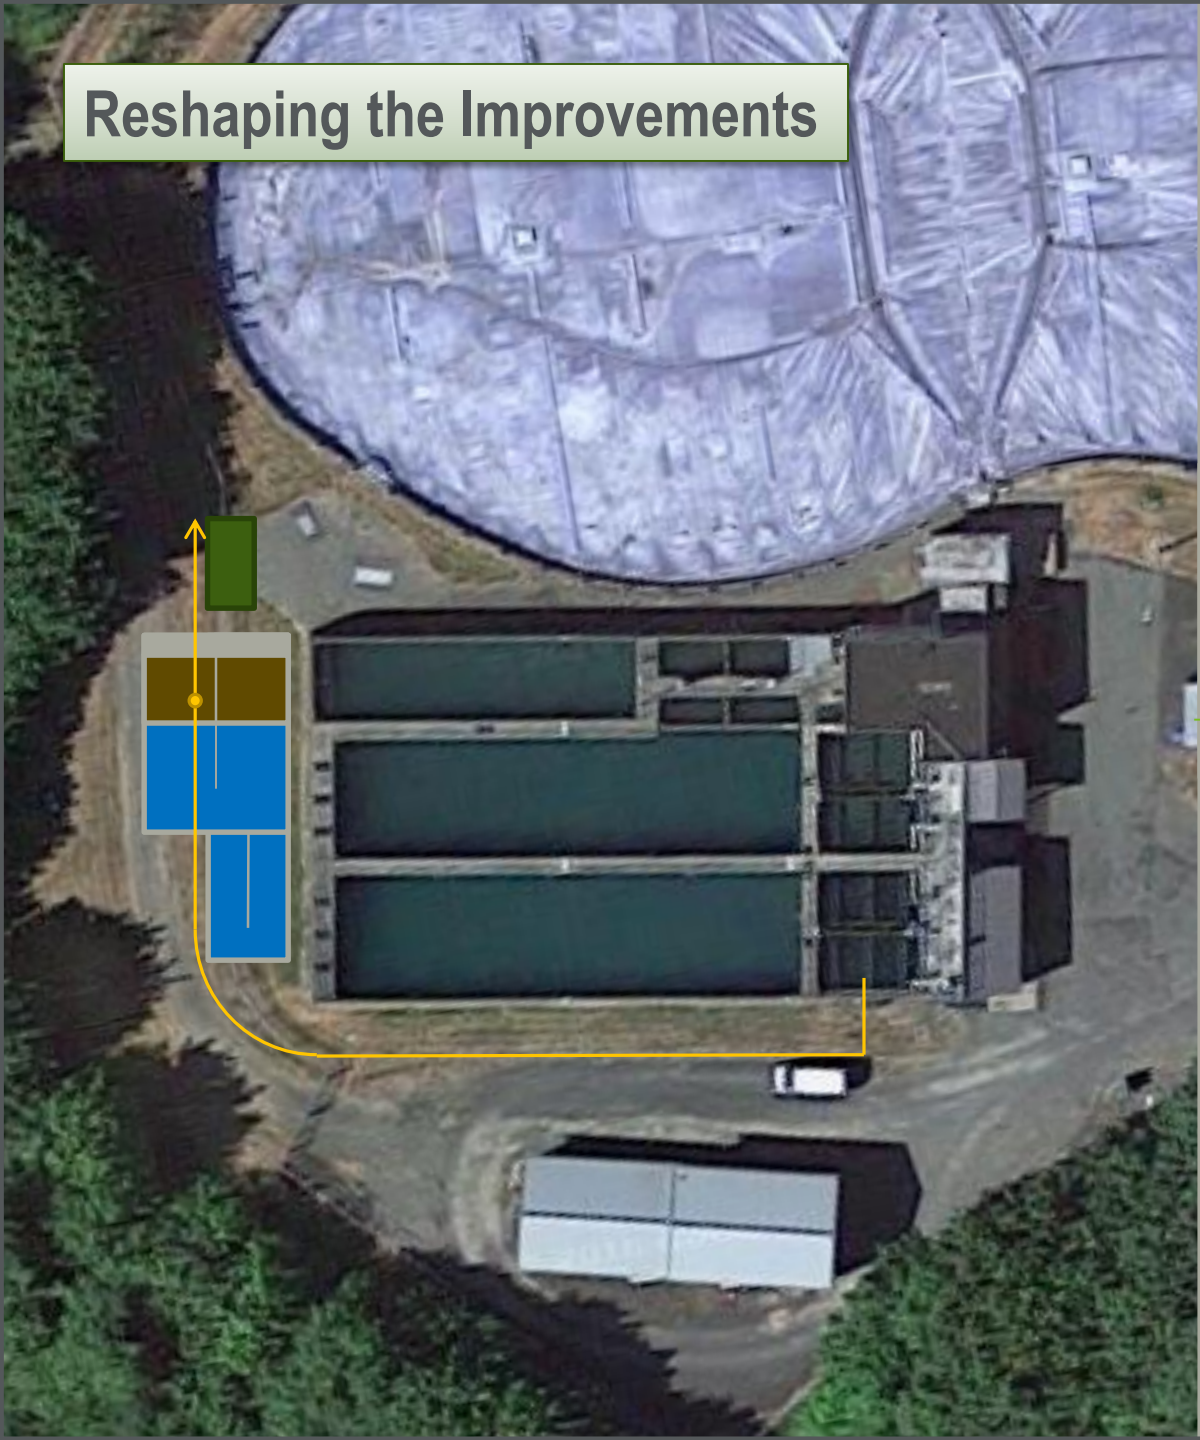
Reducing Footprint

New Basin

Existing Basin

- Baffling and short circuit prevention.

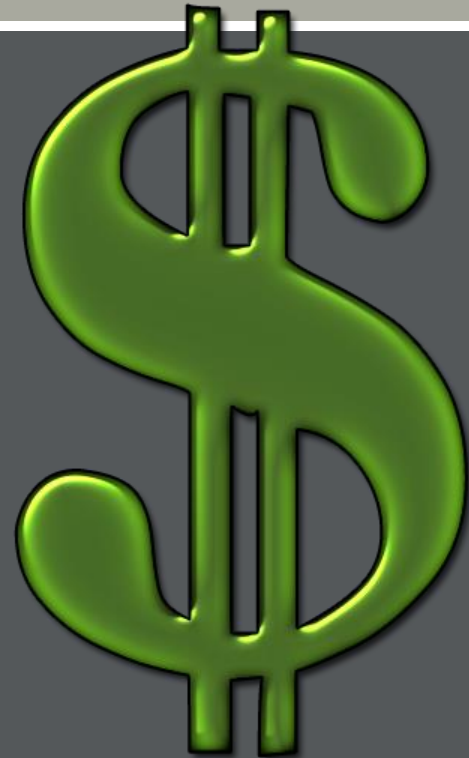
Remove Presedimentation Basin

- Removal of Presedimentation Basin removed 19 pilings from the project.
- Decrease the overall footprint by 50%.
- Removed complex diffuser wall.

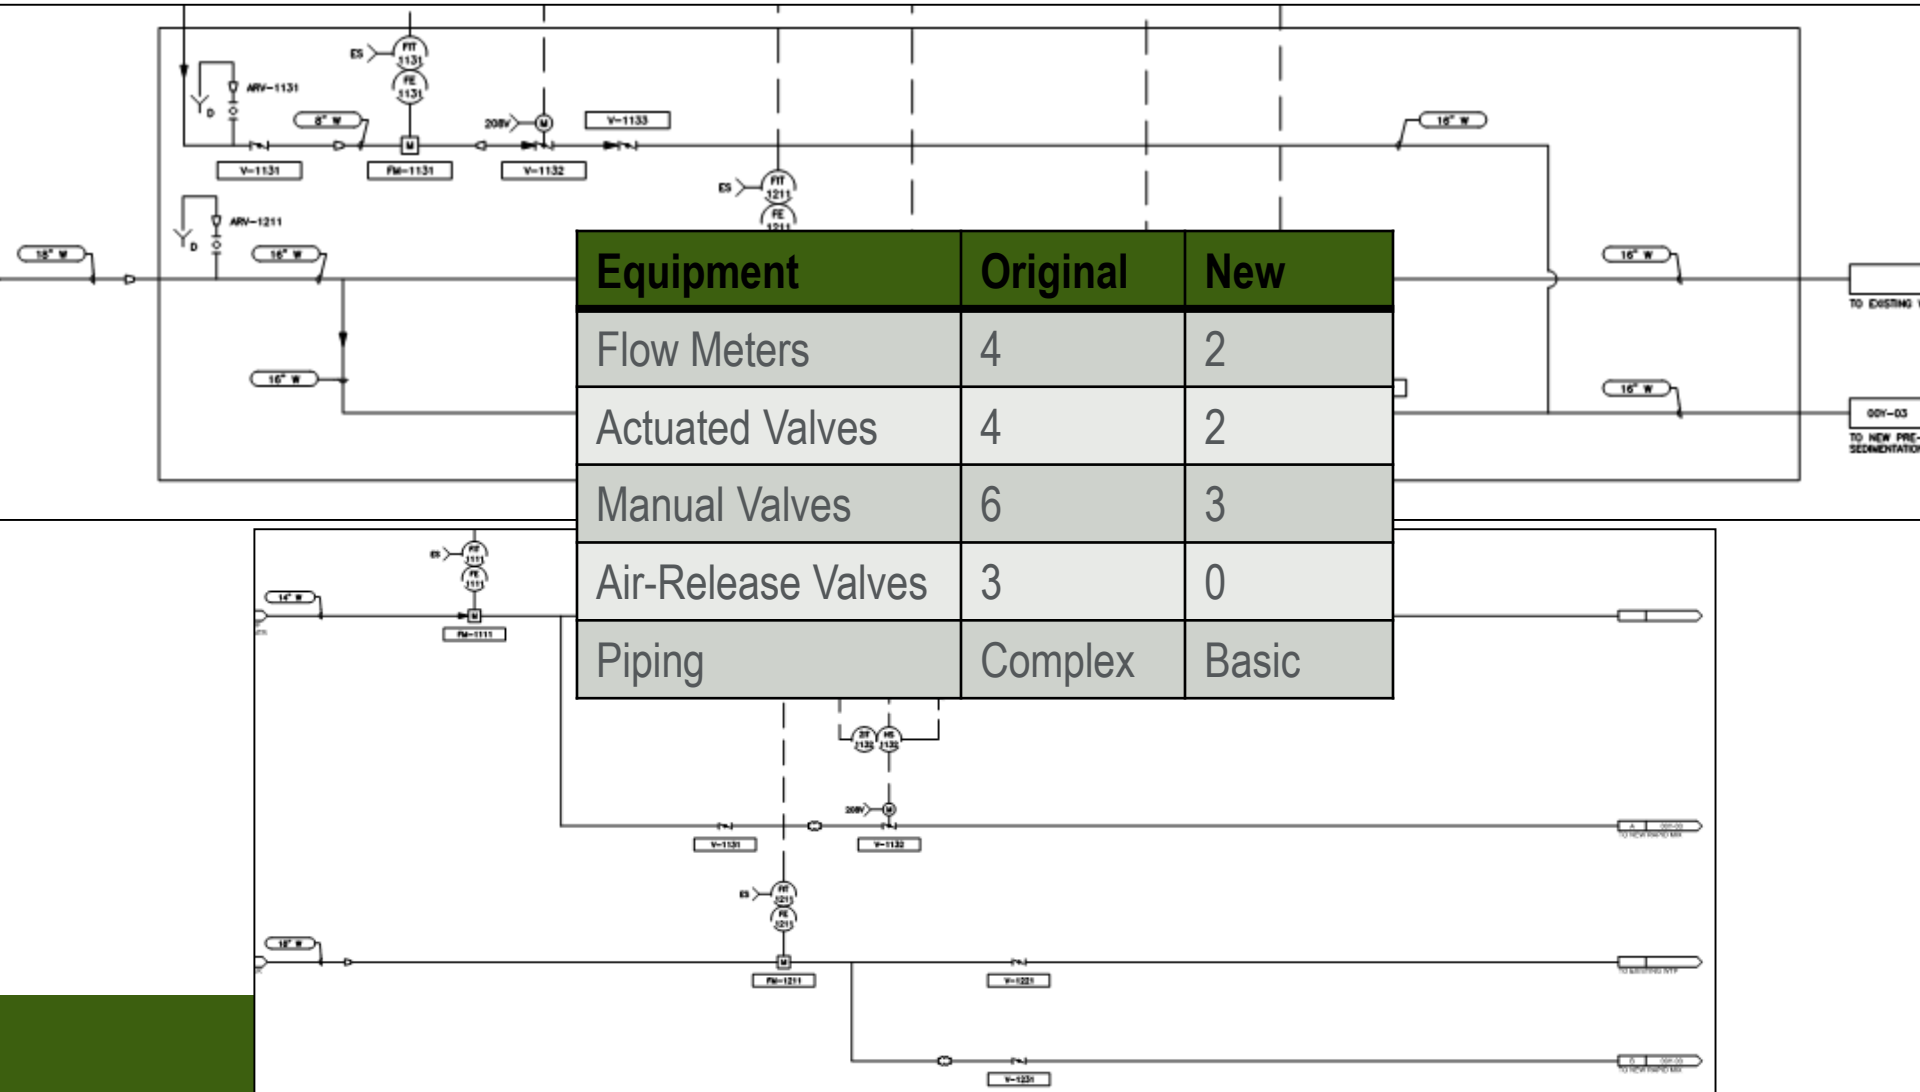
Reconfigure flow control

- Automated flow control on a manually operated pump station.

Equipment	Original	New
Flow Meters	4	2
Actuated Valves	4	2
Manual Valves	6	3
Air-Release Valves	3	0
Piping	Complex	Basic

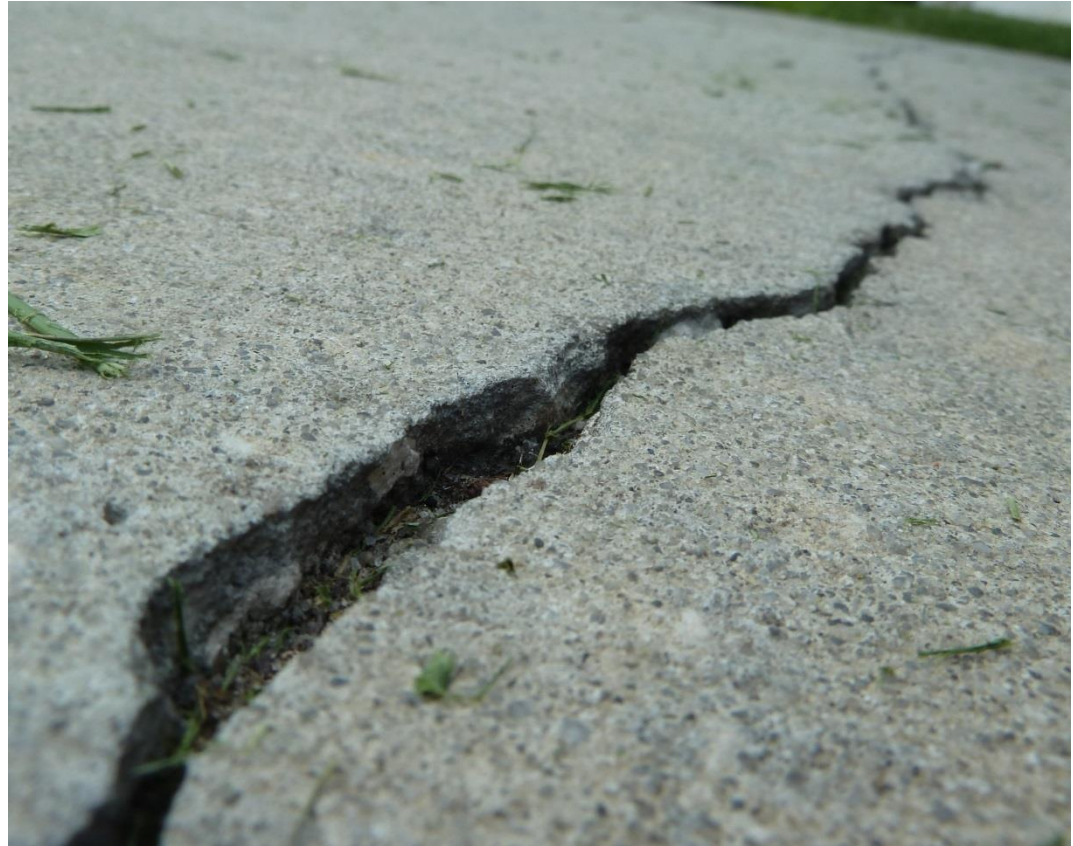
OUR BASINS ARE ON PILINGS????

- High potential for differential settlement.
 - Flexible HDPE piping for inter-basin connections
 - Flexible joints on yard piping connections
