40 Years and Counting: How To Keep A Good Tank Going

Presented by: Lael Alderman, PE | Murray, Smith & Associates, Inc.

Pleasant Home Water District

600,000 Gallon Standpipe

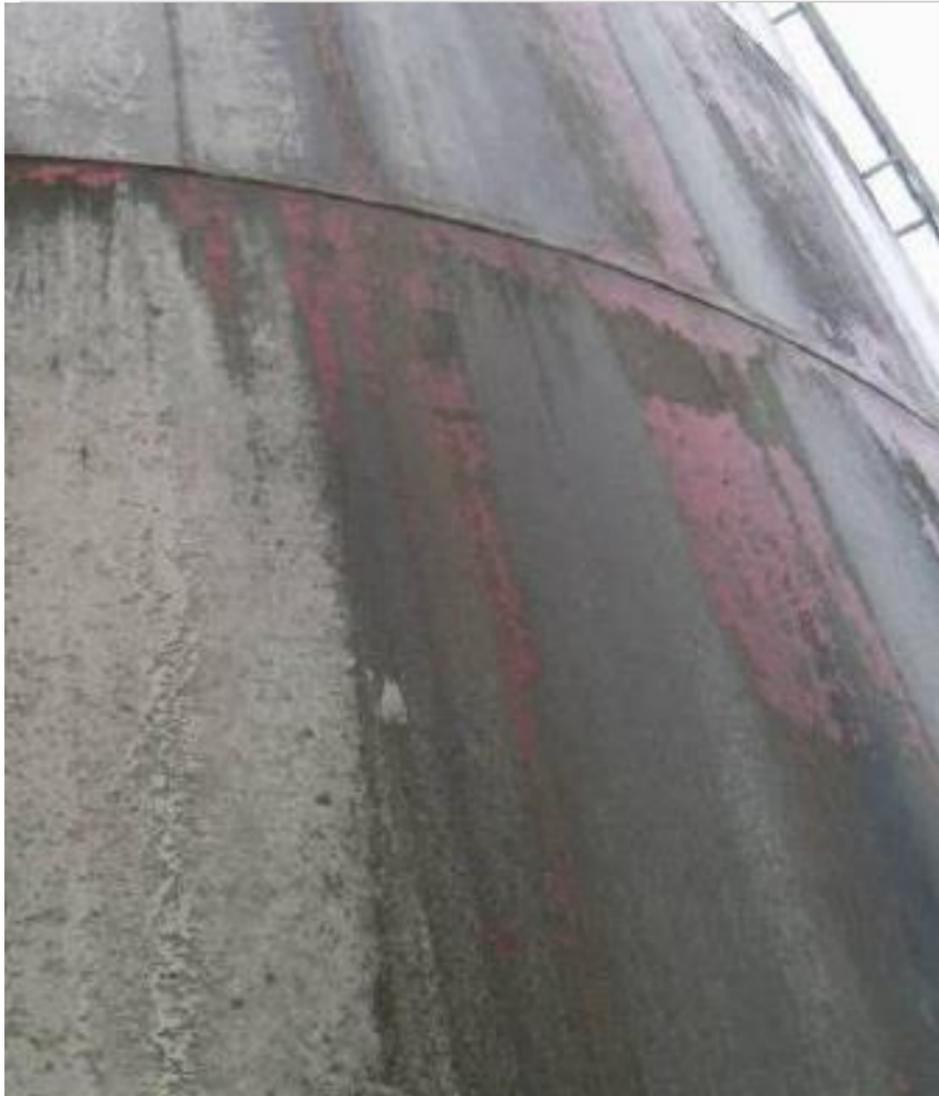
Coatings

Rehabilitation of interior & exterior coating systems

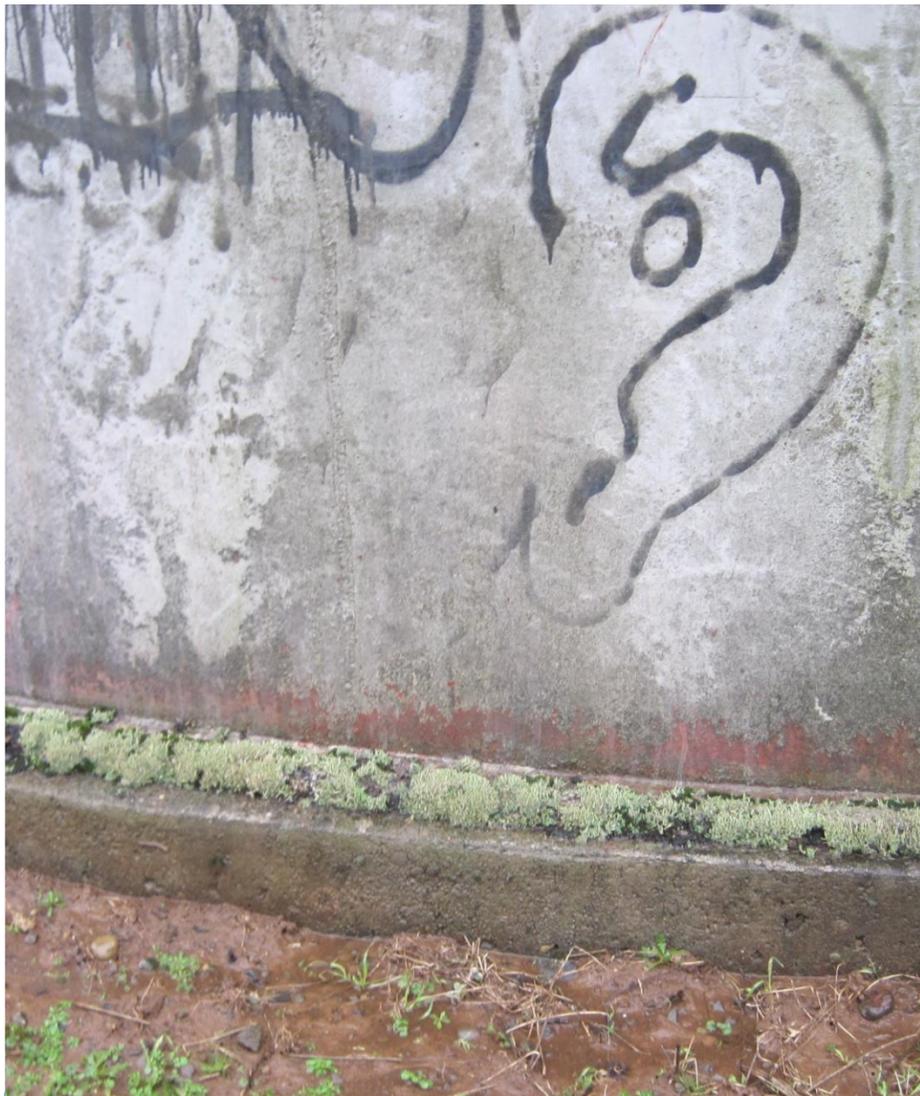
Wall-to-foundation sealant

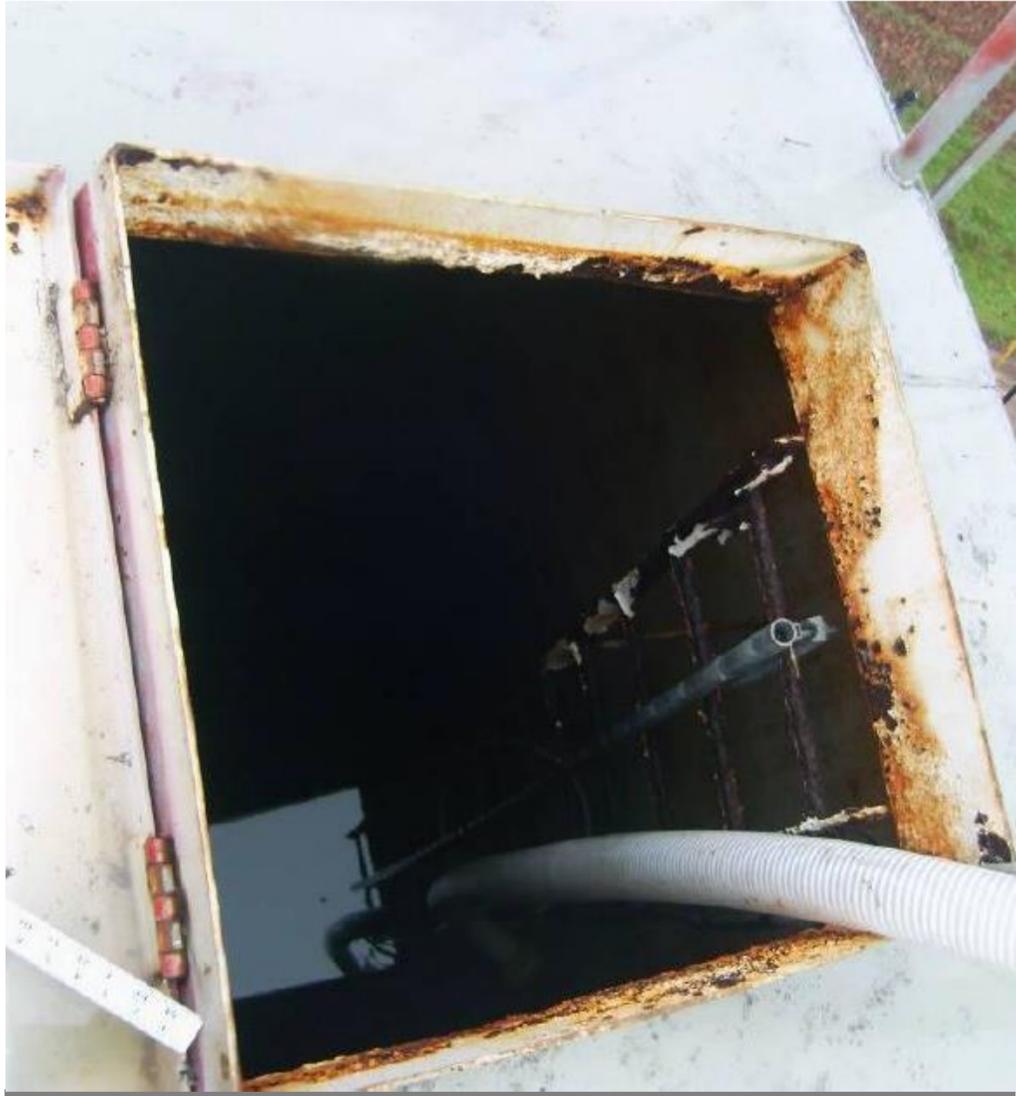
Roof hatch

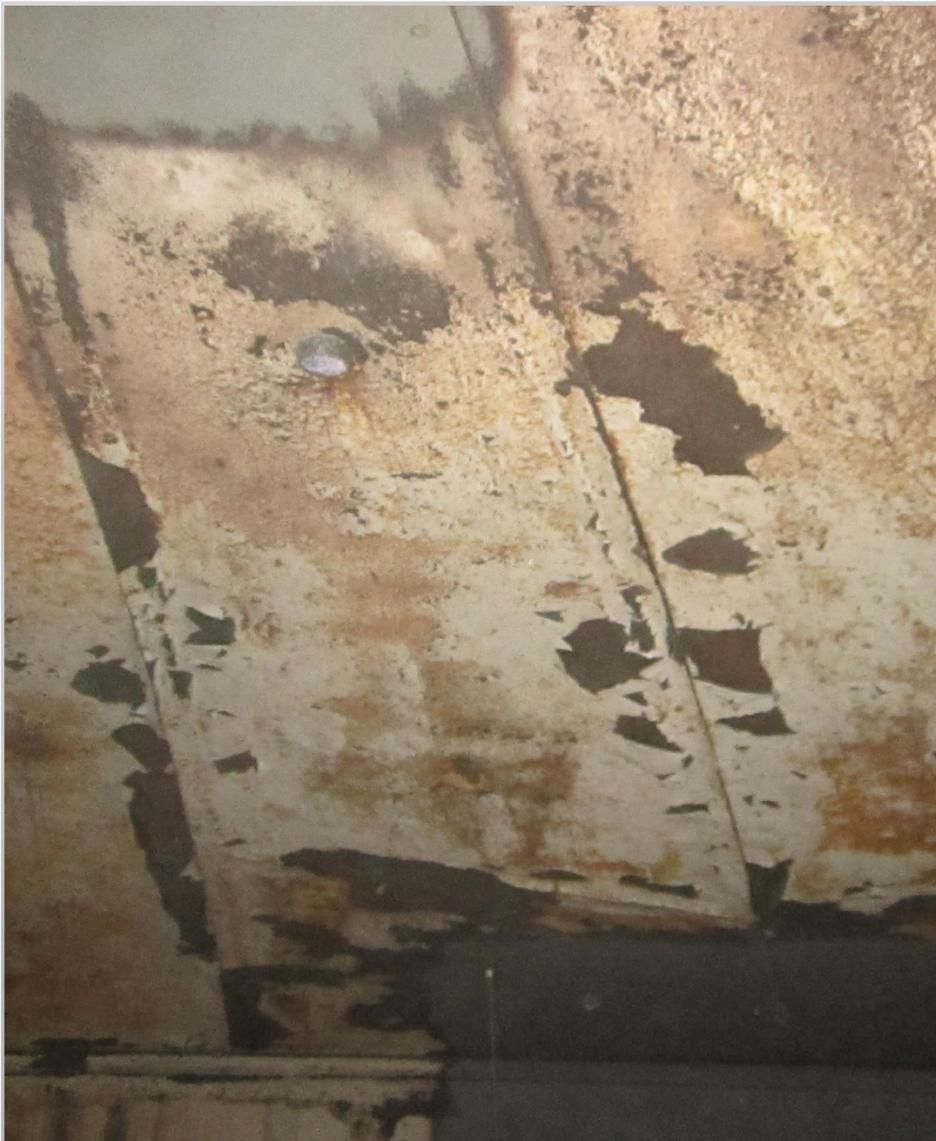
Failed coatings | Ceiling

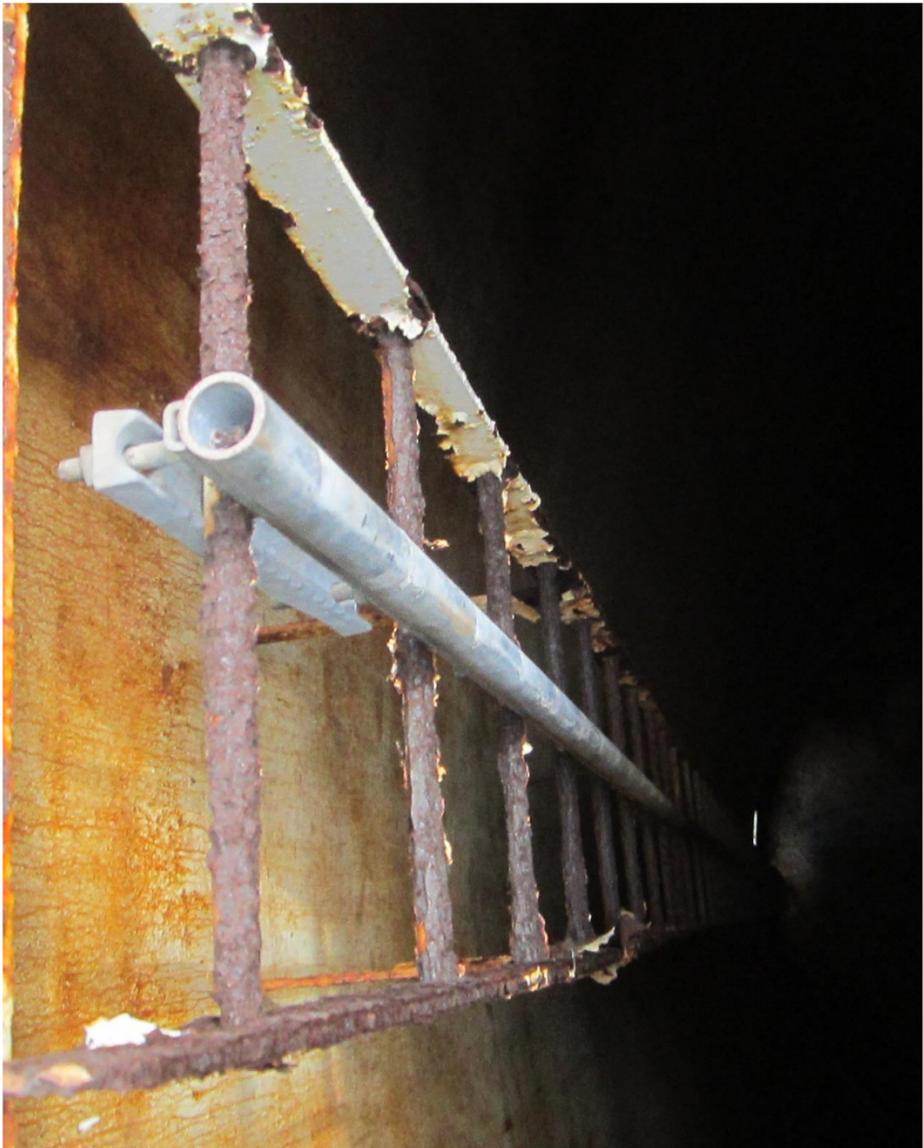
Interior ladder

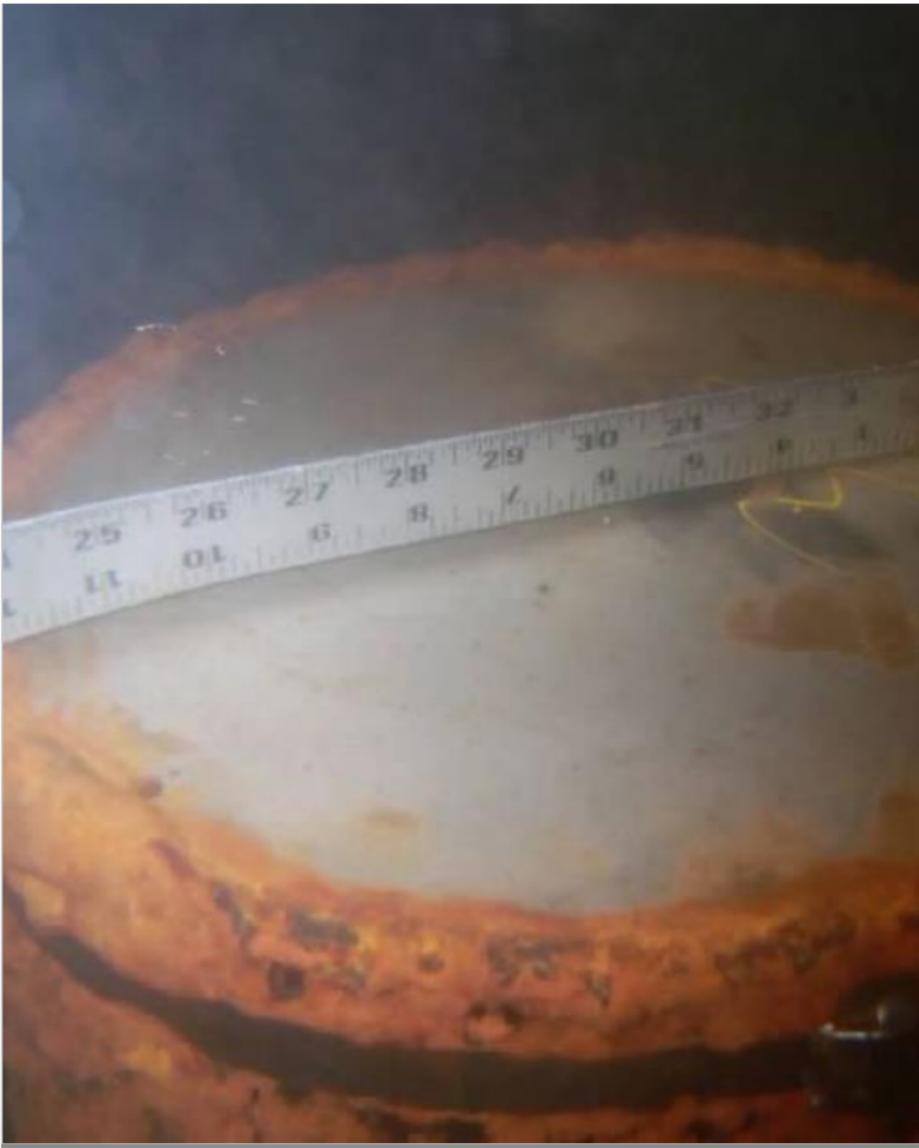
Corroded outlet screen

Replacement of appurtenances

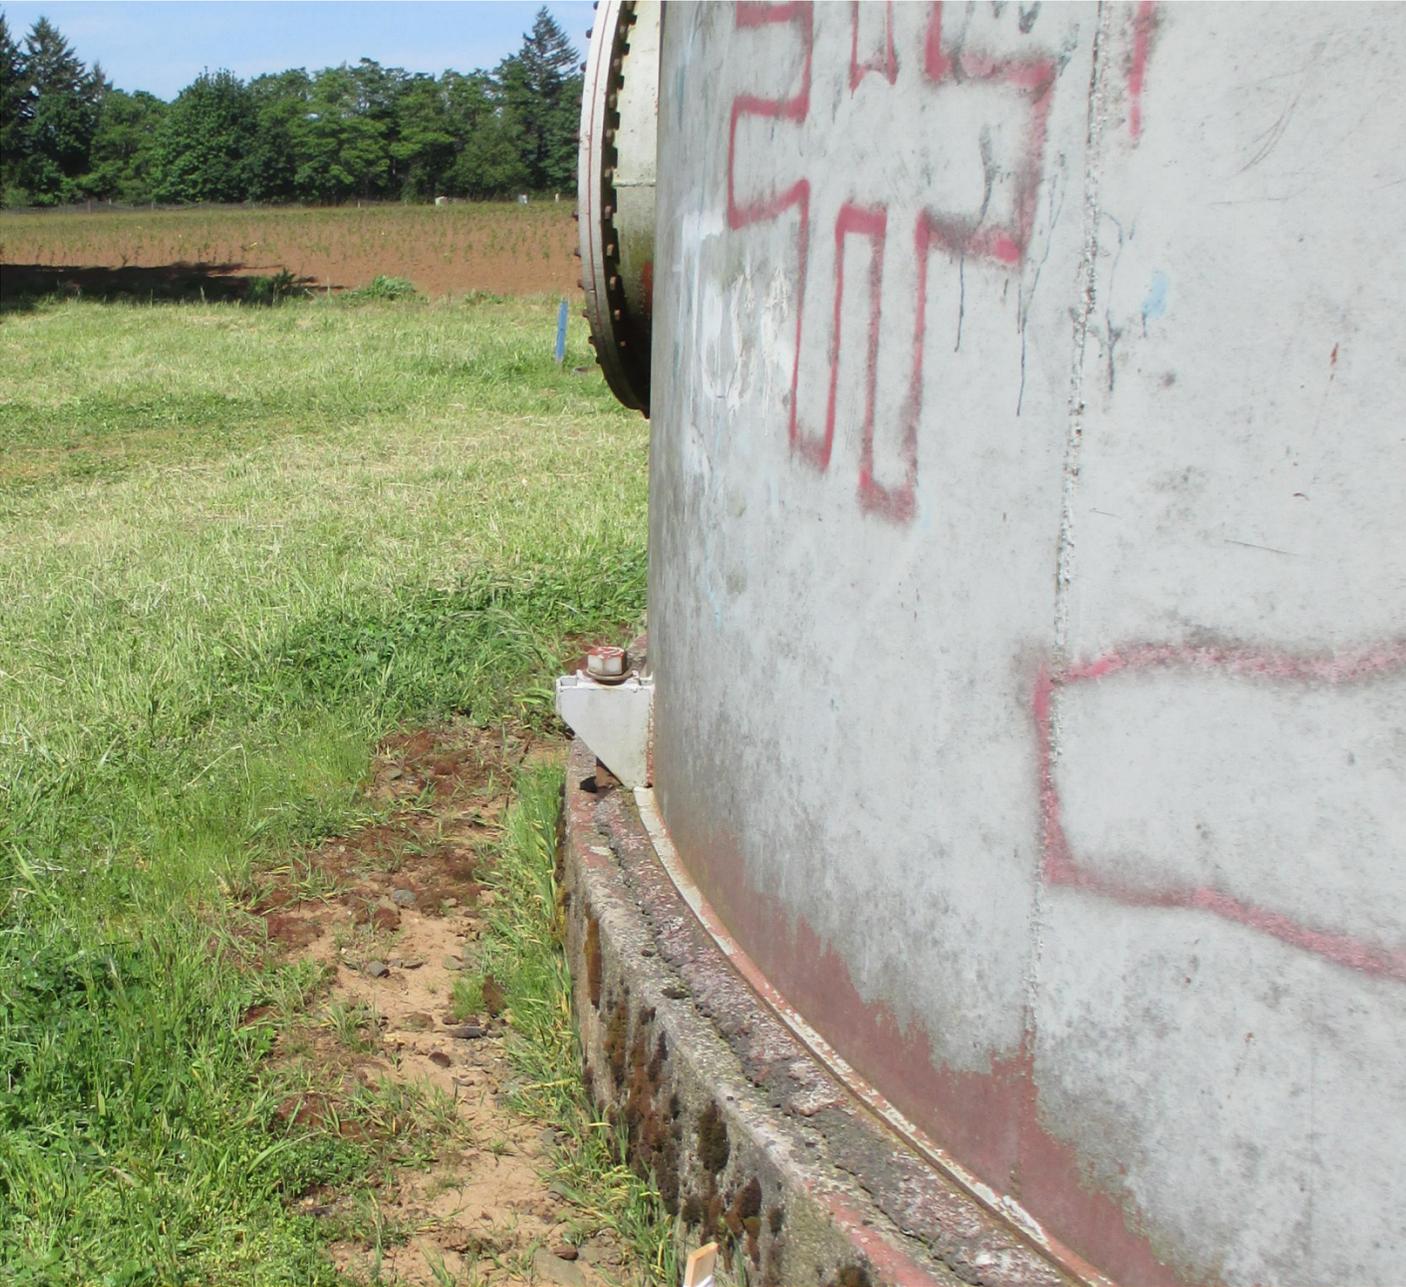
Anchor chairs

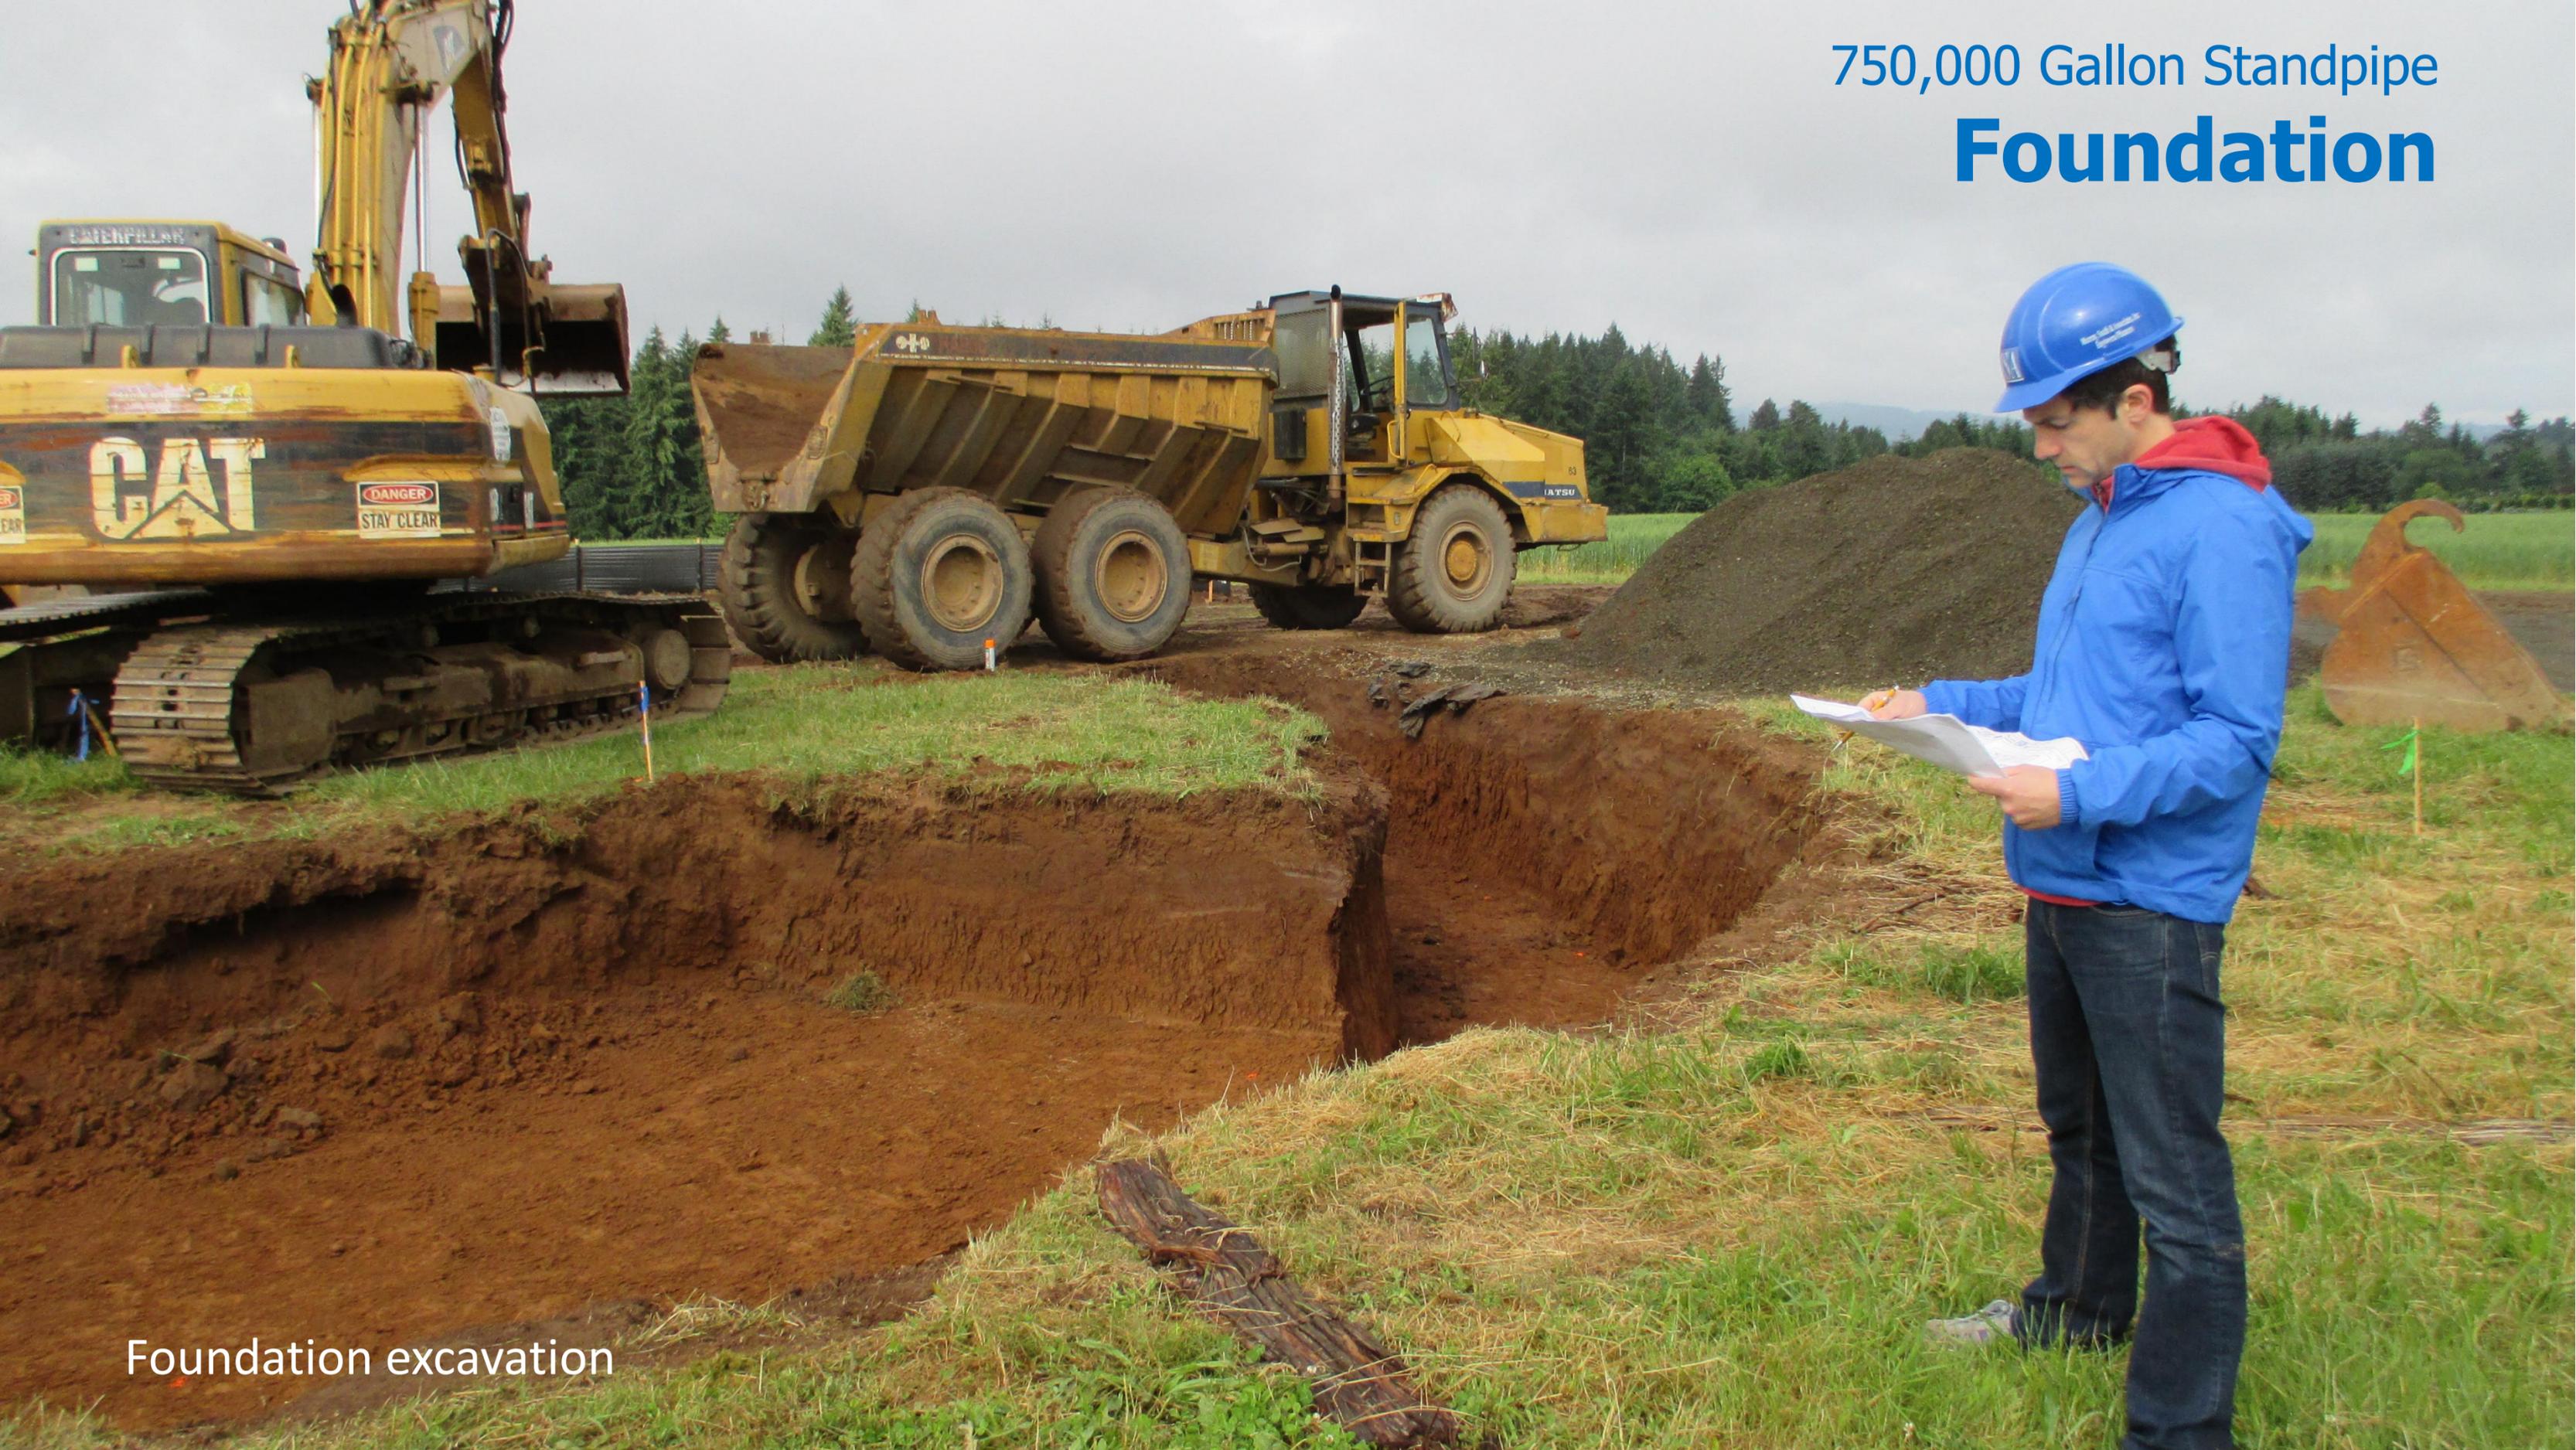
Foundation excavation

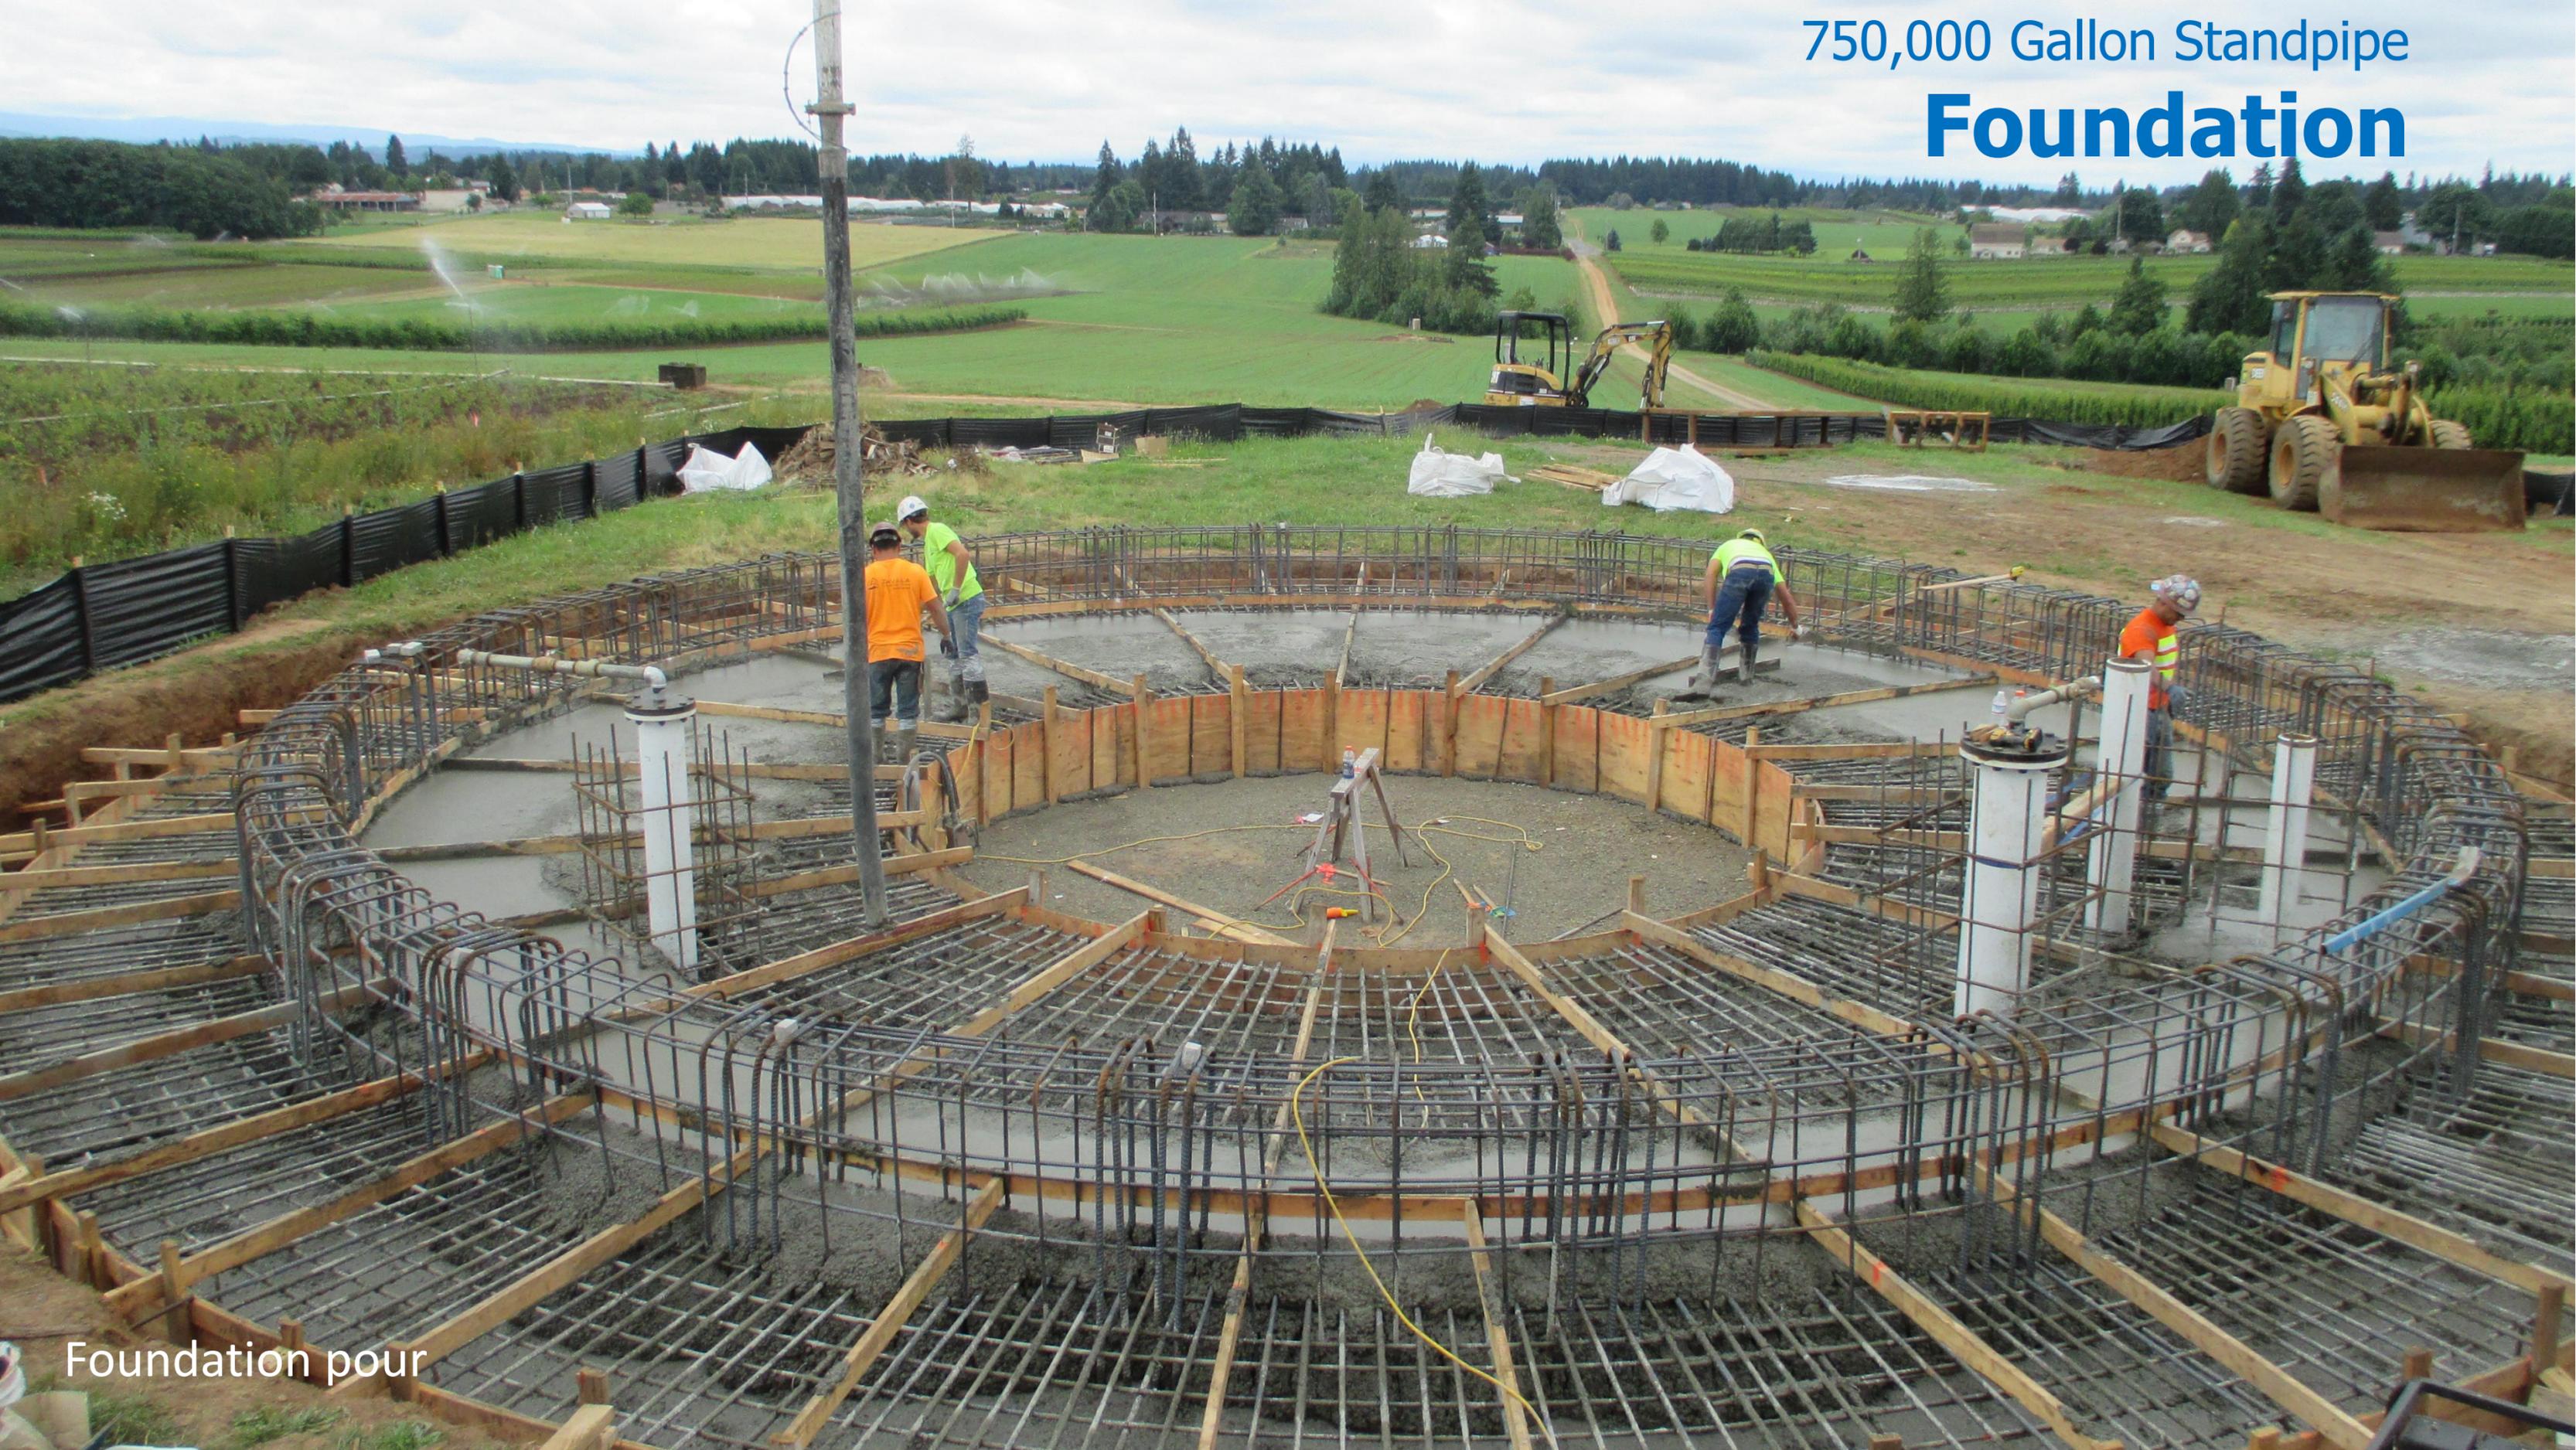
Foundation pour

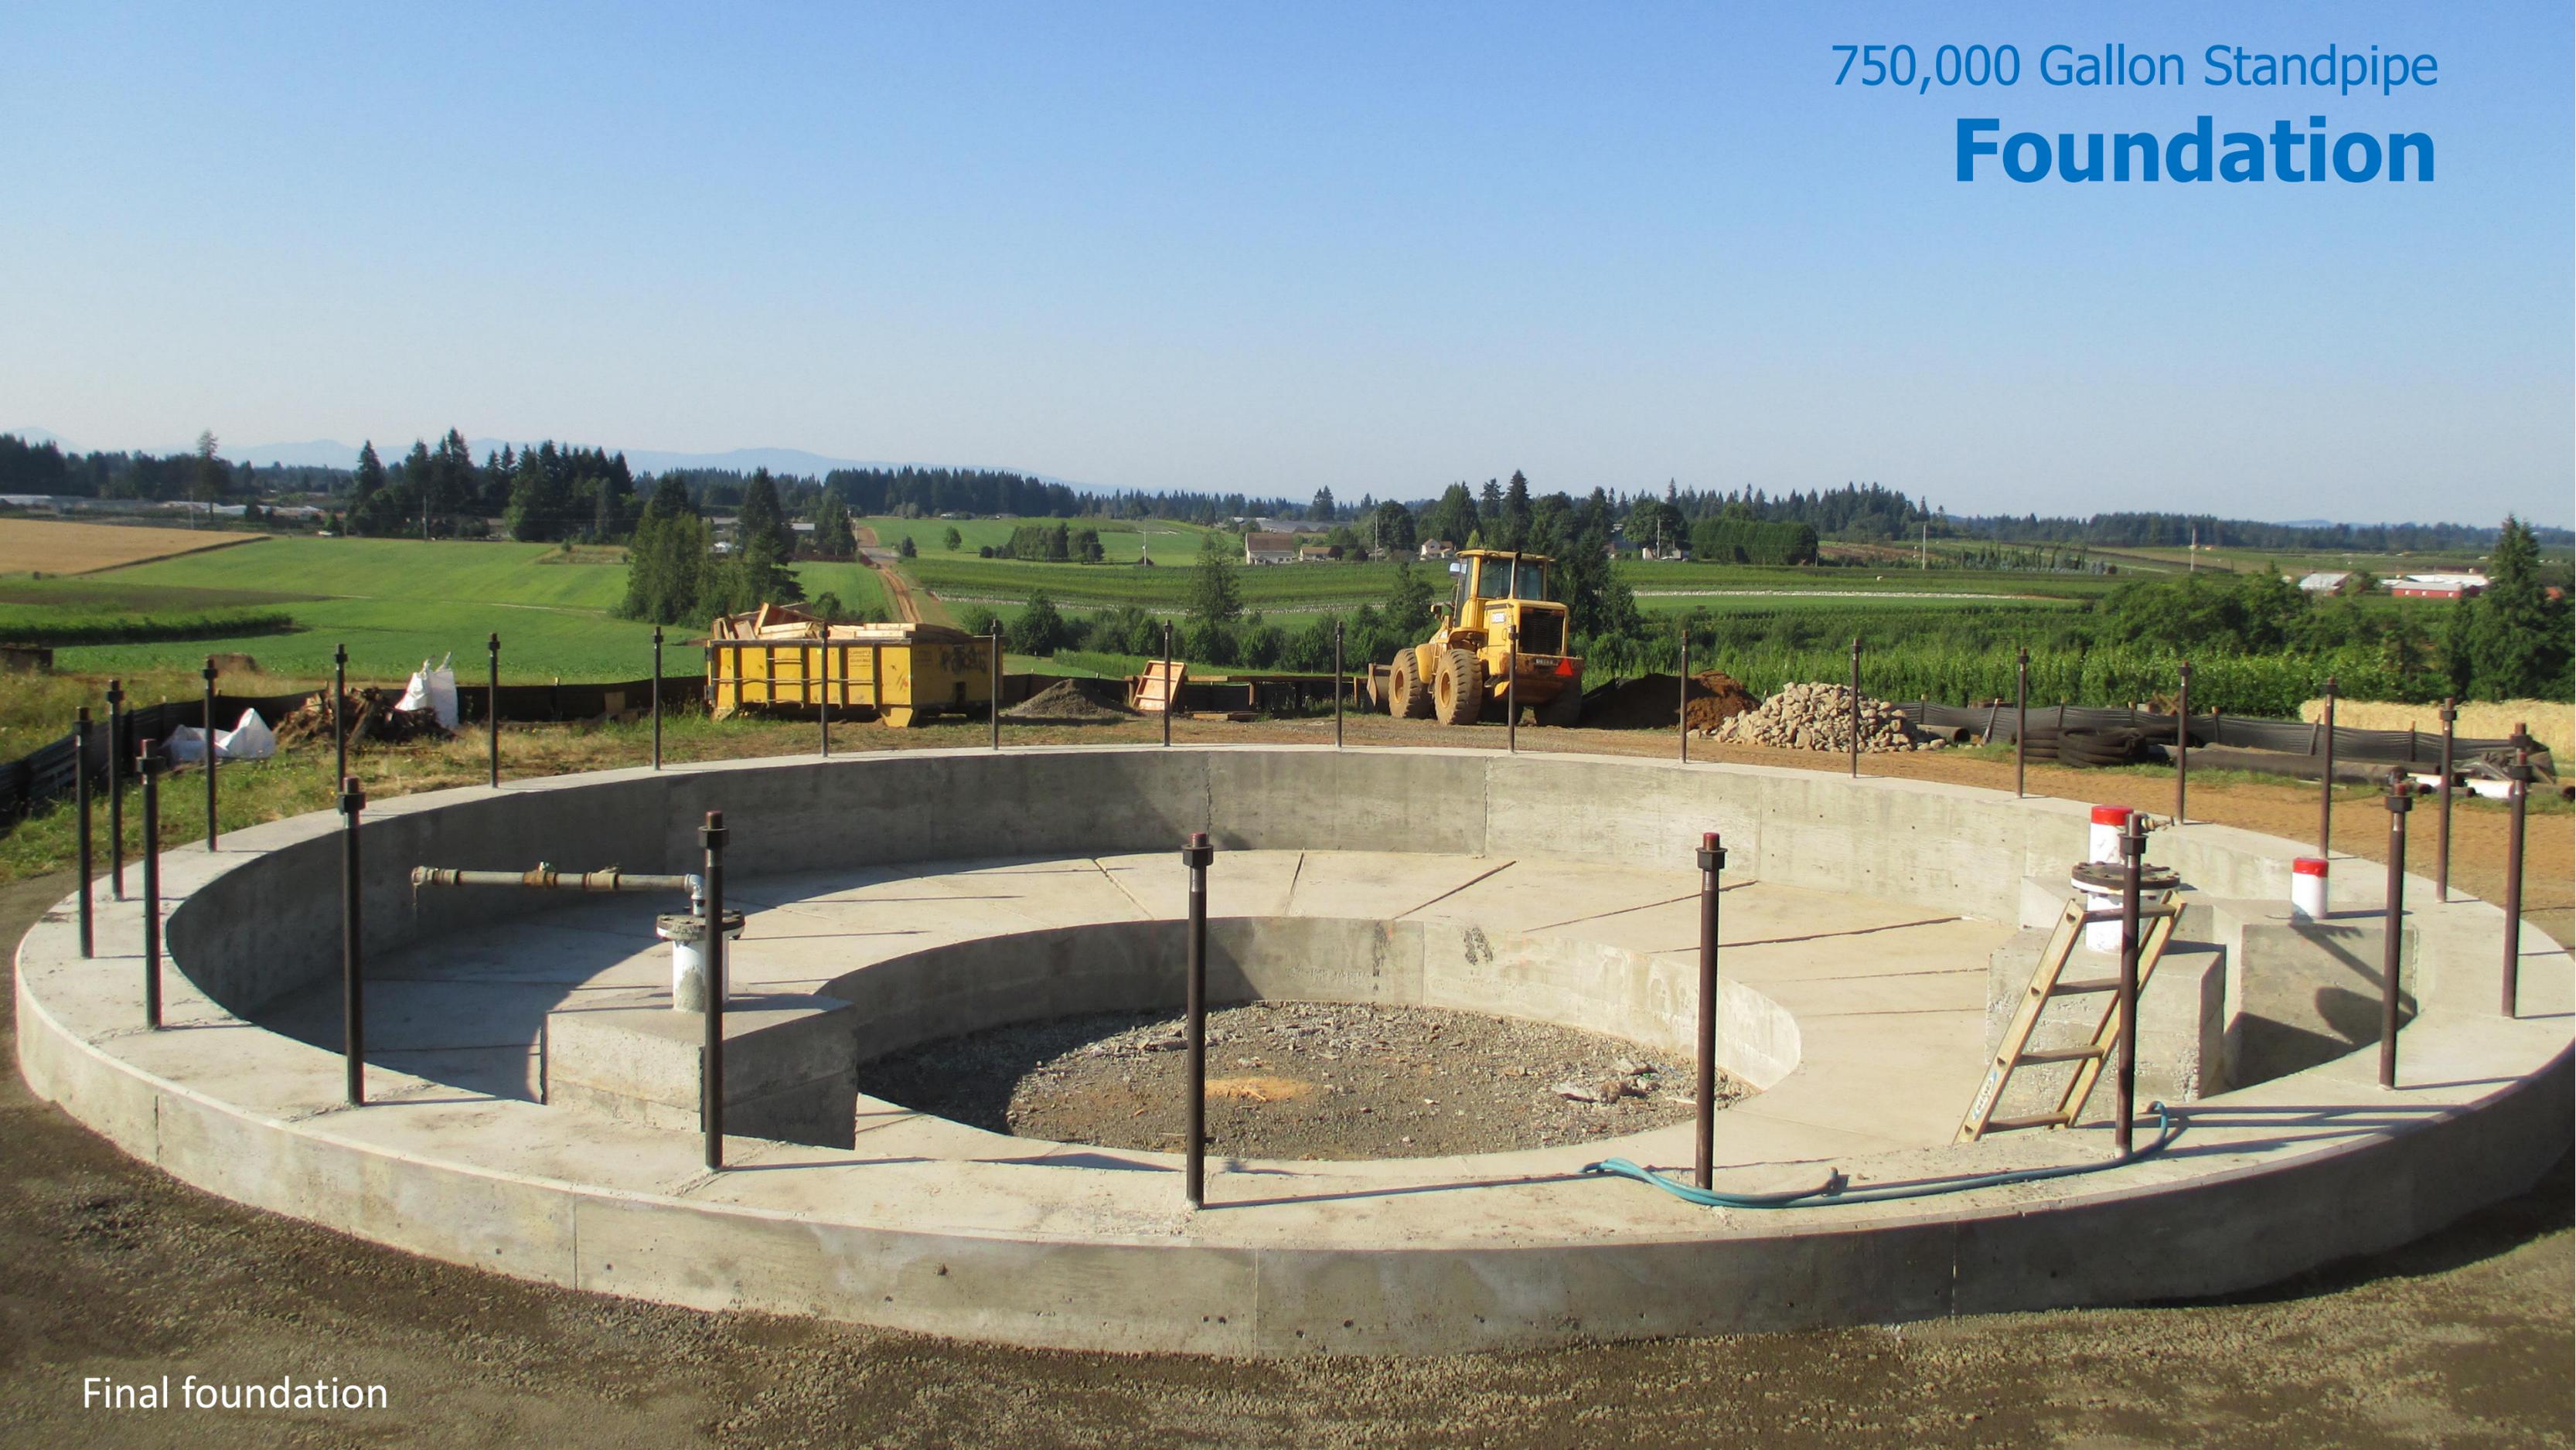
Final foundation

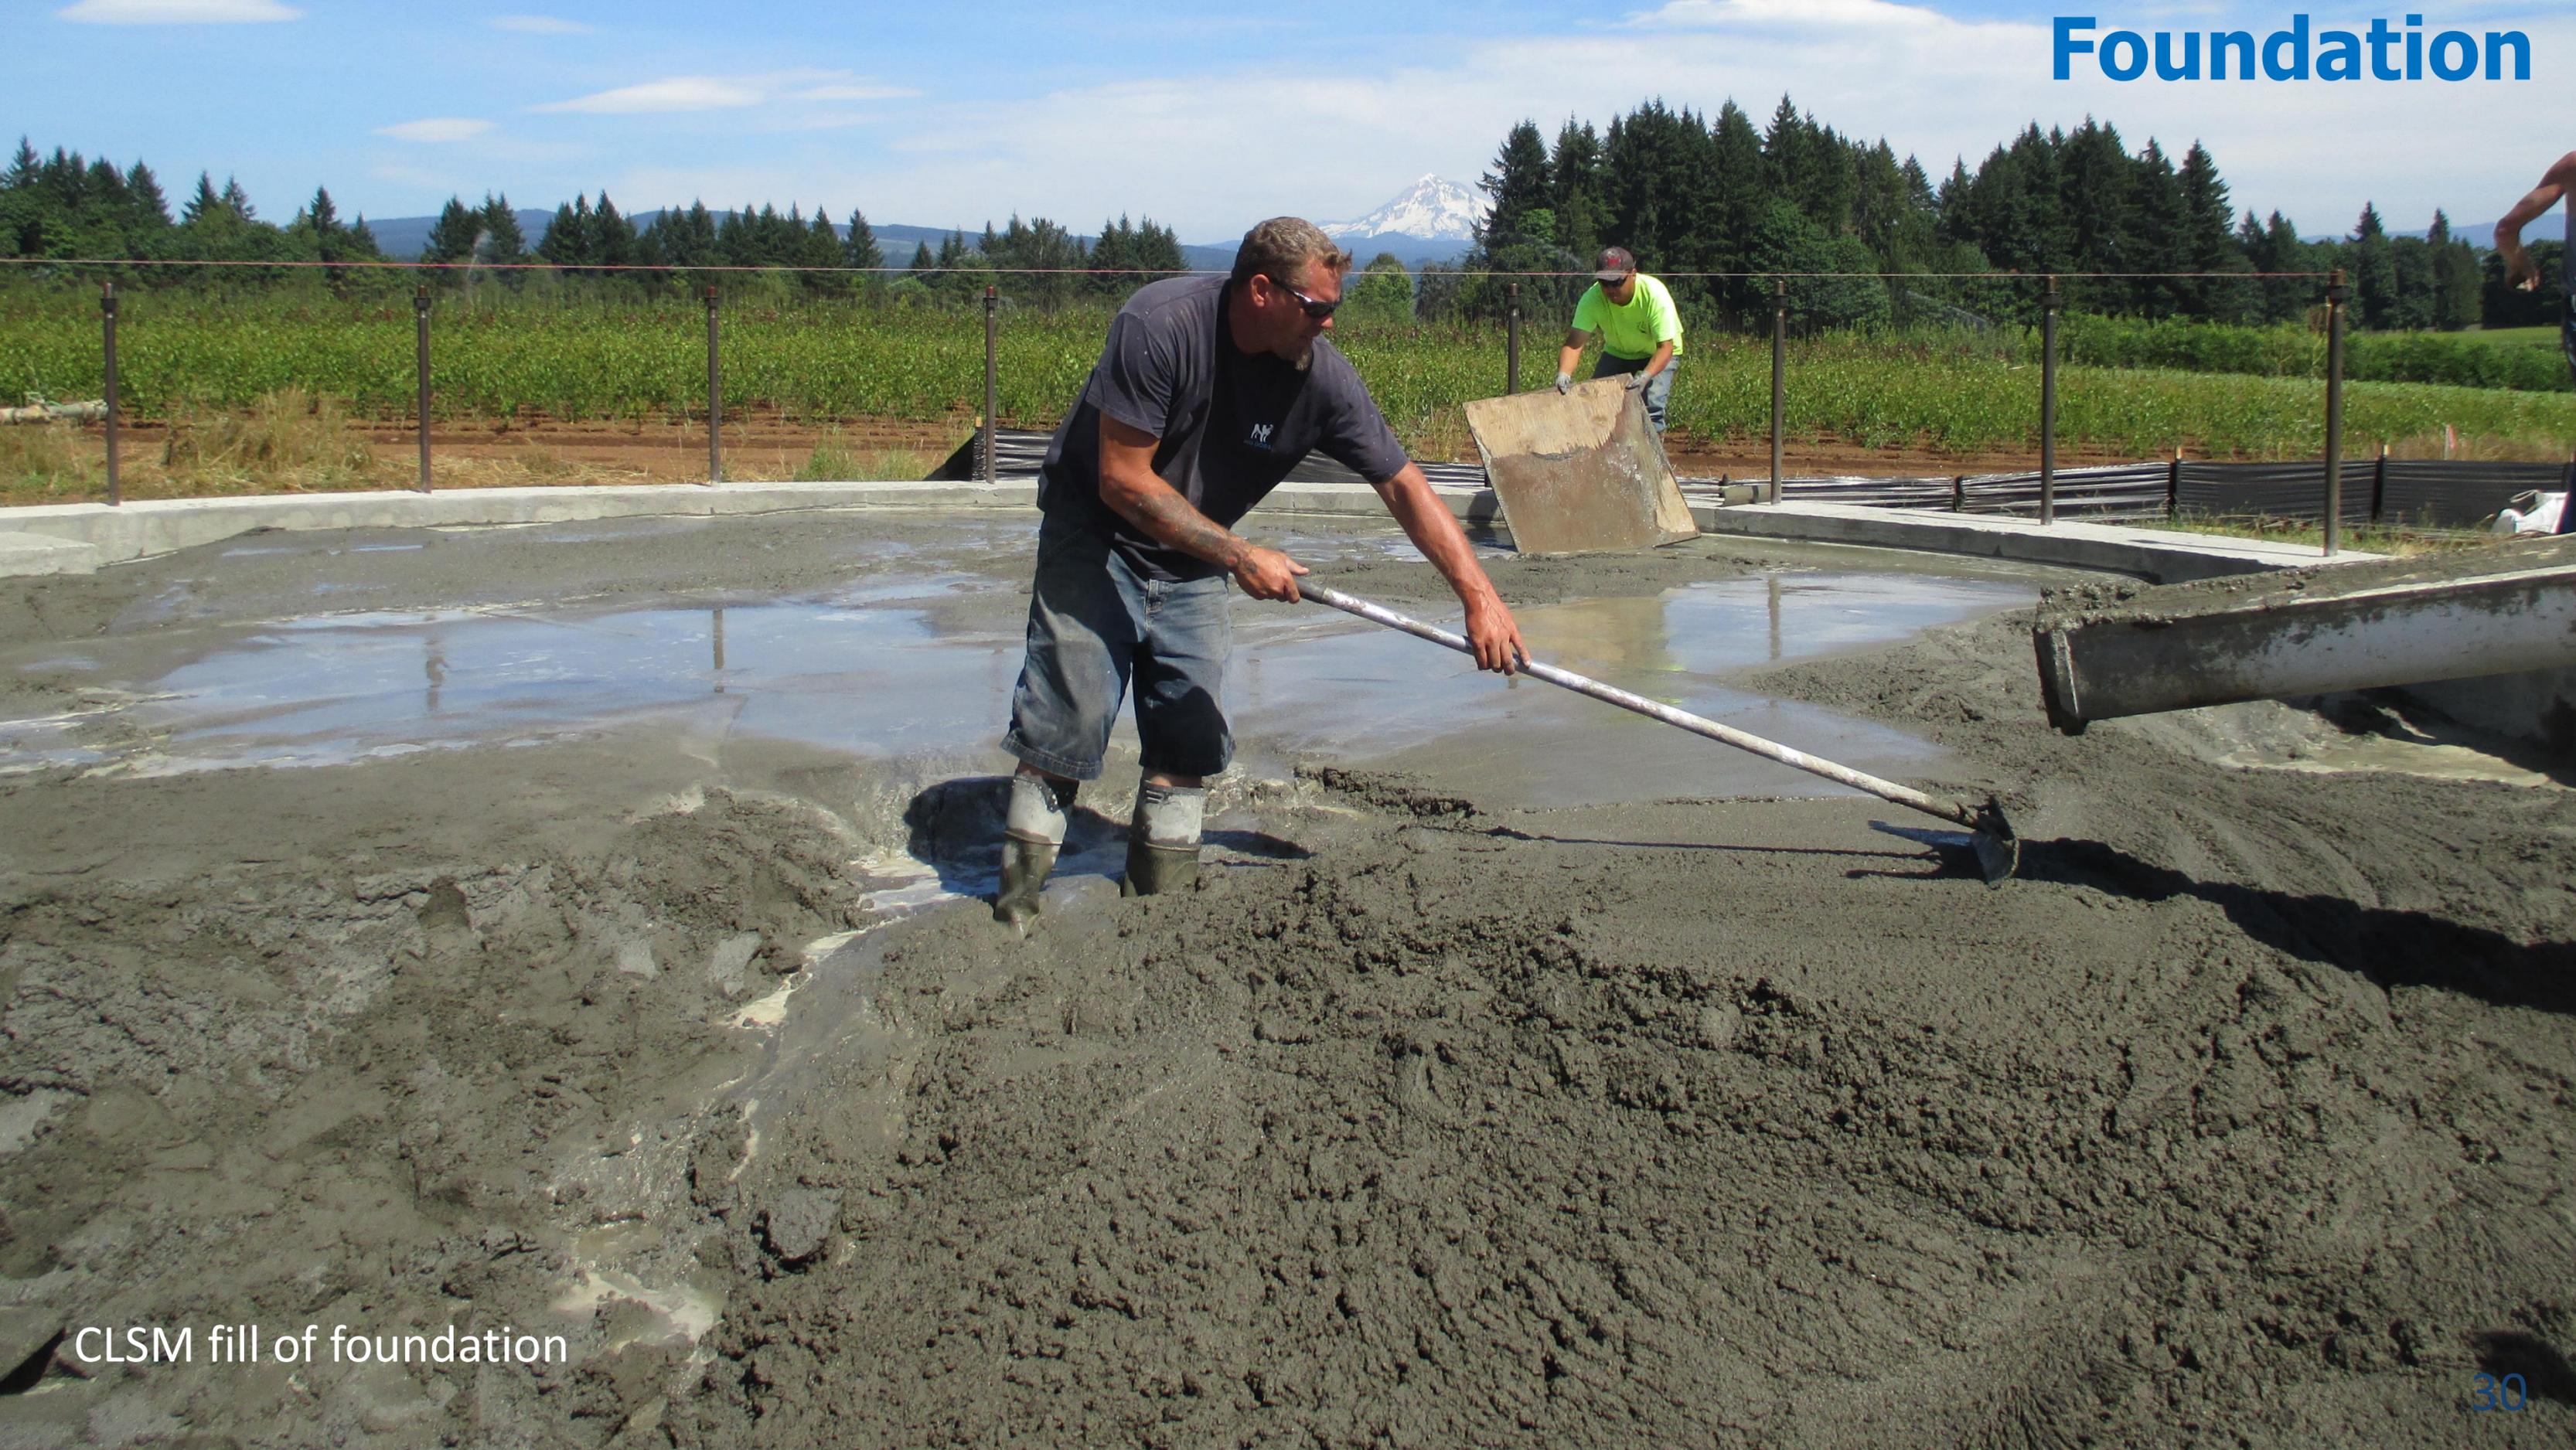
CLSM fill of foundation
