40 Years and Counting: How To Keep A Good Tank Going

Presented by: Lael Alderman, PE | Murray, Smith & Associates, Inc.

Pleasant Home Water District

600,000 Gallon Standpipe

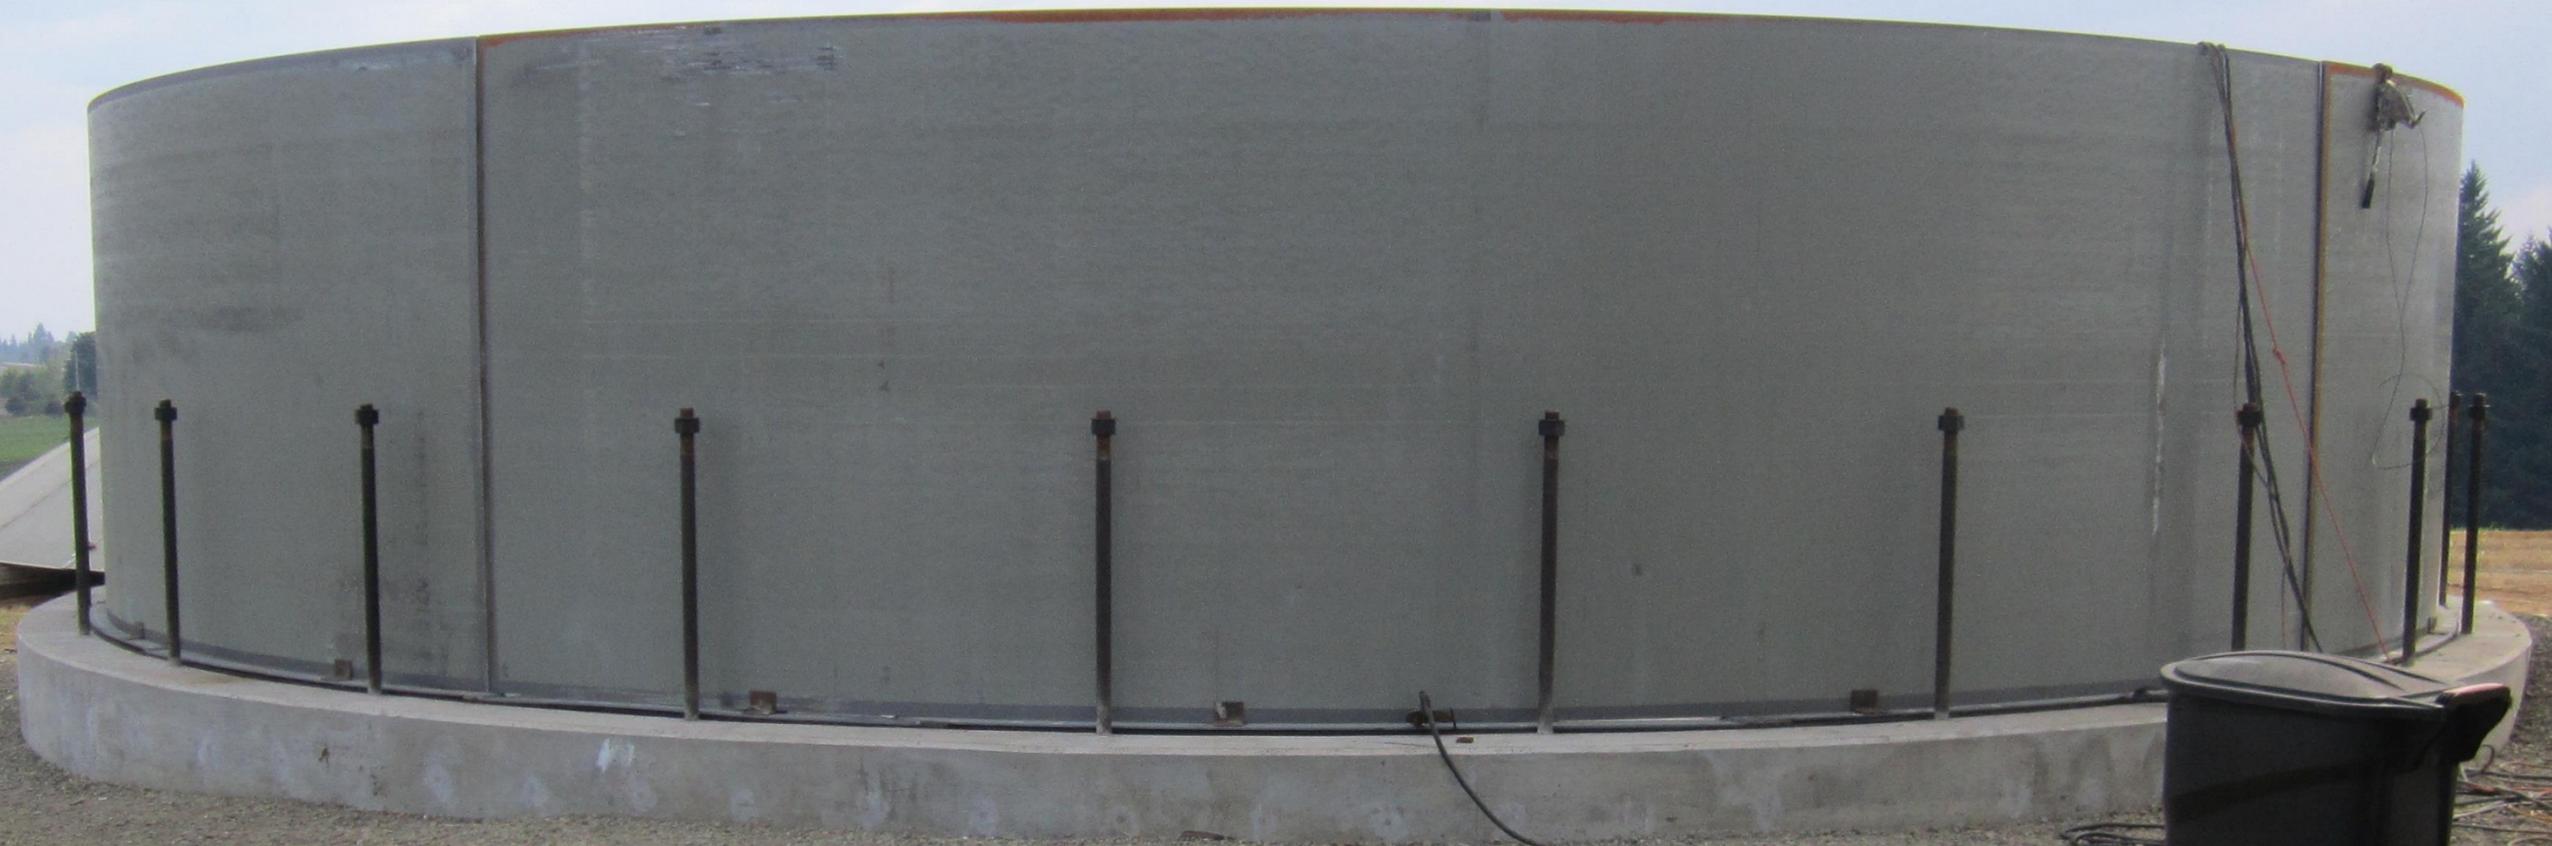
Shell base course assembly

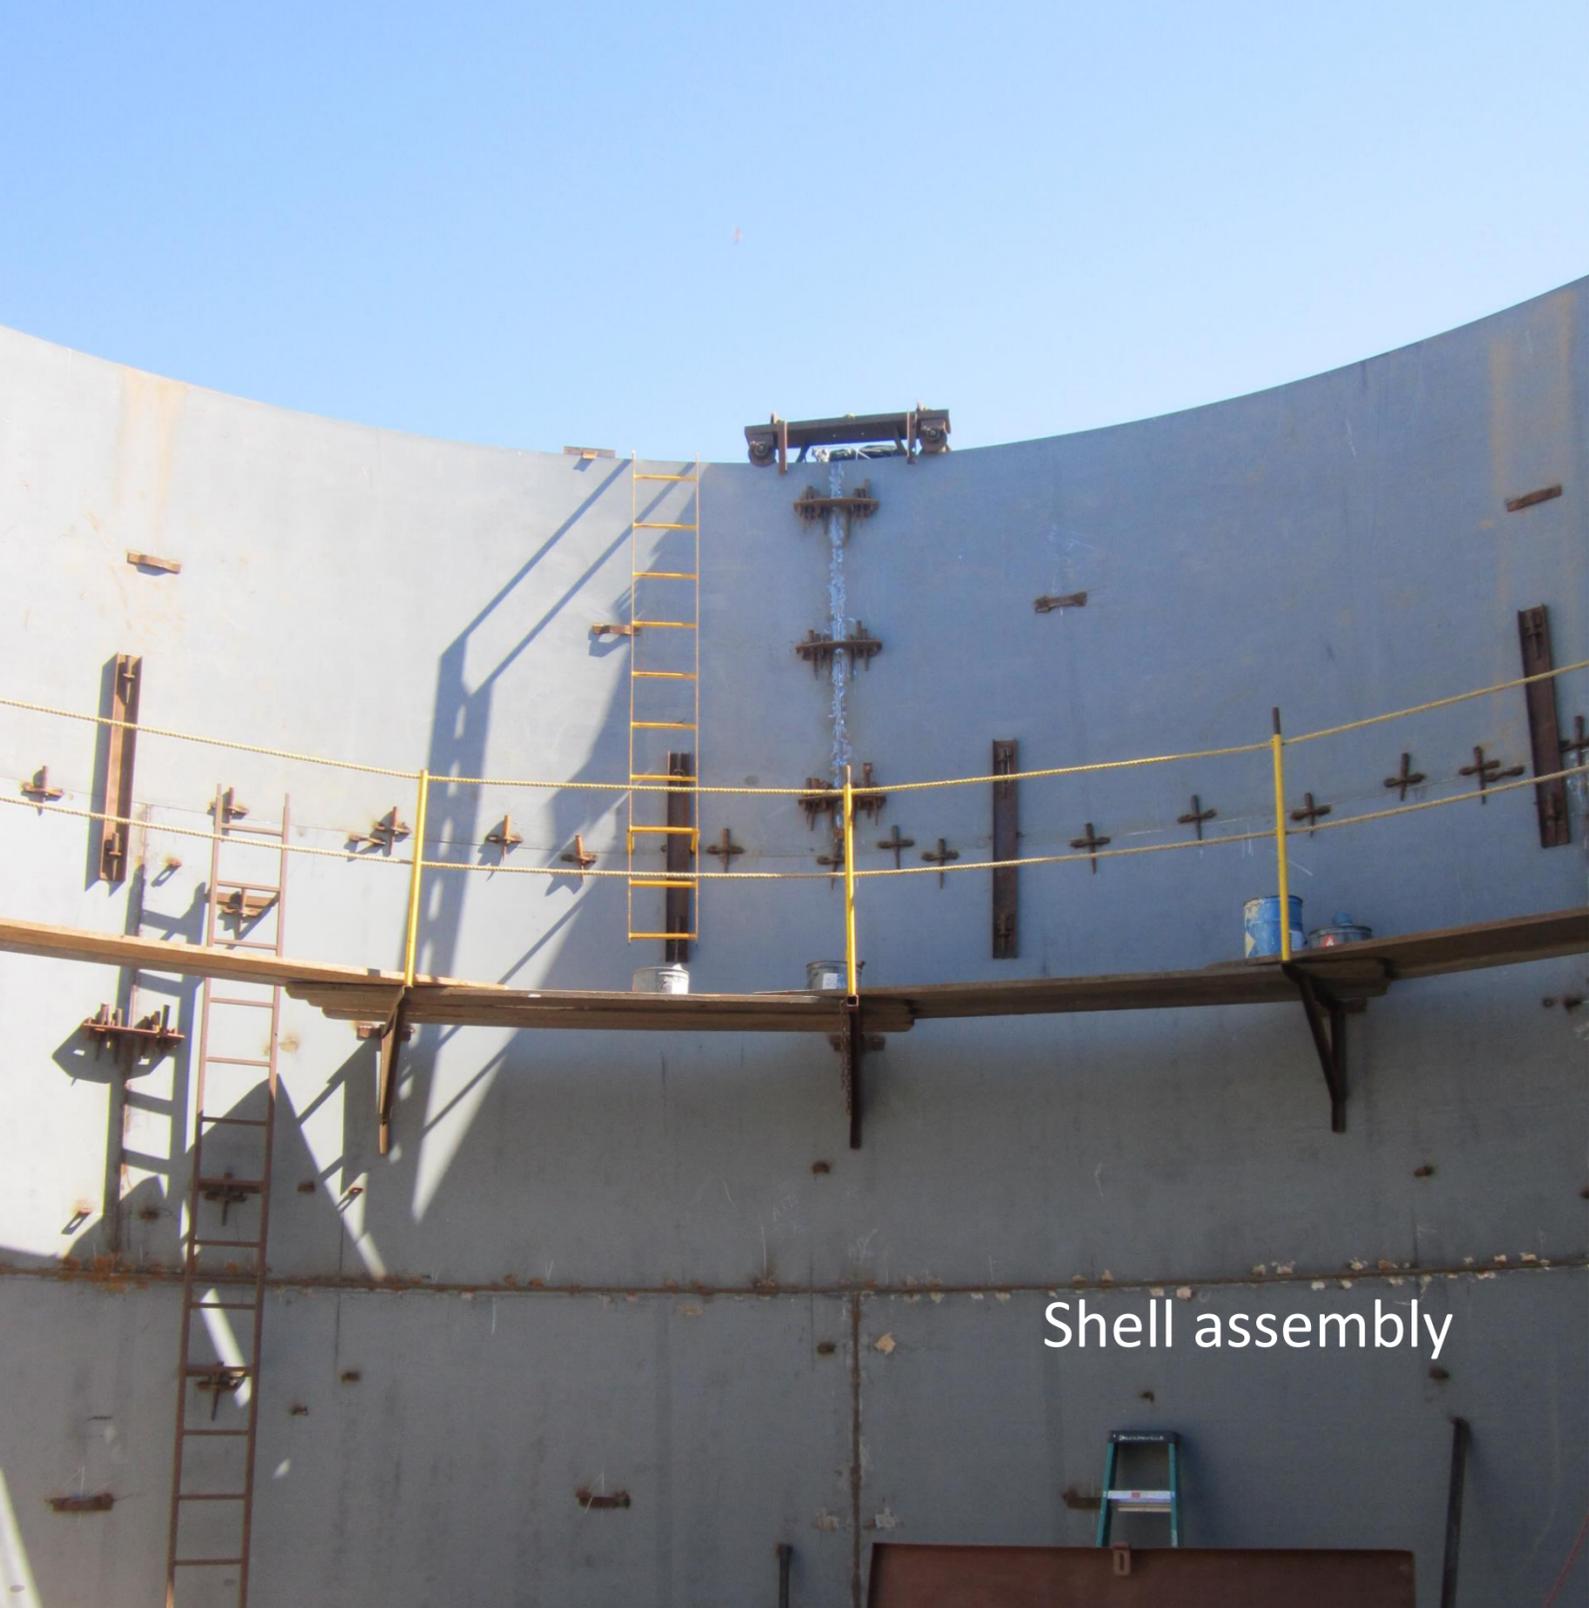
Shell assembly

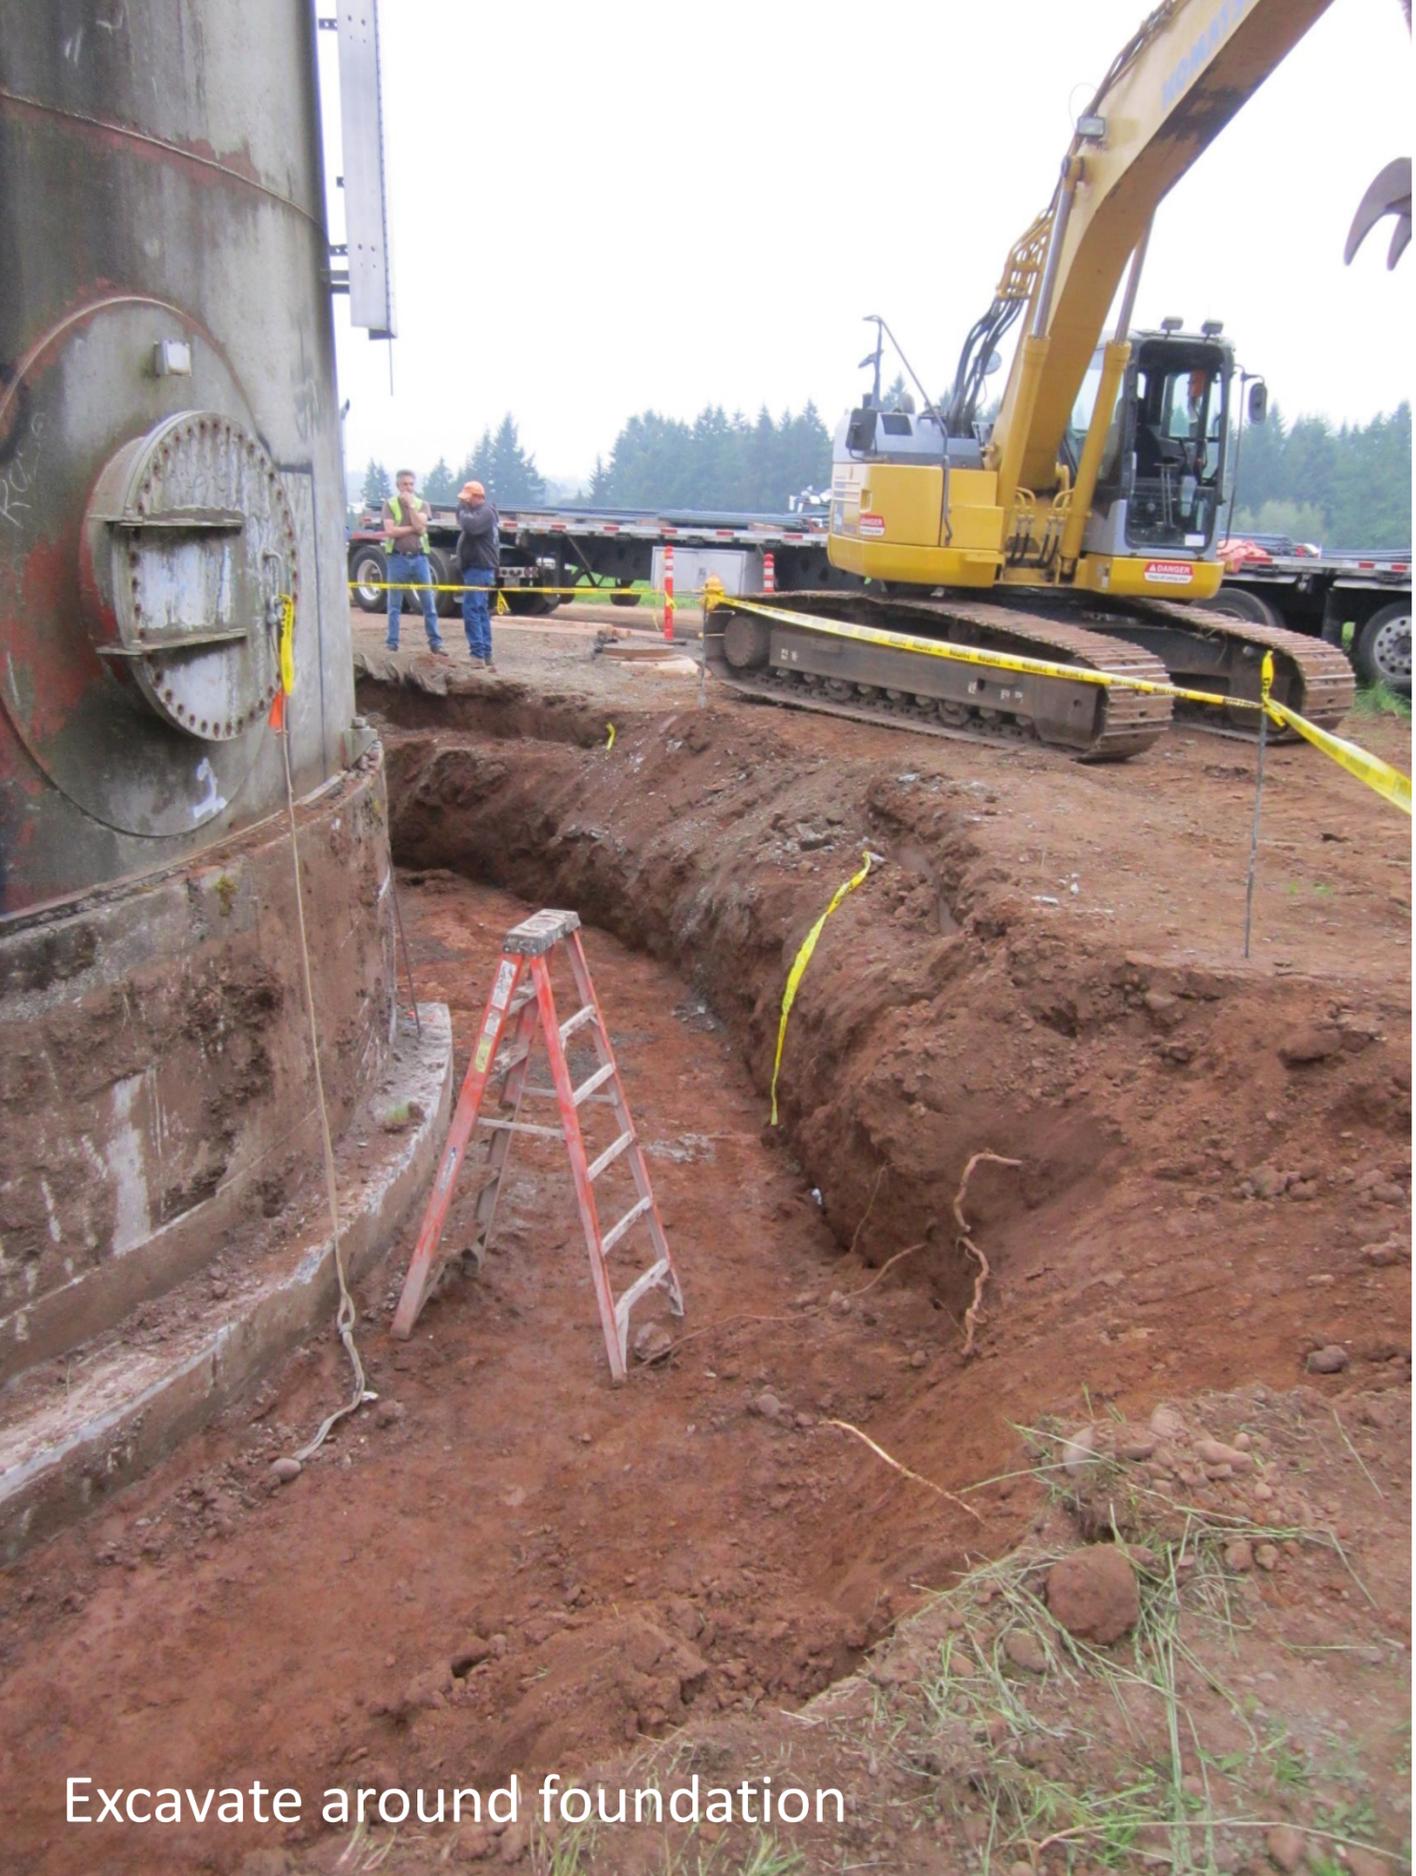
Excavate around foundation

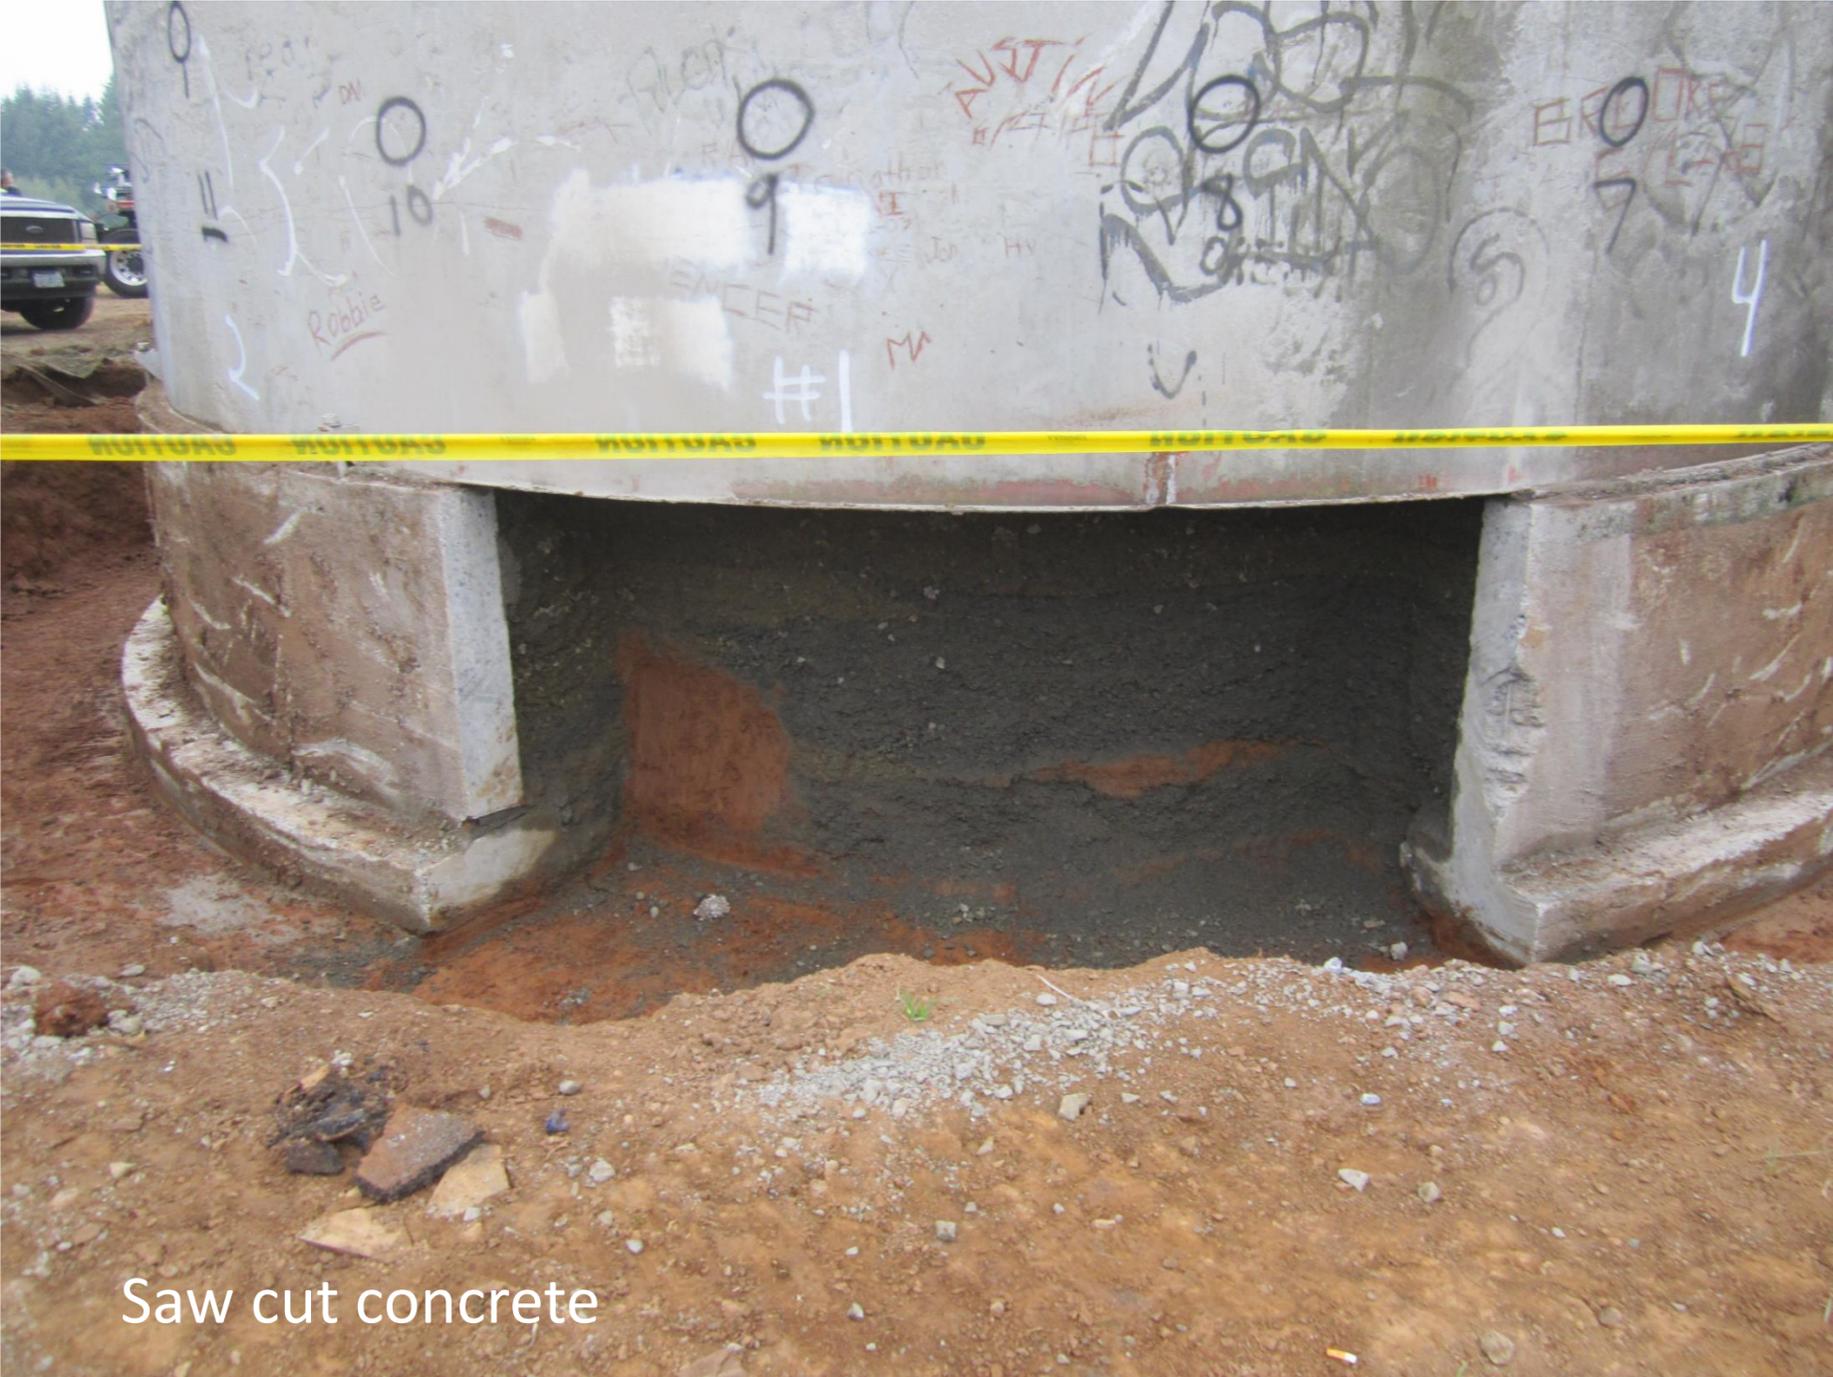
Saw cut concrete

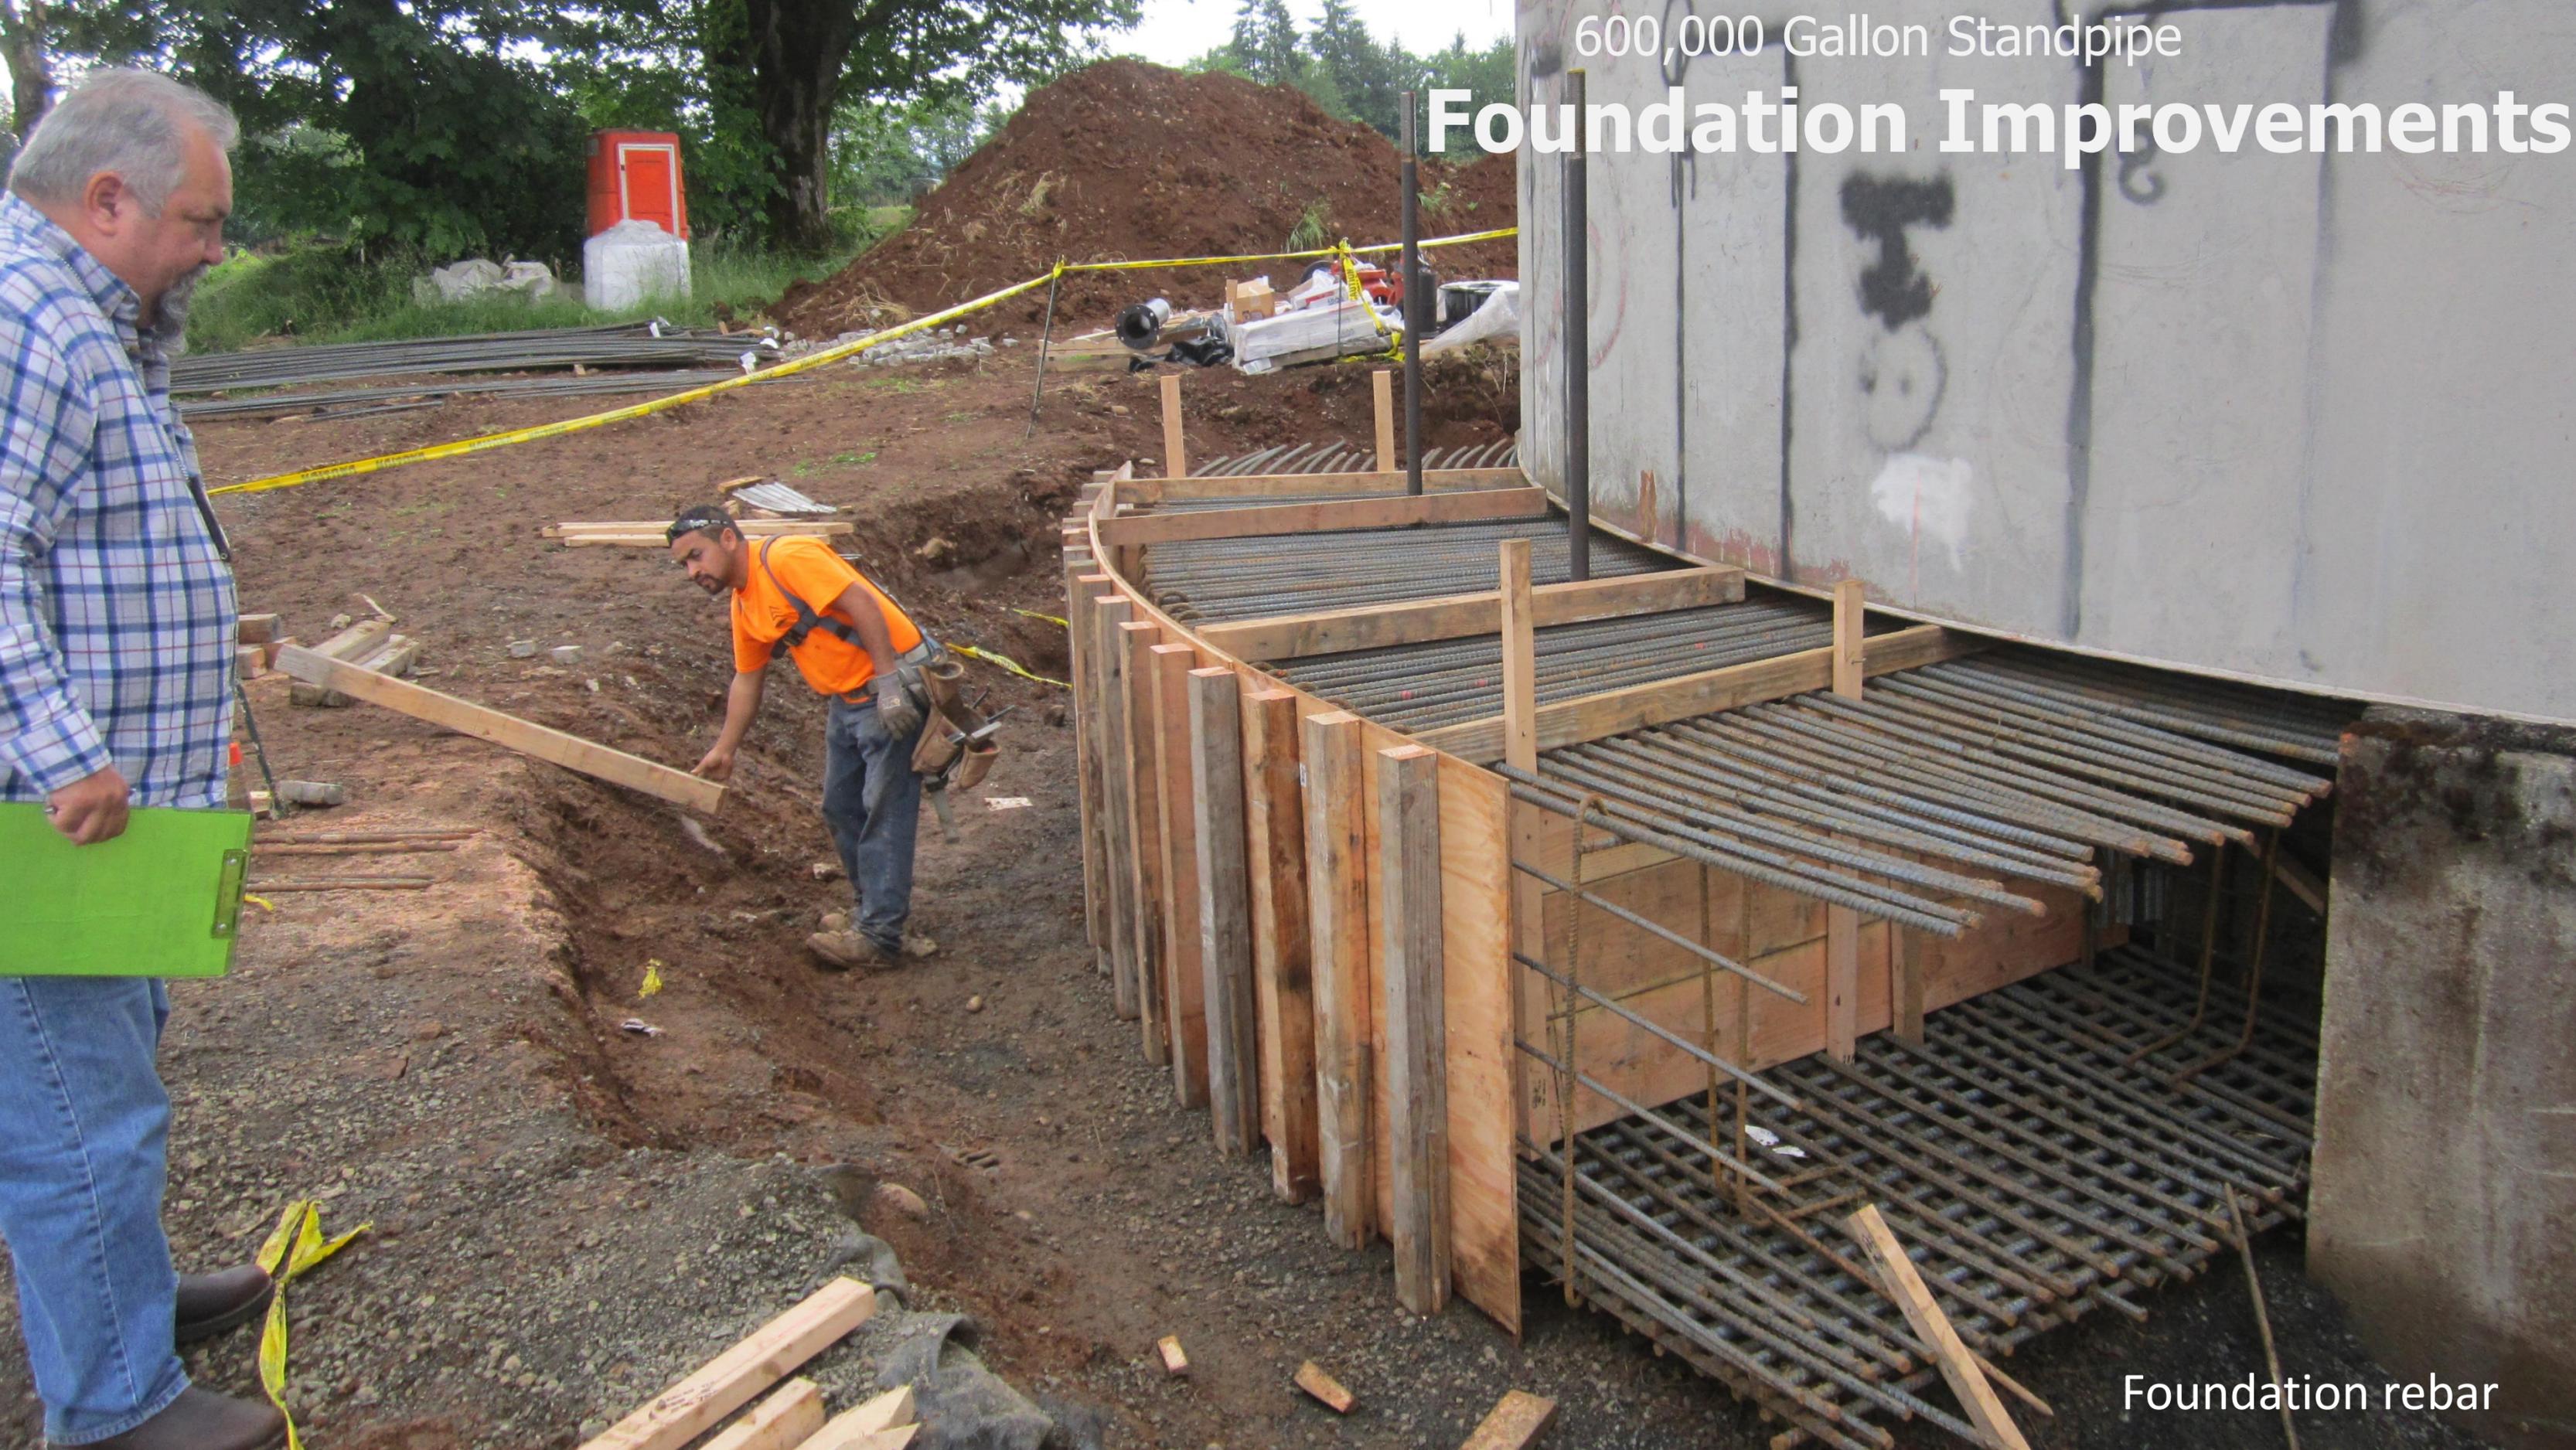
Foundation rebar

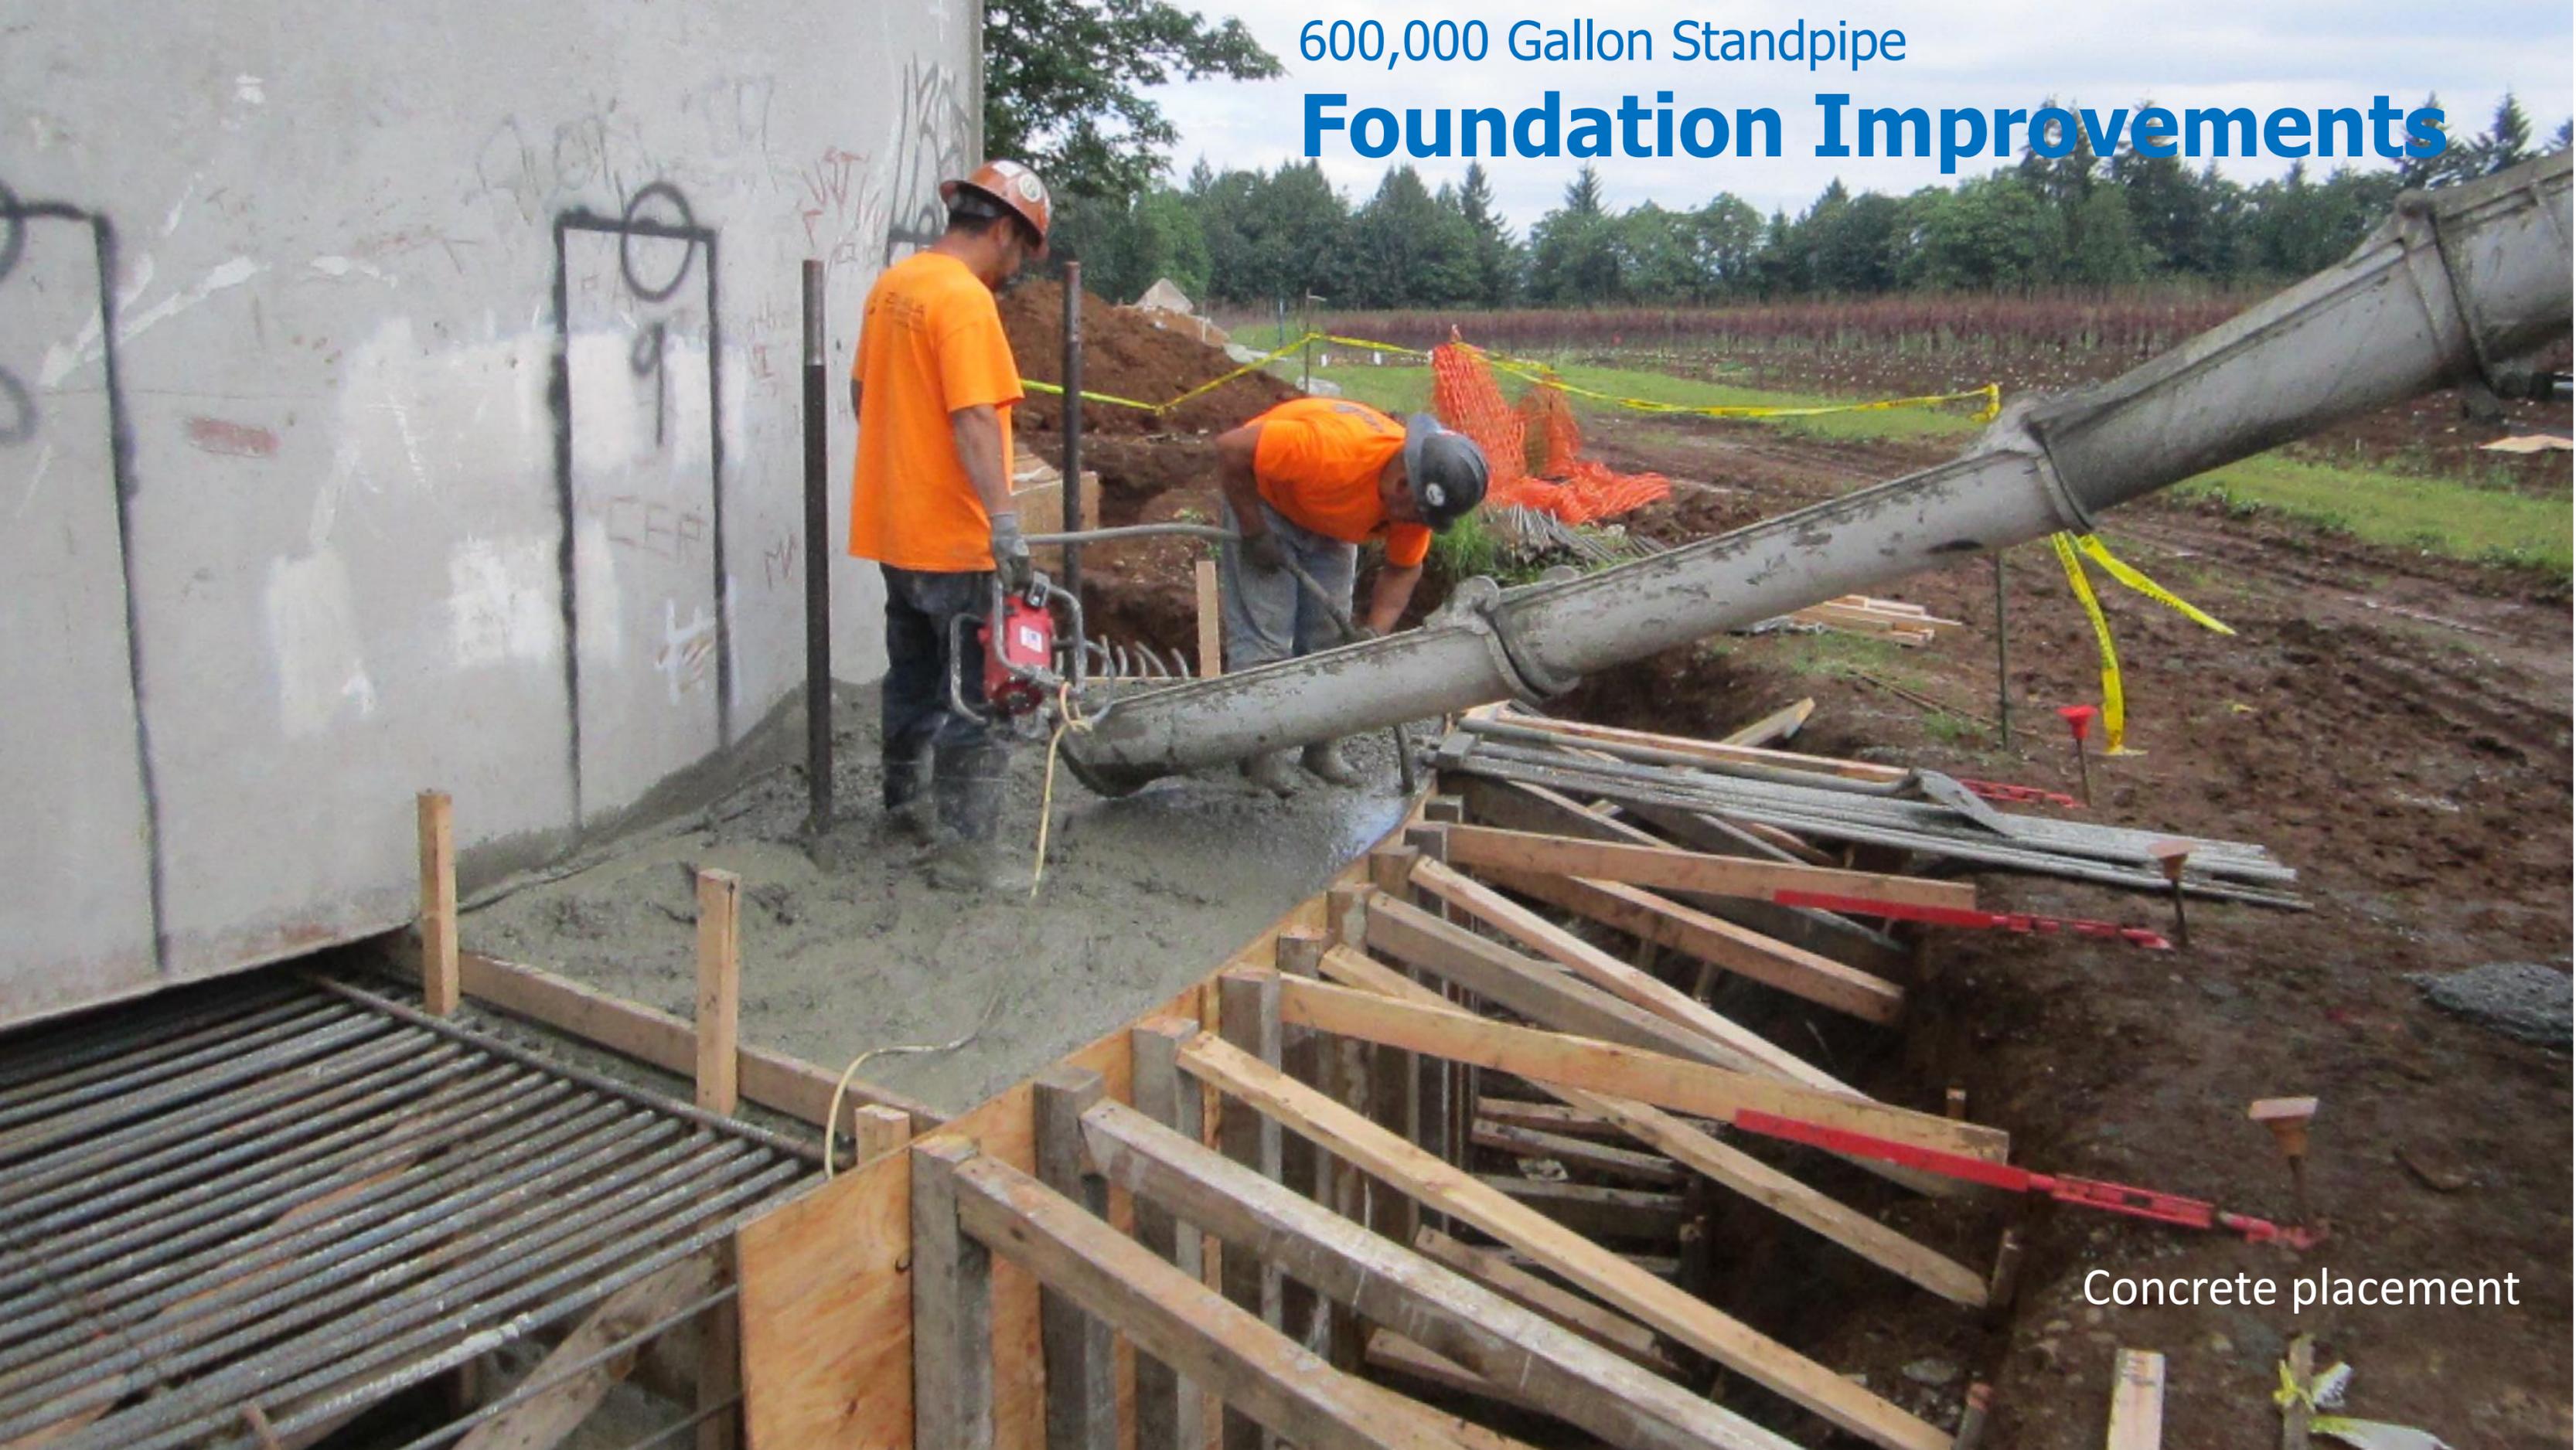
Concrete placement

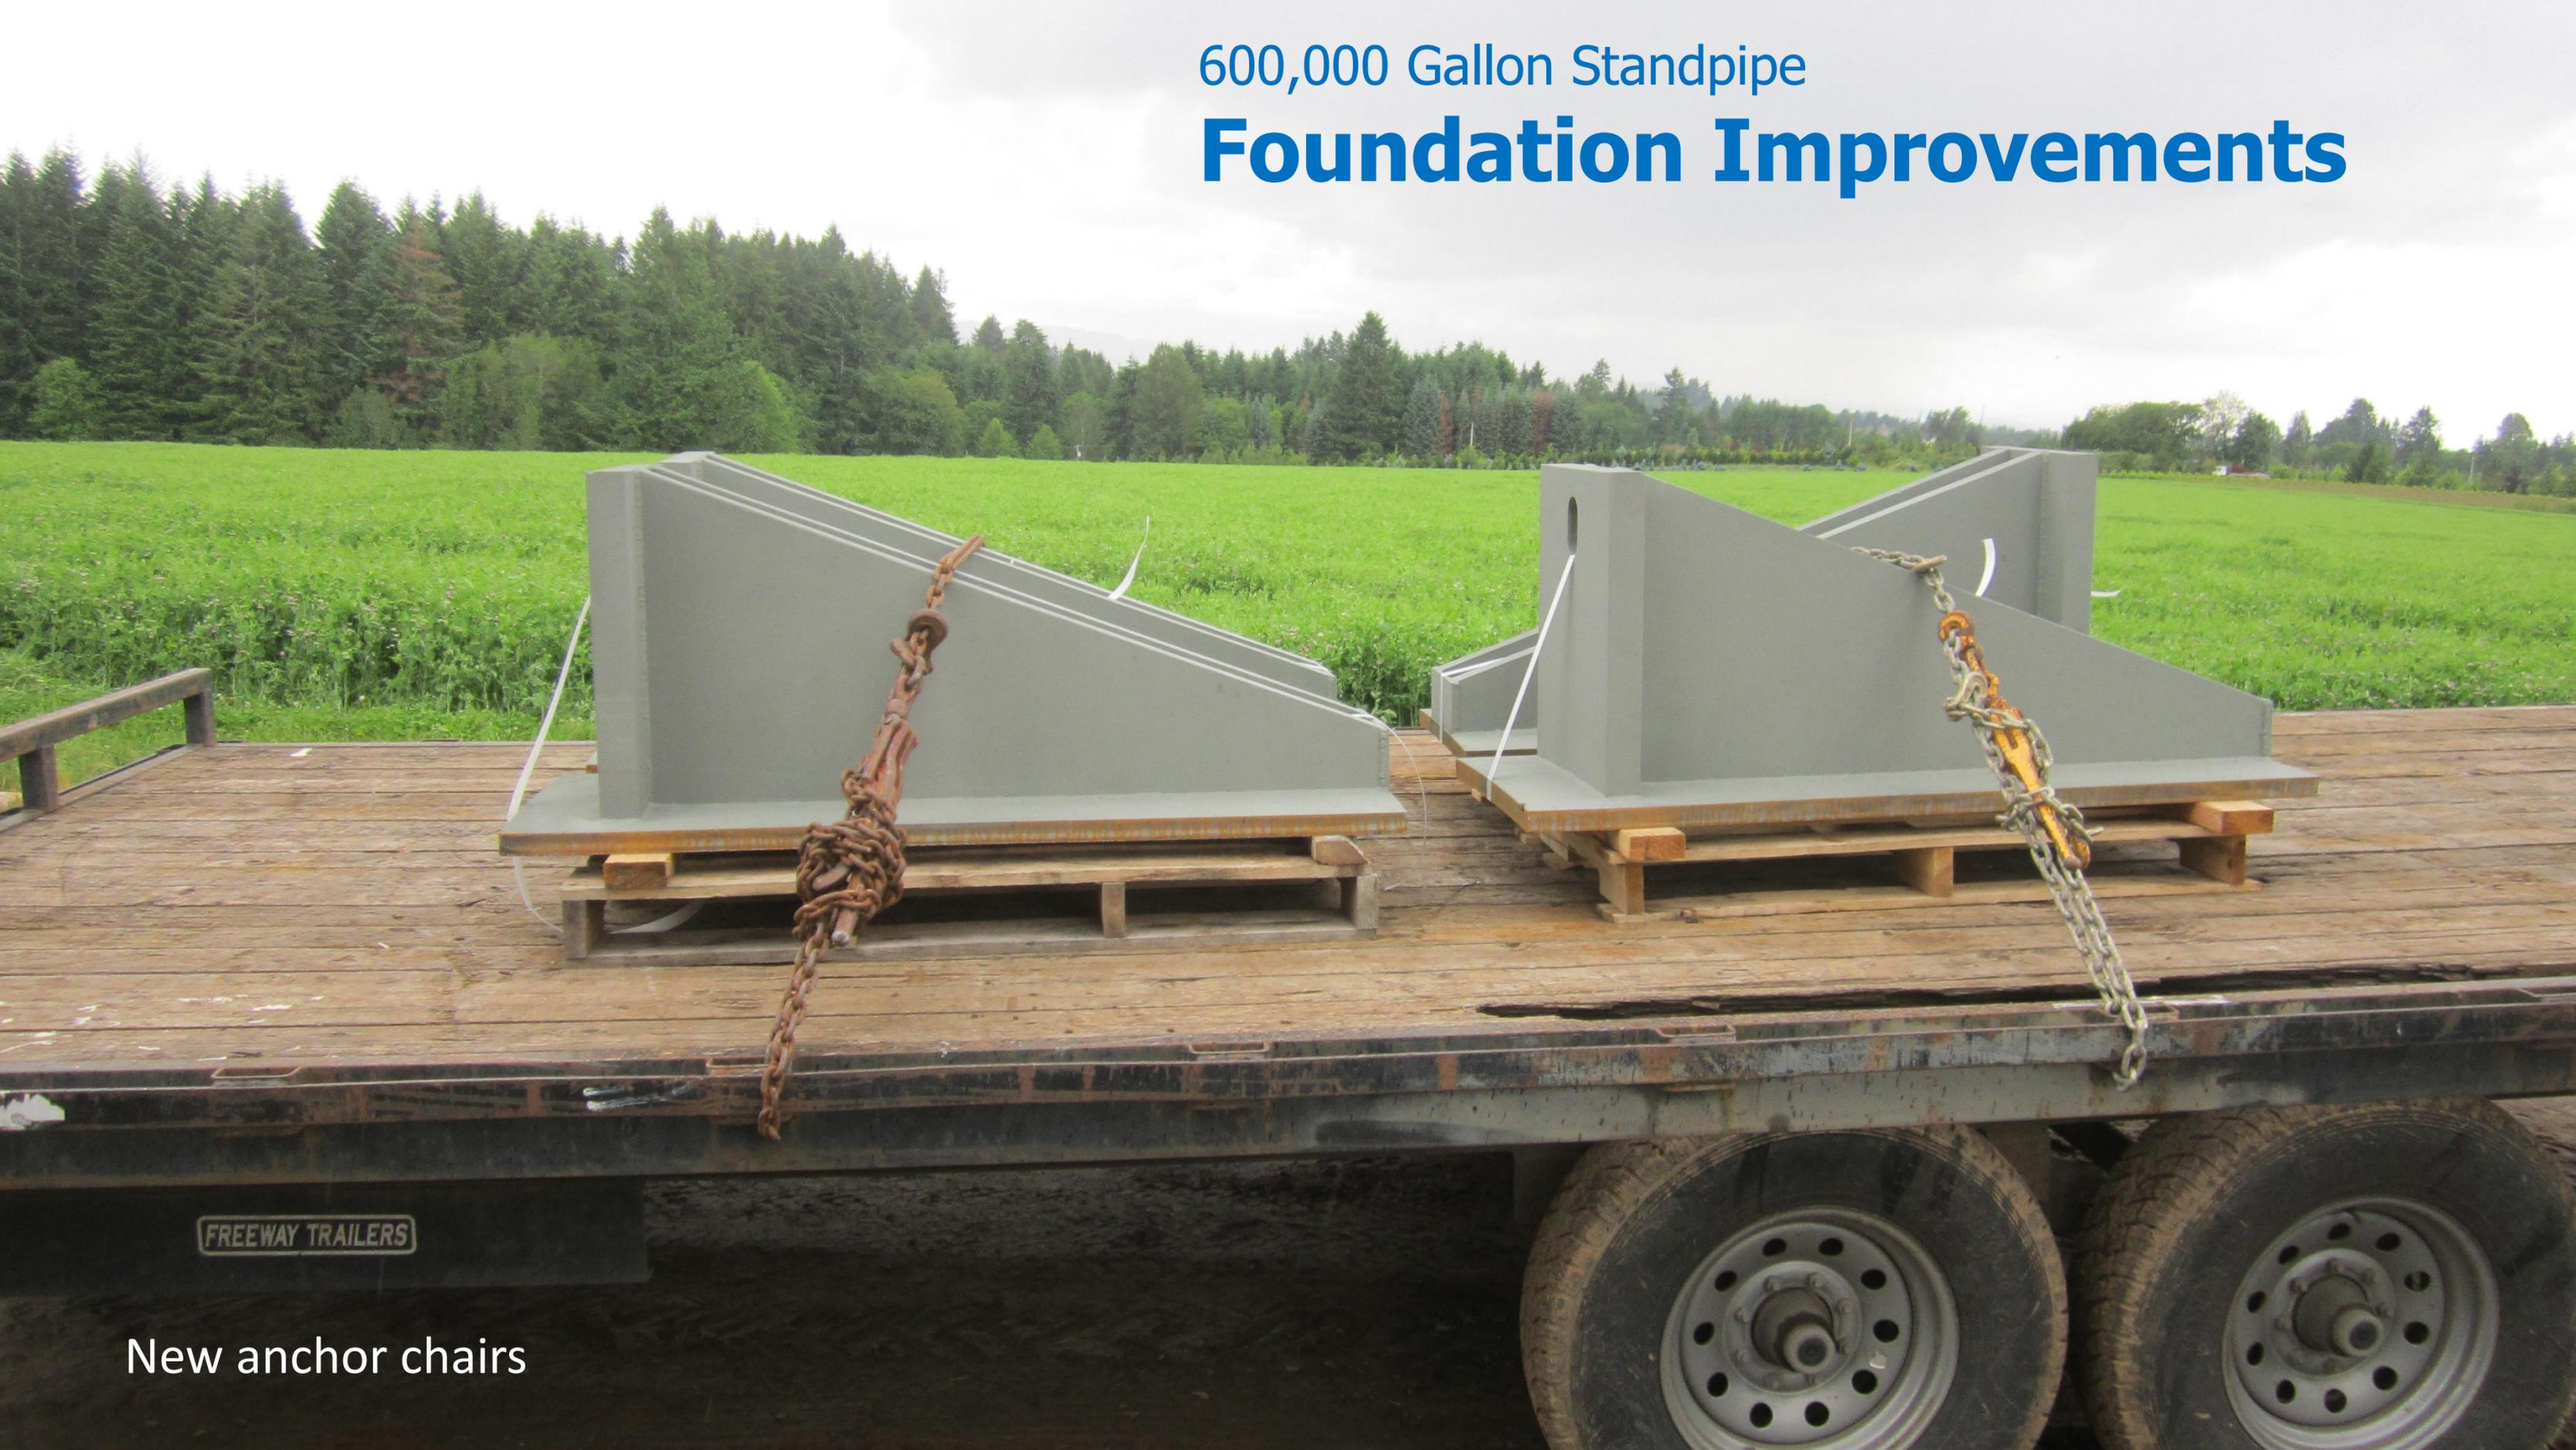
New anchor chairs
