40 Years and Counting: How To Keep A Good Tank Going

Presented by: Lael Alderman, PE | Murray, Smith & Associates, Inc.

Pleasant Home Water District

600,000 Gallon Standpipe

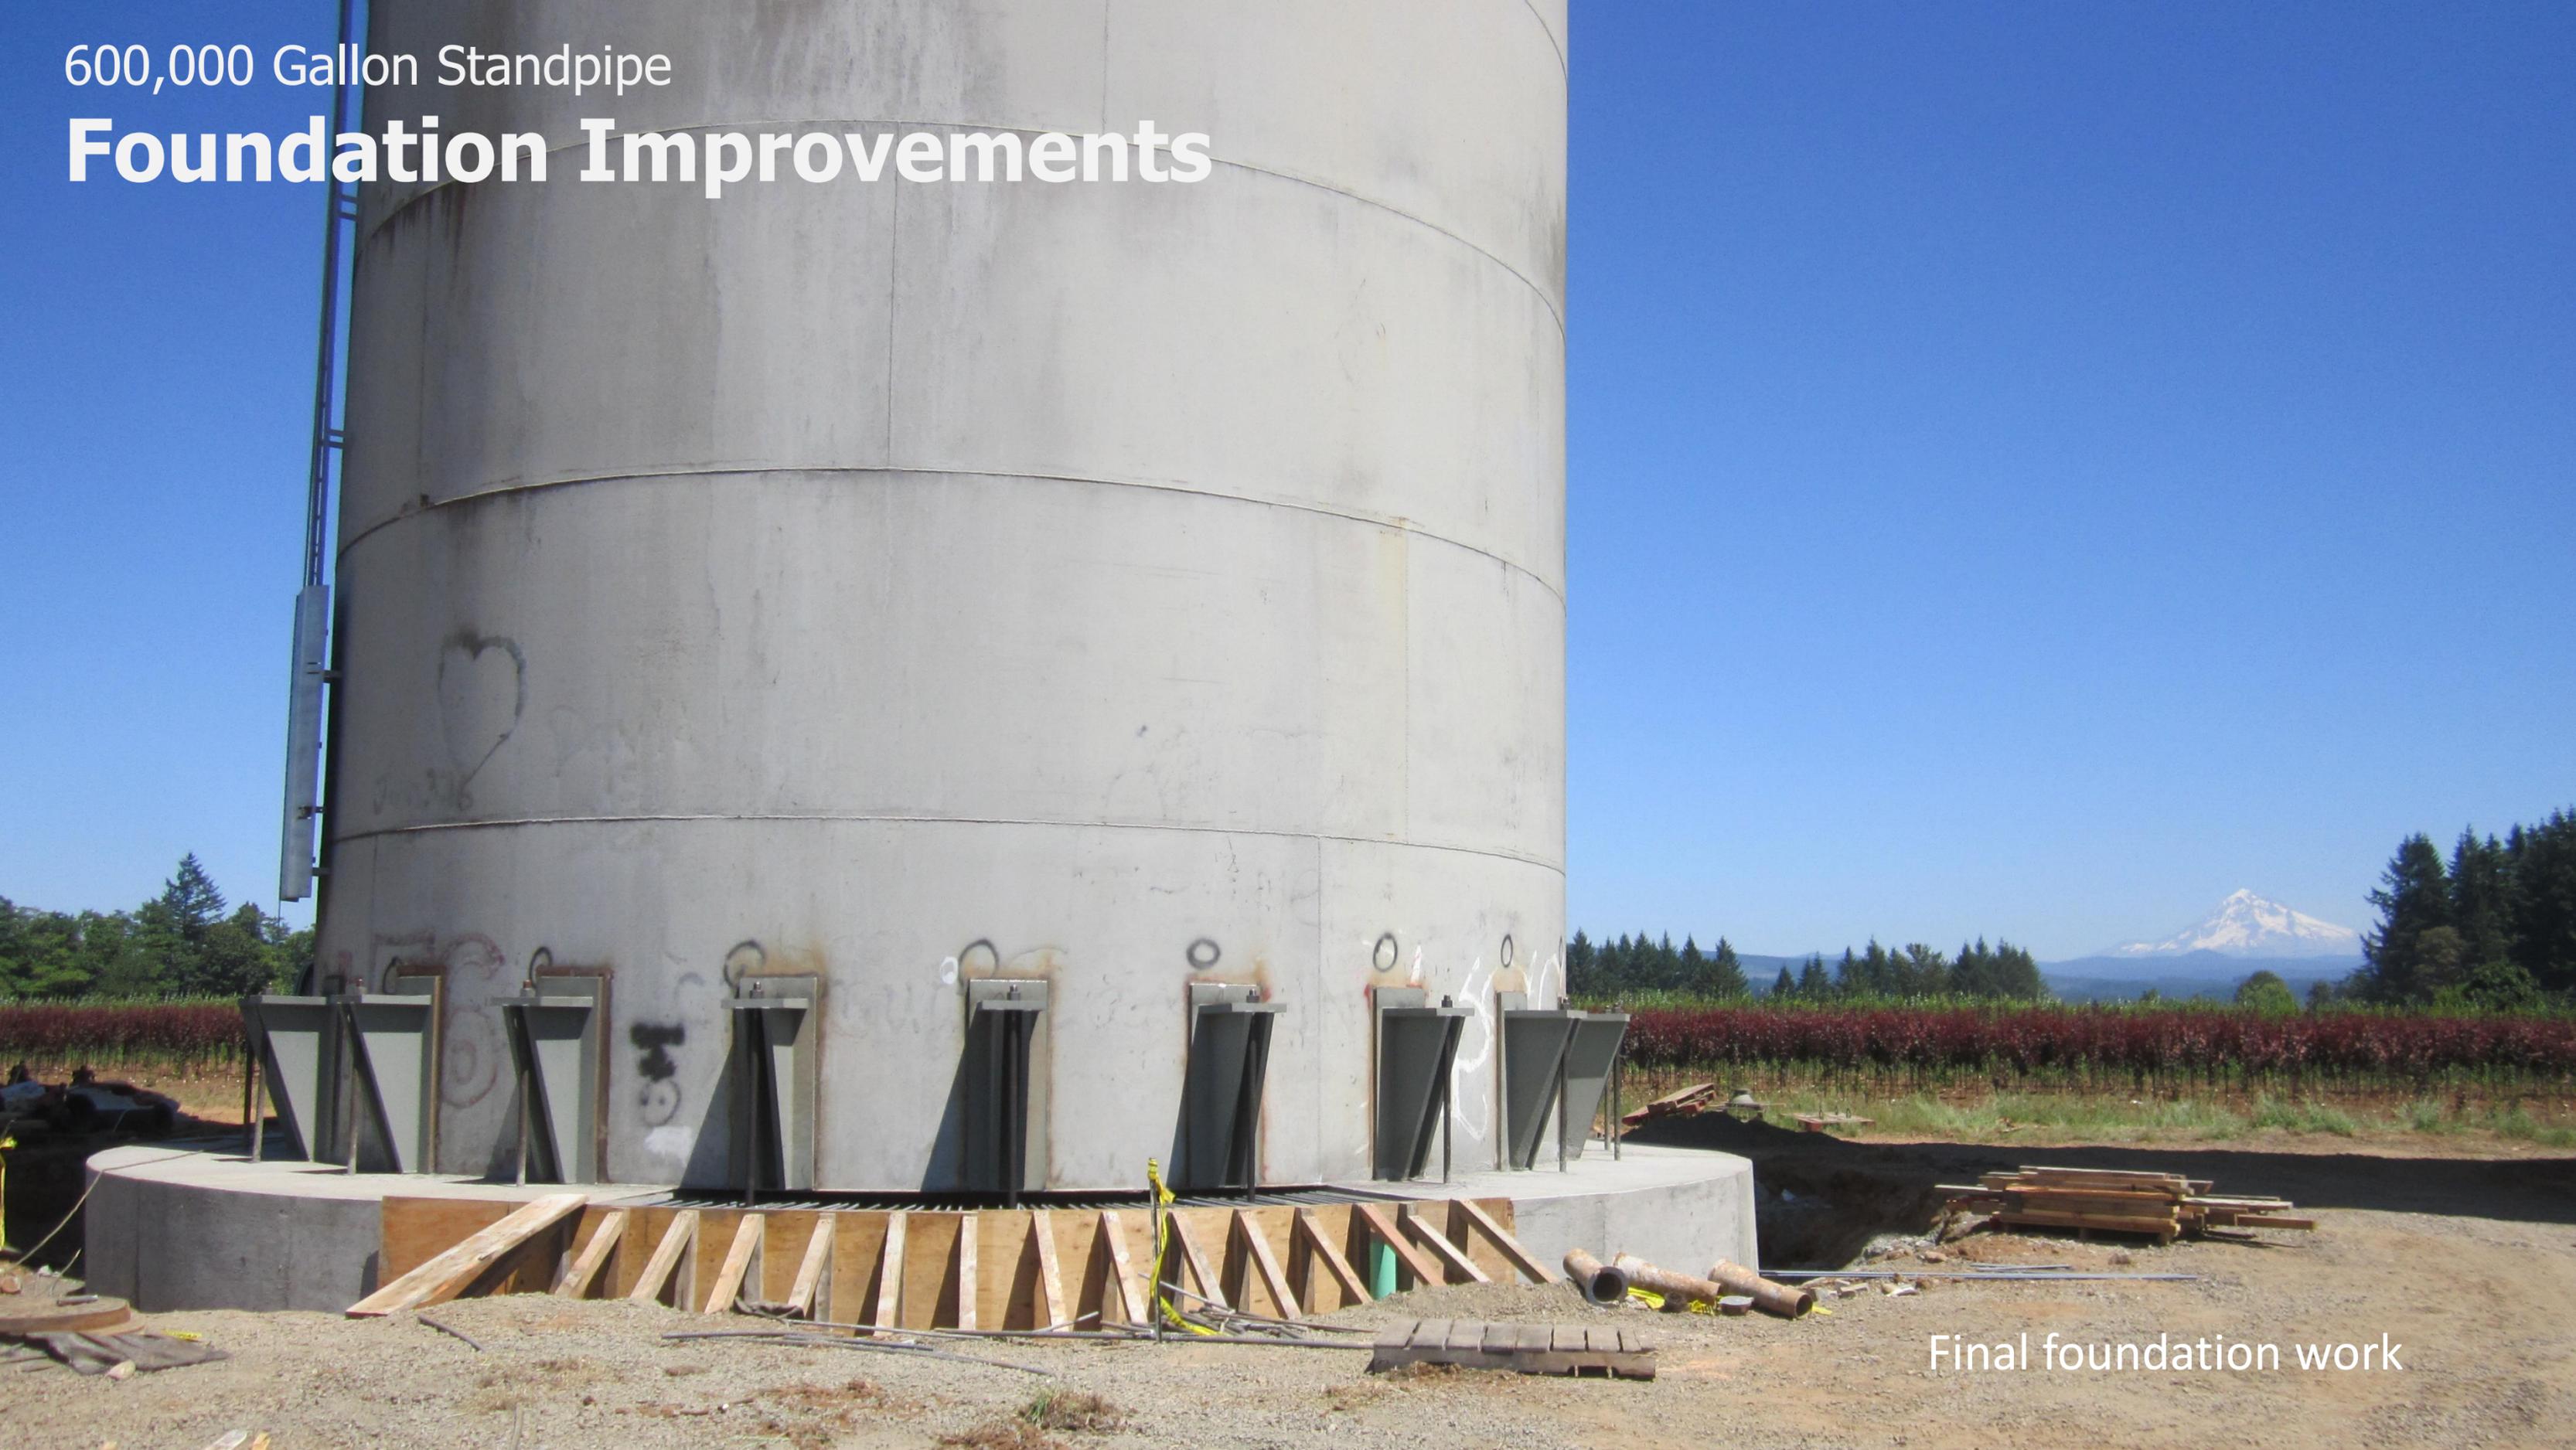
Final foundation work

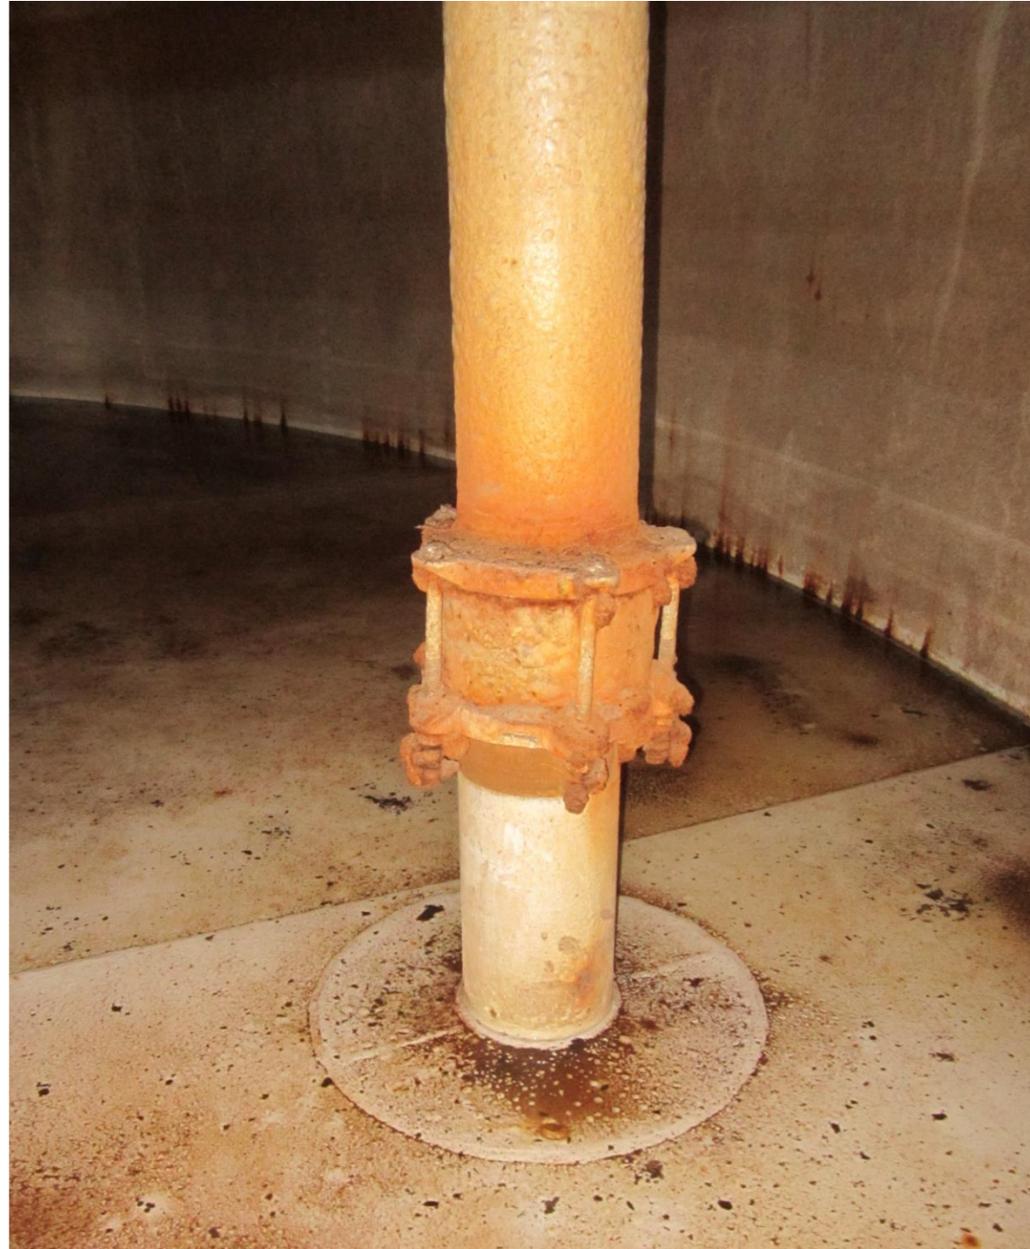
Old overflow coupling

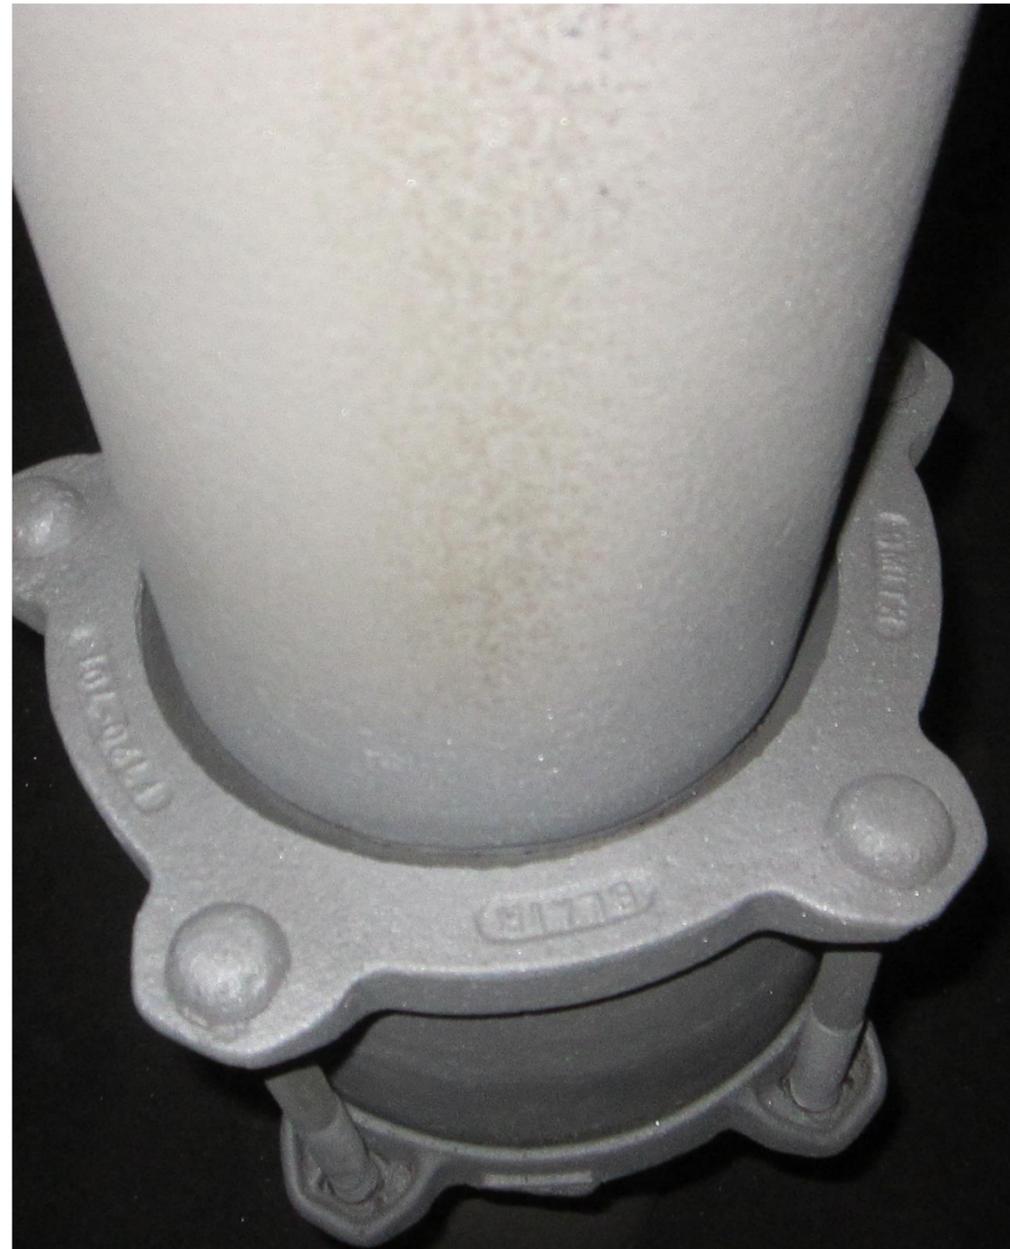
Rehab of old coupling

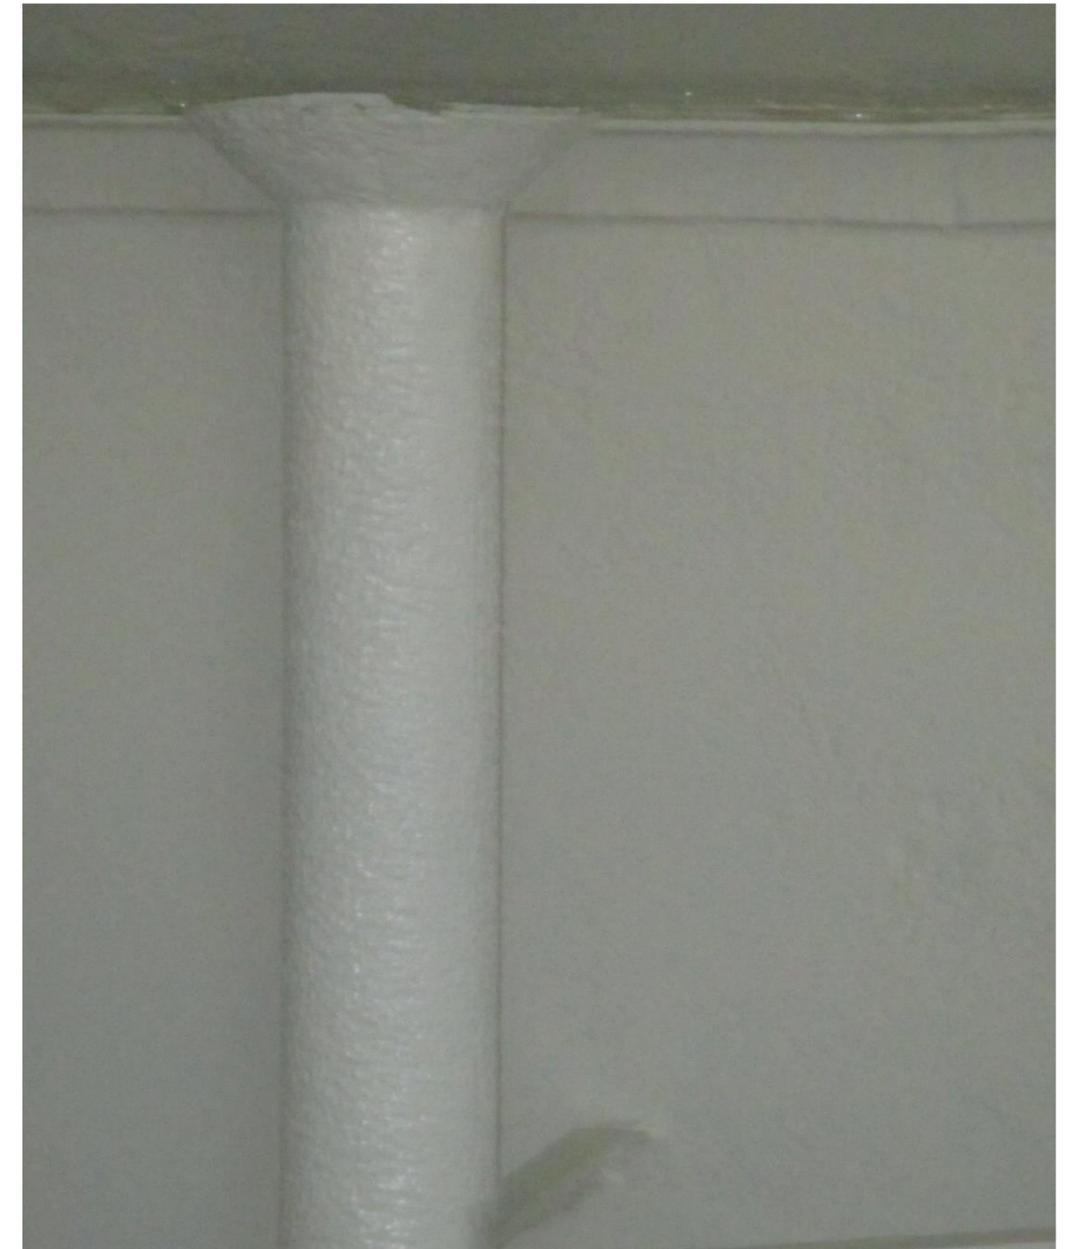
Rehab of existing overflow pipe

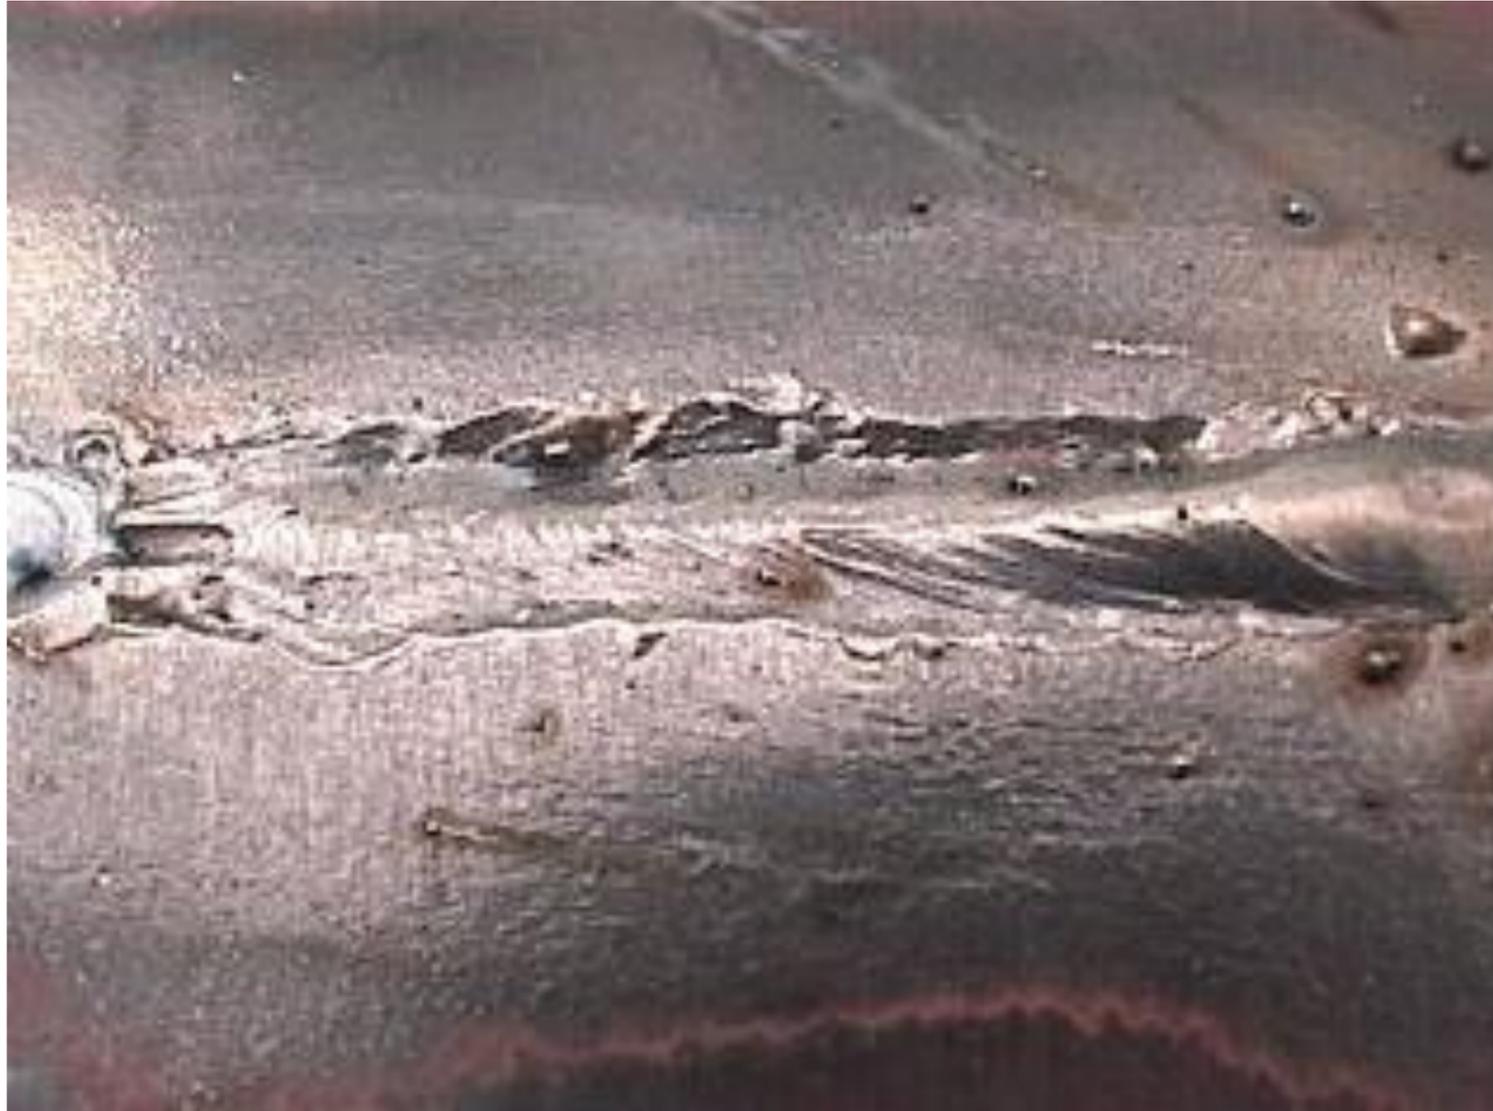
Poor welds at plate seams, splatter

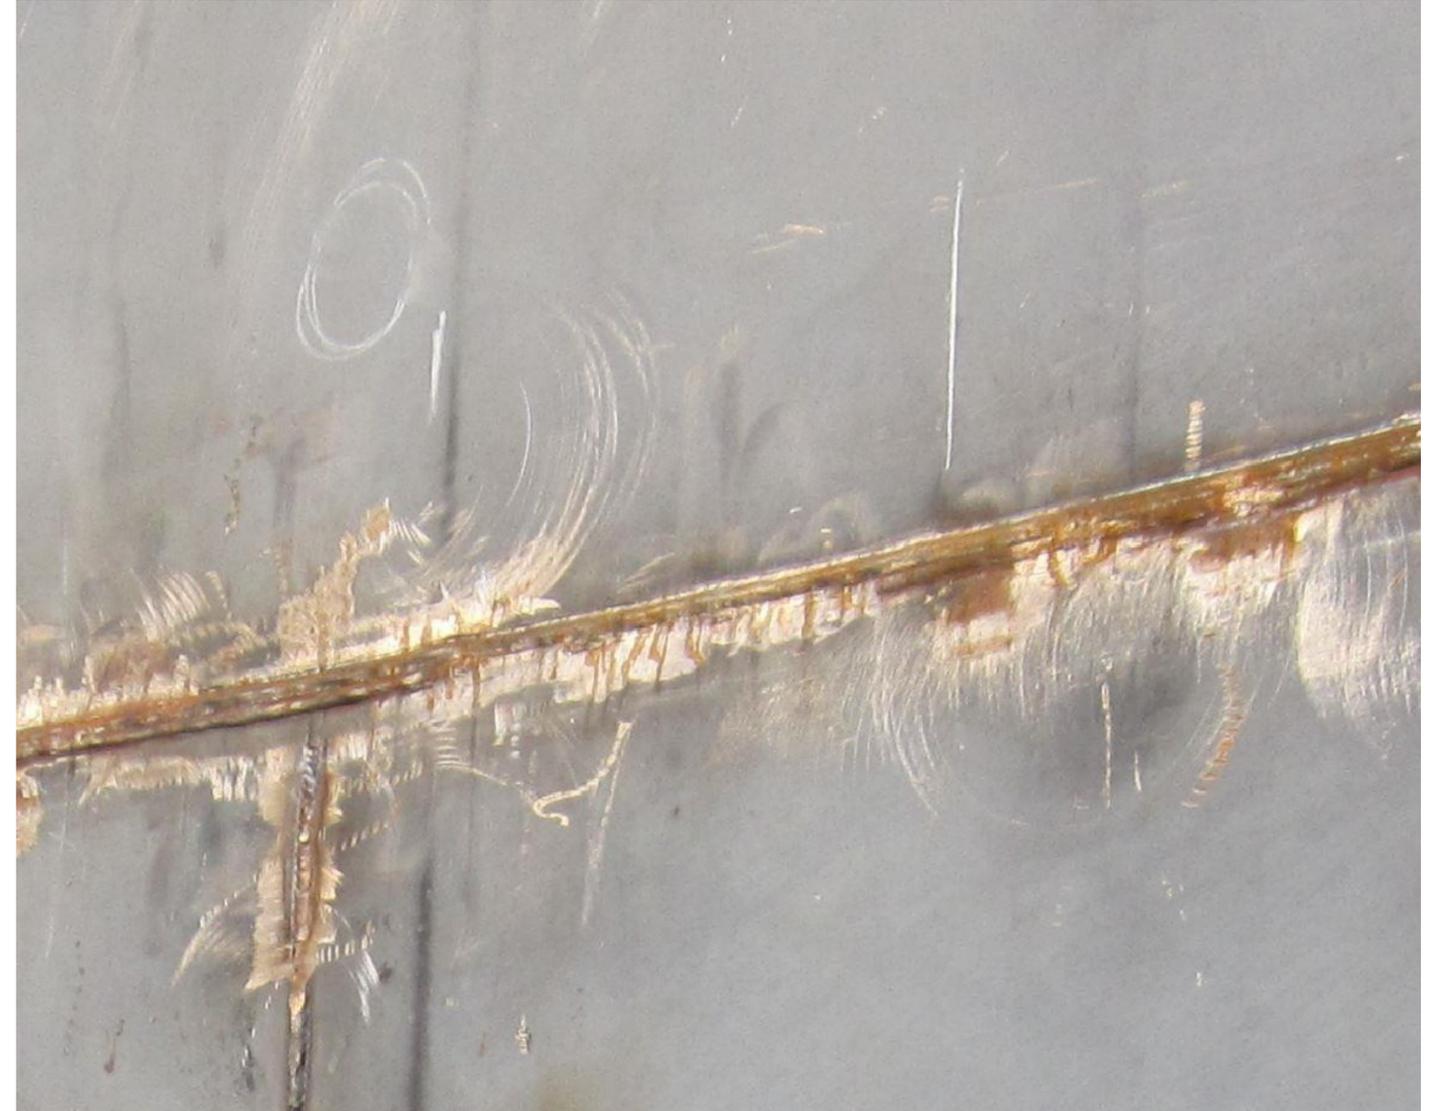
Reconditioned welds (grind)

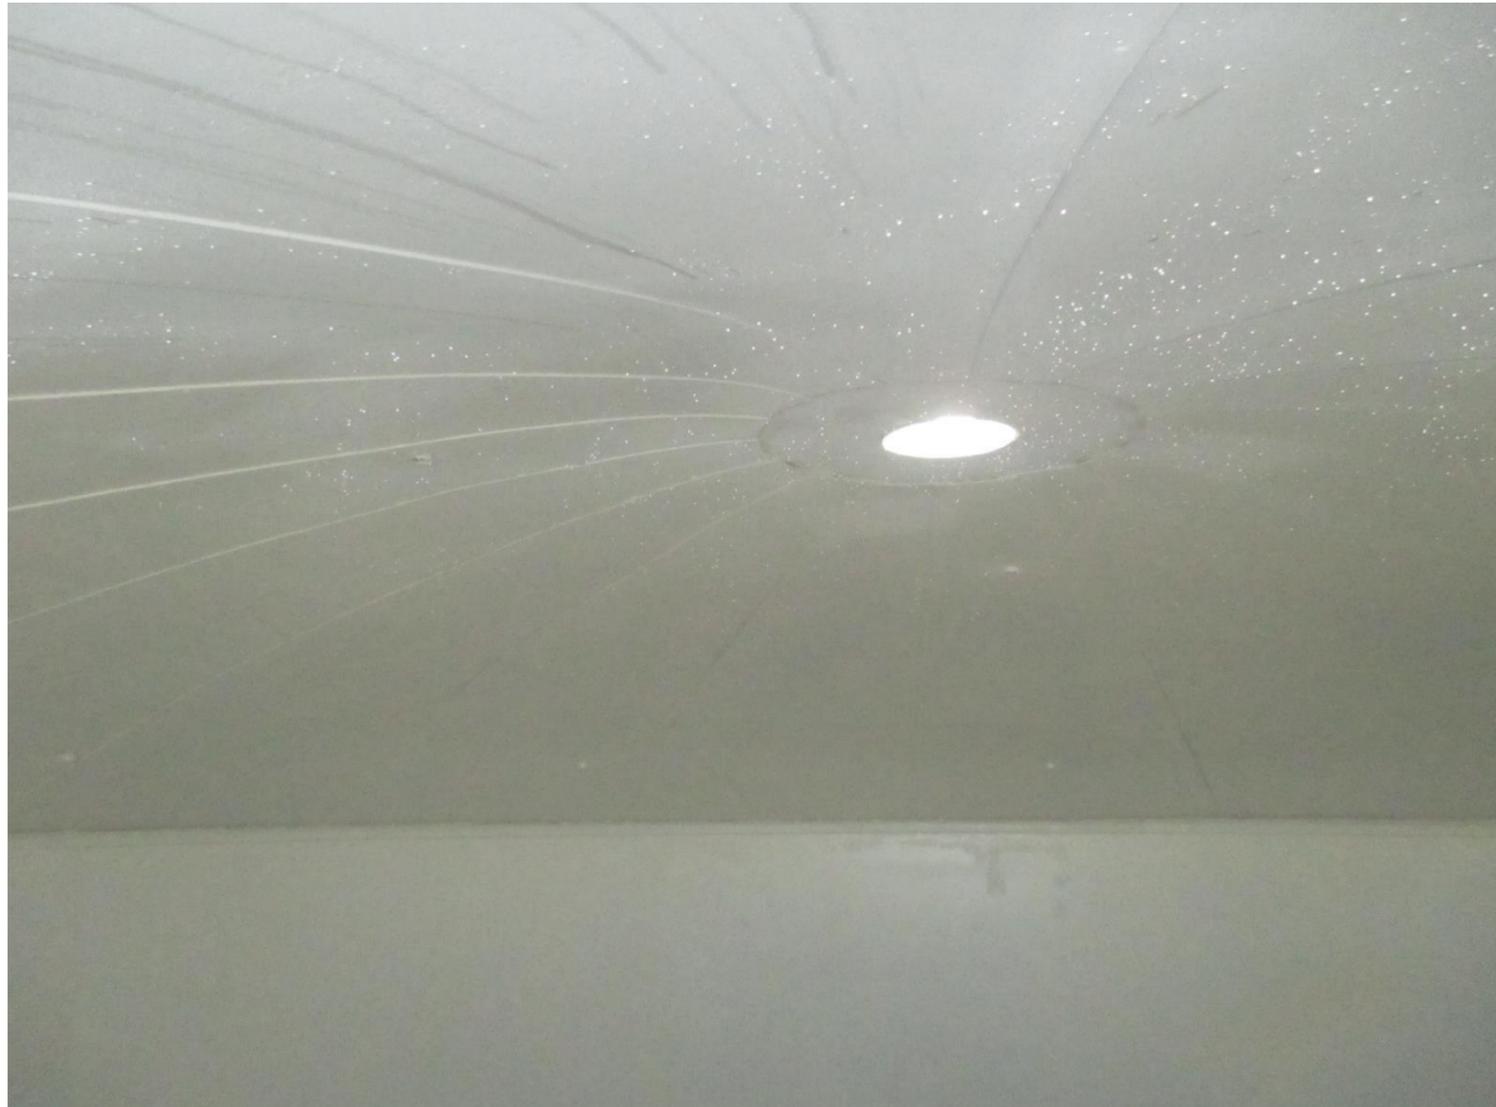
Recoated ceiling

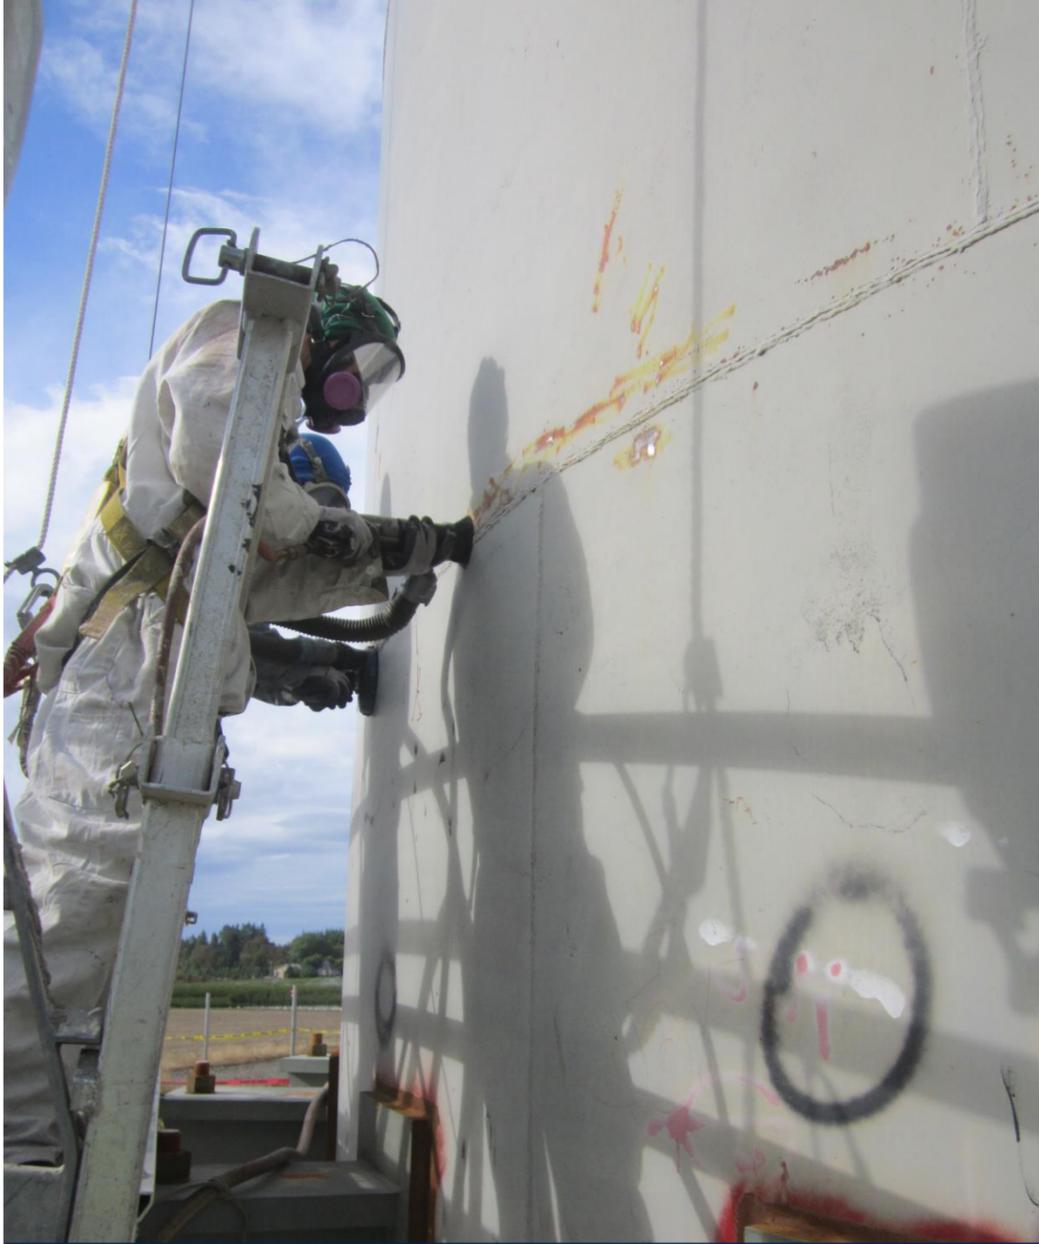
Surface preparation

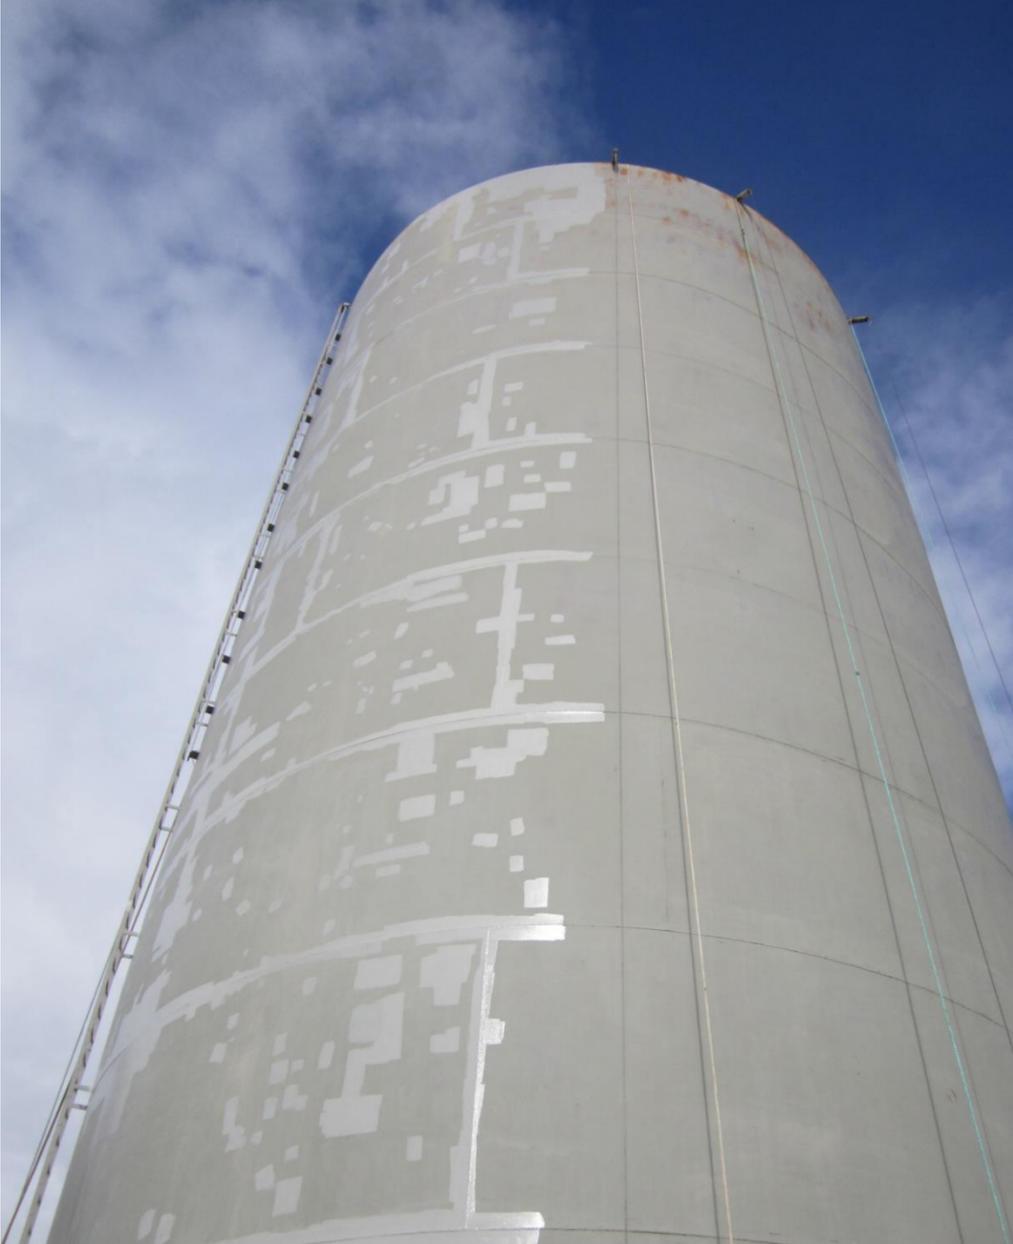
Spot priming

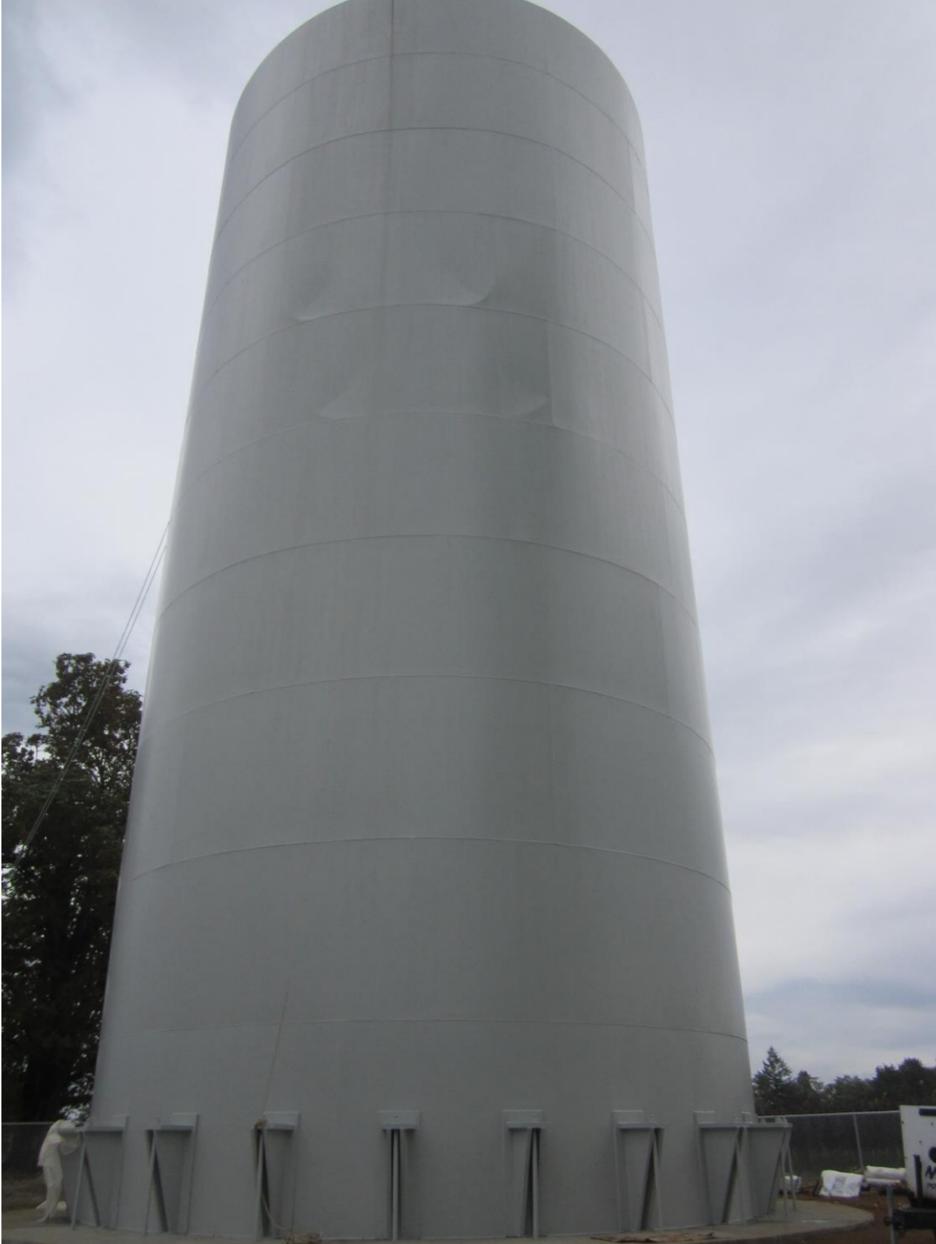
Tie coat
