Chinook, Montana WTP

Challenges with Treating the Milk River

Jeff Ashley, P.E.

PNWS-AWWA
2017 Annual Conference

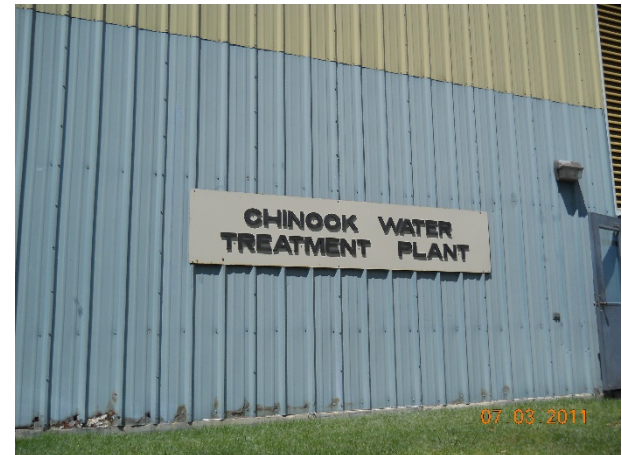
Treatment Plant

Conventional Filtration (1976) 0.75 mgd

1. Raw Water Pumping
2. Coagulation / Flocculation / Settling
 - ✓ Suspended solids
 - ✓ Total Organic Carbon (TOC)
3. Mixed Media Filtration
4. Disinfection
 - ✓ Chlorine gas
5. High Service Pumping

Aging equipment, antiquated electrical & controls

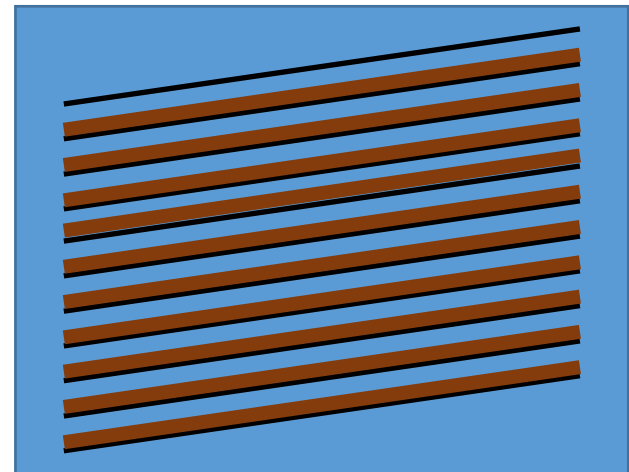
Microfloc
7.5-deg Tube Settlers

7.5-deg tubes

The image shows a laboratory experiment setup. A wooden frame contains a black corrugated tube. A channel within the frame is filled with a yellow liquid, likely oil, which is used to observe the flow characteristics of the 7.5-degree tubes. The setup is designed to study fluid dynamics in a controlled environment.

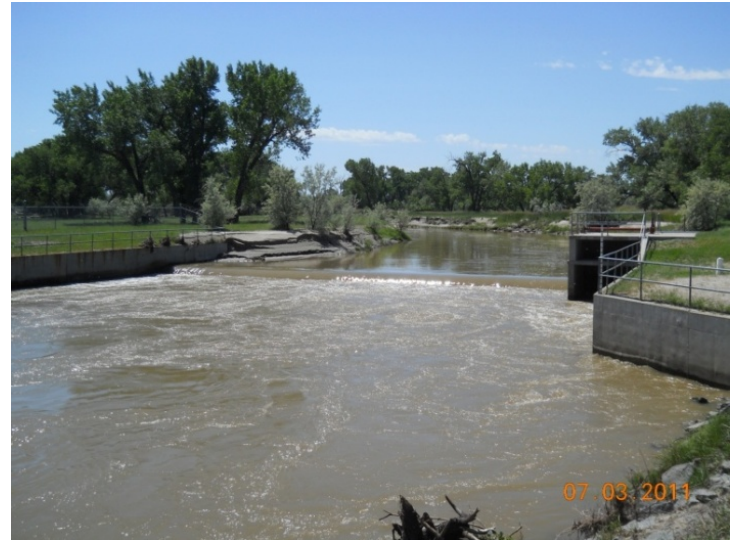
Water quality parameters

- ✓ Suspended solids
- ✓ Turbidity (~ 2,500 NTU)
- ✓ Sand, grit, etc.
- ✓ Organic material

Measured as Total Organic Carbon (TOC)

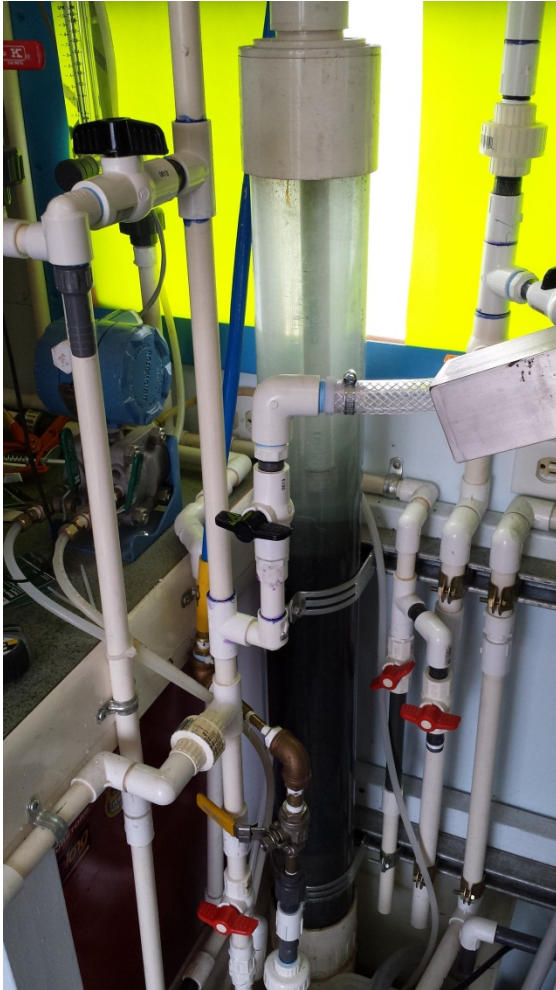
Filtration

- ✓ Mixed-media
 - Anthracite
 - Silica sand
 - Garnet sand

- ✓ 3.0 – 5.0 gpm/sf

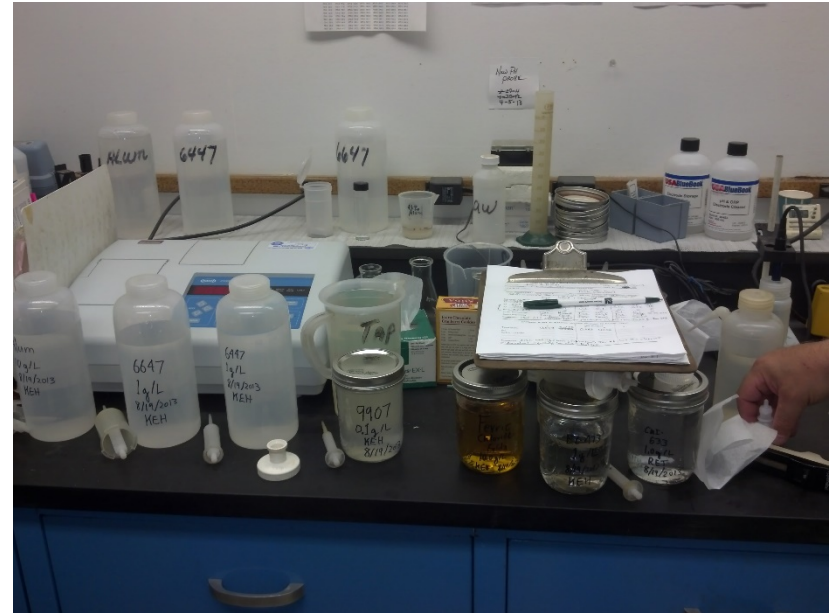
Pilot Testing

Results

- ✓ Permanganate 1-3 mg/L
- ✓ Alum 90-120 mg/L
- ✓ Powdered Activated Carbon 5-30 mg/L
- ✓ TOC → 40-50% removal
- ✓ 20 hour filter runs

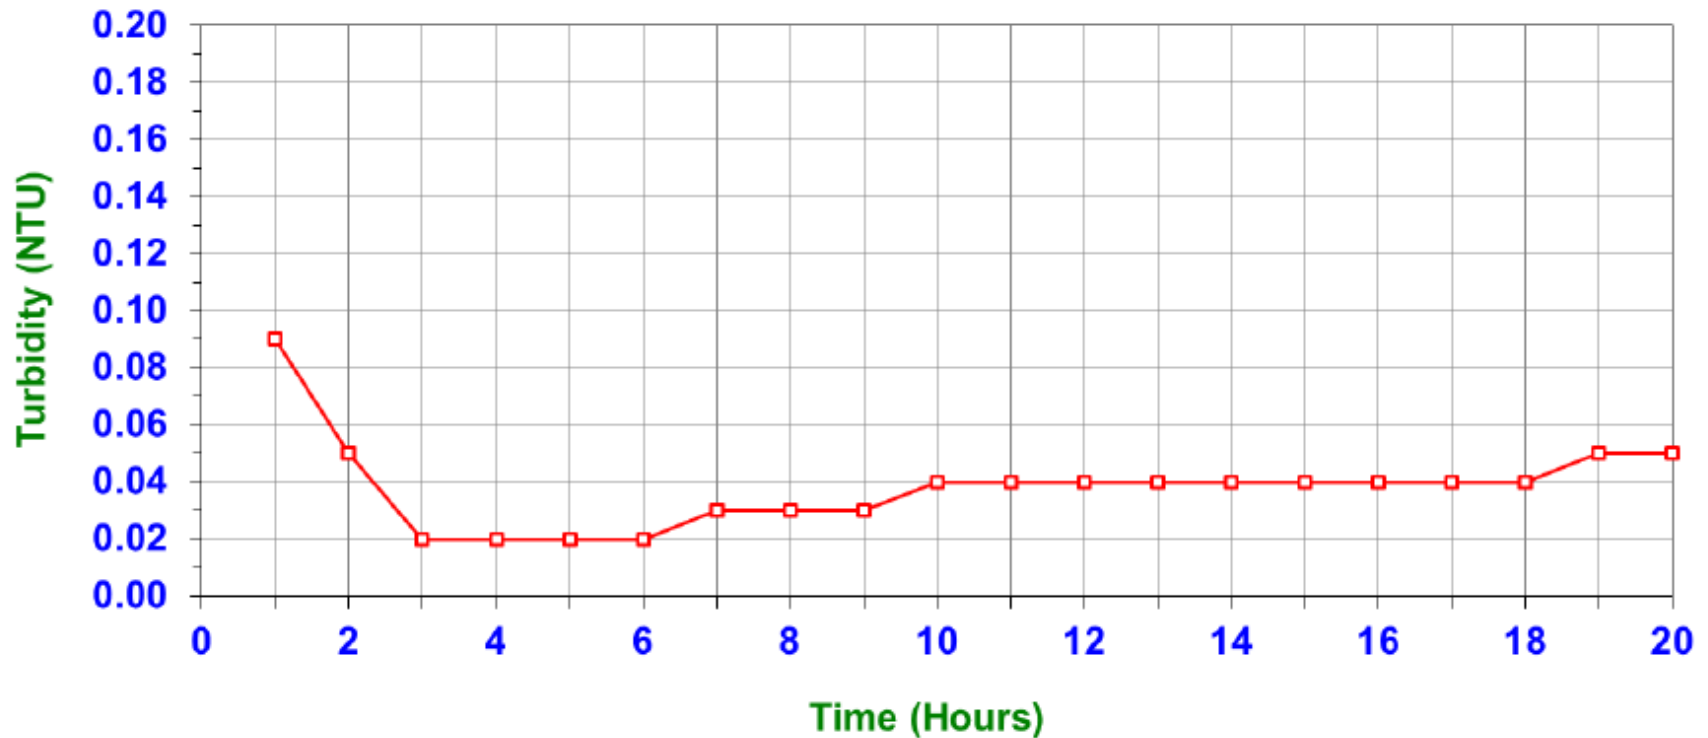
Run 6 - Chinook, MT

—□— Finish Water Turbidity

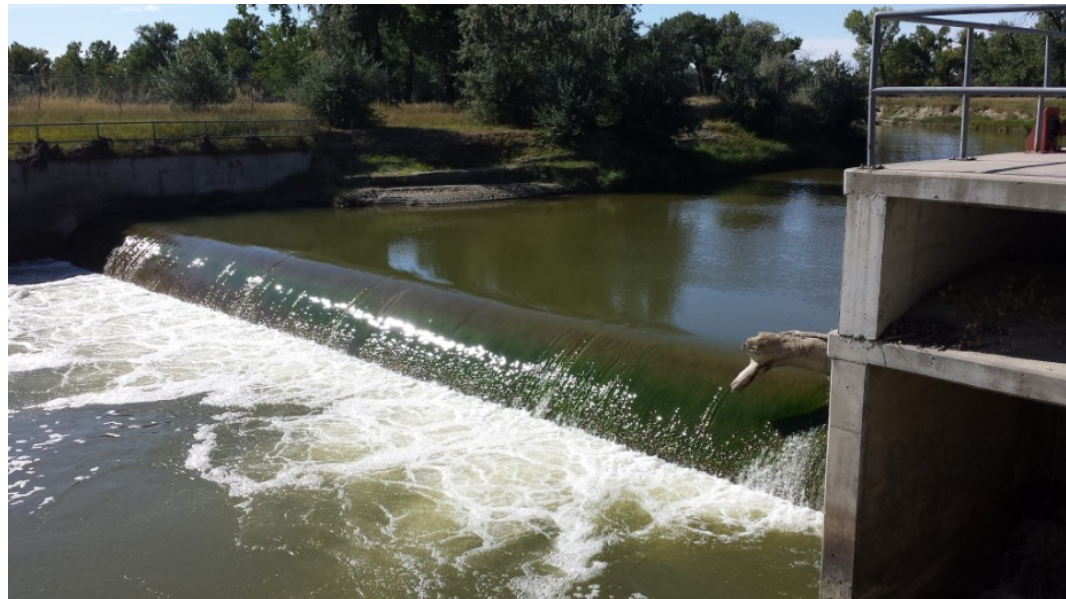
Pilot Testing

Design Considerations

- ✓ Conventional Filtration (Package Plant)
- ✓ Pre-oxidation basins = 3 hours detention time
- ✓ Permanganate
- ✓ PAC

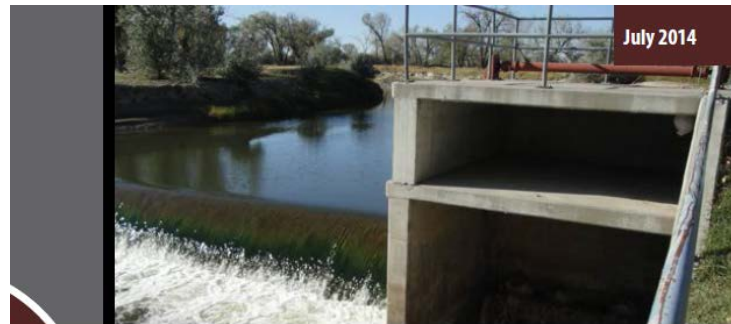
Water Treatment Plant Improvements Project
Chinook, MT
Basis of Design Report

Proposed Upgrades

Design Elements

- ✓ Raw water pump station
- ✓ Pre-Oxidation basins
- ✓ New package plant trains
- ✓ Backwash pumps
- ✓ UV disinfection
- ✓ Electrical & control upgrade
- ✓ Permanganate & PAC feed
- ✓ Chemical feed upgrade

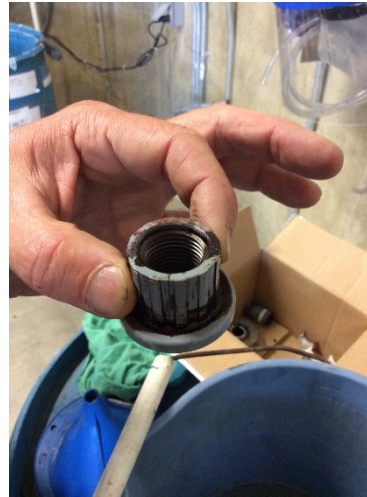
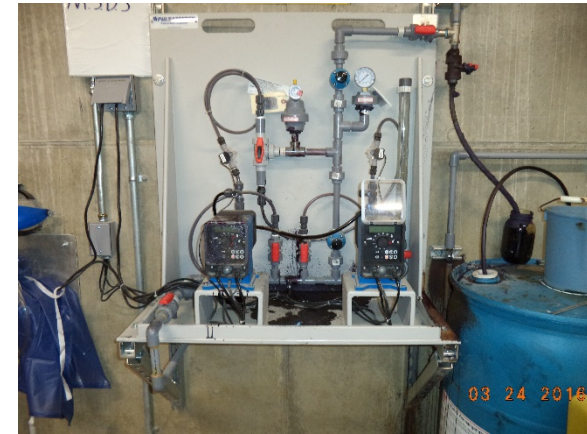
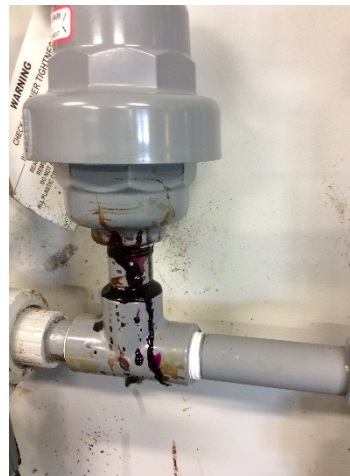
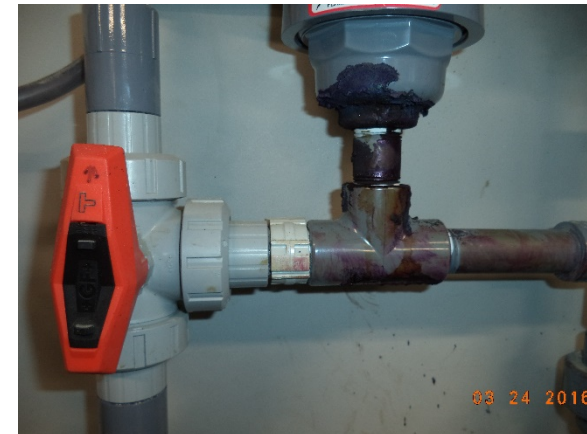
Sodium Permanganate

- ✓ 20% solution
- ✓ CPVC components
- ✓ Small leaks
- ✓ Compatibility ???
 - ❑ Conflicting info
- ✓ Replaced with Polypropylene

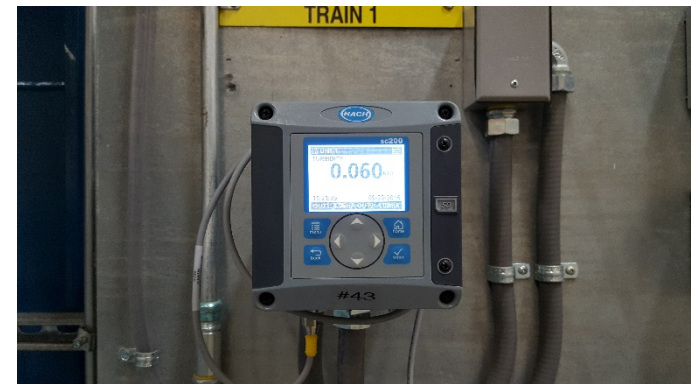
Filter Breakthrough

- ✓ Summer operation went well
- ✓ **Poor floc this Winter**
- ✓ Short filter runs
- ✓ Does Filter Aid help?
- ✓ Polymer dosing

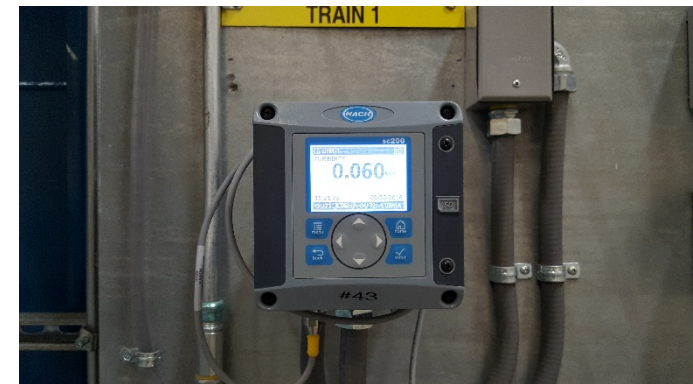
Filter Breakthrough

- ✓ Conclusions from Winter Optimization
 - ❑ Overcharging with polyamine cationic polymer
 - ❑ Pre-oxidation very effective
 - ❑ Filter aid → has some effect
 - ❑ Acrylamide cationic polymer to floc tanks

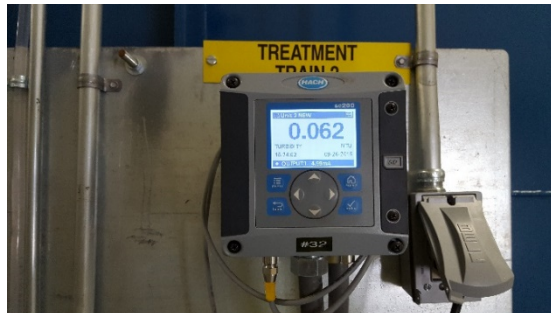
Overall

- ✓ Pre-Oxidation
 - Settling in tank (grit, sand, etc.)
 - Improvement in treatment
- ✓ Optimized polymers
 - Summer vs. Winter
- ✓ TOC removal 33-50%
 - Alkalinity > 200 mg/L
 - DBPs in compliance
- ✓ Filter performance excellent
 - Turbidity < 0.08 NTU
