Idaho Water Resources Board

# Snake Water, Algae, Spiders and more! Pilot Plant Operations on the Snake River

PNWS AWWA Conference  
April 27, 2018

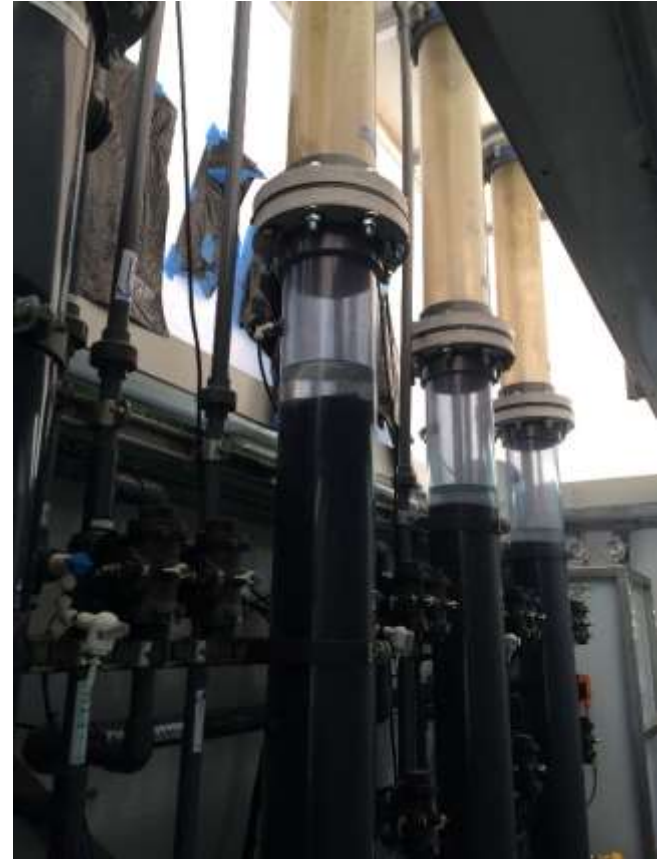
*Pilot Plant Filters*

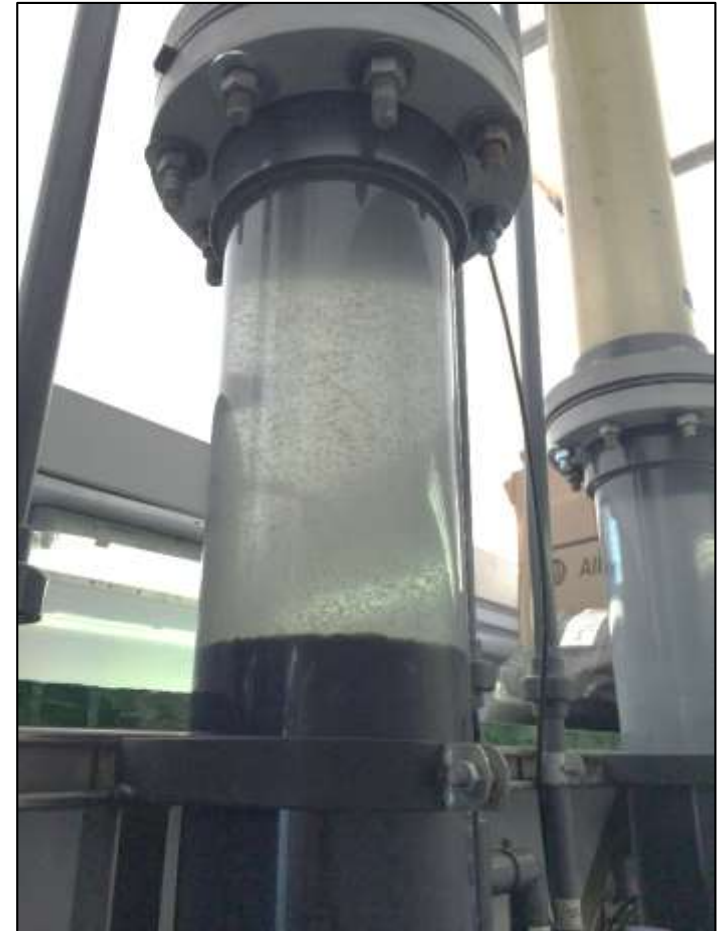
- Required constant supervision
- Media backwashed for fines removal
- Sidewall forces affected backwashing
  - Added air scour and backwash flow
- 48 Hour Media Acclimation

*Filter backwashing in progress*

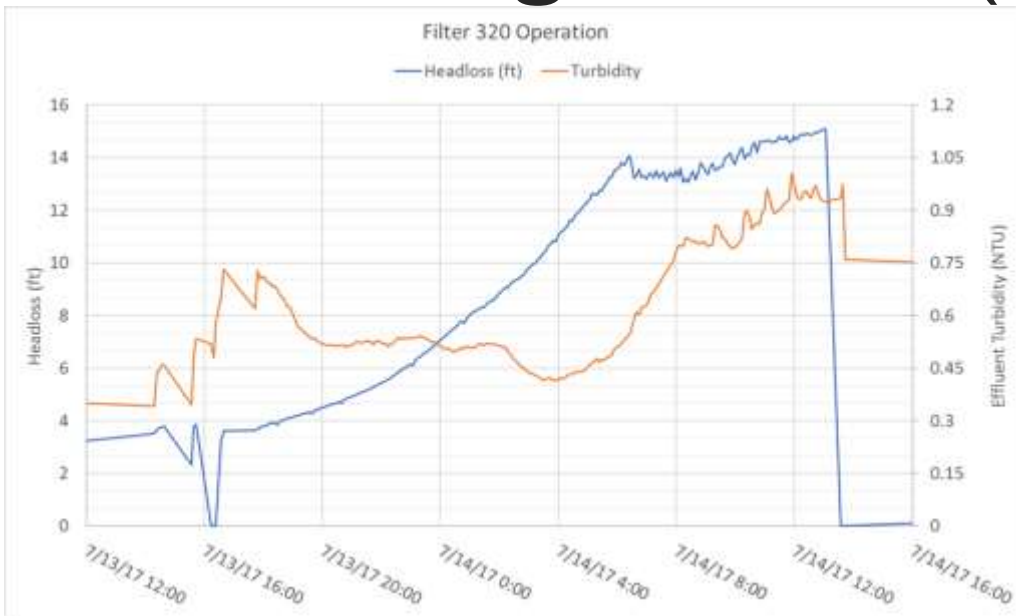
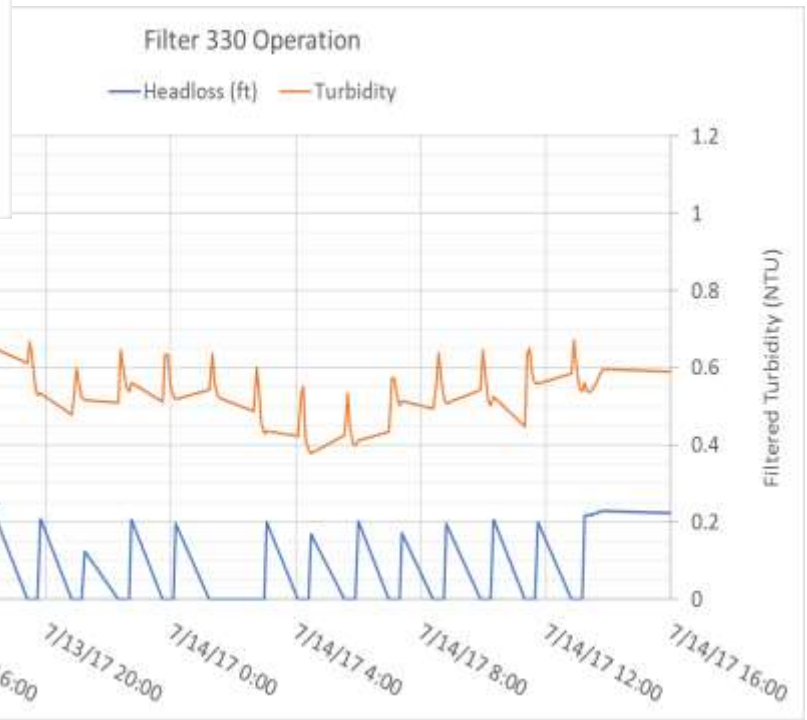
Backwash Water Production

Filter Continuously Backwashing

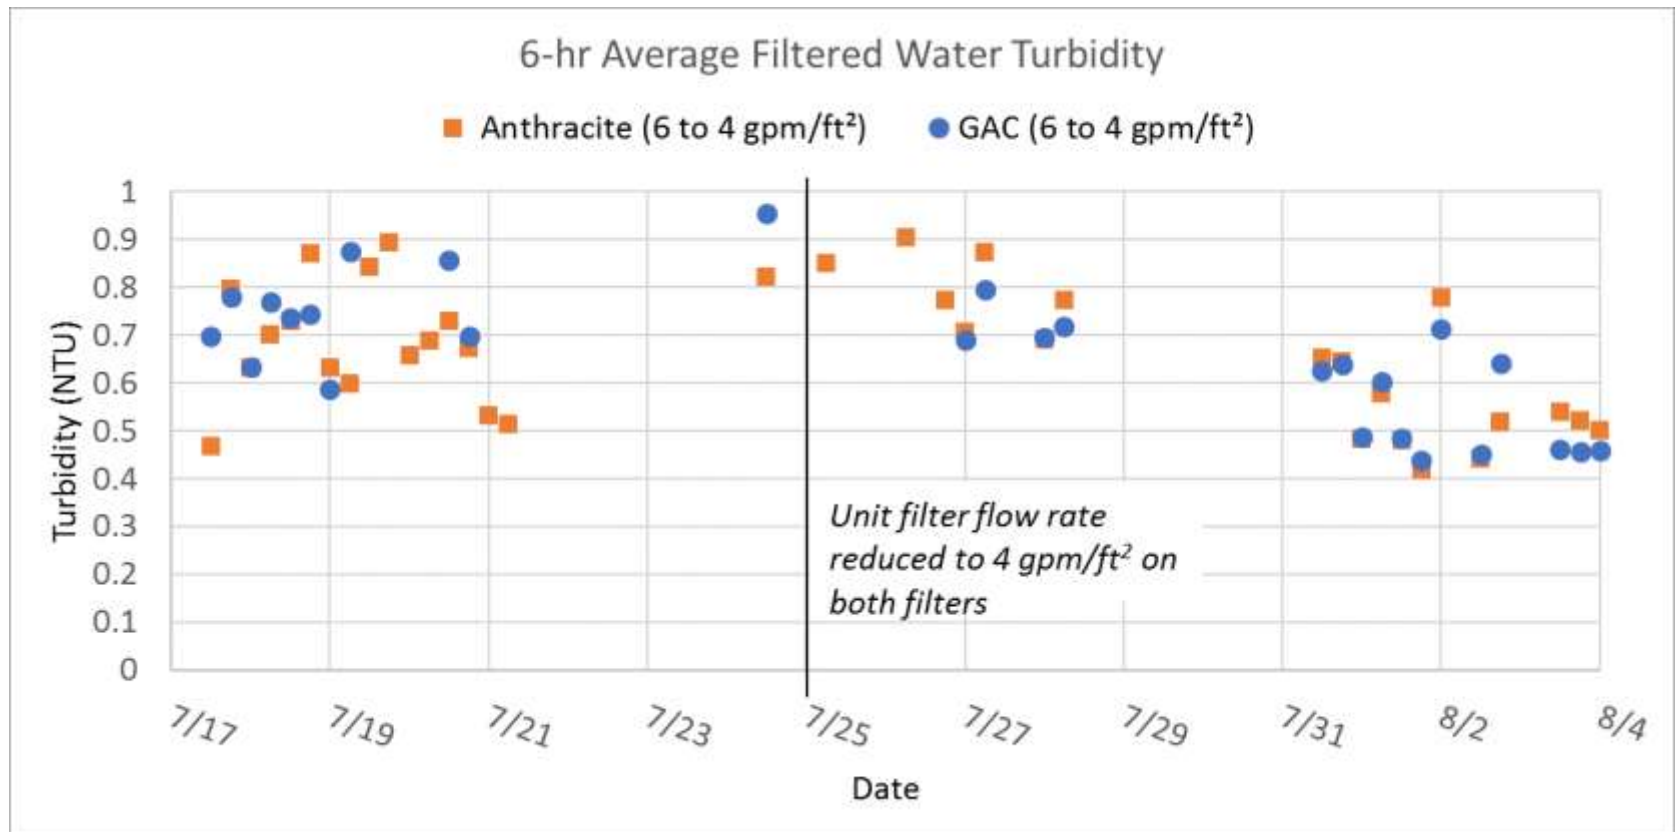
# Filter Response (July 17 – Aug 4)

- Reduced Unit Flow Rates
  - 4 gpm per ft<sup>2</sup> and 6 gpm per ft<sup>2</sup>
- Cleaned filter screens

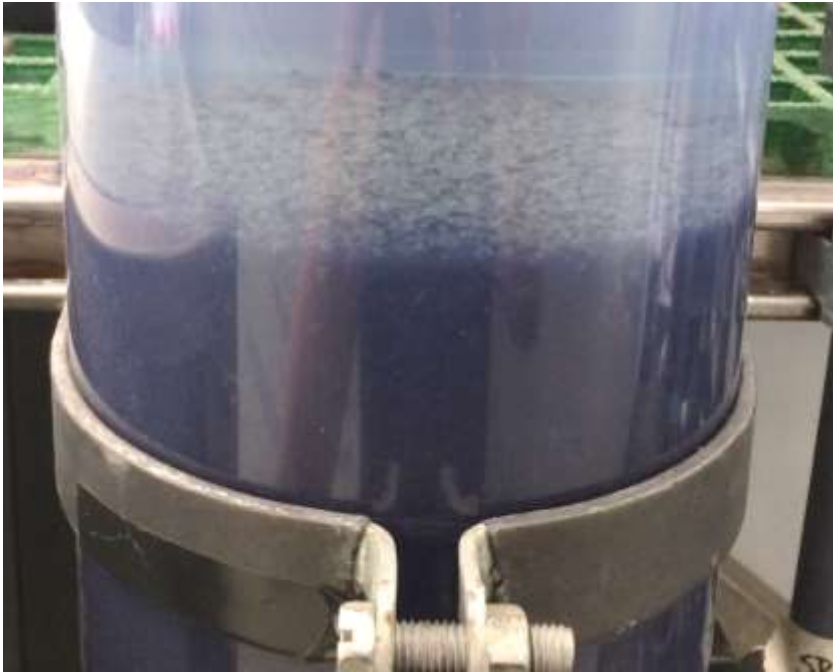
Pre Treatment

- 25 mg/L Free Chlorine
- 24 Hour Contact Time
- Intense backwash and screen cleaning

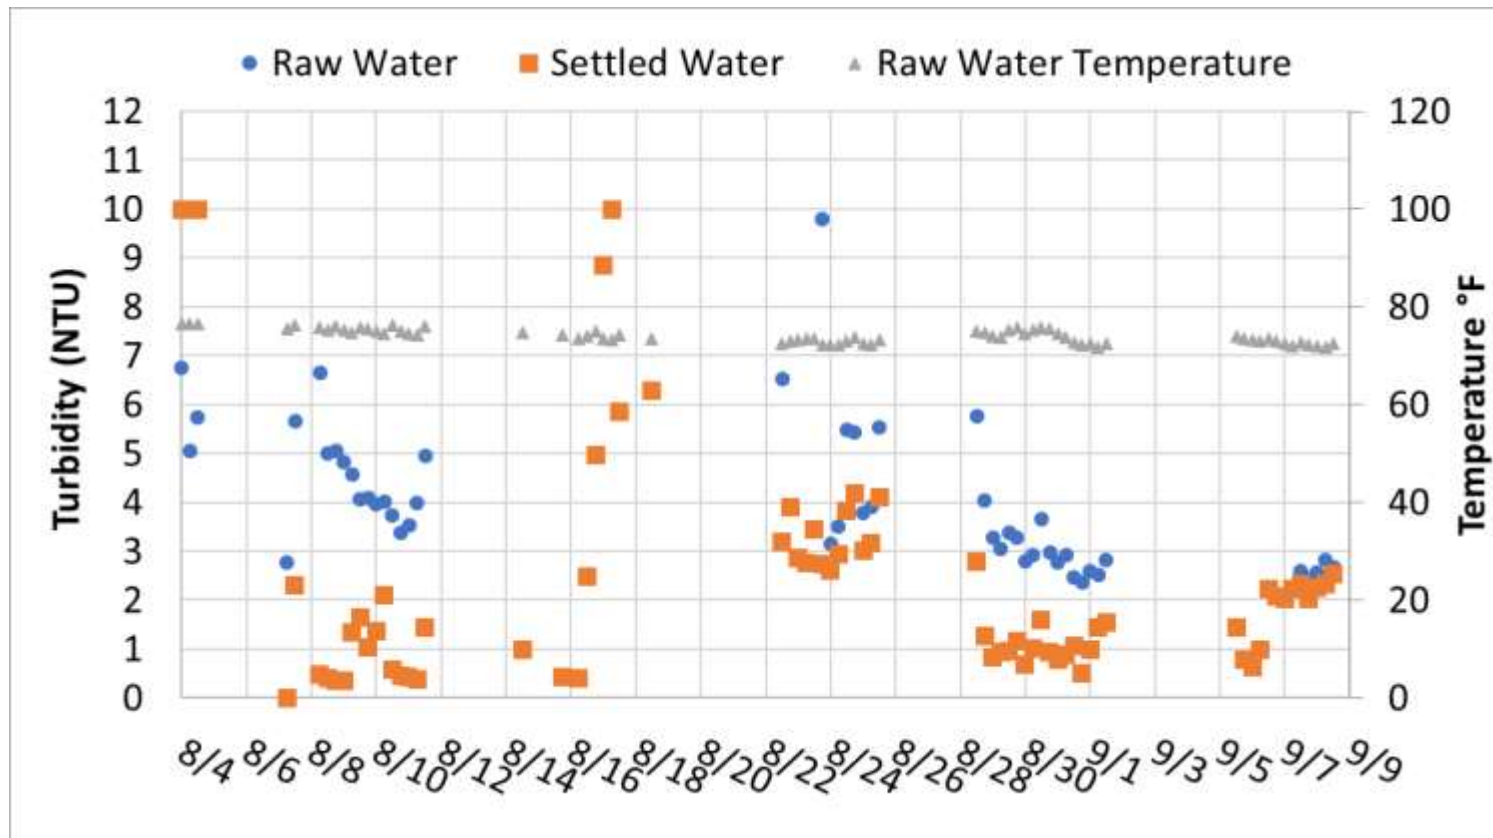
- Raw Water Turbidity Drops
- Settled Water Turbidity Stabilizes

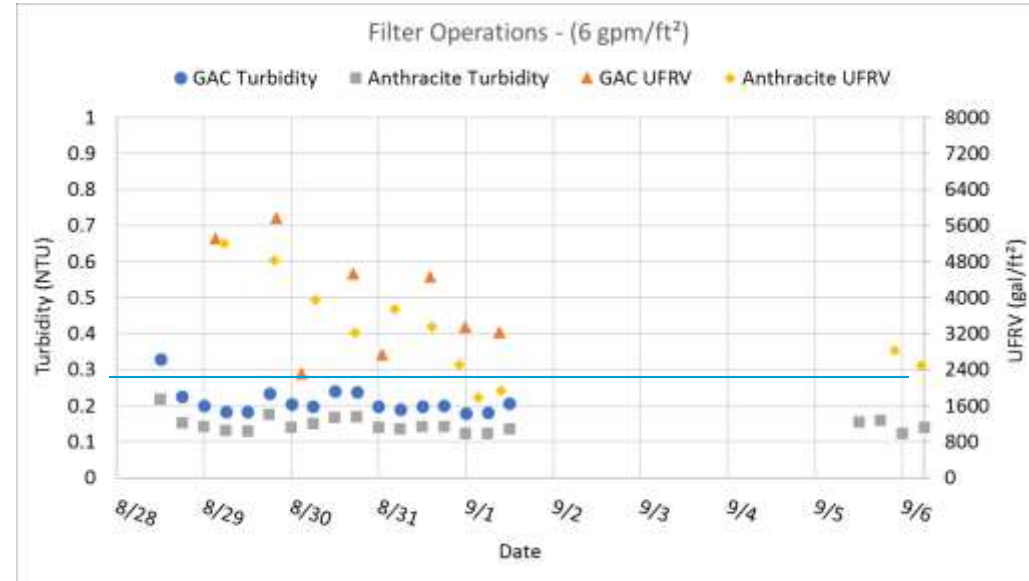
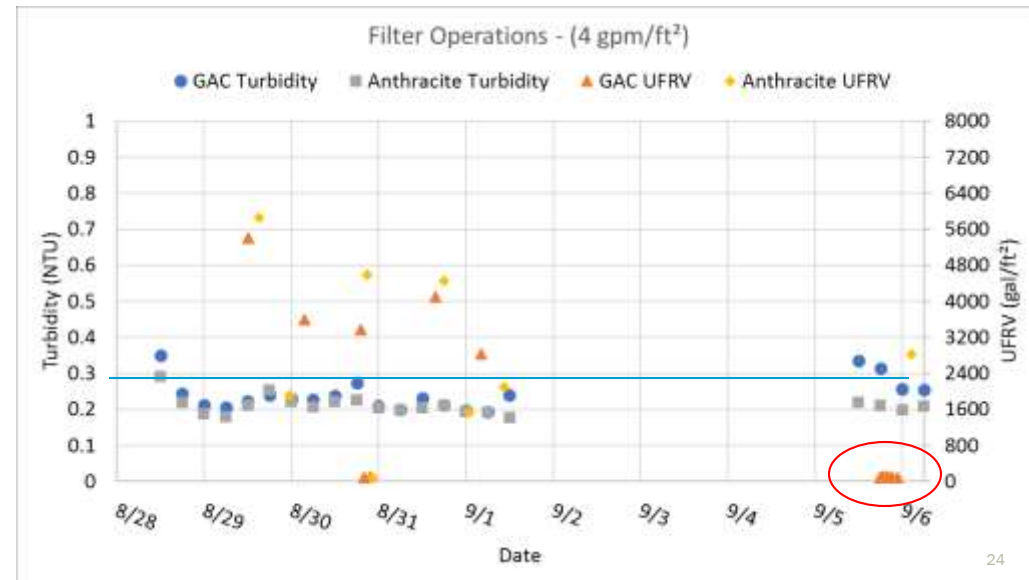
- Post cleaning filtrate turbidity improves
- Backwash triggered by high headloss
- Improvements began week of August 28<sup>th</sup>
- Mechanical malfunctions early September

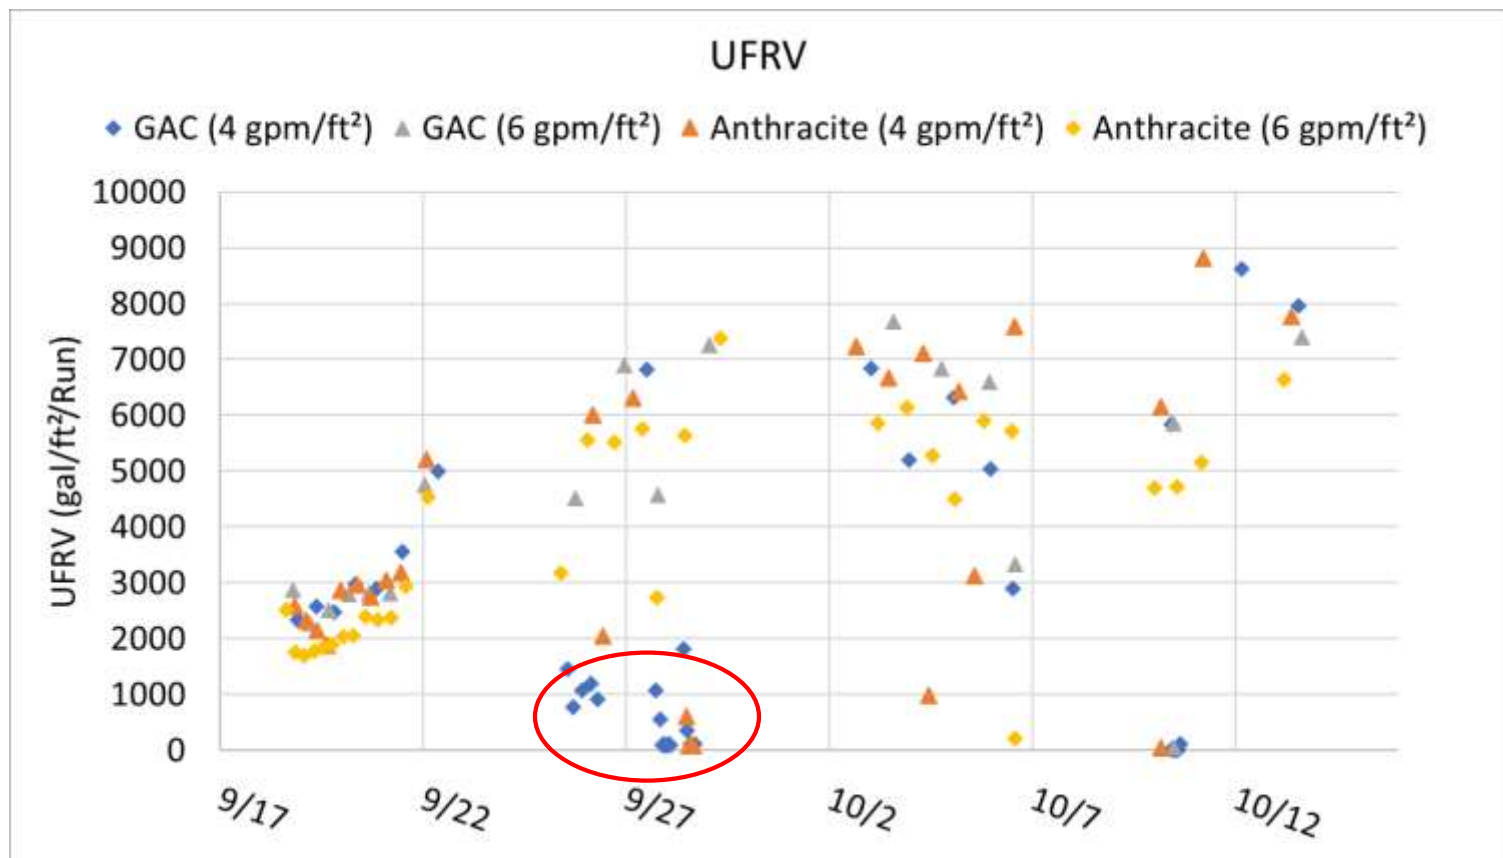
- Multiple Media and Screen Cleanings
- UFRV Improves

Sep 27<sup>th</sup> physically cleaned screens and media surface

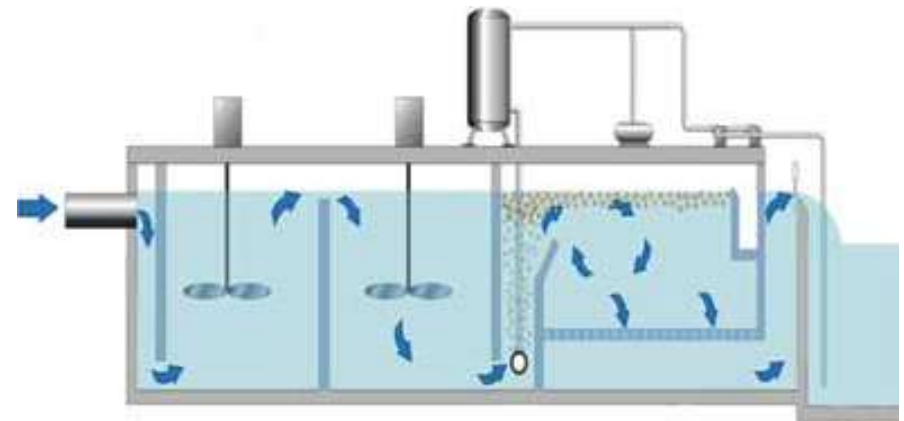
*Dissolved Air Flotation  
Process*

- Shut plant off early
- Conventional filtration plausible when algae not present
- Potential Algae Solutions
  - Covered Pre-Sed Basins
  - DAF
  - Ozone (*Potential Bromate*)
  - *Filtration*
- Proposed 2018 Pilot Plant Work
