**A RIVER RUNS THROUGH IT**

**LESSONS LEARNED  
IN USING  
CIPP FOR WATER MAIN  
REHABILITATION**

**Michelle Henry, PE  
City of Vancouver**

**2019 PNWS-AWWA CONFERENCE  
VANCOUVER, WASHINGTON**

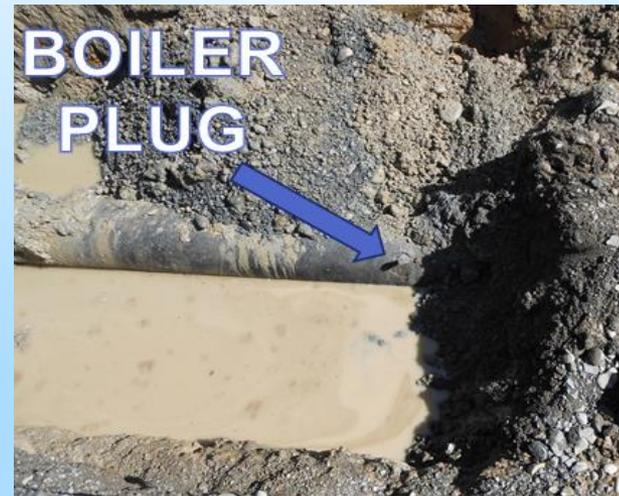
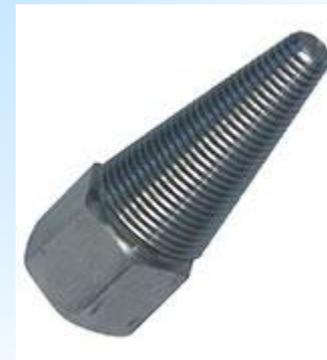
# 1<sup>st</sup> CCTV Inspection (after water jetting - Nov 6 2017)

- Protruding boiler plugs.
- Pipe abnormalities and condition
- Obstructions
- Unknown service connections.

- 2 Inactive Service Taps
- Mitered Bends
- Heavy rust tubercles and sedimentation
- Water bellies - unable to get camera all the way thru pipe crossing SR14
- Obstruction

- Boiler Plugs (?)

- Pipe not satisfactorily cleaned -3000 psi water jetting method failed to remove eroded materials in the form of tubercles and scaling which have built up on the inside of the pipe walls over time. In addition, sediments collected in the bottom of the pipe by using the water jetting method were not cleared from the pipe.
- Incomplete CCTV - water Jetting left standing water in areas which did not allow for camera inspection.
- City agrees to pay for excavation to remove wood chunk if not able to remove with additional cleaning.
- Contractor concerns about mitered pipe bends contradictory to CIPP manufacturer's literature— requiring written documentation from the lining manufacturer as to ability to navigate these bends.

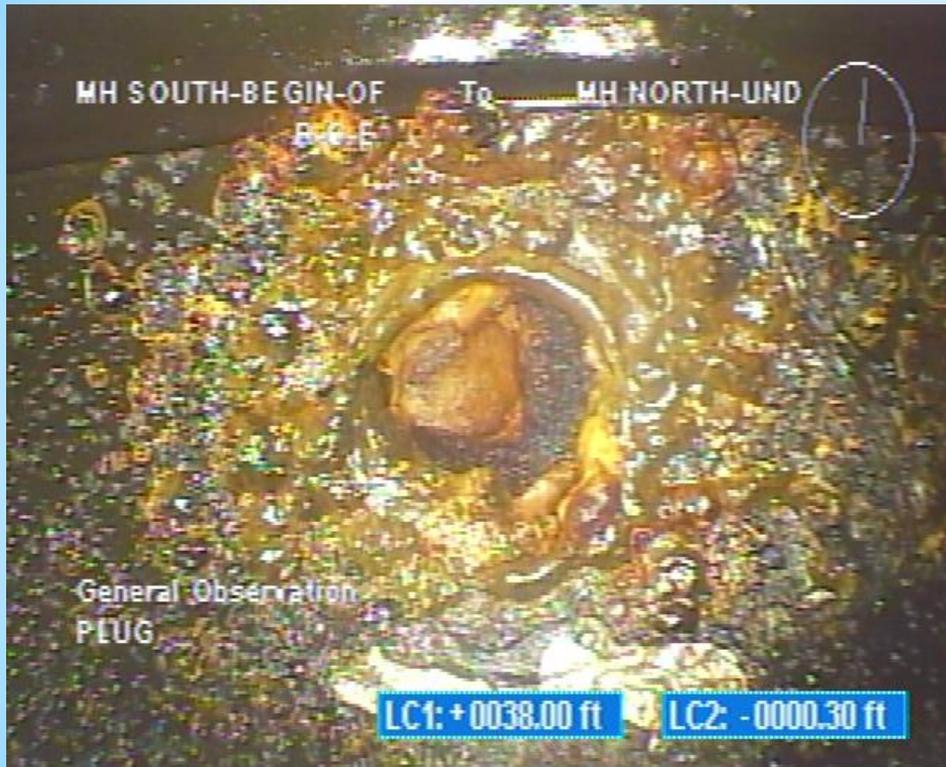
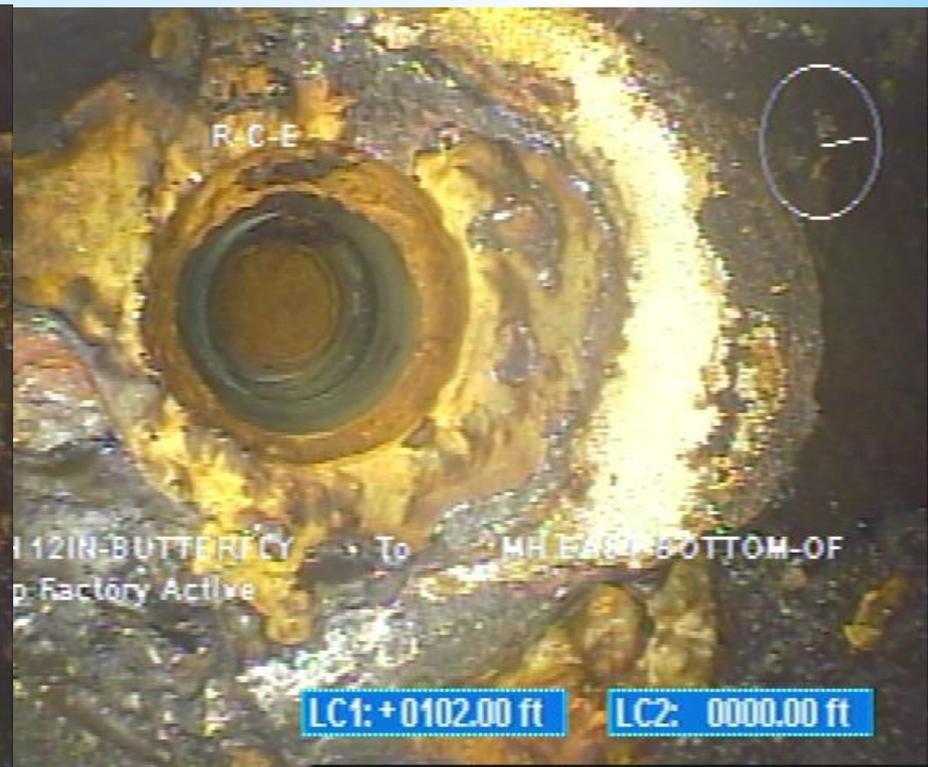
# Service Taps

## Plugged Service - Corp Stop

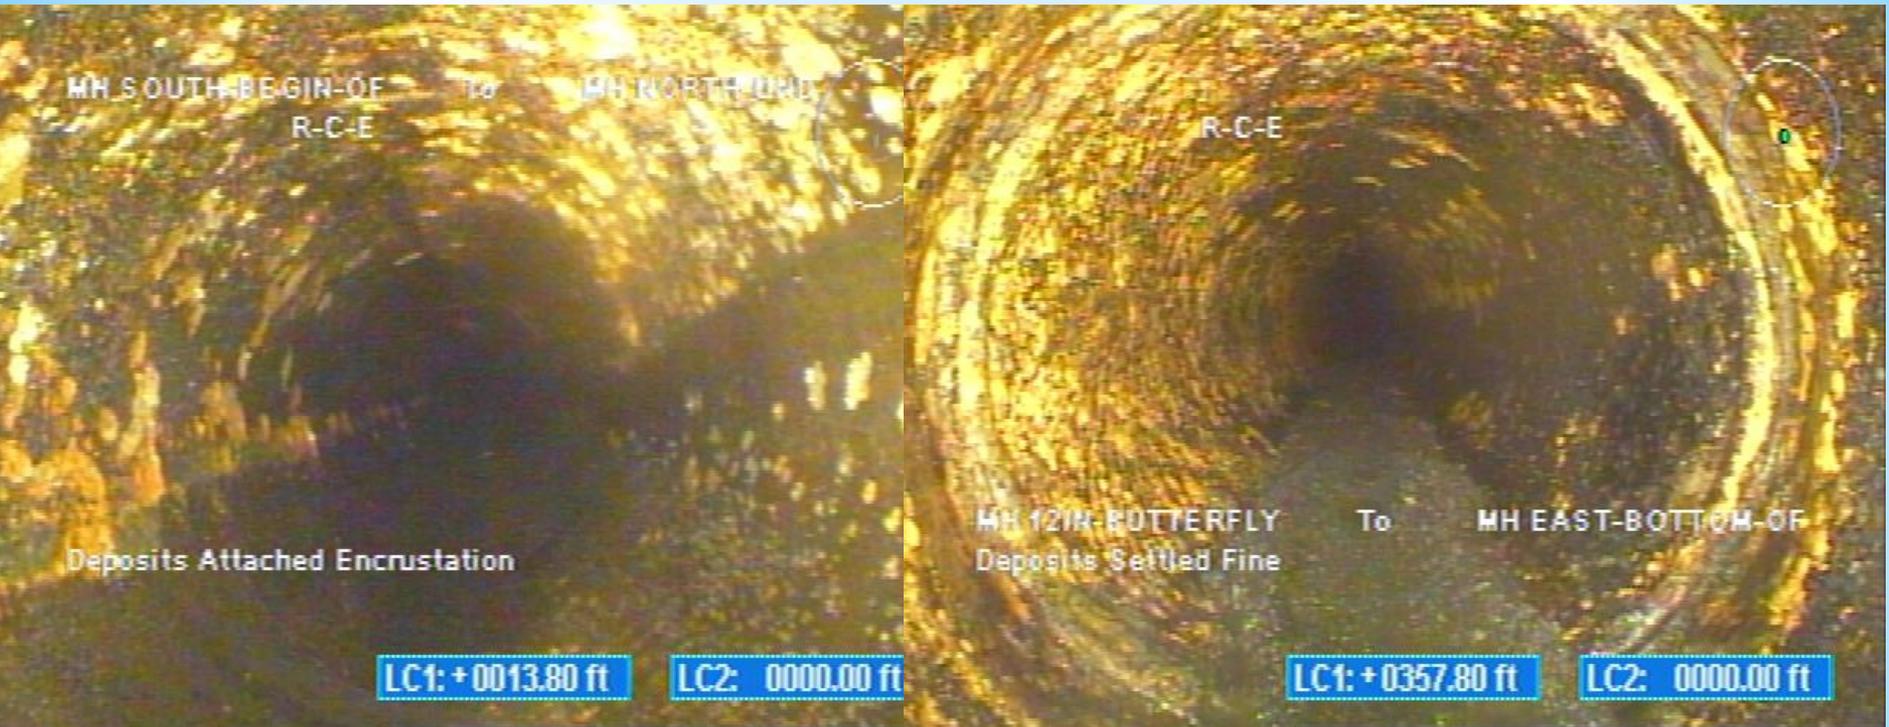
# Internal Pipe Condition

## Rust Tubercles and Sedimentation

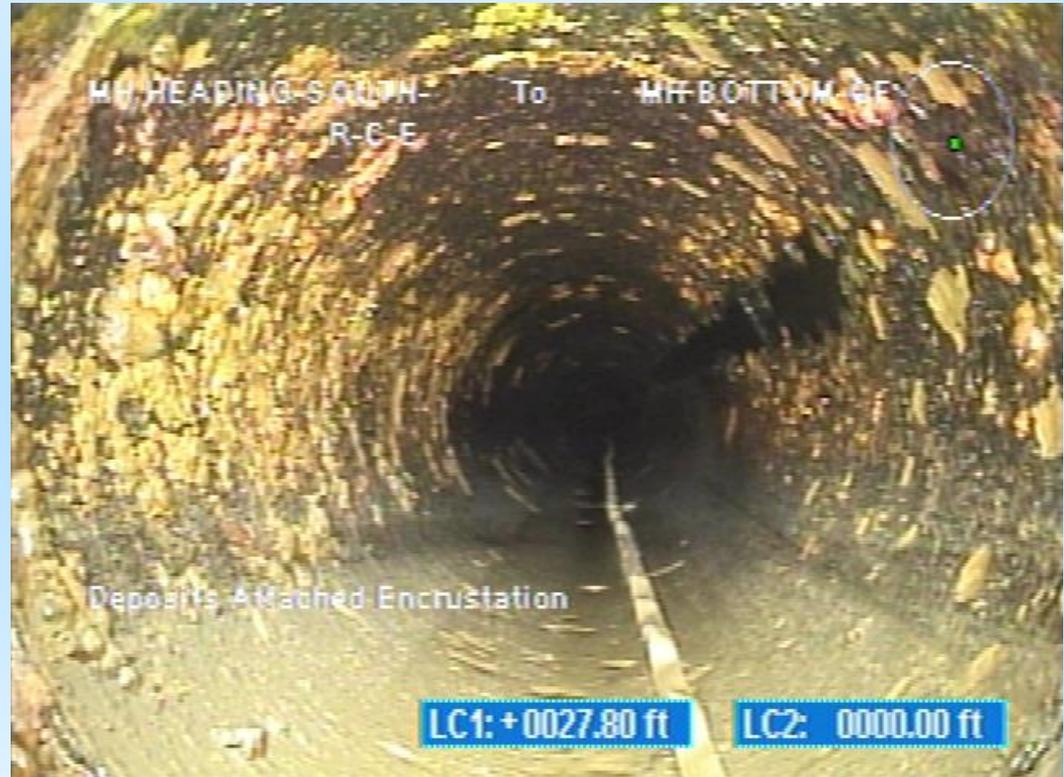
# Results of 2nd CCTV

- Pipe satisfactorily cleaned?
- Obstructions Removed
- Water Gushers

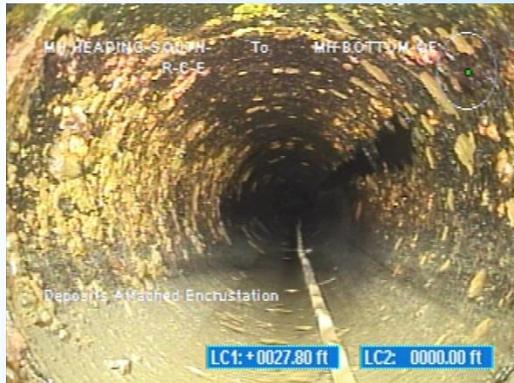
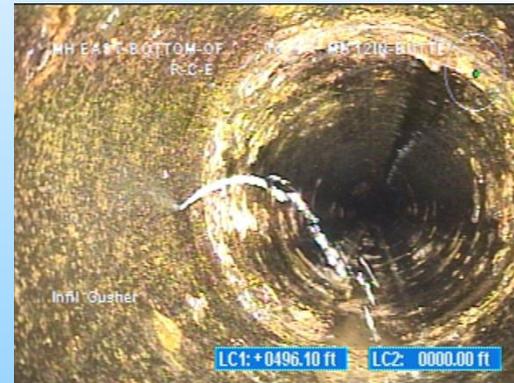
# Results of 2nd CCTV

Pipe satisfactorily cleaned? No

Six Gushers - Lining manufacturer recommends point repairs.

- To give time to the lining manufacturer to review TV reports and make recommendations for path forward.
- To allow for notification of additional ramp closure to perform additional work in preparation of lining.

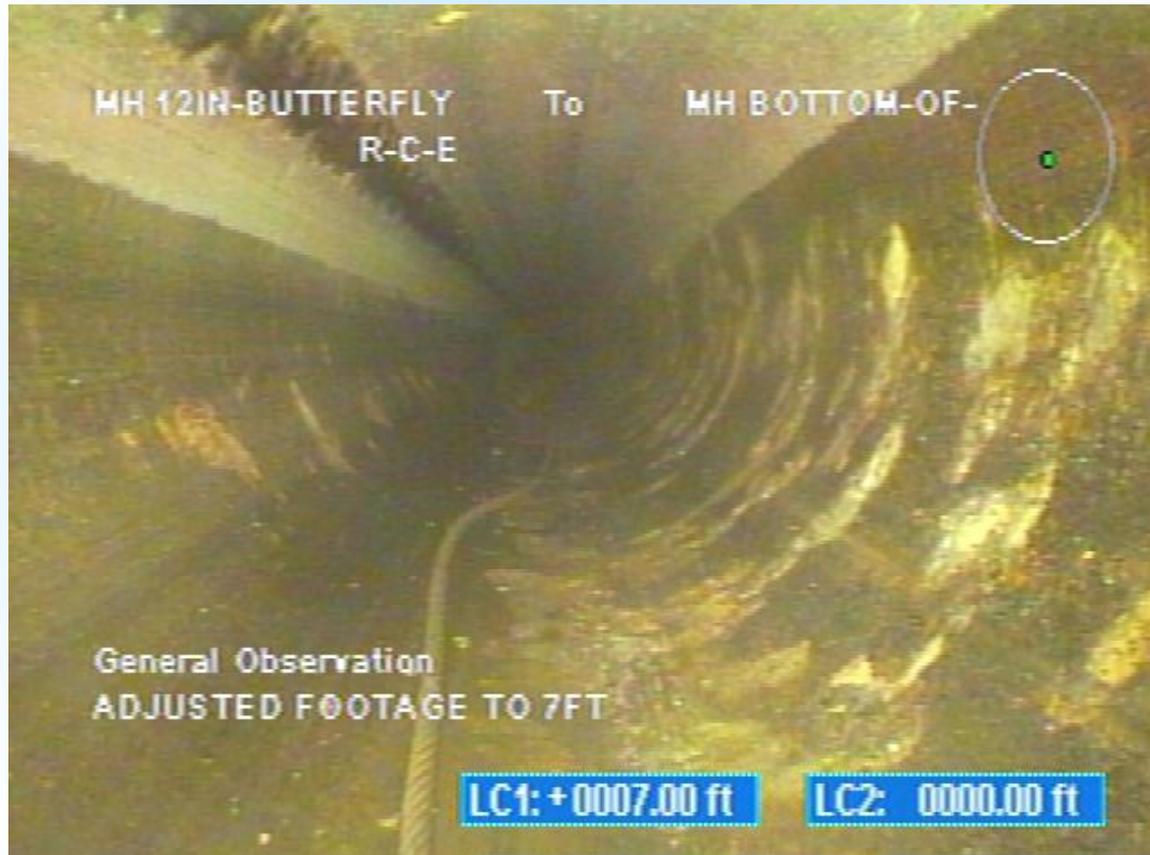
# 3<sup>rd</sup> CCTV after 3<sup>rd</sup> Cleaning - Dec 15, 2017

Dry due to drier weather.  
Pipe surface cleaner.

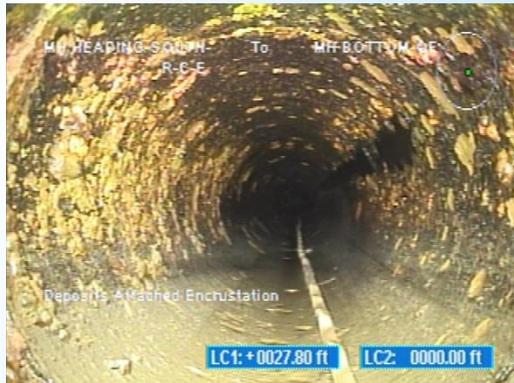
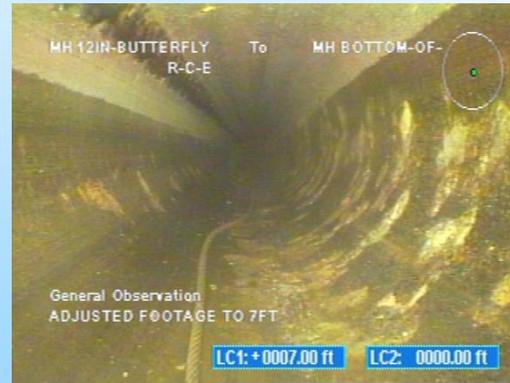
# Results of 3rd CCTV

Pipe satisfactorily cleaned? Yes per manufacturer.

Six Gushers – Point repairs not done but no gushers this time around. However, City decides to move forward with point repairs prior to lining.

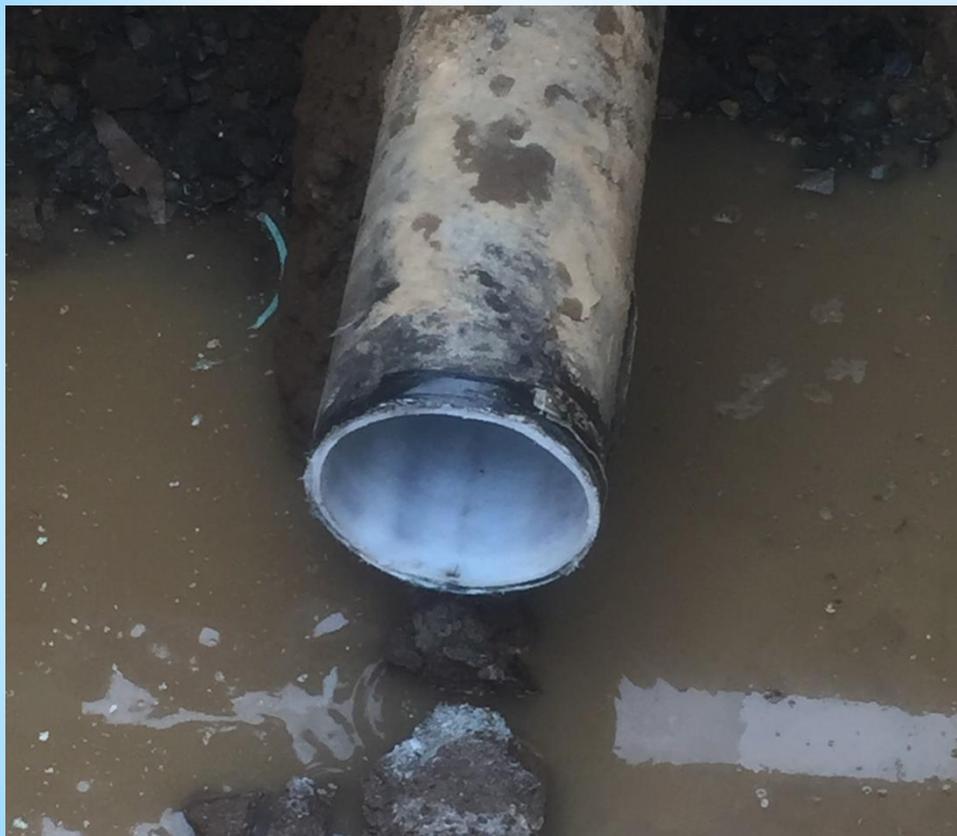
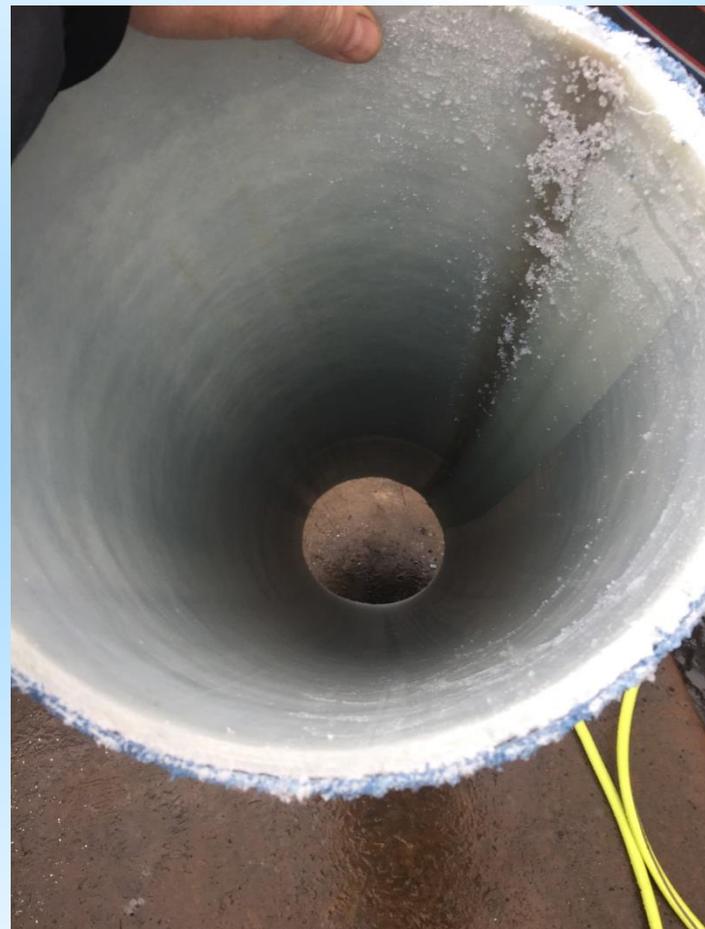
# Liner Installed – Jan 26, 2018

**FAIL**

After a 2<sup>nd</sup> hydrostatic test the lower segment across SR 14 passes - deemed acceptable.

The long segment in the ramp fails again and again.

- No end seals? Is water leaking behind the liner and finding an exit?

# Install 700 LF 12" DIP in Off Ramp

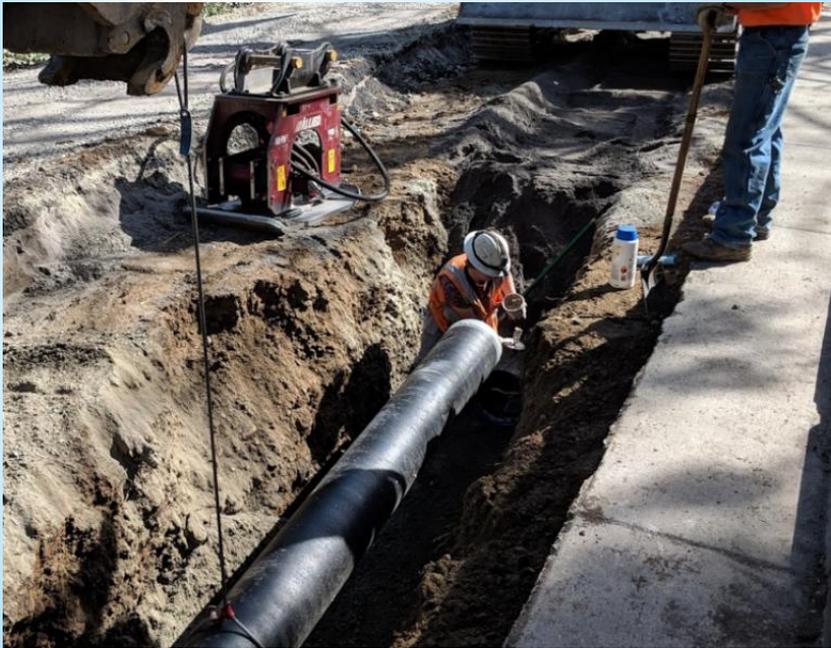
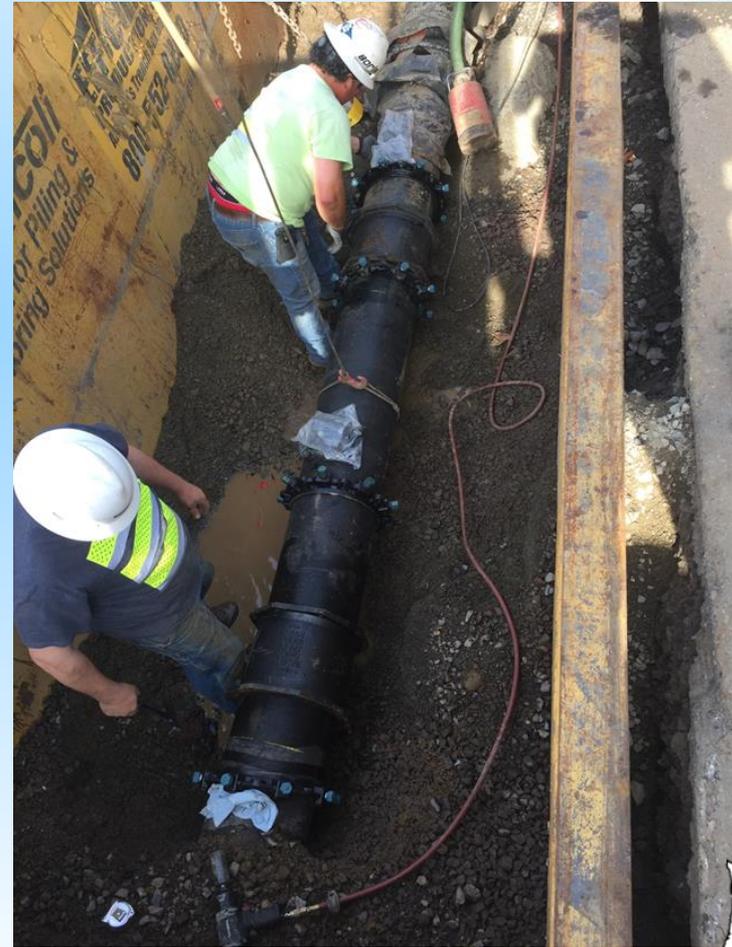
# New DI pipeline installed - April 16, 2018

Open cut trench - install new pipe in Evergreen off ramp.
