Why Coat Concrete Tanks?

Jeff Austin
Water Systems Consultant
Advanced Solutions

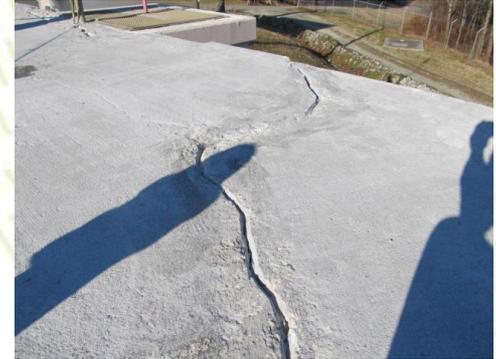
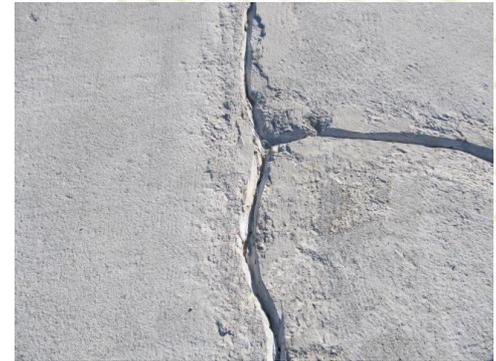
Problems Inherent with Concrete

- Concrete cracks, spalls, and leaks.
- Two types of concrete:
 - Concrete that has cracked
 - Concrete that is going to crack

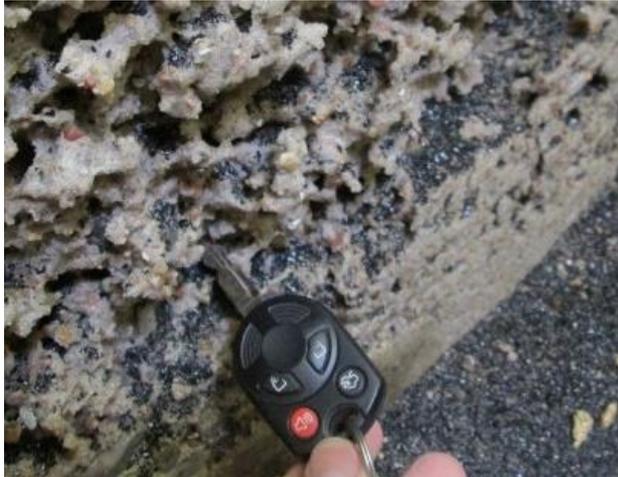
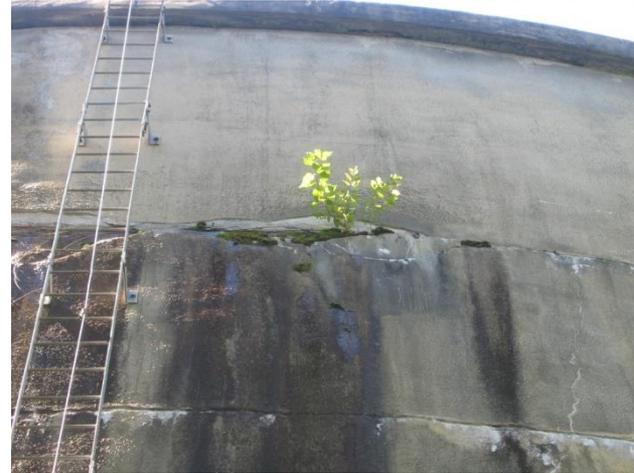
- **Certain regions with high sulfur content in the water will experience rapid degradation of concrete above the high water line and on the underside of the roof. Roof replacements are common.**
- **Below grade tanks often have infiltration concerns.**
- **Concrete is typically marketed as “maintenance free” when in fact it is not.**

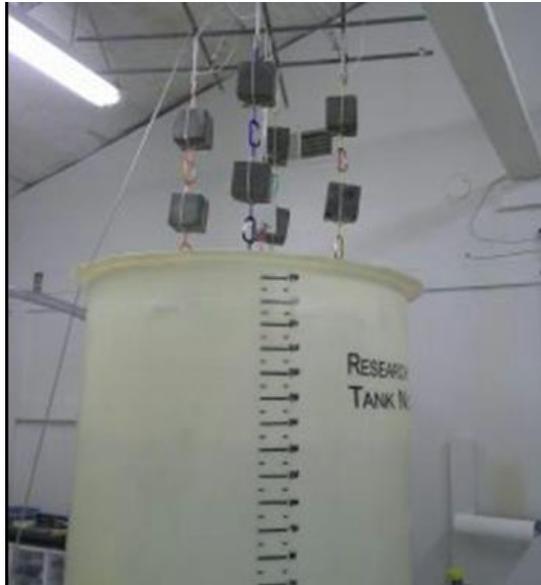
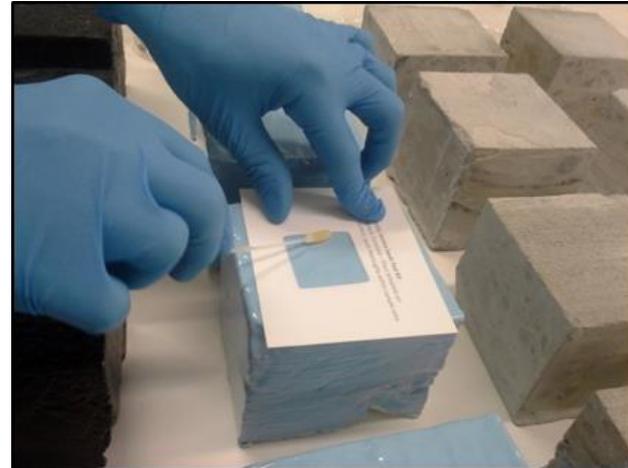
Test Procedure

- All samples were disinfected and immersed in a 200 gallon holding tank. Water was drawn and added at cycles to mimic an actual operating system.
- Samples raised and tested for Adenosine Triphosphate (ATP) and Iron (Fe) after the initial 24 hours and every 7 days thereafter for four weeks: 29 days total.

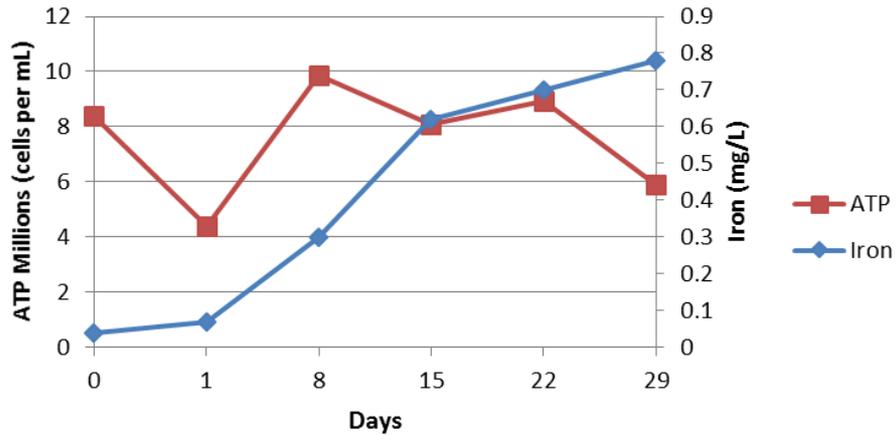
Figure 1. Tank Water ATP and Iron Levels over Time

Tank Water Data

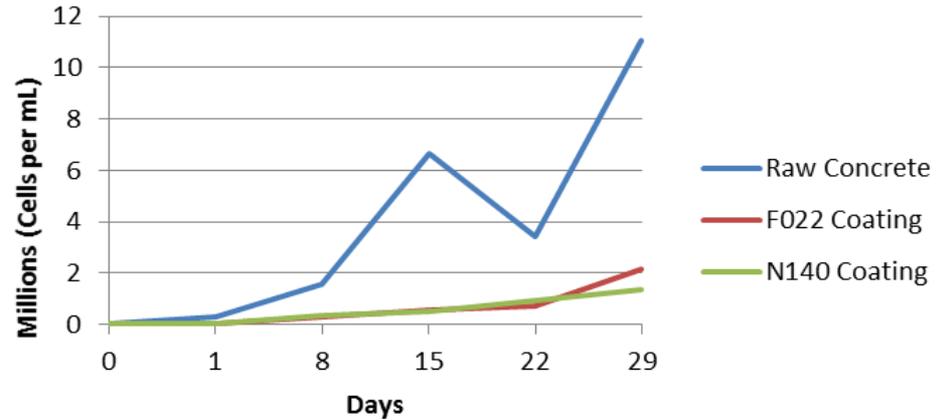
Figure 2. ATP Levels on Coated and Uncoated Coupons over Time

Average ATP By Coating Type

- **Raw concrete coupons exhibited considerably higher levels ATP levels than either of the coated coupons.**
 - 6X more bacteria than the coated coupons by the end of the 30 day project.
- **The type of paint (i.e. standard epoxy vs high performance 100% solids epoxy) did not appear to make a difference in the study.**

Uncoated concrete surfaces are more susceptible to biofilm development and accumulation compared to coated concrete surfaces.

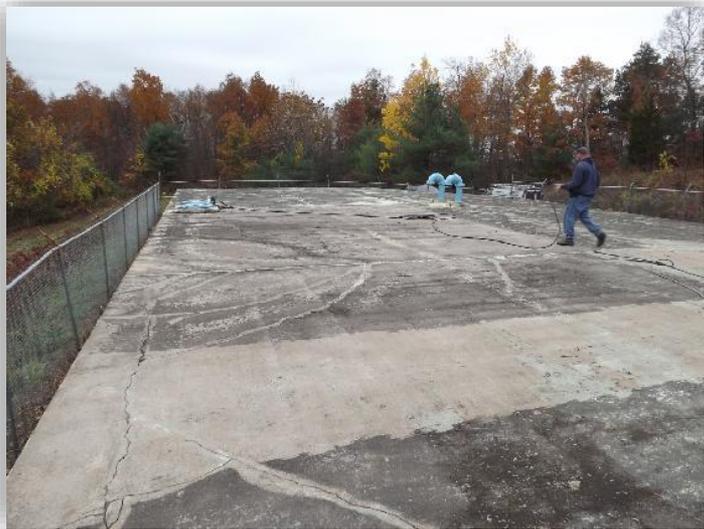
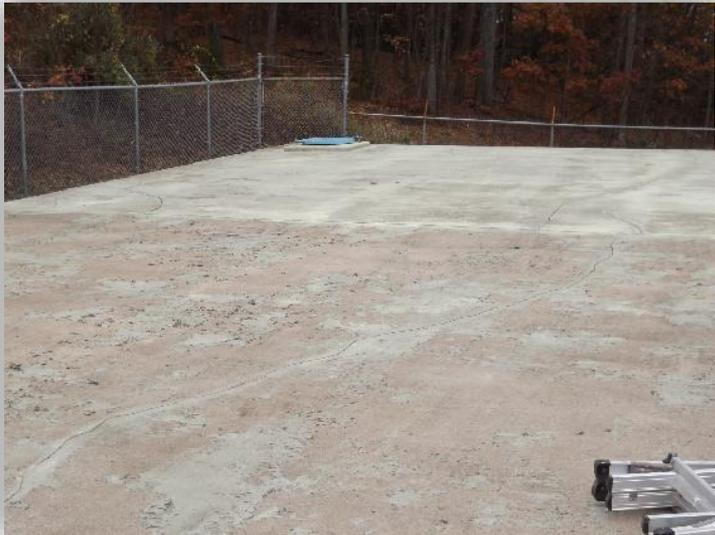
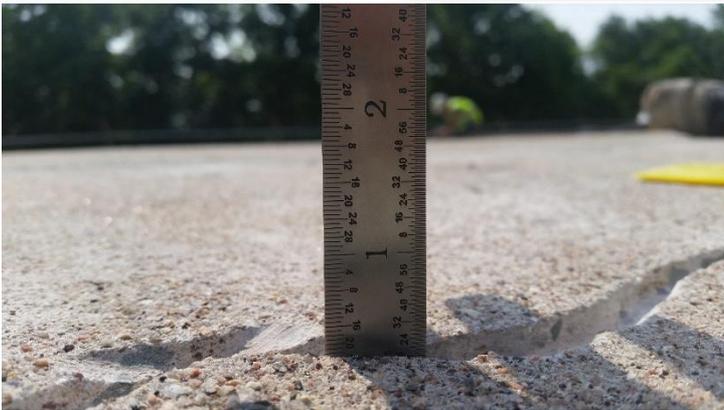
Avon, CT: Before

- **Exterior**
 - Exterior coating failure
 - Significant cracking, freeze/thaw has deepened cracks.
- **Interior**
 - no protective coating
 - frequent cracking, rebar exposure
 - efflorescence visible in walls and roof.

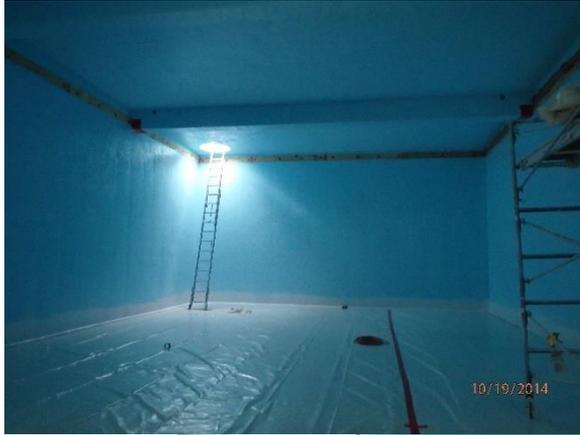
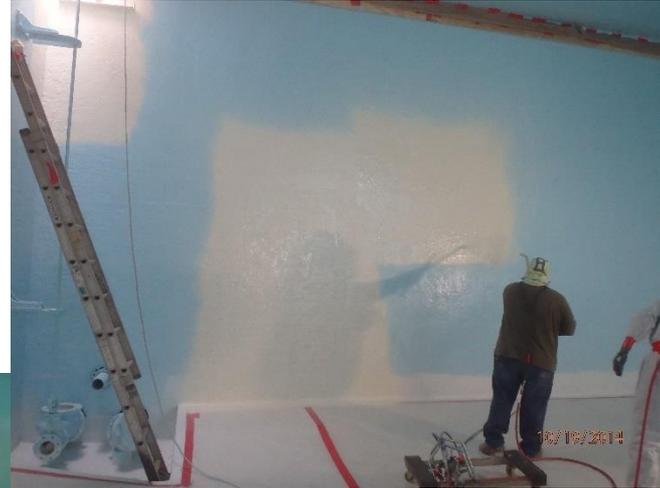
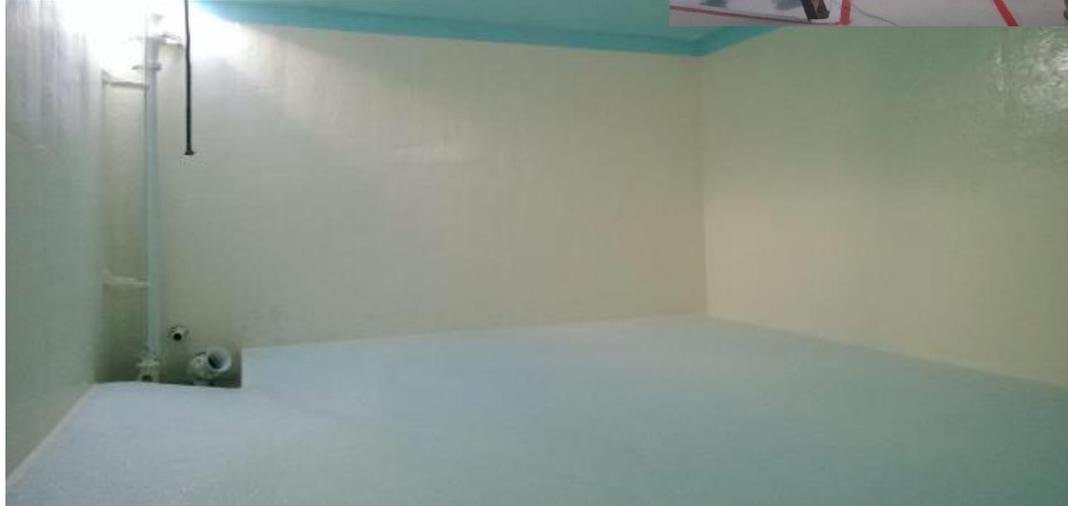
Avon, CT: After

- **Pressure washed to remove loose debris and efflorescence.**
- **All cracks and spalling areas were repaired as needed.**
- **The exterior roof received a 3-coat system**
 - High build epoxy, a high millage coat of polyurethane, and a top coat of polyester polyurethane;
- **The exterior walls received two coats of latex.**

- **Pressure washed**
- **All exposed rebar abrasive blast cleaned to an SSPC SP-10 and coated with a zinc primer.**
- **All cracks and spalling areas were repaired as needed by utilizing repair mortar or grout injection, if necessary.**
- **Walls received a cementitious parge coat to provide a uniform surface.**
- **High build NSF-approved epoxy applied to the walls, roof, and floor.**
- **Walls and floor were top coated with a high millage of NSF-approved polyurethane.**

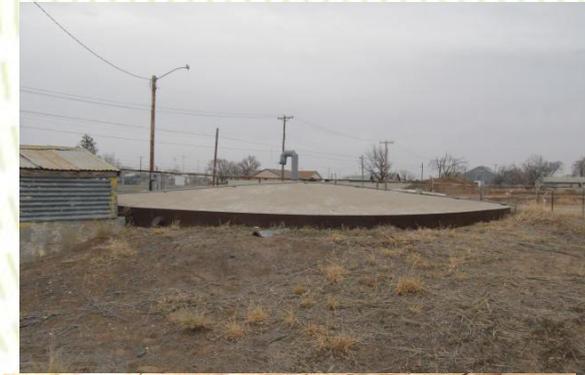
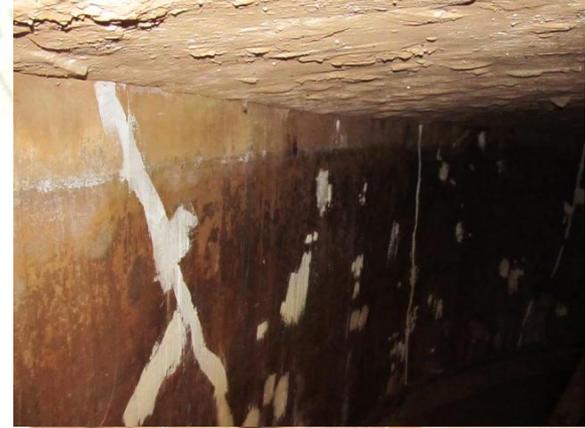
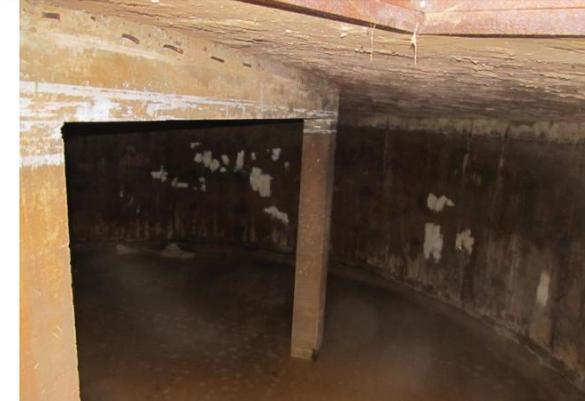
- **Exterior – Cracks**
 - Customer previously attempted to repair cracked surfaces with latex. Repairs were failing.
- **Interior - never been coated**
 - Pinholes and hairline cracks in the walls.
 - Exposed aggregate in the roof.
 - Tank was leaking.

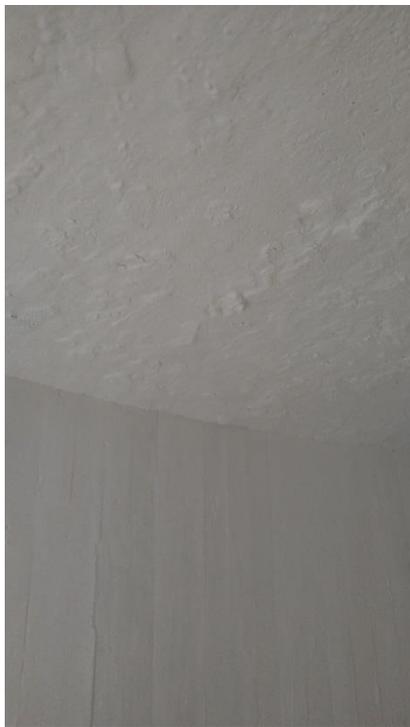
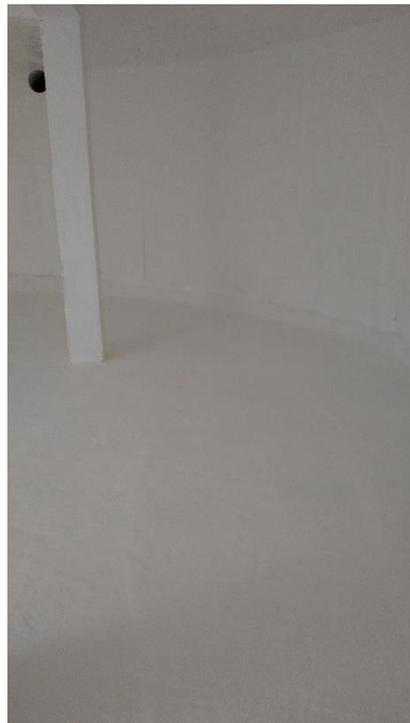
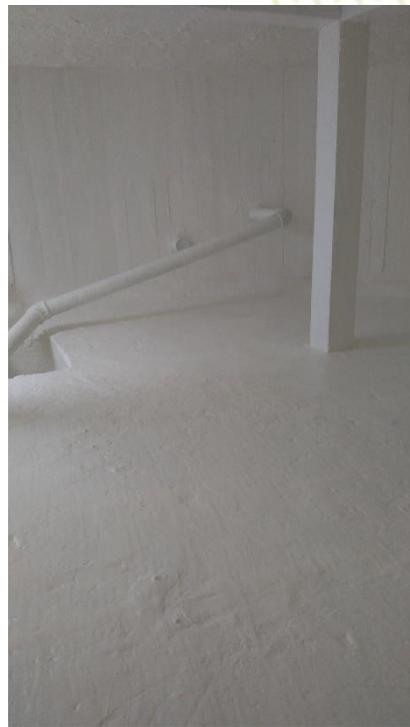
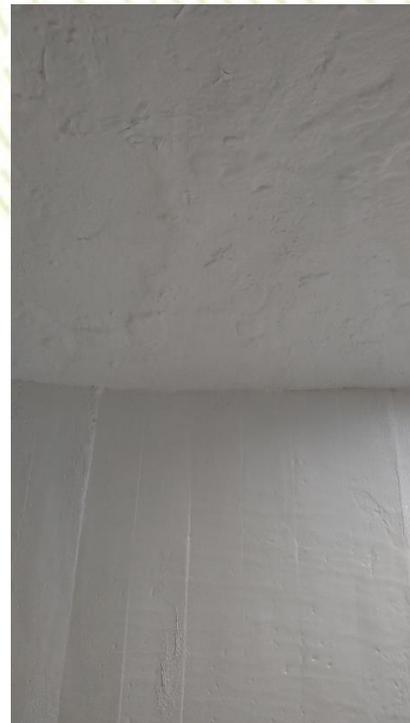
Ralls, TX: After

- Interior pressure washed and chemical cleaned
- Interior piping was blast cleaned to an SSPC SP-10 and primed with organic zinc.
- All surfaces were sprayed with once coat of an NSF-approved 100% solids epoxy.
- Pinholes and small cracks were filled during the spraying process.
- Exterior was pressure washed and overcoated with two coats of a modified waterborne acrylic paint.
- All cracks were filled with the paint prior to coating.

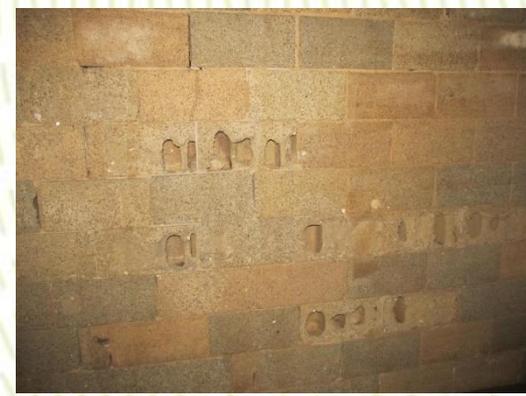
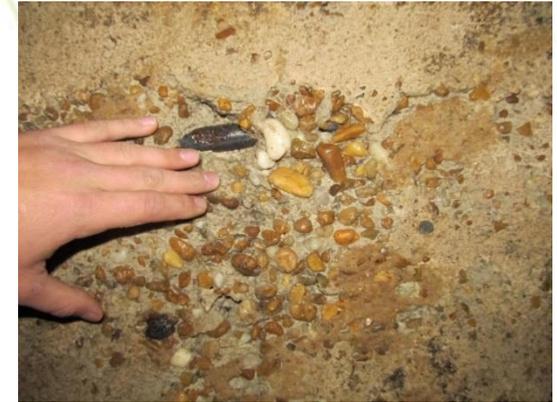
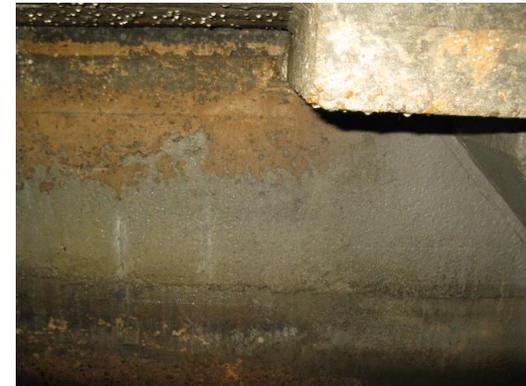
- **Concrete clearwell built in the 1920s.**
- **Additional chambers were built.**
- **Concrete is deteriorating; untreated water was leaking into tank.**
 - Leaking water came from rain water and untreated water that bypassed the chlorination process.
- **Vertical stress cracks along the perimeter walls and along the floors.**
- **Spalling concrete exposed rebar.**

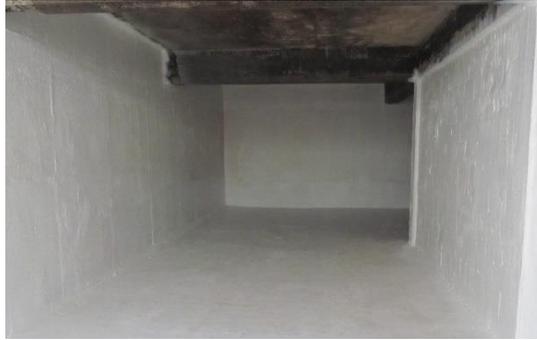
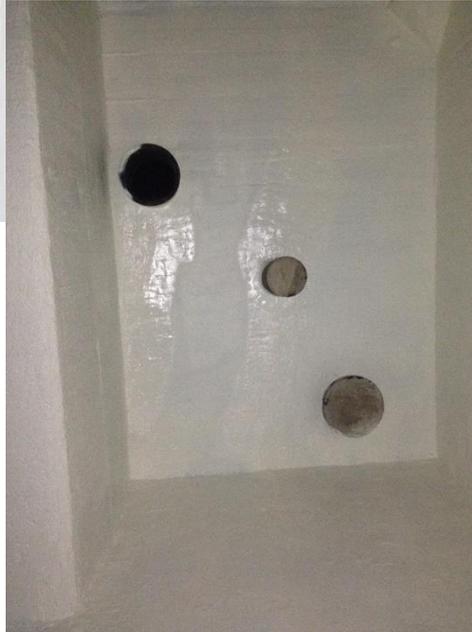
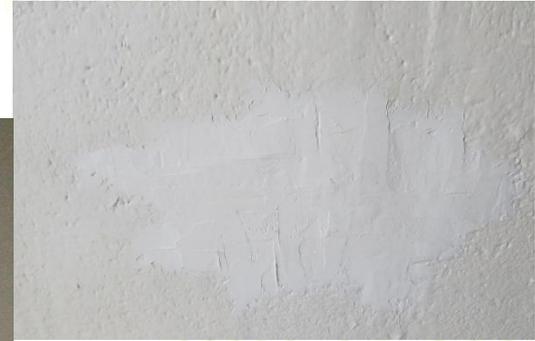
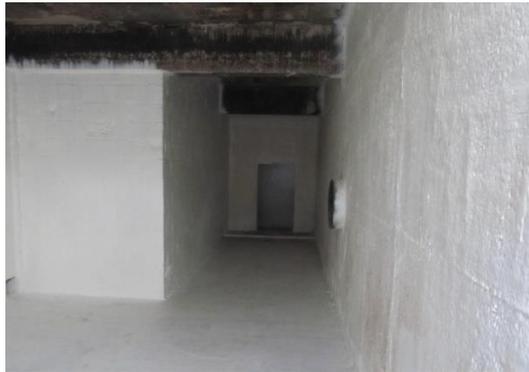
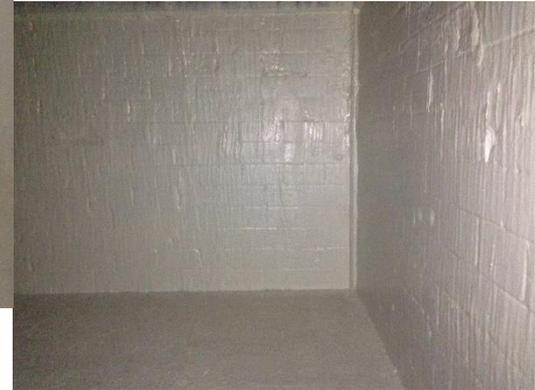
Fort Valley, GA: After

- **Concrete walls and floor were pressure washed to remove loose concrete and biofilm.**
- **Tank was acid etched with muriatic acid to open the pores of the substrate.**
- **Large cracks were filled addressed as follows:**
 - Filled with 100% solids epoxy mastic.
 - Embedded mastic with fiberglass mesh for additional reinforcement.
 - Coated with the primary coating system.
- **All floors, walls, and small cracks were coated/filled with 100-125 mils DFT of 100% solids epoxy.**

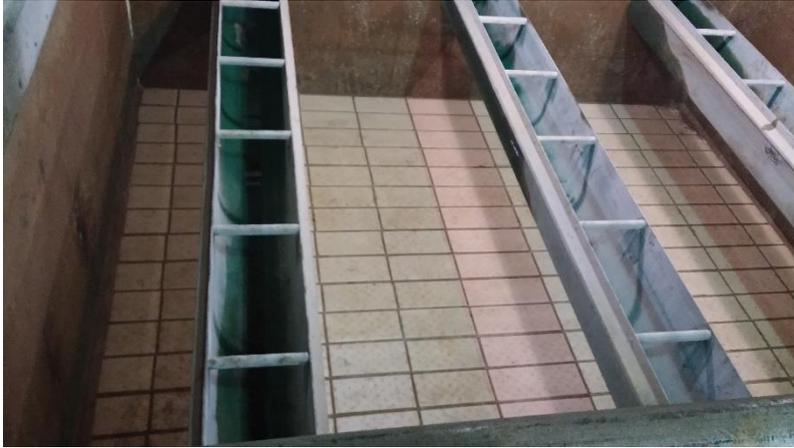
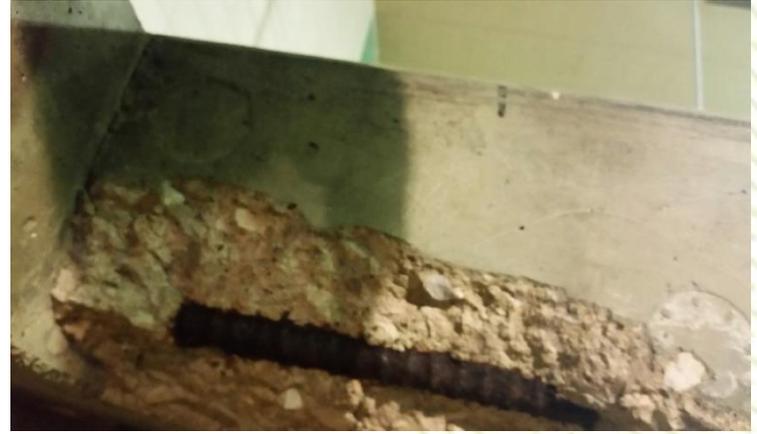
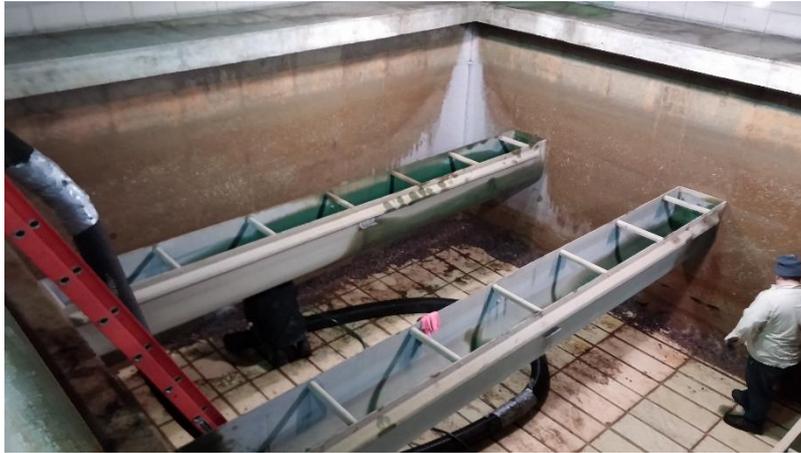
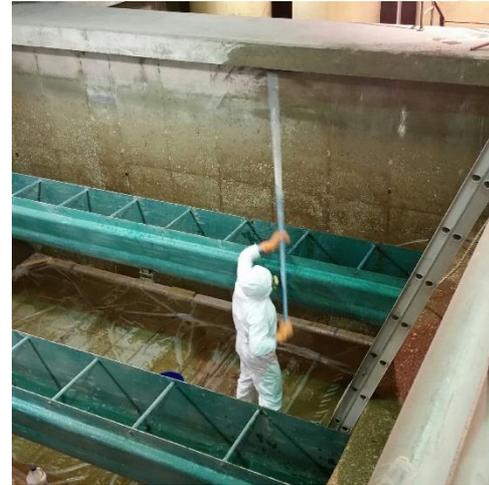
Wyandotte, MI: Before

- **Six deteriorating concrete filters.**
- **Protection of the asset was the purpose of the project.**
- **Walls were prepared and coated with high build 100% solids epoxy.**
