# CONTINUING EVALUATION OF HDPE PIPE FOR MARINE OUTFALLS

**King County**

**Wastewater Treatment Division**

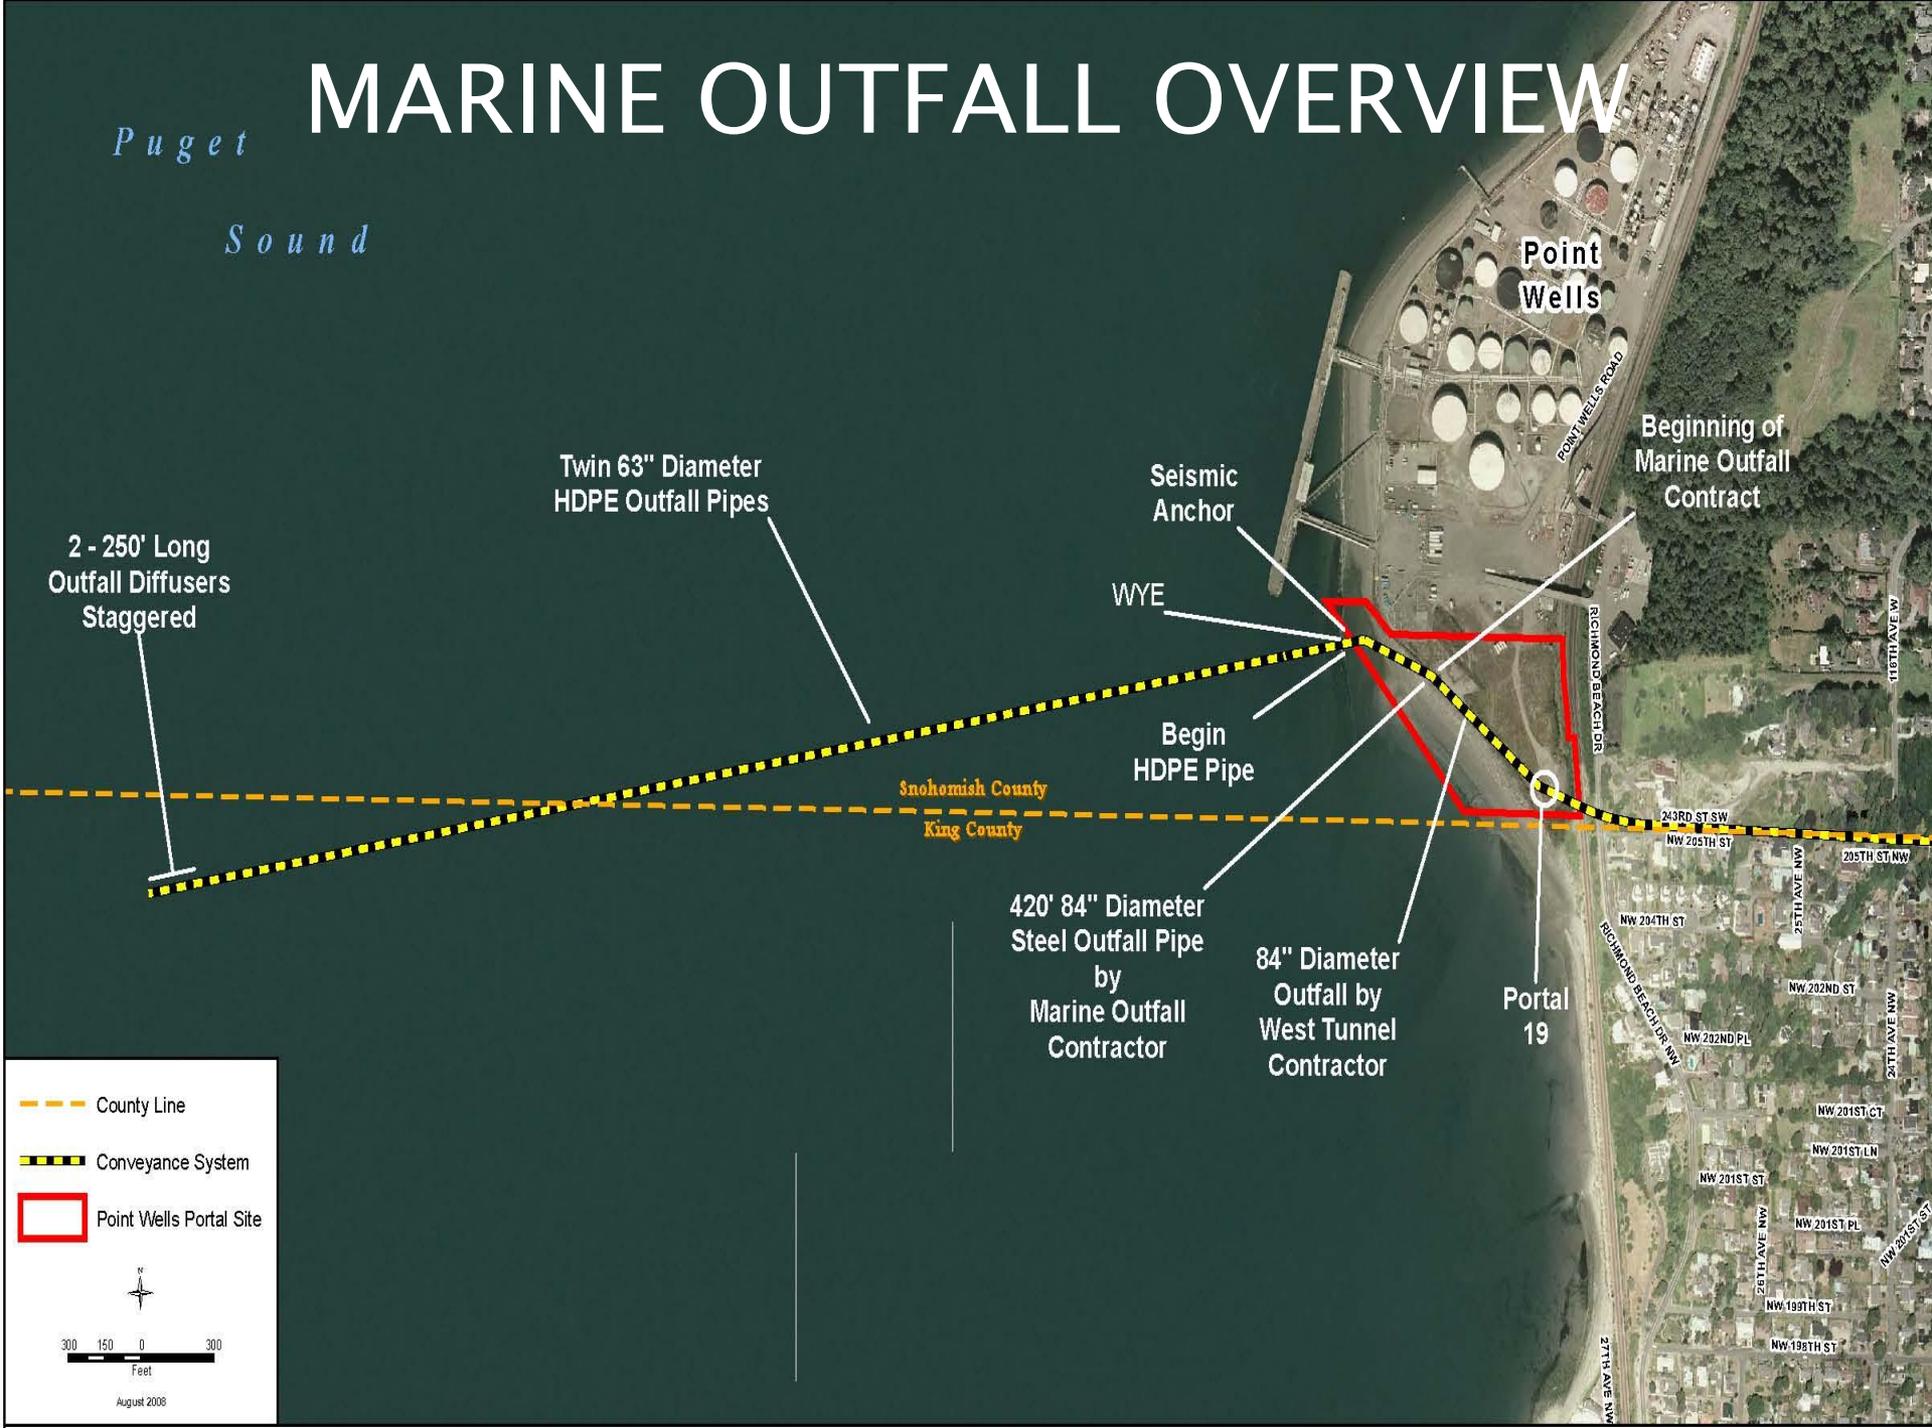
# MARINE OUTFALL OVERVIEW

- County Line
- Conveyance System
- Point Wells Portal Site

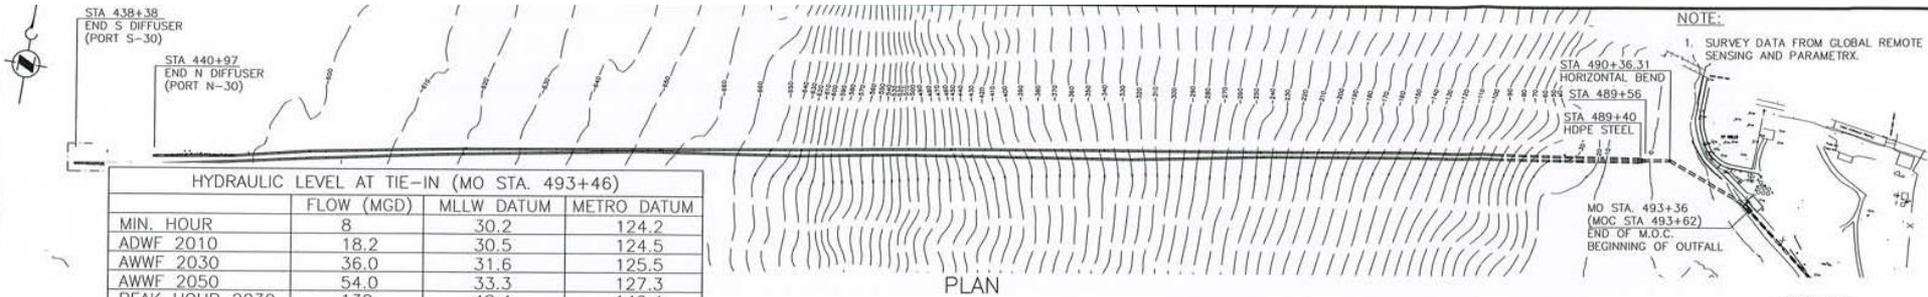
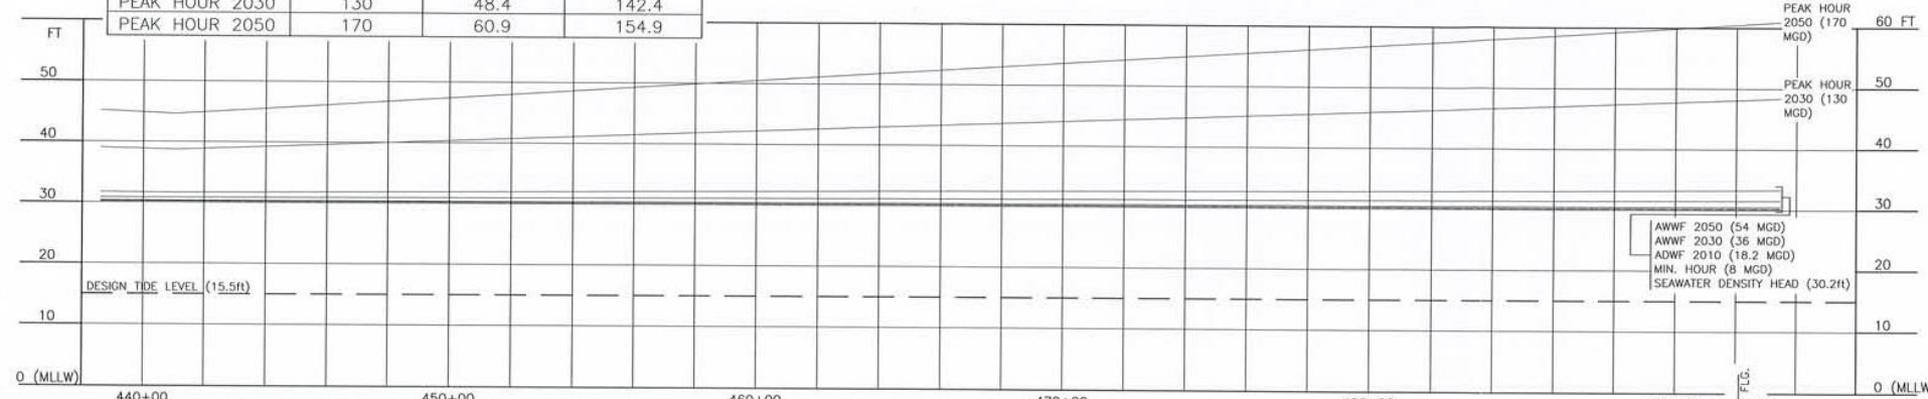
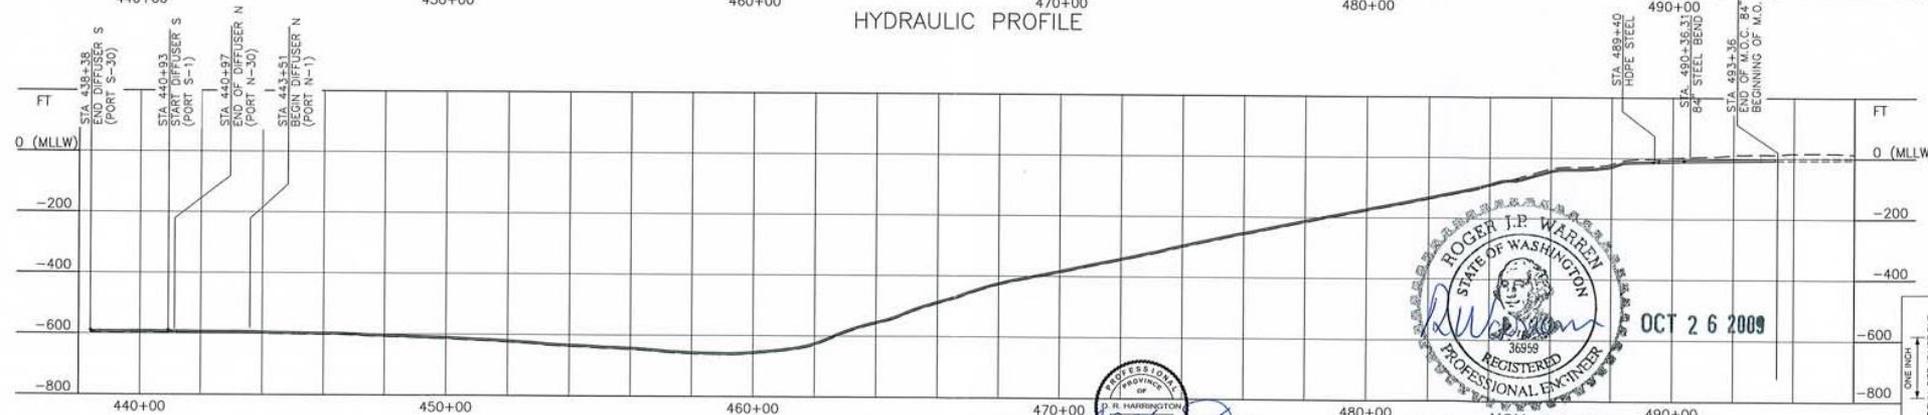
# MARINE OUTFALL PLAN/PROFILE

HYDRAULIC LEVEL AT TIE-IN (MO STA. 493+46)

FLOW (MGD)	MLLW DATUM	METRO DATUM
MIN. HOUR	8	30.2	124.2
ADWF 2010	18.2	30.5	124.5
ADWF 2030	36.0	31.6	125.5
ADWF 2050	54.0	33.3	127.3
PEAK HOUR 2030	130	48.4	142.4
PEAK HOUR 2050	170	60.9	154.9

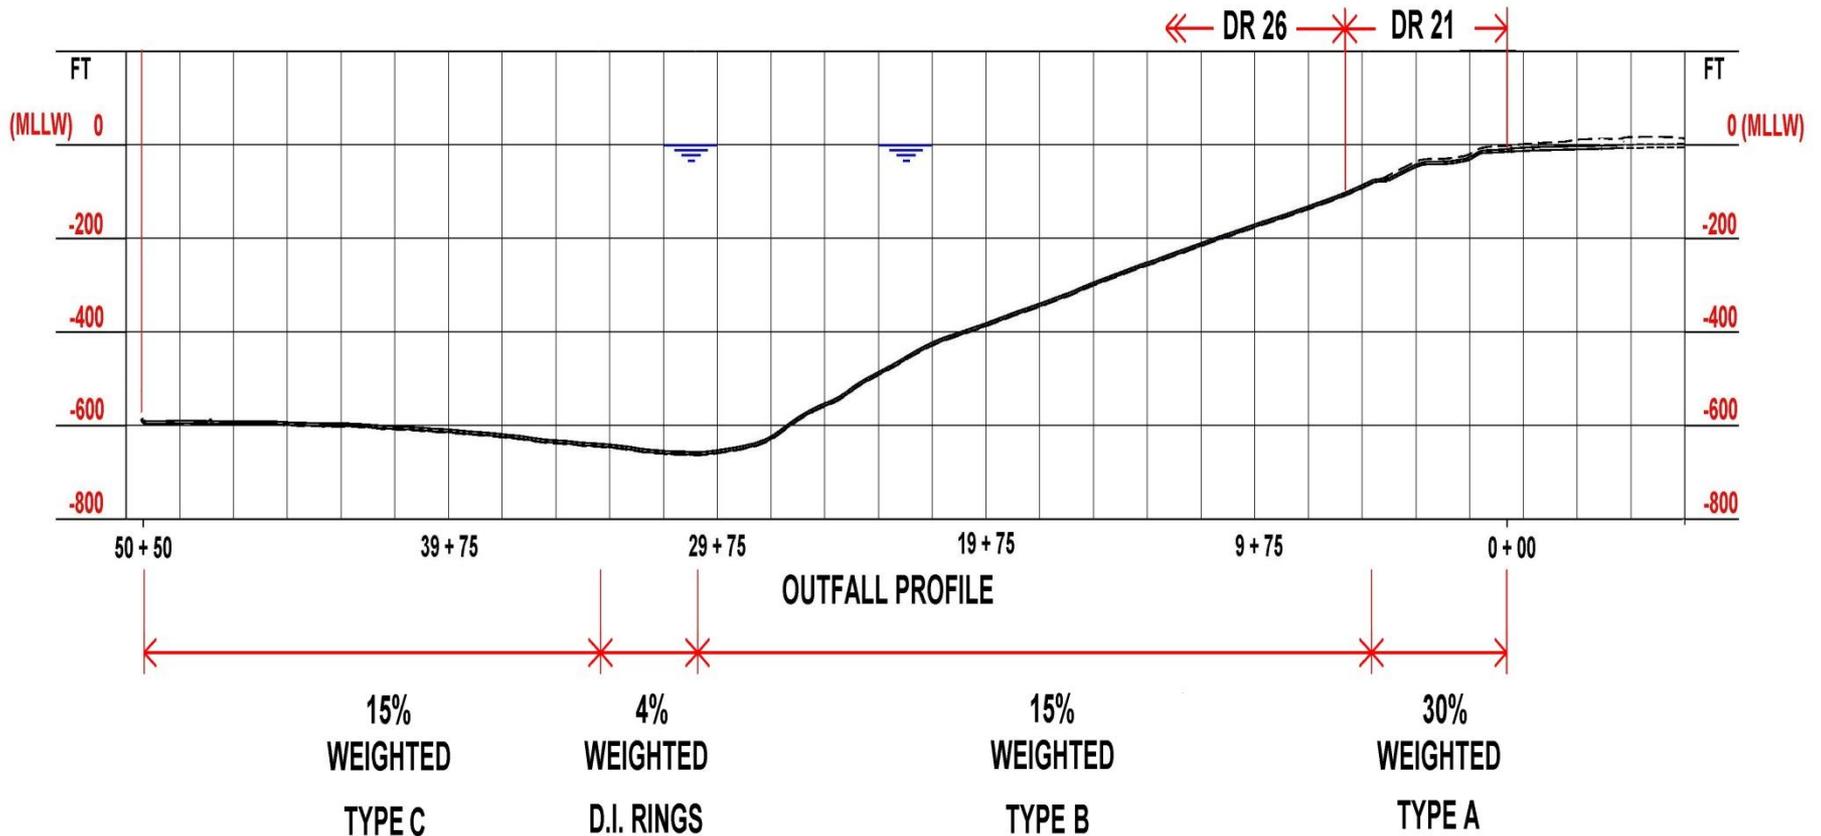
# BRIGHTWATER MARINE OUTFALL PROFILE

END OF DIFFUSERS

START OF TWIN  
63" DIA. PIPELINES

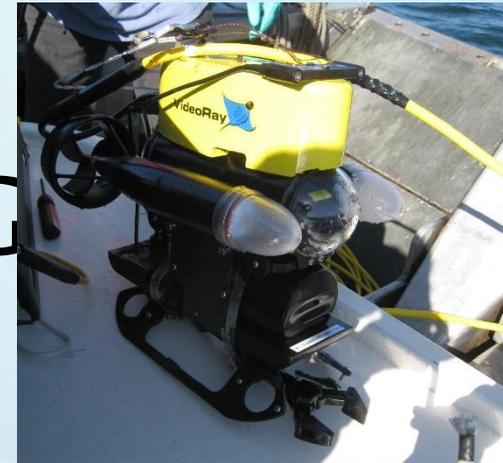
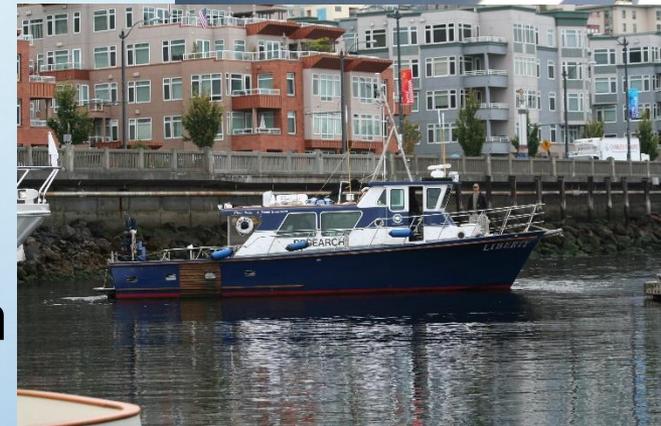
- Annual visual inspection with Remote Operated Vehicle (ROV)
  - King County research vessels Liberty or Sound Guardian with small ROV
  - In year 2, 5 & 10 using work class ROV and salvage contractor barge
- 5 year diffuser elevation

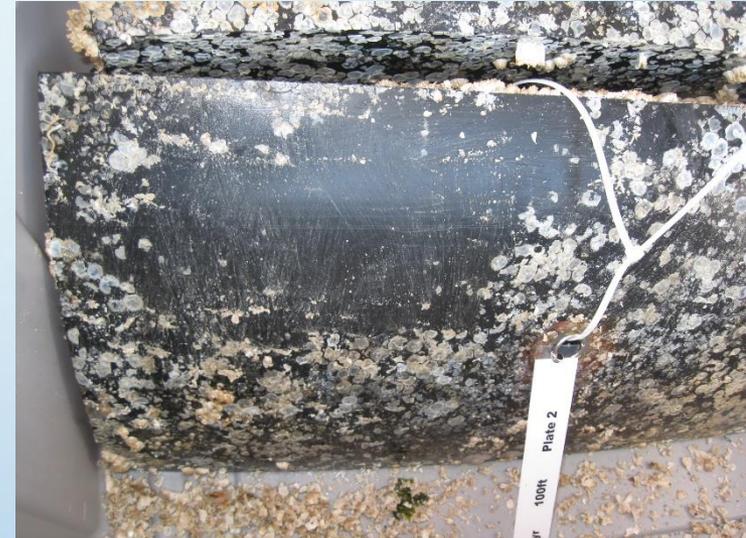
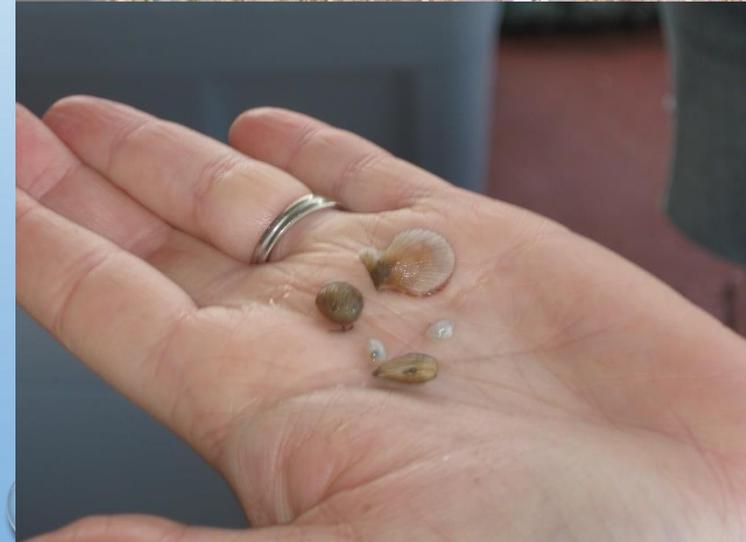
- 2 ft x 1 ft sections of pipe deployed in 2012
  - -100, -300, -600 ft MLLW
  - Reference site (-600 ft)
- 10 “settlement plates” for each site
- 3 replicates to be collected at each depth year 2 & 5 and 4 in year 10

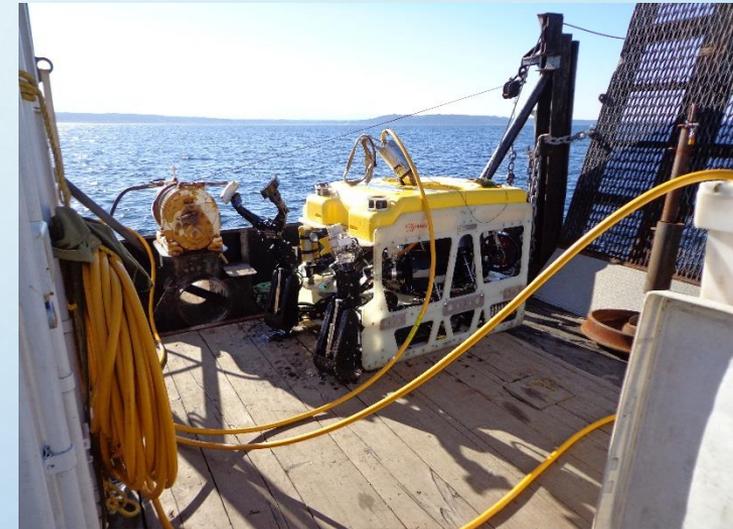
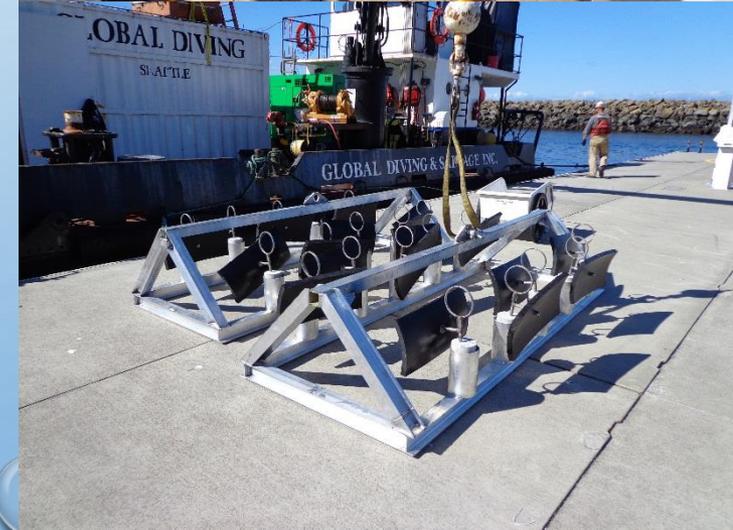
- ROV collection
- Samples assessed for % cover
- Flexible mesh grid aids in estimation – 21 cells
- Macroscopic biota identified in the field
- Photographs of each cell
  - Future identification
  - Better estimate of % cover

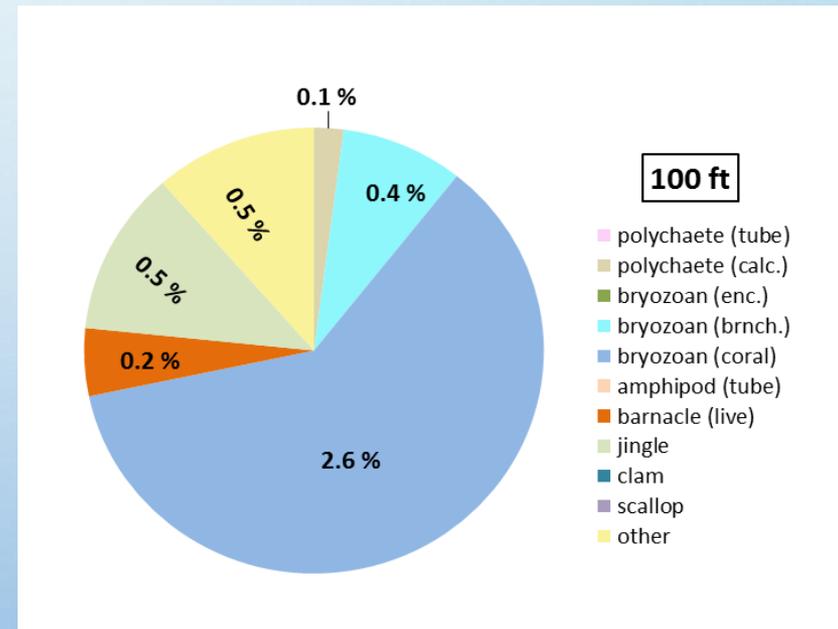
# 2014 SAMPLE 100 FEET

- Least Diverse
- High % of barnacle scars (52.1% coverage)
- Avg. total % cover was 56.3%
- Avg. % cover for live organisms was 4.2%
- Barnacle settlement was substantial however, predation likely limited the presence
- It is expected that recruitment of new

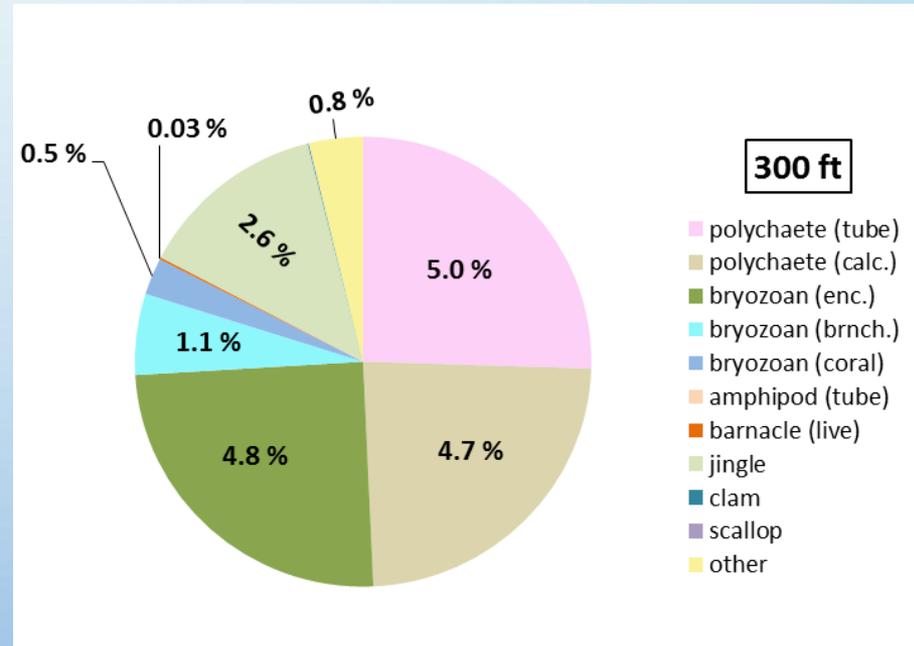
# 2014 SAMPLE 300 FEET

- Tube worms were the most abundant
- Live barnacles 0.03%
- Total percent cover 47.9%
- Due to the presence of dead barnacles
- 19.6% cover of live organisms

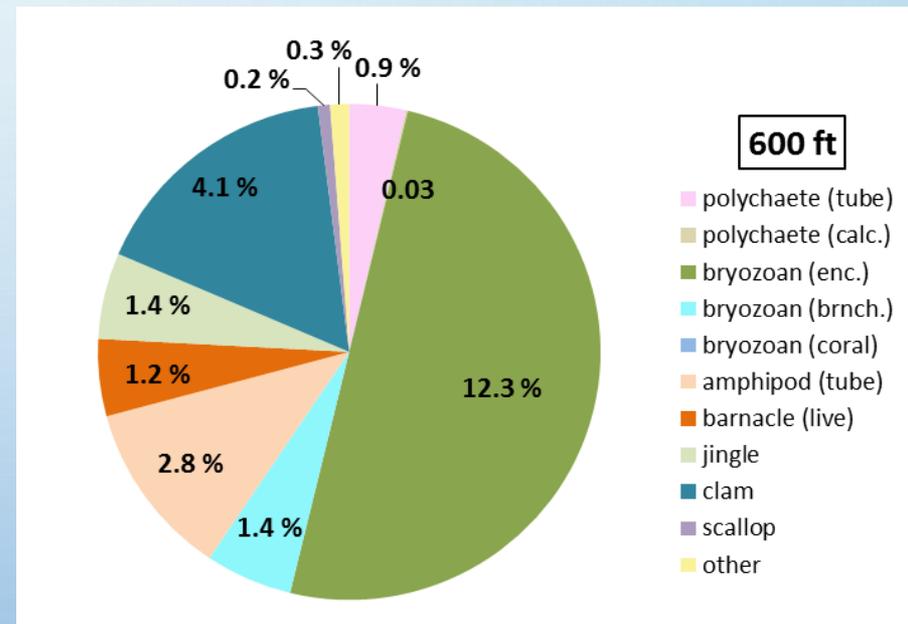
# 2014 SAMPLE 600 FEET

- The coral bryozoan was seen at lower depths but not at 600ft
- The scallops were recently settled (small), not seen at other depths
- Few motile organisms
- Total percent cover at this depth averaged 60%

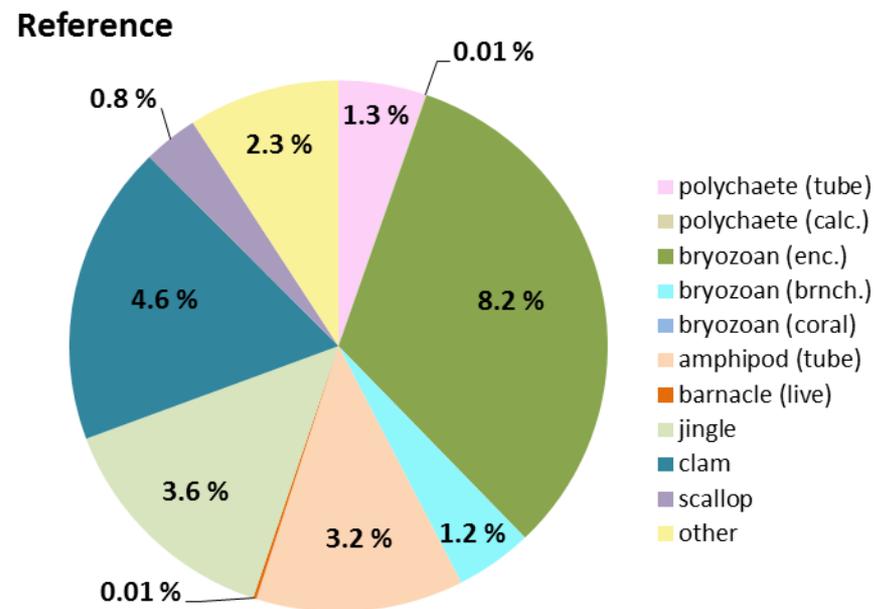
# 2014 SAMPLE 600 FEET REFERENCE

- The most motile organisms
- Total percent cover at this site averaged 67.8%, the highest of all four sites
- Percent cover of live organisms is 25.2%

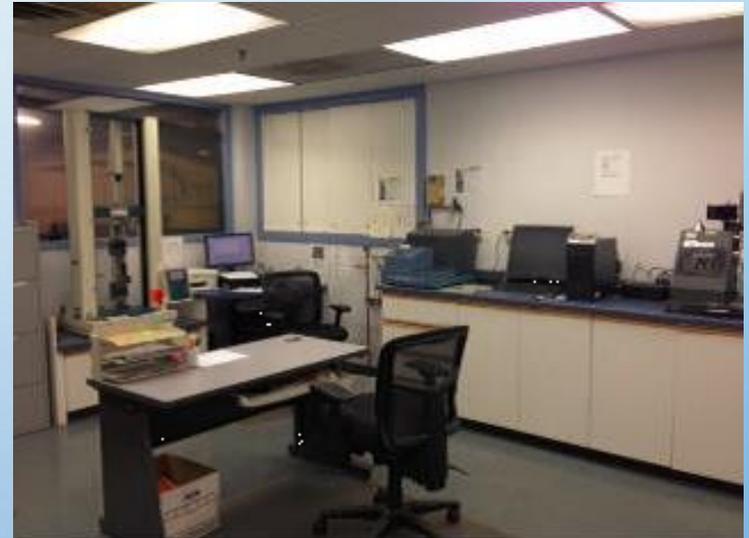
- Uponsor's QA material testing lab in Saskatoon, Saskatchewan.
- Samples tested for:
  - Tensile strength,
  - Flex modulus @ 5% strain,
  - Flex modulus @ 2% strain

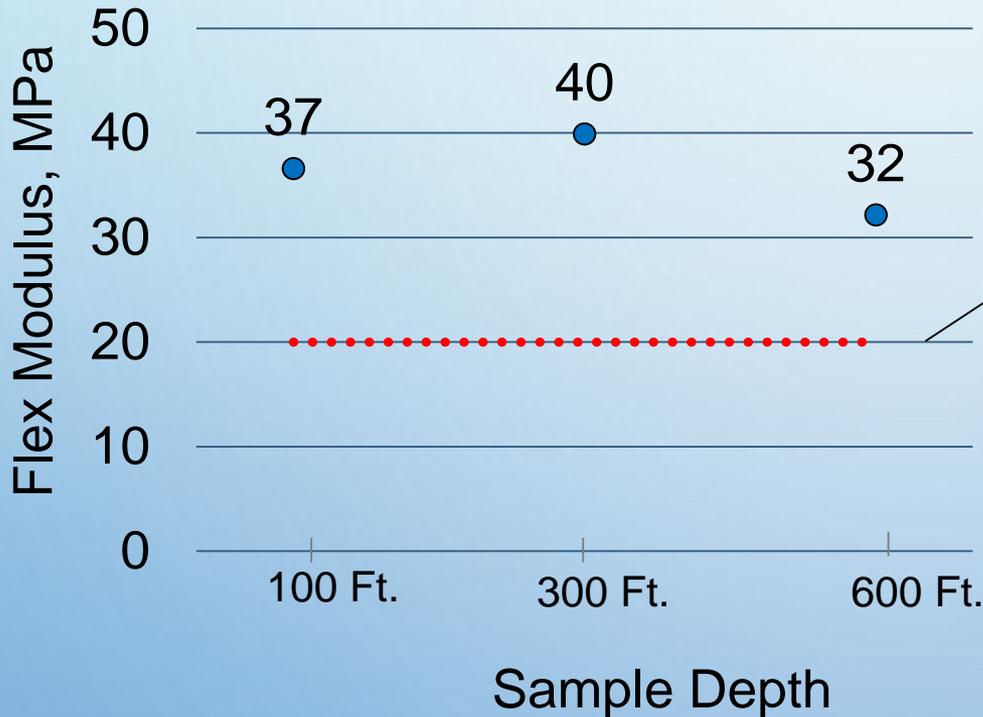
# FLEX MODULUS @ 5% STRAIN - 2 YEAR

Reference minimum flex modulus-5% value for Uponor's solid-walled HDPE (20 MPa)

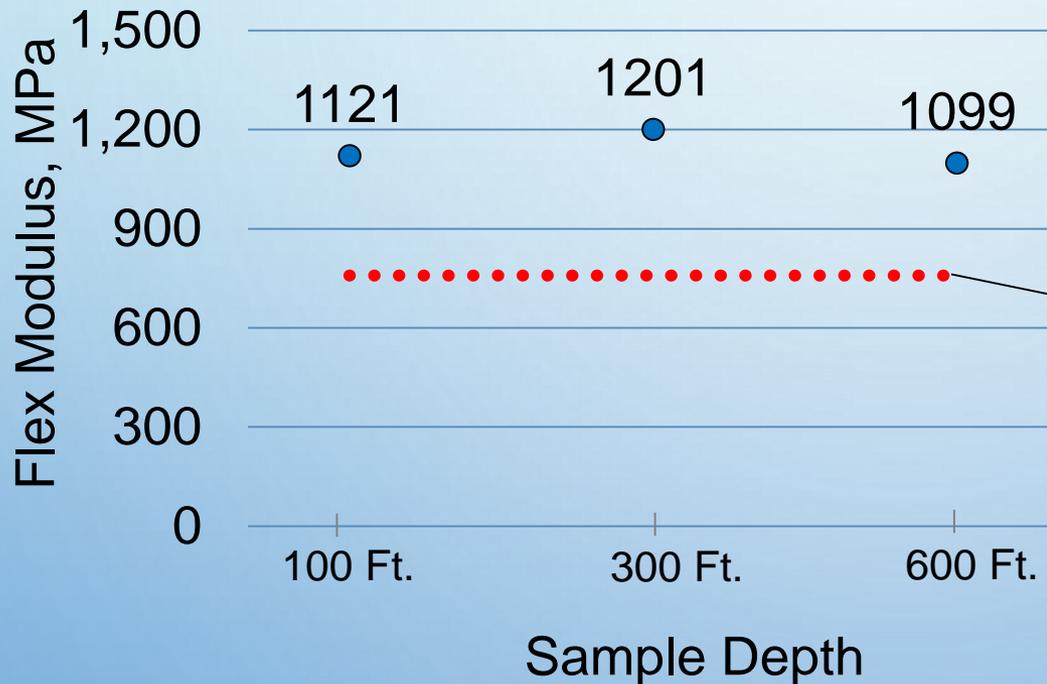
# FLEX MODULUS (SECANT) @ 2% STRAIN - 2 YEAR DATA

Reference minimum flex modulus-2% value for Uponor's solid-walled HDPE (758 MPa)

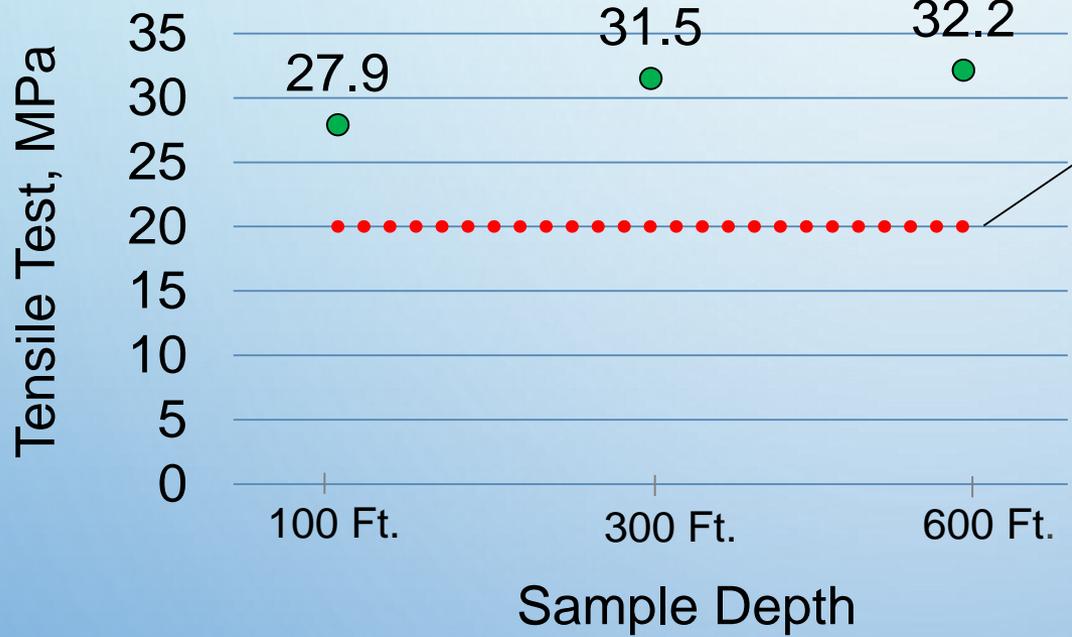
# TENSILE TEST

Reference minimum tensile strength value for Uponor's solid-walled HDPE (20 MPa)

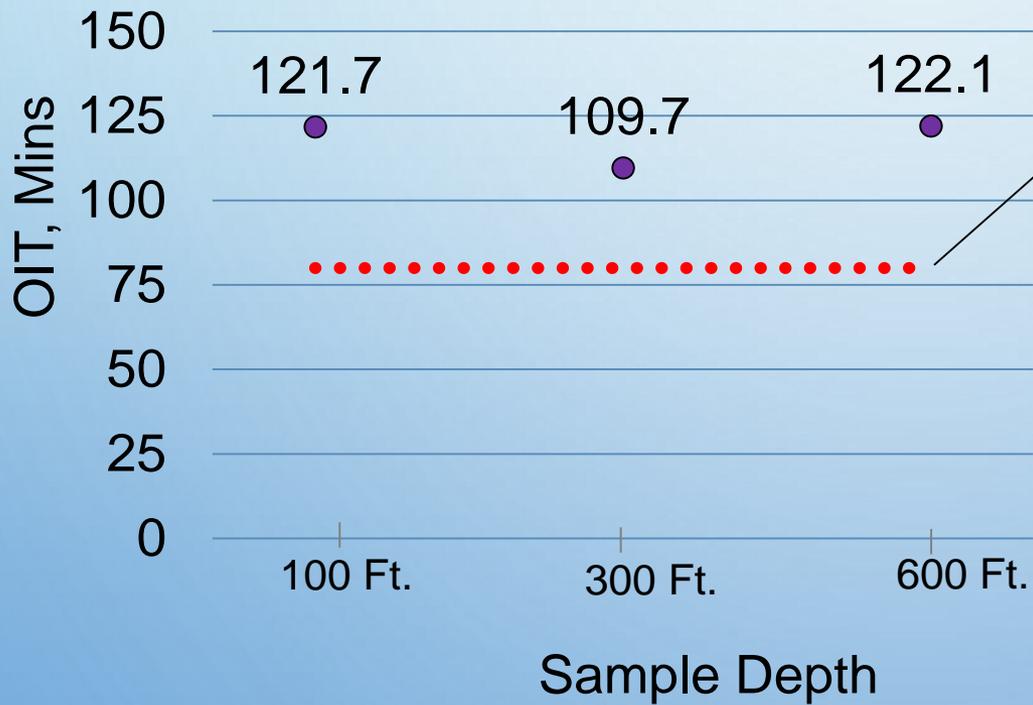
# OXIDATIVE INDUCTION TIME

Reference minimum tensile strength value for Uponor's solid-walled HDPE (80 mins)
