TAMING THE WILD - UNDERSTANDING RISKS AND RESPONSES TO WATER SUPPLIES FROM WILDFIRES

Glen Leverich ¹
Rodrigo Prugue ²

2019 PNWS-AWWA
Conference,
Vancouver, WA

CASE STUDY: CITY OF BROOKINGS MUNICIPAL WATERSHED POST-FIRE ASSESSMENT

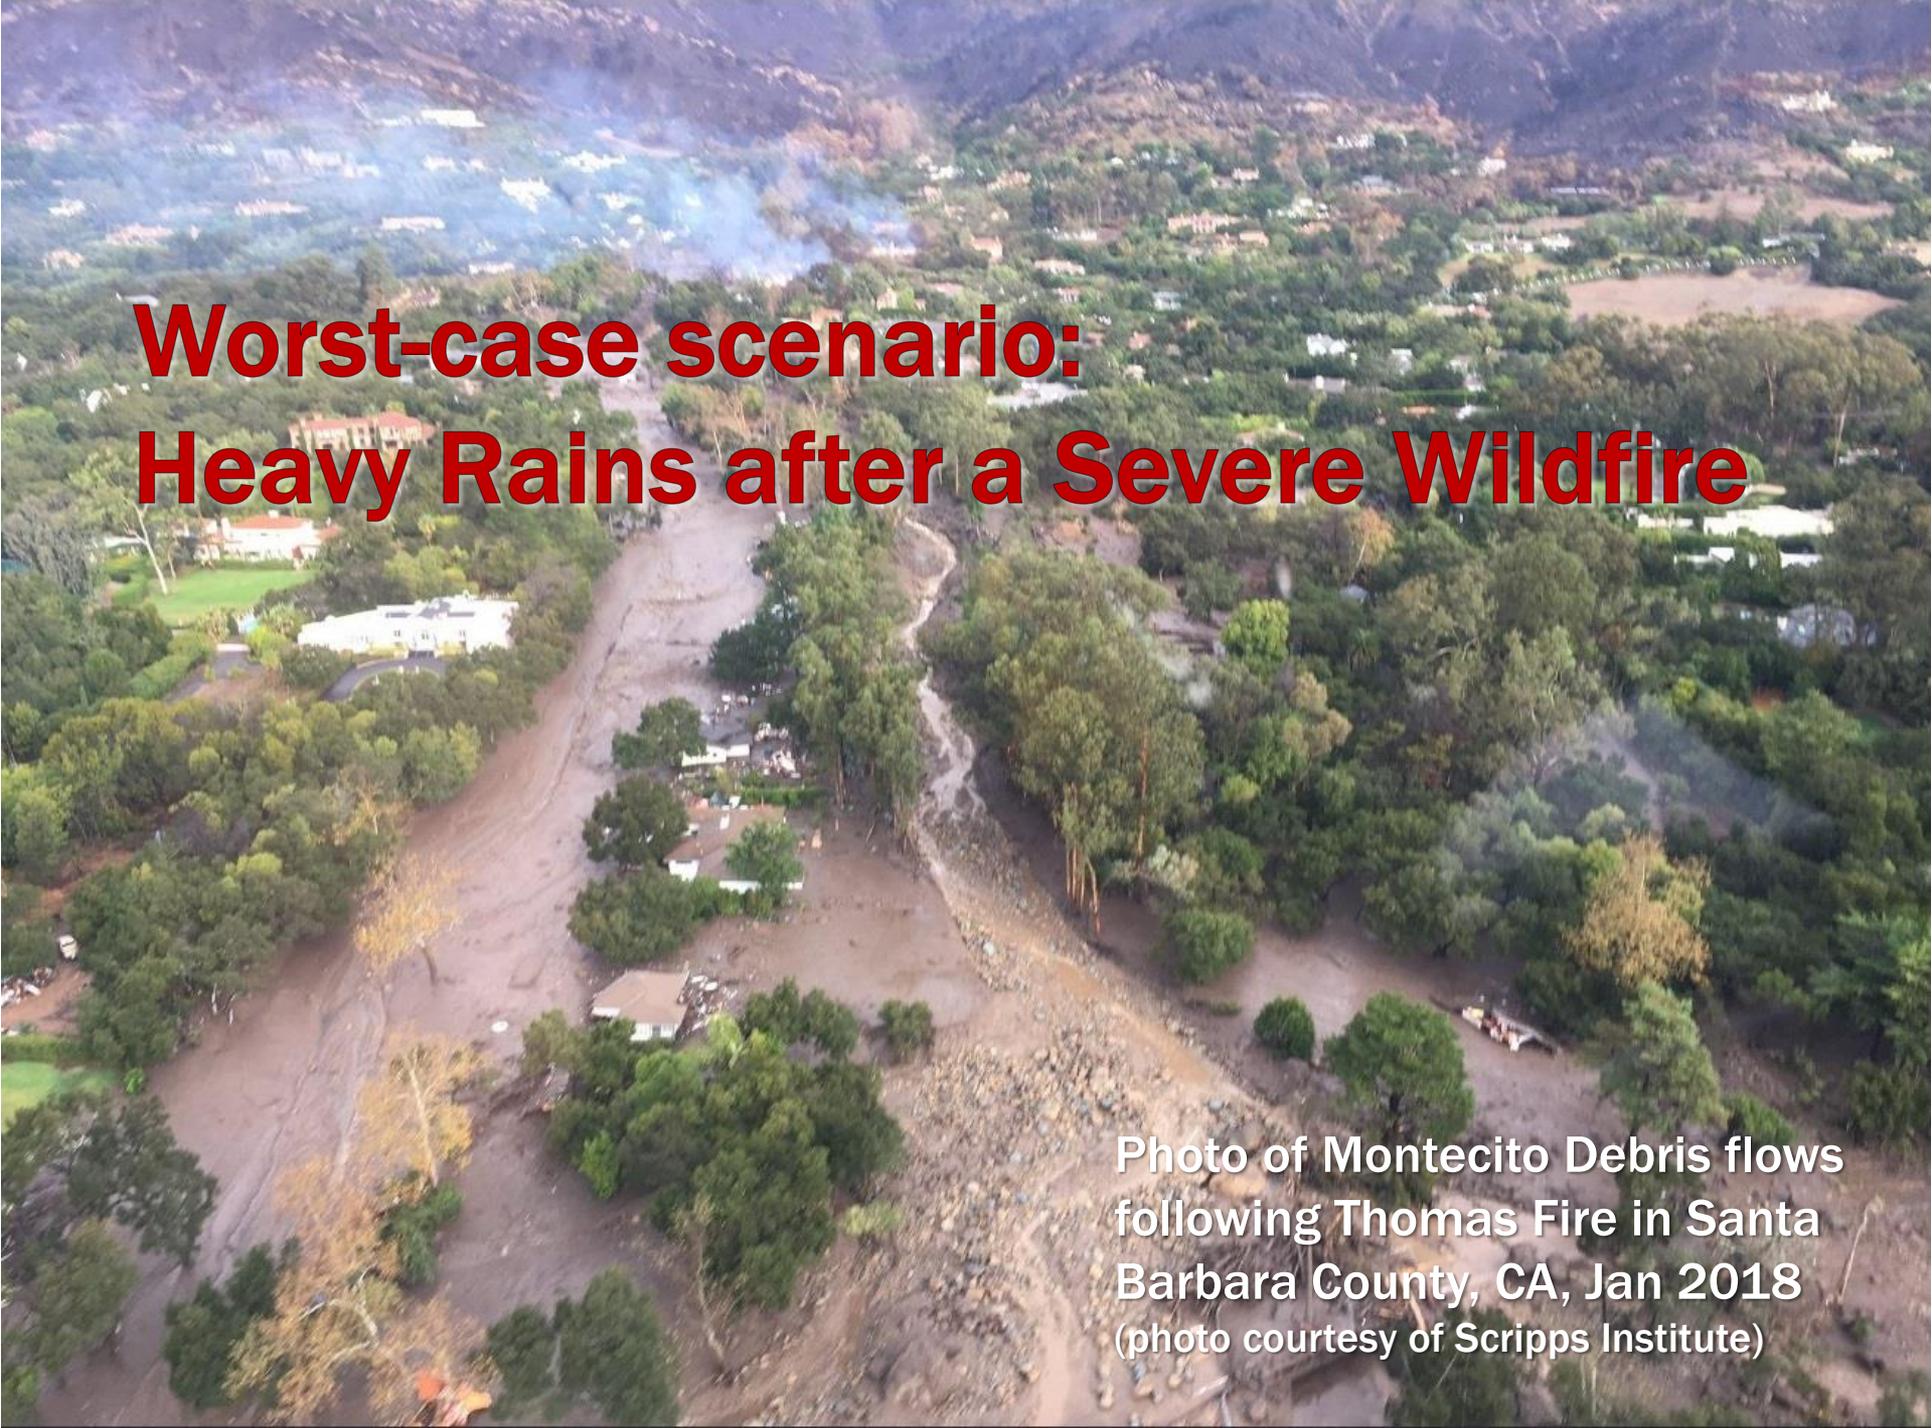
An aerial photograph showing a wide, muddy debris flow channel cutting through a residential area. The flow is dark brown and turbulent, with some houses partially submerged or surrounded by the mud. The surrounding landscape is a mix of green trees and brown, charred vegetation. In the background, there are mountains and more residential buildings. The sky is clear and blue.

Worst-case scenario: Heavy Rains after a Severe Wildfire

Photo of Montecito Debris flows
following Thomas Fire in Santa
Barbara County, CA, Jan 2018
(photo courtesy of Scripps Institute)

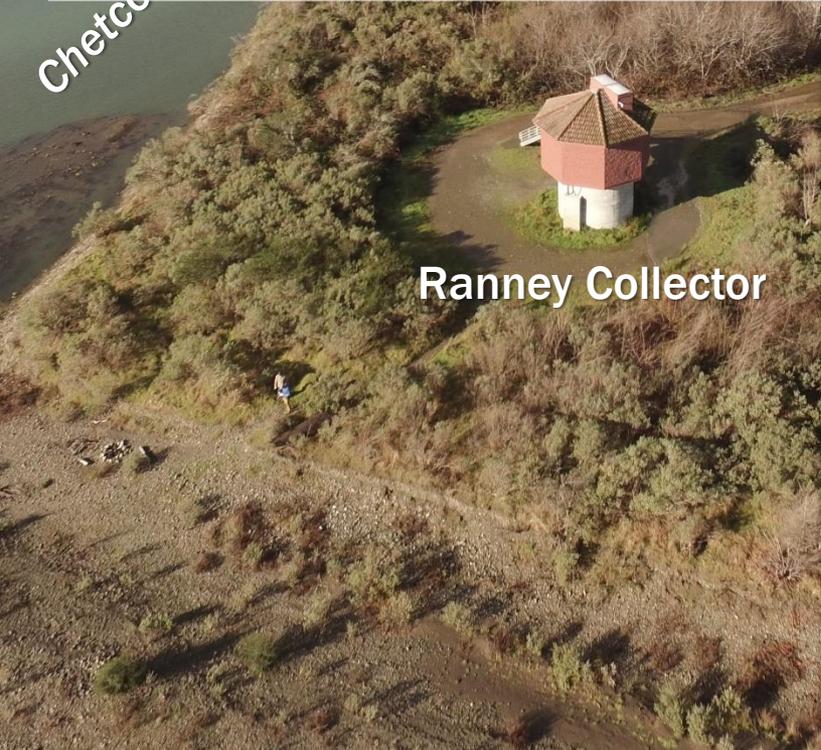
Chetco River

- Frequent wildfires and increasing air temps in recent years
- 350 mi² area
- Wildfires have occurred during above-normal and below-normal water years
- Population = 1.2 MGD
- Major storm and flood events (>5 yr RI) have not occurred within 3 years of any of the major wildfires

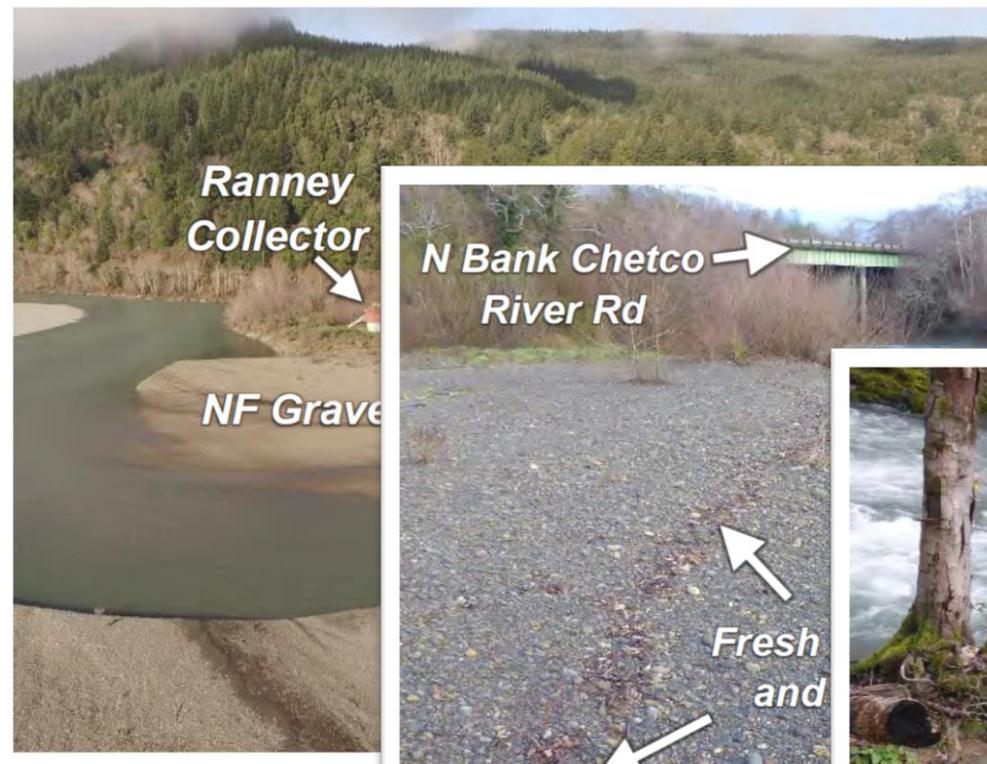
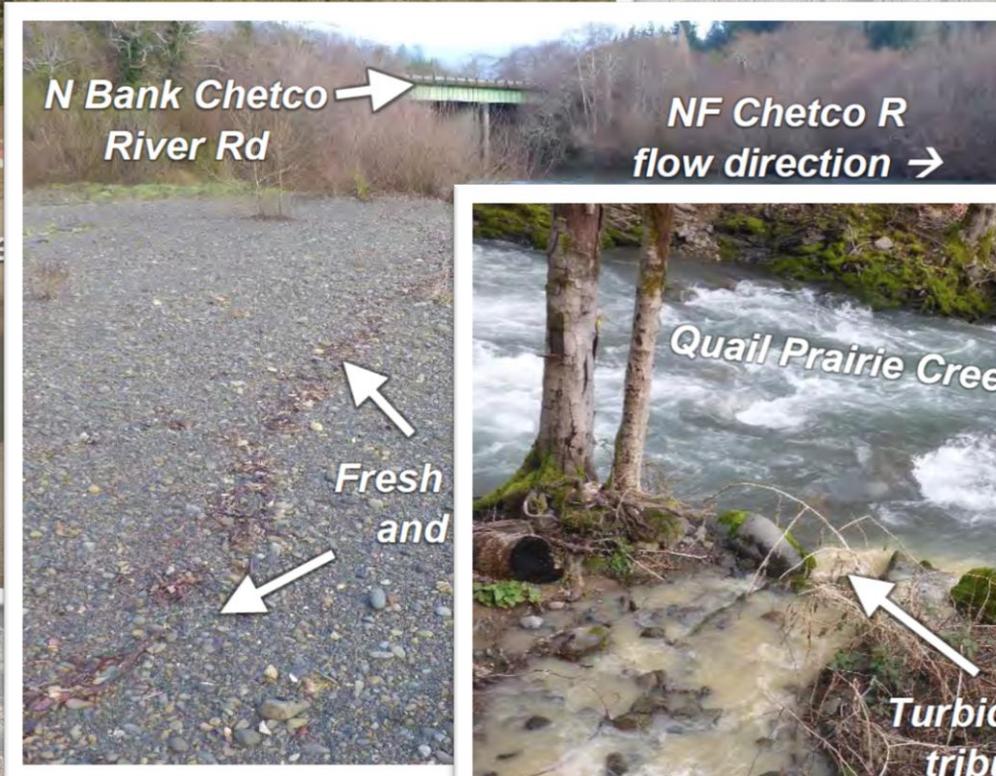
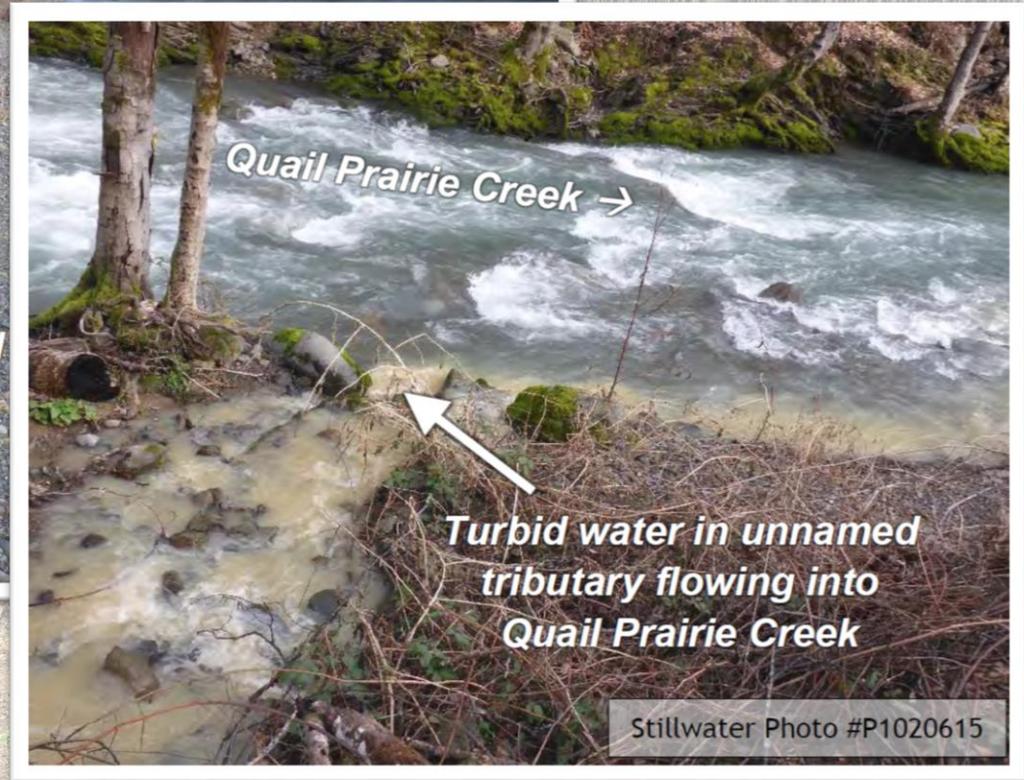
long-term photo-points

- Conducted soon after largest storm of year

- Assess post-fire changes to runoff hydrology and channel morphology at infiltration gallery
 - Understand effects from past wildfires (Biscuit Complex)
 - Utilize USFS BAER information and interviews
 - Field reconnaissance
- Establish photo-log monitoring locations to identify changes in channel morphology → low cost and repeatable by City staff
Geomorphically active channel location
Confluence of mainstem and NF river

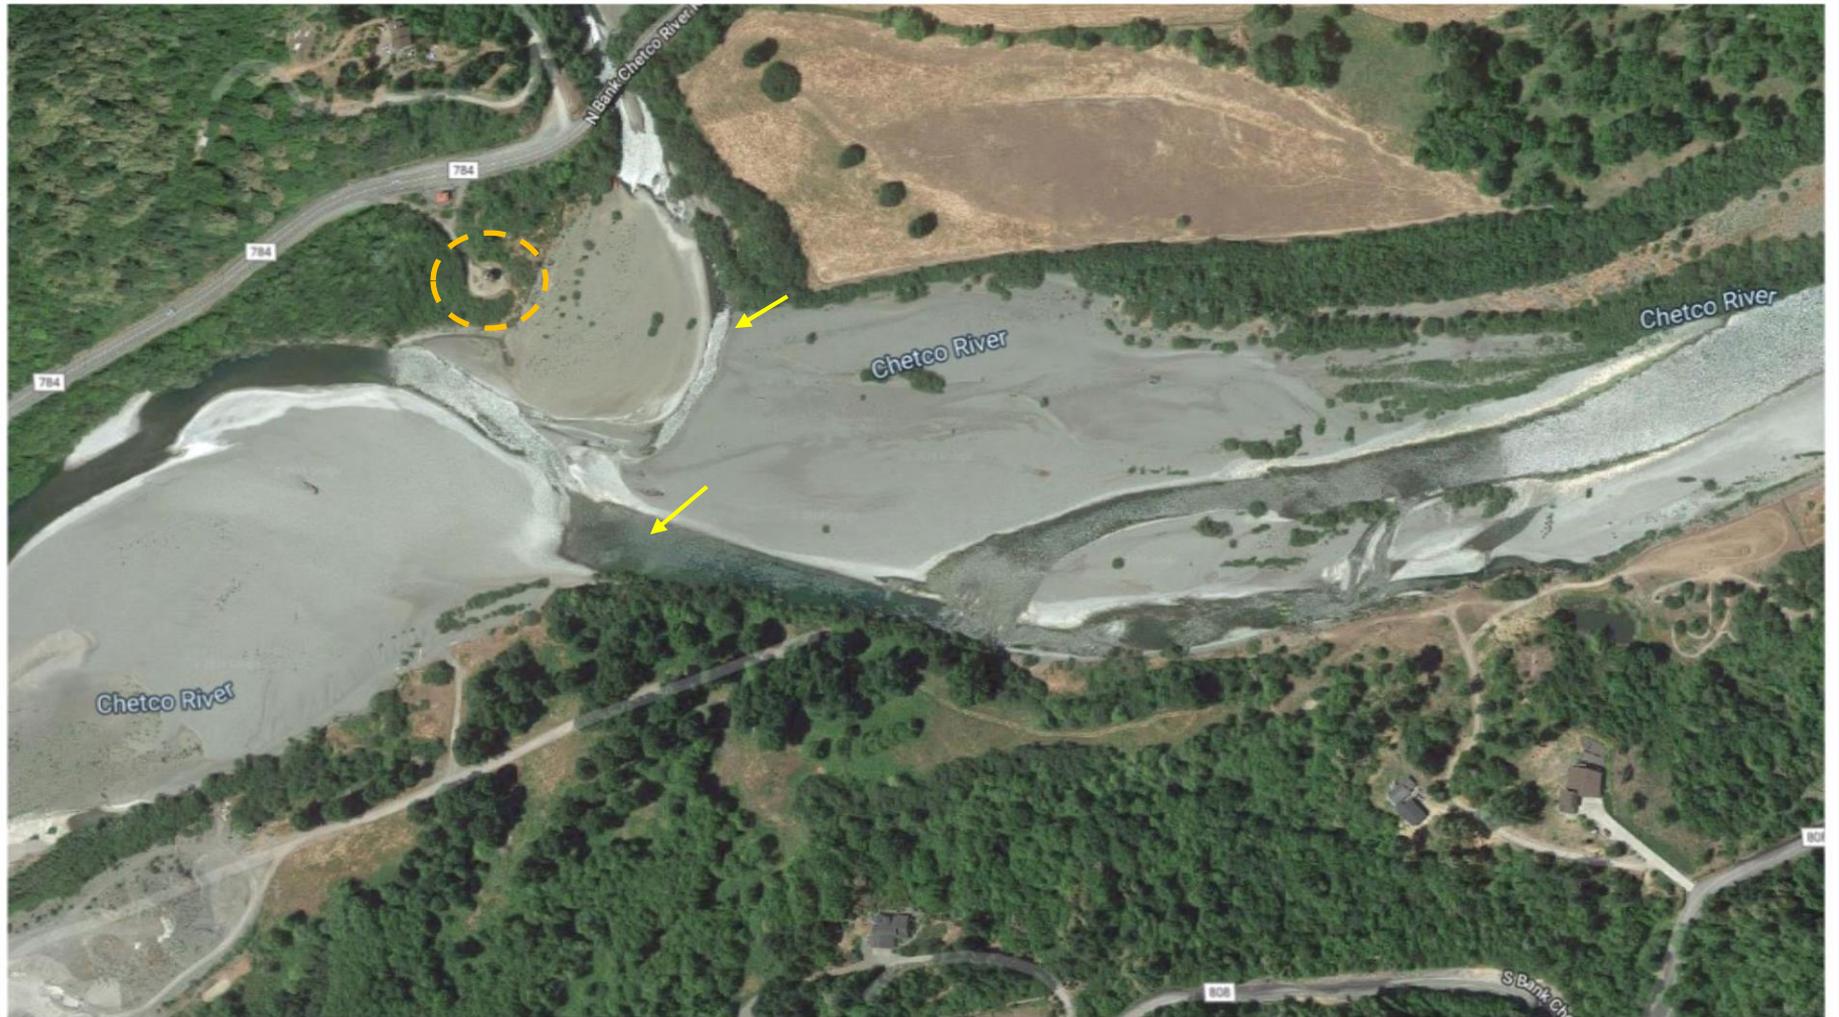
FIELD METHODS

- Two post-fire sampling events conducted.
 - January 30, 2018 (relatively dry conditions)
 - March 23, 2018 (relatively wet conditions)
- Parameters
 - General
 - Major Anions/Cations
 - Nutrients
 - Metals
 - Microbial
