Beginning the Treatment Journey

The City of Meridian's Path to Bring Online
Their First Drinking Water Treatment Plant

PNWS AWWA 2016

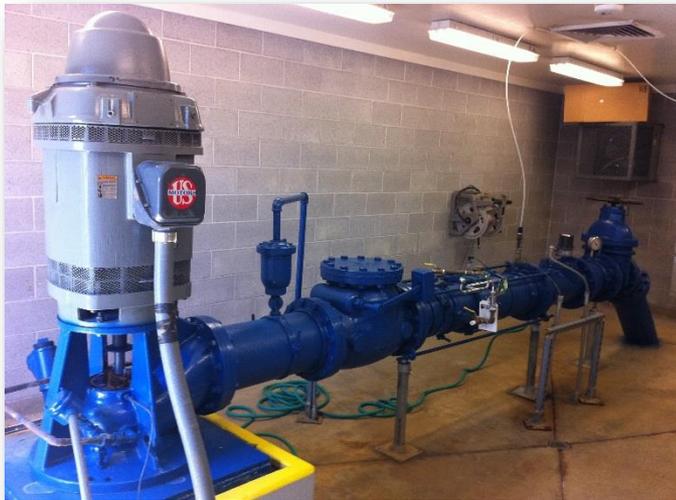
Why Well 21

- Located in the largest pressure zone
- Higher levels of iron/manganese
- Larger producer in the pressure zone

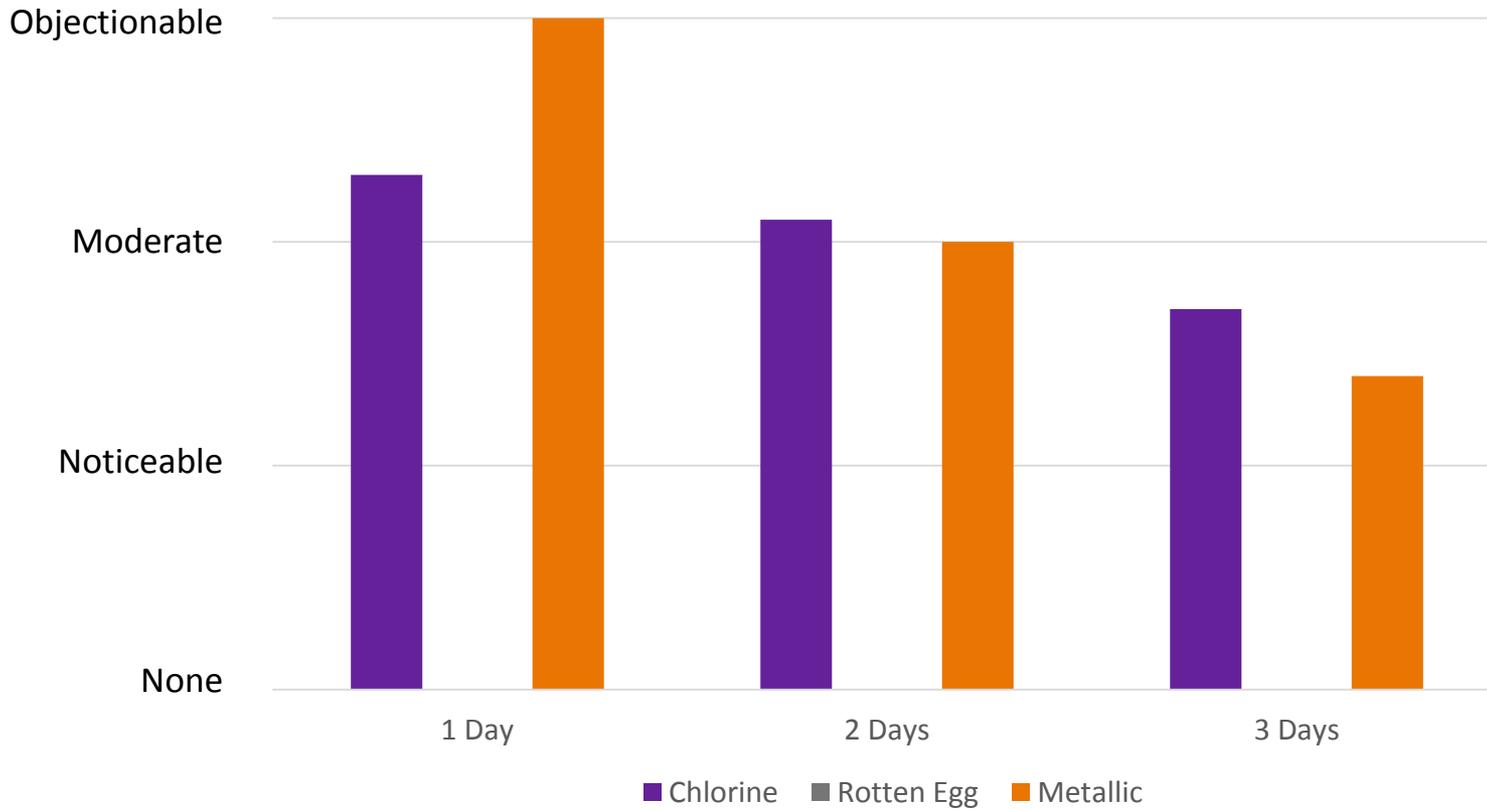
Well 21 Pilot Testing Taste and Odor Panel Results

Pilot Testing – Round 1

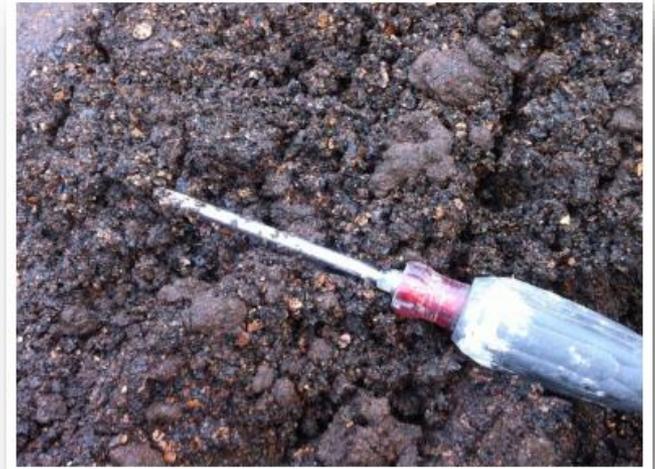
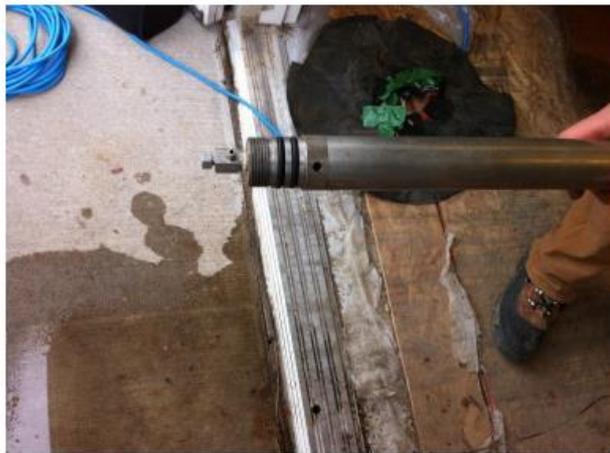
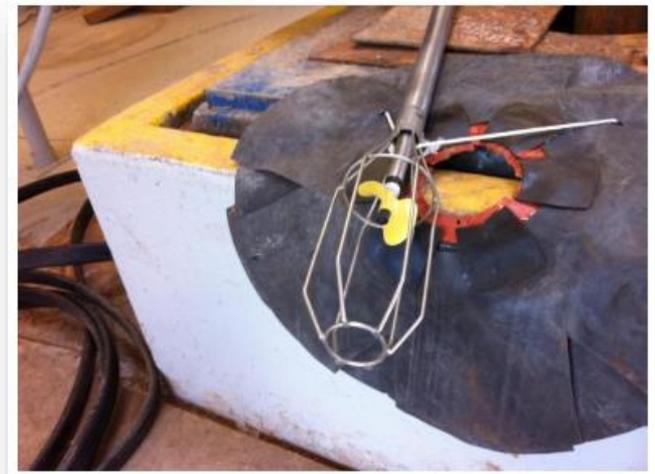
Well Zone Water Chemistry Determination

- Cleaning and redevelopment of the well
- Spinner logging performed
- Depth-specific sampling performed

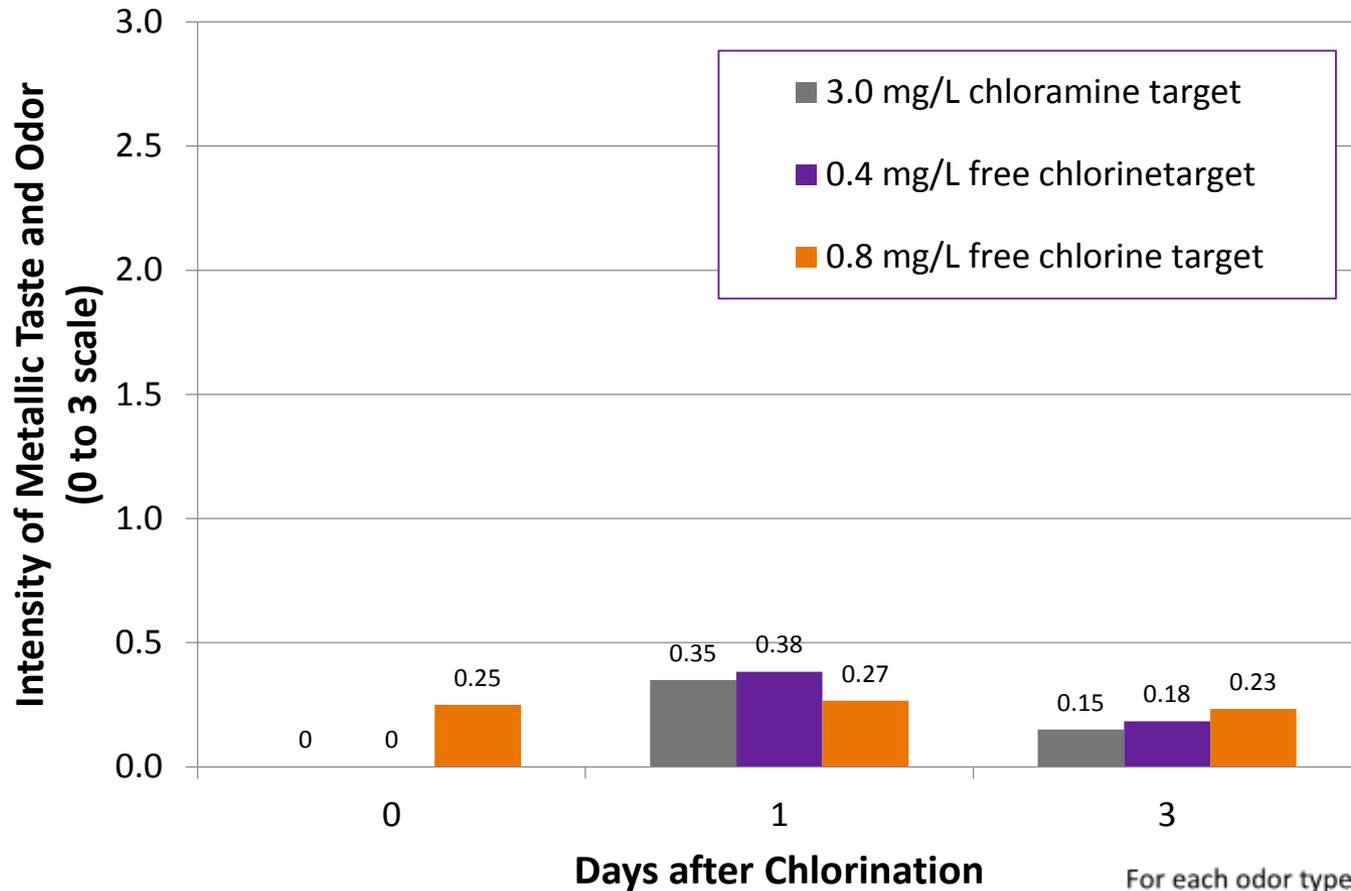
Metallic Taste and Odor

For each odor type, a common scale was used:

- 0 = nothing (no odor)
- 1 = noticeable
- 2 = moderately strong
- 3 = objectionable

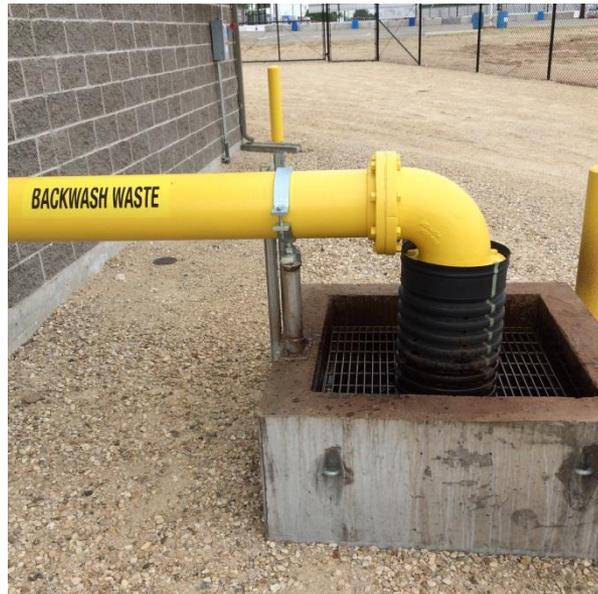
Operational Data – Backwash Frequency

- Dependent upon flow rates through the filter based on system demands
- At full flow of 1,600 gpm, backwash cycles once every 24 hours
- Lower flows result in longer duration between backwash cycles- up to 3 days
