What's the Status of Your Assets?

Use Repeatable Condition Assessment to Track Changes Over Time

*PNWS AWWA
Annual Conference
May 4, 2016*

Timeline of Condition Assessment and Risk Evaluation for Hoodland Service Area

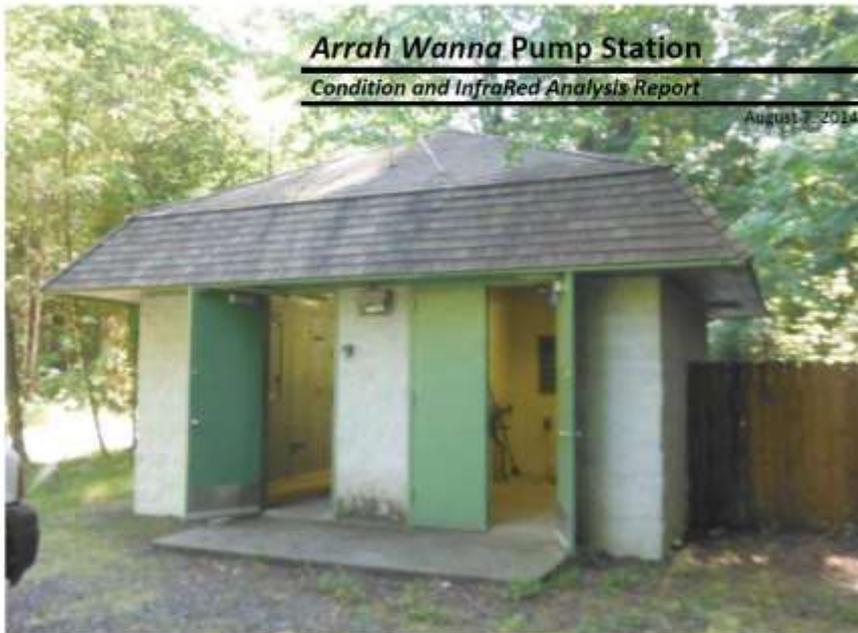
WES used 2008 Format to Perform Condition Assessment on Hoodland Pump Stations

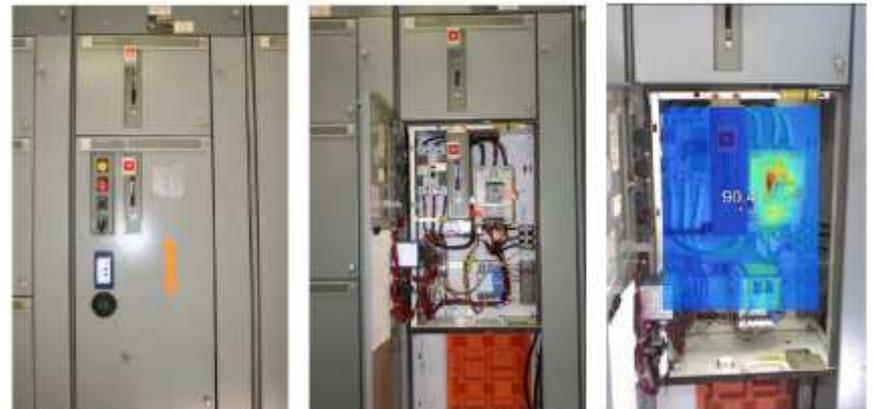
Timberline Rim Pump Station Control Panel – Motor Control Center #1

Condition Question	Answer	NA	Flag*	Comments
Absence of Burn Marks	5 - No			
Acceptable Noise	5 - No			
Acceptable Smell or Heat	1 - Yes			
All Components	1 - Yes			
All Safety Features Present	5 - No			
Operating at Inspection	1 - Yes			
Appearance (Carbon Dust)	3 - Moderate			
Control Gauges (Hour Meters Volts & Amps)	3 - Operational			
Control Lamps	3 - Operational			
Control Switches	3 - Operational			
Corrosion - Structural Metals	2 - Slight staining/small chips/holes in coating			
Good House Keeping	5 - No			
Good Wire Labeling	5 - No			
Grounding	1 - Yes			
Infrared	2 - Normal			
Installation/ Accessibility	3 - Moderate Defects			
Main Breaker	3 - Moderate Defects			
Proper Drawings Accessible	5 - No			
Structural Integrity (panel)	3 - Moderate Wear			
Condition Score: 3.105	Condition Category

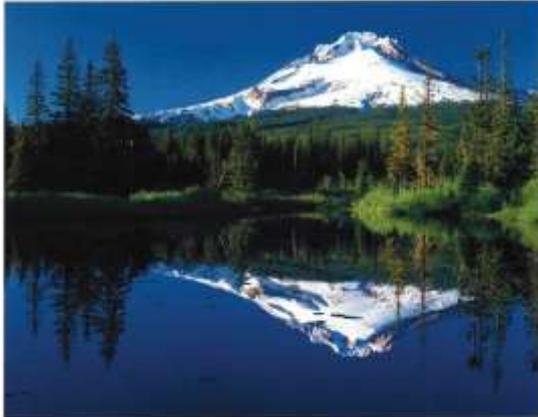
HOODLAND CONDITION ASSESMENTS 2013

CLACKAMAS COUNTY, WATER ENVIORNMENT SERVICES

In 2013, Clackamas County, Water Environment Services, conducted a comprehensive TV inspection of the Hoodland sanitary system. This system comprises of 7 basins, and the purpose of the inspections was to perform a condition assessment on the assets. The average age of the sanitary system is 40 years old, predominantly consisting of 8" concrete pipe. The substrate is comprised of sandy loam and river rock, topped with a dense layer of trees. Due to the nature of the soil, most of the concrete pipe was laid at minimal depth, therefore causing it to be in a higher risk area. The issues observed were cracks, fractures, holes, separated/offset joints, infiltration and extensive root intrusion. These issues will be intensified exponentially if left alone.

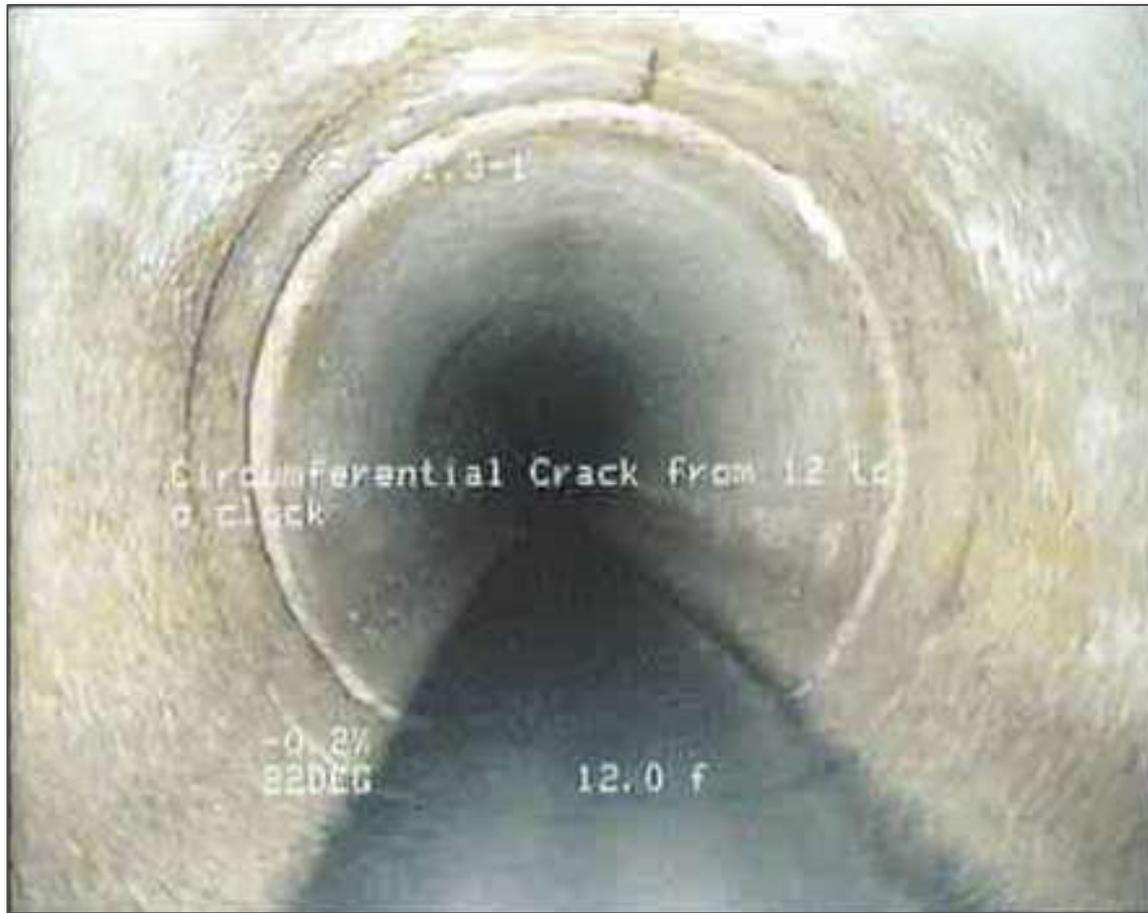
250 Segments Inspected with CCTV

186 Pipe Segments were found to have no defects – Condition Score = 1

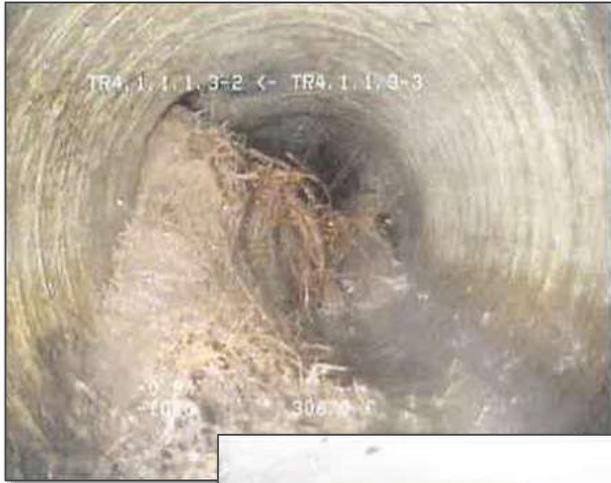
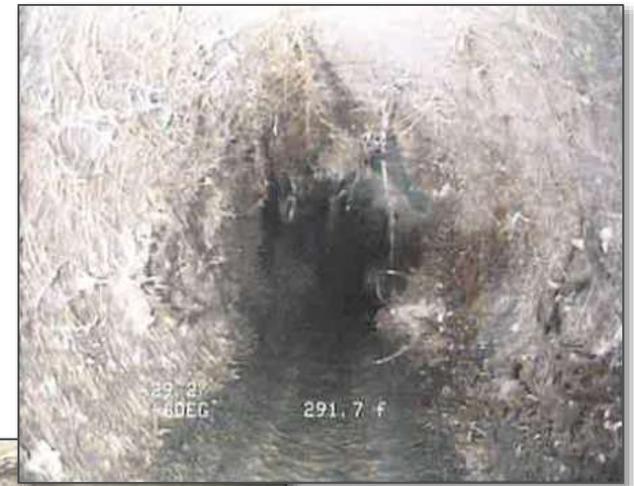
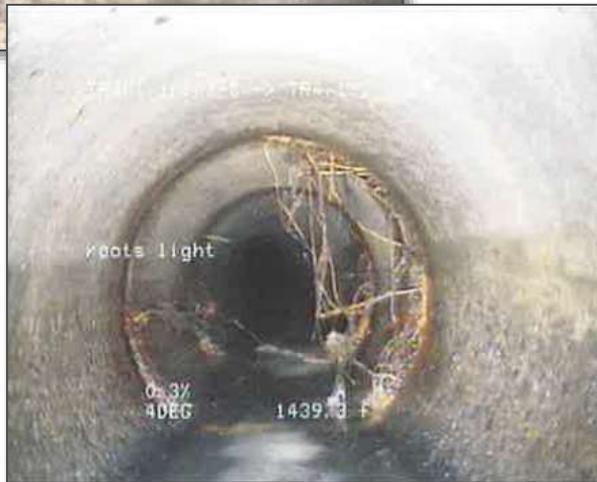
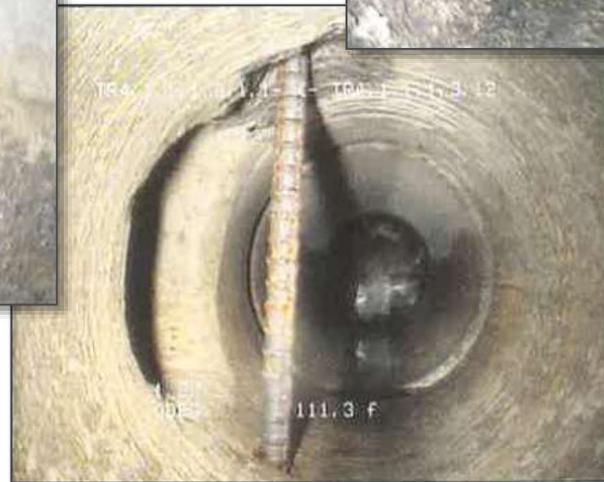
Reports Prepared for 64 Segments with Defects

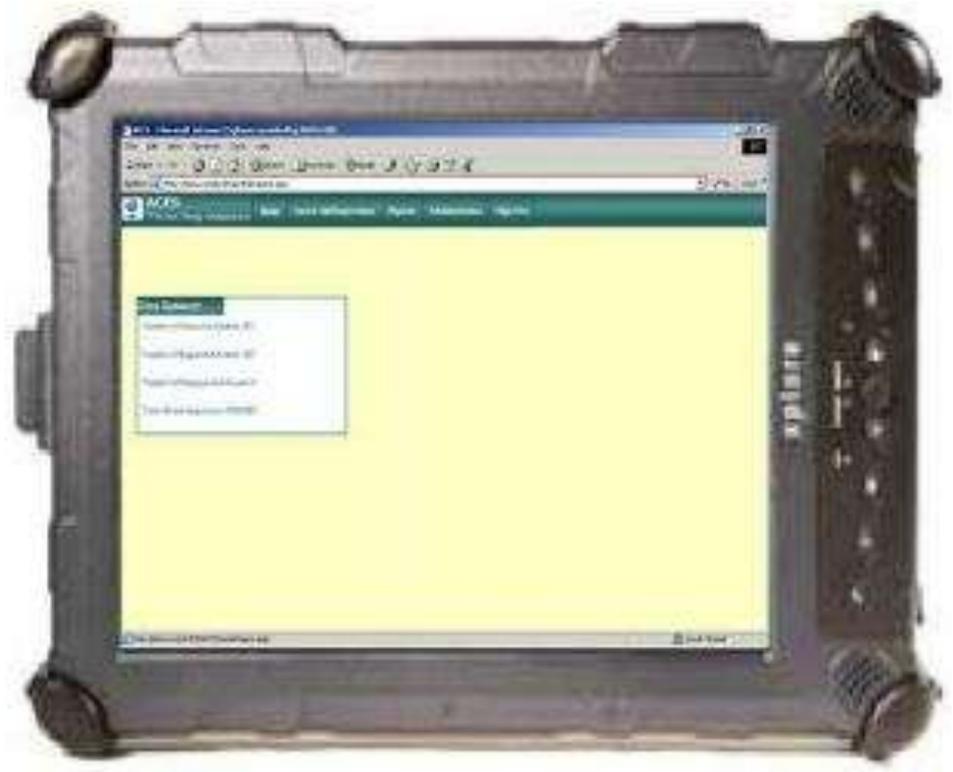
Asset Data is Uploaded into ACES¹

- Asset list
- Asset types
- Asset Condition questions

¹ACES[®] is an asset management reporting and data collection software application for storing and analyzing asset condition and risk assessment information

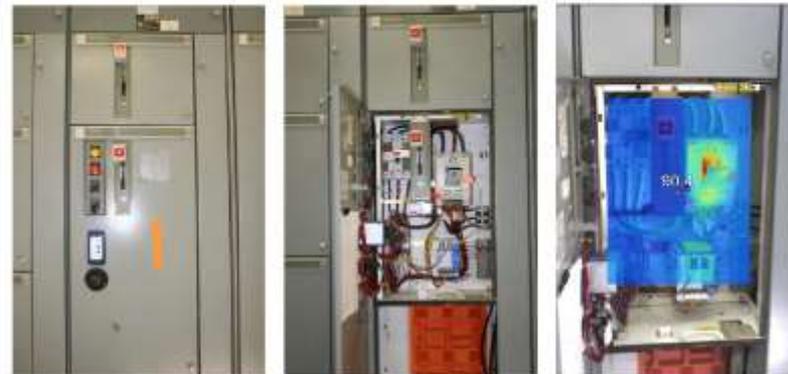
Timberline Rim Pump Station

Control Panel – Motor Control Center #1

Condition Question	Answer	NA	Flag*	Comments
Absence of Burn Marks	5 - No			
Acceptable Noise	5 - No			
Acceptable Smell or Heat	1 - Yes			
All Components	1 - Yes			
All Safety Features Present	5 - No			
Operating at Inspection	1 - Yes			
Appearance (Carbon Dust)	3 - Moderate			
Control Gauges (Hour Meters Volts & Amps)	3 - Operational			
Control Lamps	3 - Operational			
Control Switches	3 - Operational			
Corrosion - Structural Metals	2 - Slight staining/small chips/holes in coating			
Good House Keeping	5 - No			
Good Wire Labeling	5 - No			
Grounding	1 - Yes			
Infrared	2 - Normal			
Installation/ Accessibility	3 - Moderate Defects			
Main Breaker	3 - Moderate Defects			
Proper Drawings Accessible	5 - No			
Structural Integrity (panel)	3 - Moderate Wear			
Condition Score: 3.105	Condition Category
