30-inch Water Main Rehabilitation Design Case Study

PNWS-AWWA Conference

**Weber
Basin
Water
Conservancy
District**

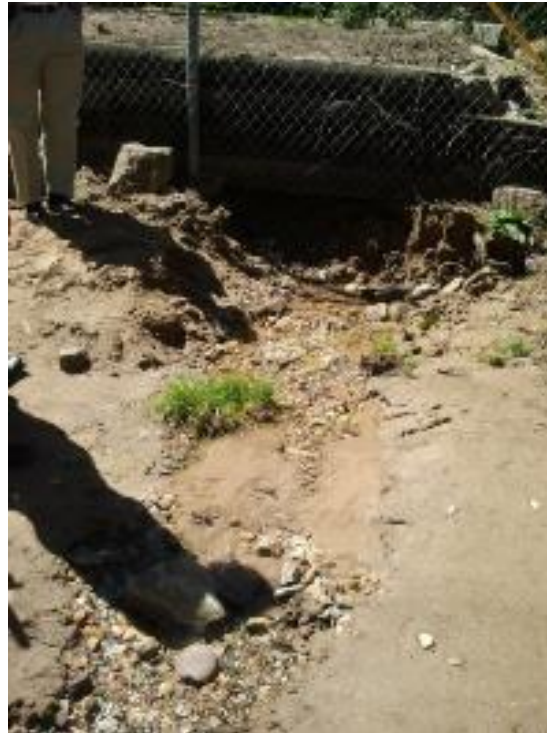
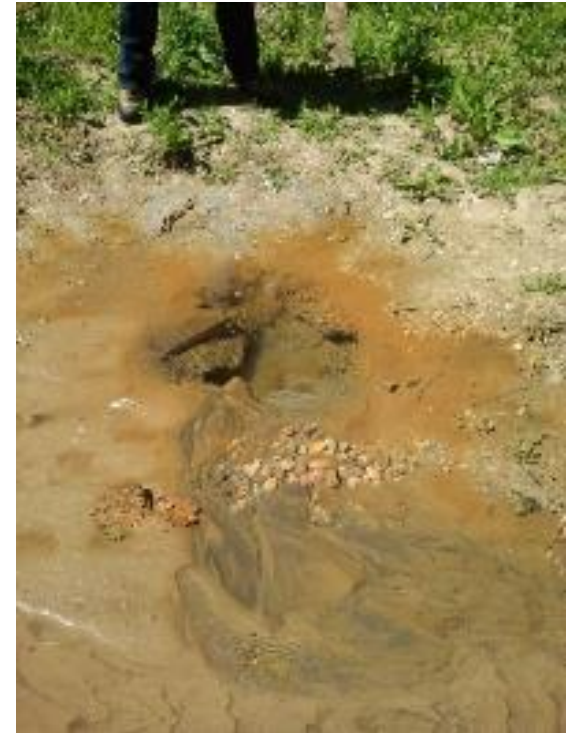
- Change in operations detrimental to aged pipe
- Introduced cyclical vacuum pressures
- Surface leaks and sinkholes manifested

- Pressures up to 100 psi
+15 psi surge
- Negative pressure swings exceeded the unrestrained gasketed joint tolerances

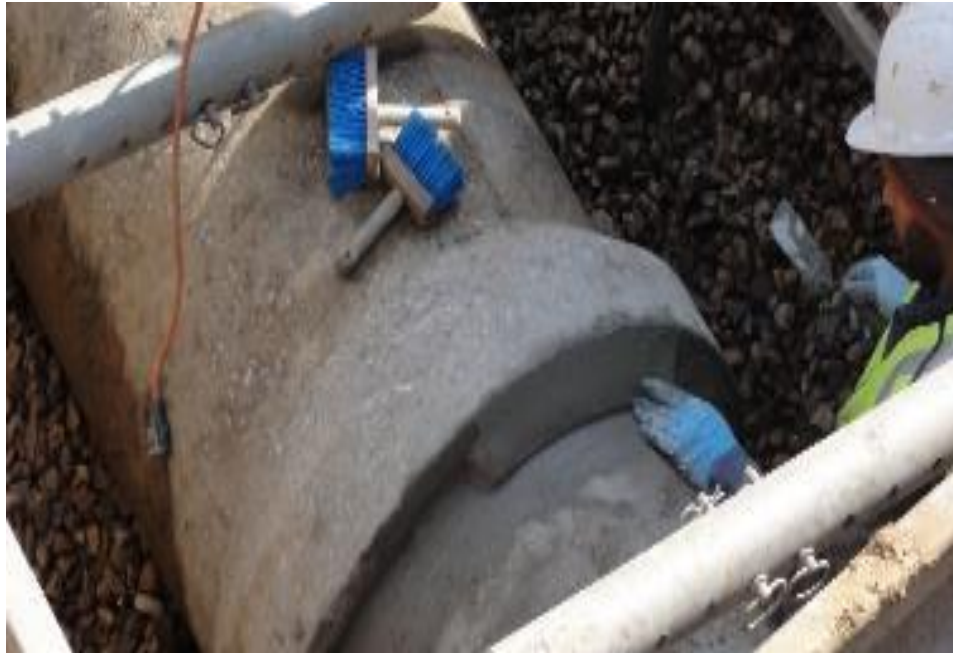
- Exterior sealing of joints provided a temporary solution
- Sealing not durable for long-term
- Large sinkhole developed

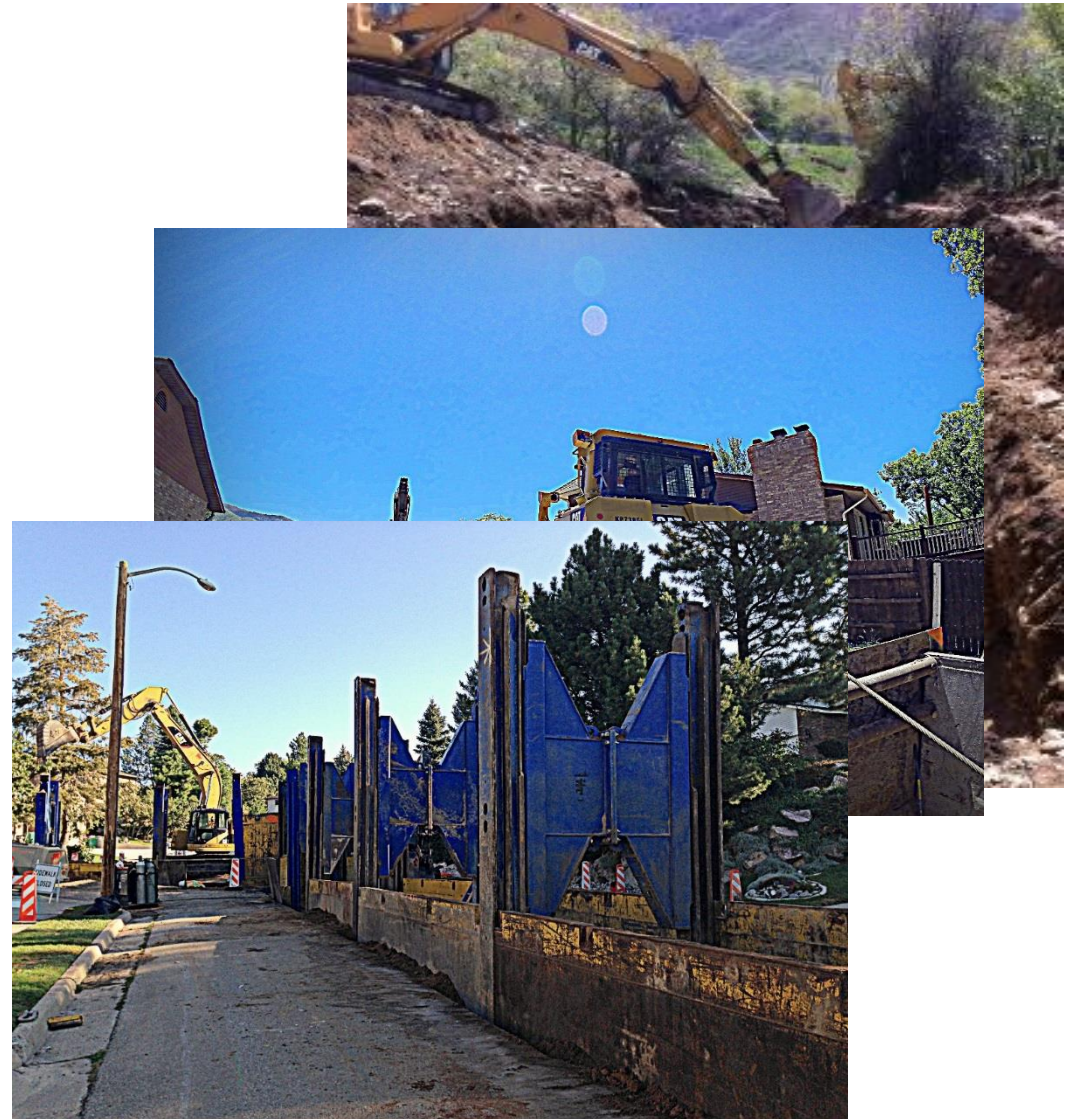
Condition Assessment and Forensic Analysis

- Emergency sliplining repair performed
- Installation of redundant welded steel pipeline
- Decommissioning of the concrete pipeline

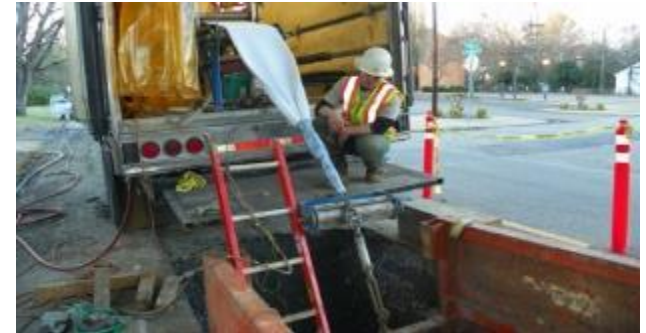
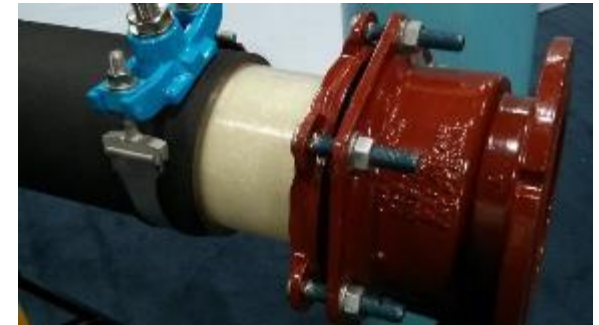
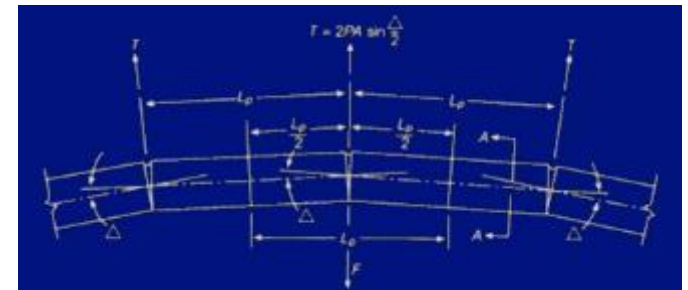
- Flexible tube saturated with resin is inserted, expanded, and cured to form new pipe
- Thin, smooth liner can increase hydraulic capacity
- Pre-cleaning required
- Full isolation required
- Multiple available contractors, out-of-state crews possible
- Main technical issues were:
 - High test pressure rating requirements
 - Liner terminations and transition to existing pipe
 - Gap and hole spanning

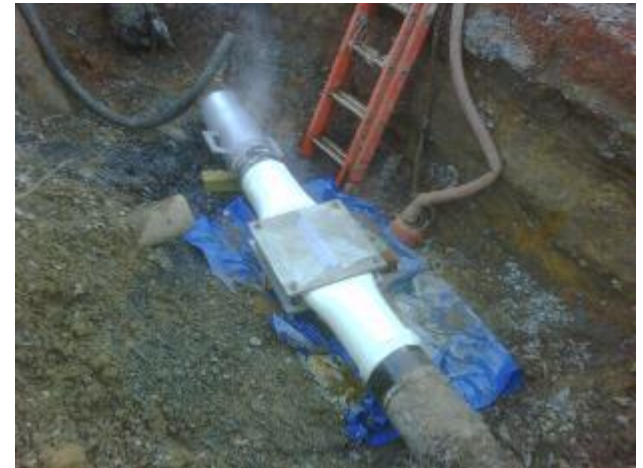
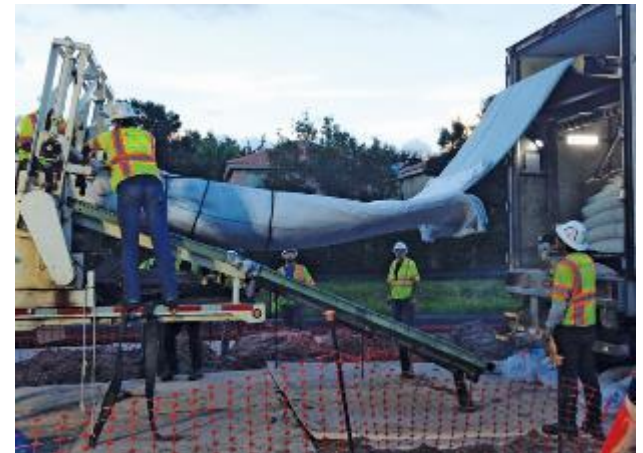
CIPP Design

- ASTM F-1216 (design and installation)
 - AWWA M28 Class III/IV
- “Partially Deteriorated Pressure Pipe”
 - Resists external groundwater
 - Spans holes (assumed post-install)
- “Fully Deteriorated Pressure Pipe”
 - Bears all external live and dead loads
 - Bears all internal pressure and vacuum loads
- No codified design standard for “interactive” liner+host structural rehab

CIPP

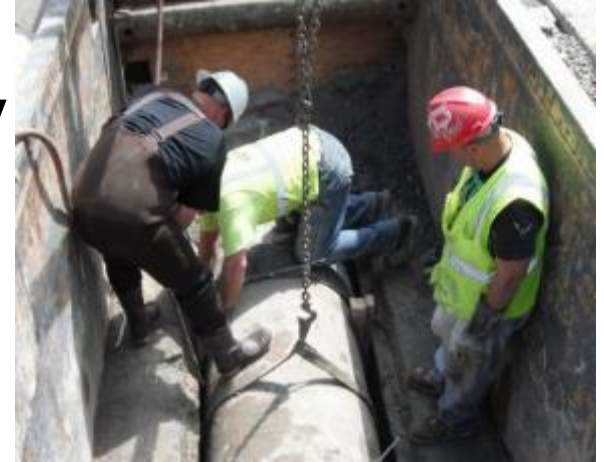
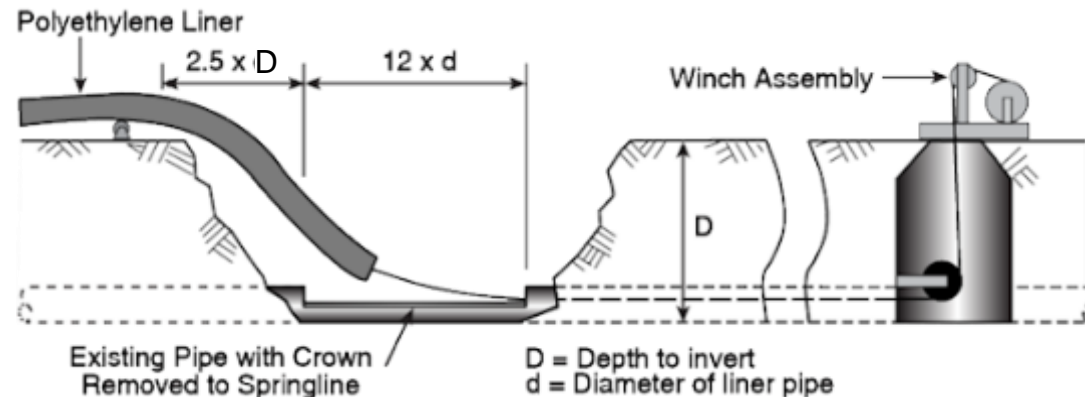
- Oldest trenchless rehab method
- Reduction in ID reduces capacity
- Minimal cleaning required
- Full isolation required
- Multiple available contractors
- Main technical issues were:
 - Providing access for stringing out of pipe
 - Hydraulic capacity
 - Controlling grout pressures

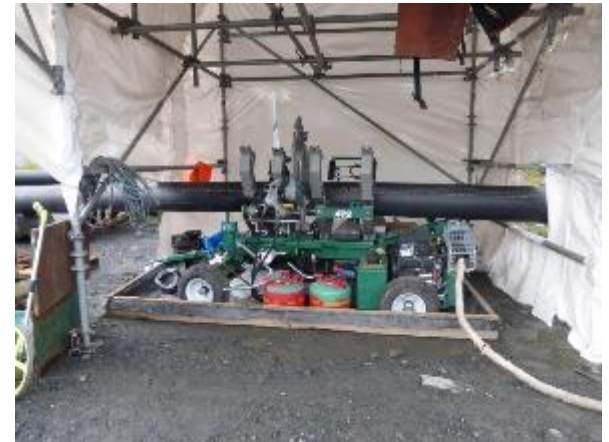
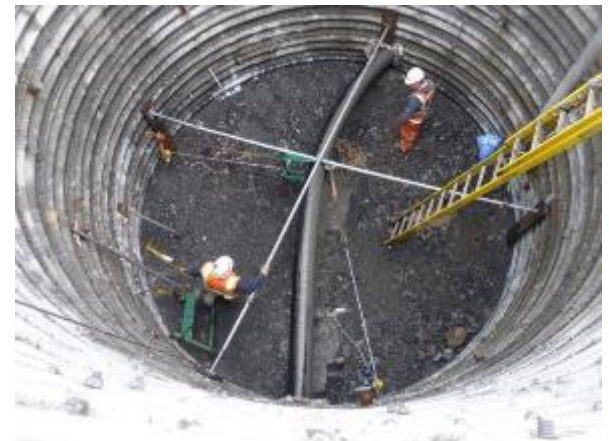
Sliplining Design

- ASTM F-585 (Installation), AWWA M55 (HDPE pipe design), PE Handbook Chp. 11 (HDPE pipe design),
 - AWWA M28 Class IV
- Design methods focus on buried HDPE pipe loading
 - Designer needs to loads during install (e.g. unconstrained buckling from groundwater, grouting)
- No formally defined “Partially Deteriorated” design case
 - but specific loads may be included/omitted (no calculation for hole/gap spanning)
- Design method is applicable for a “Fully Deteriorated” design case
- No codified design standard for “interactive” liner+host structural rehab

Sliplining

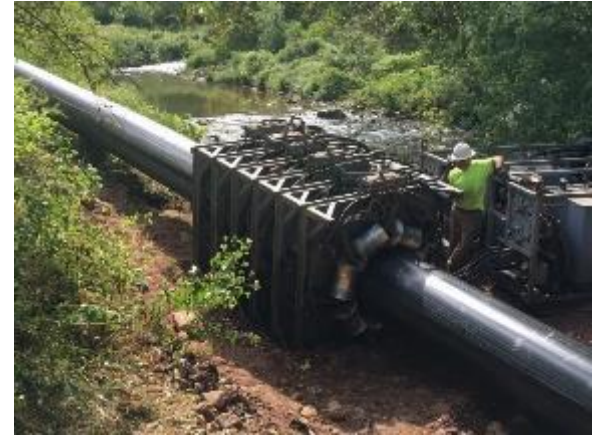
- HDPE is pushed/pulled through a reduction dye/rollers and inserted in cleaned host pipe. Relaxes and expands to form close-fit new structural pipe.
- Thin liner can maintain hydraulic capacity
- Pre-cleaning required
- Full isolation required
- Few available contractors, out-of-state crews likely
- Main technical issues were:
 - Access for stringing out of pipe
 - Radius of curvature tolerances

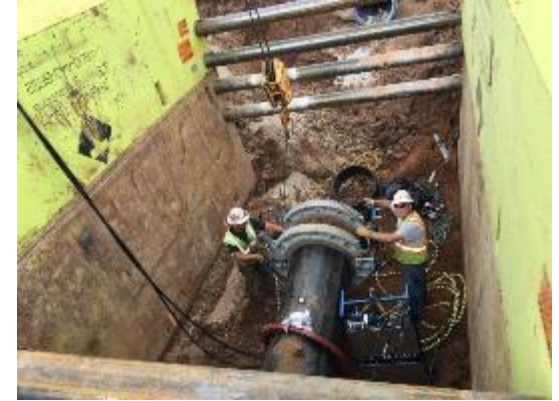
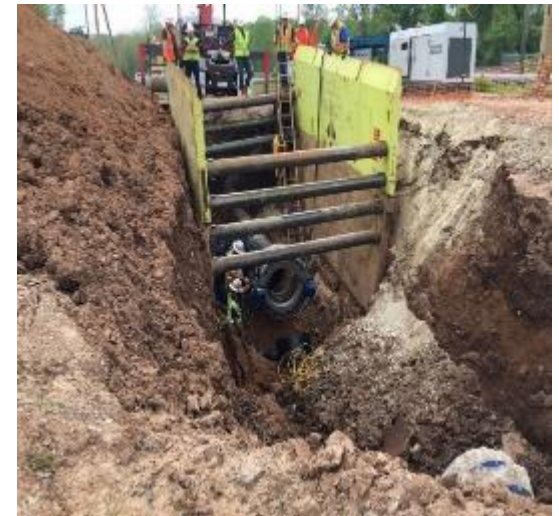
Tight-fit Lining Design

- AWWA M55 (Design)
 - AWWA M28 Class III/IV
- Design methods focus on buried HDPE pipe loading
- No formally defined “Partially Deteriorated” design case
 - but specific loads may be included/omitted (no calculation for hole/gap spanning)
- Design method is applicable for a “Fully Deteriorated” design case
- No codified design standard for “Partially Deteriorated” (e.g. external hydrostatic resistance only) nor “interactive” liner+host structural rehab

Tight Fit Lining

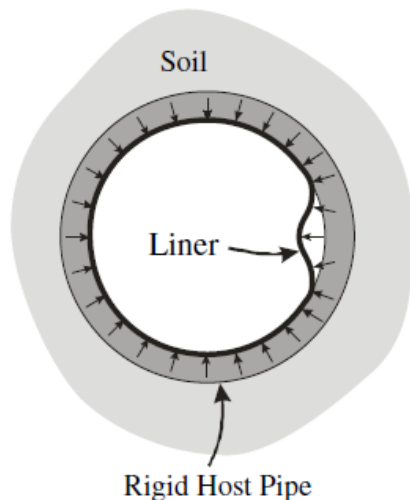
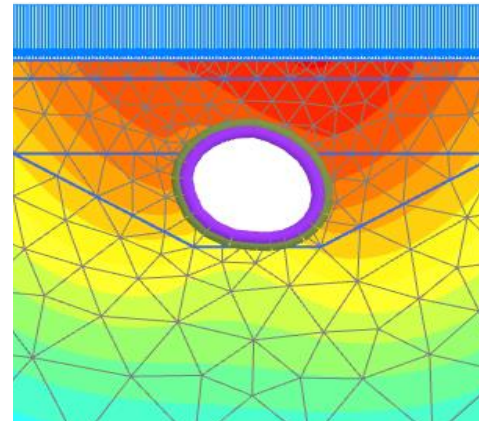
- Rigid host pipe may be represented as a very high soil modulus in the AWWA M55 calculations for constrained hydrostatic buckling resistance.

...For a fully deteriorated host pipe, FEA or other numerical methods may be required to calculate interactive behavior.

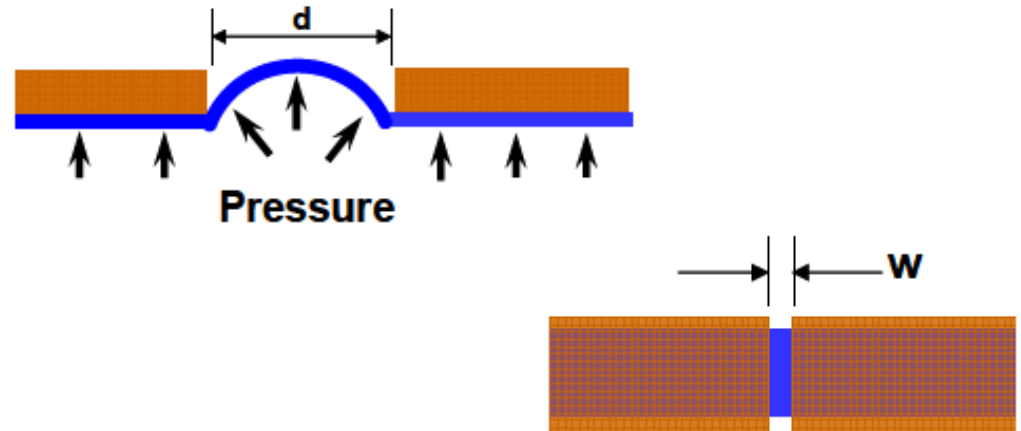
- Flexible thermoplastic liner theory (presented succinctly by Downey, Heavens, and Ngo (2007))
- Assume the hole/gap occurs after the liner is installed
- Imperfections, burrs, and load cycling are assumed in the safety factor

For gap spanning:

$$\sigma/N = 3P_i(1-\nu^2)/(\beta^2 t^2) \times (\sinh \beta W - \sin \beta W)/(\sinh \beta W + \sin \beta W)$$

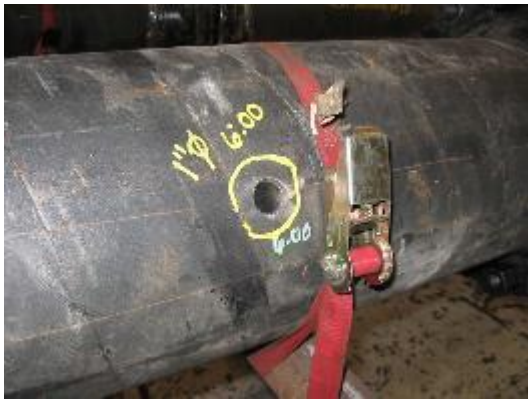
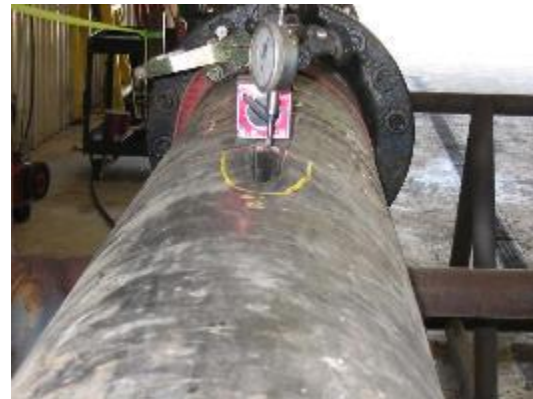
- Commercially sponsored reports tested larger diameter, proprietary pressurized lining system under different gap spanning conditions (United Pipeline Systems, 2007).
- Results can be qualitatively compared to similar cases

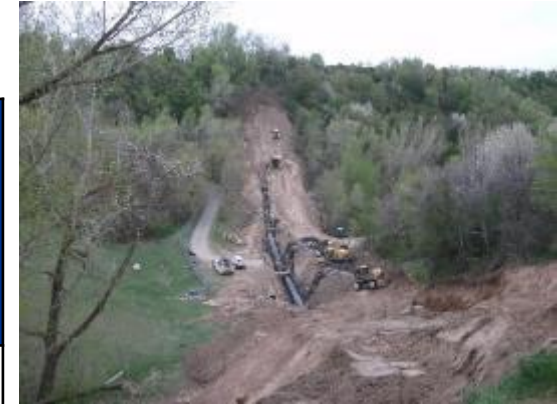
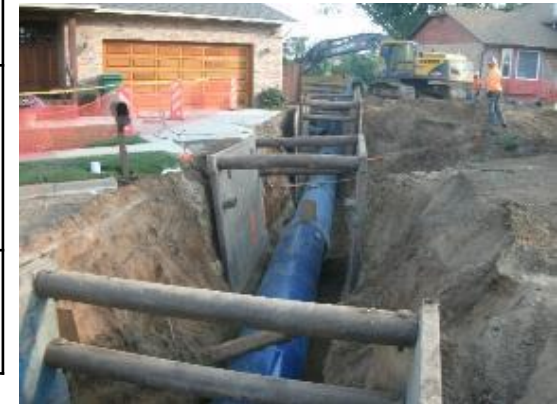
Comparison of “Partially” and “Fully” Deteriorated Host Design Conditions

| Design Factor and/or Performance Implication | Partially Deteriorated Design Condition | Fully Deteriorated Design Condition |
|--|---|---|
| Percent Loss of Original Hydraulic Capacity | 12% | 22% |
| Anticipated Installation Rate | 220LF/day | 170LF/day |
