Responding to a System Contamination

- Loren Searl
 - City of Spokane, Water Superintendent

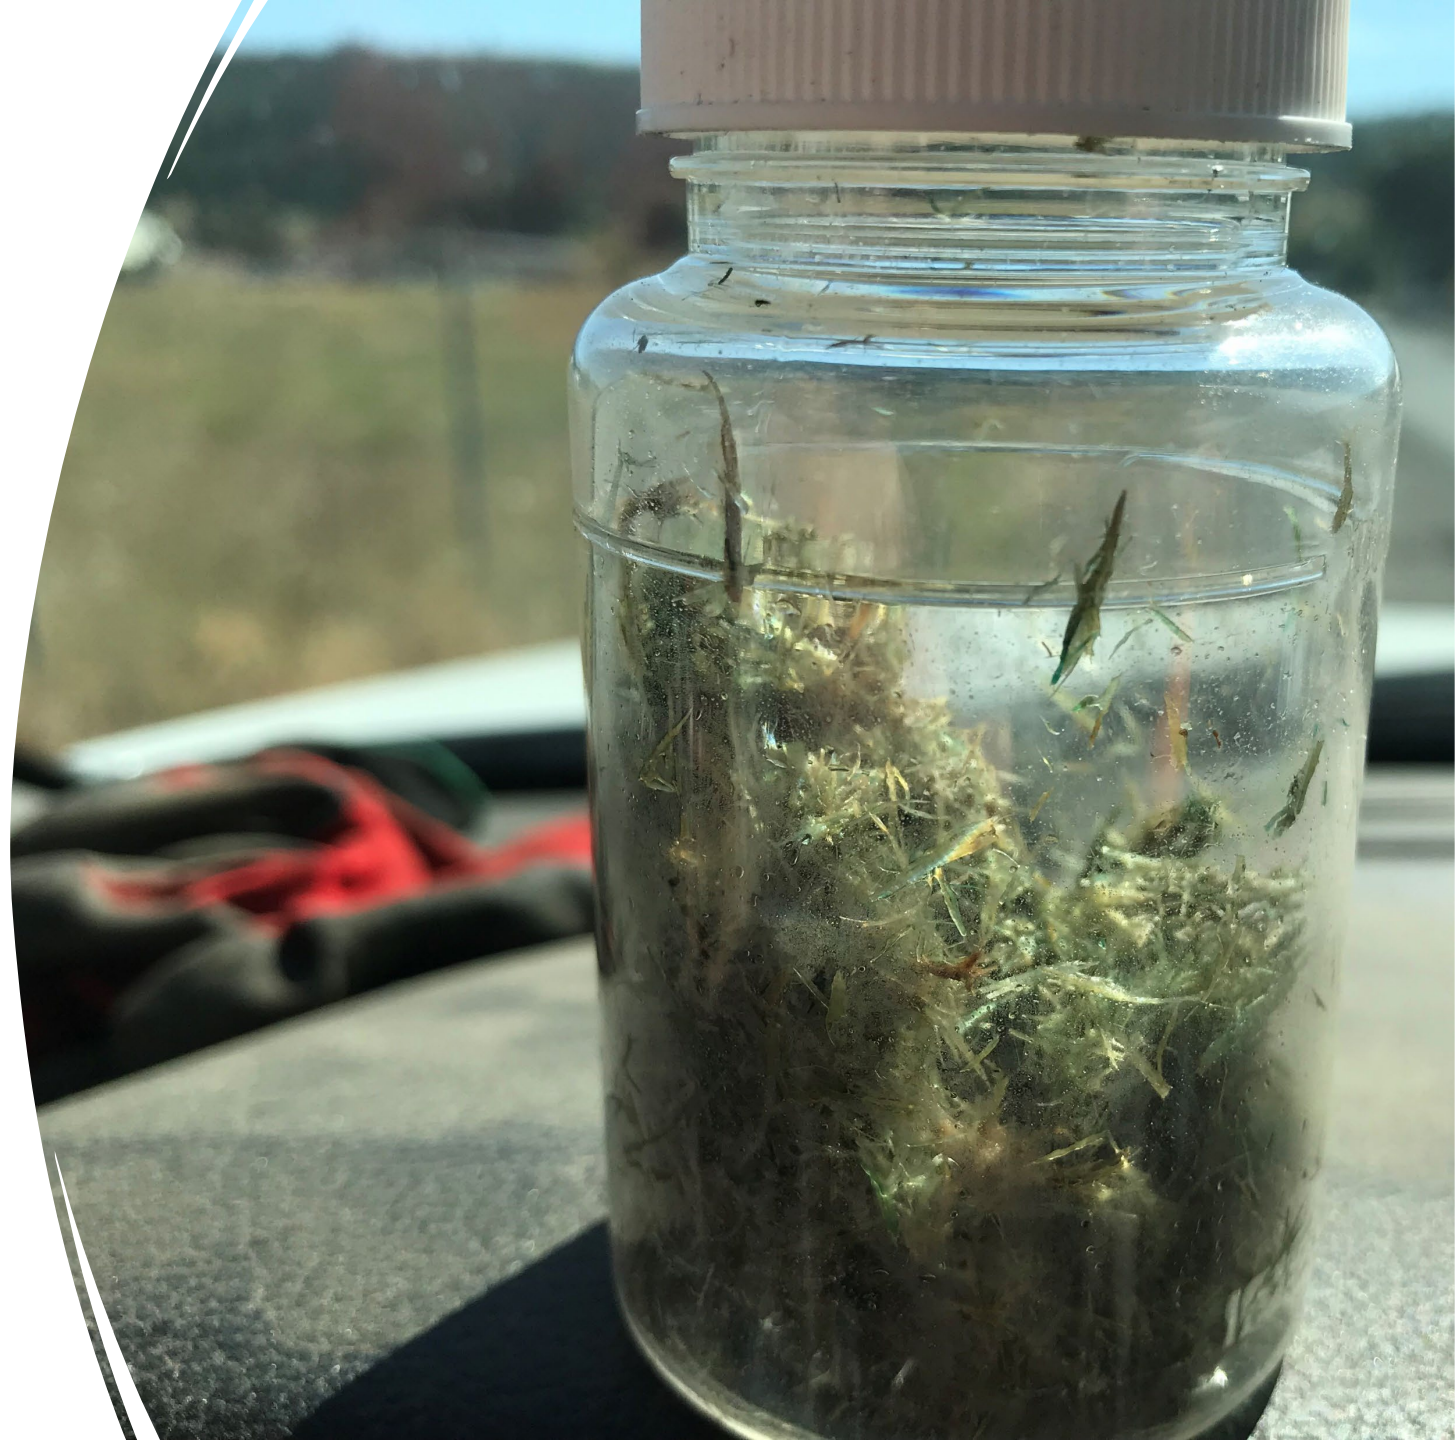
- Site investigation showed green fiber material in the water.

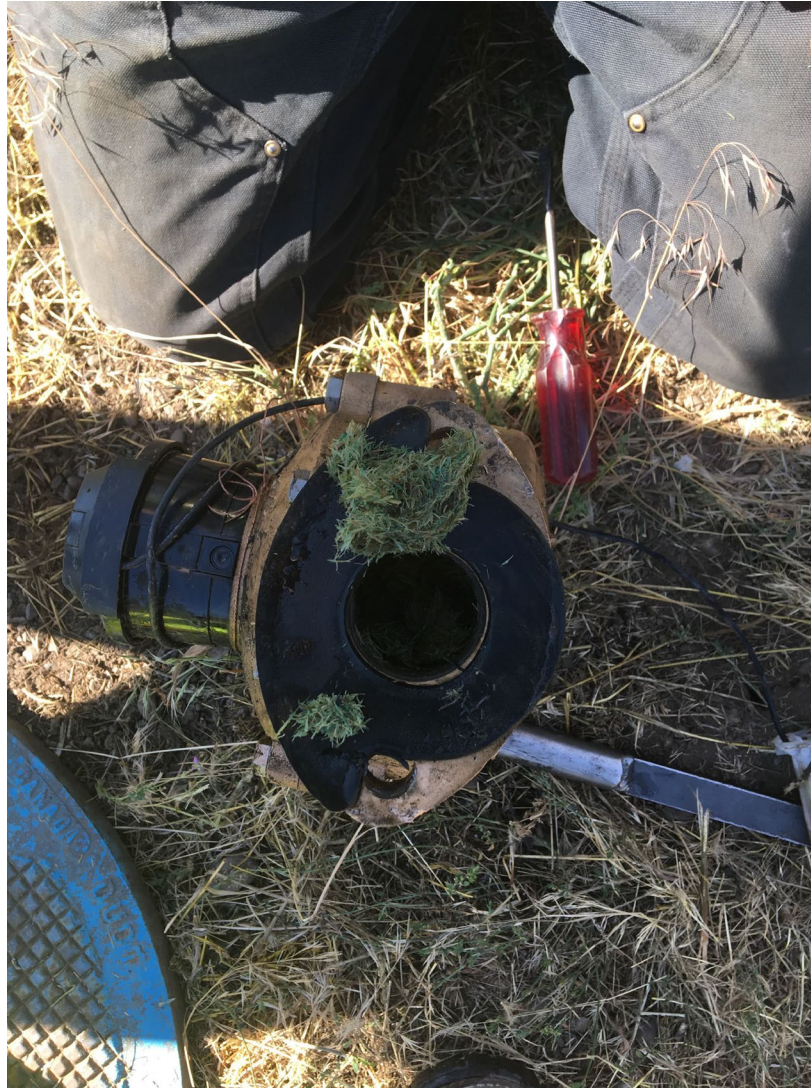
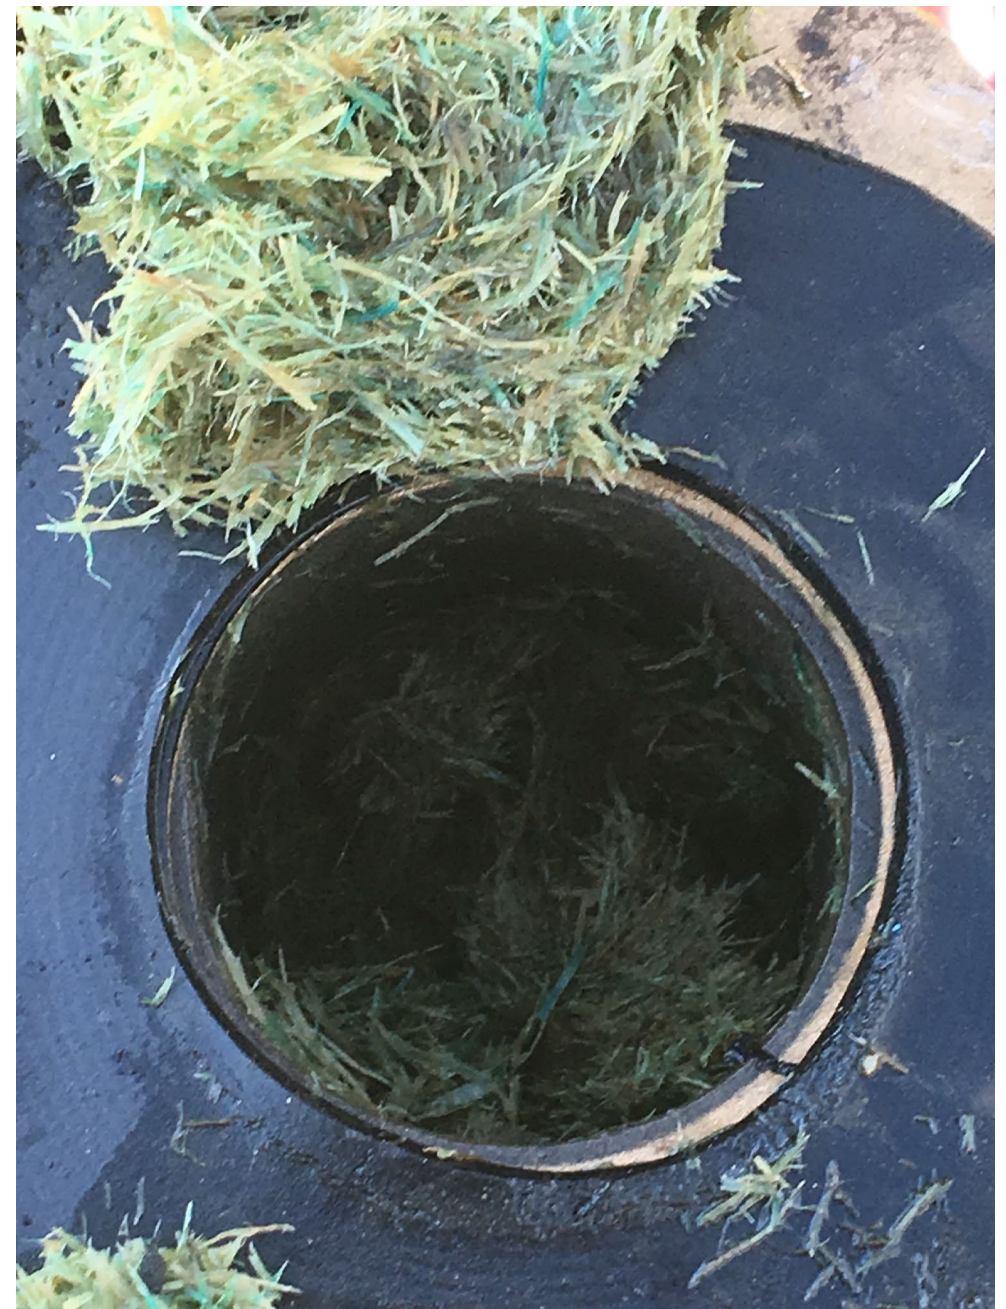
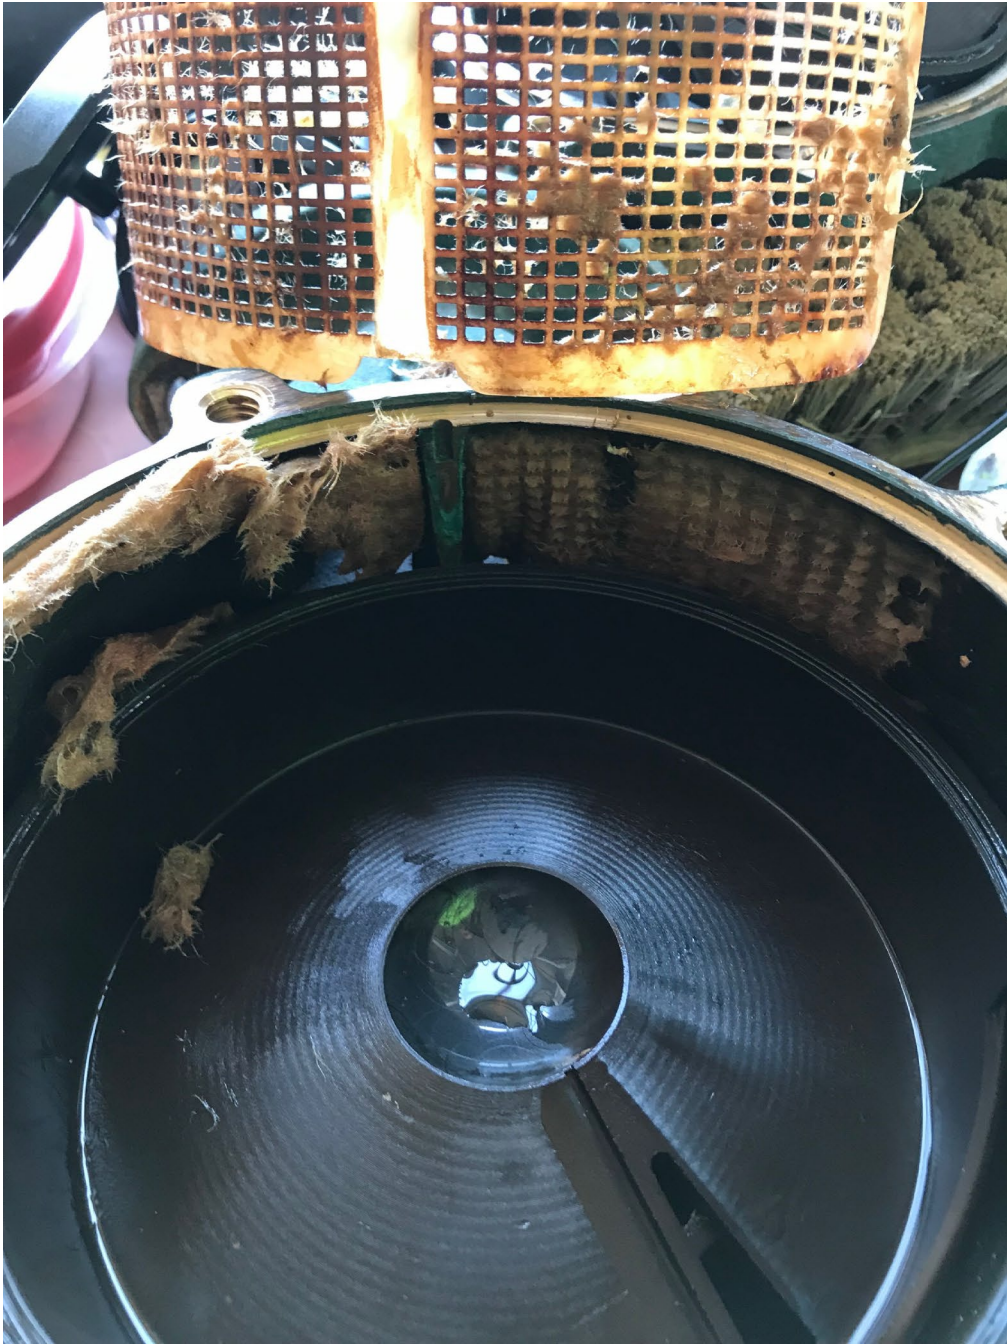
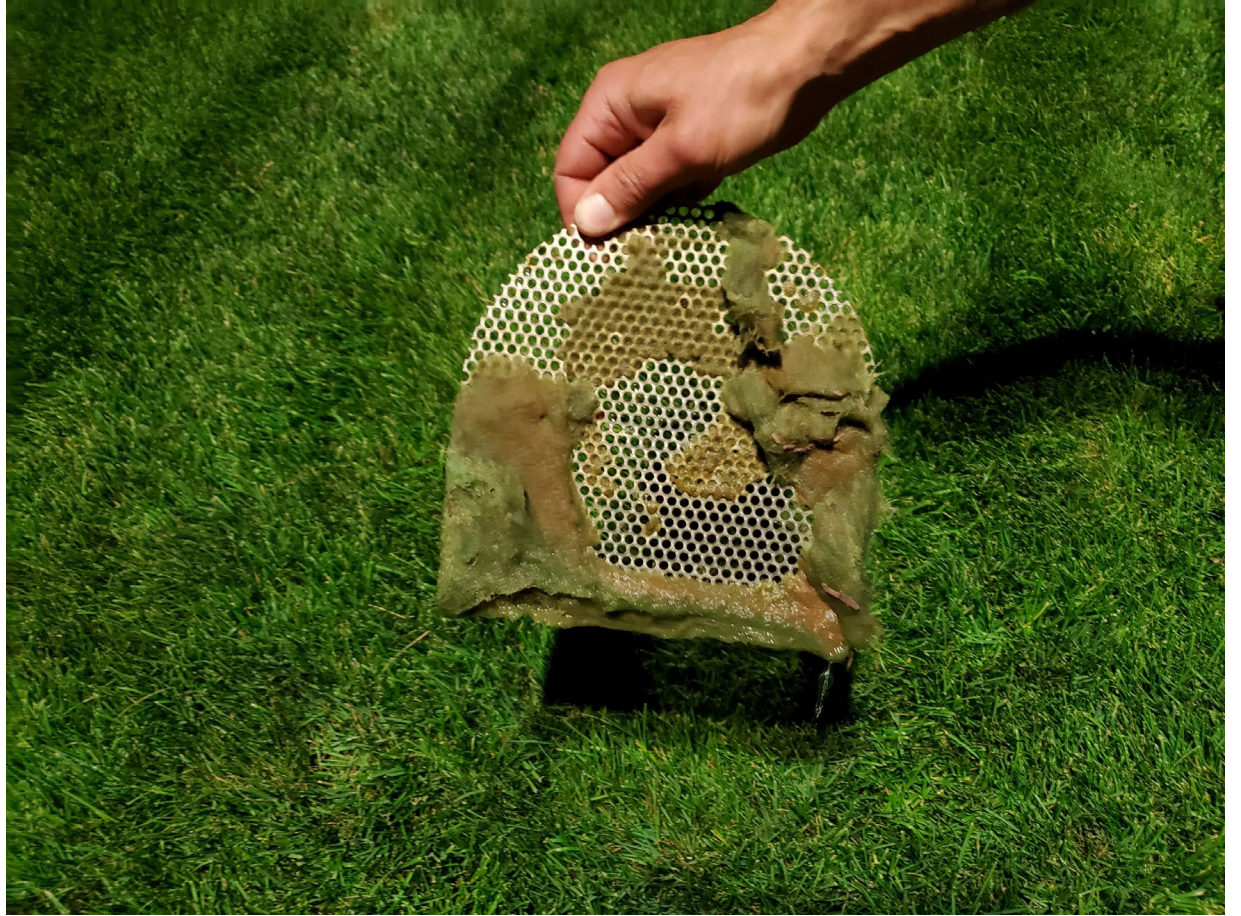
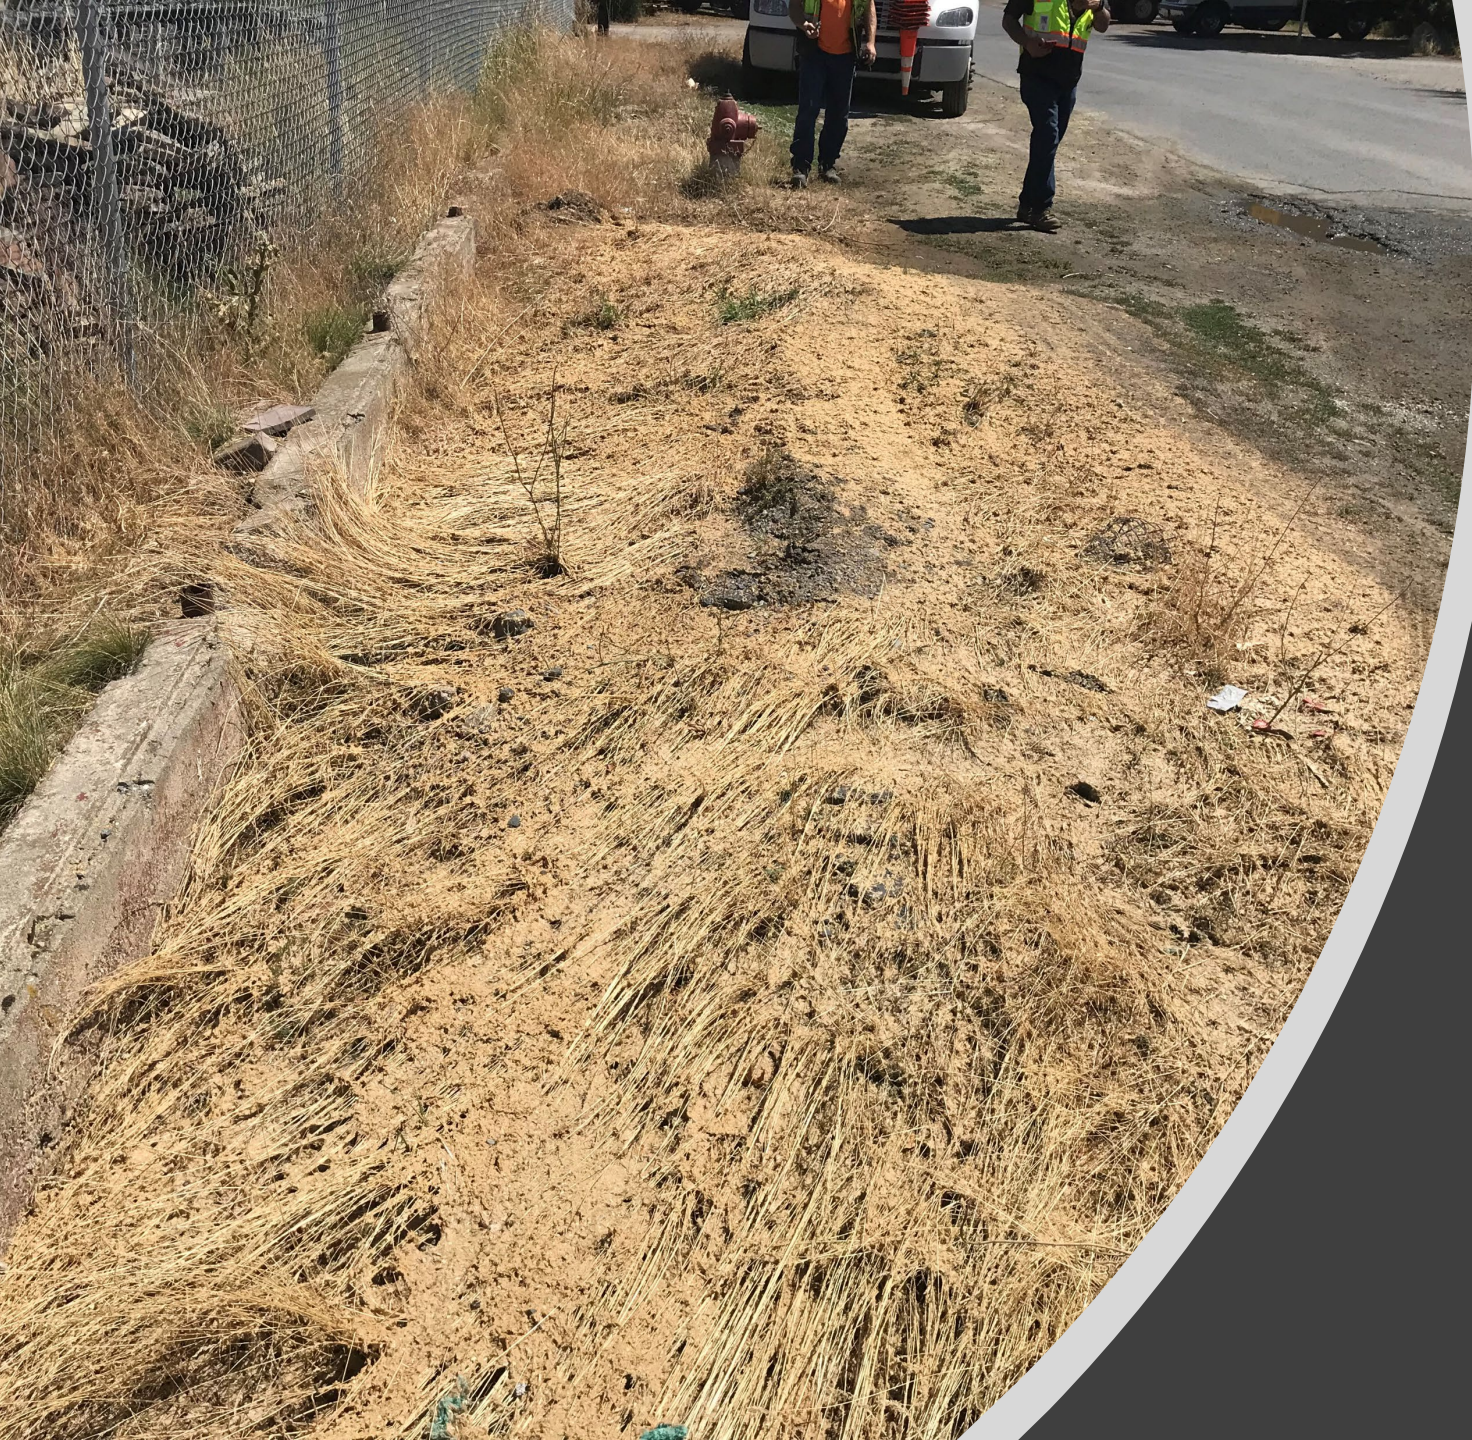
- Additional Addresses found to have plugged meters.

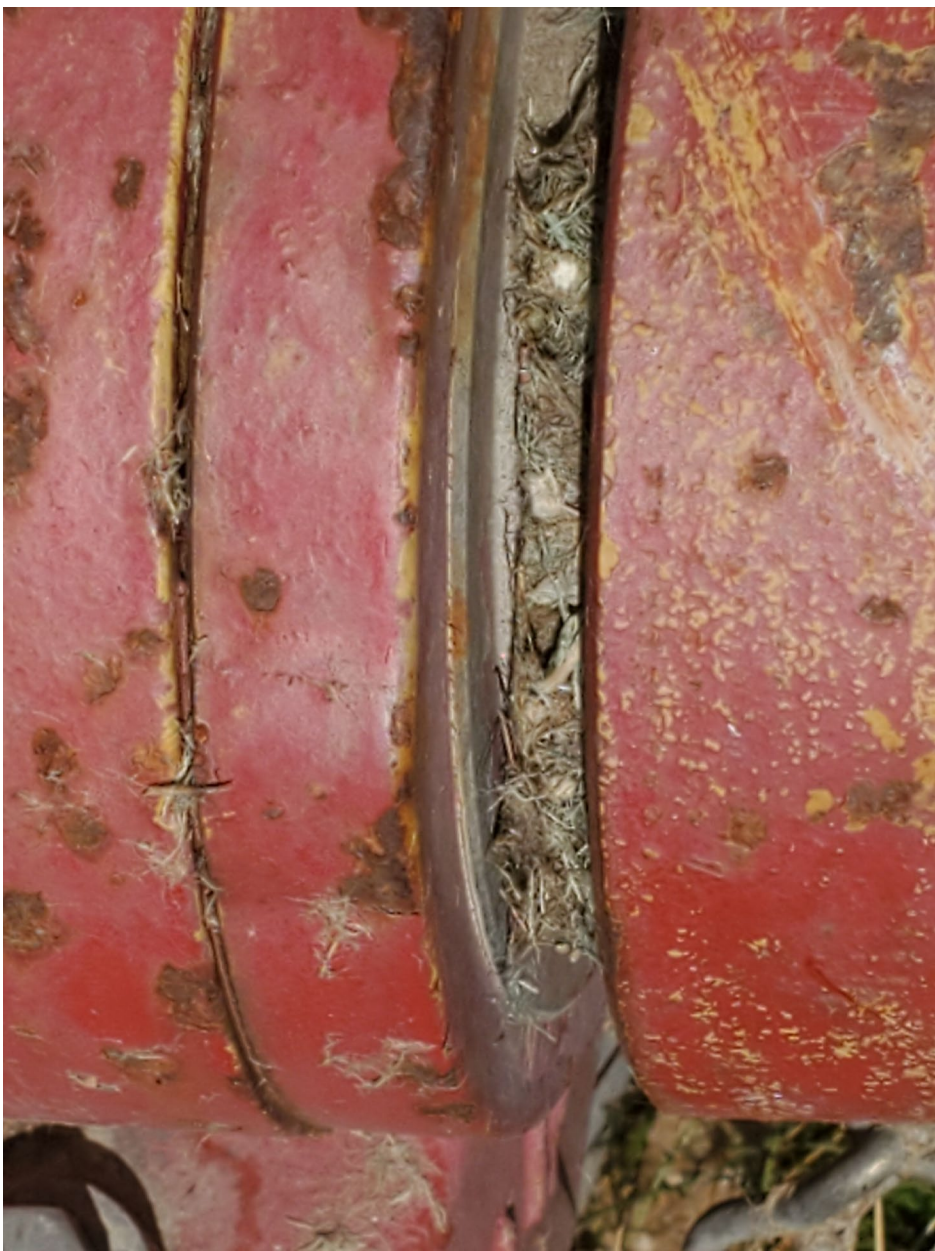
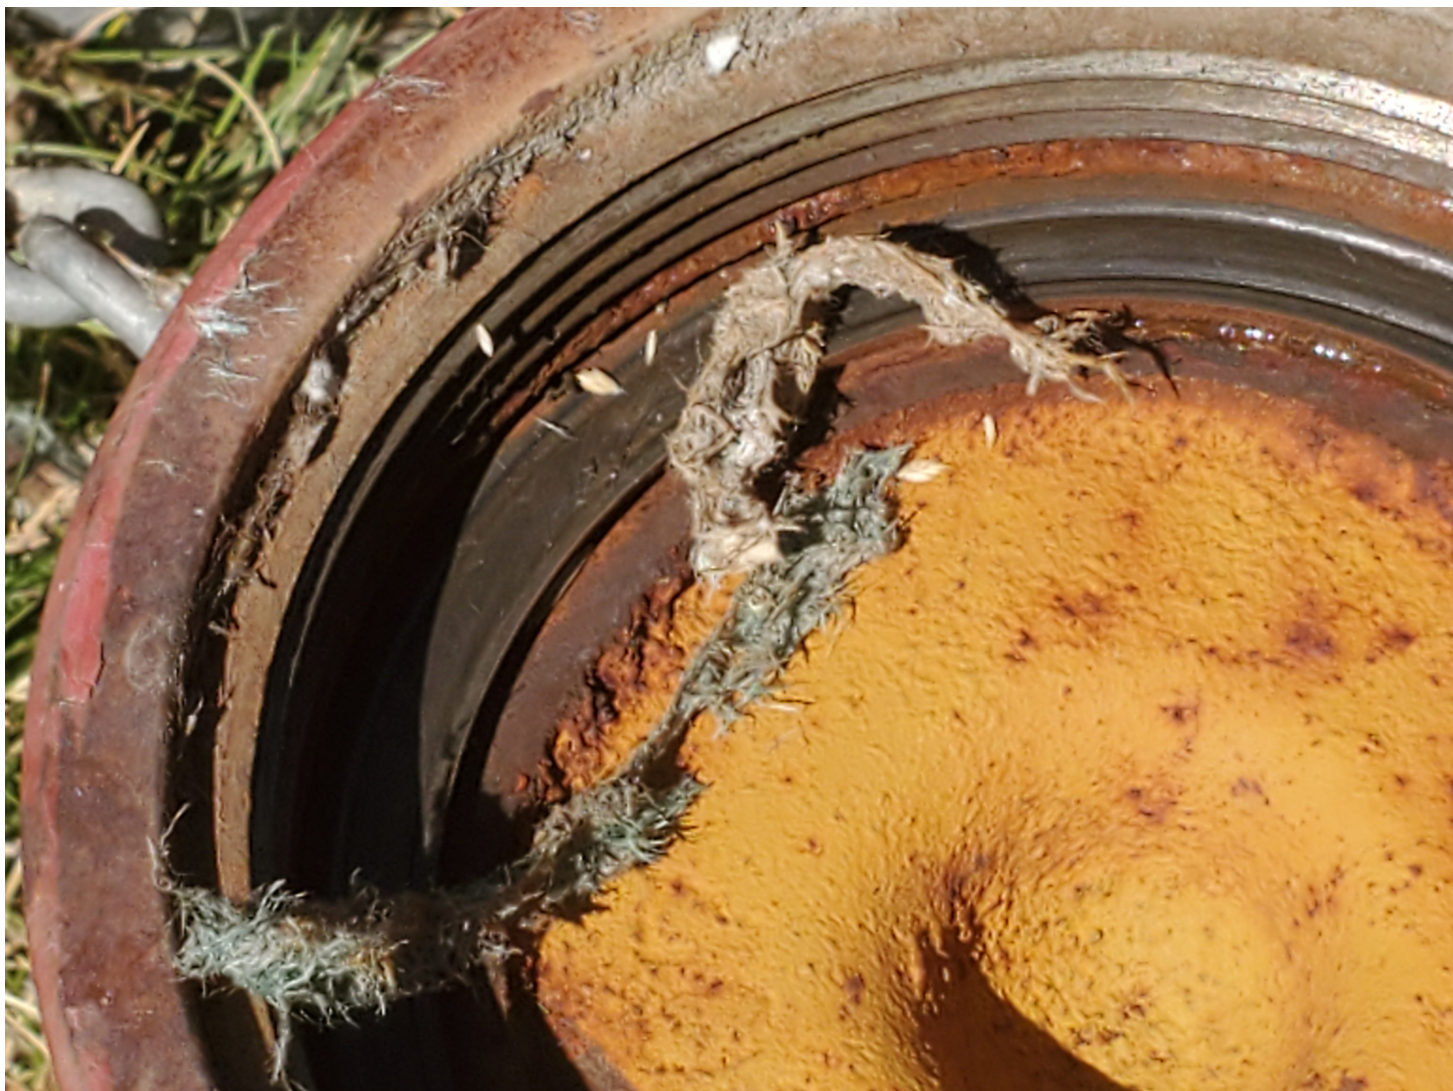
A hydrant was
found with
signs of
hydroseed use.

*Happened to be across the street
from a landscaping company.*

A commercial hydroseed vehicle that used water from City fire hydrants appears to have allowed some contamination to backflow into the City's system when filling with water on Friday, July 26th.

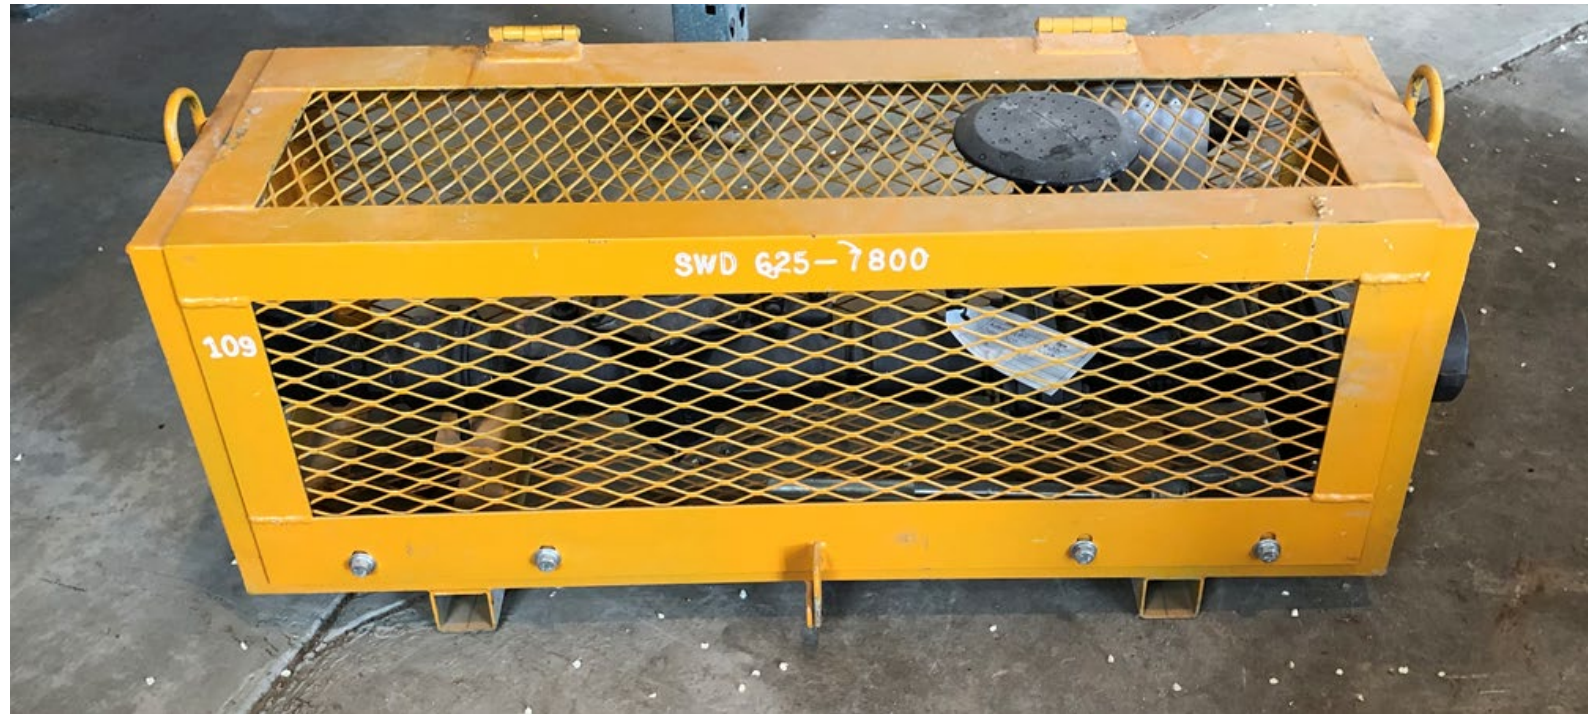
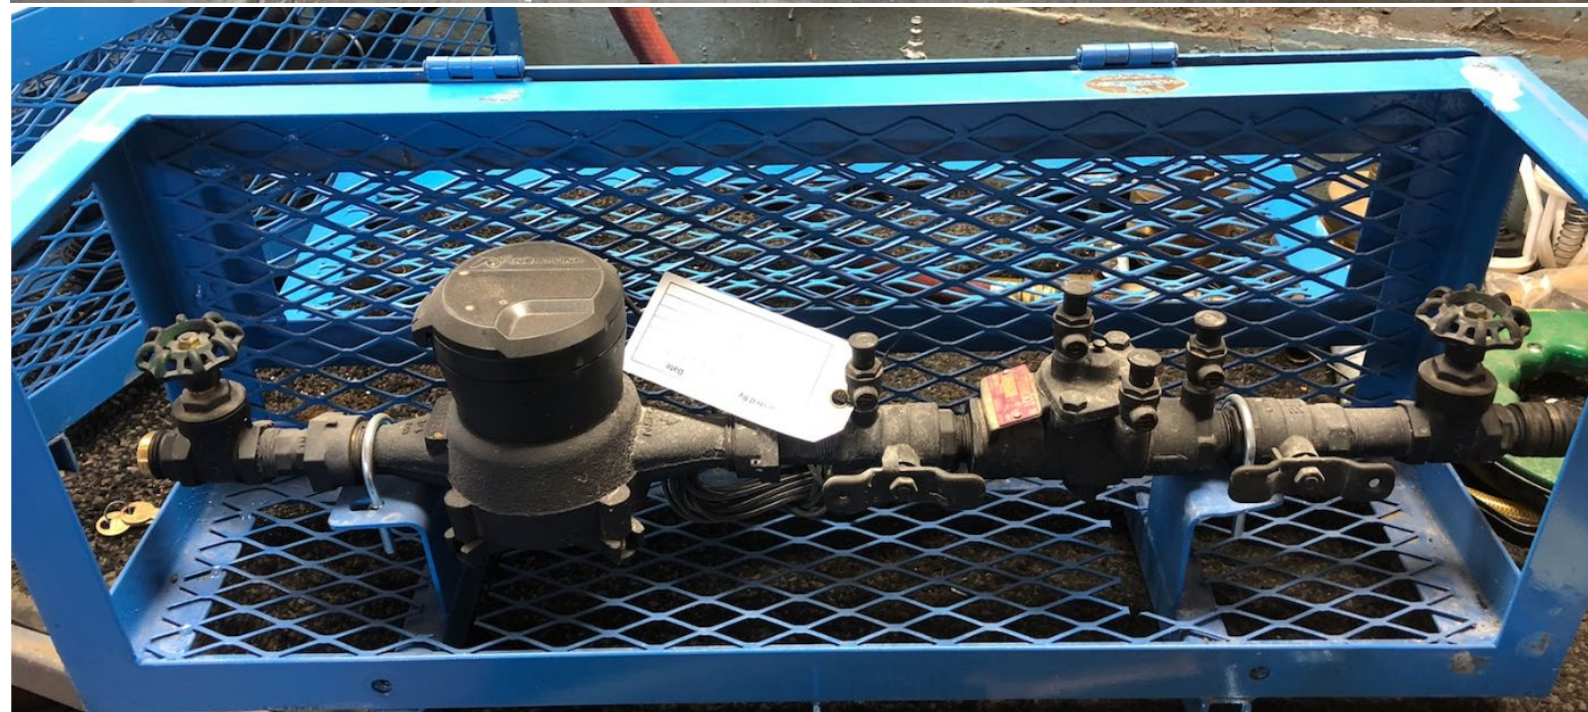
Public use of Hydrants

- Must have Hydrant meter cage.
- Administrative fine created if found not using the cage.
