# An Experimental Technique for Protecting Wells Without Pump Systems

PNWS – AWWA Conference  
April 29, 2022

Andrew Wentworth – GSI Water Solutions, Inc.  
Larry Eaton – Summit Water Resources

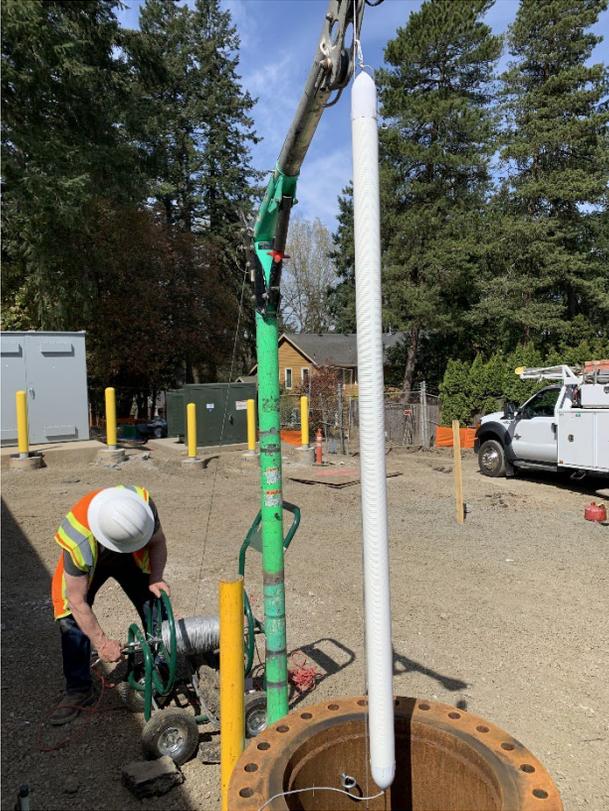
- Goal: Develop a low-cost method to inhibit bacterial growth while waiting for permanent pump installation
- Two designs tested
  - PVC canisters with chlorine tablets suspended in the water column
  - Low-flow injection (10 gpm) of chlorinated tap water

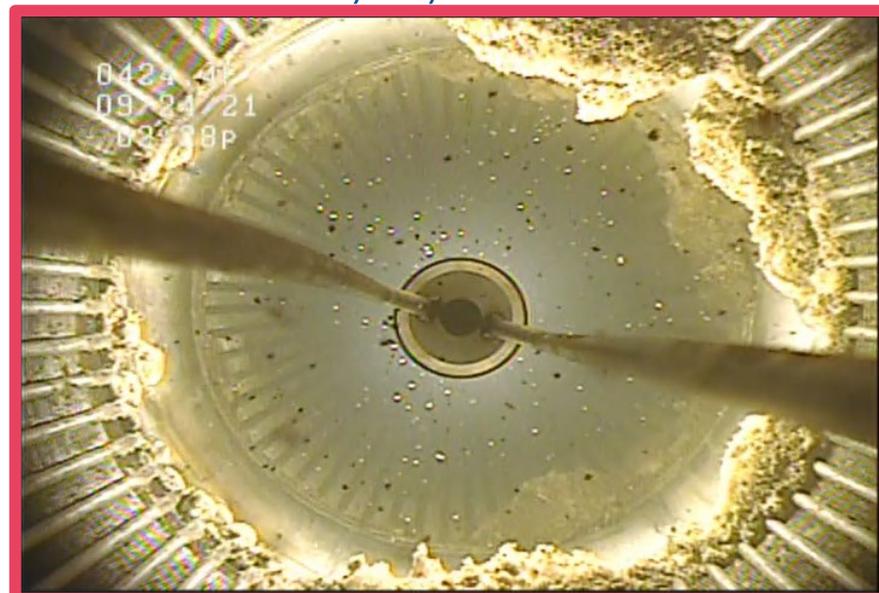
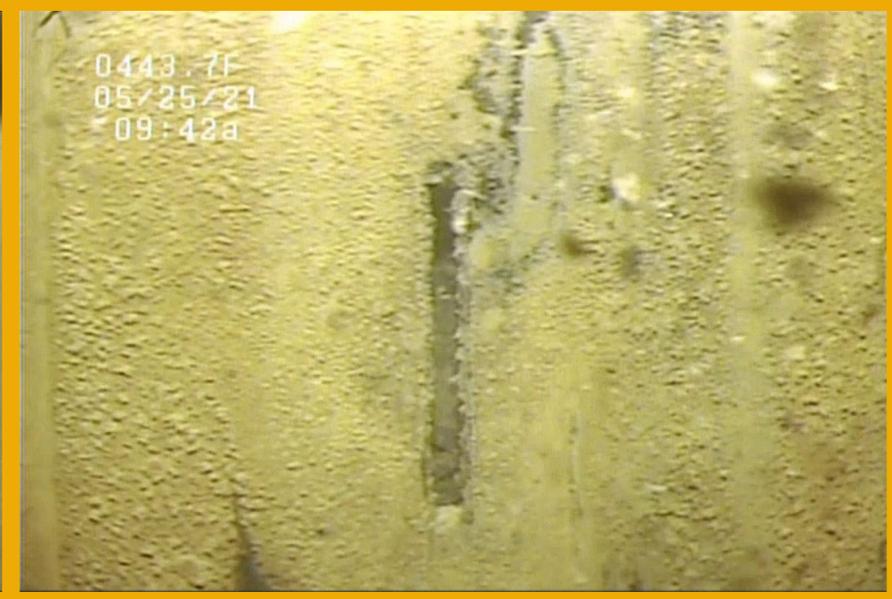
Canister System  
-  
Video Survey Comparisons

- Chlorine treatment appears to have reduced ATP concentration
- Canister slots clogged and slowed dissolution of chlorine tablets
