City of Othello

Aquifer Storage and Recovery (ASR) Program: Phase 2 Test

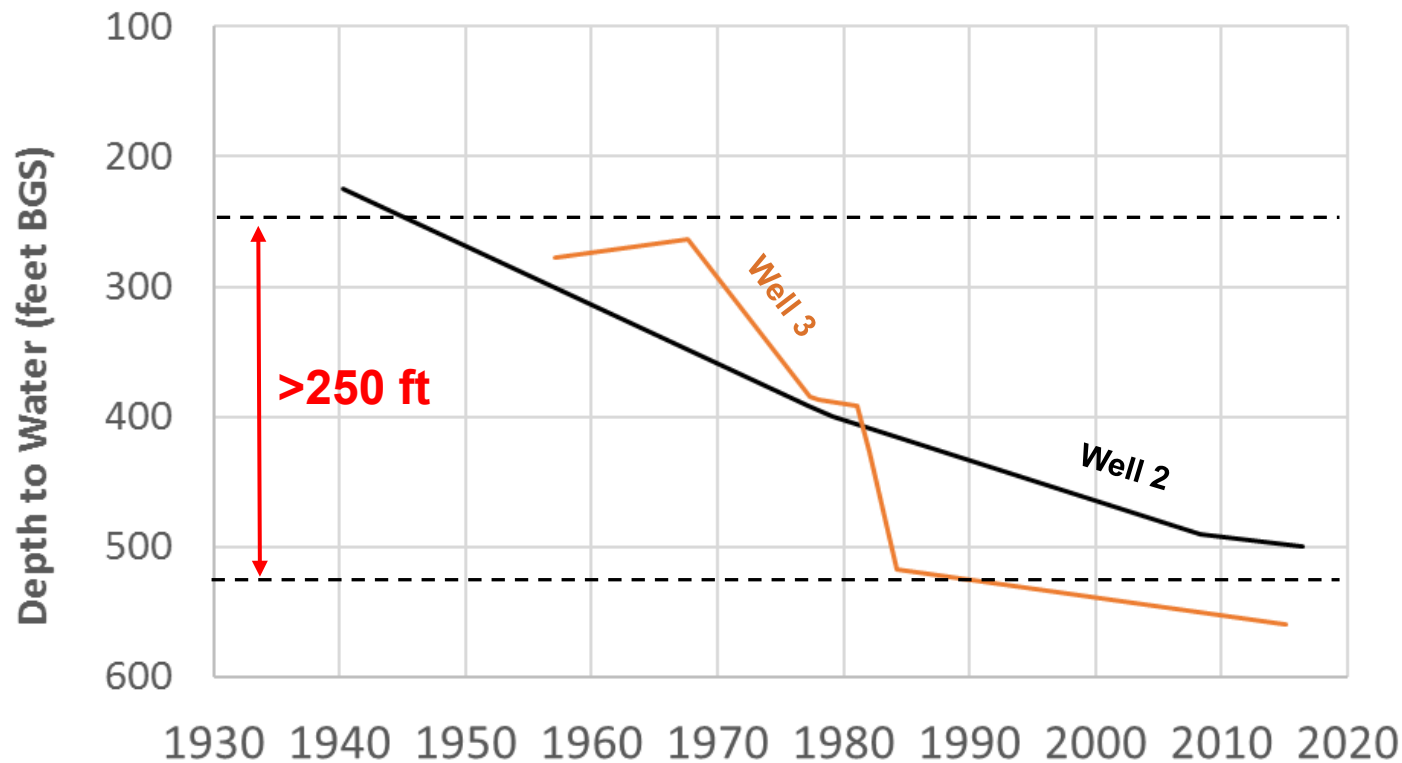
Demonstration-Scale Test

- Follow-up to FS and Phase 1 Test
- Divert up to 500 a-f from BoR Canal
- Treat with Mobile MF System
 - Assess Water Quality
- Recharge Deep Basalt Aquifer
- Store Water, Monitor, then Recover

City Wells

ASR Phase II Pilot Test Injection Site

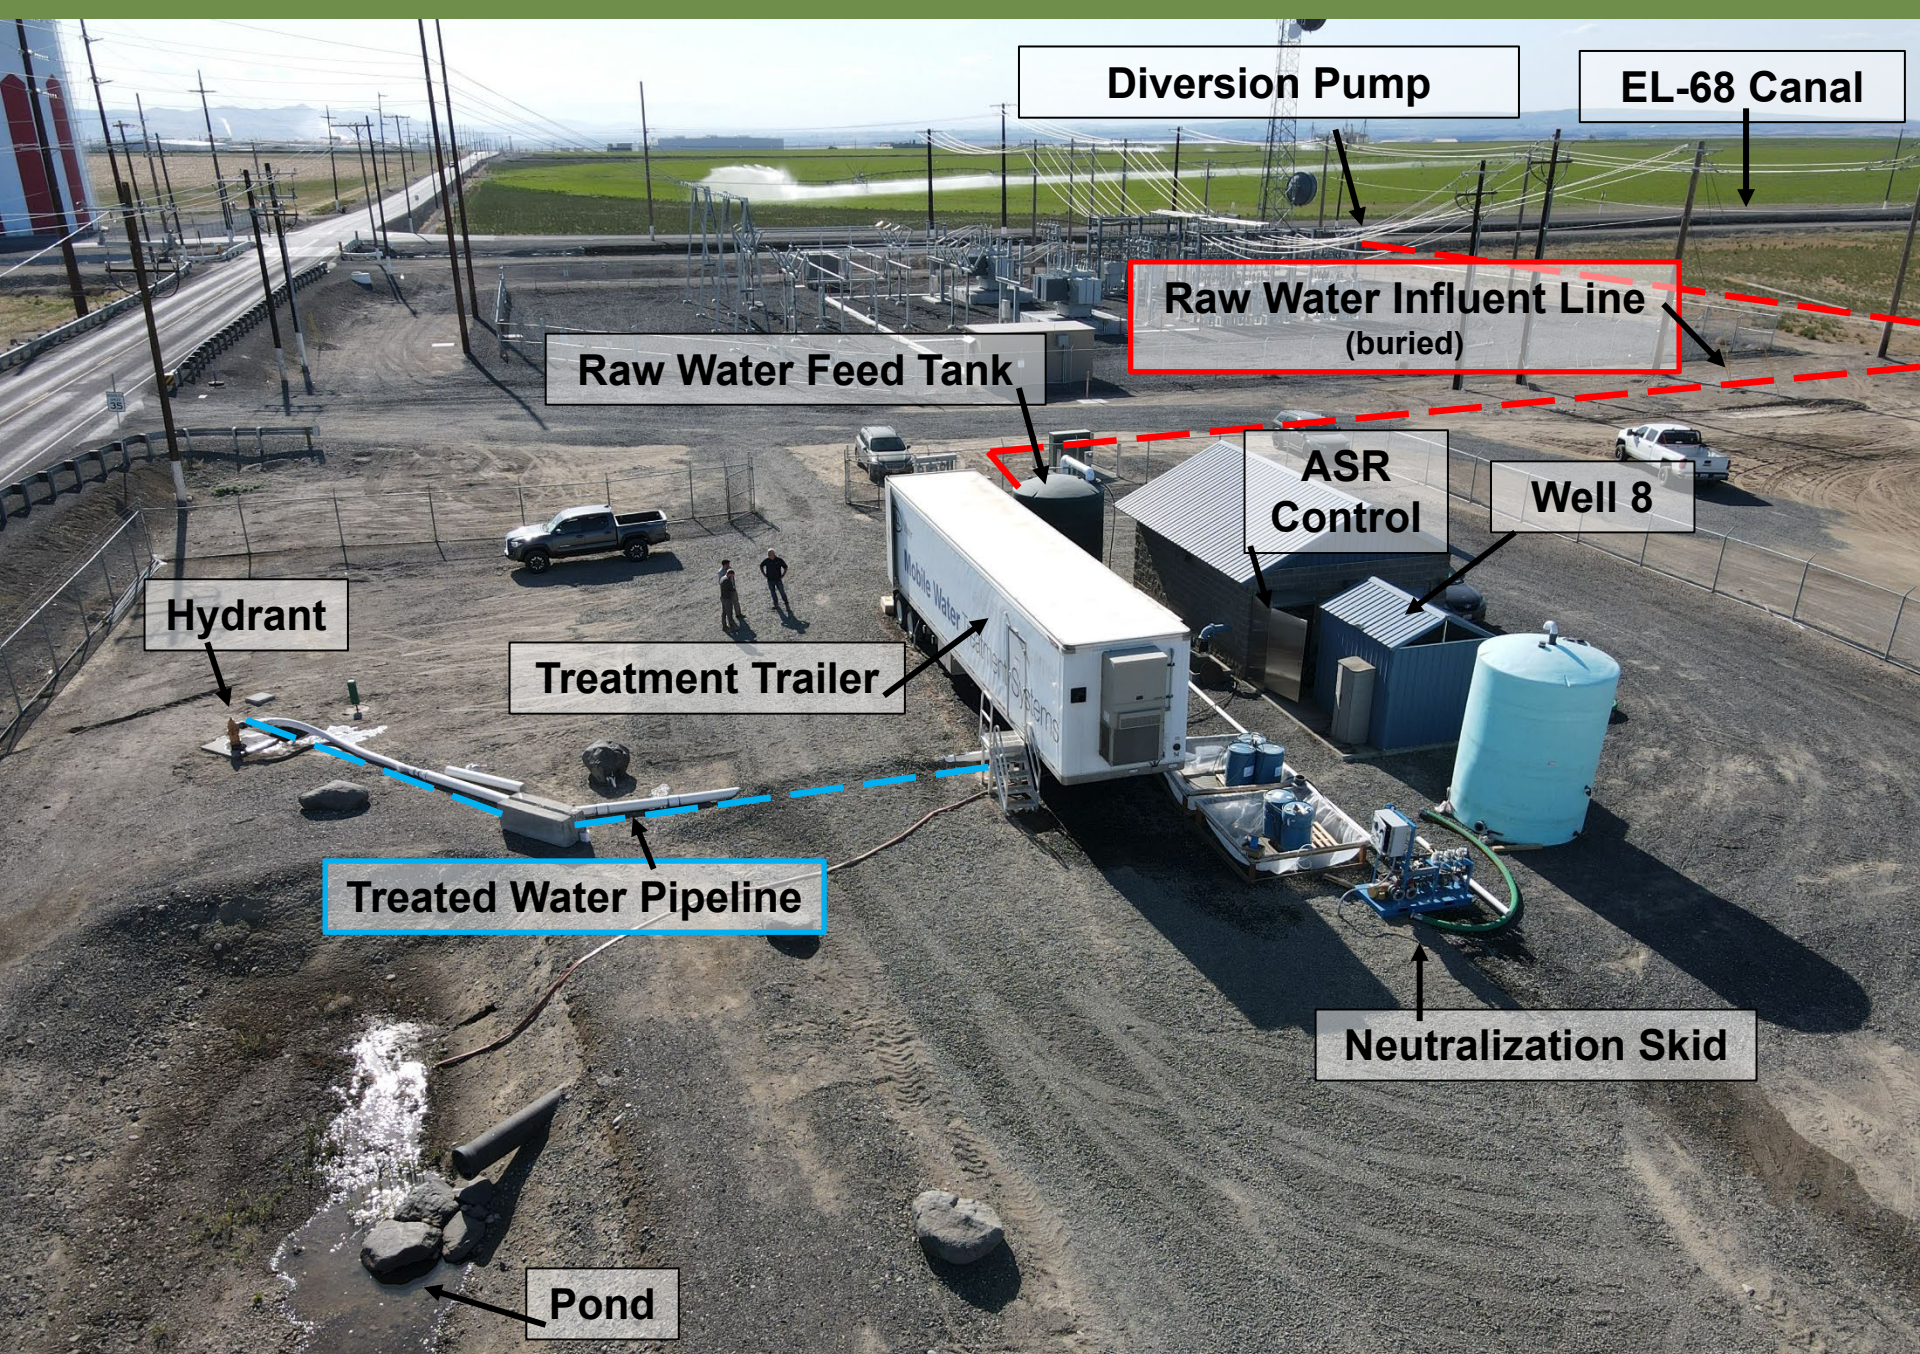
Diversion Pump

EL-68 Canal

Raw Water Influent Line
(buried)

Raw Water Feed Tank

ASR
Control

Well 8

Hydrant

Treatment Trailer

Treated Water Pipeline

Neutralization Skid

Pond

Backwash & Neutralization

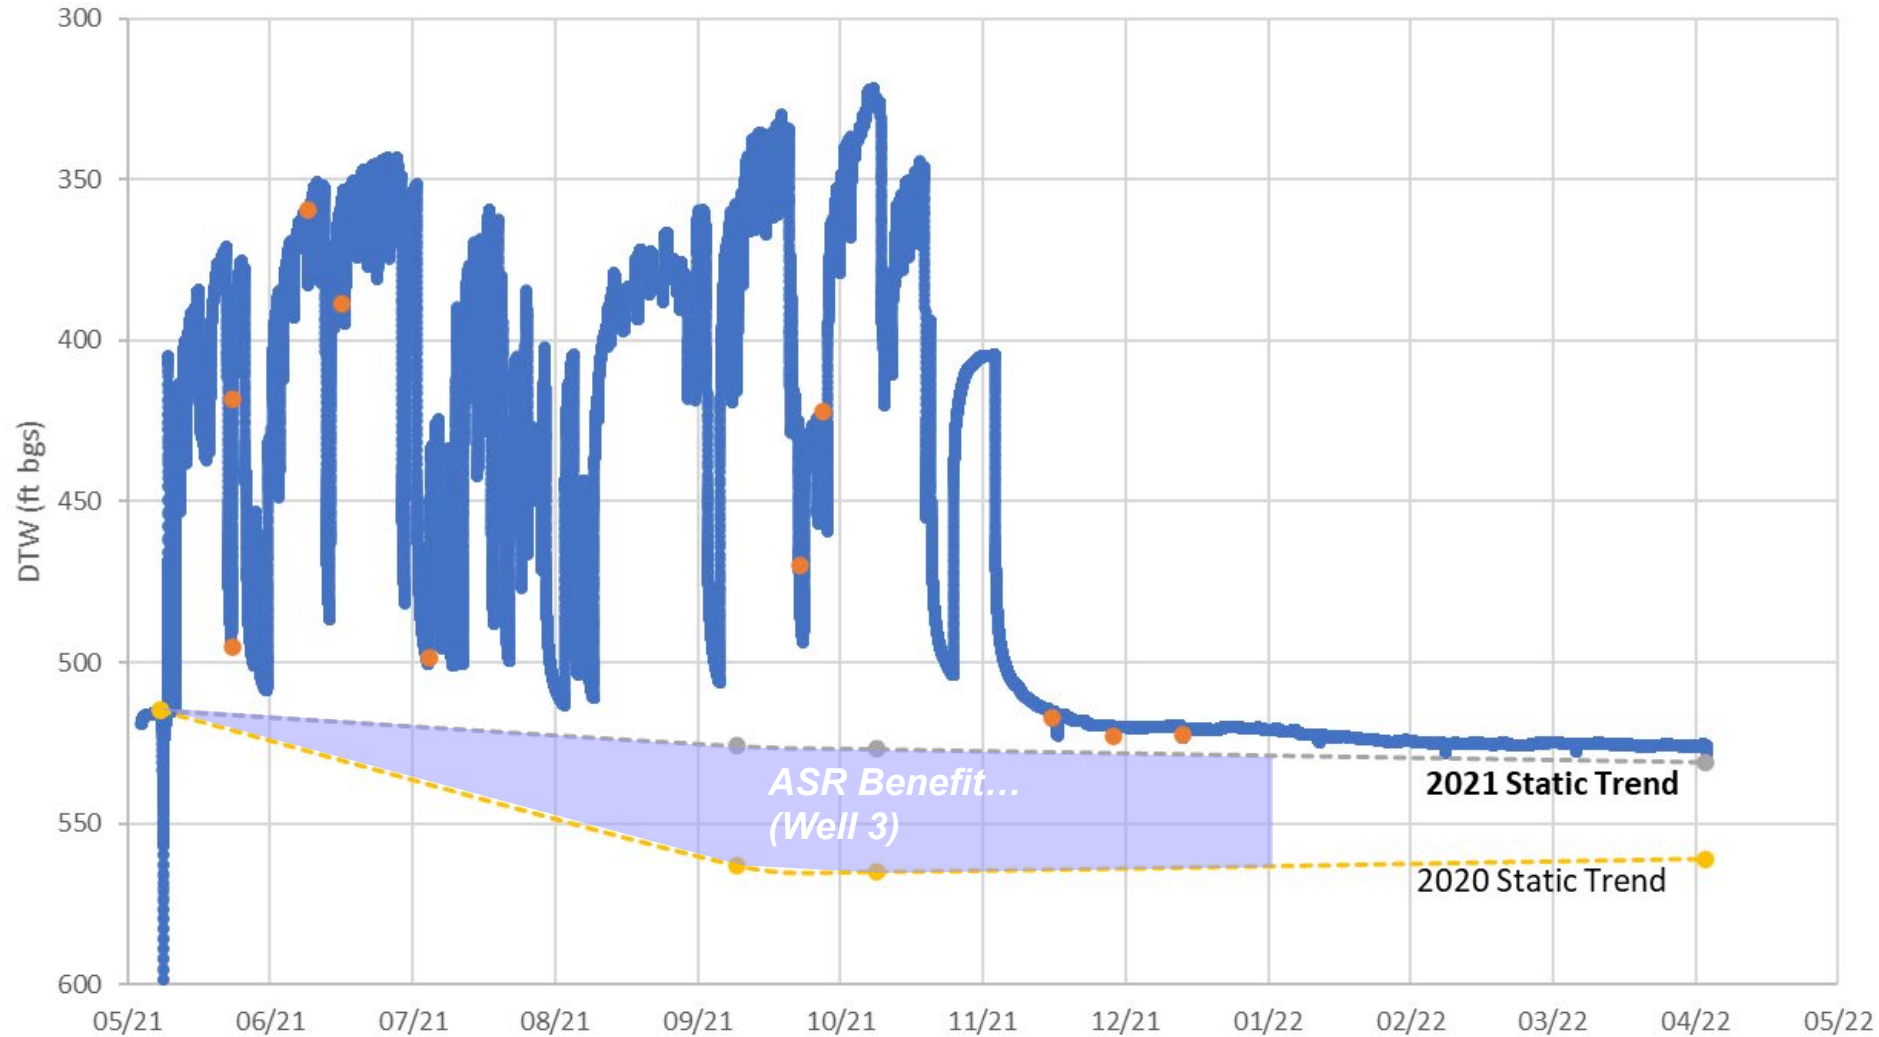
Summer Water Level Trends

- **78% Reduction in Declining Trend in 2021**

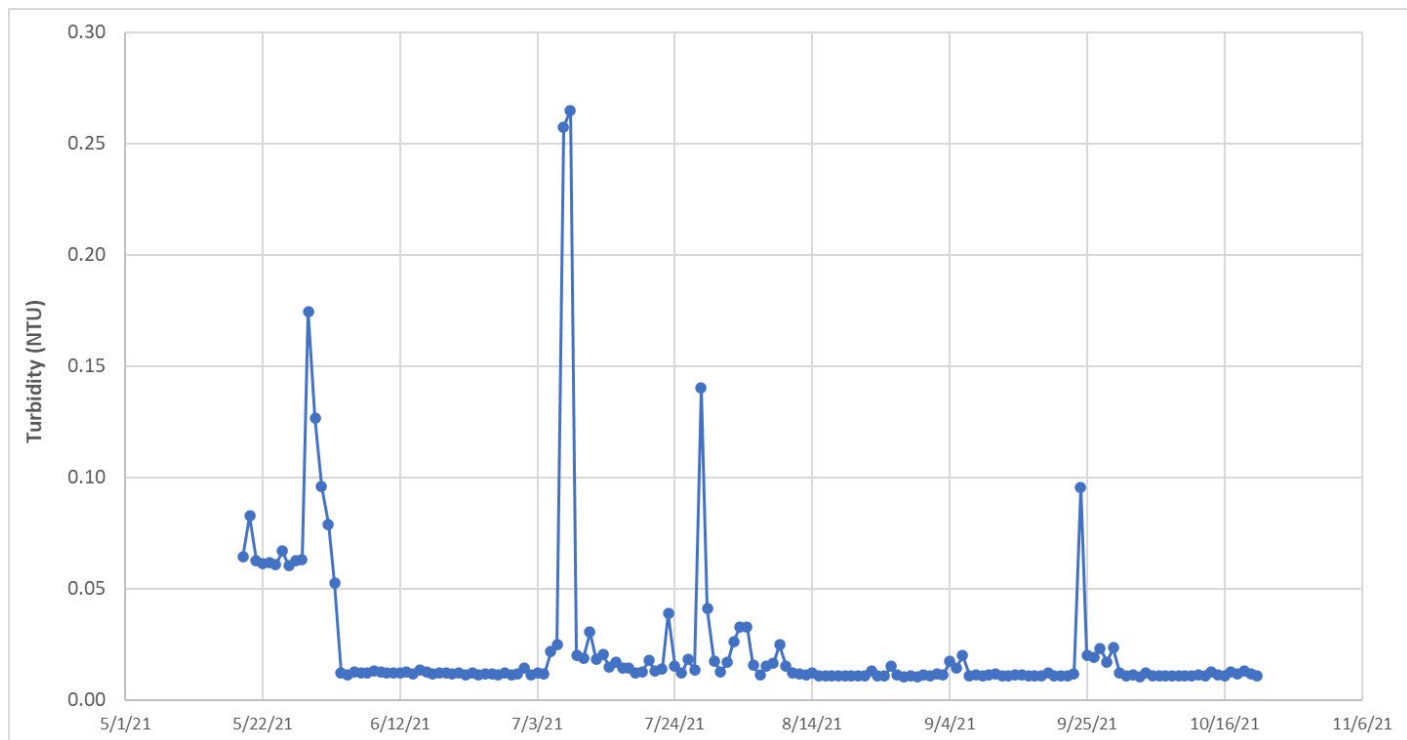
Filtration Performance

Analysis	Result	Flag
2105210-01: Raw Canal Water (Potable)		
E. Coli	Present	U
Total Coliform	Present	U
Analysis	Result	Flag
2105218-01: Recharge (Potable)		
E. Coli	Absent	U
Total Coliform	Absent	U

- Bacteria non-detect
- Recharge water: 0.07 ntu
- 4-log reduction at 3 μm

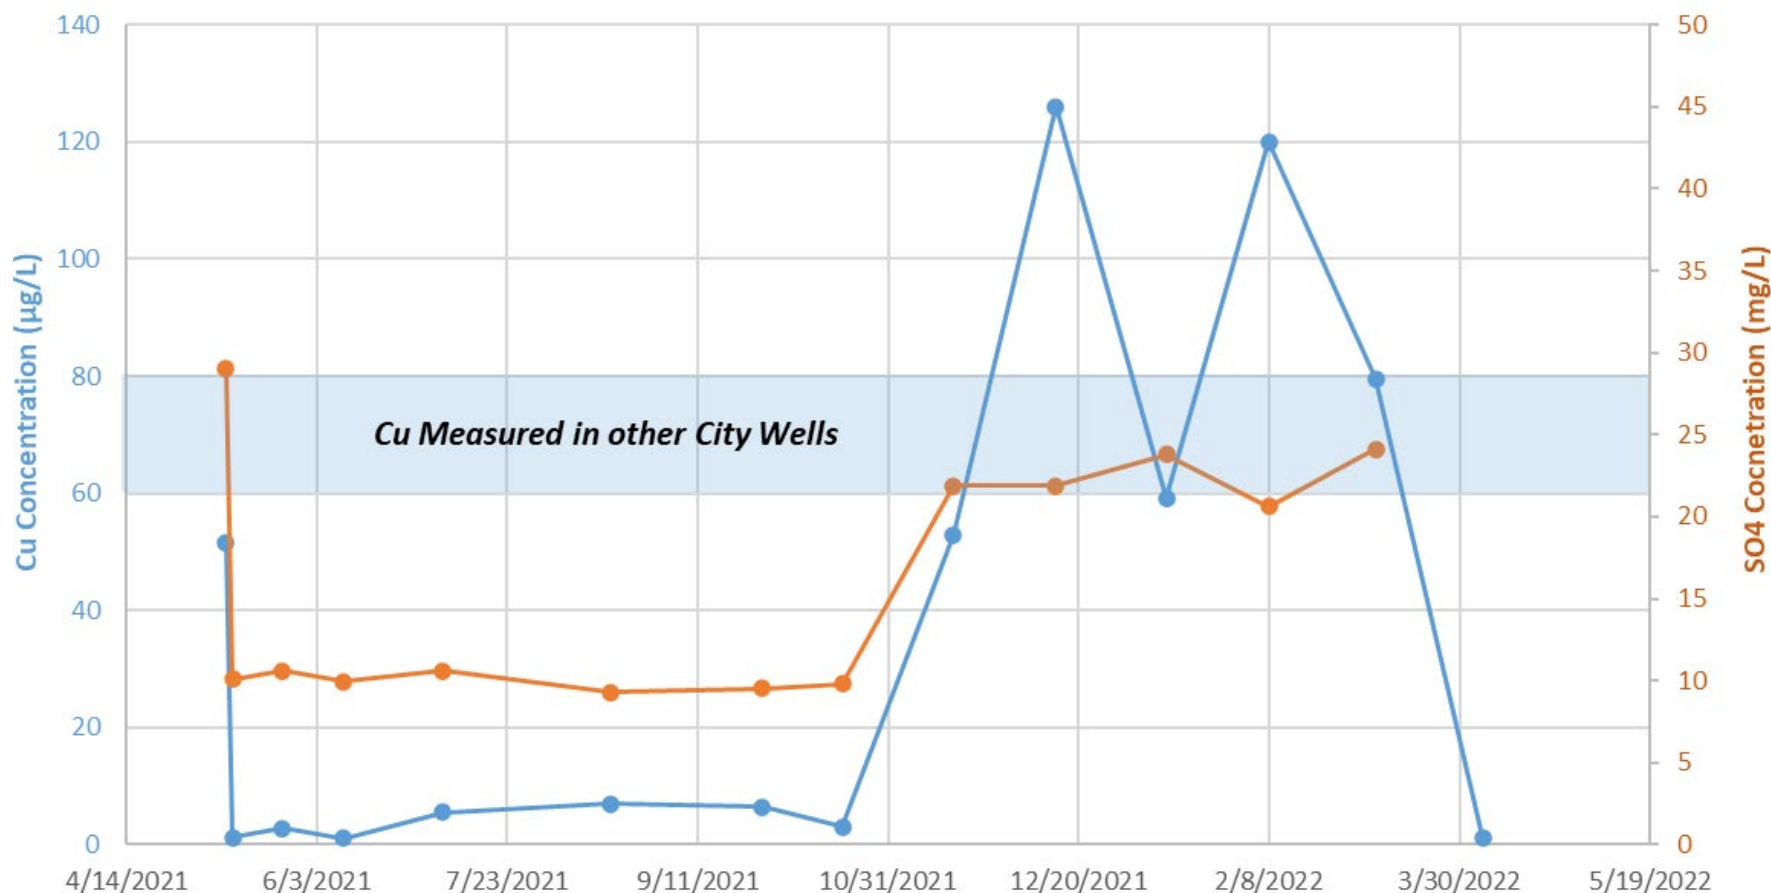
Copper Sulfate

- Modeling does not support increase in Cu

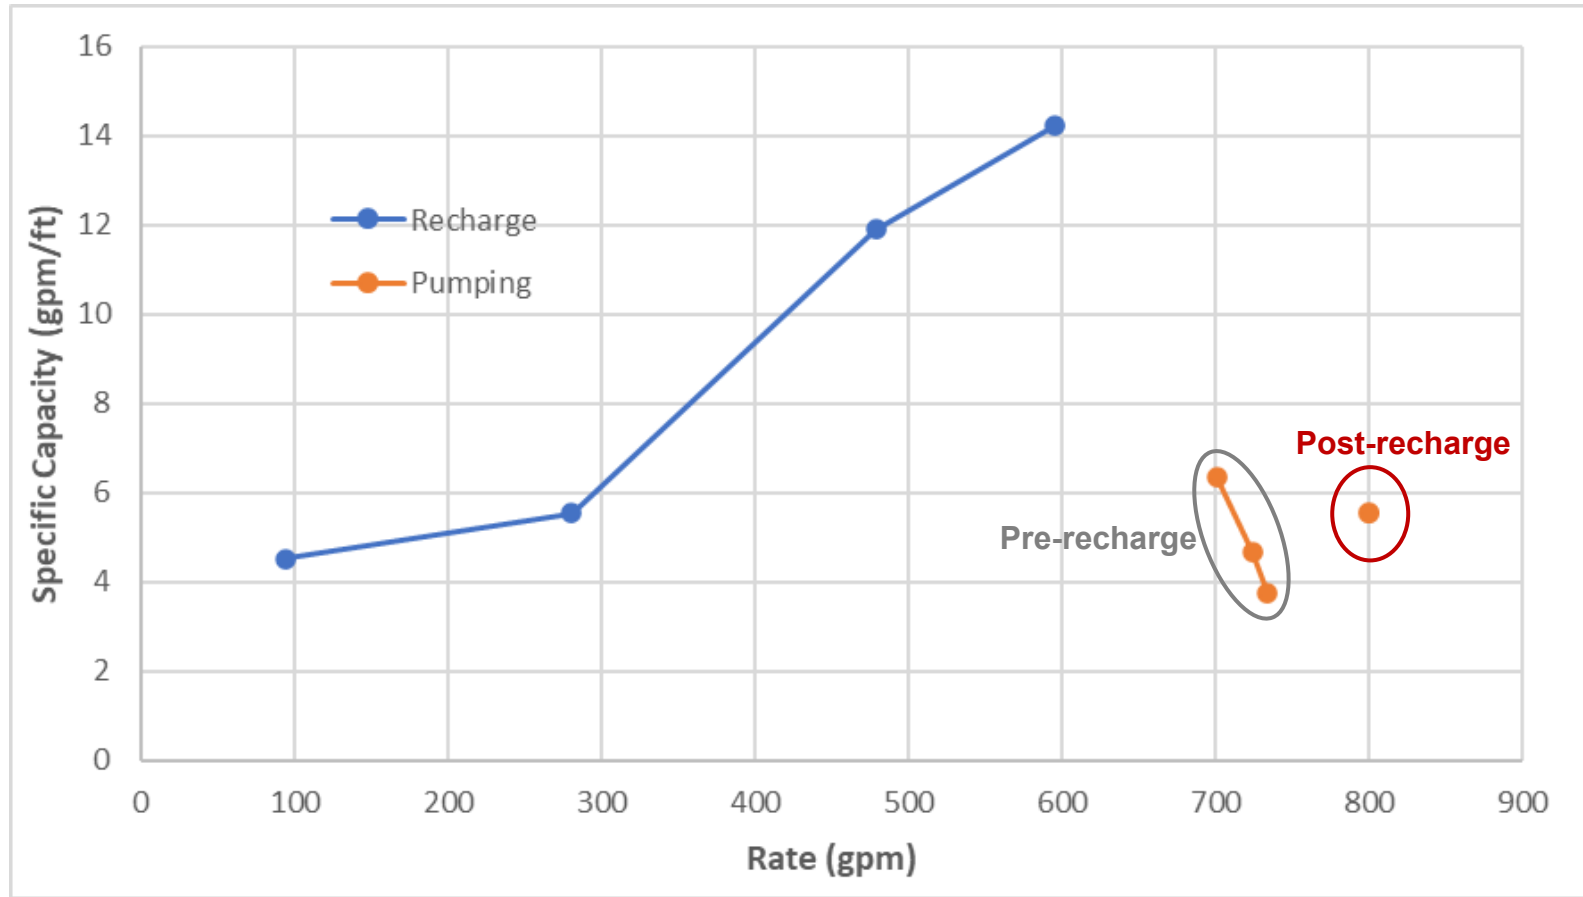
Well Performance

- Specific capacity remains slightly elevated during storage
- No indications of well fouling
