# **Converting an Unchlorinated System to Full Chlorination/ Arsenic/Manganese Treatment**

Beth Mende, PE

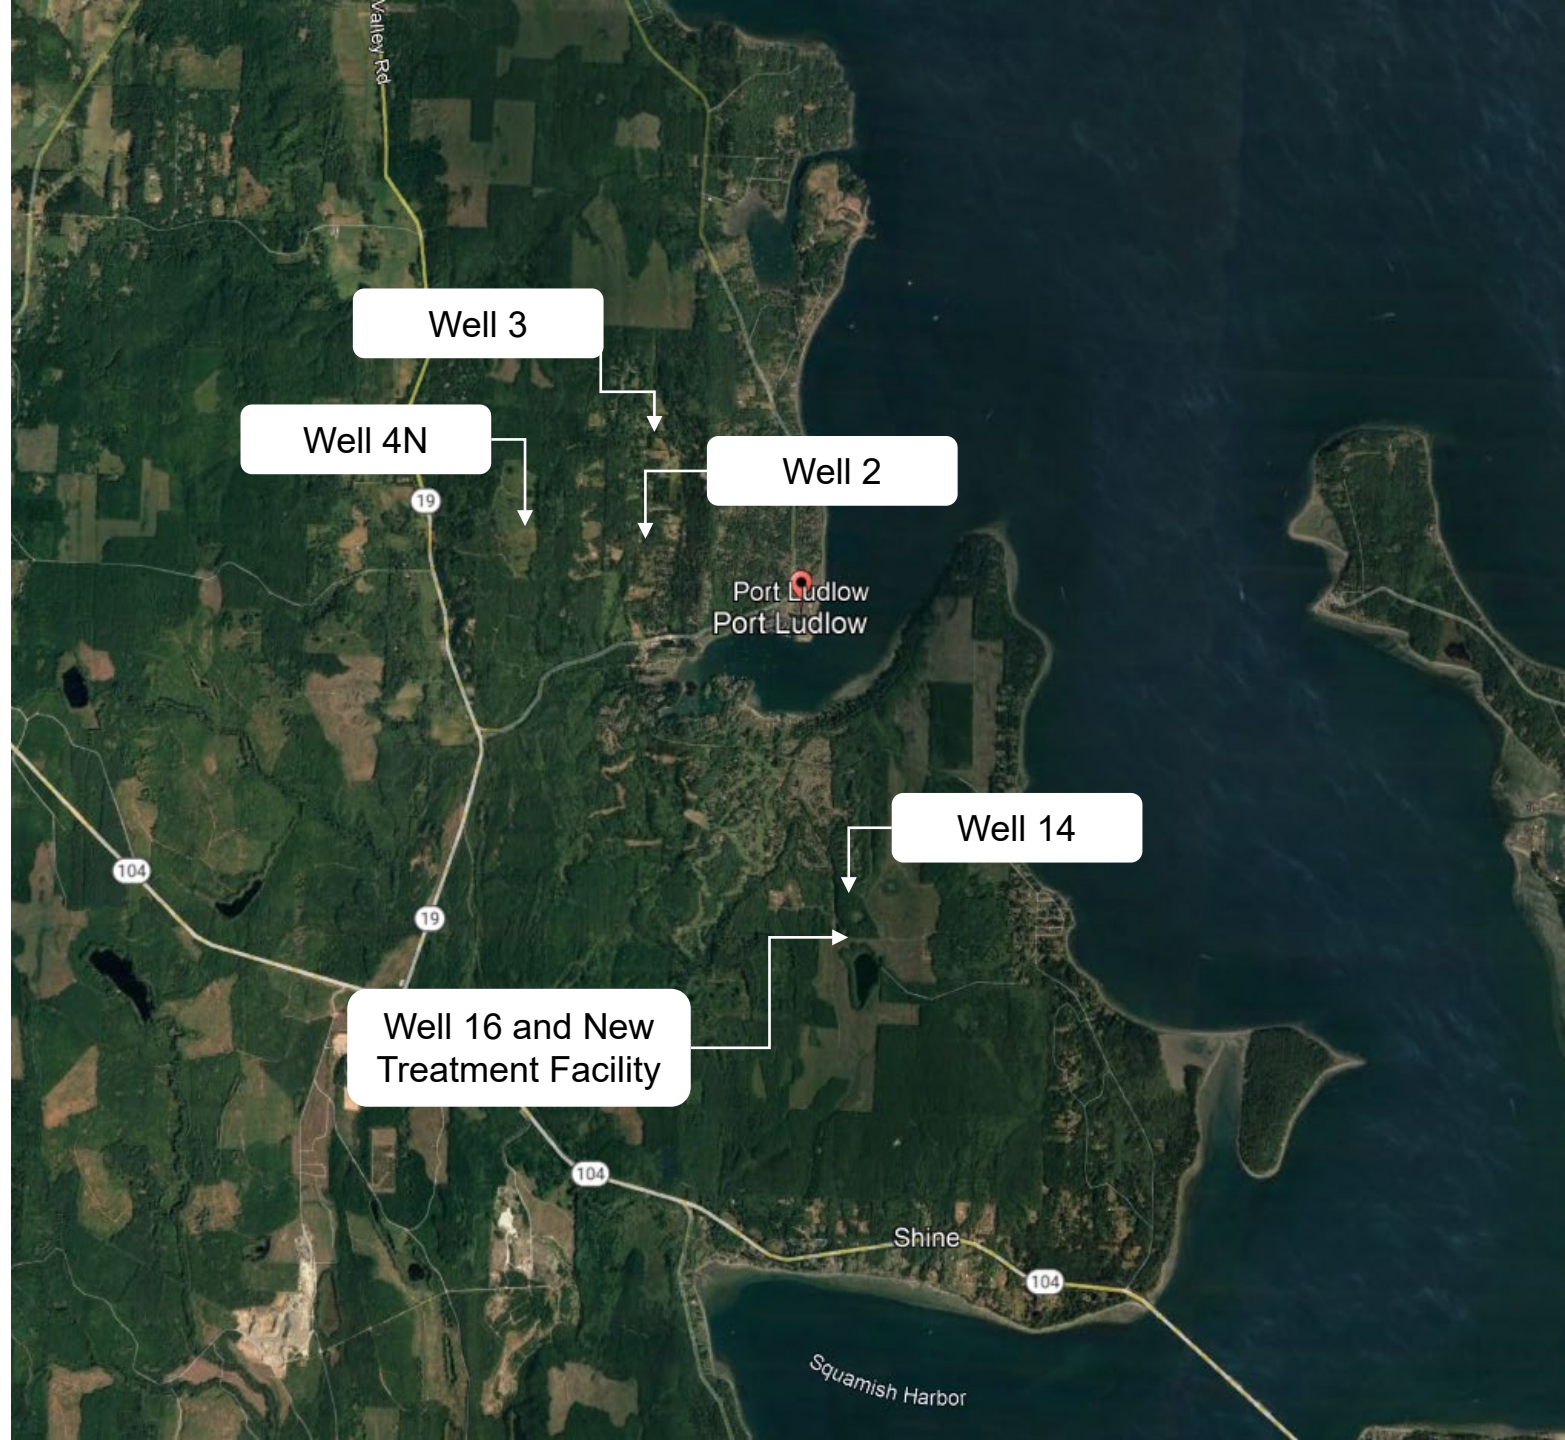
# Well Locations

- Service Zone A
  - Well 2, 3 and 4N
- Service Zone B
  - Well 14 and 16

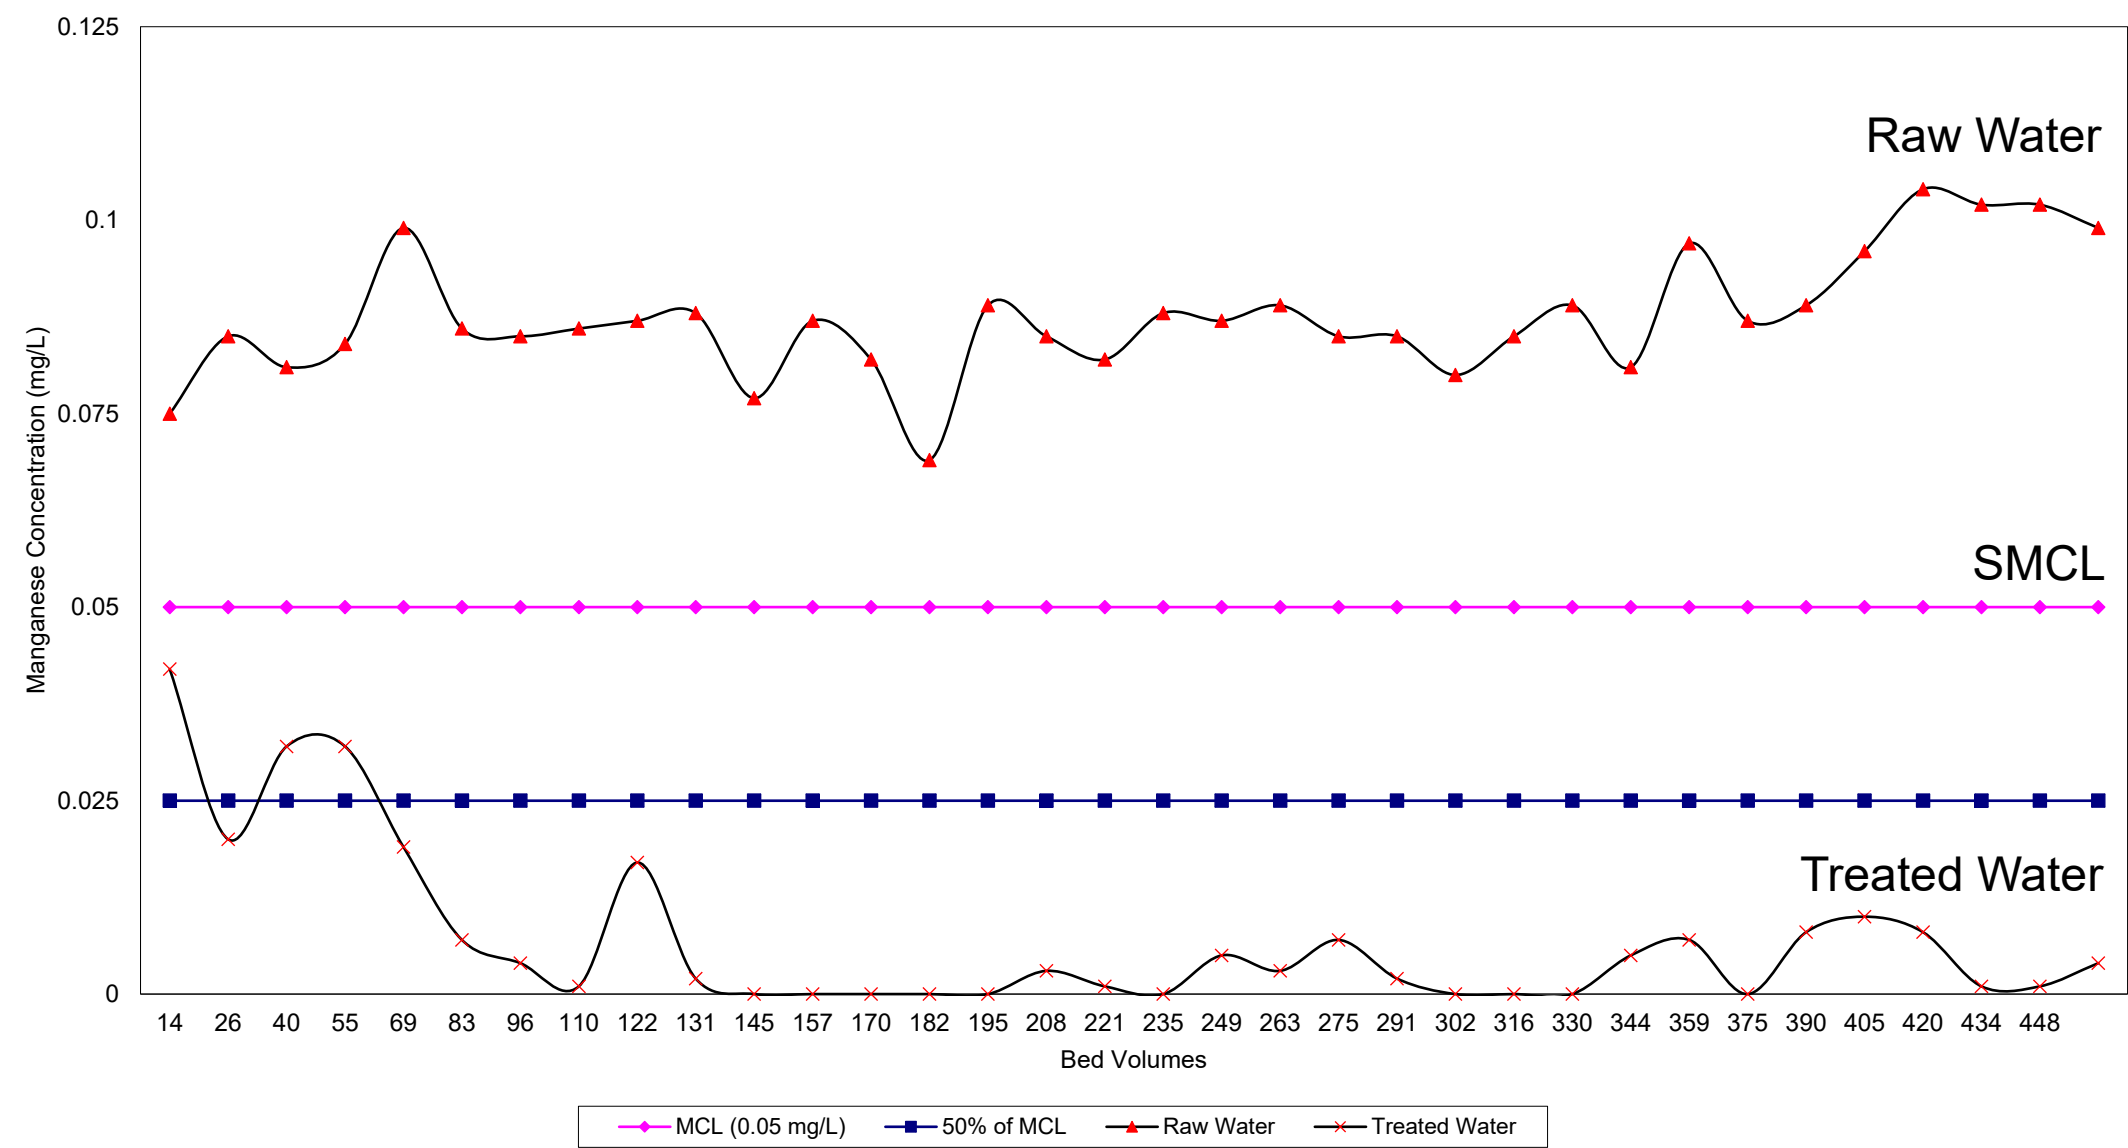
# Pilot Testing – Manganese Removal Results

- Week of testing
- Chlorine demand averaged 0.67 mg/L
- pH was reduced from 8.4 in the feed water to just below 7.5 to prevent silica coating
- Ferric chloride was added for arsenic removal
- Supported a reduction in:
  - Manganese concentrations of 0.087 mg/L to below 0.007 mg/L
  - Arsenic concentrations of 9 µg/L to below 2 µg/L
