Implementation of Taste & Odor Improvements at Scotts Valley

Milt Larsen, PE
Don Ervin, PE

Scotts Valley Water District

Orchard Run WTP

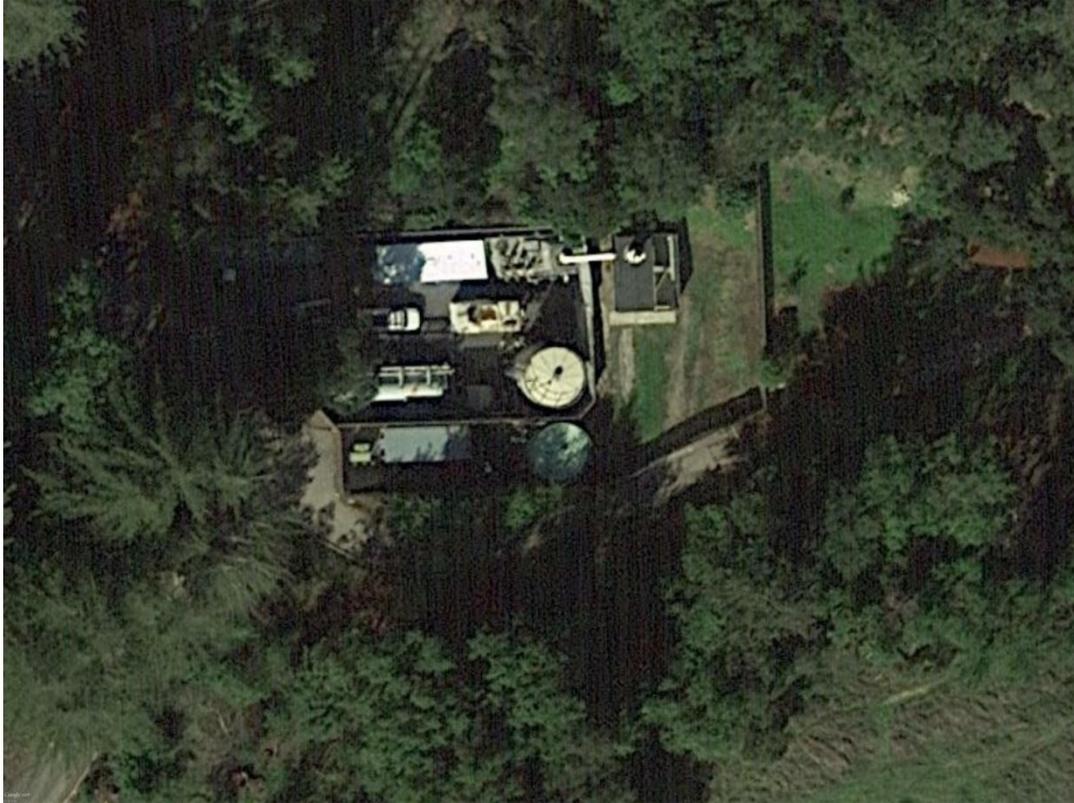
Orchard Run WTP

- Built 1993
- 800 gpm capacity
- Tight site
- Periodic odor complaints
- High end residential development going in on adjacent property
- No sewer
- Discharge pressure 160 to 175 psi

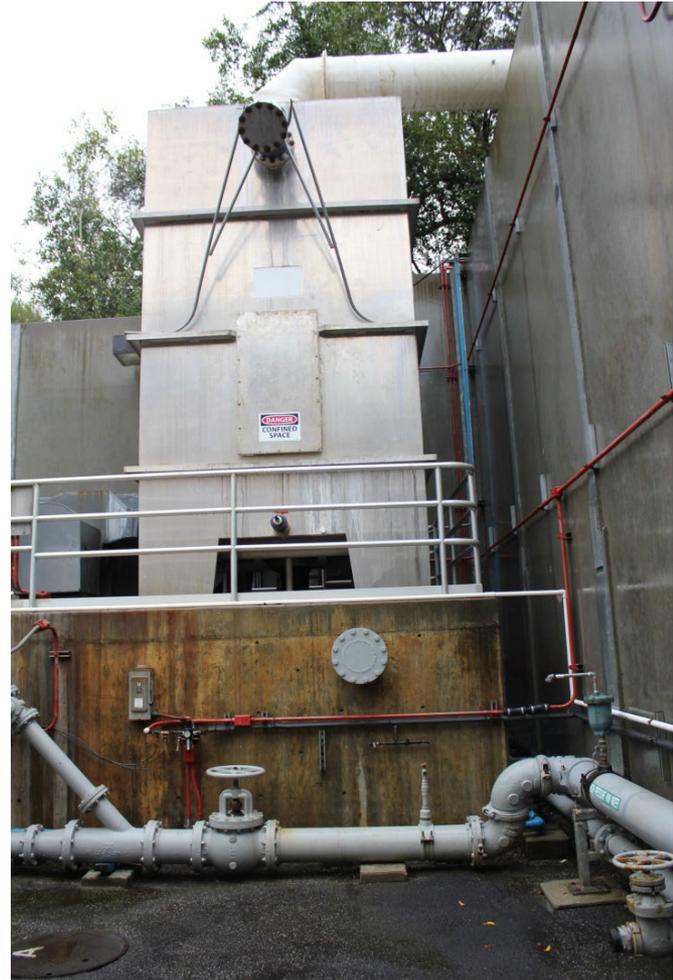
Inadequate Foul Air Odor Scrubber

- 💧 30% ammonia solution
- 💧 Packed bed scrubber
- 💧 \$25K± annual aqua ammonia cost
- 💧 \$25K± for waste ammonia disposal
- 💧 Staff complaints
 - Handling safety
 - Odors
- 💧 Neighbor odor complaints

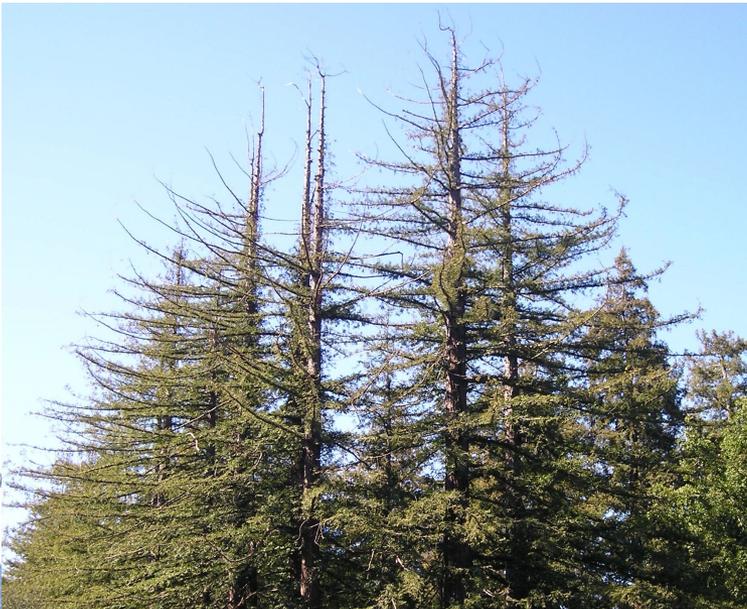
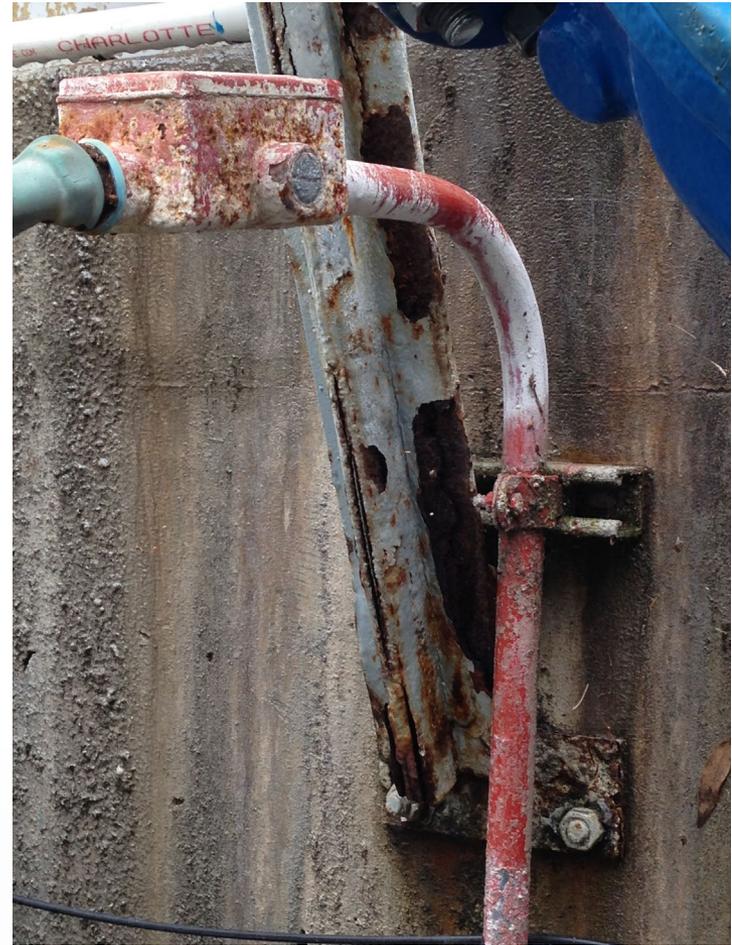
Hydrogen Sulfide Emissions

- 💧 Damage to adjacent redwood trees
- 💧 Corrosion
- 💧 Odor complaints from neighbors

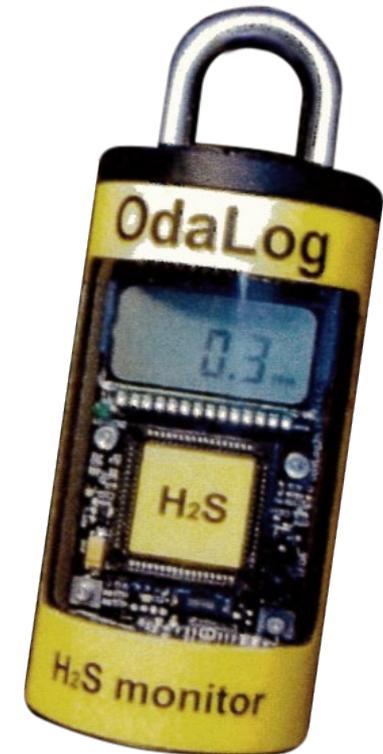
H₂S in Air Stripper Discharge

- 24" FRP duct prior to air scrubber
- Anemometer for air velocity measurement
 - ✓ 3,000 CFM
- OdaLog gas monitor (0 to 1,000 ppm H₂S)
 - ✓ 1 minute time intervals
 - ✓ 8 ppm H₂S average
 - ✓ 29 ppm H₂S peak

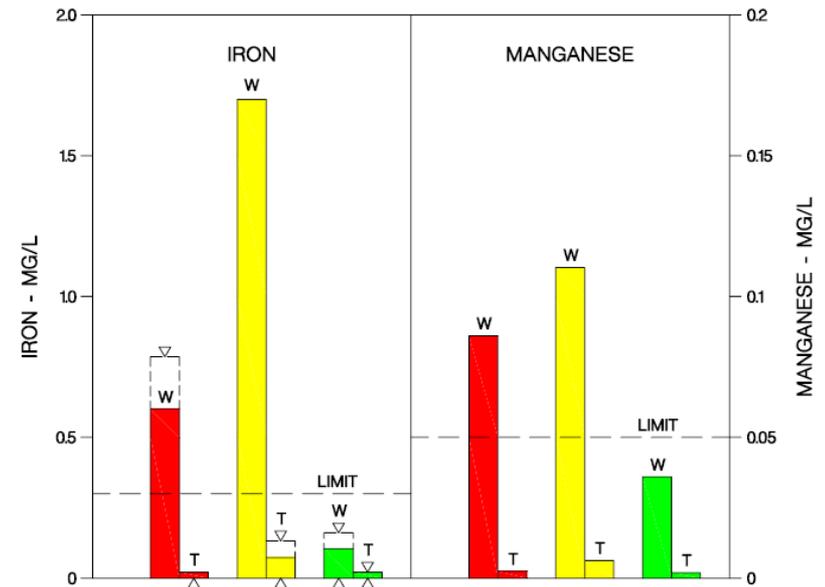
Oxidation/Filtration has been effective at SVWD for iron and manganese

Filter media

- Anthracite and silica sand
- Filter media develops a manganese oxide coating
- Low loading rates
 - ✓ 3 to 5 gpm/SF

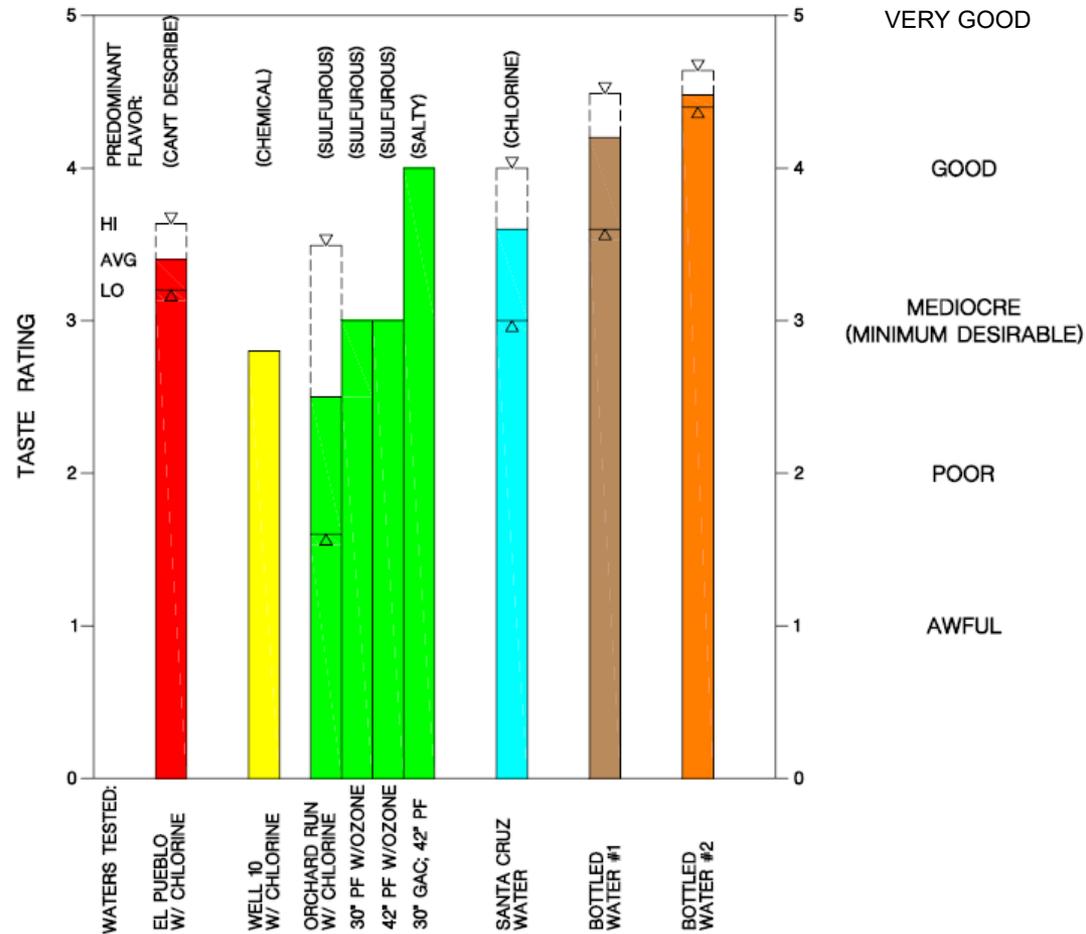
Sulfide and chemical tastes have been issues for Orchard Run and Well 10 WTP

- 💧 Simplified flavor profile analysis
- 💧 Panel of SVWD staff & customers met twice a week
- 💧 Pilot treated water at ambient temperature
- 💧 Rated 1 to 5
 - 3 – Mediocre (minimum acceptable)

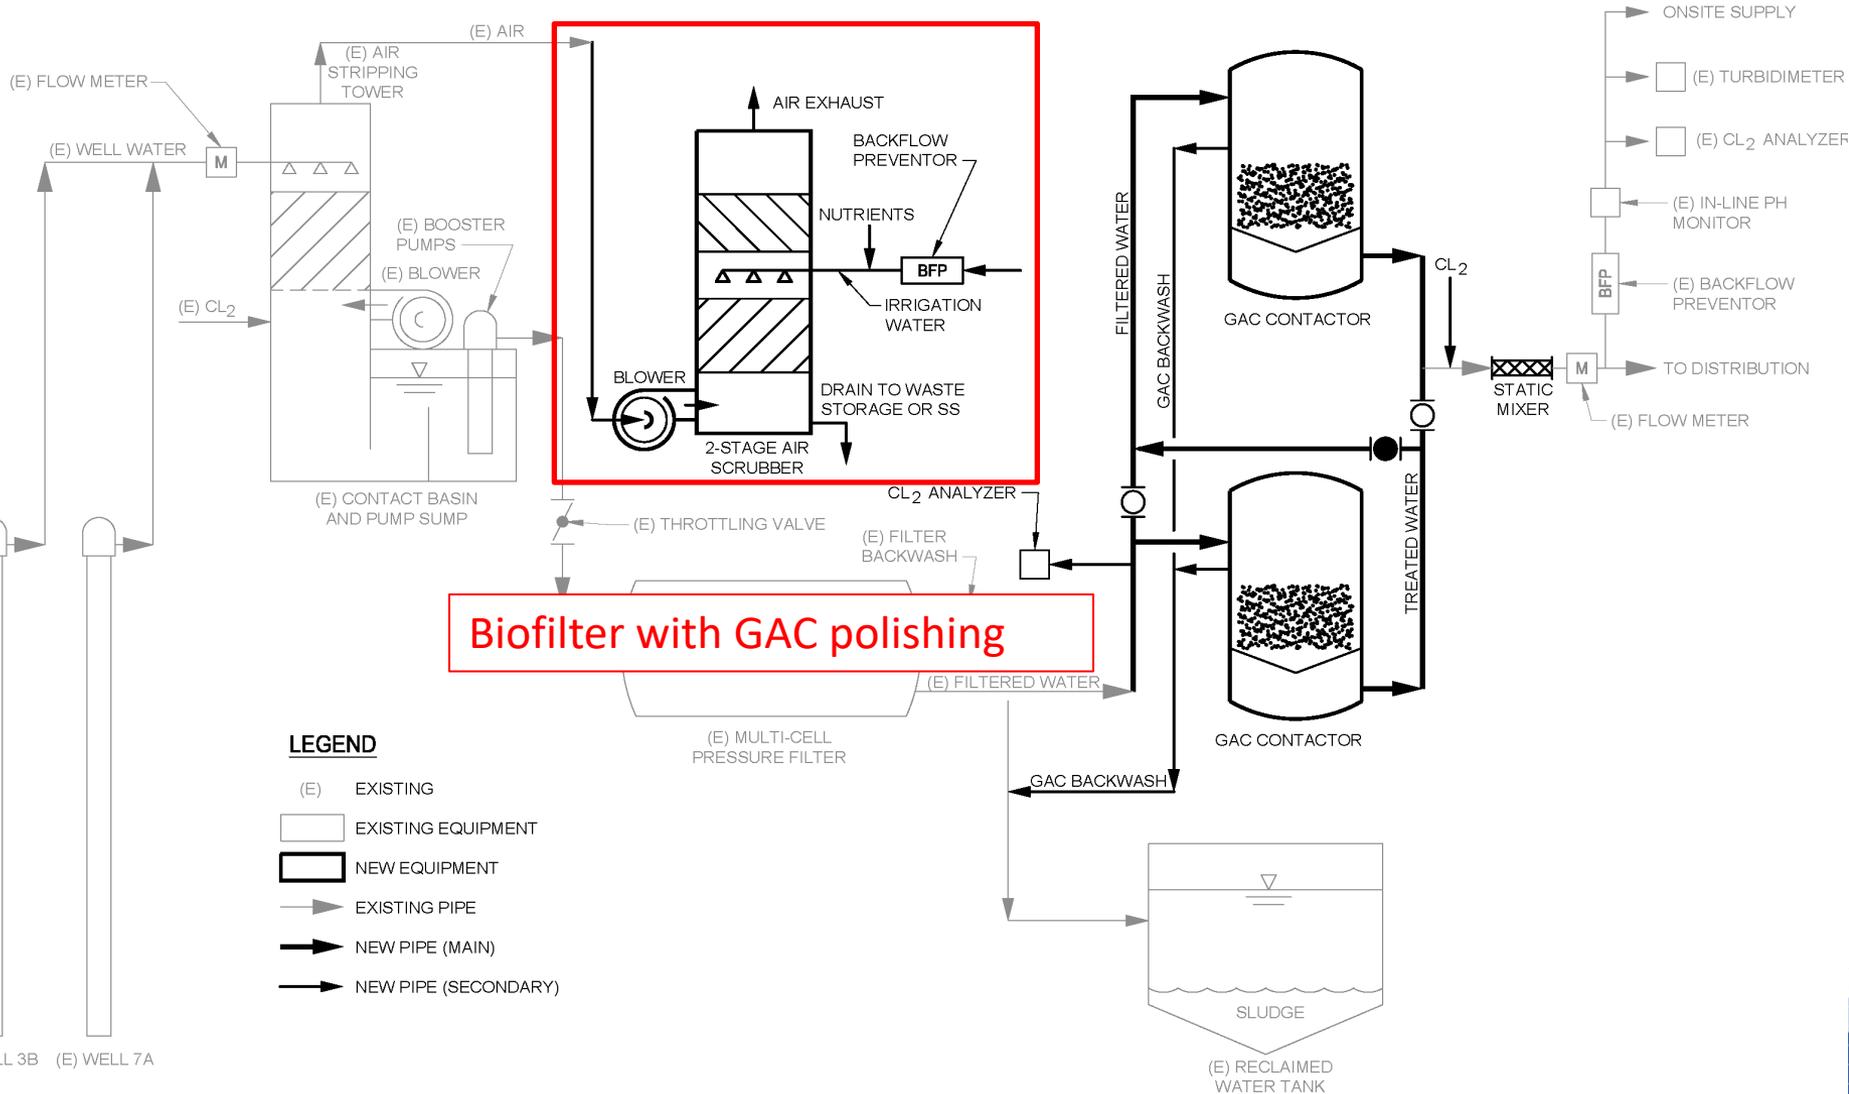
Air Quality Improvements

(E) WELL 3B (E) WELL 7A

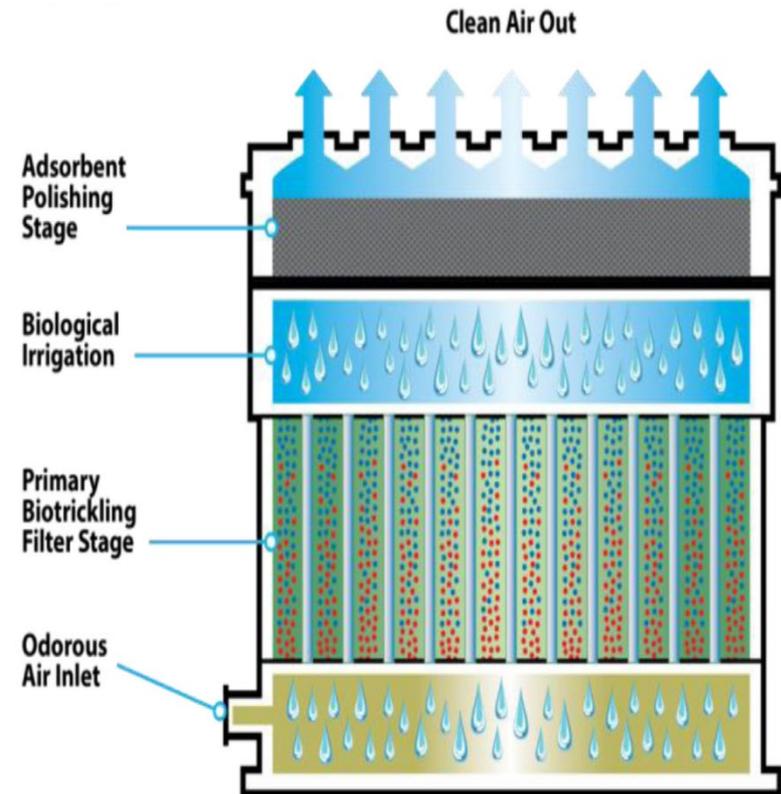
Foul Air Scrubber

- 2 stage scrubber
 - Biological oxidation with GAC polishing
- Design parameters
 - Air flow rate = 3,000 cfm
 - Air head loss = 2.2 inches WC
 - H₂S = 10 ppm average, 50 ppm peak
- Irrigation water
 - 1,267 gals/day (20 sec/10 minutes)
- Drainage pH 2.0 to 2.5

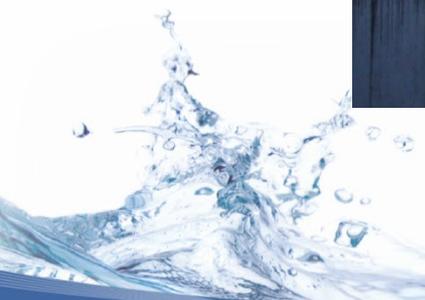
Scrubber Discharge Neutralization

- Scrubber drainage pH 2.0 to 2.5
- Did not meet sewer discharge limits
- pH neutralization pellets followed by dilution

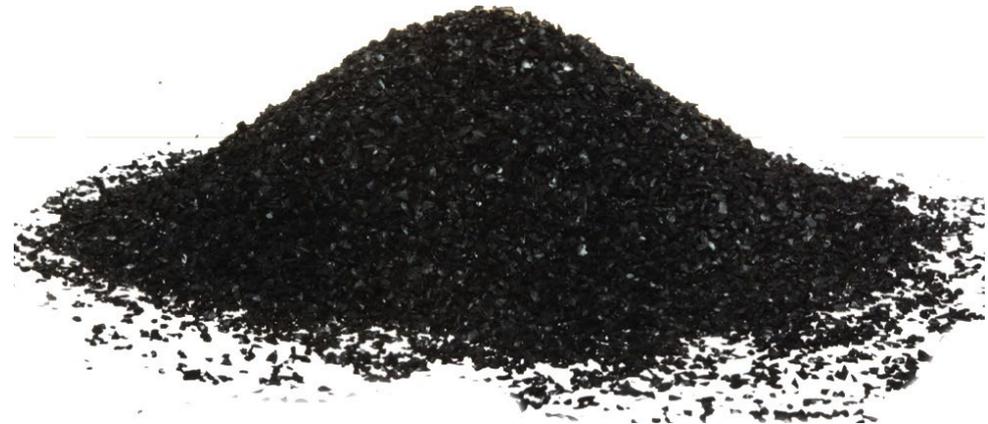
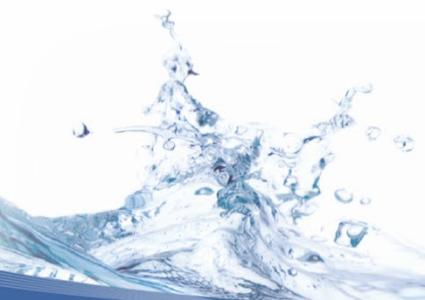
GAC Contactors

💧 20,000 lbs GAC per vessel

💧 EBCT

- 800 GPM = 11 mins
- 420 GPM = 20 mins

💧 Two 10 ft diameter contactors

💧 200 psi working pressure

💧 Operating configuration

- Lead-lag operation under normal production
- Parallel operation under high-demand production

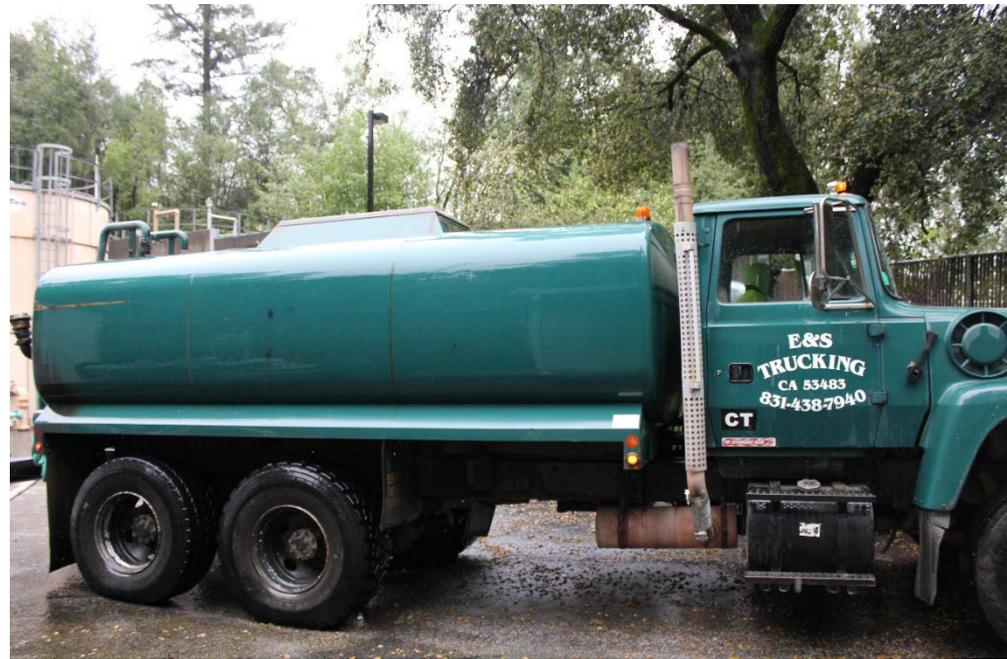
Arsenic (As) Leaching

- As naturally occurs in GAC (coal & coconut shell)
- Flush-to-waste ≈ 20 bed volumes prior to start up typical
- Future sewer connection capacity 50 gpm
- Used 24 hr soak & drain
- 8.5 & 9.1 $\mu\text{g/L}$ As after 4 cycles
- Startup delay-ORP dropped
- As 13 & 14 $\mu\text{g/L}$
- Repeated soak & drain
- As 3.8 $\mu\text{g/L}$
