Investigating Manganese Accumulation, Release, and Mitigation in Tacoma Water's Large Diameter Transmission Main

Melinda Friedman, P.E.
PNWS AWWA Annual Conference Tacoma
April 29th, 2022

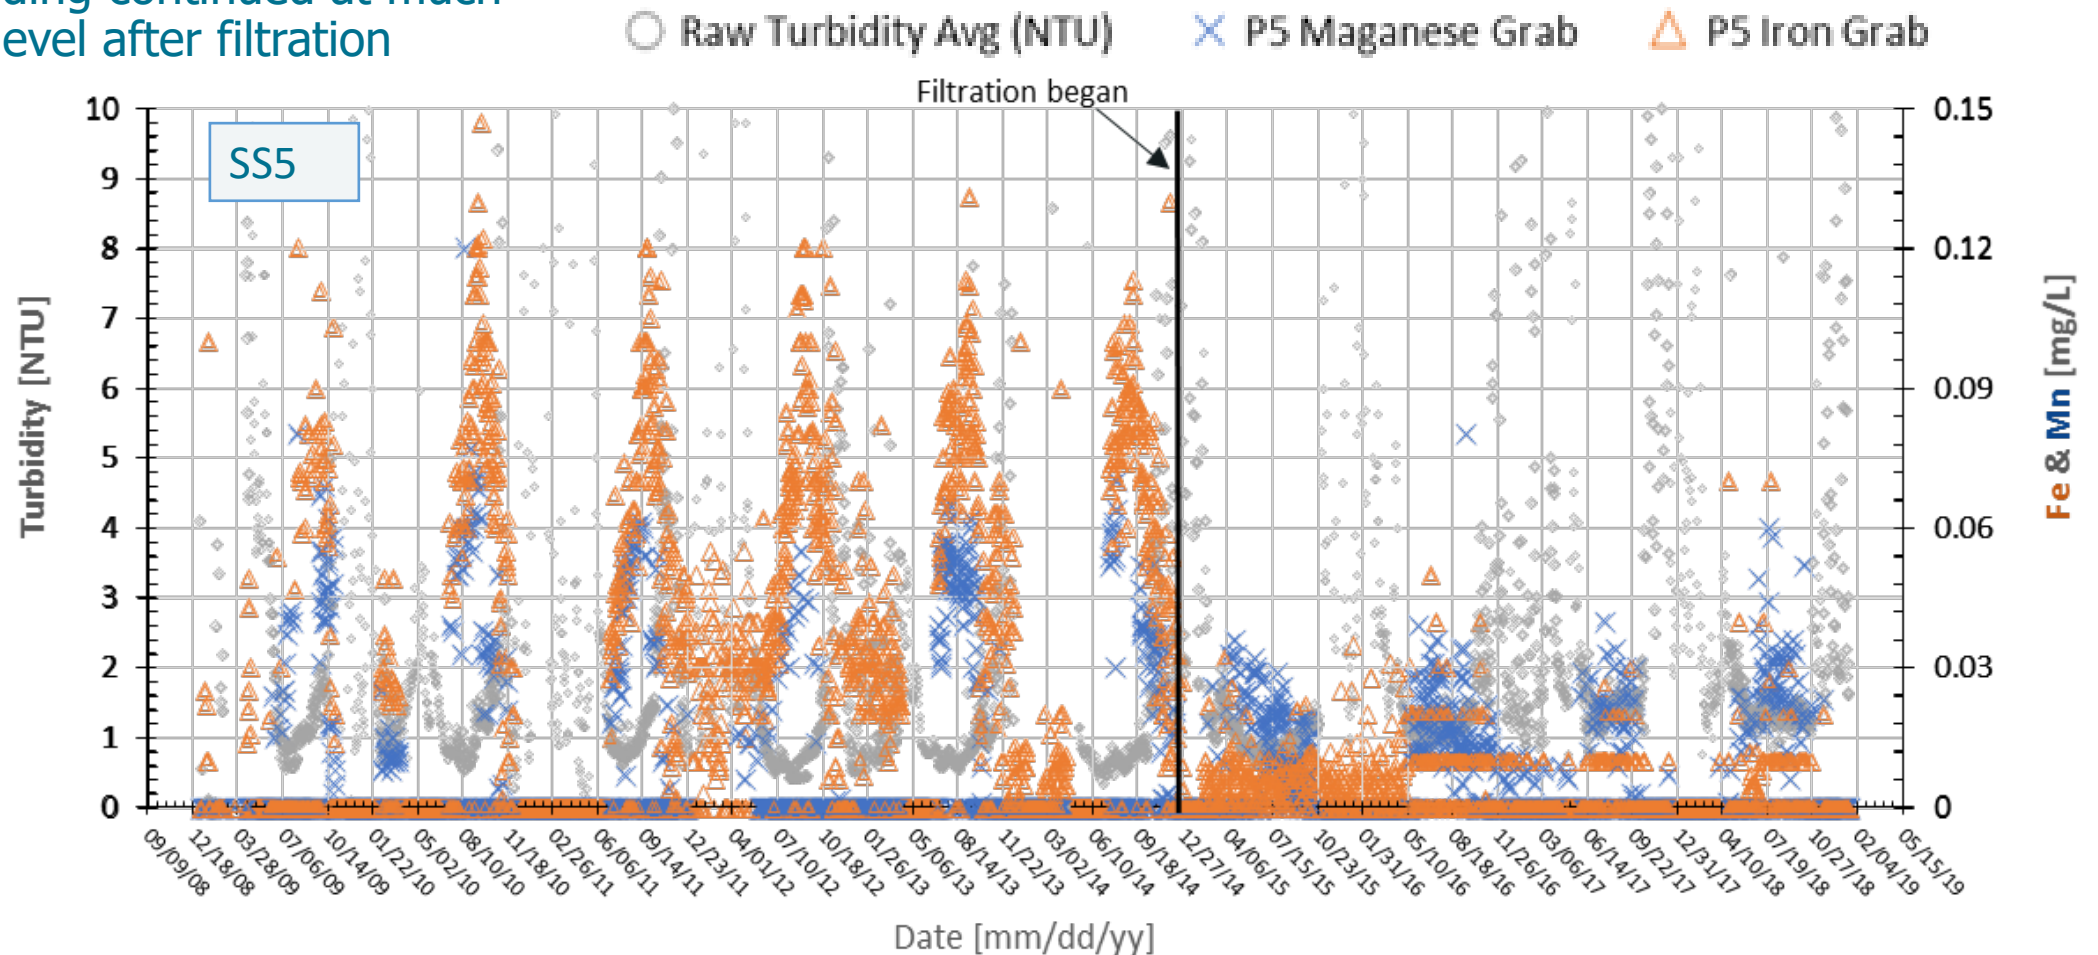
Filtration Impact

- Prior to filtration, seasonal loading of both Fe and Mn
- Minimal Fe loading following filtration
- Mn loading continued at much lower level after filtration

- Did removal of Fe affect behavior of Mn?
 - More mobile
 - Less likely to settle out
 - Colloidal/Organically bound?

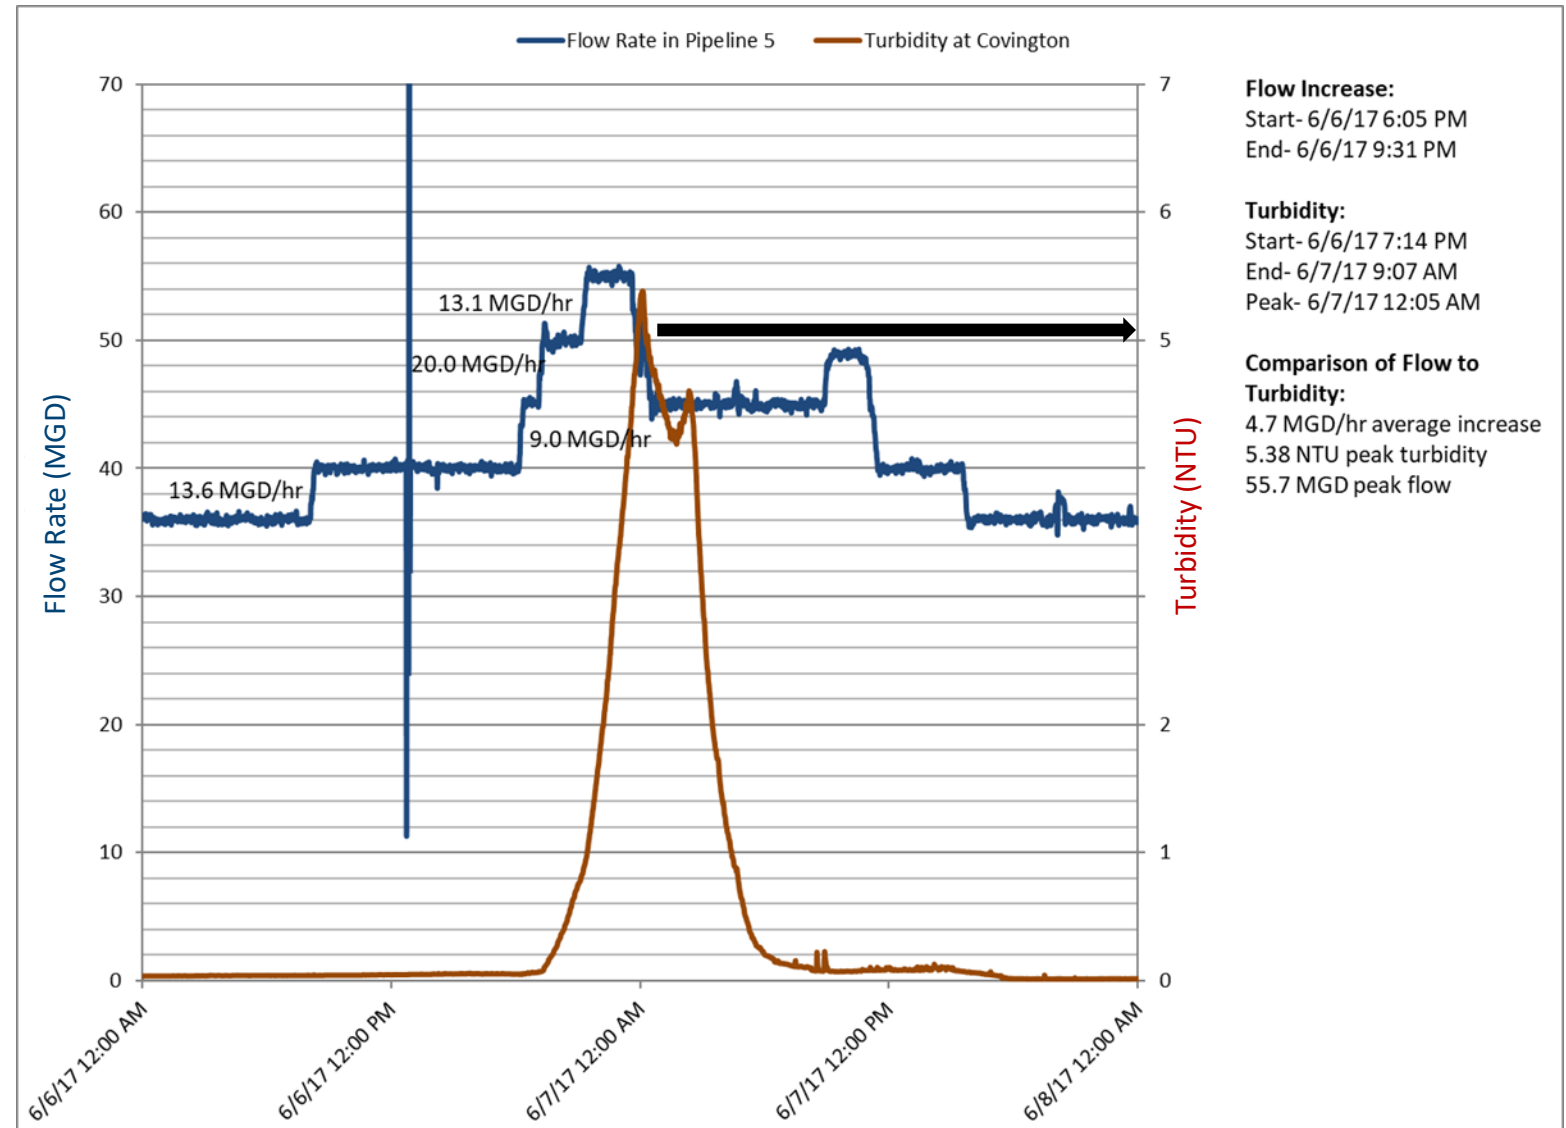
June 6-7, 2017 Mini-Flush Turbidity at CK and Water Quality at 356th St. PS

- Effective at mobilizing sediment but significant water quality impact at 356th St. Pump station:
 - Turb = 23 NTU vs. 5 NTU at Covington
 - Fe = 2.96 mg/L
 - Mn = 0.57 mg/L
 - Pb = 0.010 mg/L
 - TOC = 1.9
- Moving forward, made flow changes more slowly
- Added turbidimeter at 356th St. PS

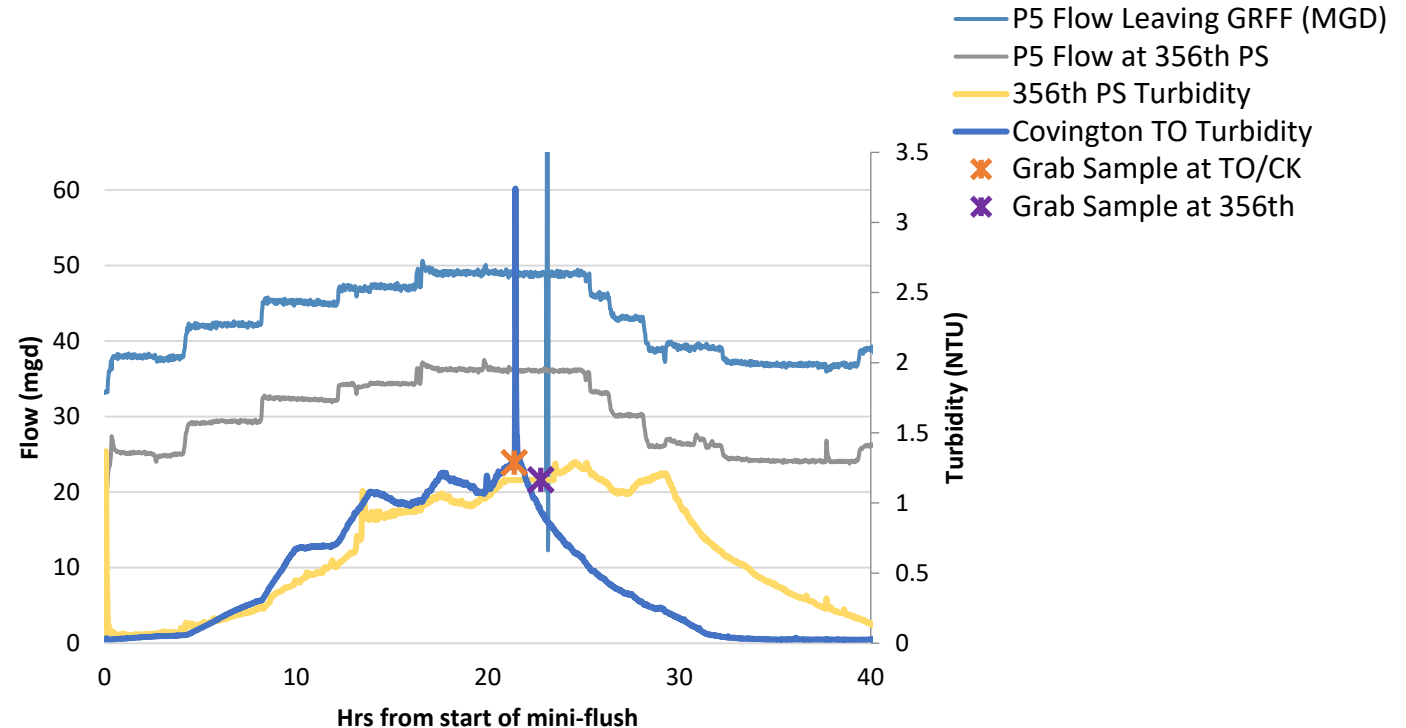
June 2020 Mini-flush

- Flow 33 → 49 MGD over 16 hrs (1 MGD/hr)
- Controlled to 1 NTU at CK
- Mn in particulate form and similar concentration at CK and 356th
- Very low Fe
- Much higher Mn at Portland Ave
 - 48" main
 - Additional release
- Findings:
 - Mn originated upstream of CK
 - Plug flow behavior
 - Suggests other turbidity events of similar magnitude are also releasing significant Mn

Turb (NTU)	Fe-T (mg/L)	Mn-T (mg/L)
TW-CK	1.71	<0.005	0.192
TW-356 th	1.82	<0.005	0.190
TW-PA	2.50	0.006	0.249

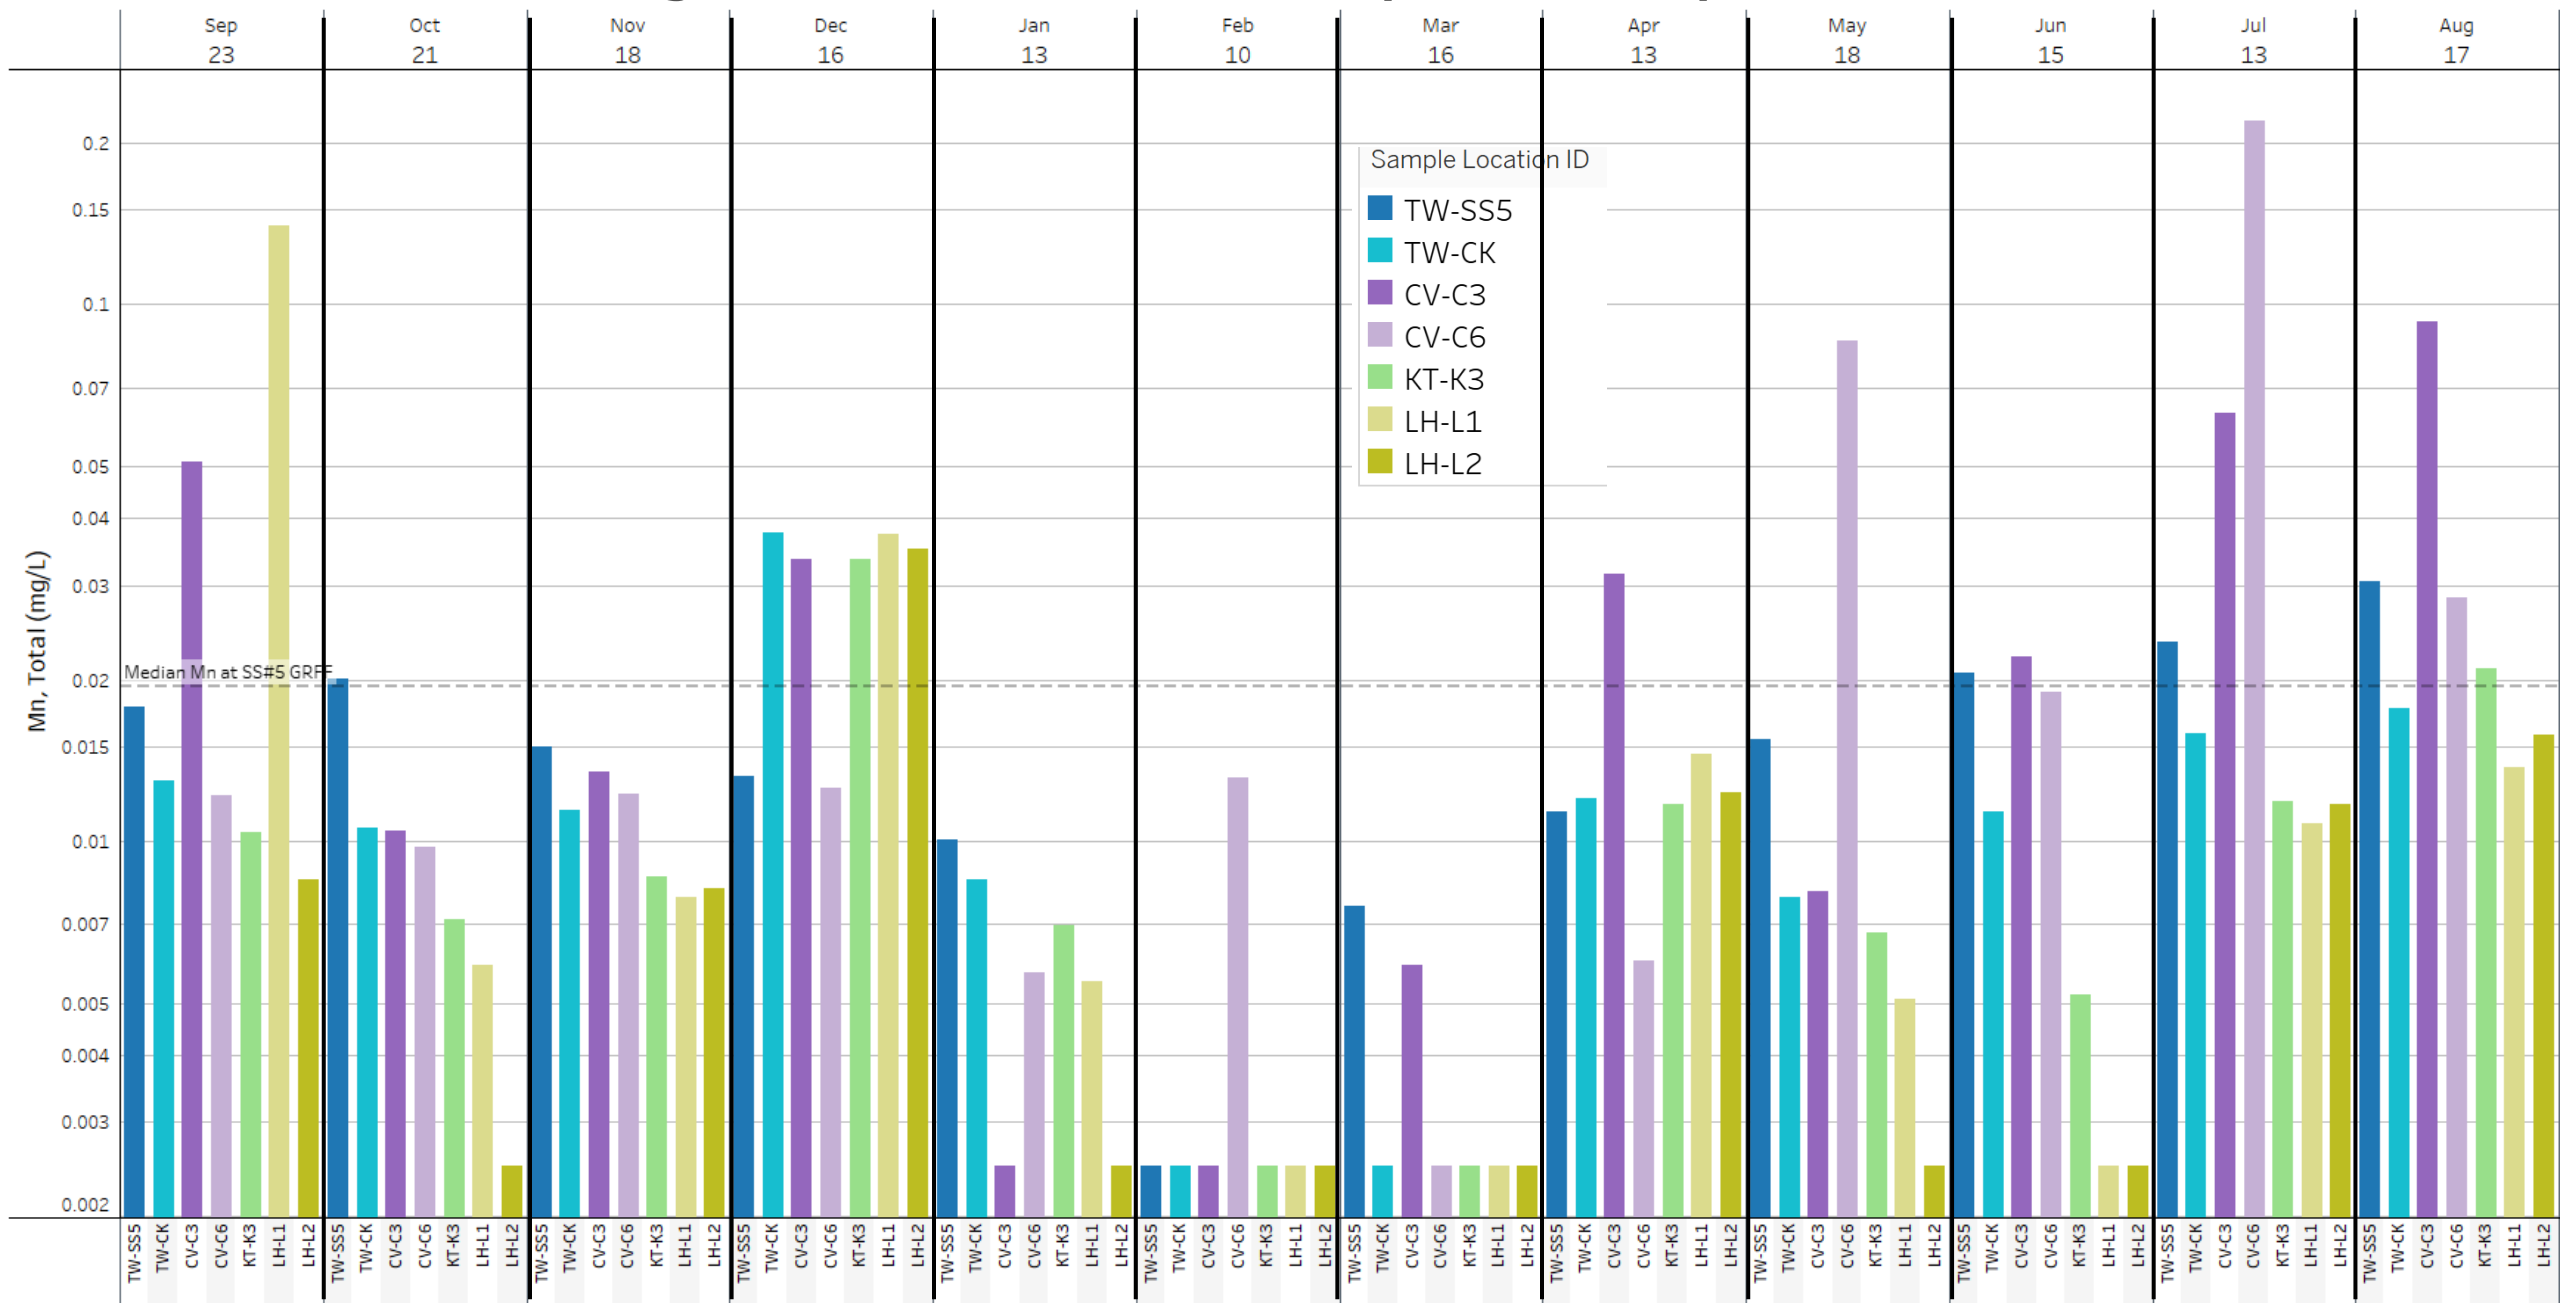
Coordinated Monitoring Plan Mn Results for P5 (2019-2020)

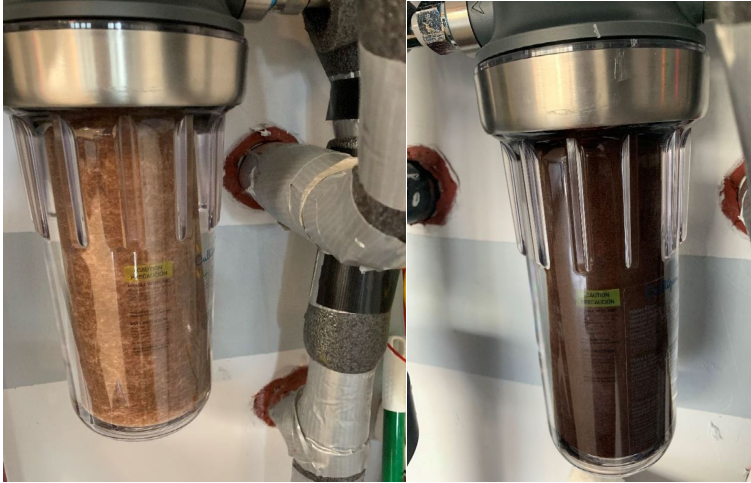
Customer filter, Covington
June 2020 July 2020

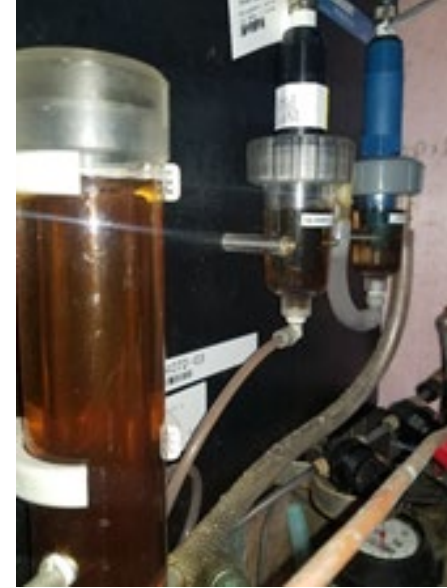
Analyzers at end of CK
transmission line September 2020

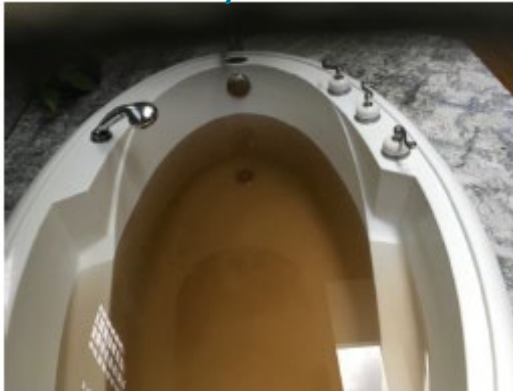
Near C3
May 2020

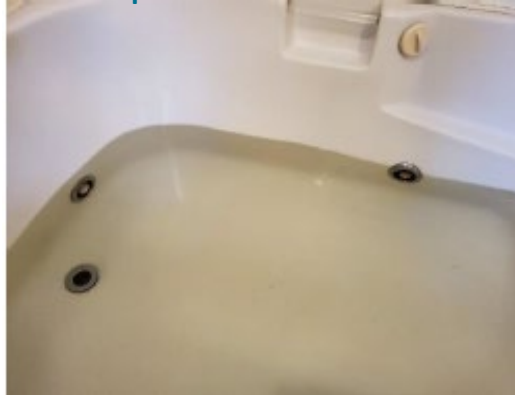
Near C6
September 2020

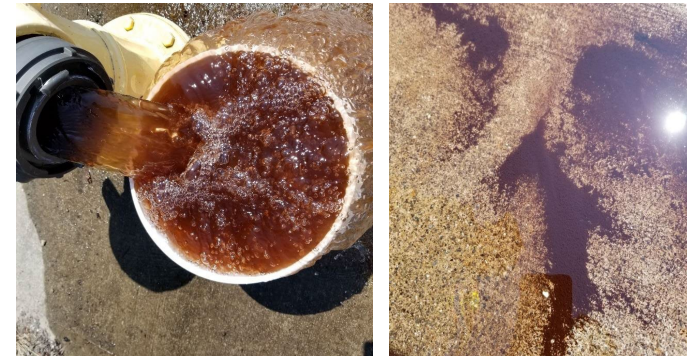
Observed very fine light sediment
that is easily stirred up in the main
(770 zone) August 2020

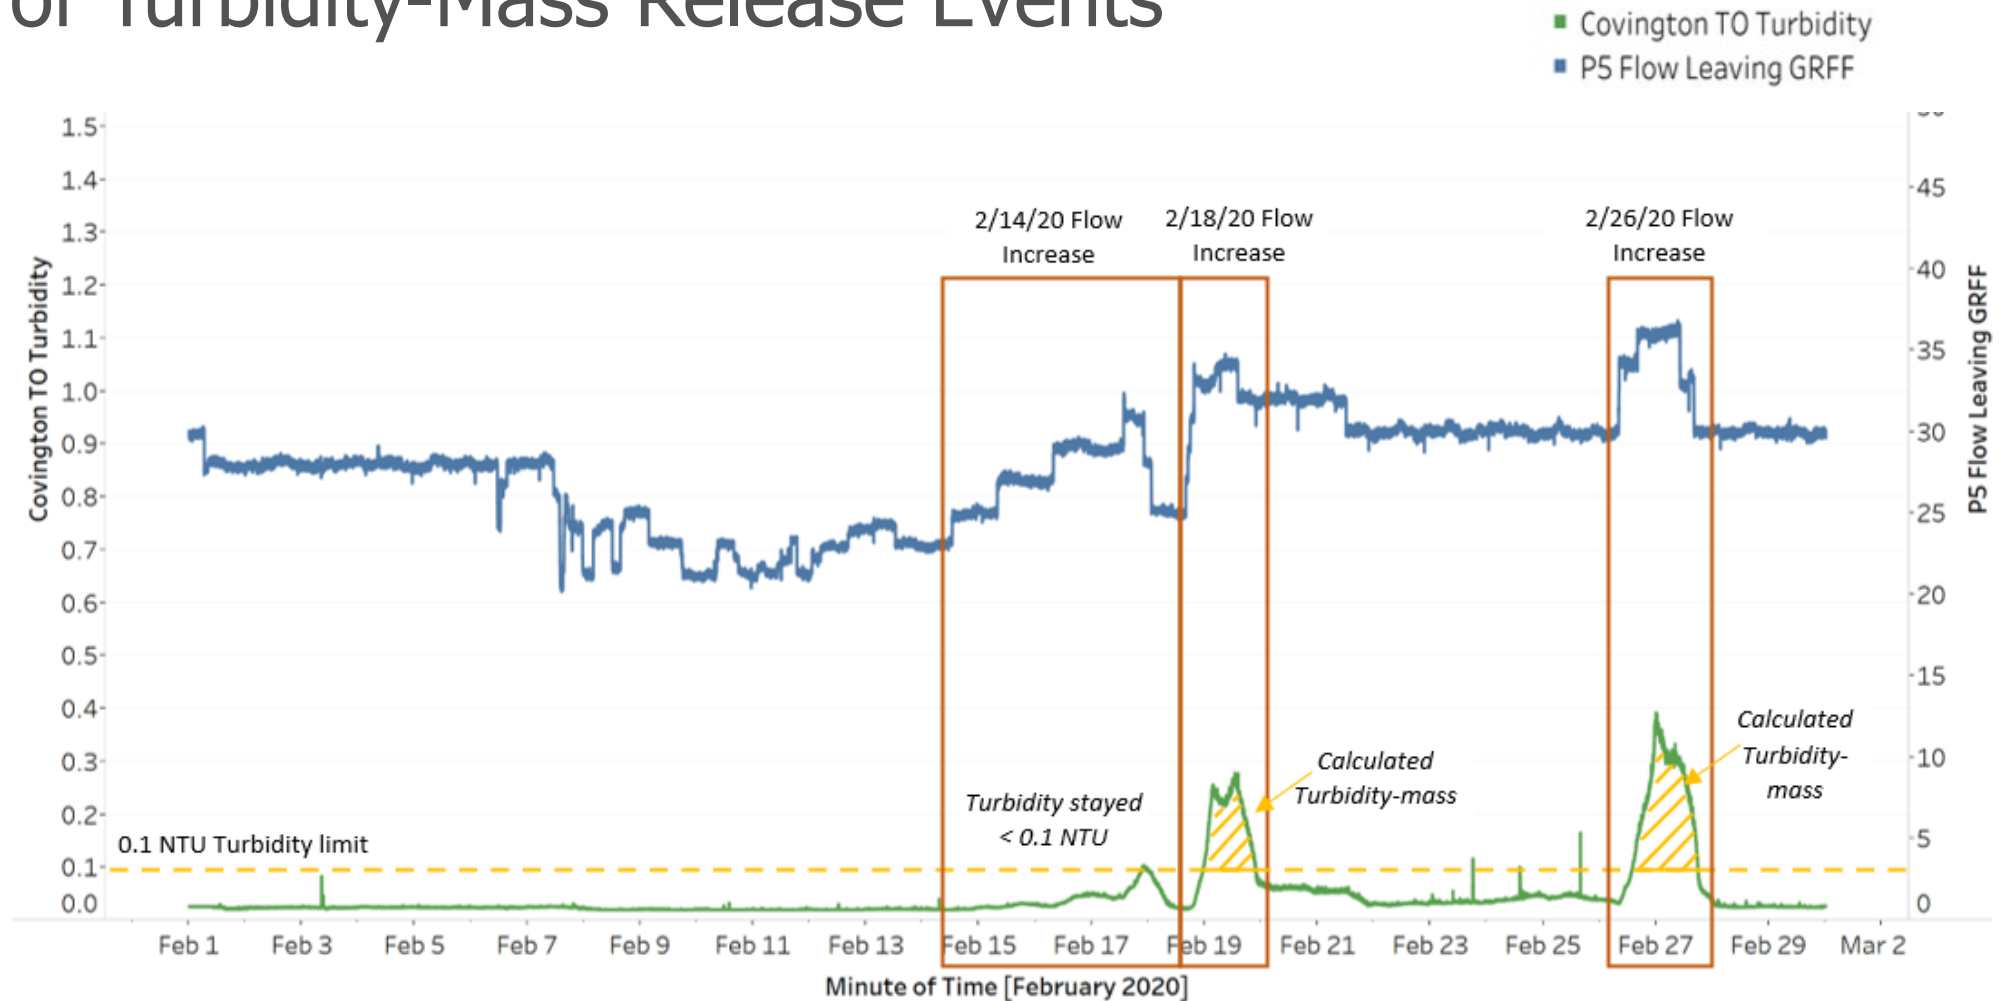
Evaluation of Turbidity-Mass Release Events

- Area under the turbidity-curve
- Calculated parameter:
NTU-reading x water volume (MG) each minute
- Represents the “mass” of material that traveled with the flow to CK and then to 356th
- Any spike > 0.1 NTU

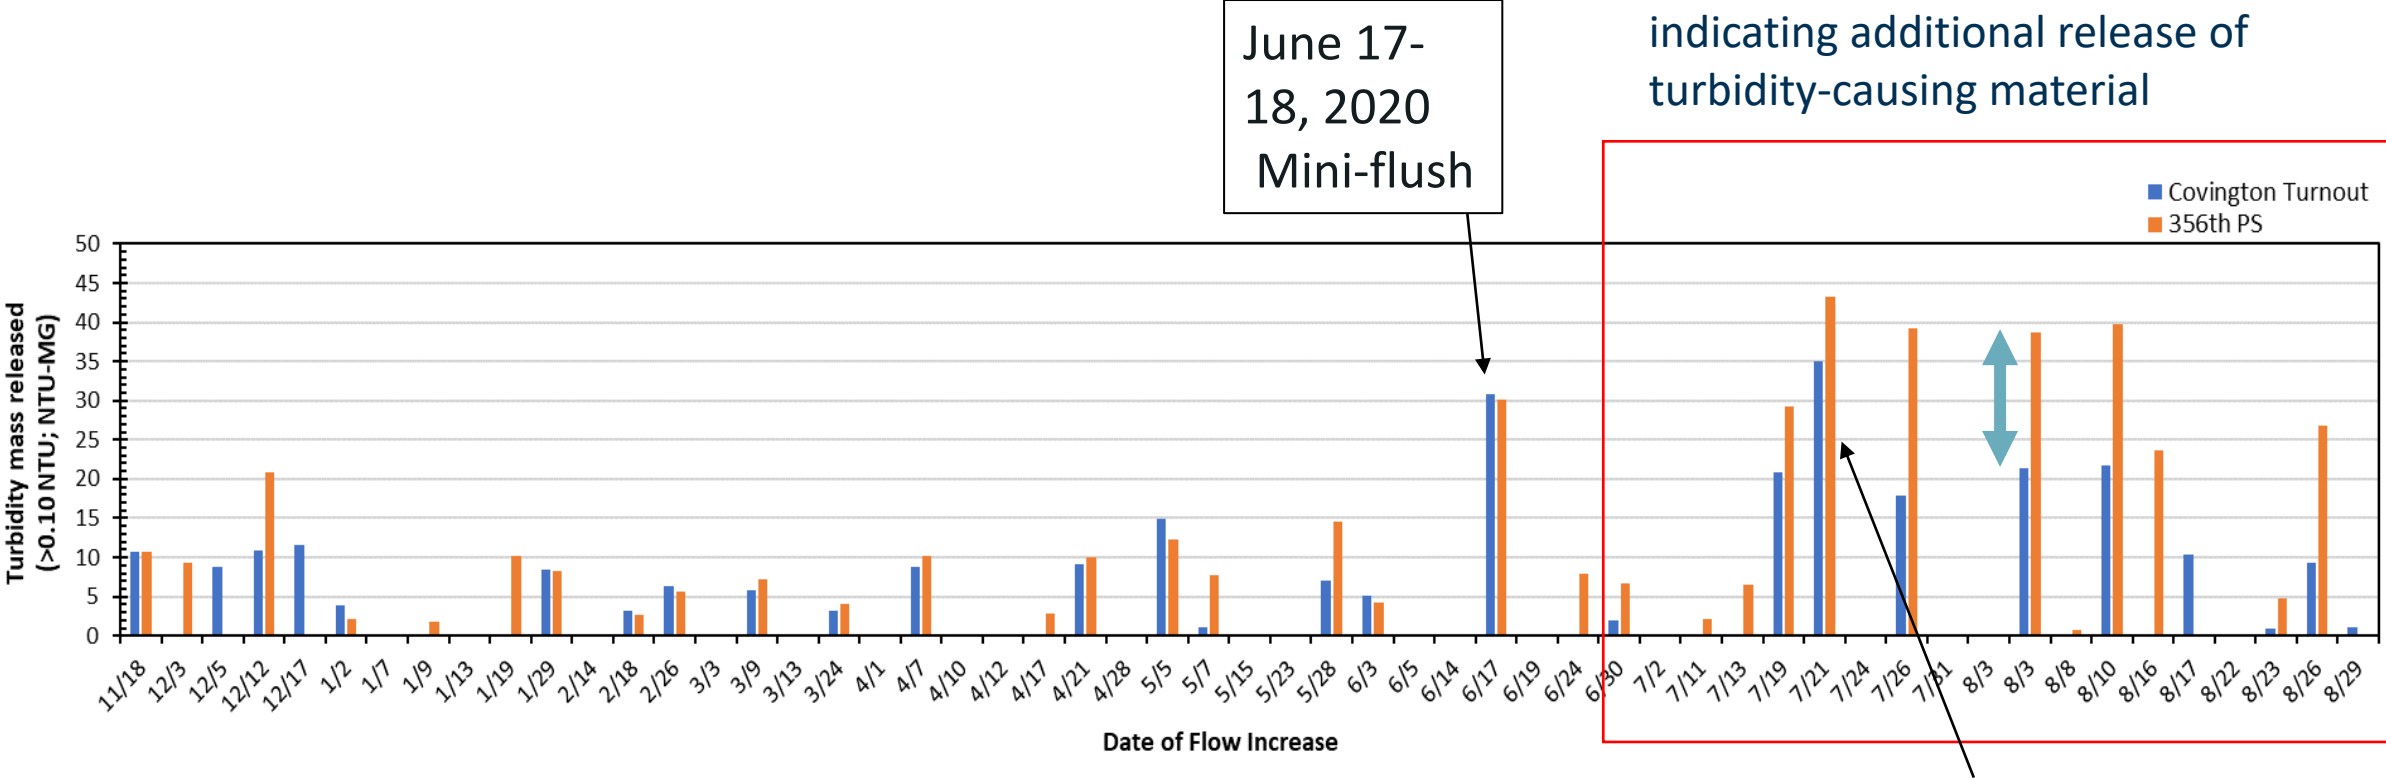
Evaluation of Turbidity Release Events

In summer, when flows > 40 MGD,
Turb-mass higher at 356th
indicating additional release of
turbidity-causing material

If material represented by the blue lines can be removed (originating in the 72" section of P5), the rest of P5 would only see the delta between orange and blue

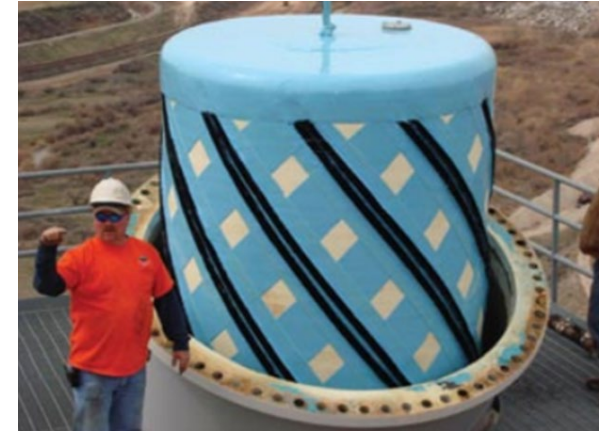
Flowmore Services, Houston, TX

- Cannot achieve cleaning shear force in 72-inch main
- Possible to provide some scouring of 48-inch main
- Can certainly release some material, but Mn is notoriously “sticky”
- Likely need physical cleaning of 72” section

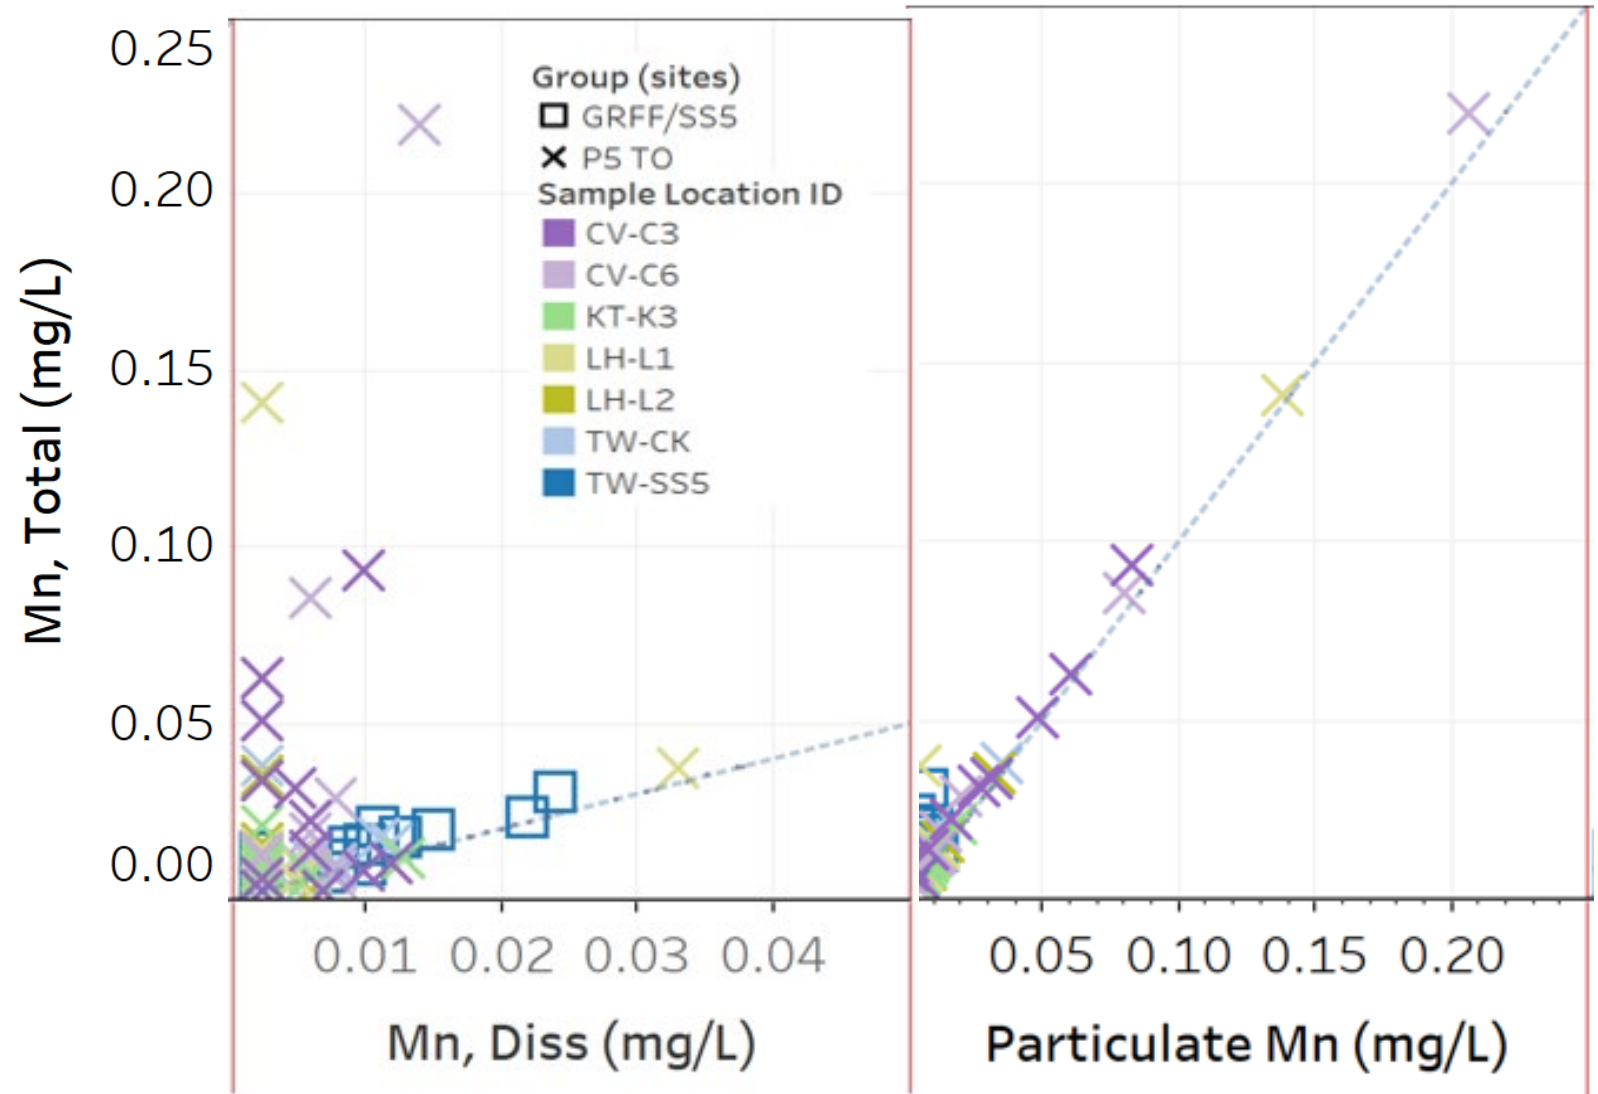
P5 Dissolved and Particulate Mn Results

- Mn tended to be in soluble form leaving plant
- Mn tended to be in particulate form along P5 and in DS
- Stable water chemistry
 - pH > 8.2 = promotes formation of particulate Mn(4+) species
 - Free chlorine residuals \geq 0.80 mg/L

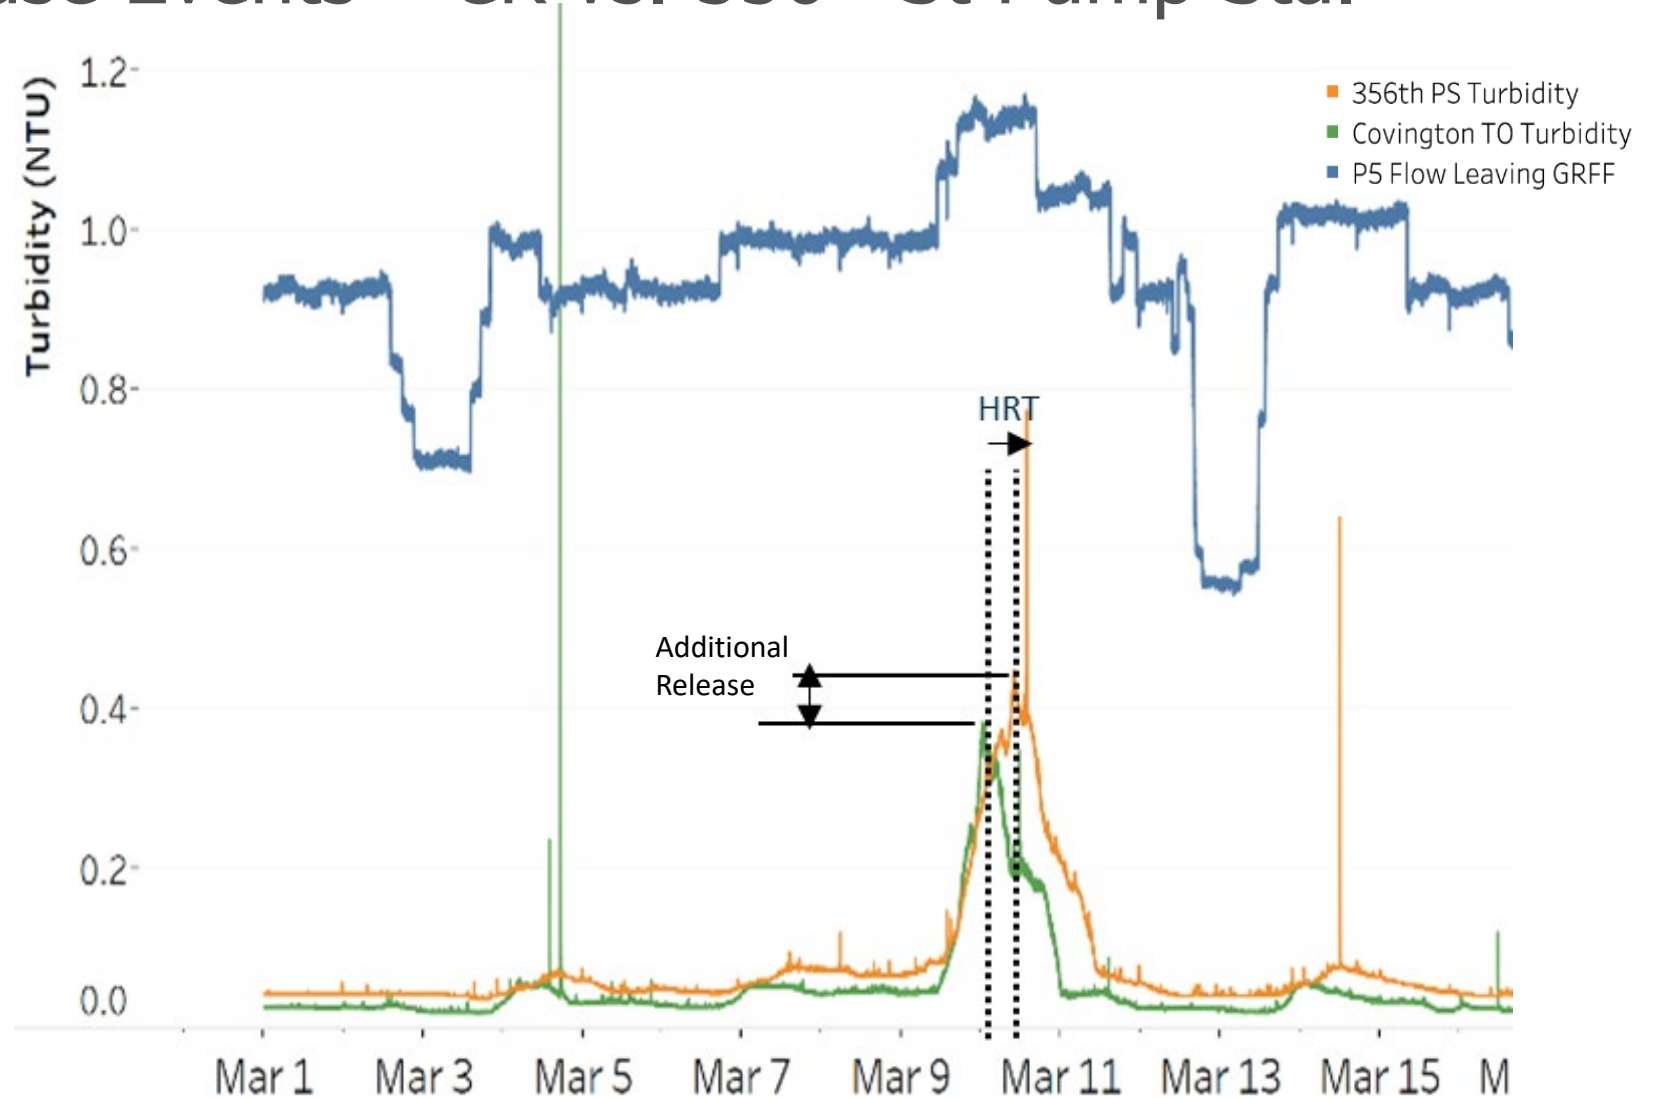
P5 Hydraulic Release Events – CK vs. 356th St Pump Sta.

- Flow increases often resulted in turbidity increase that traveled past CK
- Often traveled in plug-flow manner to 356th St. Pump Station
 - Peak of the turbidity spike typically incurred at close to hydraulic residence time between the sites
- Larger turbidity spikes at 356th indicate additional release from P5 between the two sites
